## Investigative Photographs

Peter Wentz  
Air Safety Investigator  
Eastern Region Aviation

ERA20FA012

October 26, 2020

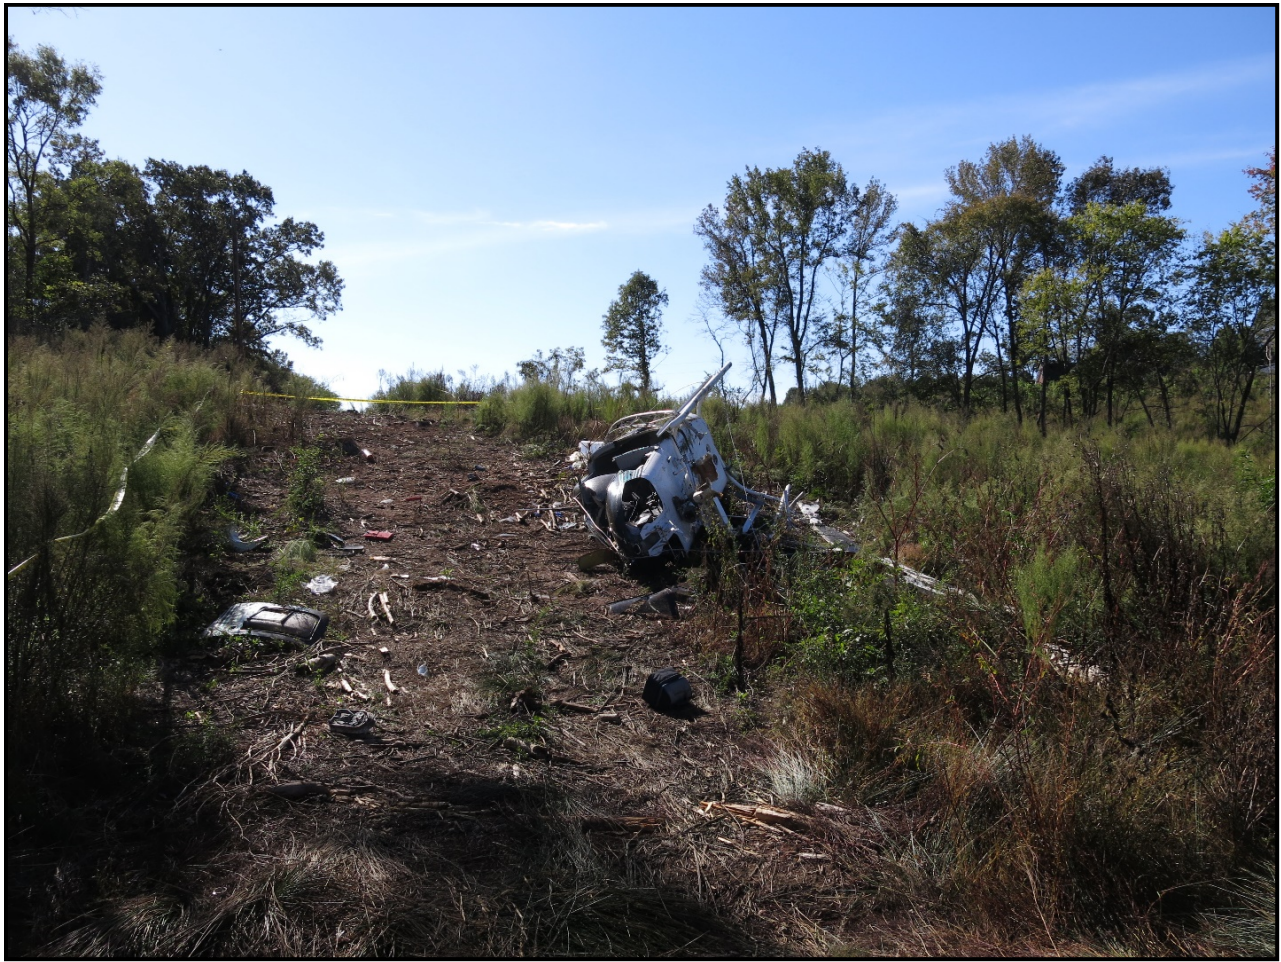
**Photograph 1 –Accident site.**

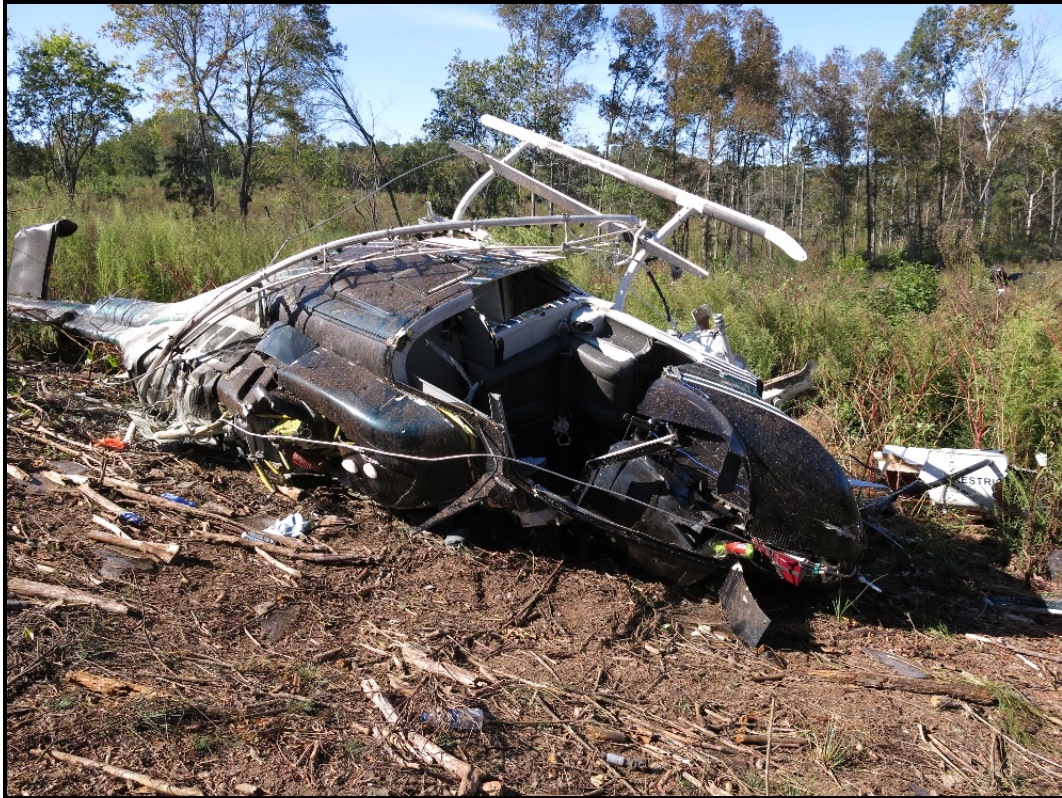
**Photograph 2 – Left side view of the accident helicopter.**

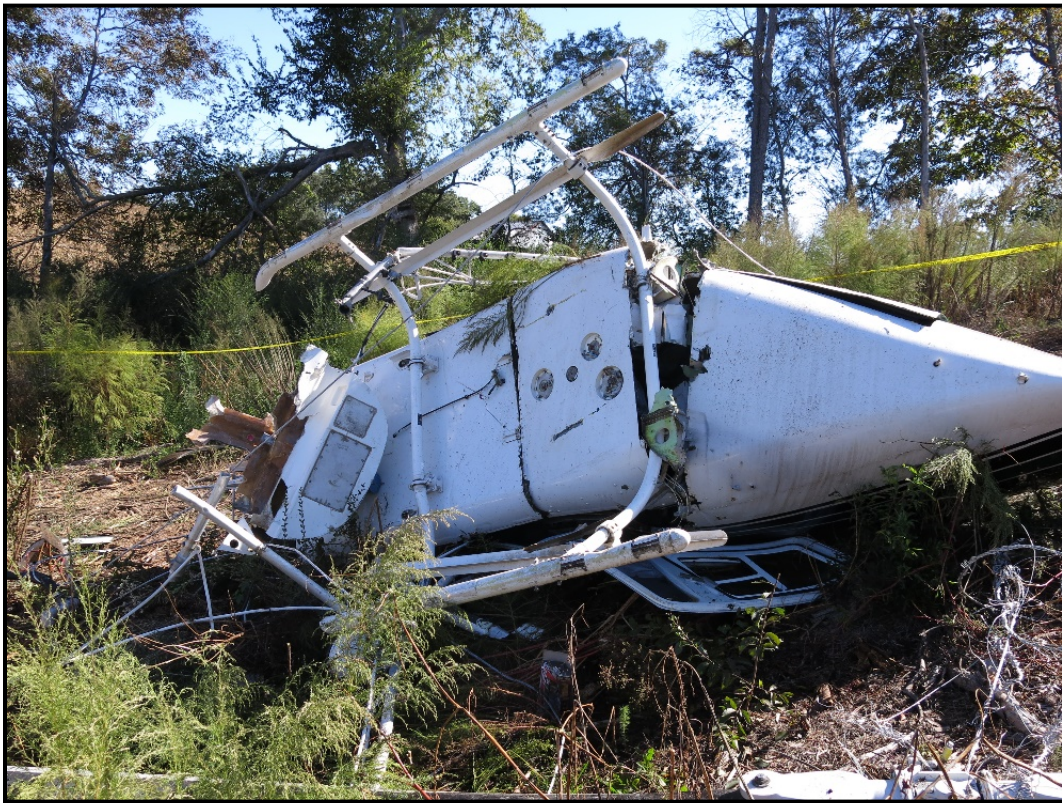
**Photograph 3 – Under side view of the accident helicopter.**

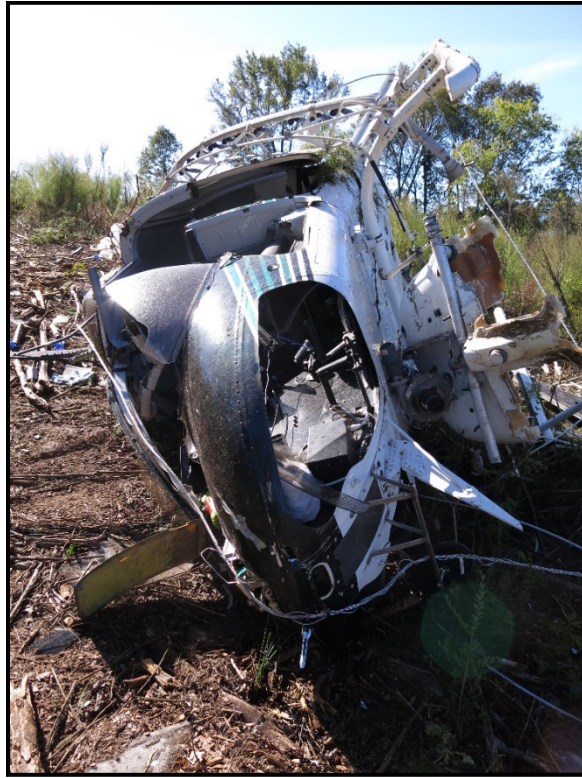
**Photograph 4 – Forward nose section of the accident helicopter.**

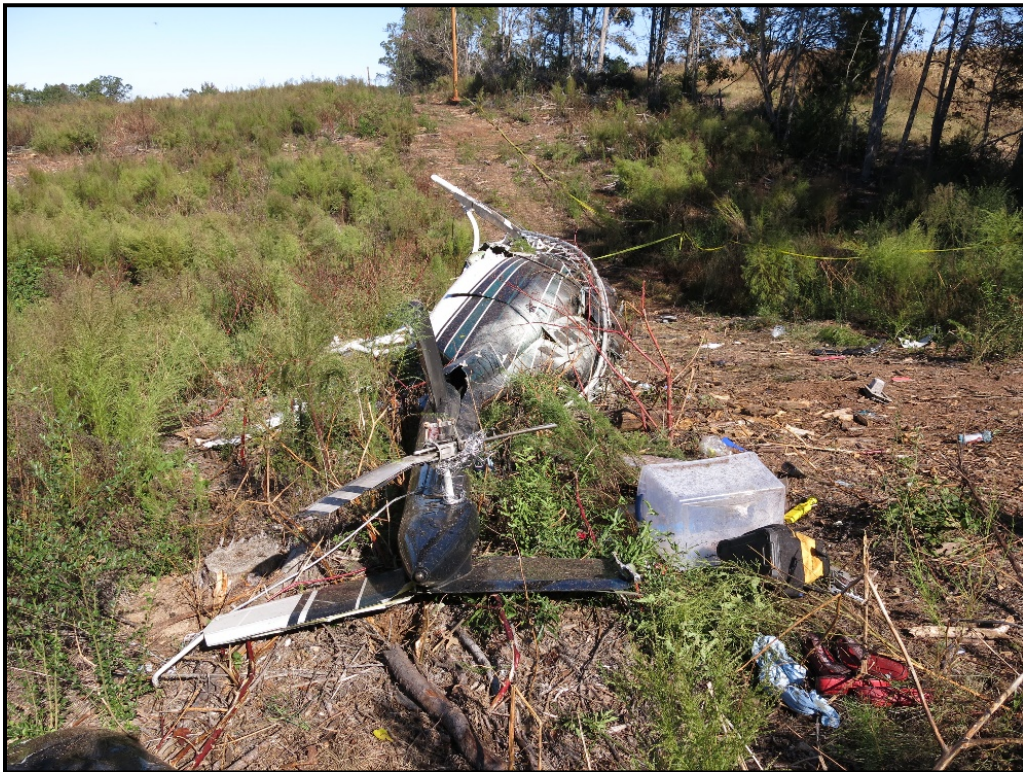
**Photograph 5 – Aft view of the accident helicopter.**

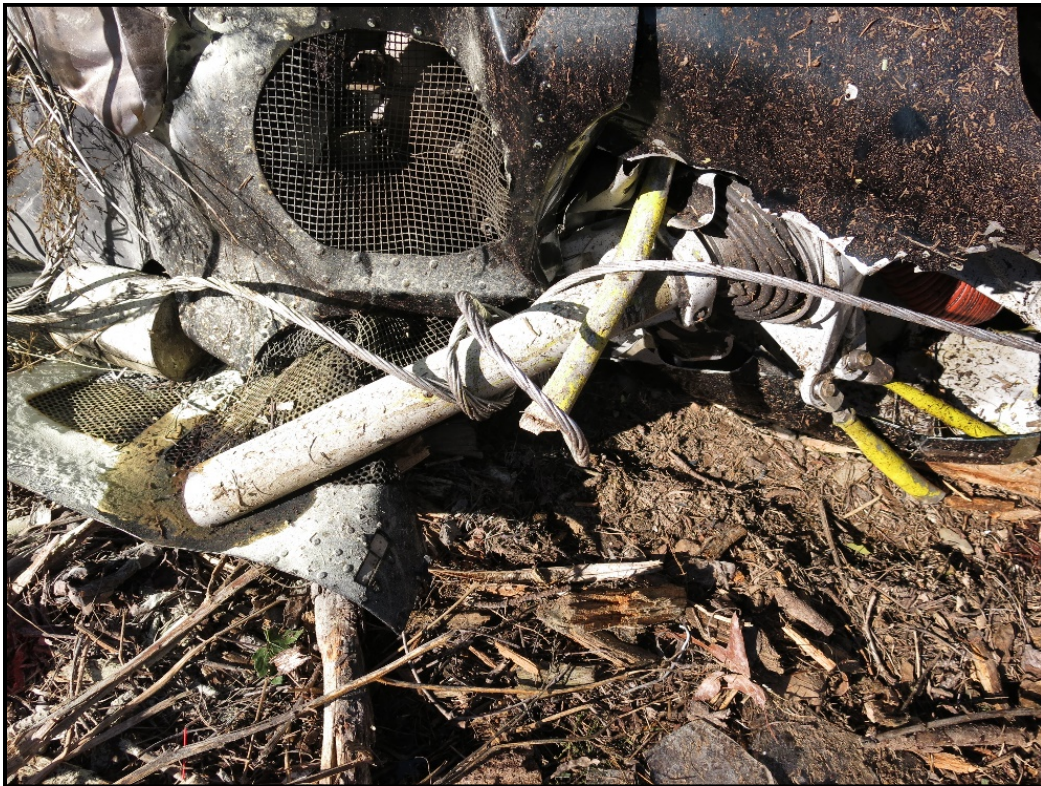
**Photograph 6 – Main rotor shaft.**

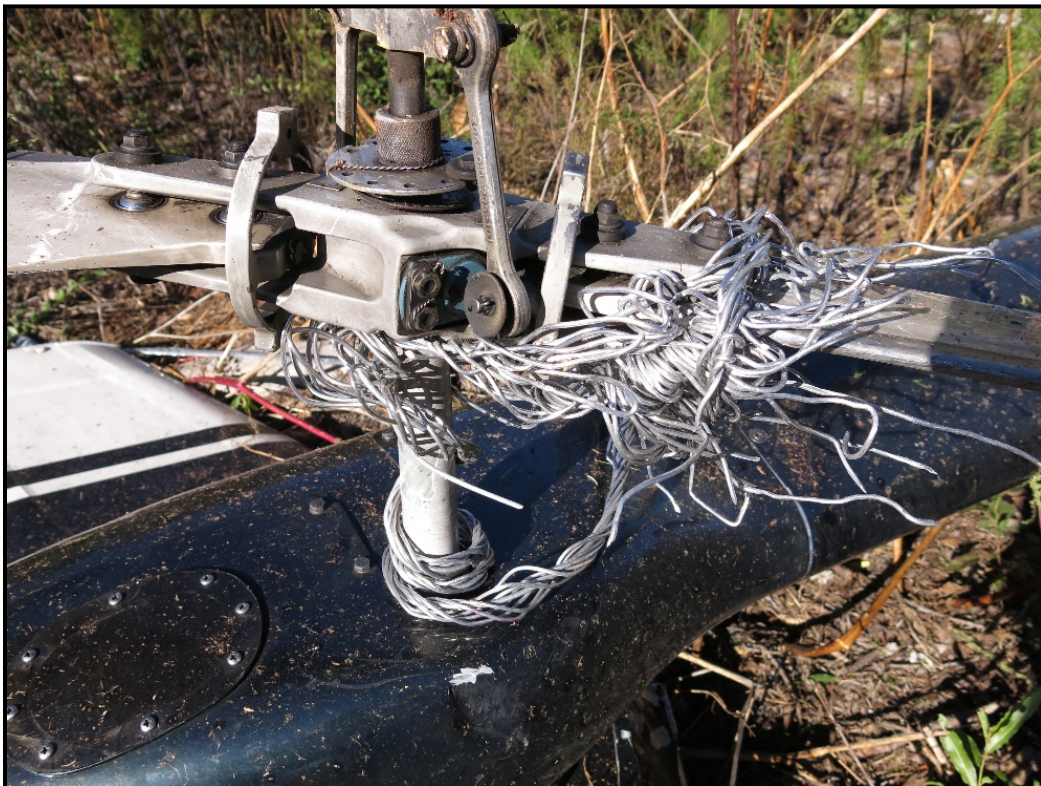
**Photograph 7 – Tail rotor.**

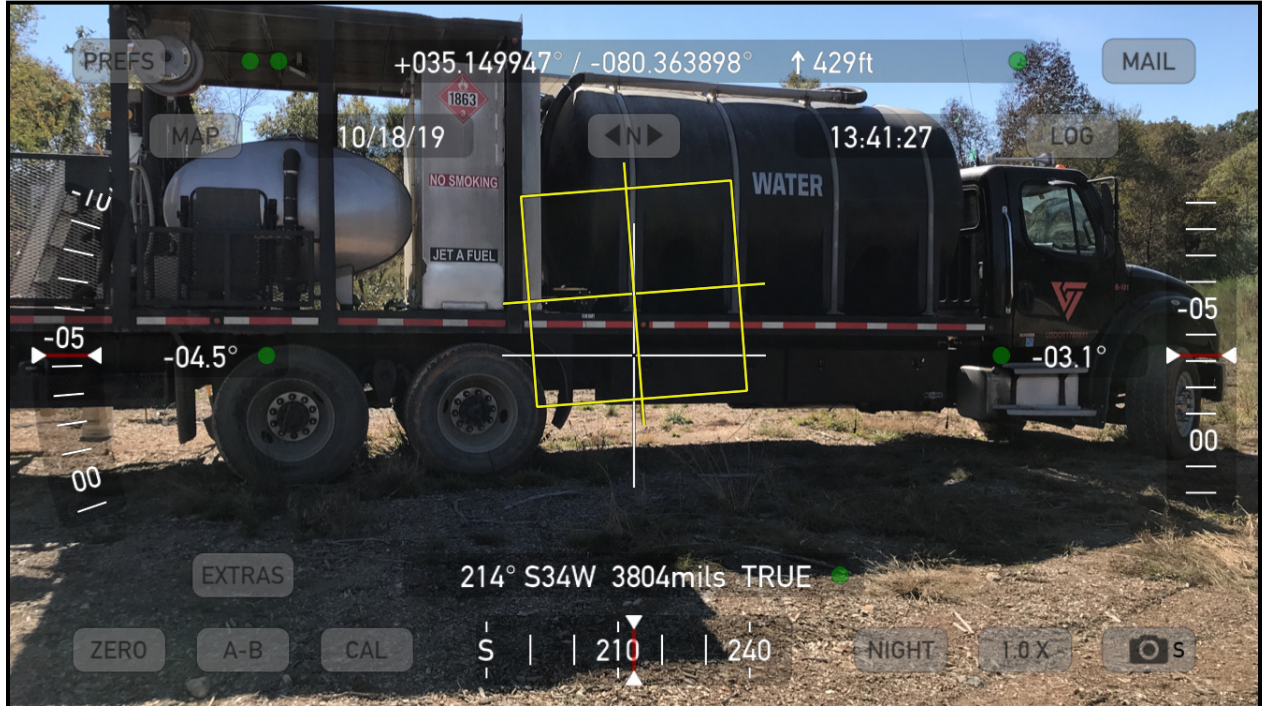
Photograph 8 – Fuel/chemical truck.

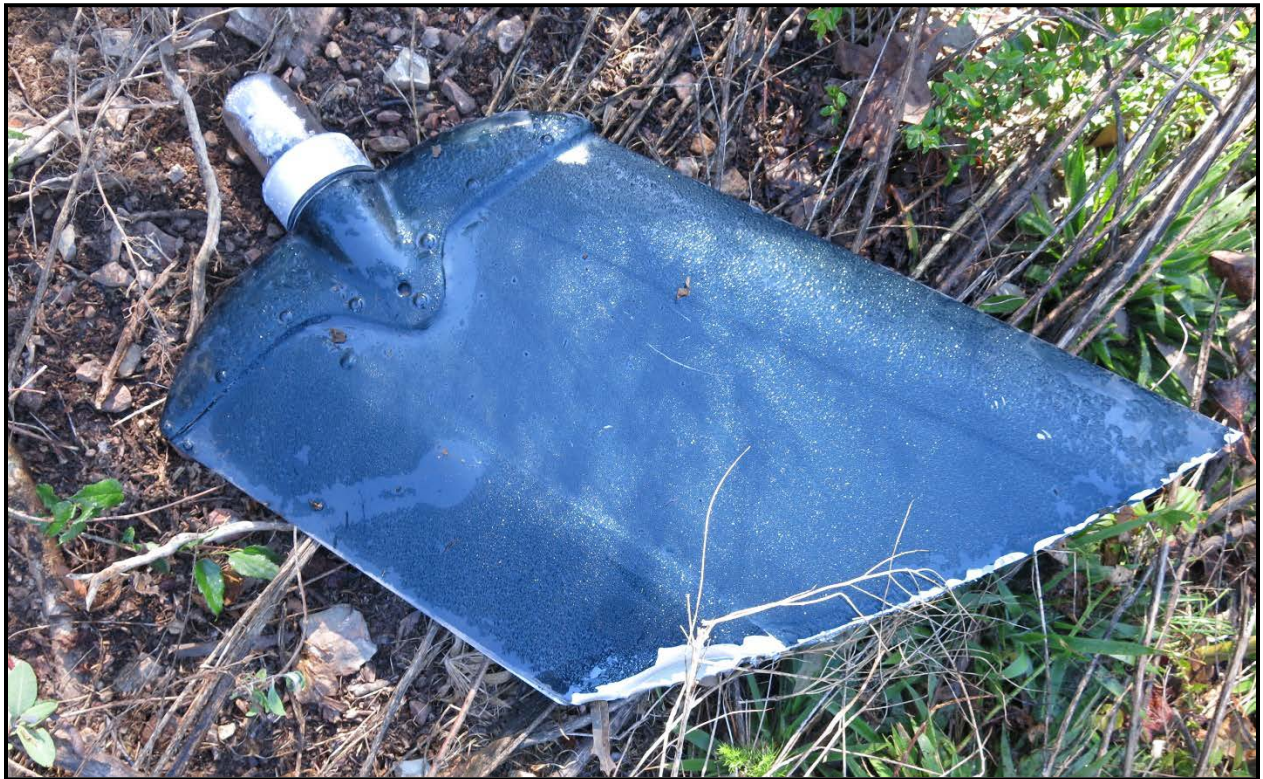
Photograph 9 – Top of vertical stabilizer.

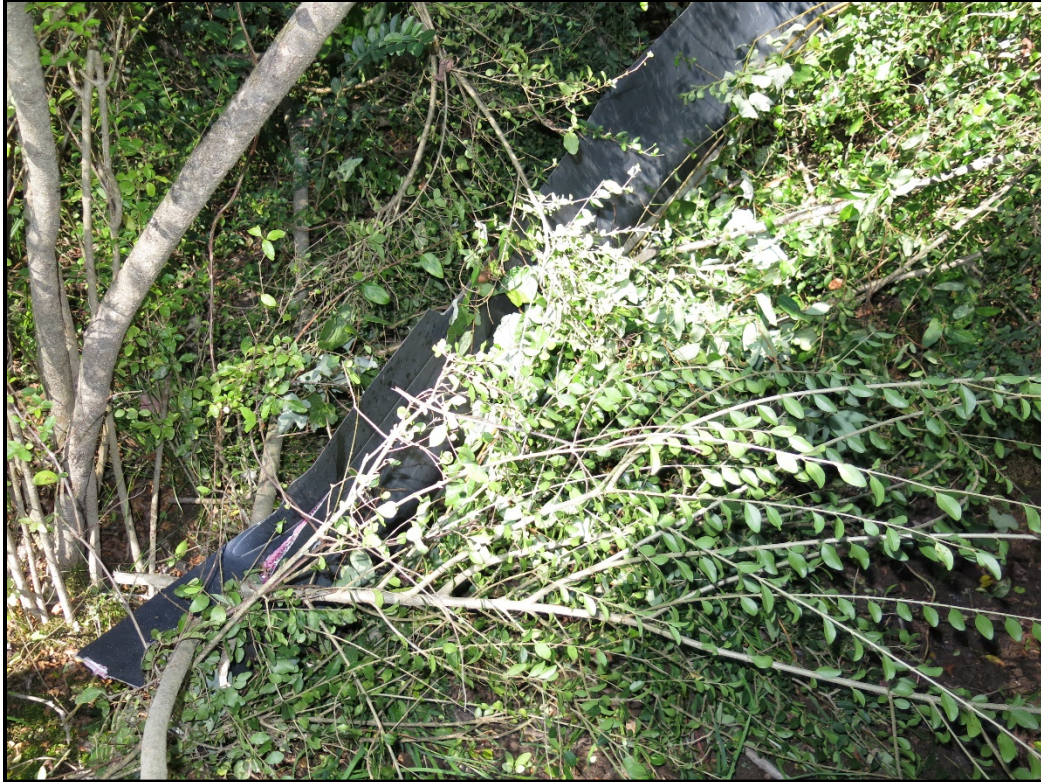
Photograph 10 – Detached rotor blade.

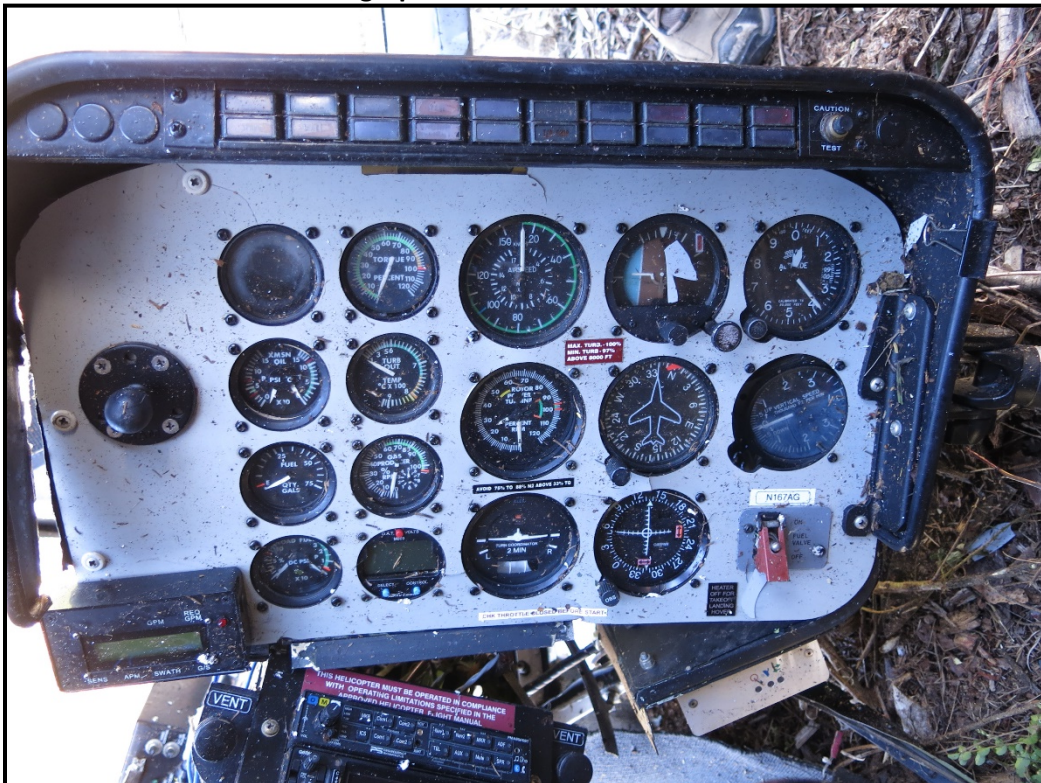
Photograph 11 – Helicopter instrument panel.
