**Douglass Brazy**  
**Air Safety Investigator**  
**Eastern Region Aviation**

**October 25, 2019**

**Subject:** NTSB investigation ERA20FA019, Mooney M20A, N8354E, Summit Point, West Virginia, October 24, 2019. Wreckage Examination

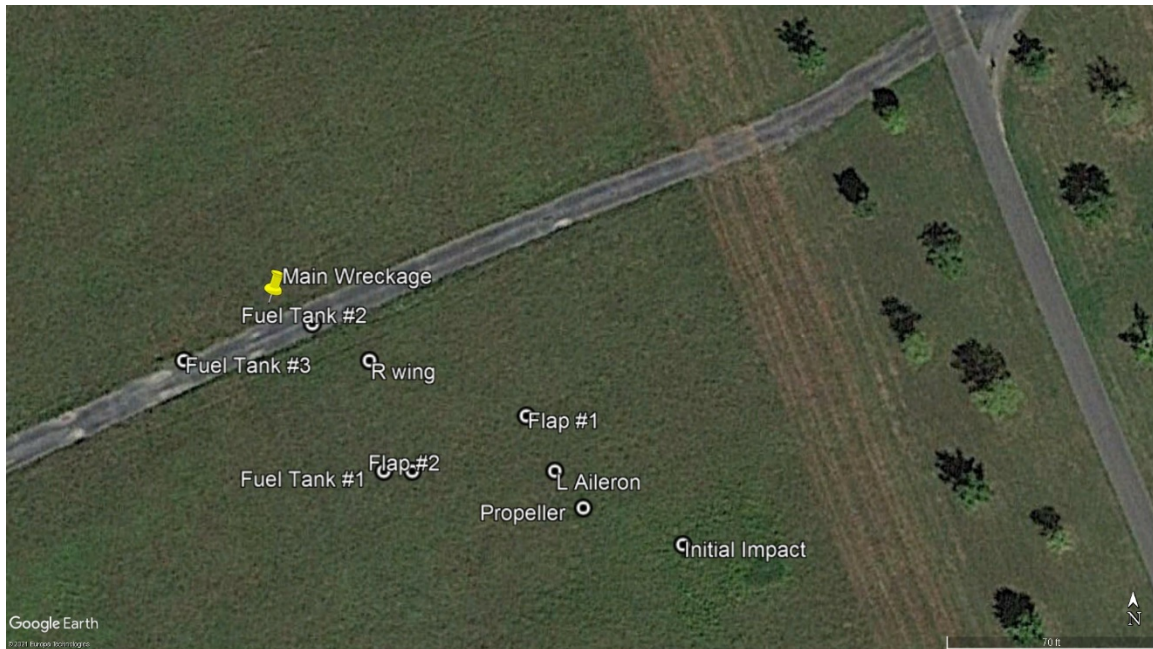
*Figure 1 Wreckage Diagram*

Examination of the accident site revealed that the airplane was partially consumed by a postimpact fire and the wreckage was spread over a 1.5-acre area of burned grass. All major components (or remnants of them) were present at the accident site. The debris path was 270 ft long and oriented on a heading of about 300° (true). The initial impact point was a 1.5 ft deep round crater with an 18 ft long impact mark radiating from the crater toward the left side of debris path. Small remnants of the left wing were found near the initial impact point. The left elevator tip weight was found about 5 ft along the debris path, 20 ft right of the path centerline. The propeller and hub were located about 40 ft along the path, on the centerline. Both propeller blades had a slight twist in them, one blade had some chordwise scratches on the front face at mid span, the other blade did not have any chordwise scratches. The spinner was crushed against the hub and was deformed in a twisted opposite the direction of propeller rotation.

Remnants of the right wing were found 130 ft along the path, about 30 ft right of centerline. The remnants were severely burned and primarily consisted of ash and wood fragments laid out in an outline of the wing and its structural components. The flap was separated and mostly consumed by fire. Most of the metal aileron control system push-pull tubes and bell crank remained in place from about near the wing root to the aileron horn. The right main landing gear was mostly intact and found in its retracted position.

The main wreckage was located 170 ft along the path on the centerline and was oriented on a heading of 281°. Only rear section of the airplane aft of the rear seat remained largely intact.

Burned remnants of the left wing, which consisted of the main landing gear, a portion of the wooden wing spar, and most of the aileron control system were found separated from each other near the right side of the main wreckage. The flight control tubes for the elevator, rudder, and trim system remained intact from the rear seat area to the control surface horns. Most of the airplane forward of the rear seat was consumed by fire or severely burned. The engine and forward section of the fuselage was found in place relative to the empennage but were inverted. The nose landing gear struts and axle were found in the retracted position; the tire and wheel were consumed by fire. Most of the cockpit panel and instruments were heat damaged and partially consumed by fire. Three steel weights, of the type used on farm tractors for counterbalance, were found near the remnants of the rear seat frame. Each weighed 44 pounds.
