# AIRFRAME AND ENGINE EXAMINATION REPORT

**NTSB ACCIDENT NUMBER: ERA20FA020**

AIRCRAFT REGISTRATION: N959MJ

ACCIDENT LOCATION: Colonia, New Jersey

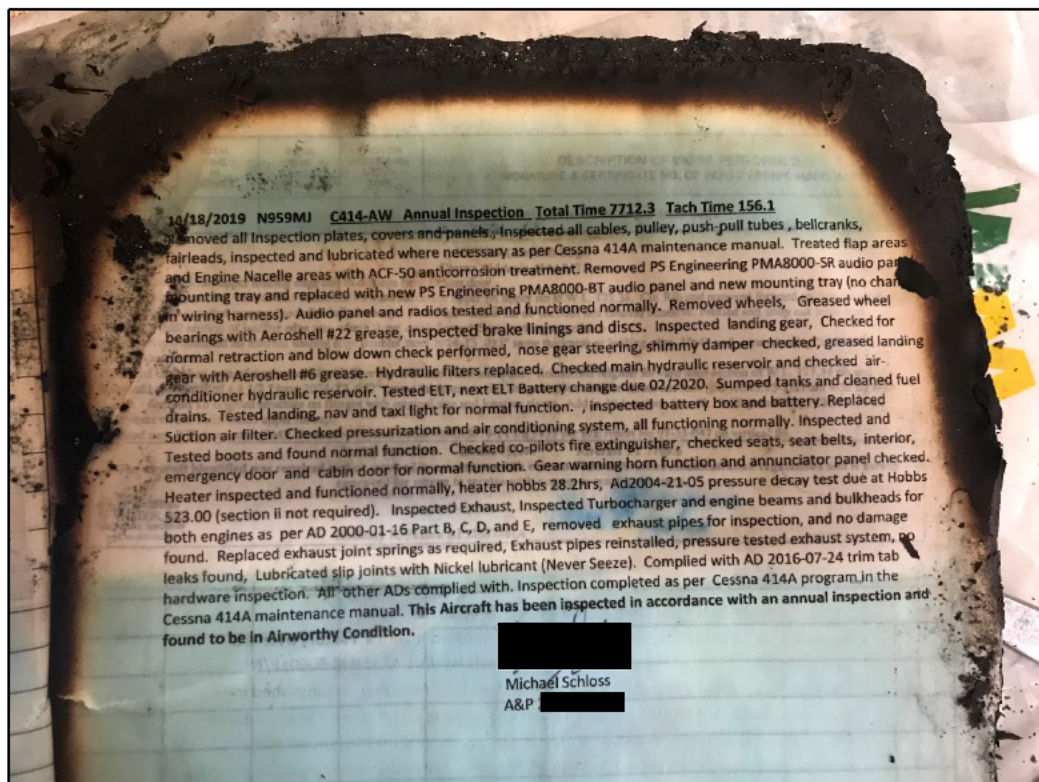
Photo 1: Annual inspection, airframe logbook maintenance record entry.

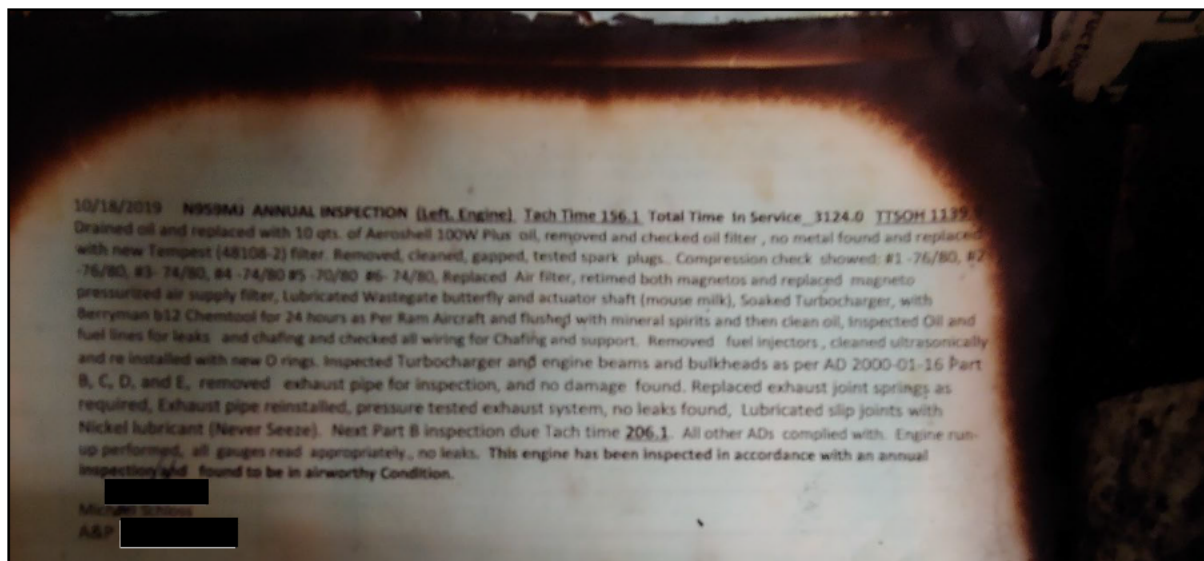
Photo 2: Annual inspection, left engine logbook maintenance record entry.

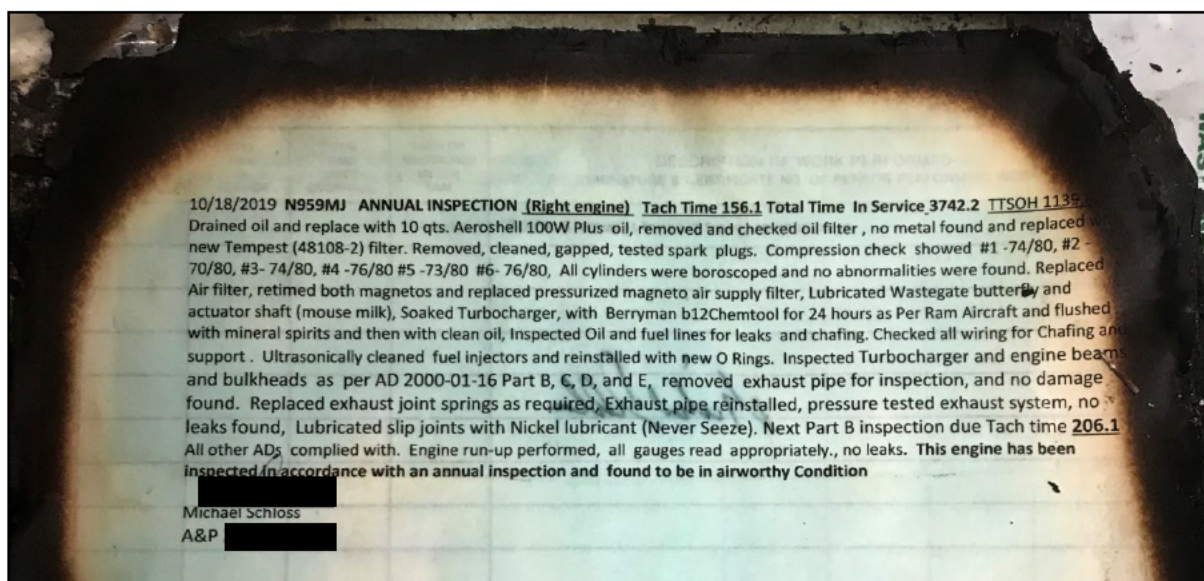
Photo 3: Annual inspection, Right engine logbook maintenance record entry.

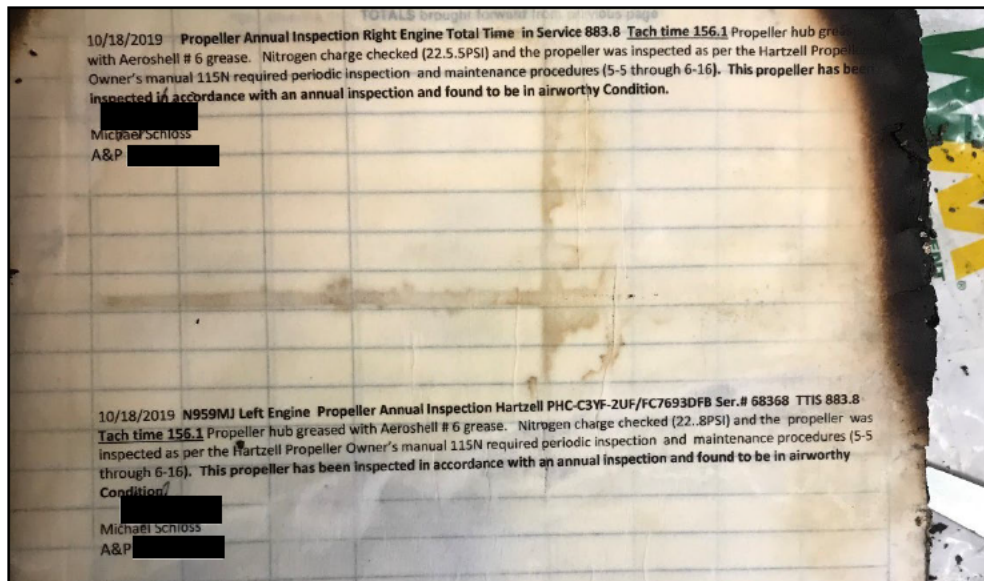
Photo 4: Annual inspection, left and right propeller logbook maintenance record entry.

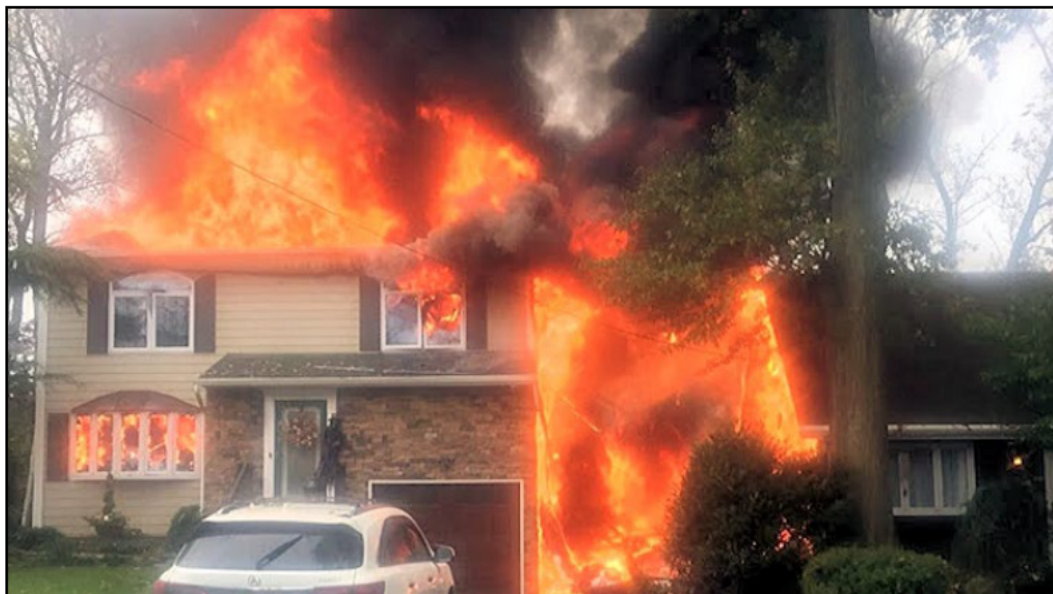
The main wreckage was located in the basement of a residential home about 3 nautical miles southwest of the Linden, New Jersey airport; the airplane sustained significant impact and thermal damage as a result a post-crash fire and was destroyed.

Photo 5: Photo of the residential home the airplane impacted (Courtesy of FAA).

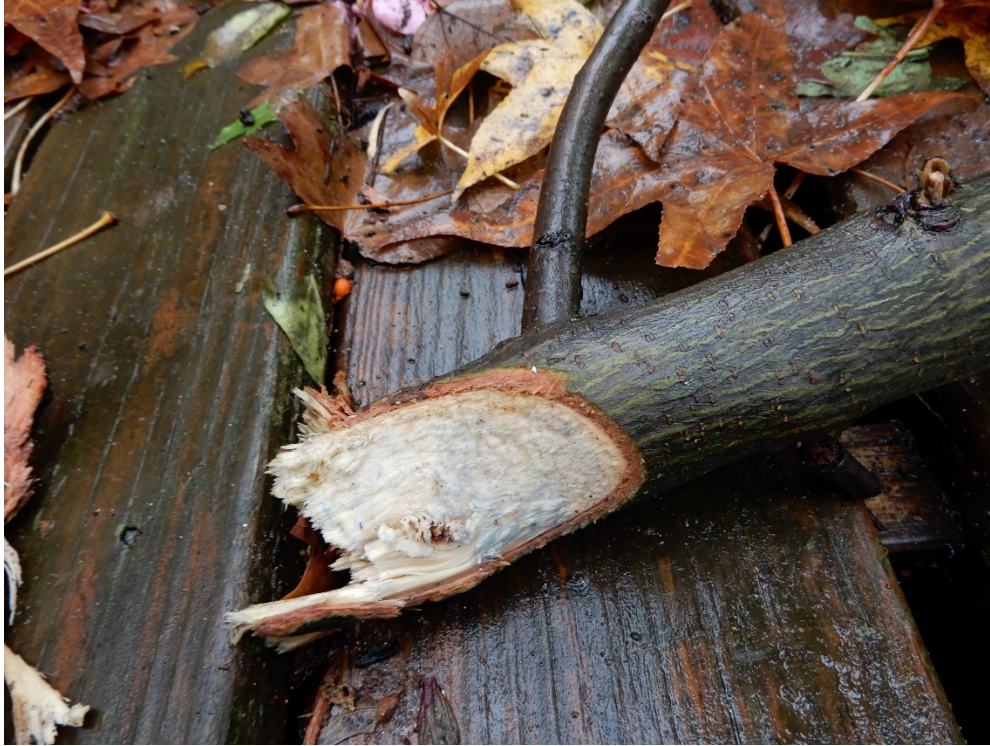
The initial impact point was observed to coincide with large broken tree branches about 40 ft from the main wreckage; the wreckage path was oriented on a true heading of 278°. Multiple trees branches located below and near the initial impact exhibited clean cut surface areas.

Photo 6: One of several clean-cut tree branches, found below the initial impact area.

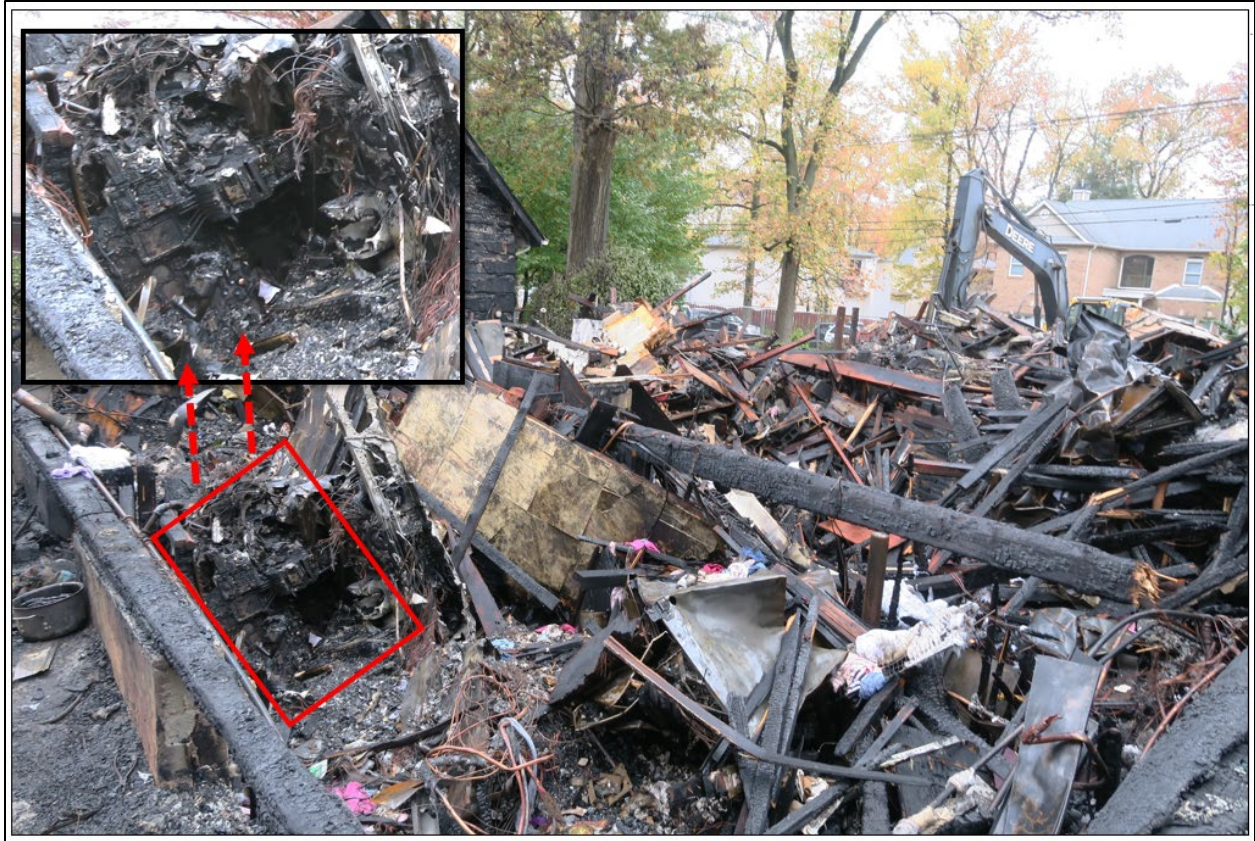
The largest piece of wreckage was the forward cabin area from the instrument panel to just aft of the pilot seat tracks.

Figure 3: The cockpit/ forward cabin area, denoted by the red box. The pop-out photo represents a closer view of the cockpit area.

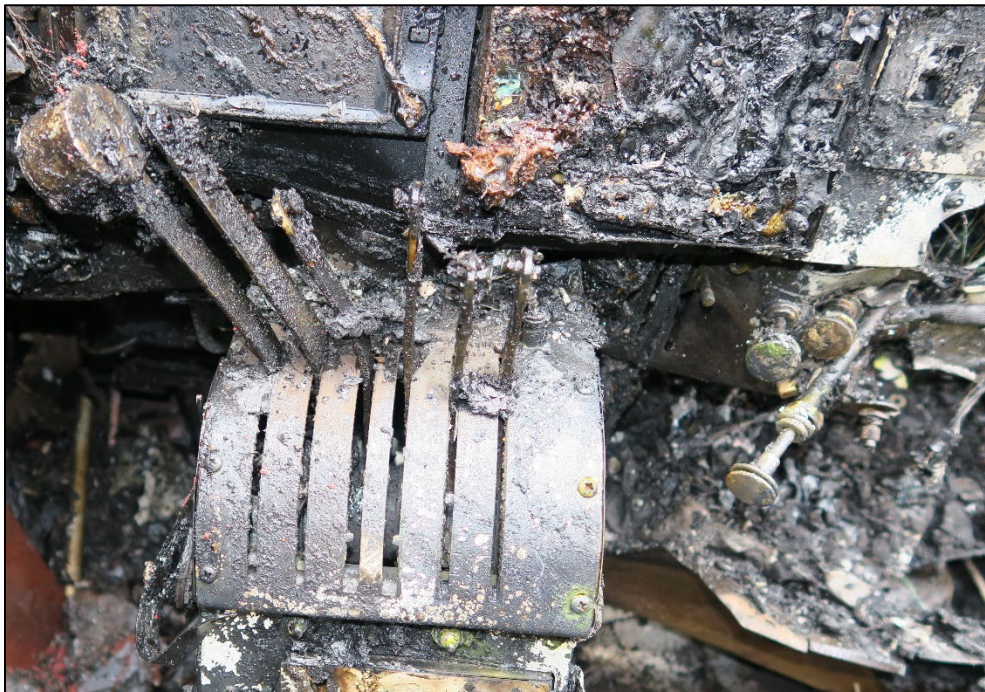
Photo 7: The throttle, mixture, and propeller control quadrant.

The fuselage crown skin and the majority of the right side of the instrument panel were consumed by fire. The throttle, mixture, and propeller control levers were found full forward. Several of the instruments in the left side of the panel sustained thermal damage. The nose cone was observed separated from the nose section; it did not appear to sustain significant impact damage and largely retained its shape.

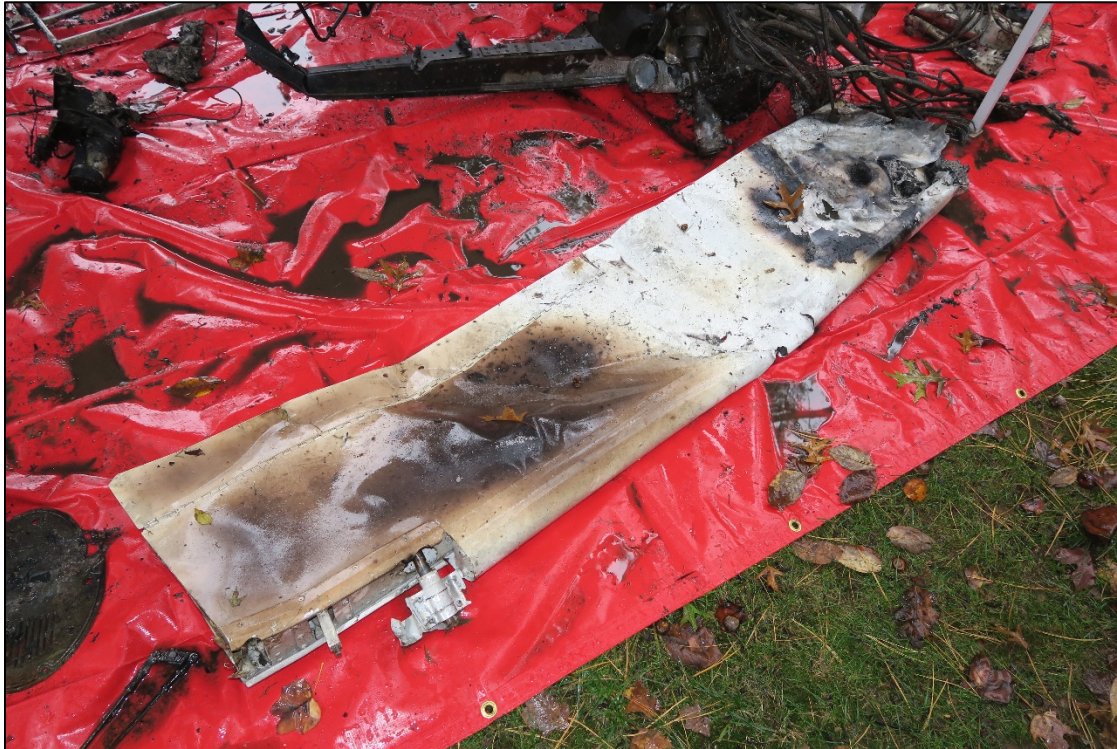
The majority of the left and right wings were consumed by the post-impact fire. The left aileron, with aileron trim tab attached, had separated from the wing and sustained minor thermal damage on the upper skin surface near the inboard end. The aileron trim tab actuator was extended approximately 1.8" which was beyond the normal maximum trailing edge up travel limit of 21°.

Photo 8: View of fragmented flight control surface

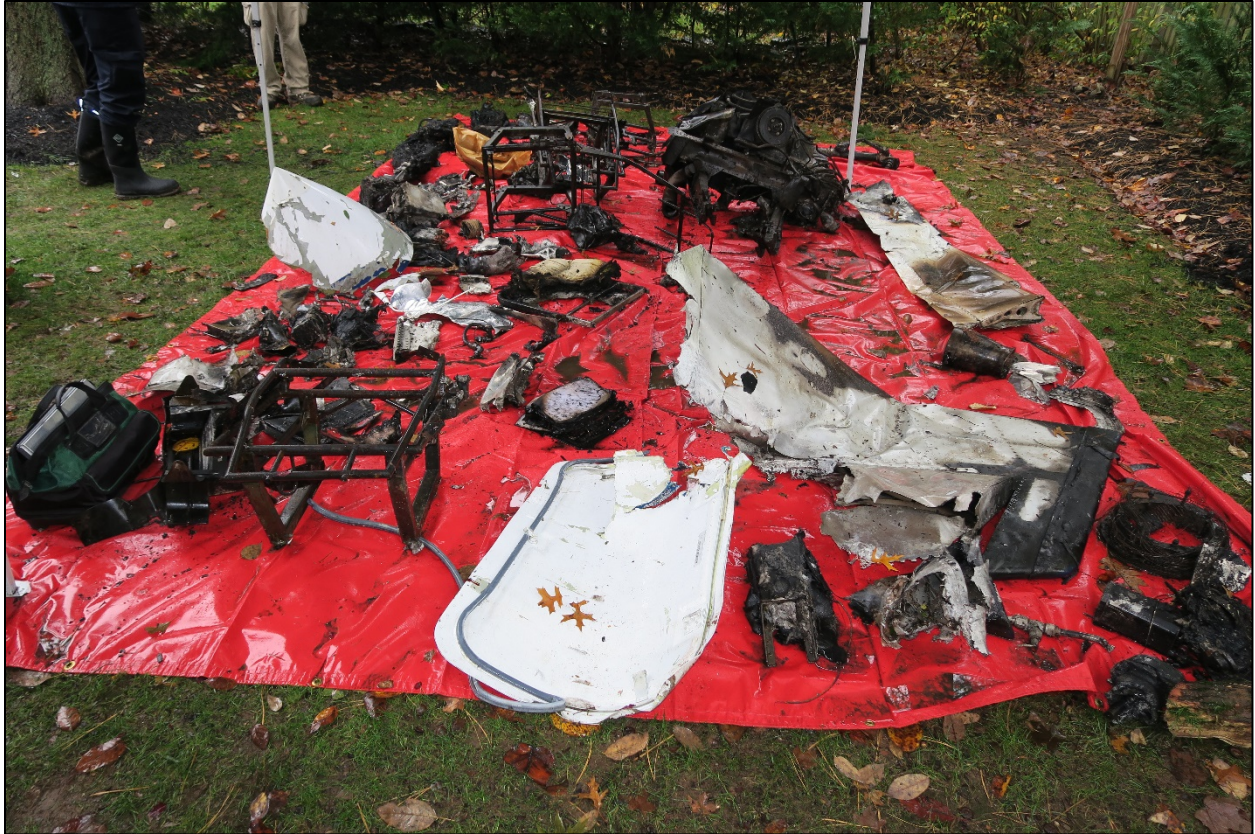
An approximately 4 ft long section of the top of the rudder and approximately 2 ft of the upper portion of the vertical stabilizer were impact separated from the fuselage. The lower portion of the vertical stabilizer, rudder, and the left and right horizontal stabilizers were consumed by fire. An approximately 2' long section of the outboard left elevator was recovered; it sustained impact and thermal damage. The right elevator and elevator trim tab were not observed.

Photo 9: Overview of airframe fragments located in debris

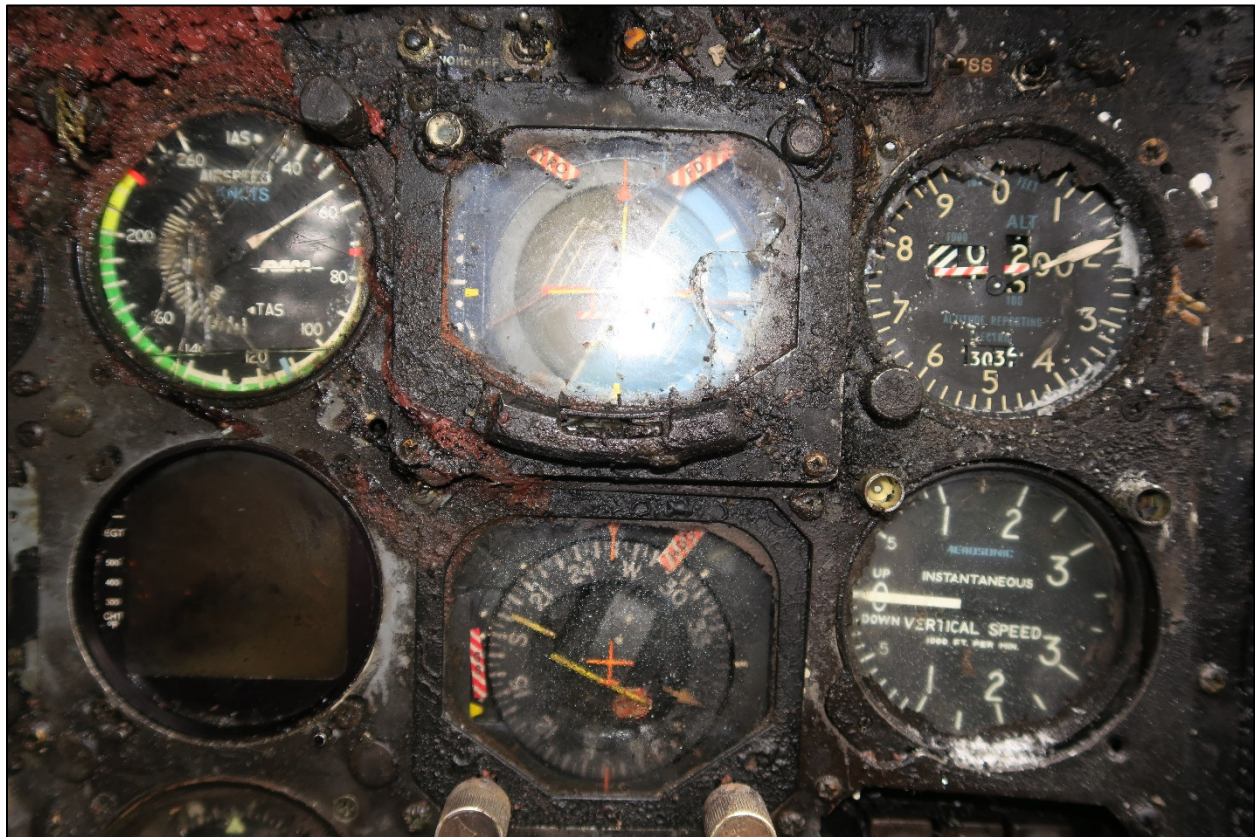
soot. The airspeed indicator was found indicating about 55 knots. The primary attitude indicator was found displaying a 120° left roll, and the pitch indicated a 5° pitch up. The altimeter was set to 30.31 inches and indicated 200 ft.

The primary heading indicator was found indicating a heading of 260°, and the course was set to 010°. The heading bug was found set to 050°. The vertical speed indicator was found to indicate 0 feet per minute. The course deviation indicator was found indicating that the airplane was left of course.

Photo 10: View of the primary flight instruments located on the left side of the cockpit.

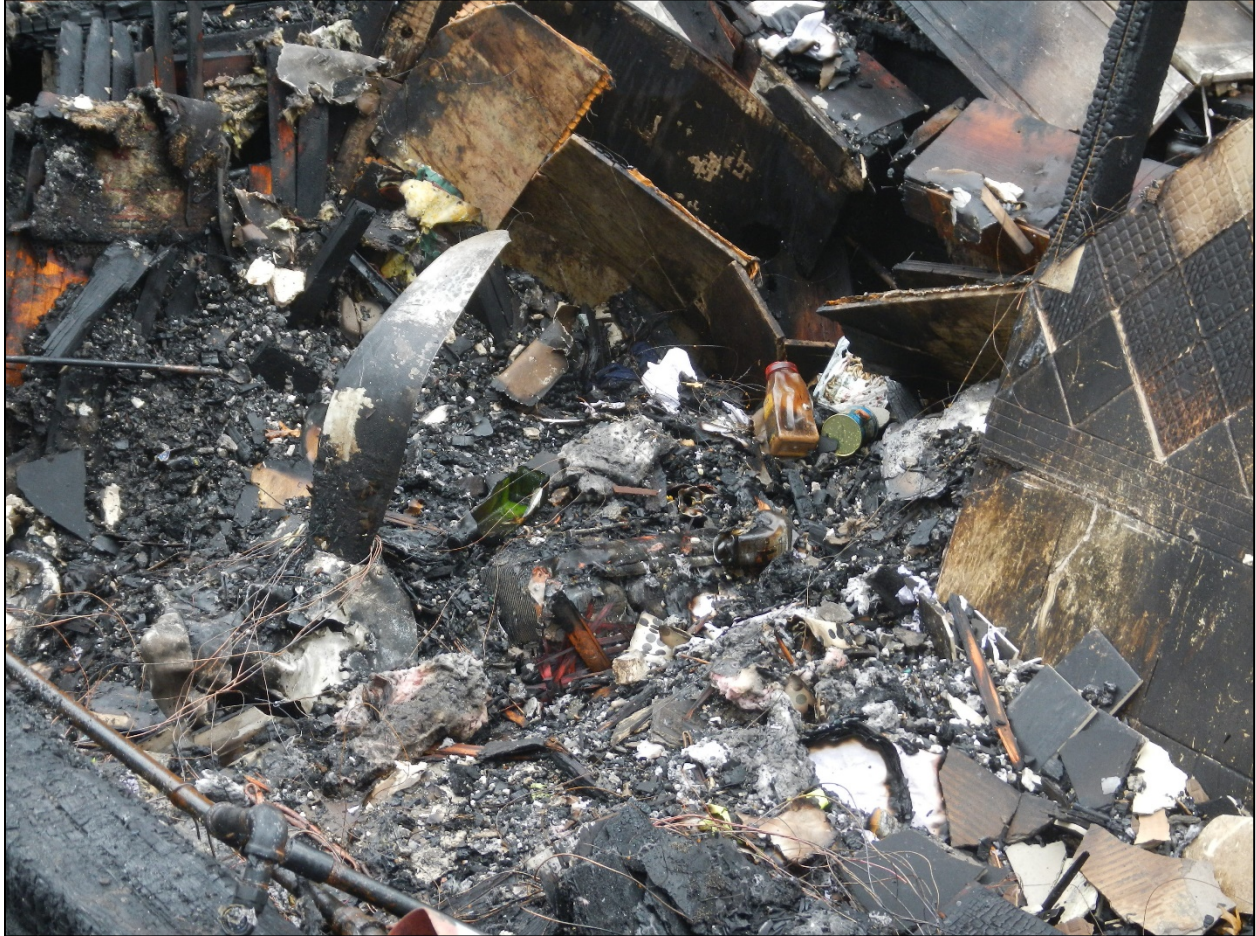
The engine was located in the basement of the house forward of the main wreckage. The engine was impact separated from the airframe and exhibited impact and thermal damage.

Photo 11: View of the propeller and engine buried in housing debris.

The 3-bladed propeller remained attached to the propeller hub; one blade had fragmented about 1/3 of its span, the two other blades remained intact and displayed chord-wise scratching, torsional twisting, and s-bending.

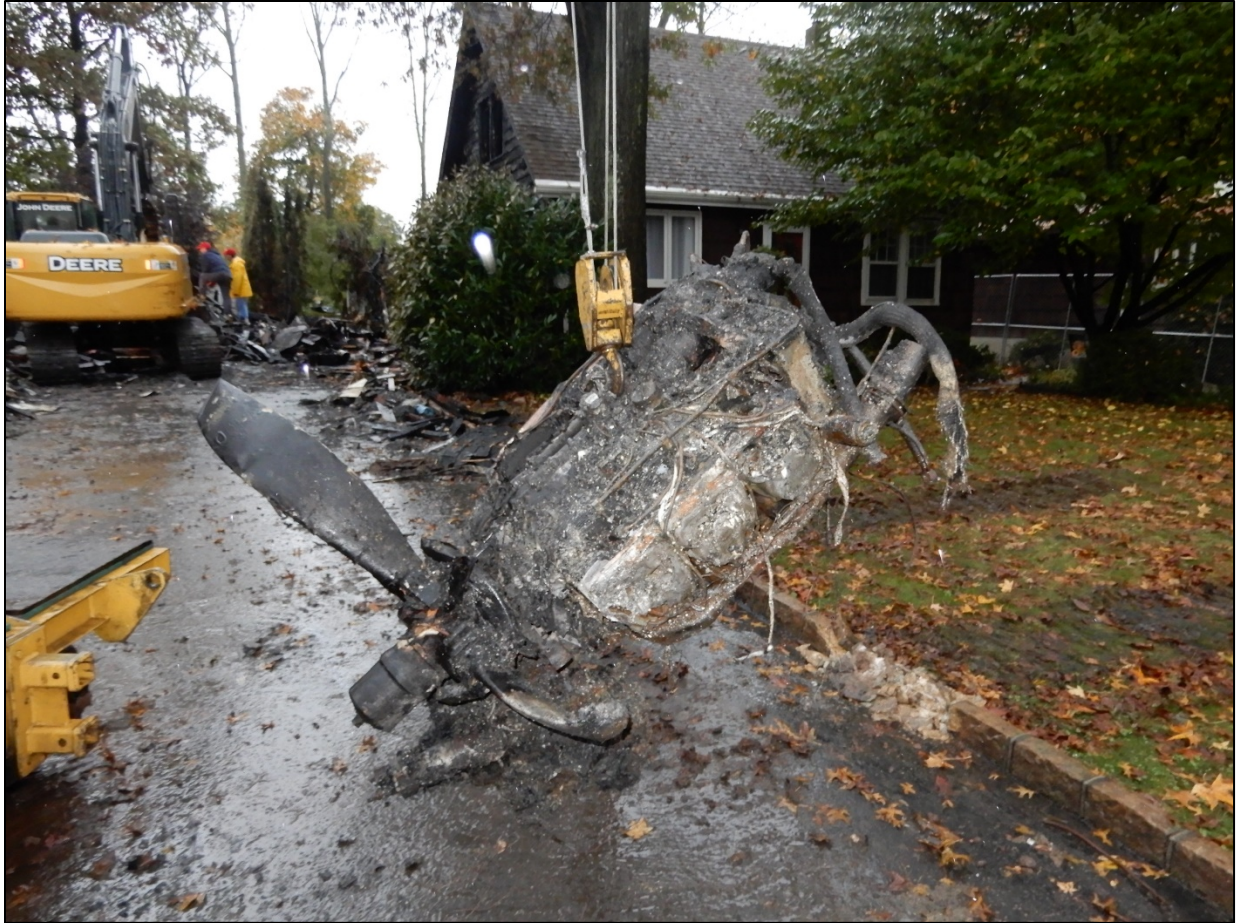
Photo 12: View of left engine being hoisted away from the housing debris.

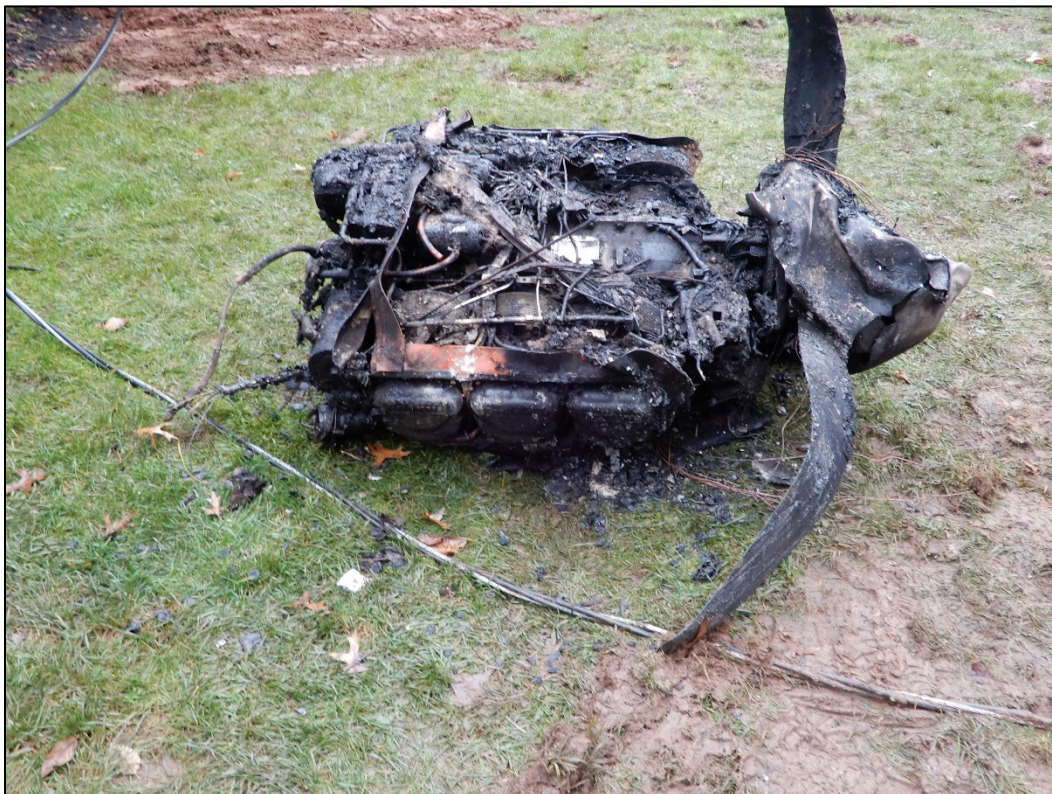
The left engine was located in the basement of the house, under the fuselage wreckage. The left engine exhibited impact and thermal damage.

Photo 13: View of the left engine after removal from the housing debris
