## **NATIONAL TRANSPORTATION SAFETY BOARD**

### **Specialist's Factual Report**

# **AIR TRAFFIC CONTROL**

ERA20FA027

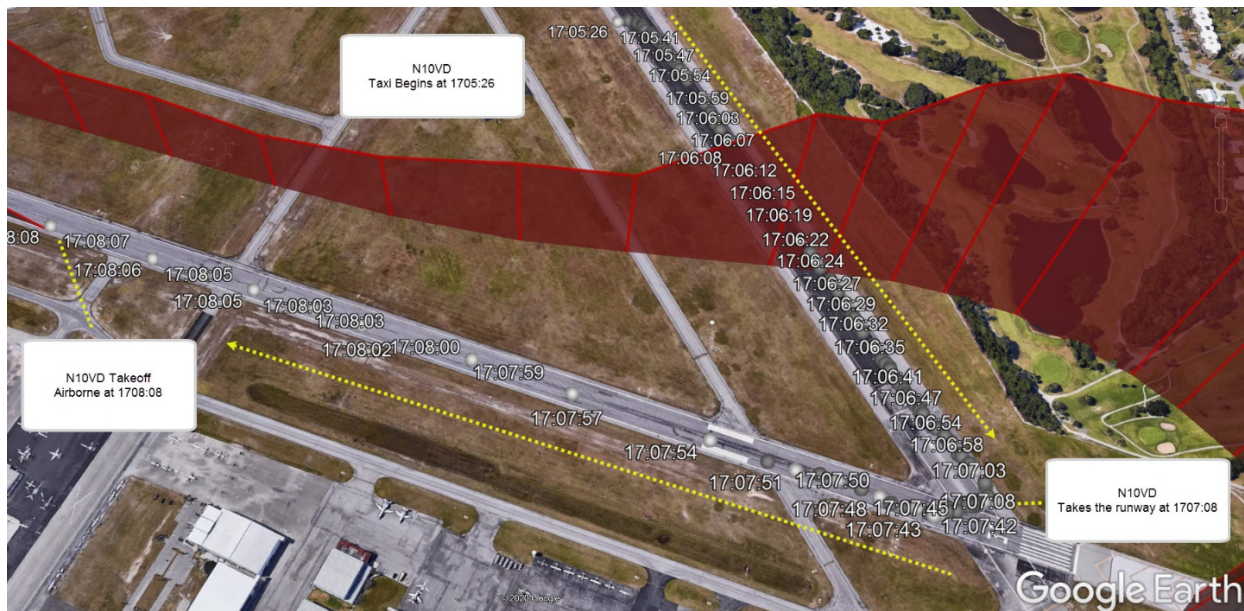
All graphics were derived from ADS-B and OpsVue data. Figure 1 illustrates the ADS-B and OpsVue data as the accident airplane taxied to runway 30 at SUA and began to takeoff.

**Figure 1** - Illustrates the ADS-B and OpsVue data as the accident airplane taxied to runway 30 at SUA and began to takeoff.

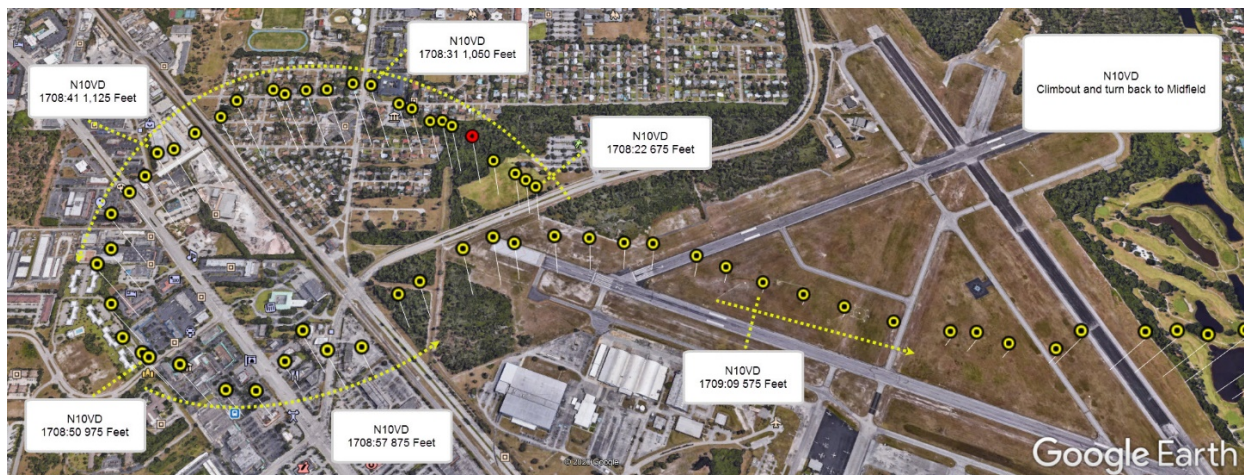
Figure 2 illustrates the accident airplane after it crossed the departure end of the runway and turned left circling back toward midfield at SUA.

**Figure 2** - Illustrates the accident airplane after it crossed the departure end of the runway and turned left circling back toward midfield at SUA.

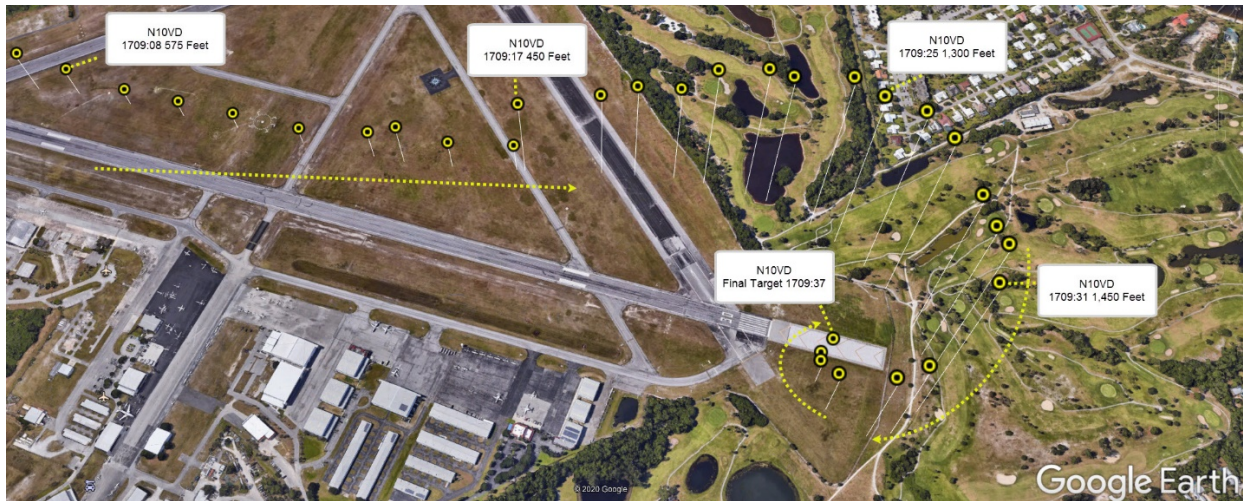
Figure 3 illustrates the accident airplane as flew back toward the approach end of runway 30.

**Figure 3** - Illustrates the accident airplane as flew back toward the approach end of runway 30.

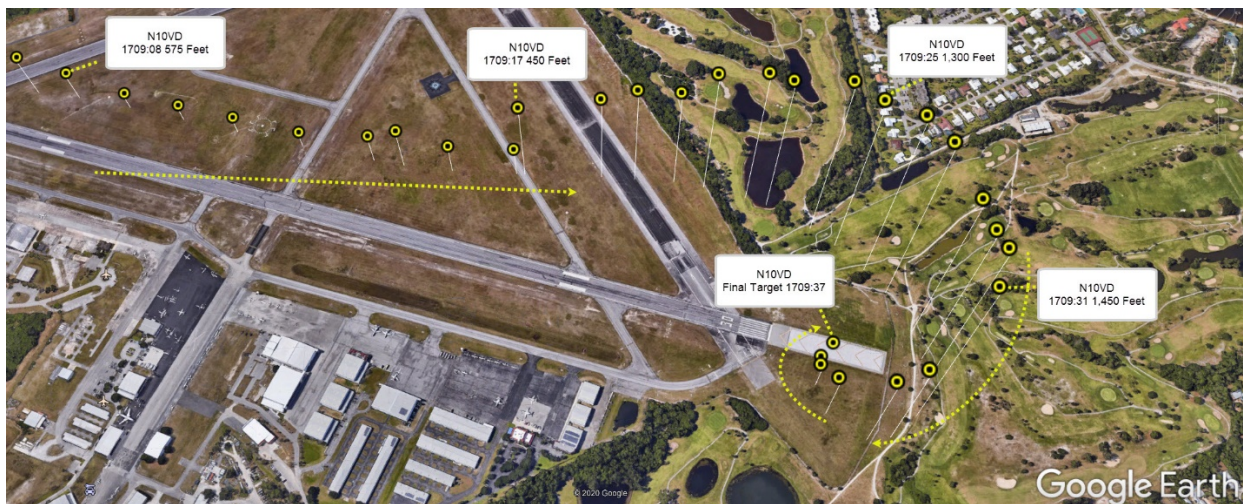
Figure 4 illustrates the accident airplane as it started a climb and a right turn to the accident site in the Engineered Materials Arresting System (EMAS) at the approach end of runway 30.

**Figure 4** - Illustrates the accident airplane as it started a climb and a right turn to the accident site in the Engineered Materials Arresting System (EMAS) at the approach end of runway 30.
