## **Memorandum For Record**

**Date: January 6, 2022**  
**NTSB Accident Number: ERA20FA027**

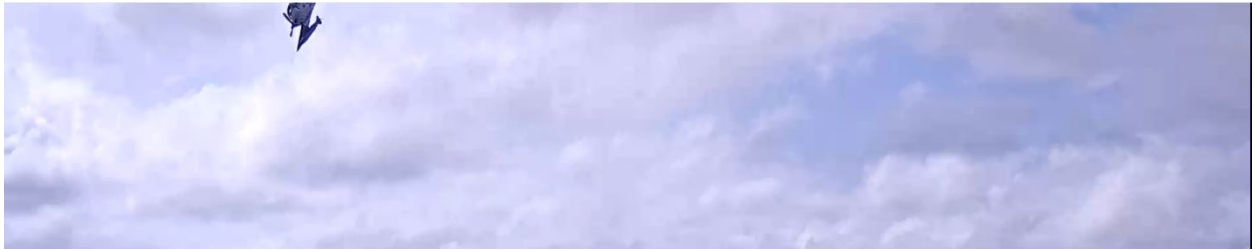
A camera captured the final portion of the flight and firefighting efforts. A review of the video frame by frame revealed that when the airplane came into view (Figure 1), the left side of the nose and portion of the cockpit area, a portion of the right wing including several propeller blades and the right external fuel tank were visible. The airplane was in a nose-low attitude. No objects were seen around the airplane at that time. In the second frame (Figure 2), nearly the entire portion of the airplane was in view. No objects were seen around the airplane at that time. The third frame occurred when the flight was about 57 ft above the ground and depicted the bottom and left side views of the airplane. In that view (Figure 3) the landing gear and left speedbrake were retracted, all three vertical stabilizers were visible, a small black coloration which was somewhat translucent was seen ahead of the left-wing leading edge just outboard of the engine nacelle, and a smaller black colored squared coloration was seen near the left wingtip behind the wing. In addition, black colored squared coloration was noted in an area of the left side of the airplane in the aft area of the window. The positions of the left aileron, left elevator, and rudder flight control surfaces could not be accurately determined. In the fourth frame, the airplane was in close proximity to the ground and no objects were seen around the airplane. The airplane was in about a 60° nose low and right-wing low attitude. In the fifth frame airplane to ground contact had occurred. No objects were seen around the airplane. A review of successive images frame by frame after impact revealed debris even as small as was seen in the third frame could be seen moving away from the impact.

Figure 1: Cropped Image from Camera depicting 1<sup>st</sup> View of the Airplane.

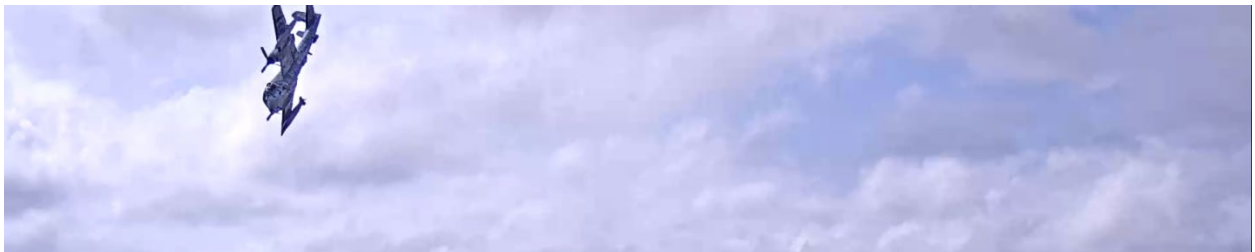
Figure 2: Cropped Image from Camera depicting 2<sup>nd</sup> Frame with Left Side View of the Airplane.

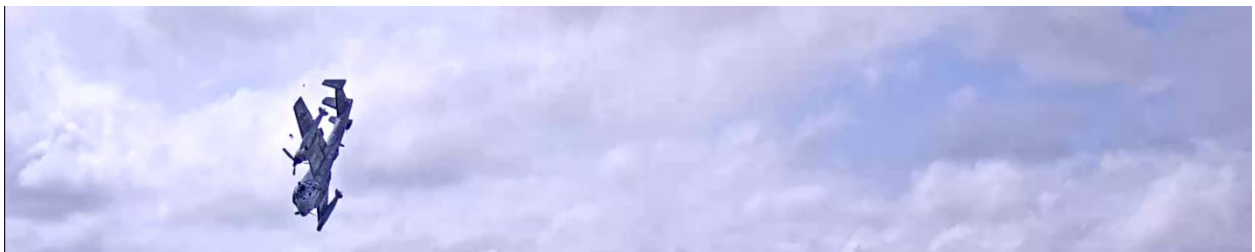
Figure 3: Cropped Image from Camera depicting 3<sup>rd</sup> Frame with Left Side View of the Airplane.
