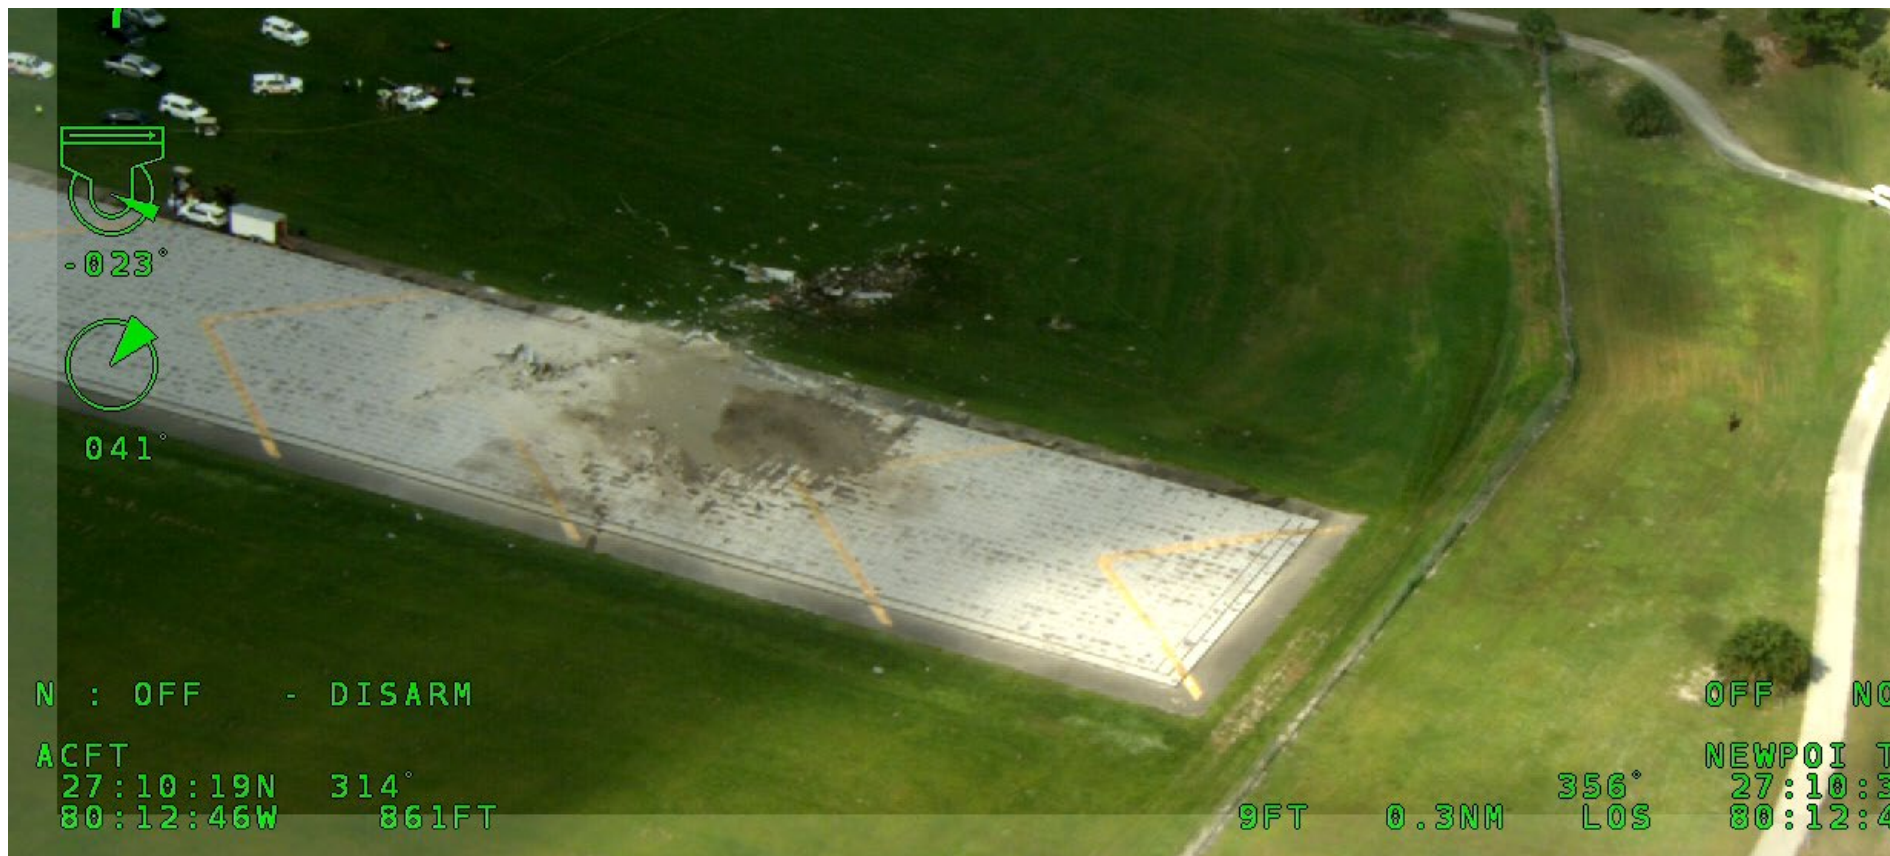
**Photo 1 – Photograph Provided by Martin County Sheriff Department. Aerial View of the Accident Site. Note the Wreckage Debris.**

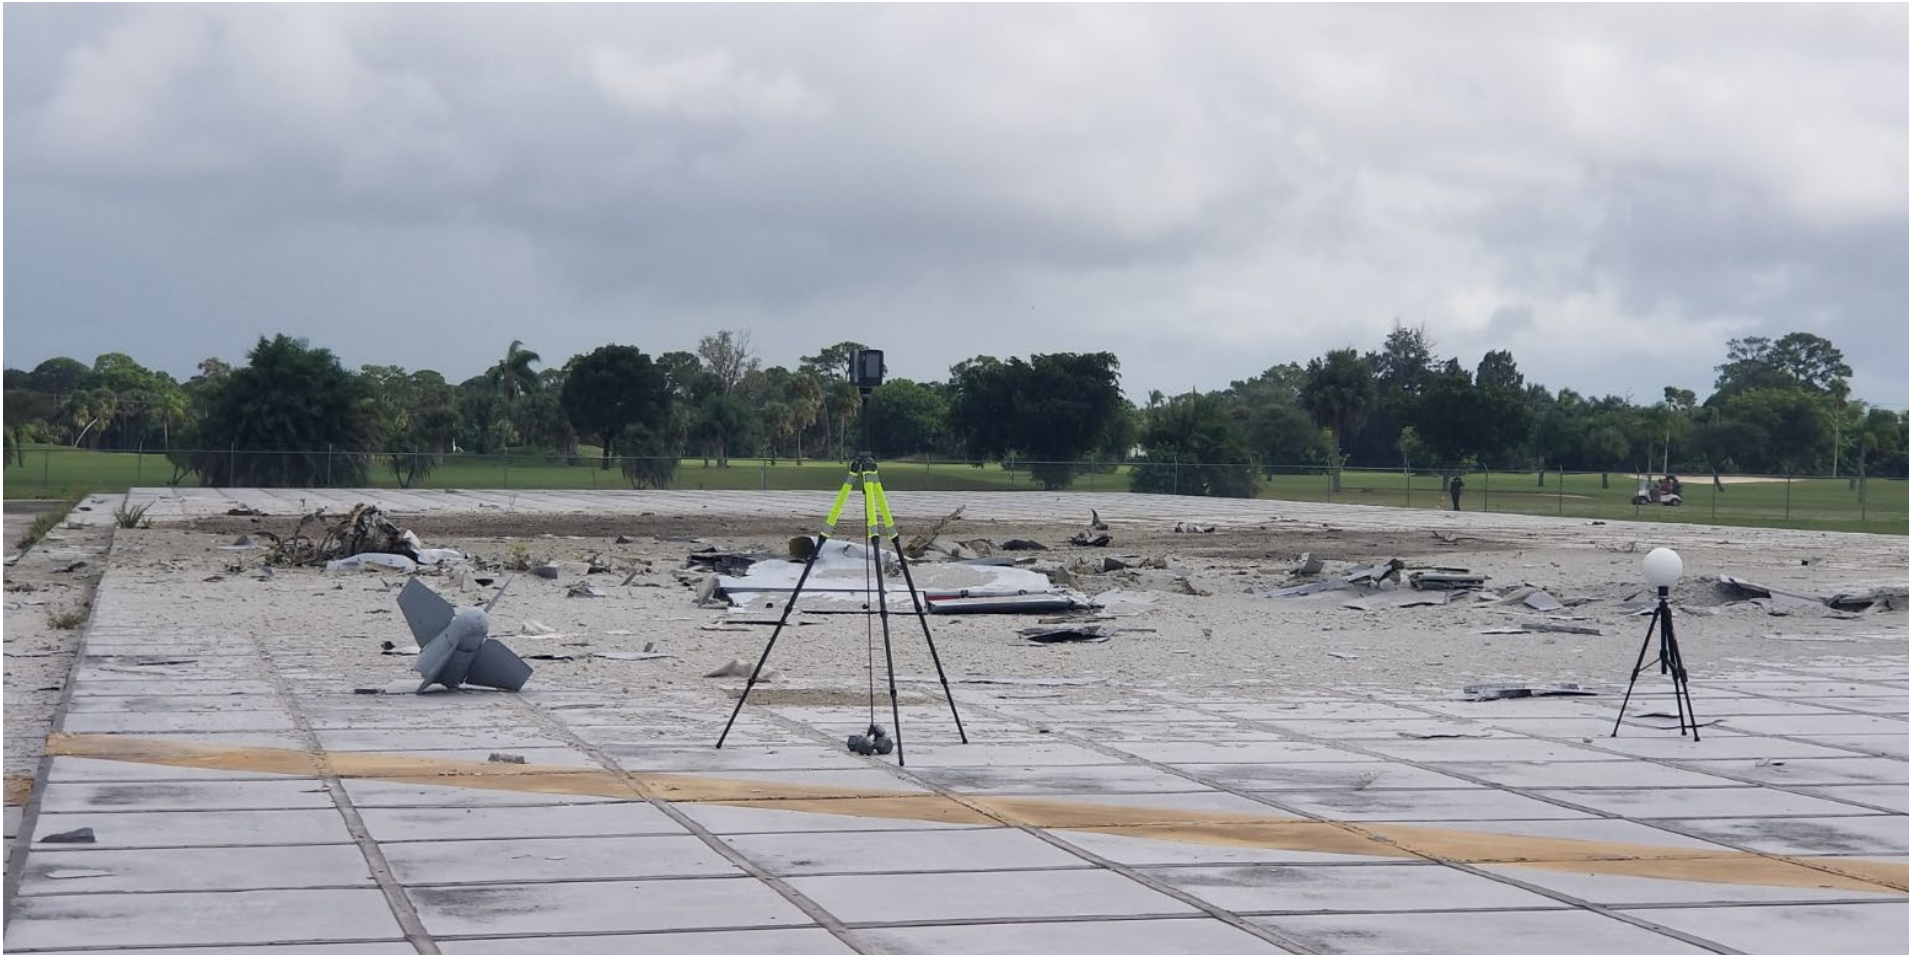
**Photo 2 - NTSB Digital Photograph. View of the Initial Impact Site. Note the Wreckage.**

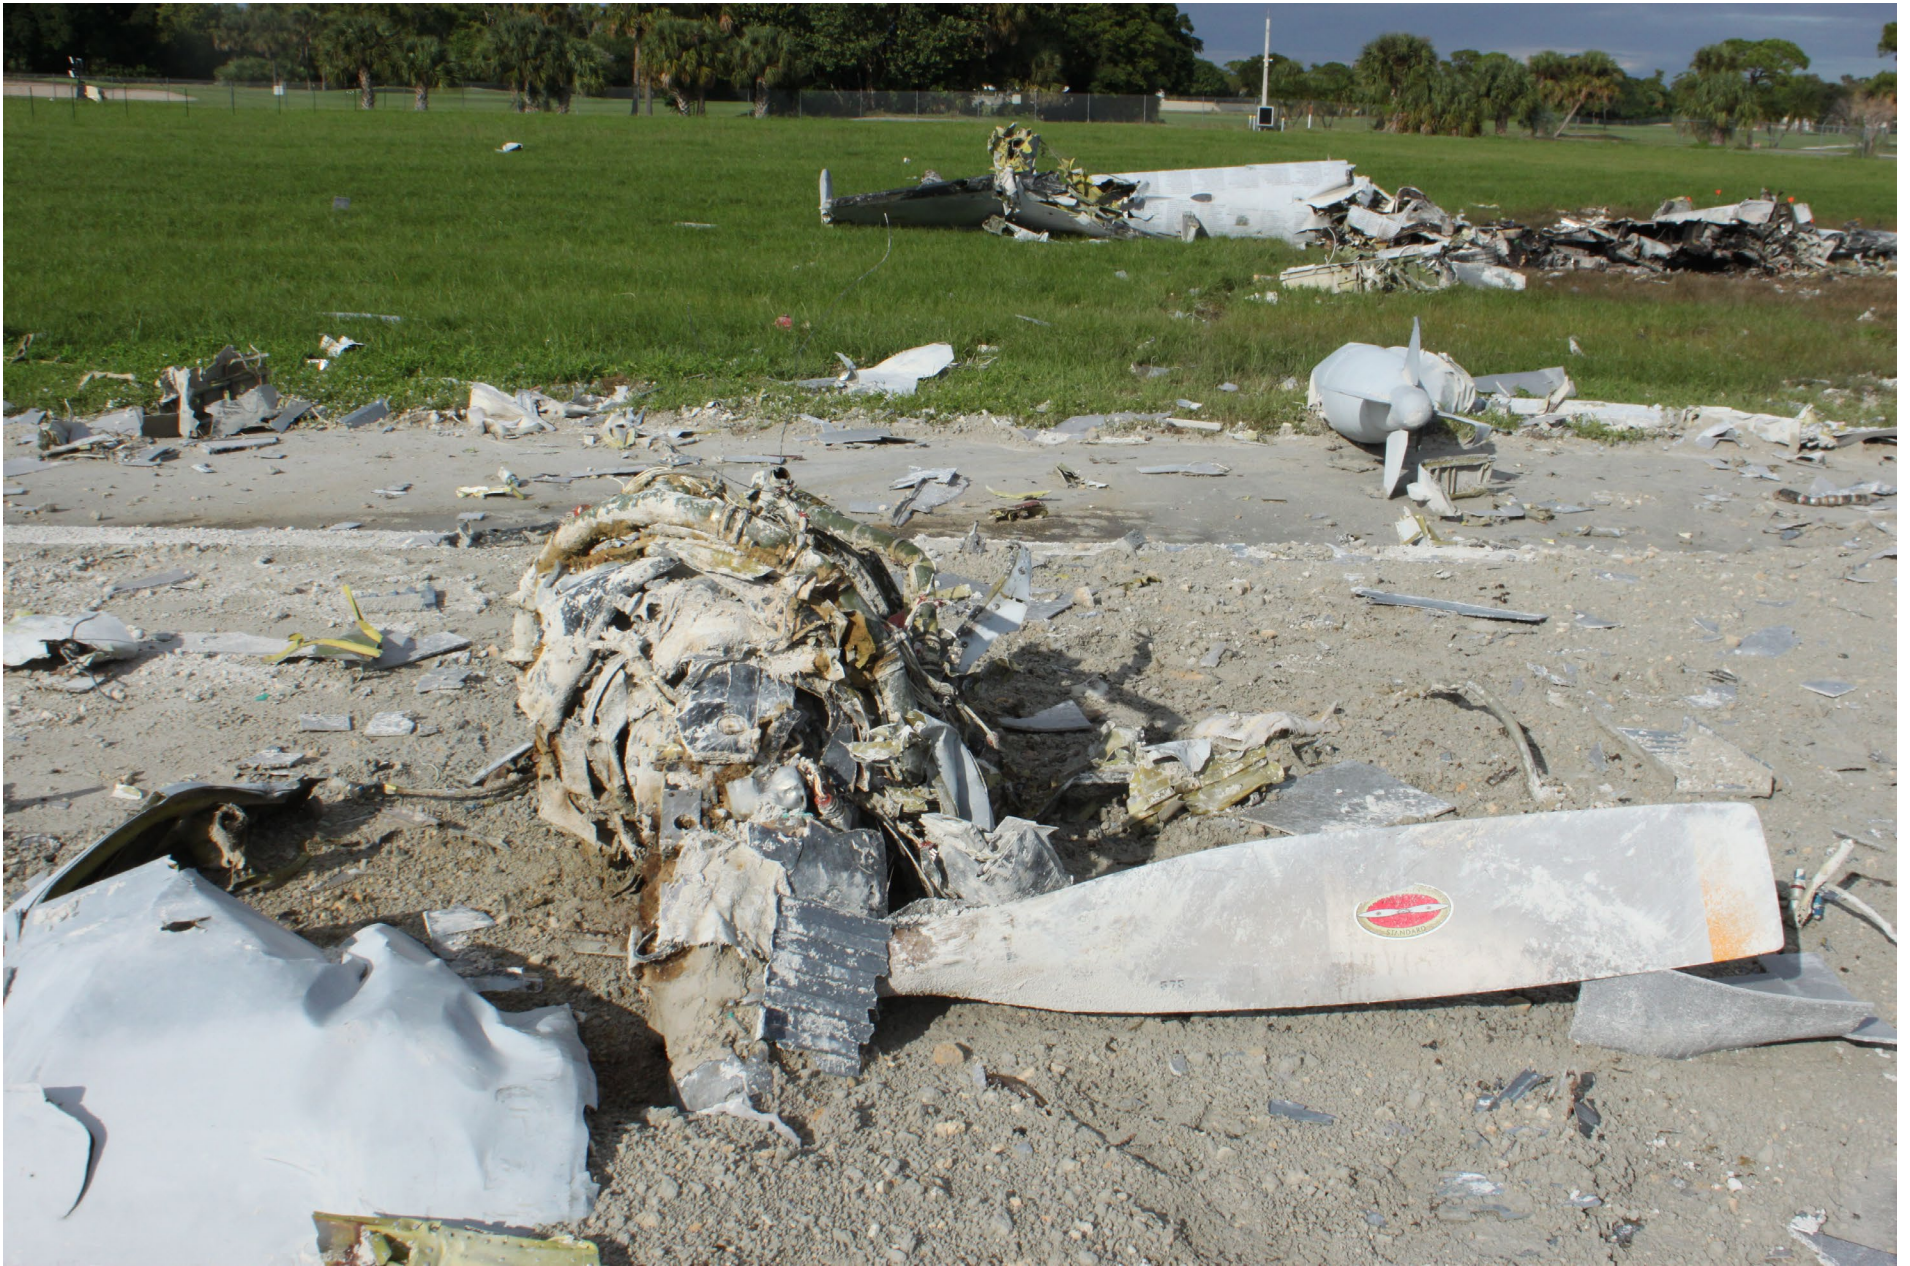
**Photo 3 - NTSB Digital Photograph. View of One Propeller Blade of the Left Propeller and Left Engine on Initial Impact Site. Also note, nearby wreckage.**

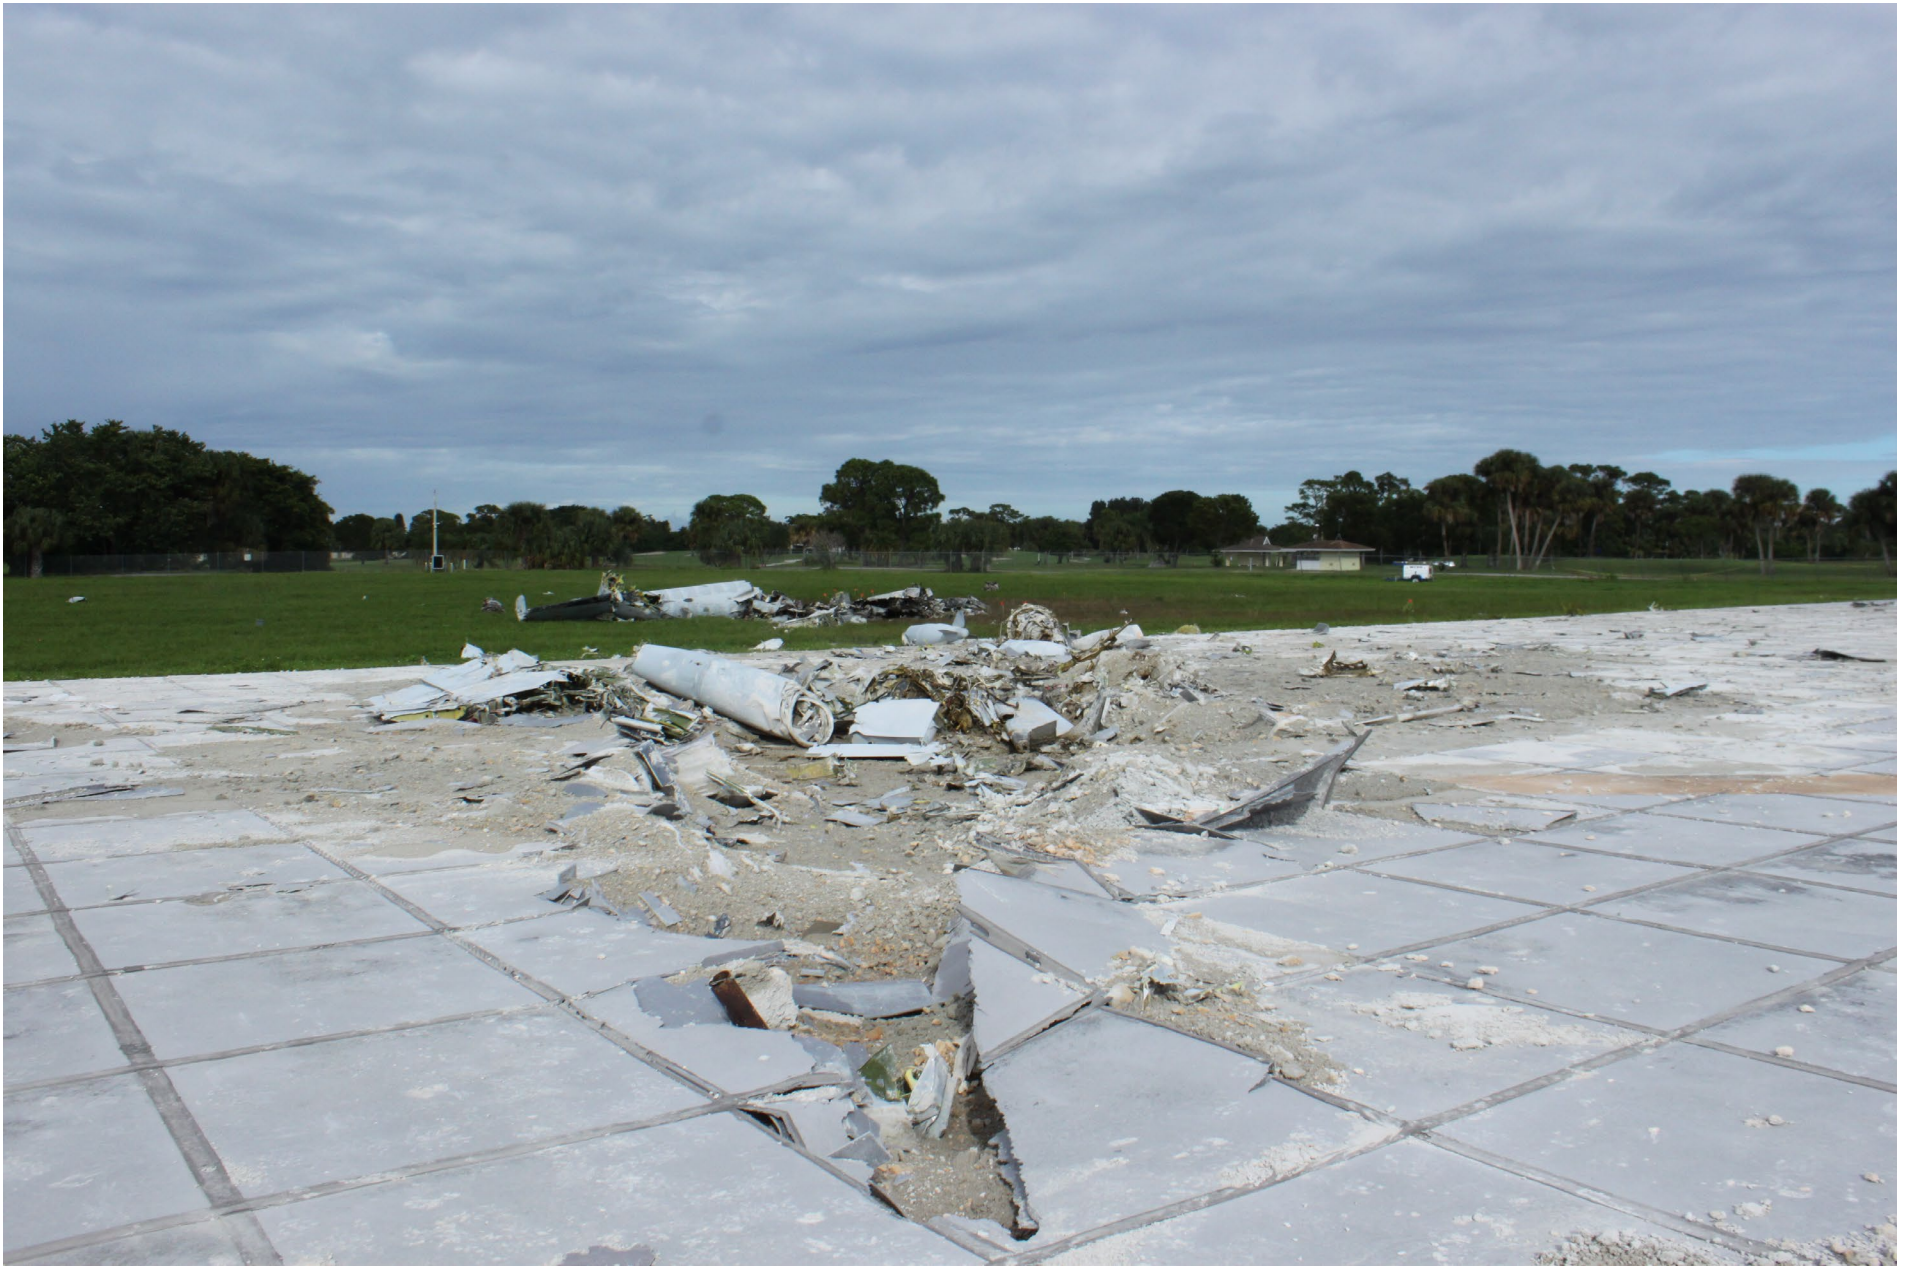
**Photo 4 - NTSB Digital Photograph. View of the Initial Impact Site. Note the Majority of Wreckage in the Background.**

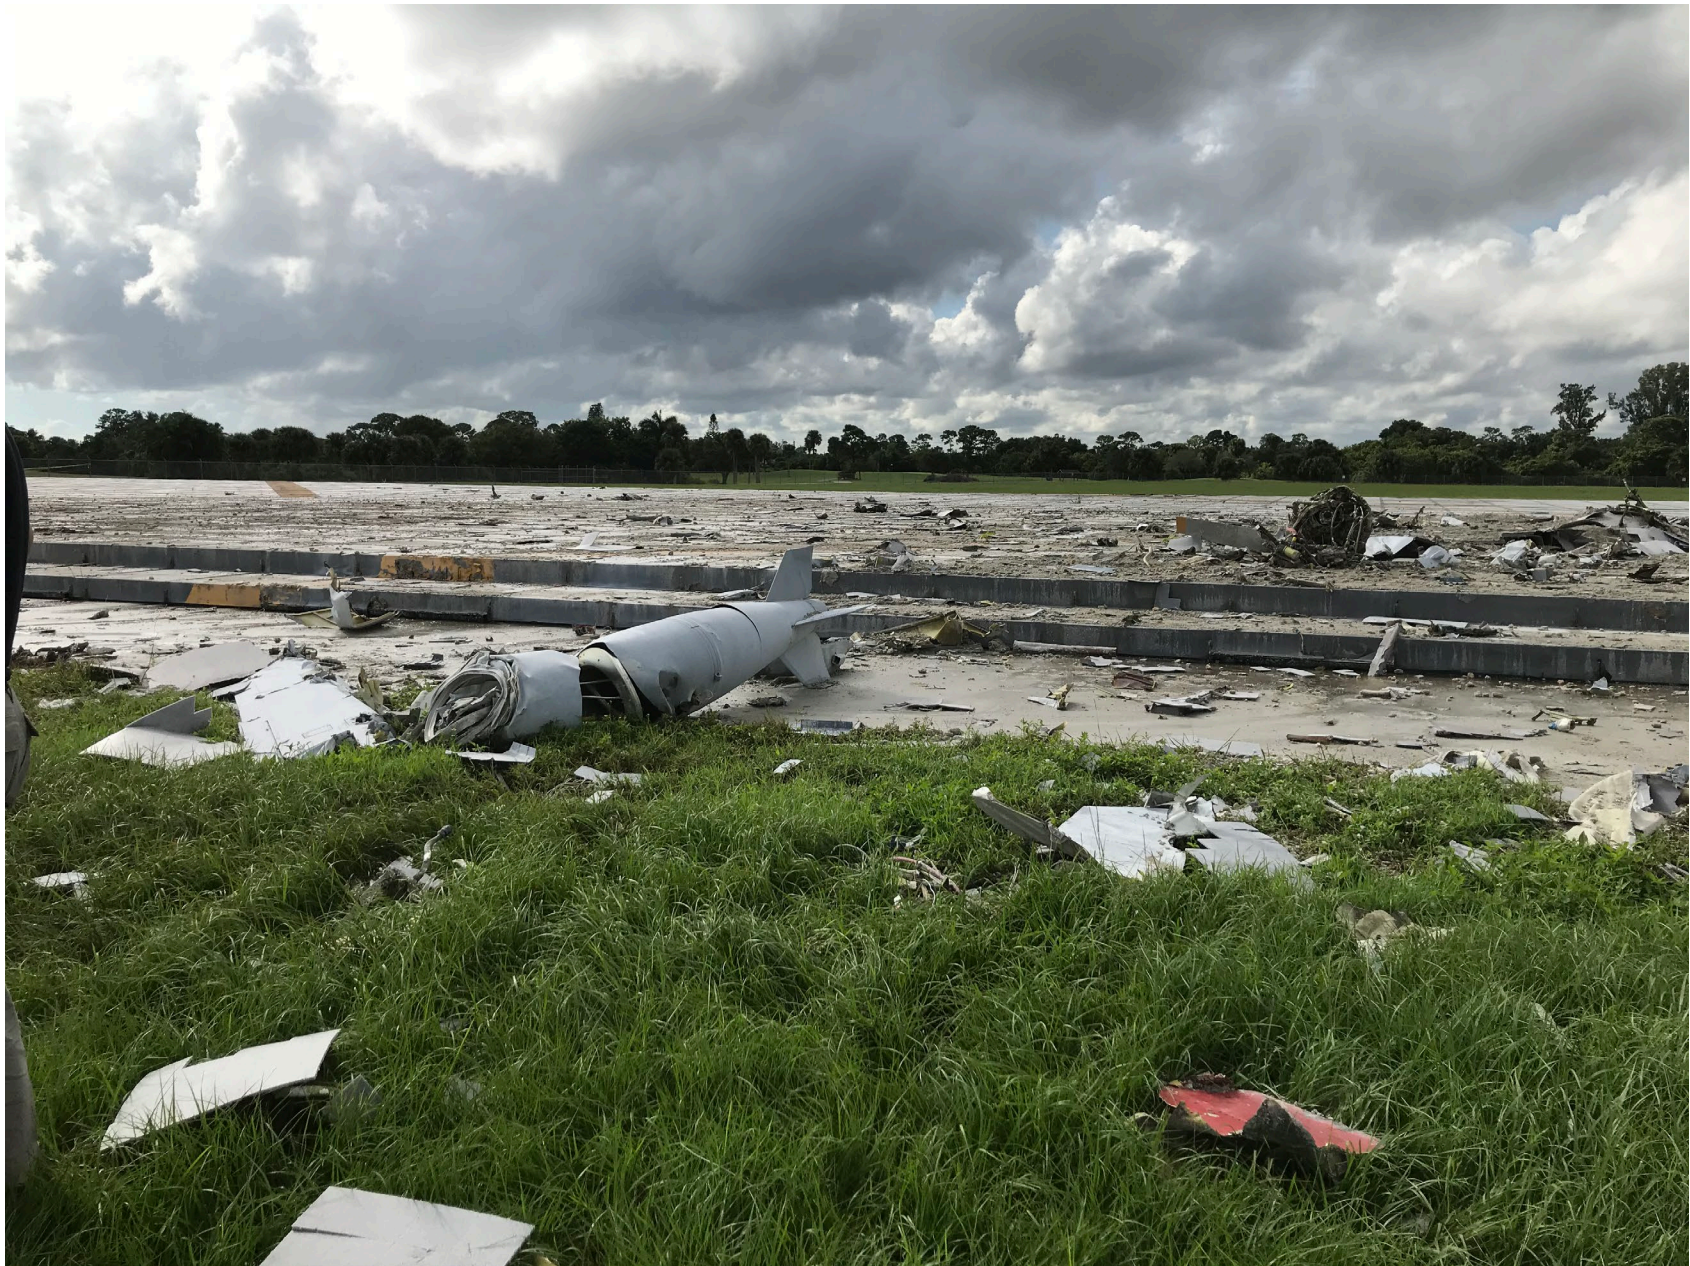
**Photo 5 - NTSB Digital Photograph. View of The Wreckage on and Nearby the Initial Impact Site.**

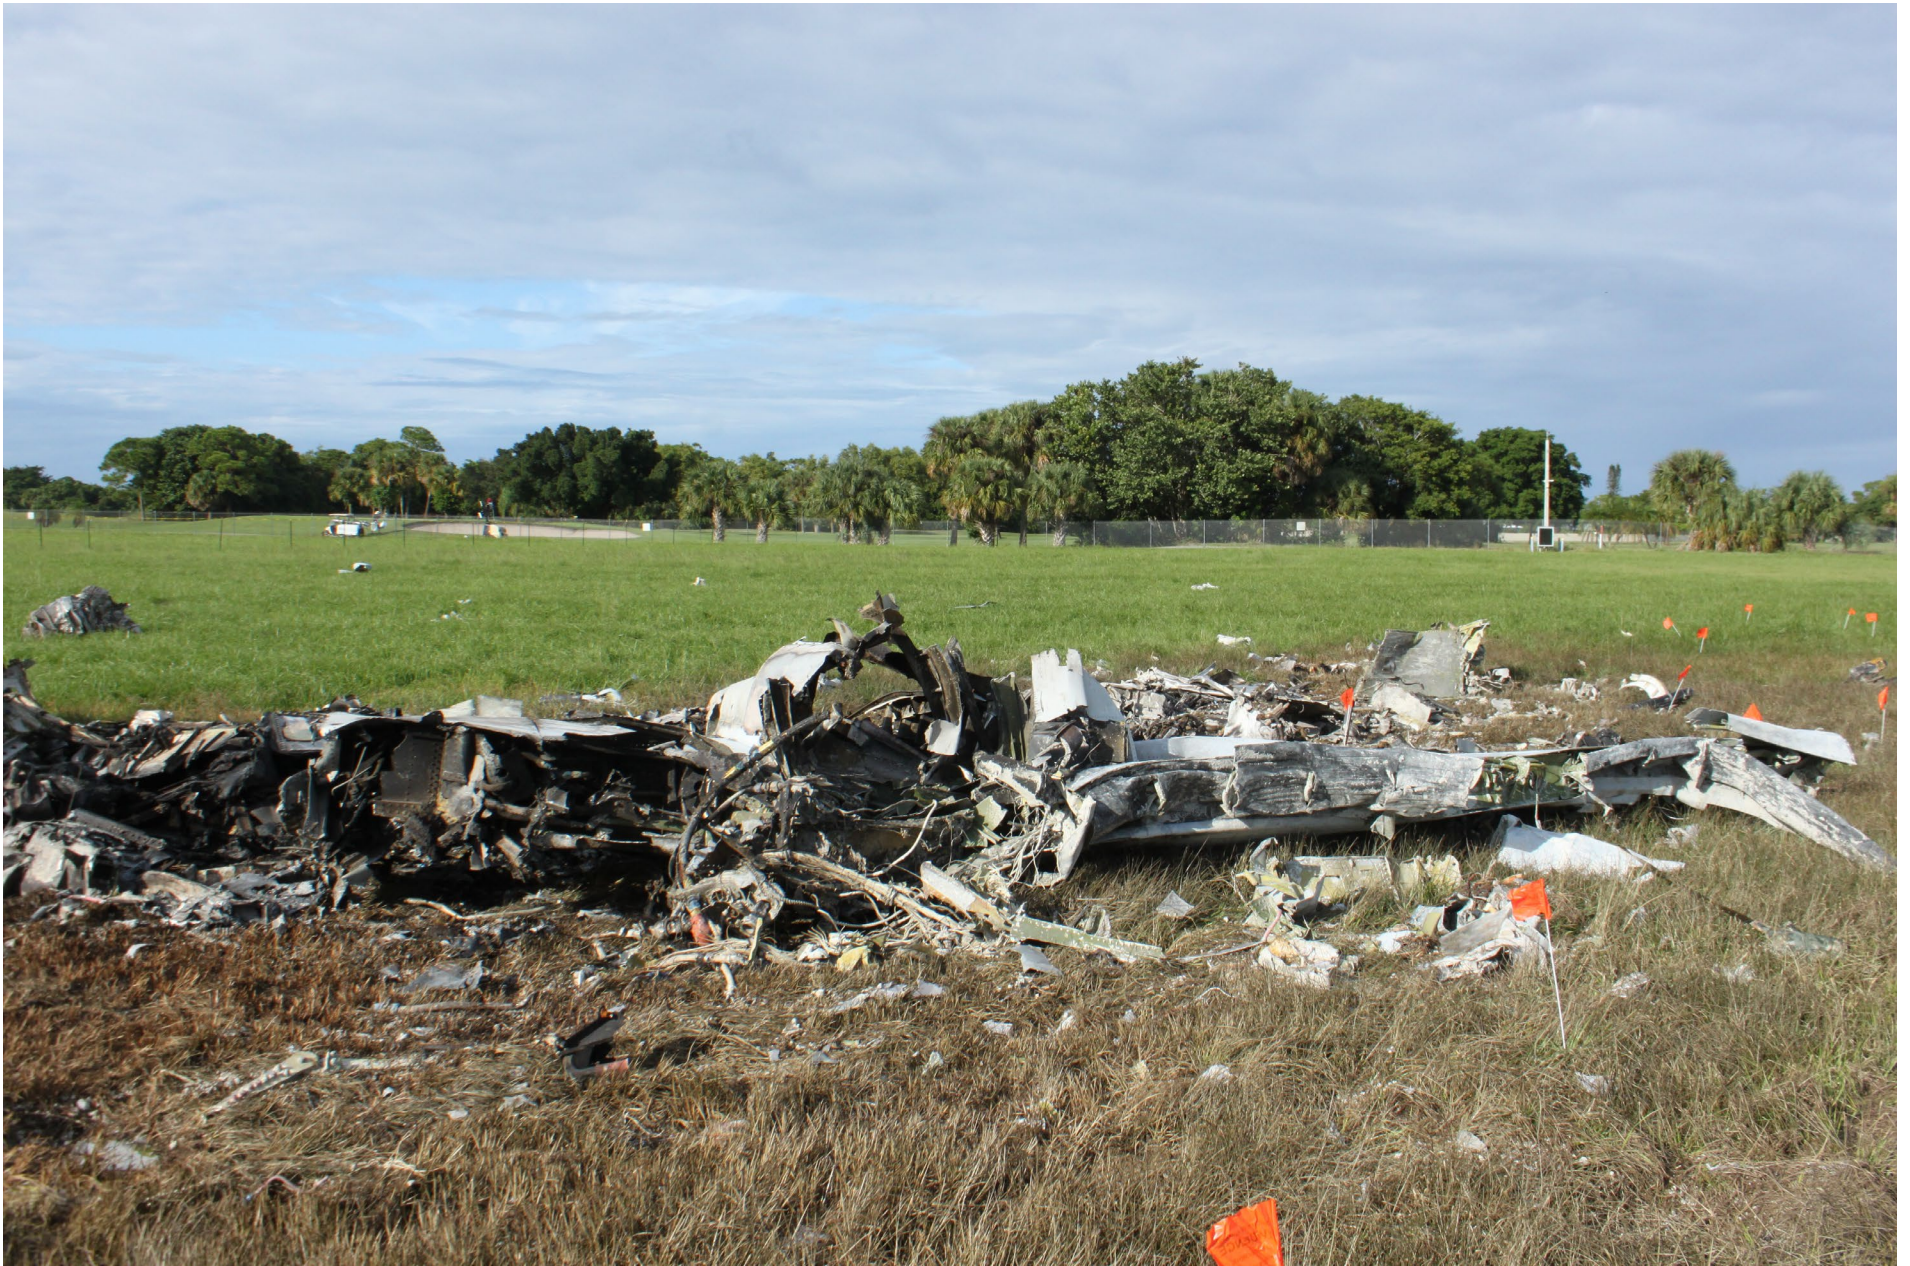
**Photo 7 - NTSB Digital Photograph. View of The Wreckage at the Accident Site.**

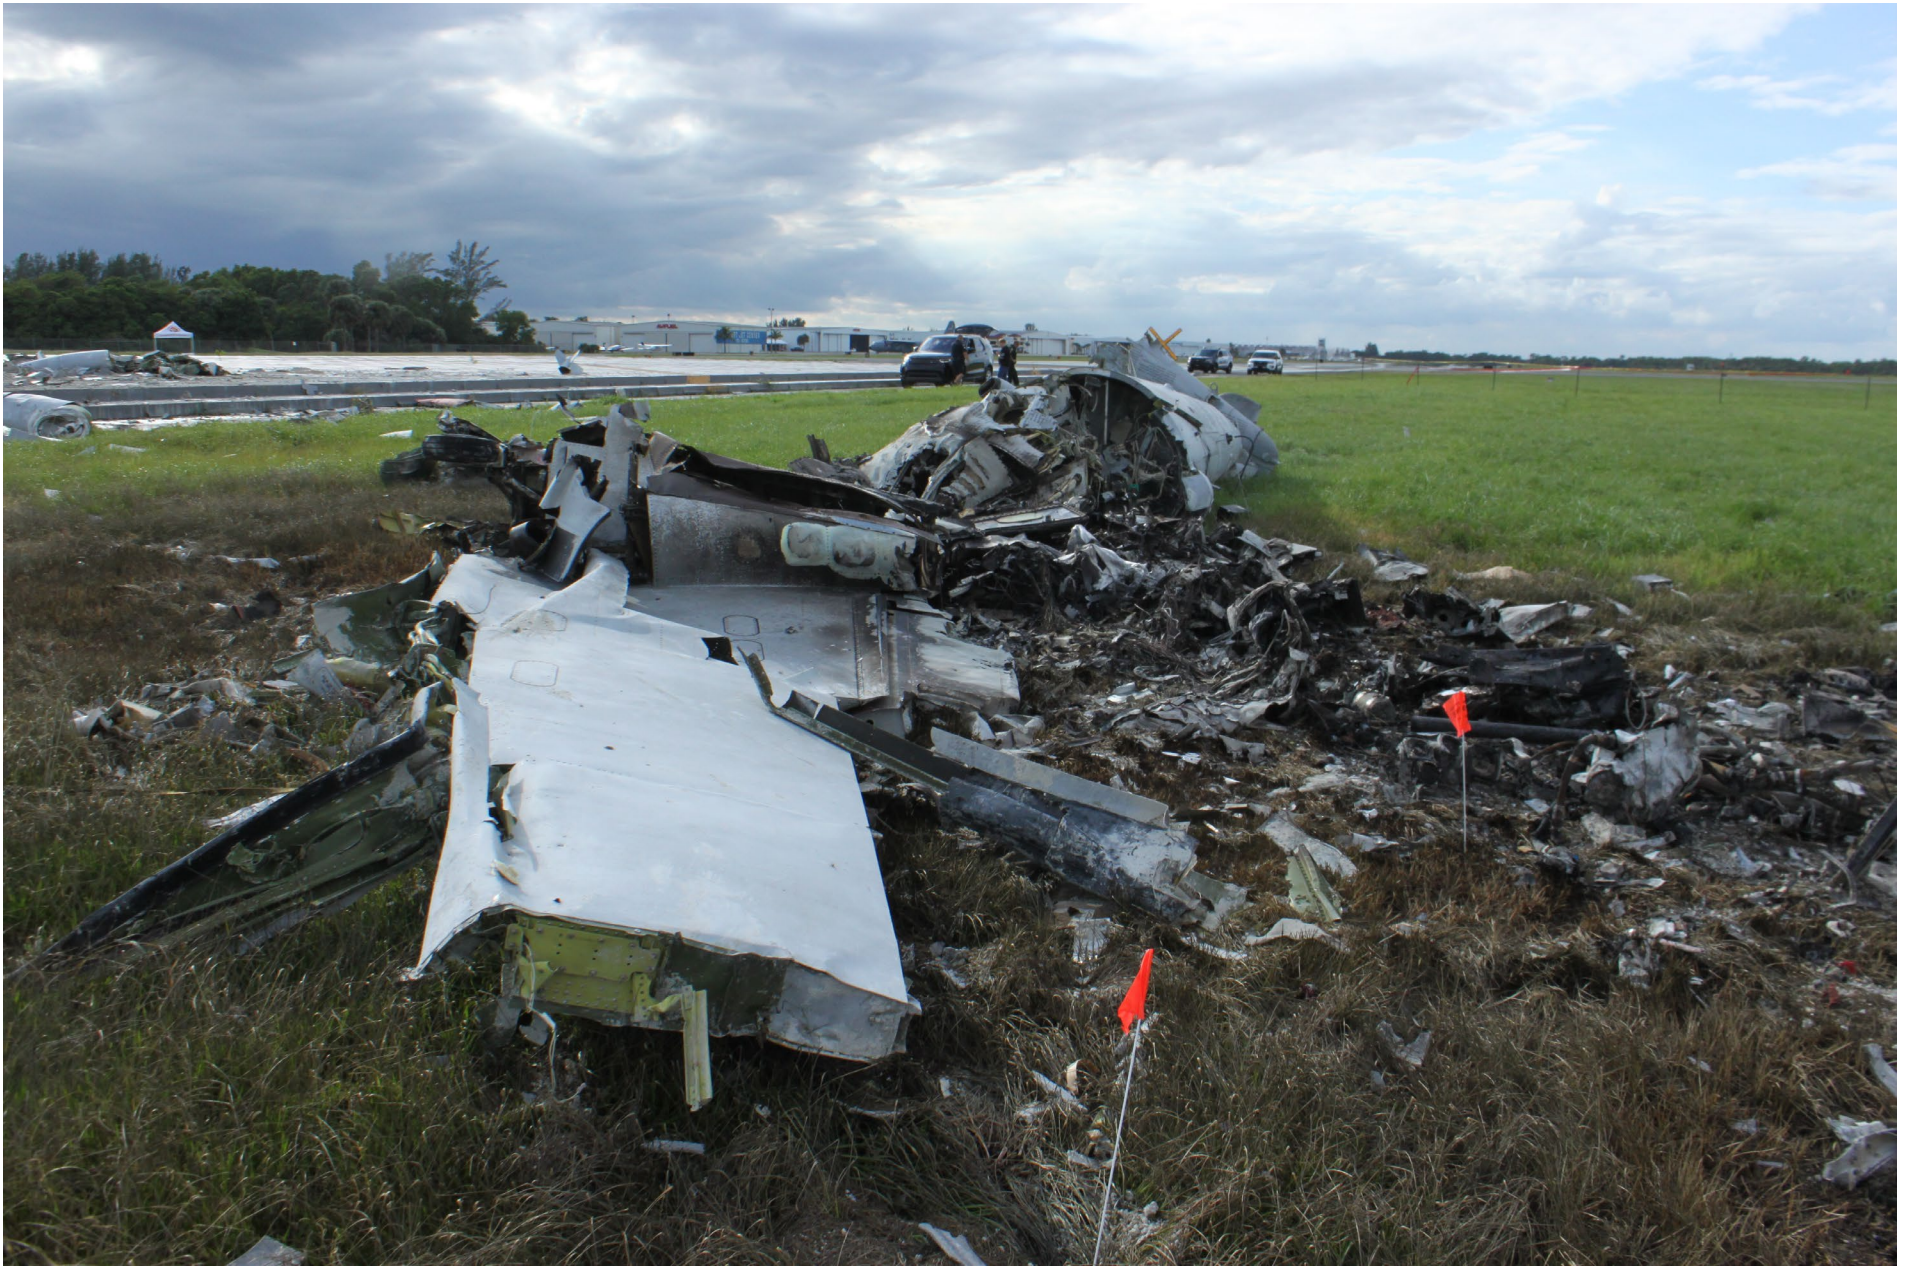
**Photo 8 - NTSB Digital Photograph. View of The Wreckage at the Accident Site. Note the cockpit in the Background.**

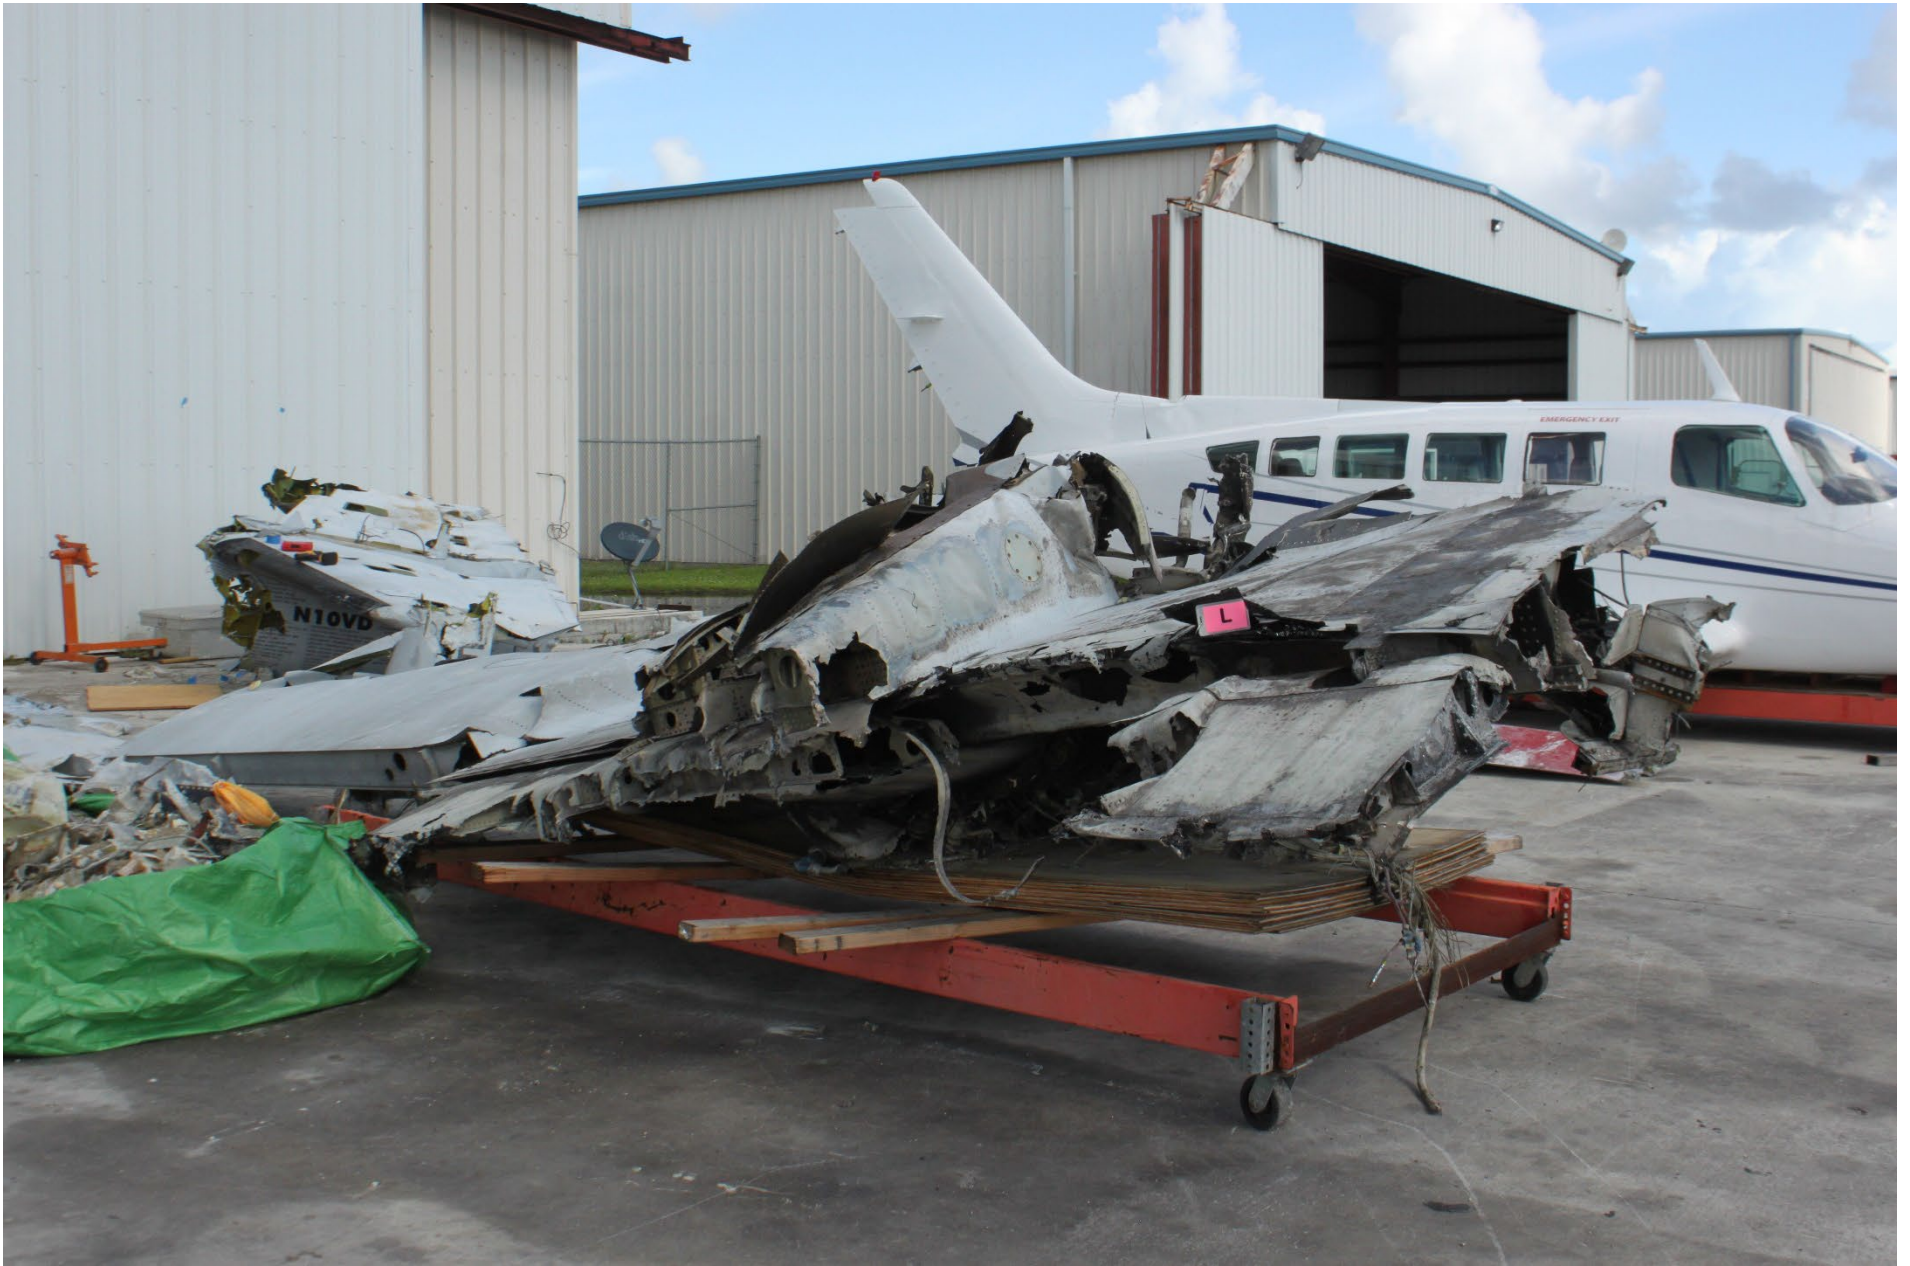
**Photo 9 - NTSB Digital Photograph. View of A Portion of the Left Wing.**

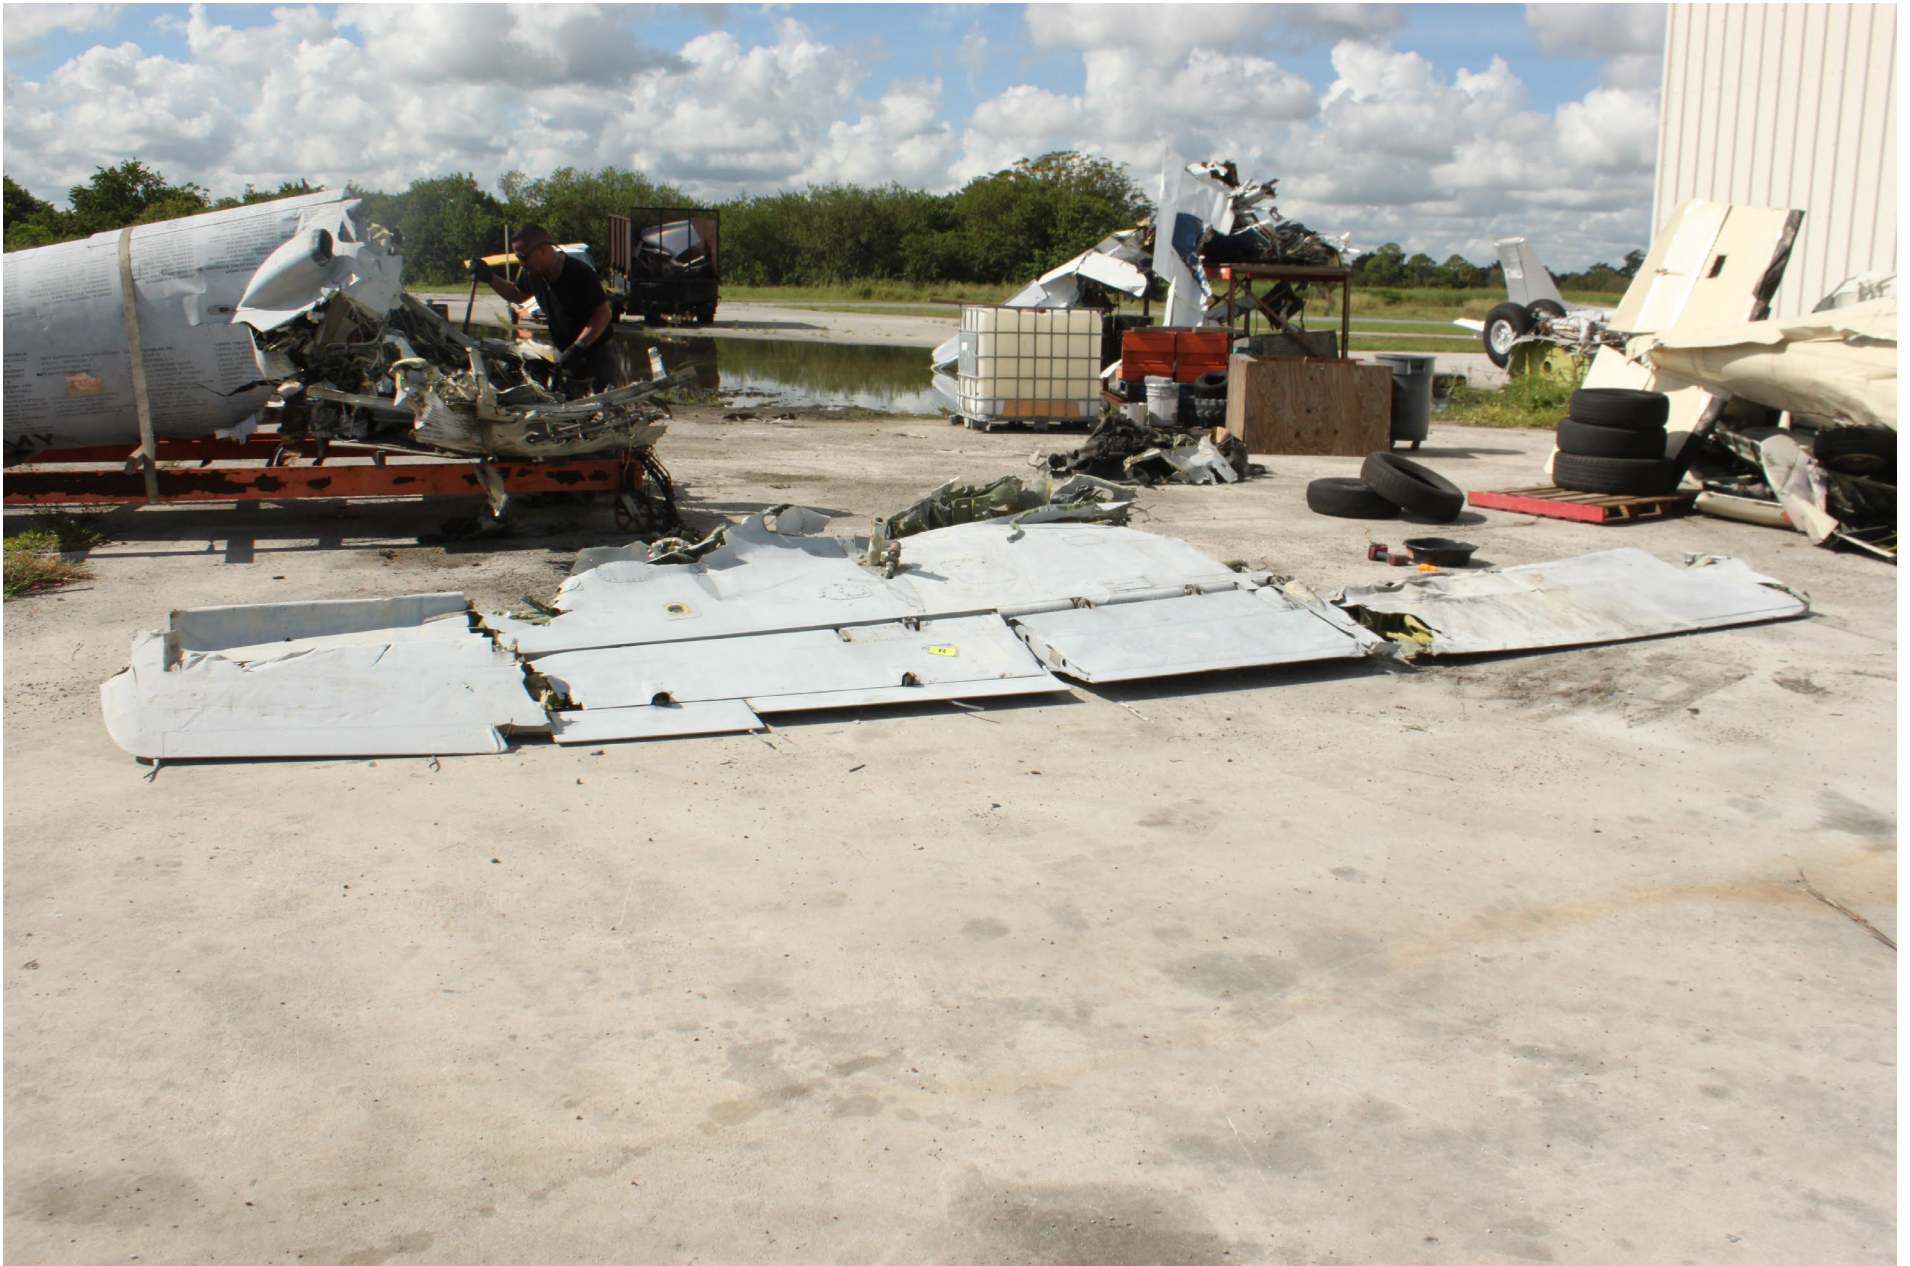
**Photo 10 - NTSB Digital Photograph. View of the Reconstruction of the Right Wing.**

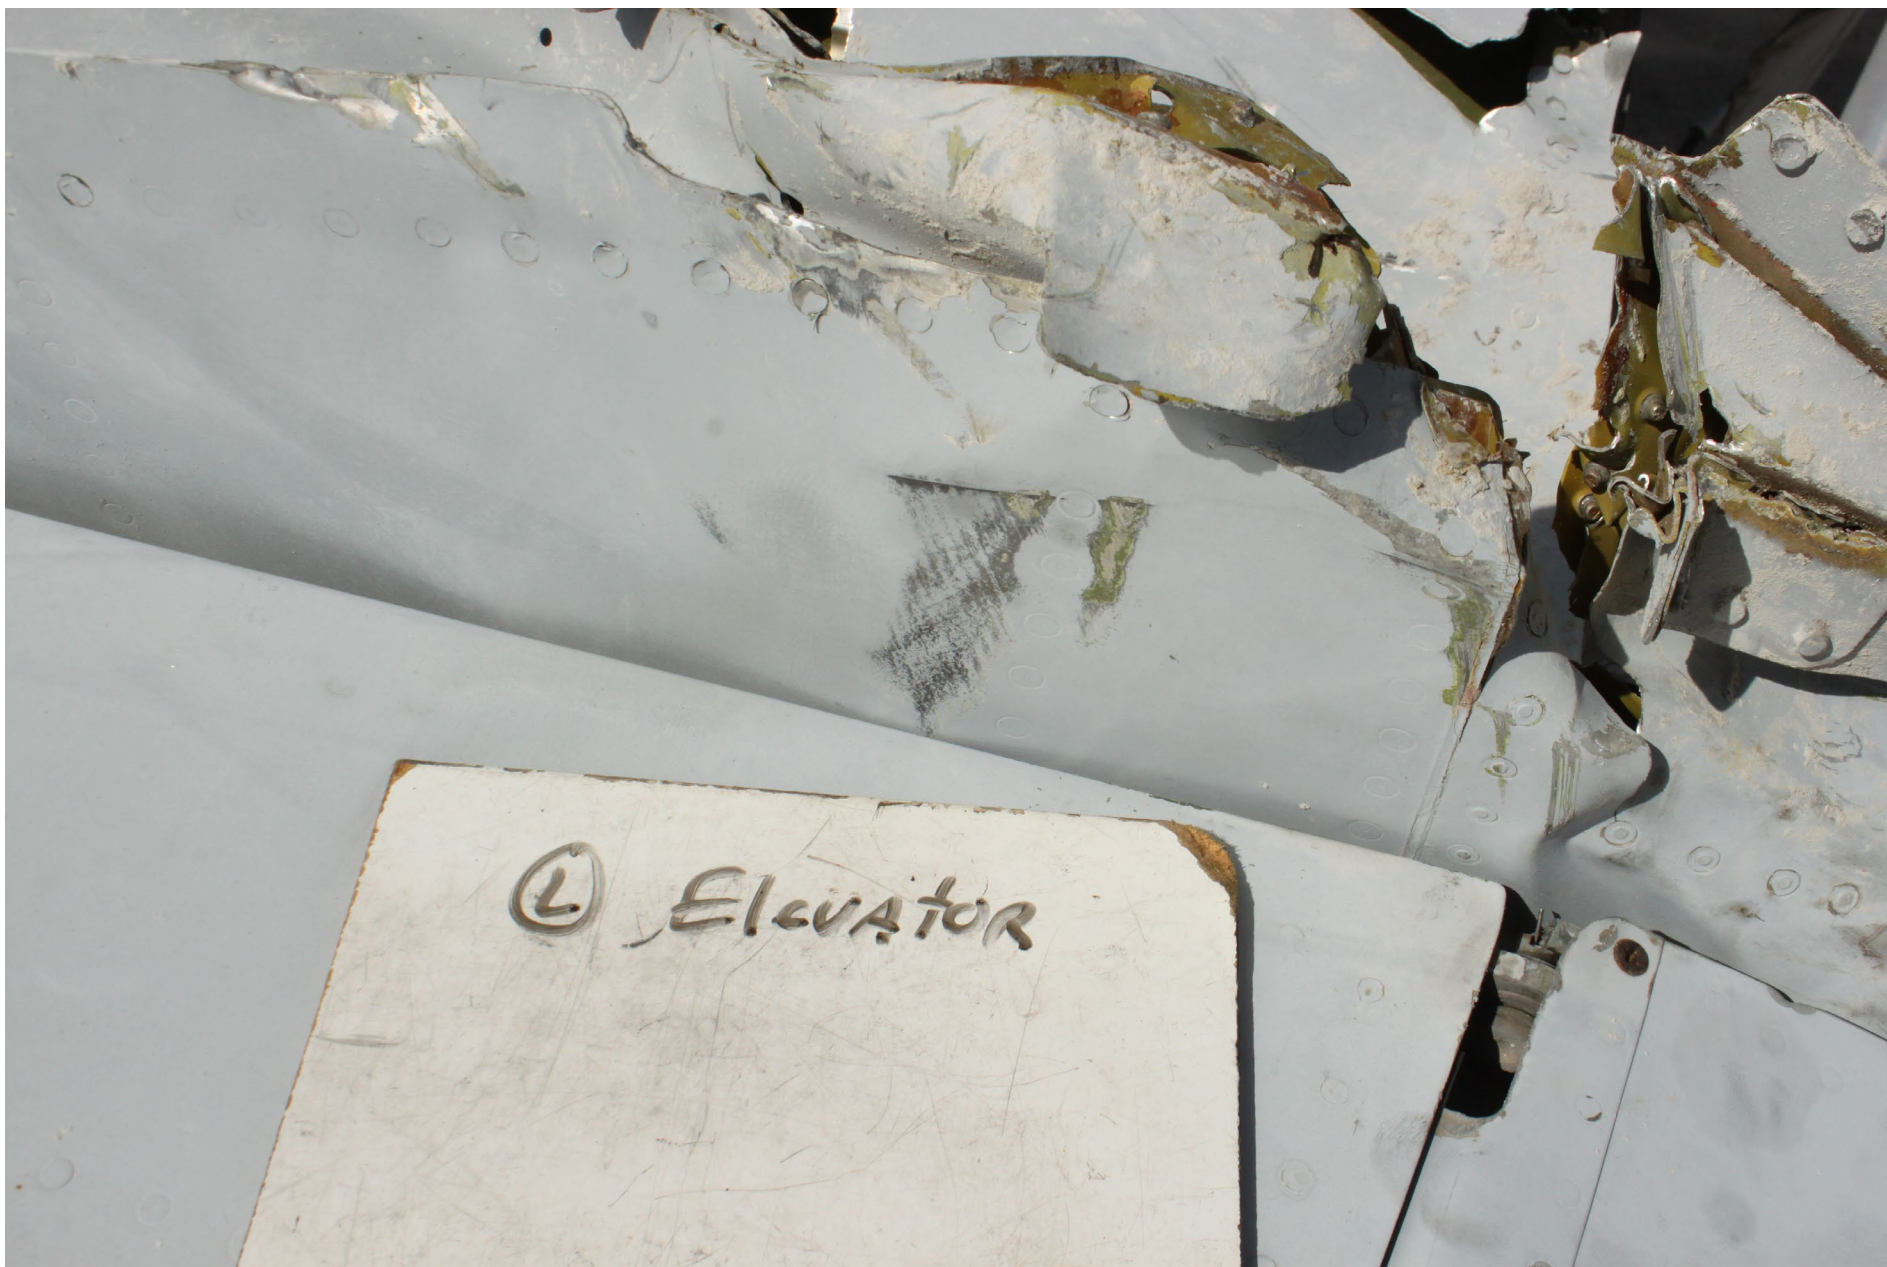
**Photo 11 - NTSB Digital Photograph. View Showing the Static Imprint of the Inboard End of the Left Elevator Against the Adjacent Aft Empennage Skin.**
