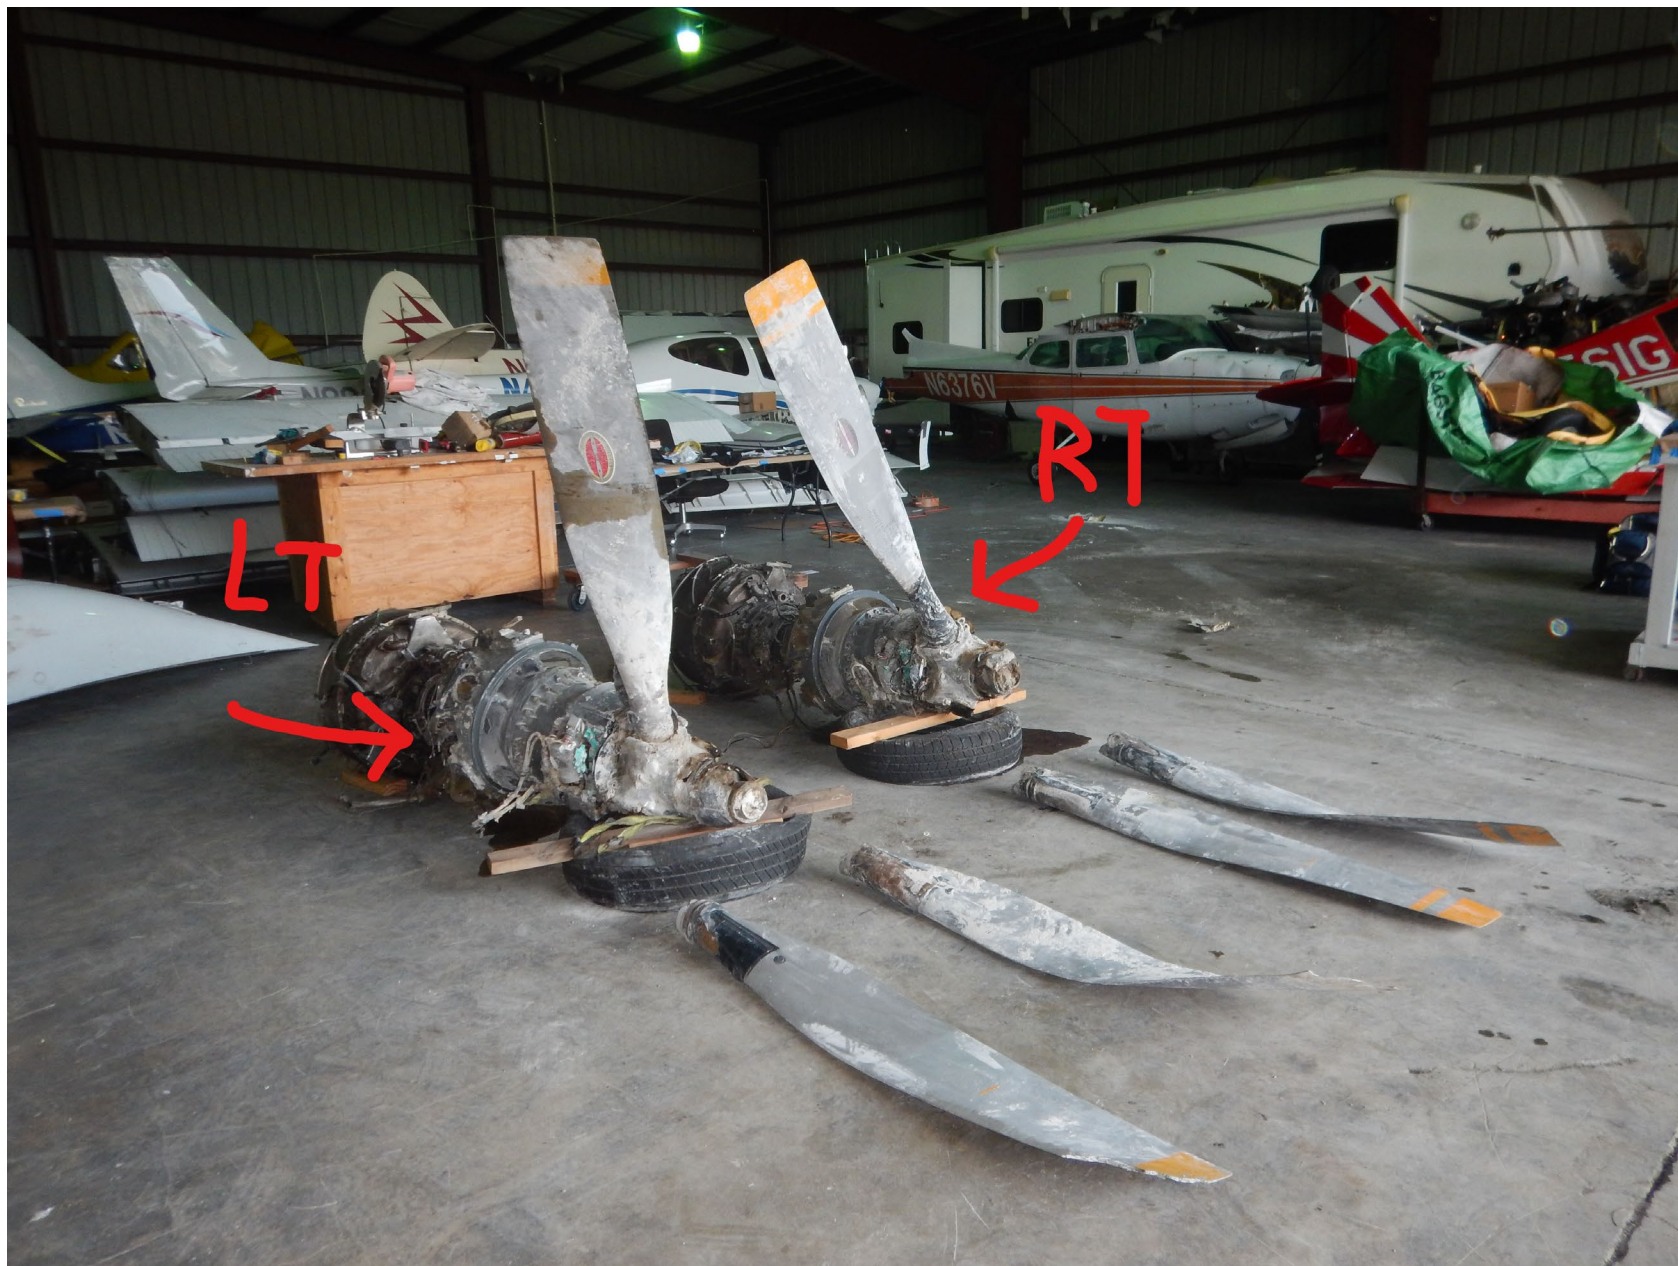
**Photo 12 - NTSB Digital Photograph. Annotated Photograph Showing each Engine, Propeller, and Separated Propeller Blades.**
