## Memorandum For Record

**Date: January 18, 2022**  
**NTSB Accident Number: ERA20FA027**

Factual observations of the engines are noted below:

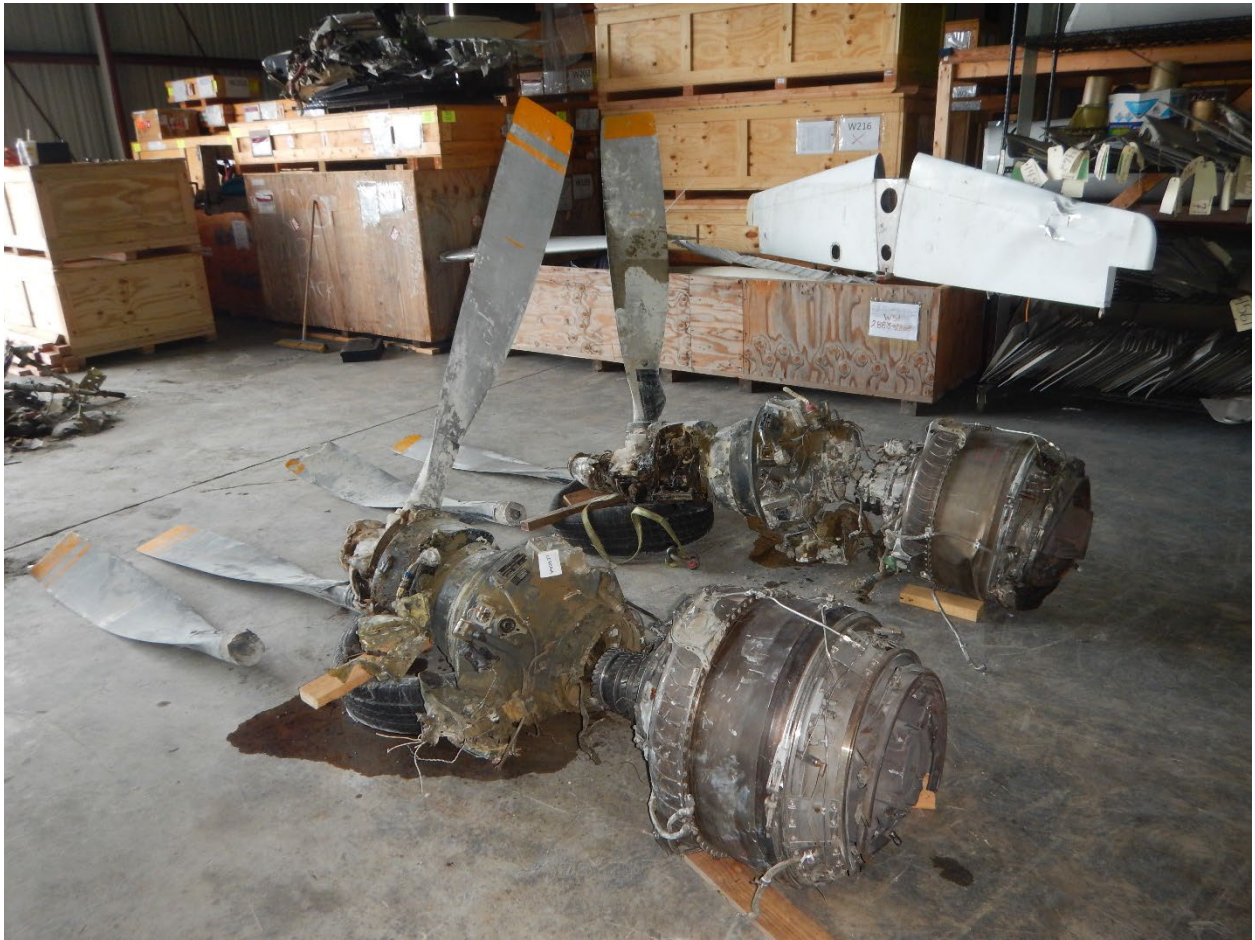
Figure 1: Honeywell Photograph. View of the engines and propellers.
