# NATIONAL TRANSPORTATION SAFETY BOARD

## MATERIALS LABORATORY FACTUAL REPORT

Report No. 20-003

Place : Stuart, Florida  
Date : November 1, 2019  
Vehicle : Grumman OV-1D, N10VD  
NTSB No. : ERA20FA027  
Investigator : Timothy W. Monville, AS-ERA

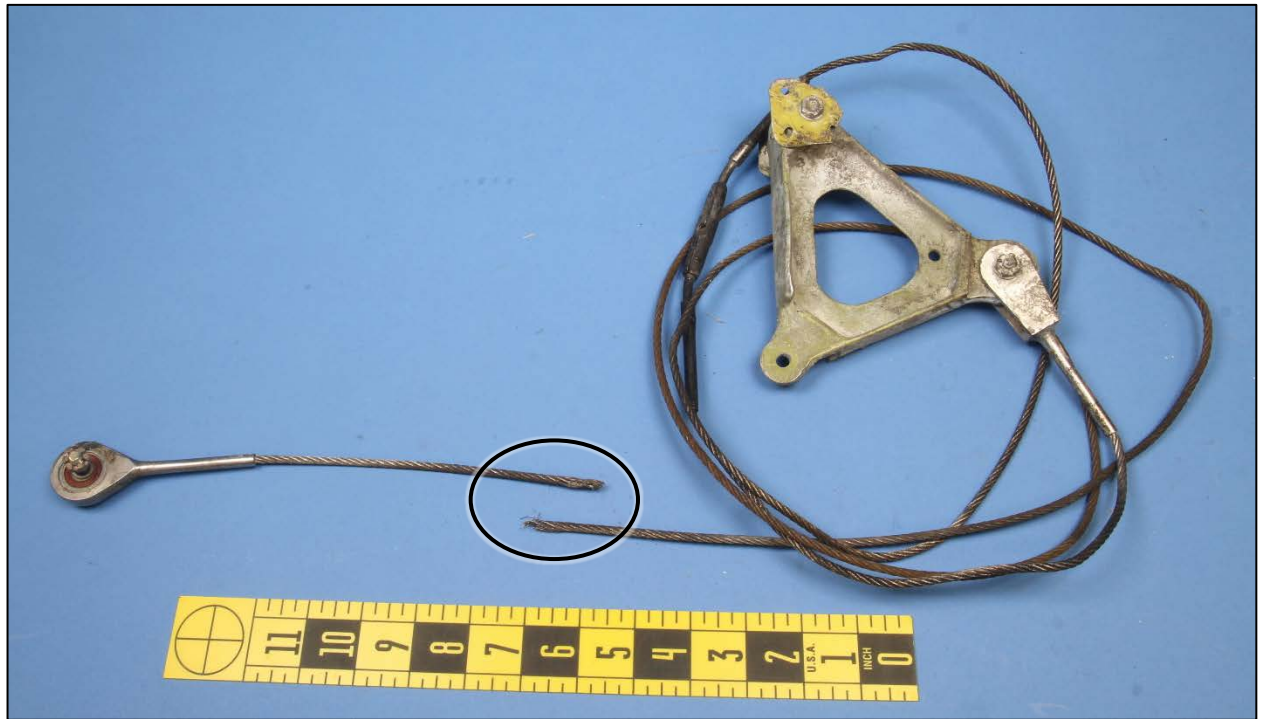
An overall view of the submitted control cable is shown in figure 1. The control cable was separated at the location encircled by an ellipse in figure 1 leaving a longer length of the cable attached to a bellcrank and a shorter segment with an eye end fitting shown to the left in figure 1. Metal tabs on the bellcrank were deformed and fractured with rough matte gray fracture features consistent with ductile overstress fracture.

Figure 1. Overall view of the submitted control cable assembly. The location of the cable separation is indicated by an ellipse.

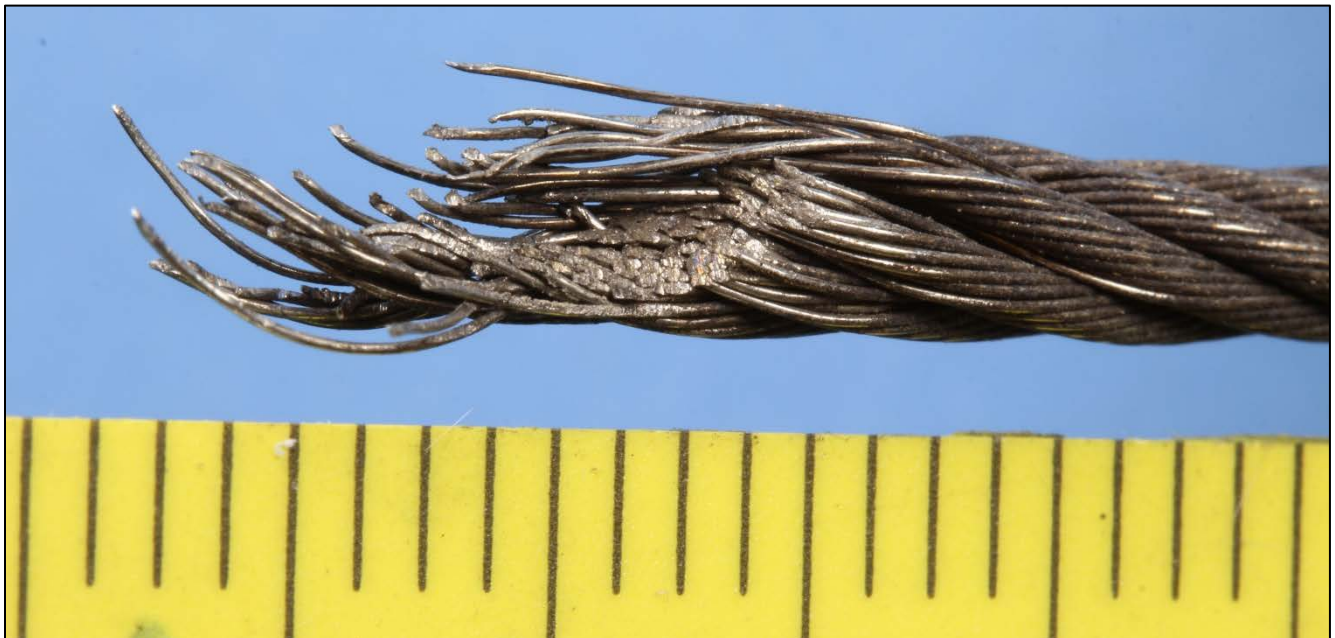
The separated ends of the control cable are shown in figures 2 and 3. The ends of the wires on each side of the cable separation had parallel grooves with deformation lips on one side consistent with sliding contact in one direction. Heat tinting was observed at the tips of several of the wires as indicated in figure 4 consistent with high-speed sliding contact as the wires were severed.

Figure 2. Separated end of the longer cable piece.

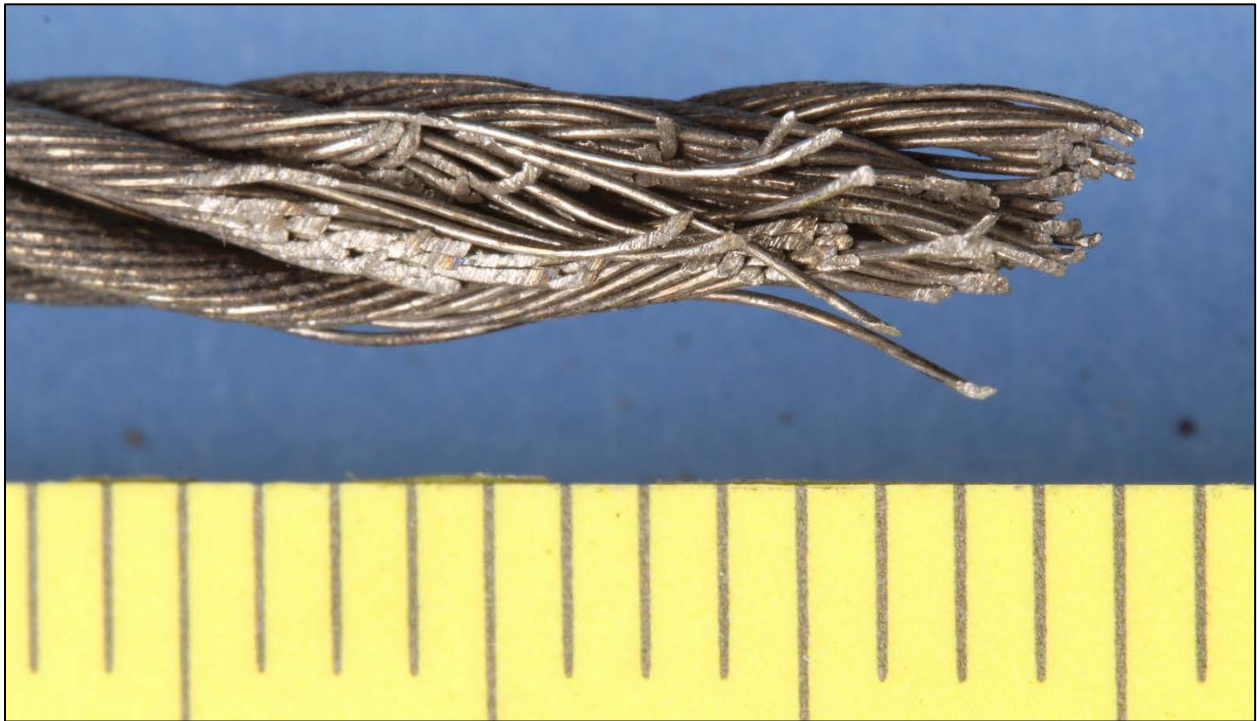
Figure 3. Separated end of the shorter cable piece.

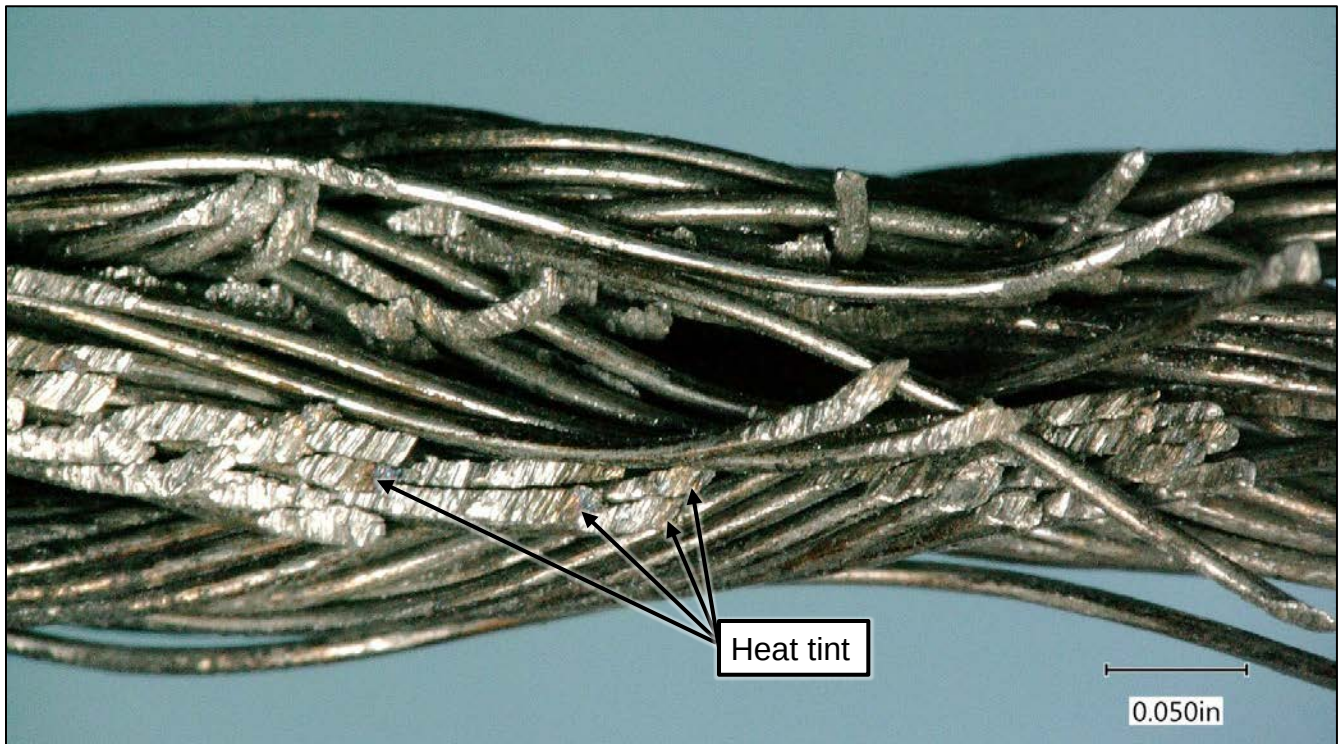
Figure 4. Closer view of sliding contact marks on the cable wires on the shorter cable piece. Several wires show heat tinting as indicated.

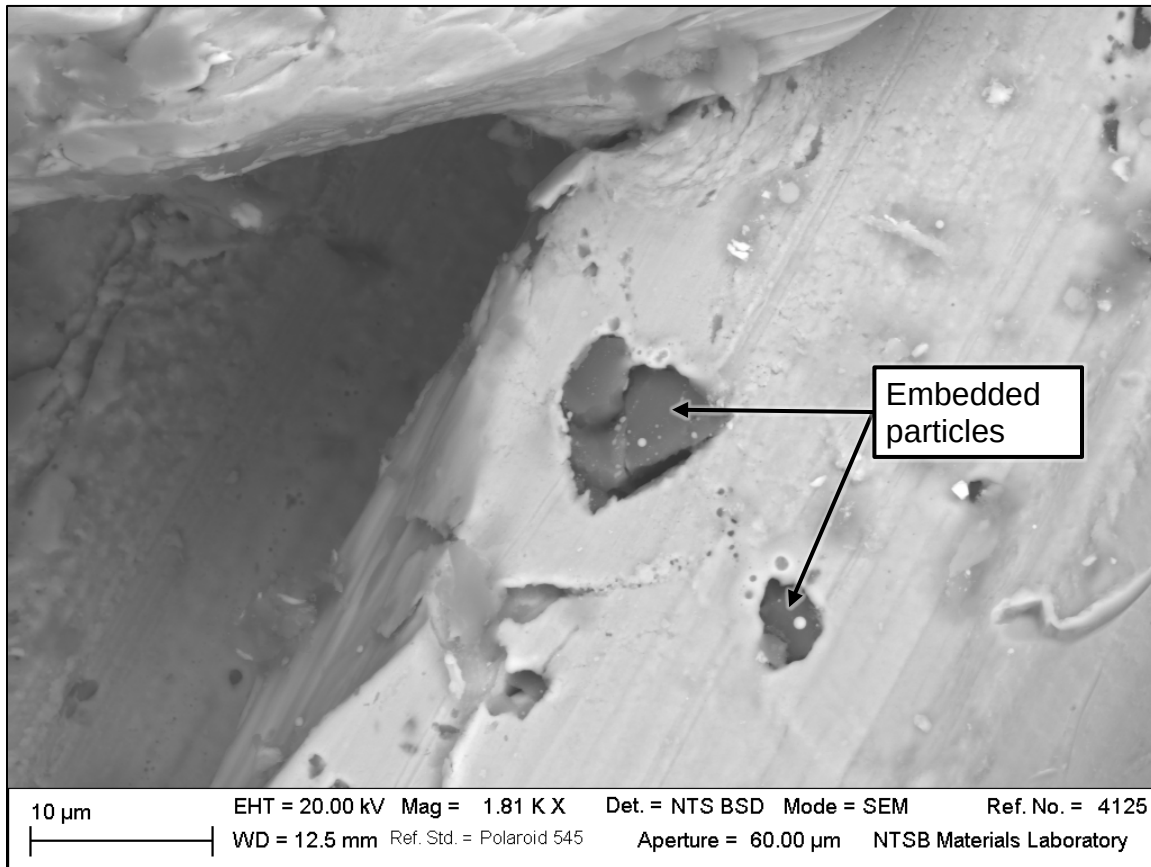
The shorter cable piece was cut using metal shears to facilitate further examination of the sliding contact marks on the separated end using a scanning electron microscope (SEM). The surfaces were examined as received and were partly covered with deposits consistent with particles entrained in grease. However, multiple embedded particles were observed in areas of sliding contact as shown in figure 5. The particles had smooth surface texture and appeared dark gray relative to the light gray color of the wire when viewed using a backscattered electron detector in composition mode.<sup>1</sup> The cable end that had been cut in the lab using metal shears was similarly examined, and no embedded particles were observed on the wire ends cut in the lab.

The overall appearance of parallel sliding contact marks with heat tinting and embedded particles with high peaks of aluminum and oxygen are consistent separation due to a cut from an aluminum oxide abrasive wheel. All wires had a similar cut appearance with no evidence of any wire fractures.

Figure 5. SEM image of embedded particles in the ground surface of the control cable as viewed using a backscattered electron detector in composition mode.

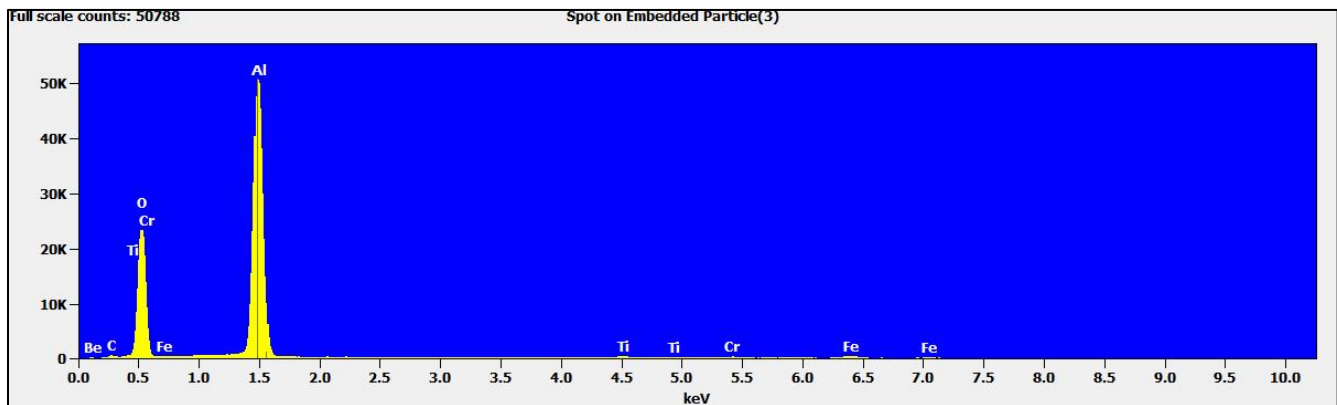
The embedded particles were analyzed using energy-dispersive x-ray spectroscopy (EDS). The particles consistently had relatively high peaks of aluminum and oxygen. An EDS spectrum of the larger embedded particle in figure 5 is shown in figure 6.

Figure 6. EDS spectrum acquired in spot mode focused on the larger embedded particle shown in the previous figure.
