# NATIONAL TRANSPORTATION SAFETY BOARD

## MATERIALS LABORATORY FACTUAL REPORT

Report No. 20-048

Place : Newborn, Georgia  
Date : 1/6/2020  
Vehicle : Cessna 172 H Skyhawk, N1612F  
NTSB No. : ERA20FA068  
Investigator : Aaron Mccarter

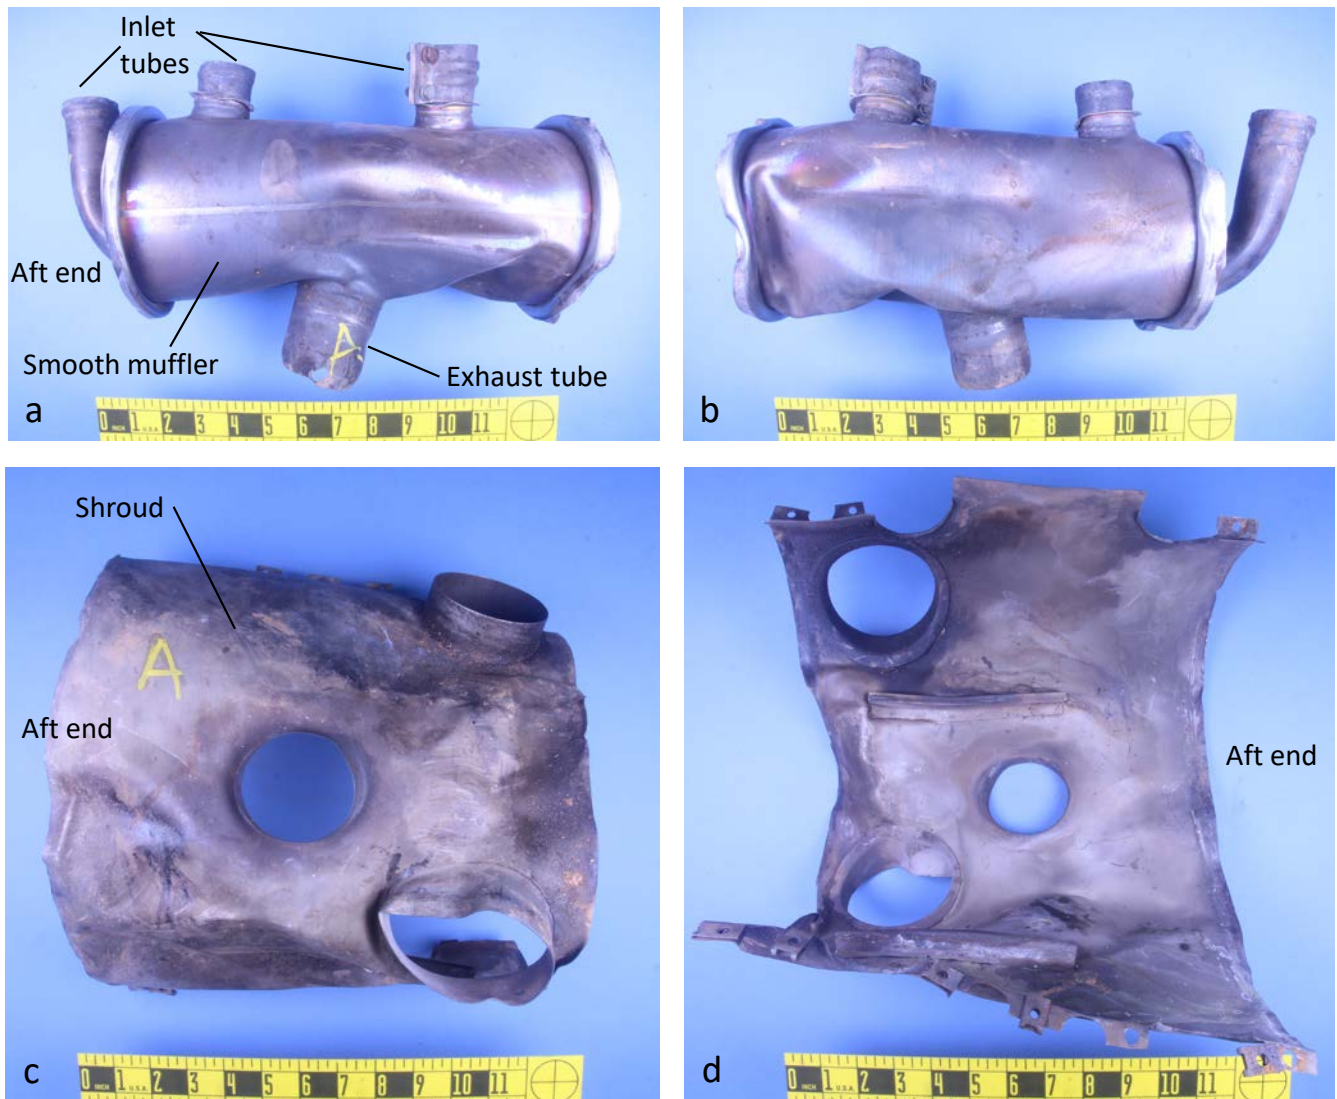
Using visual inspection methods, the left-hand smooth muffler exterior surface was sound with no evidence of cracks, or through-thickness metal wastage. Using a hand-held x-ray fluorescence spectrometer, the left-hand smooth-muffler main-tube is fabricated from type 321 stainless steel. No serial number or manufacturer identification marks were noted on the exterior surfaces of the smooth muffler. According to the airplane maintenance records, the left-hand muffler was replaced with a Nicrocraft<sup>1</sup> 568-110 (S/N 55-0005) on 4/1/2010.

Figure 1 Images of portions of the left-hand smooth muffler (views a, b) and separated shroud (views c, d) (identified as "A")

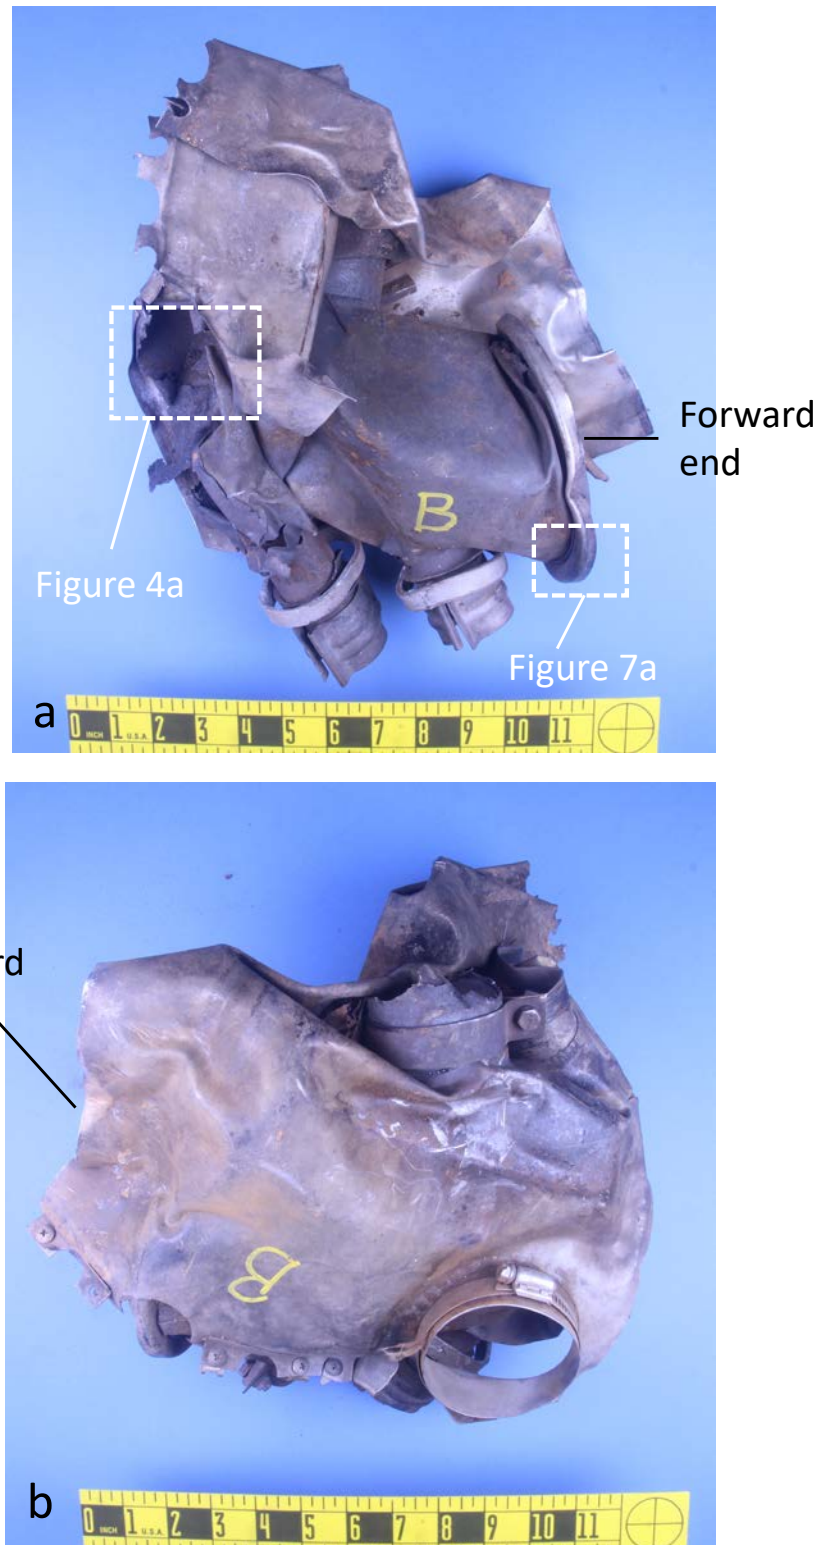
Figure 2 Images of portions of the right-hand smooth muffler and shroud (identified as "B").

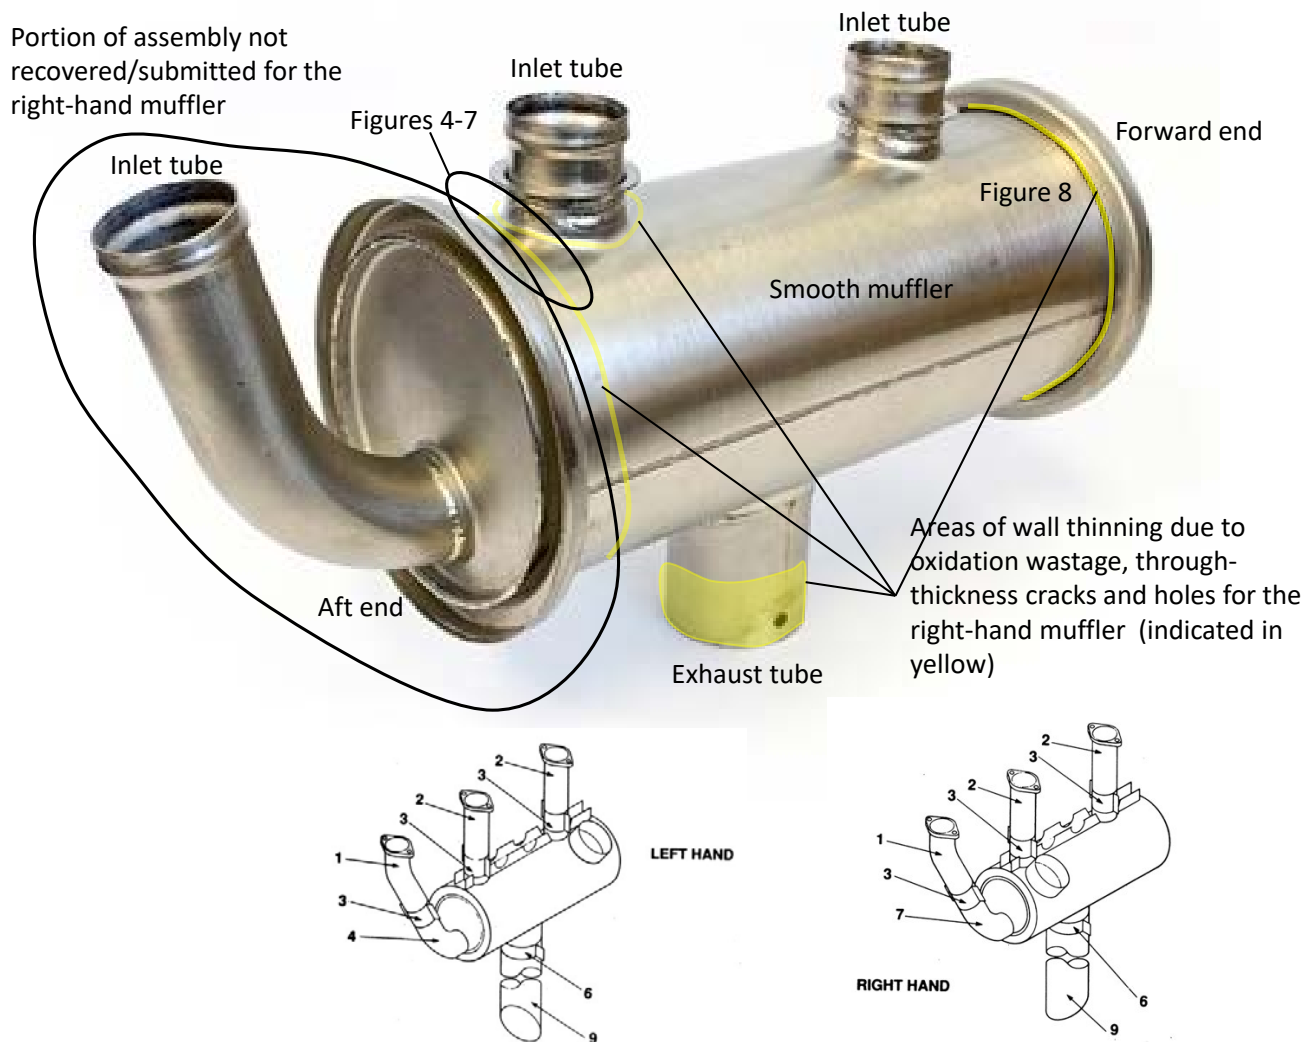
The right-hand muffler and shroud exhibited substantial mechanical damage during the accident sequence. The aft face of the muffler with inlet tube was separated from the assembly and was not recovered as depicted in Figure 3. Using visual inspection methods (5X to 50X stereo-zoom microscope), the right-hand smooth muffler surface exhibited cracks, and through-thickness metal wastage. The fractures associated with the separation of the aft face with inlet tube exhibited largely oxidized fracture surfaces and thinned walls (See Figures 3 through 6). The center inlet tube was separated from the rest of the muffler due to loss of mechanical integrity from metal wastage (see Figures 2 and 3). Holes and wall thickness loss was also noted around the muffler body at the aft face as shown in Figure 3 and 6.

Figure 3 Image of an exemplar smooth muffler showing annotations related to the right-hand accident muffler. For reference, the lower drawings are IPC images of the left and right-hand mufflers with shrouds and risers. All images are taken from the Nicrocraft catalog.

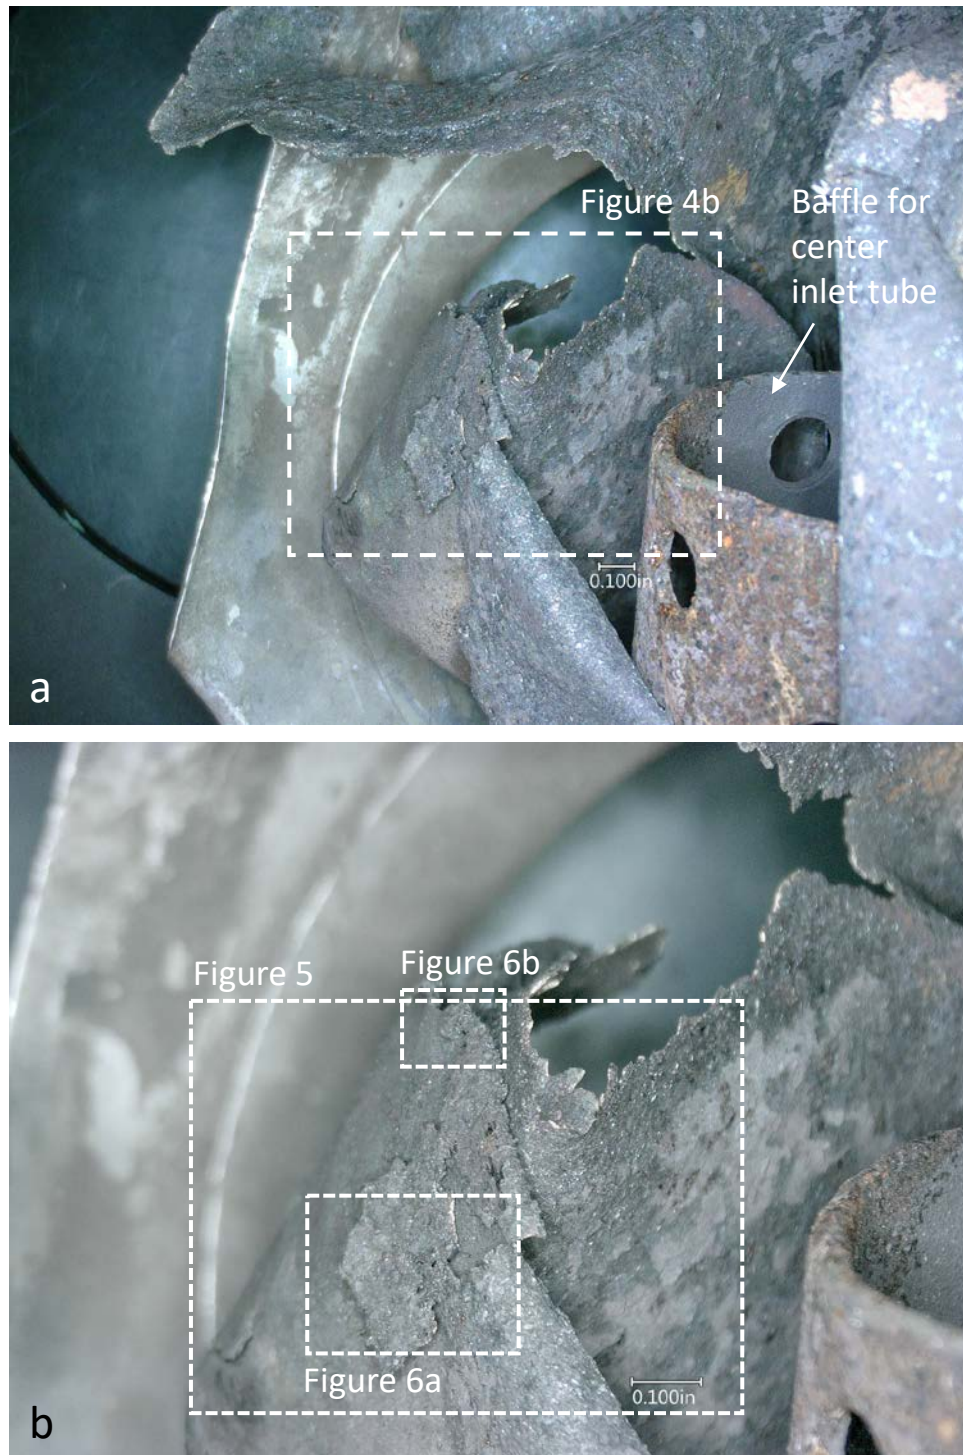
Figure 4 Digital microscope images of the fracture surfaces at the aft end of the right-hand muffler (See Figure 3 for orientation). Views a and b show the fractured edge of the muffler wall at progressively higher magnifications.

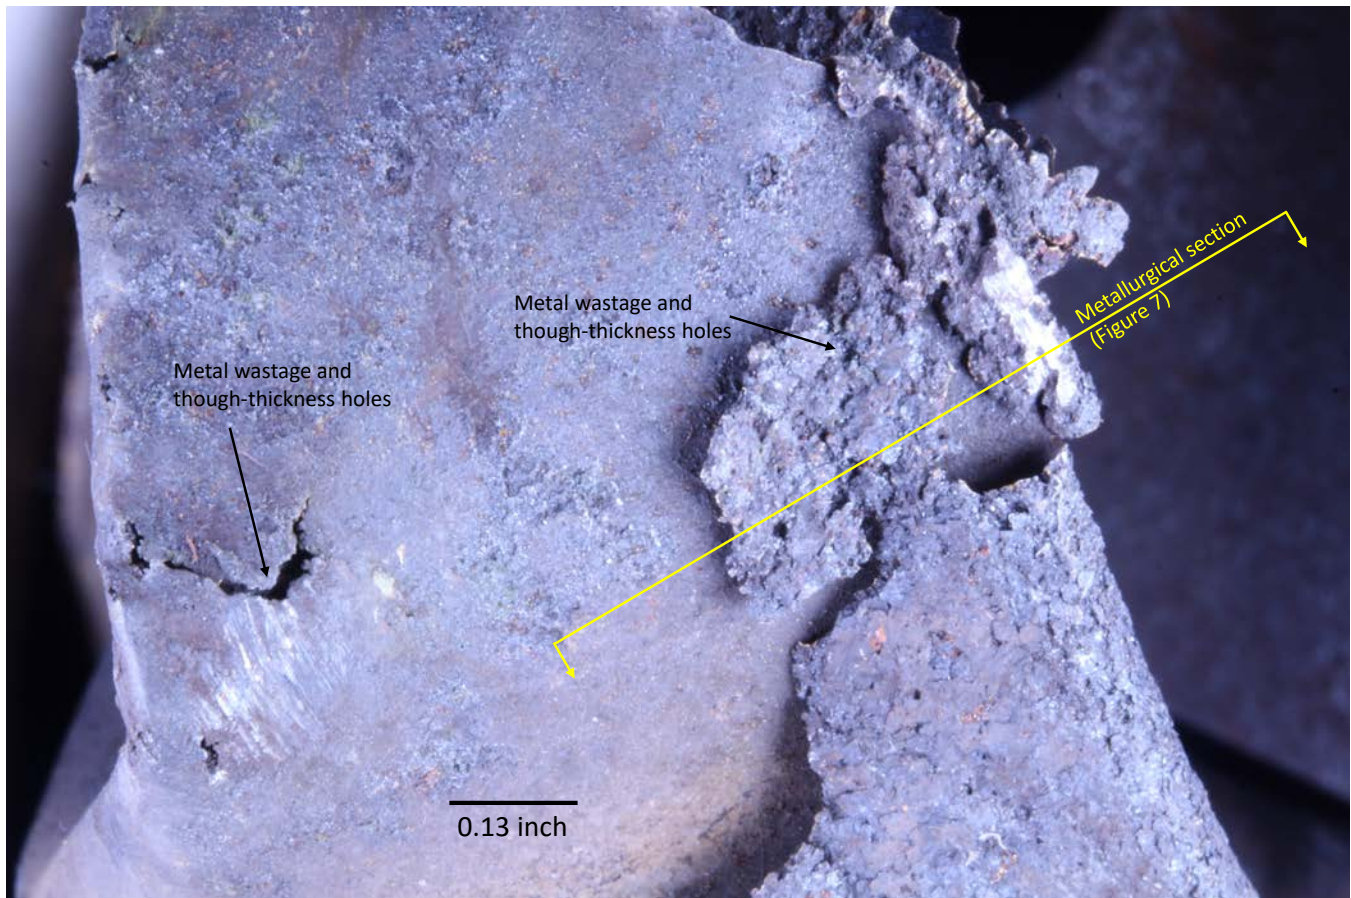
As shown in Figure 5, a metallurgical cross-section was taken through an exemplar area of metal wastage as revealed in Figure 7. The micrograph of the cross-section shows evidence of general thermal oxidative loss of material wall thickness as well as through-thickness holes and cracks

Figure 5 Close image of the fracture surfaces at the aft end of the right-hand muffler (see Figure 3 for orientation). Areas exhibiting metal wastage and holes are annotated. A reference line for a metallurgical cross-section through a representative area of metal wastage is identified. An image of the cross-section is shown in Figure 7.

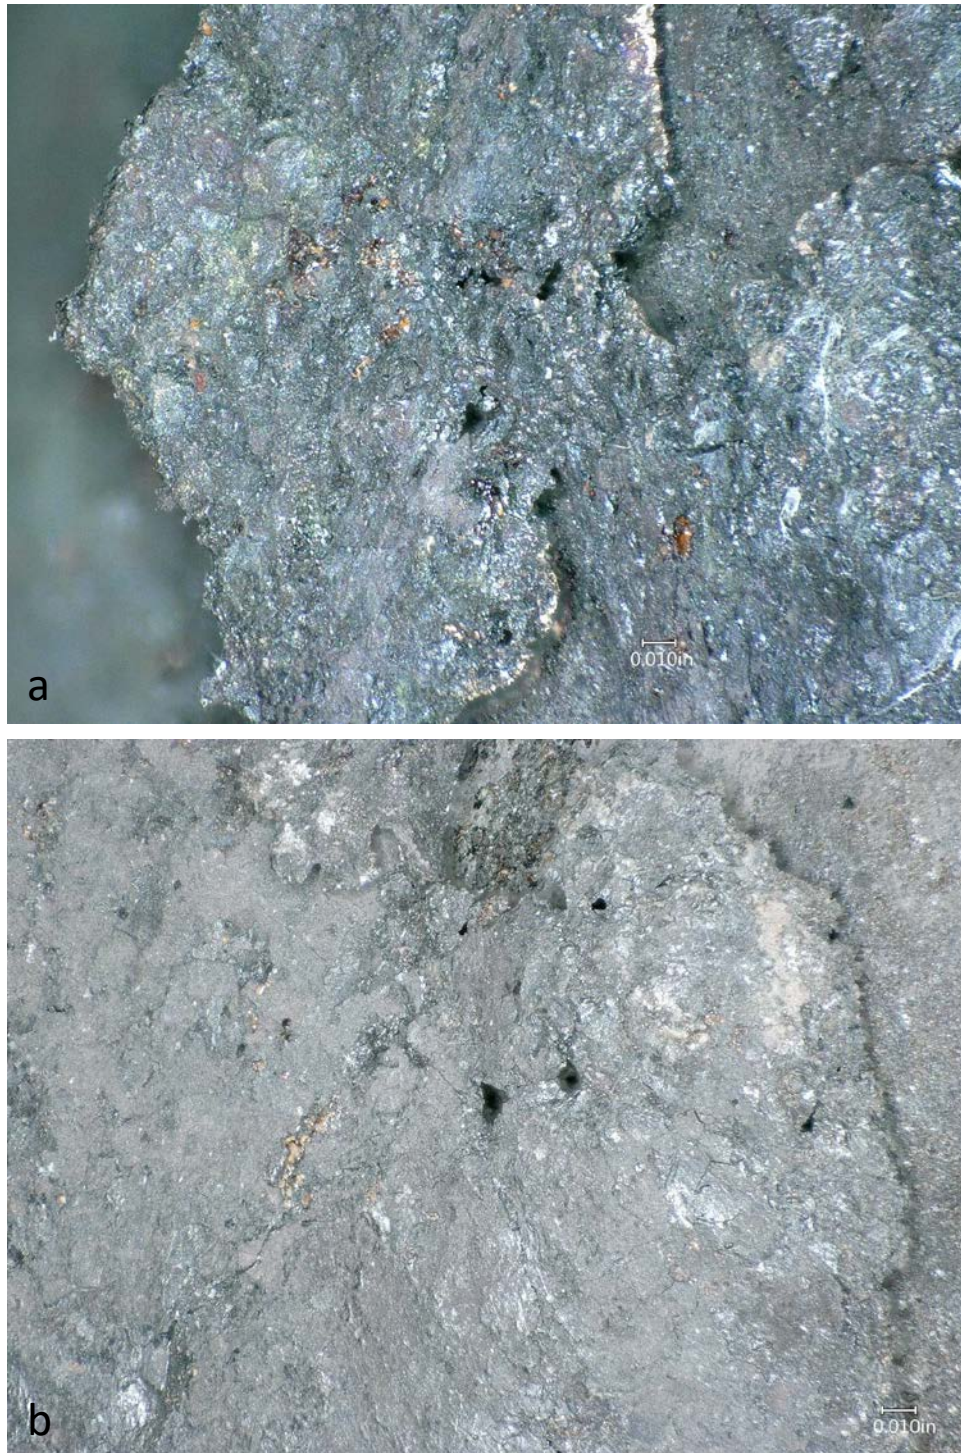
Figure 6 Close view digital microscope images of areas highlighted in Figure 4b revealing oxidized fracture surfaces and signatures of general metal wastage and holes .

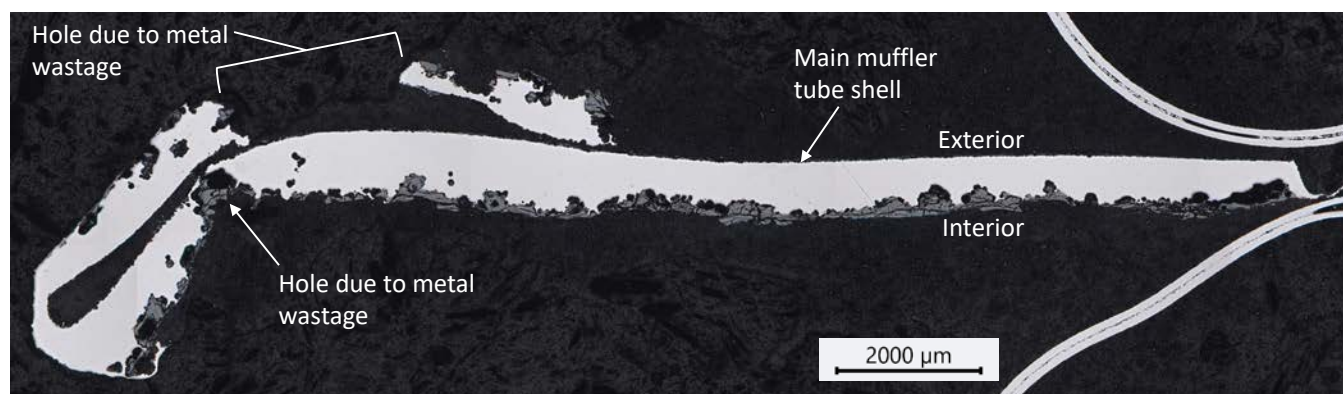
Figure 7 Brightfield optical micrograph montage of a metallurgical cross-section through an area of metal wastage indicated in Figure 5. The micrograph shows evidence of general thermal oxidative loss of the internal material wall thickness as well as through-thickness holes and cracks.

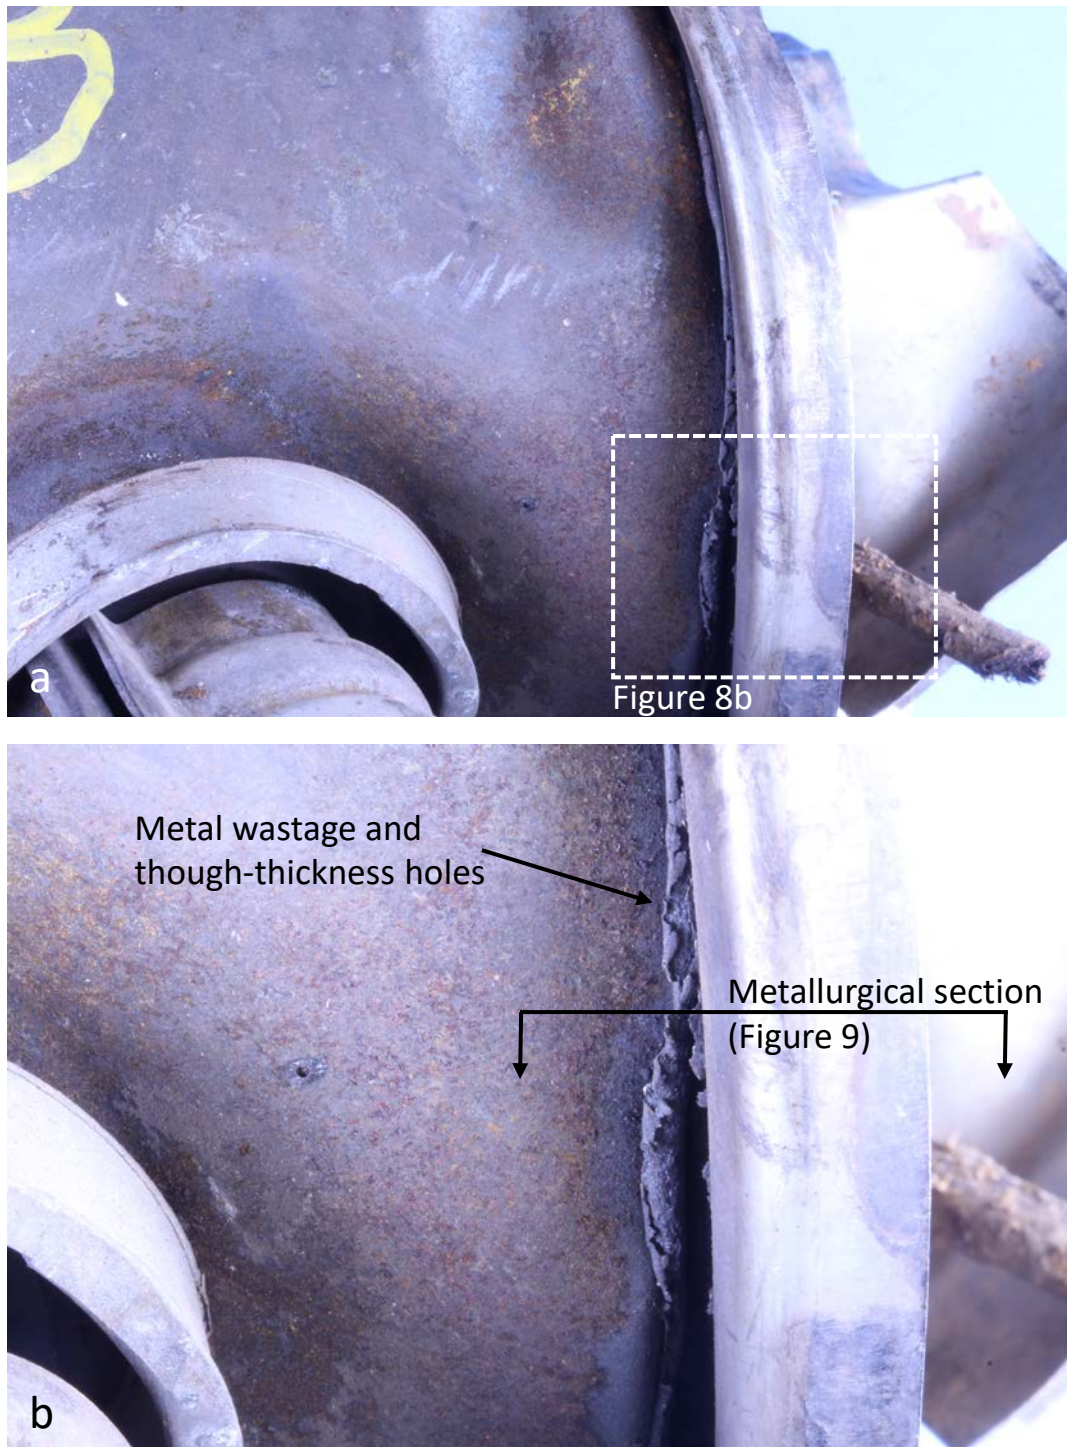
Figure 8 shows metal wastage and wall-thickness through-holes adjacent to the crimp seal between the muffler tube and the forward end plate. A metallurgical cross section was taken in the region as shown in Figures 8a and 9.

Figure 8 Images of the fracture surfaces at the forward end of the right-hand muffler (see Figures 3 for orientation) showing holes due to metal wastage. View b is a higher magnification image and is annotated to show the location of a metallurgical cross section (see Figure 9).

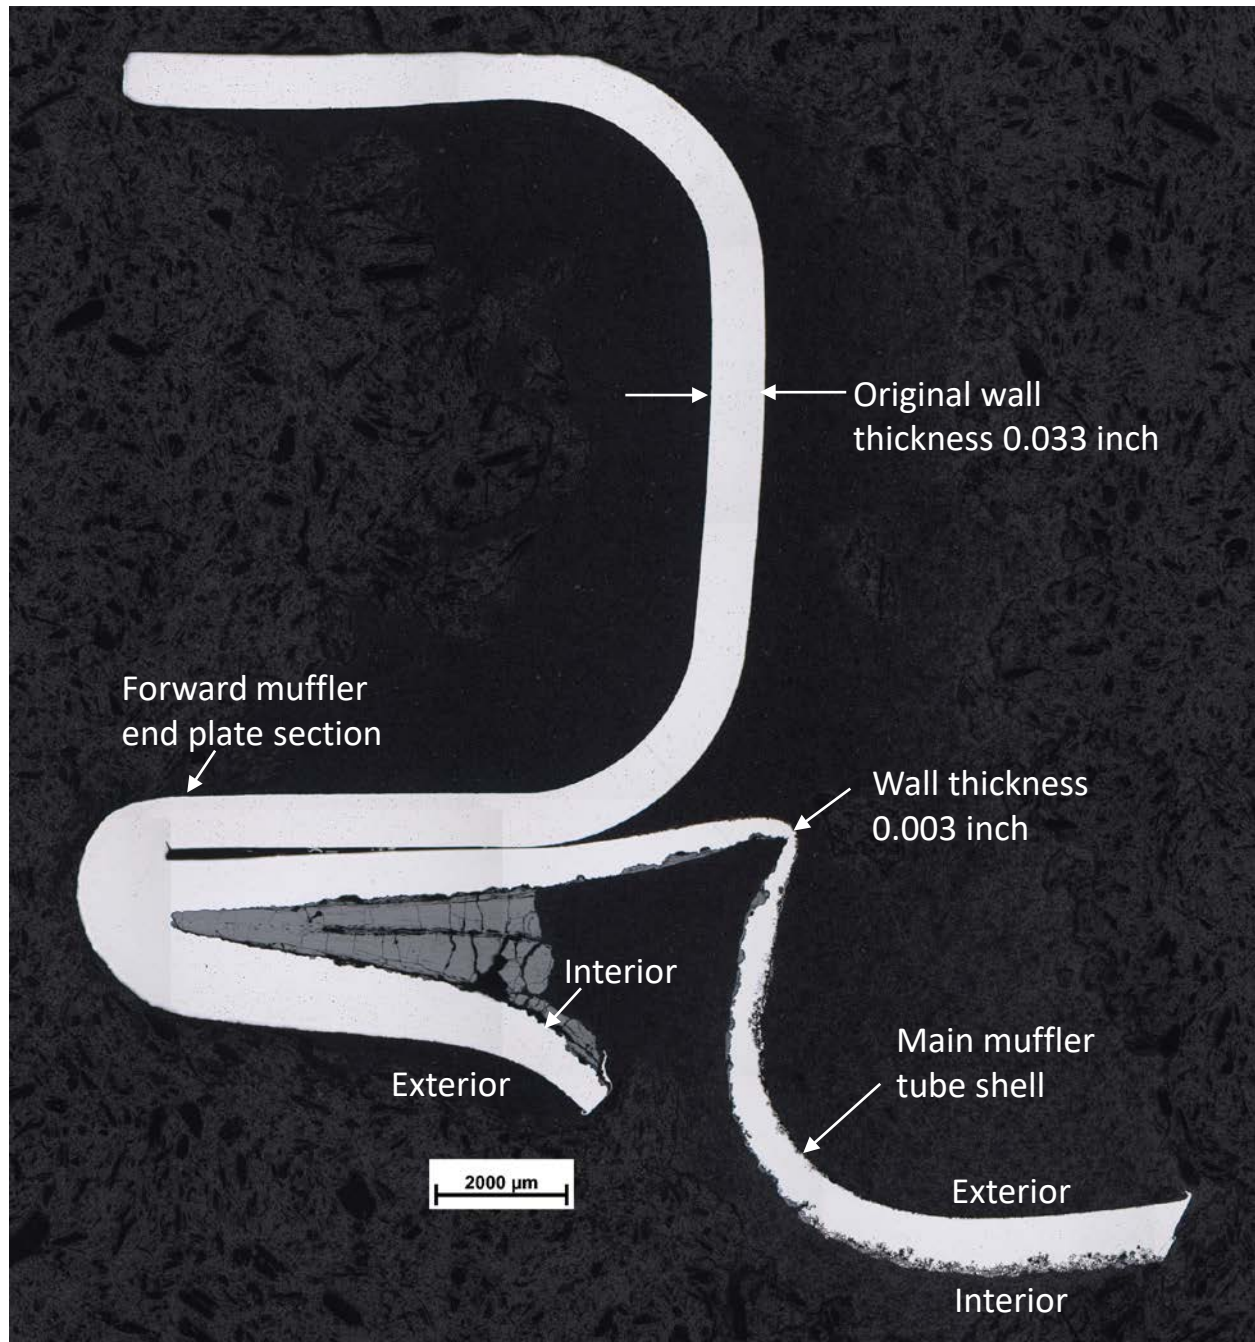
Figure 9 Brightfield optical micrograph montage of a metallurgical cross-section through an area of metal wastage indicated in Figure 8a. The micrograph shows evidence of general thermal oxidative loss of material wall thickness as well as through-thickness holes and cracks. Within the crimped joint, the original wall thickness was measured.
