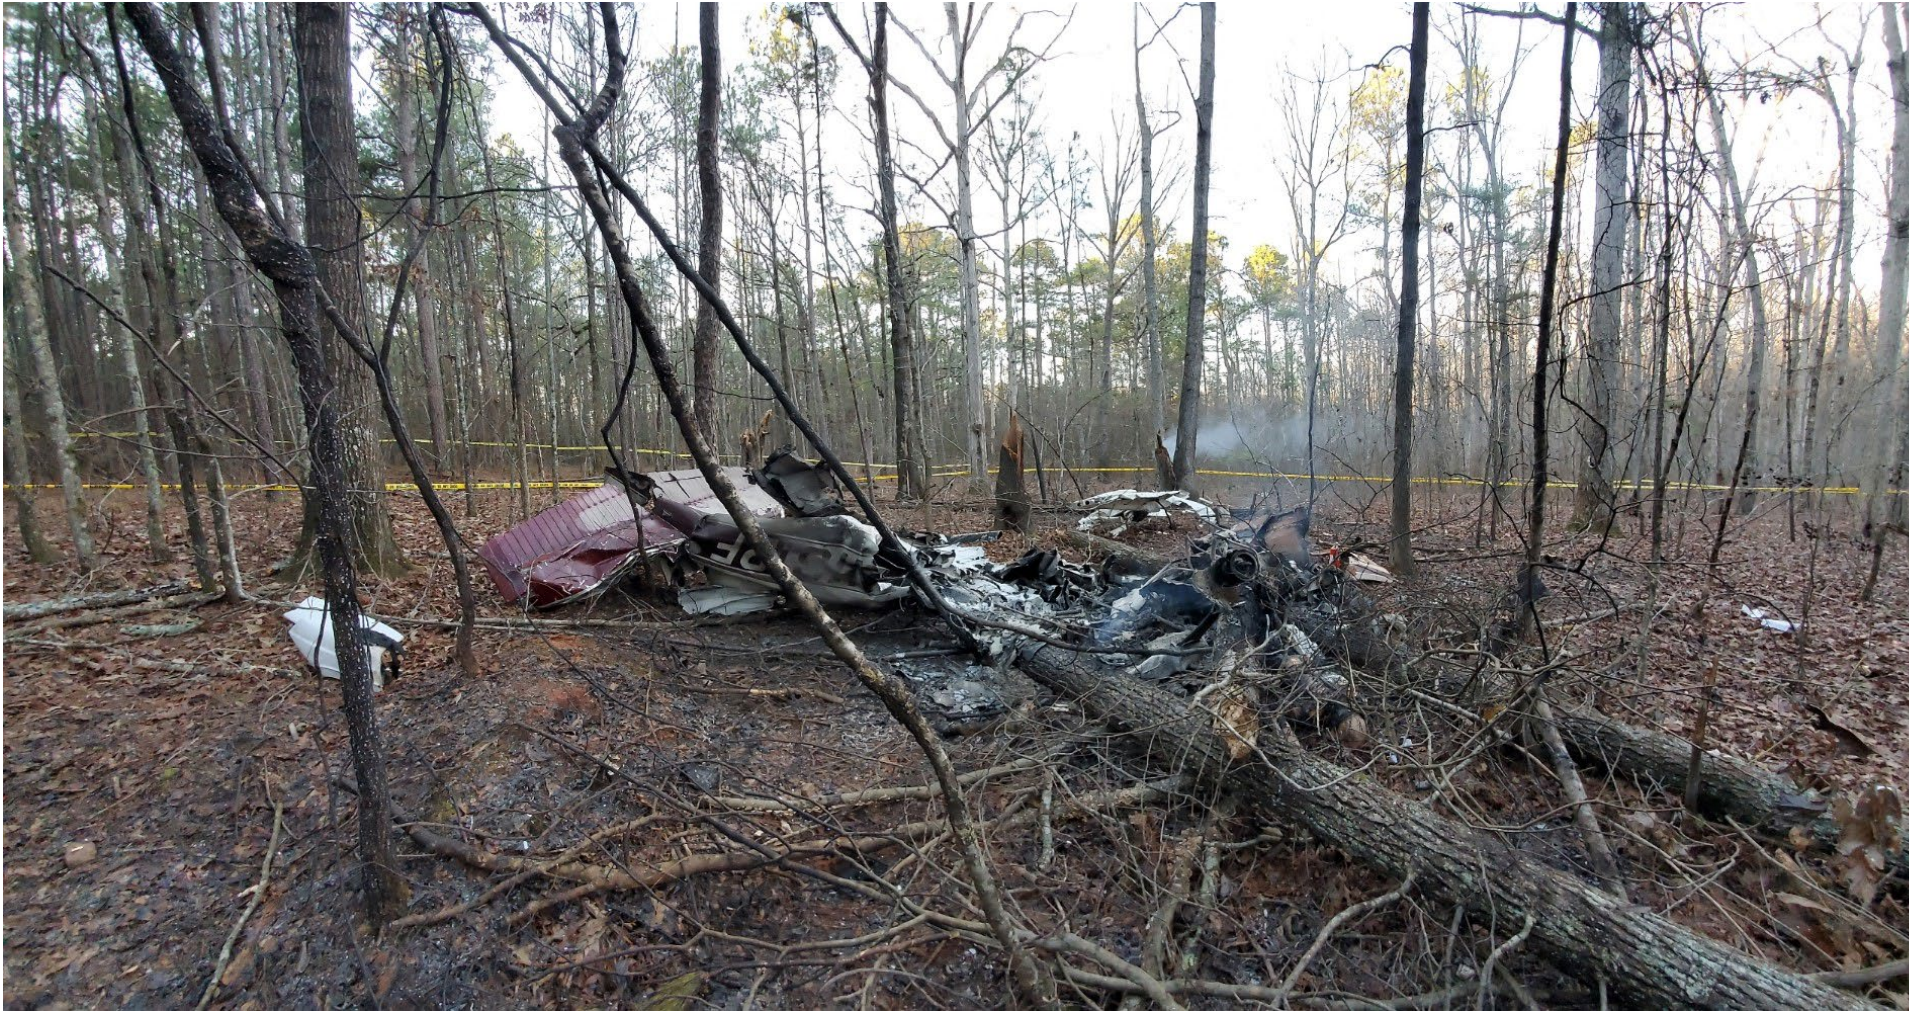
**Photo 1 – Wide angle view of airplane wreckage looking towards the initial impact site about 180 ft in the background.  
(Courtesy of Coweta County Police)**

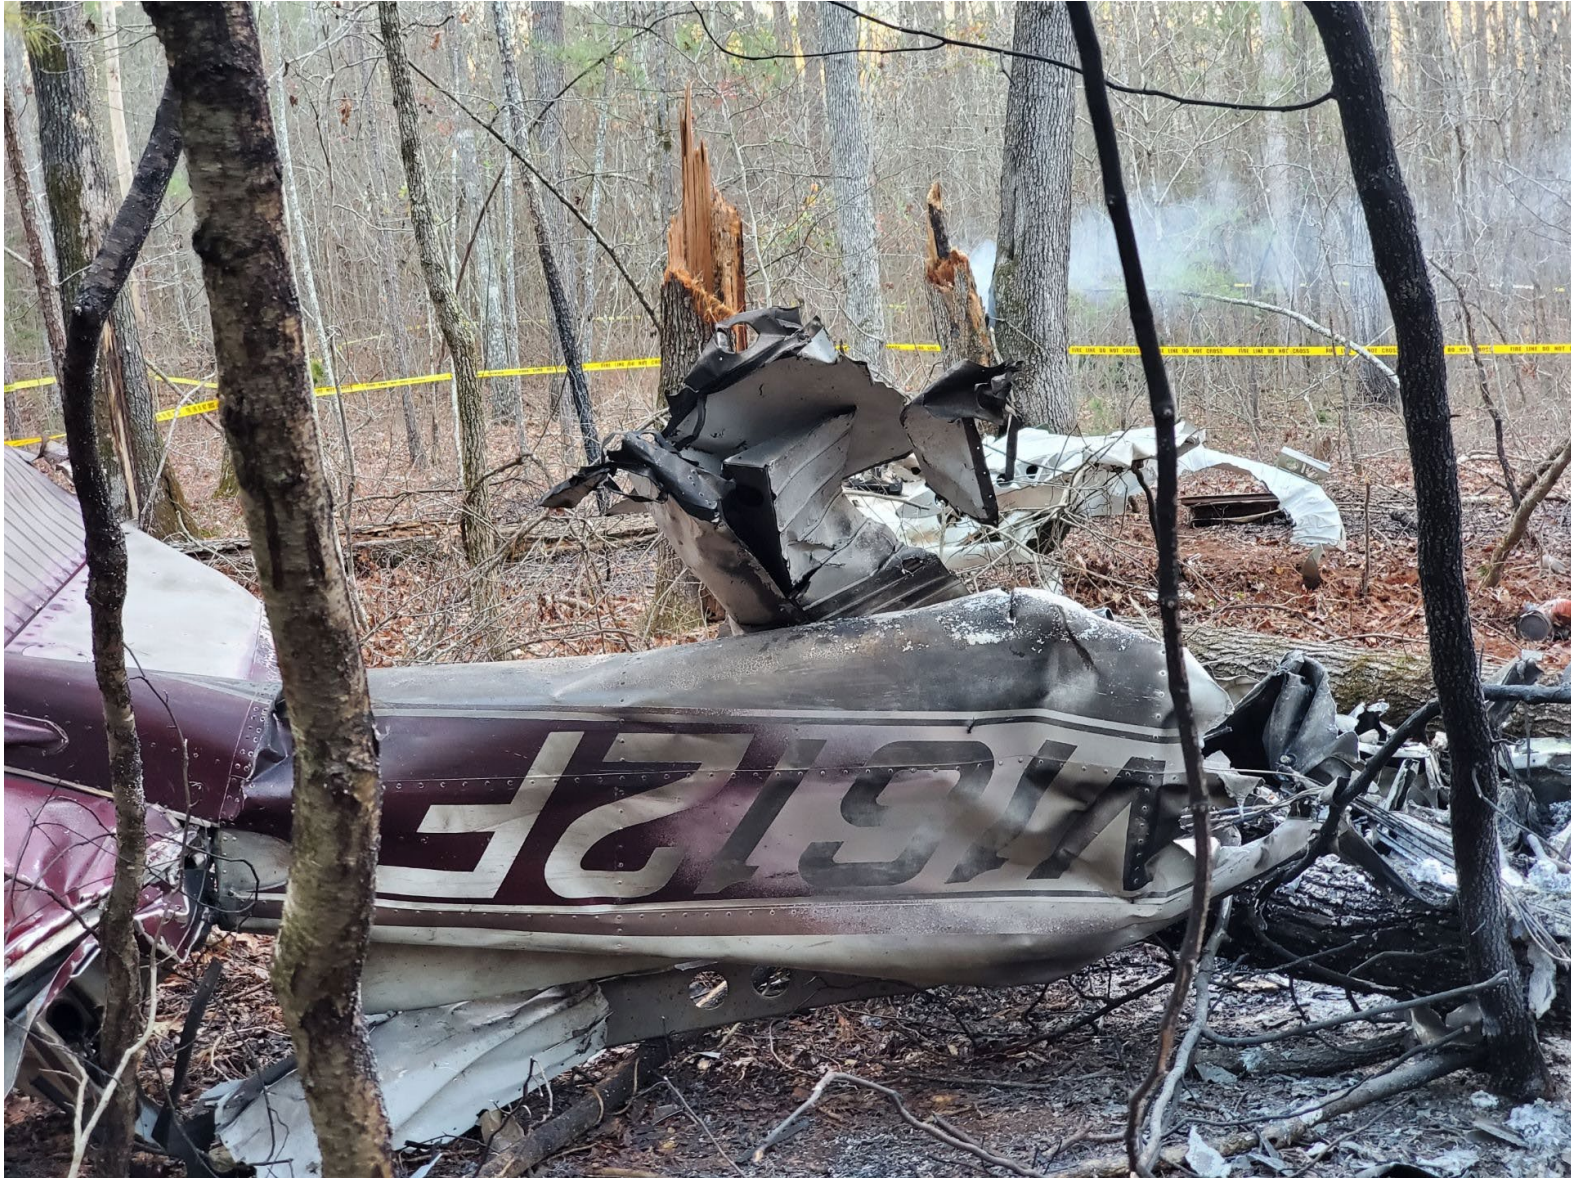
**Photo 2 – Close up view of fuselage damage looking towards the initial impact site that originated about 180 ft in the background.**

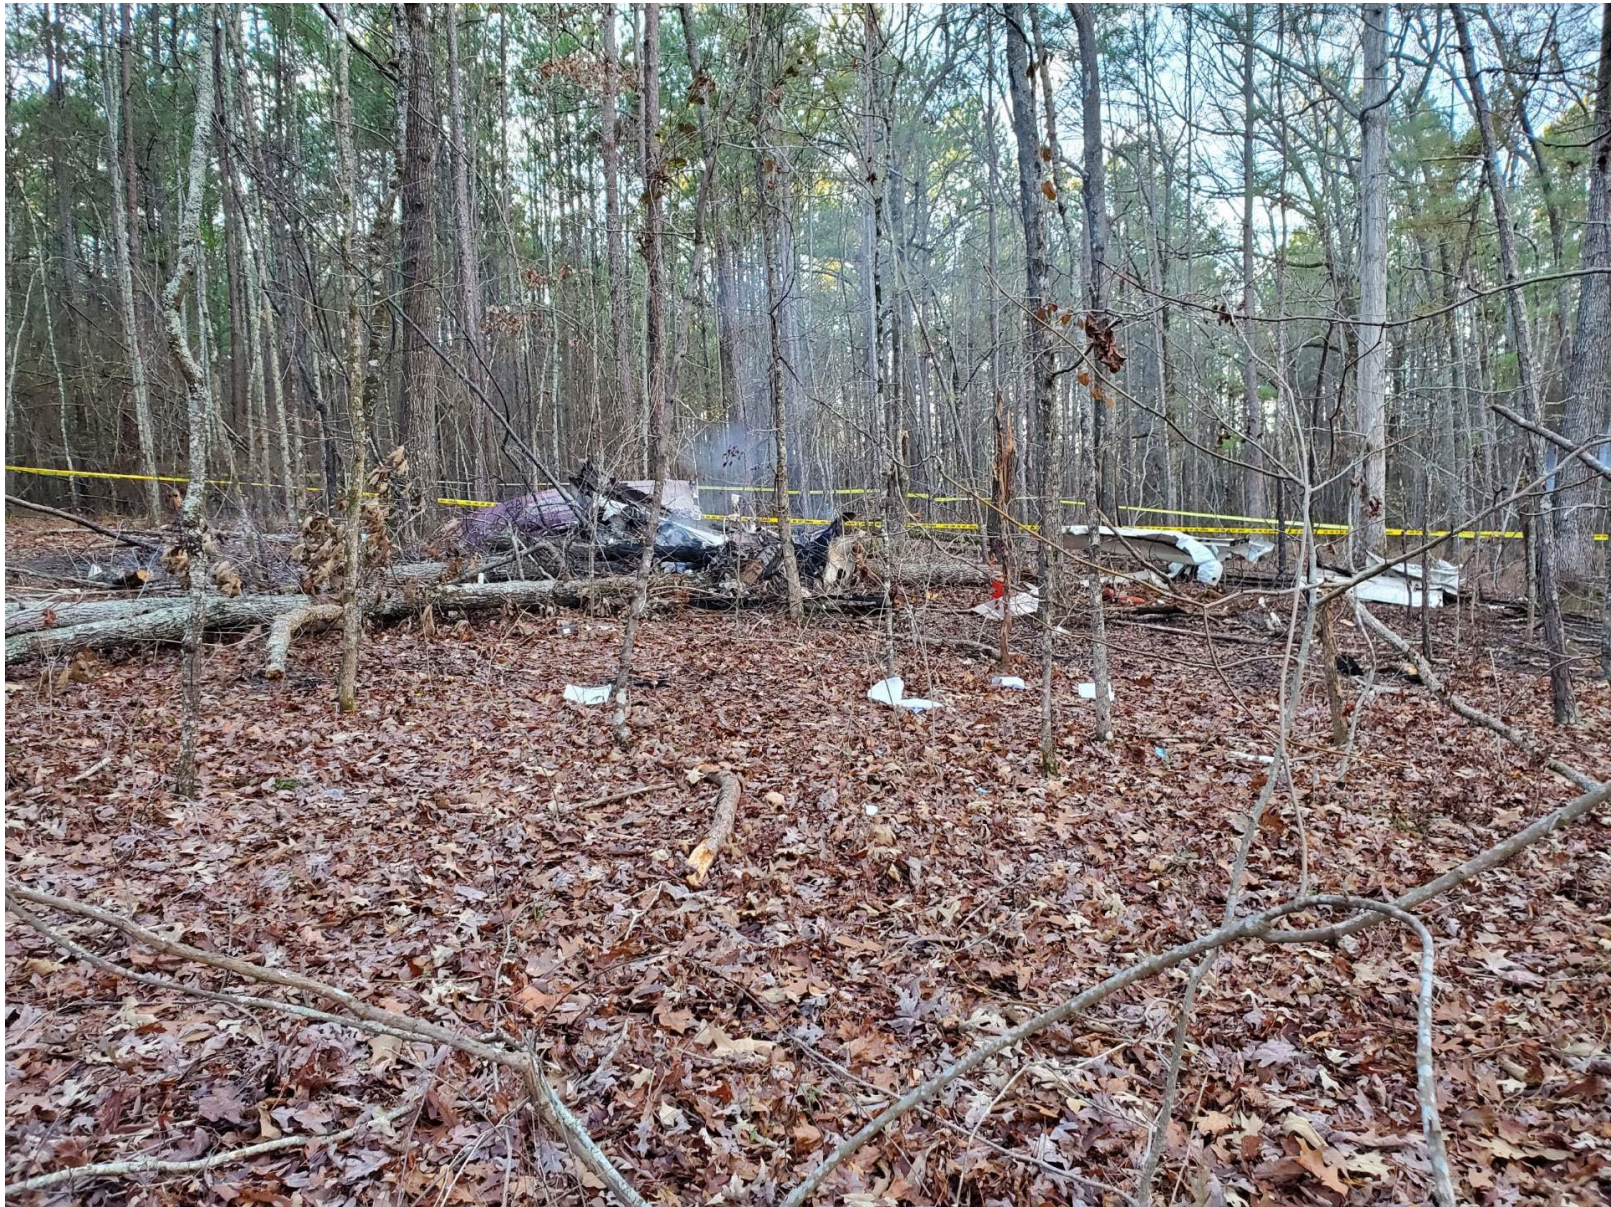
**Photo 3 – Wide view of left side of airplane wreckage and debris field.**

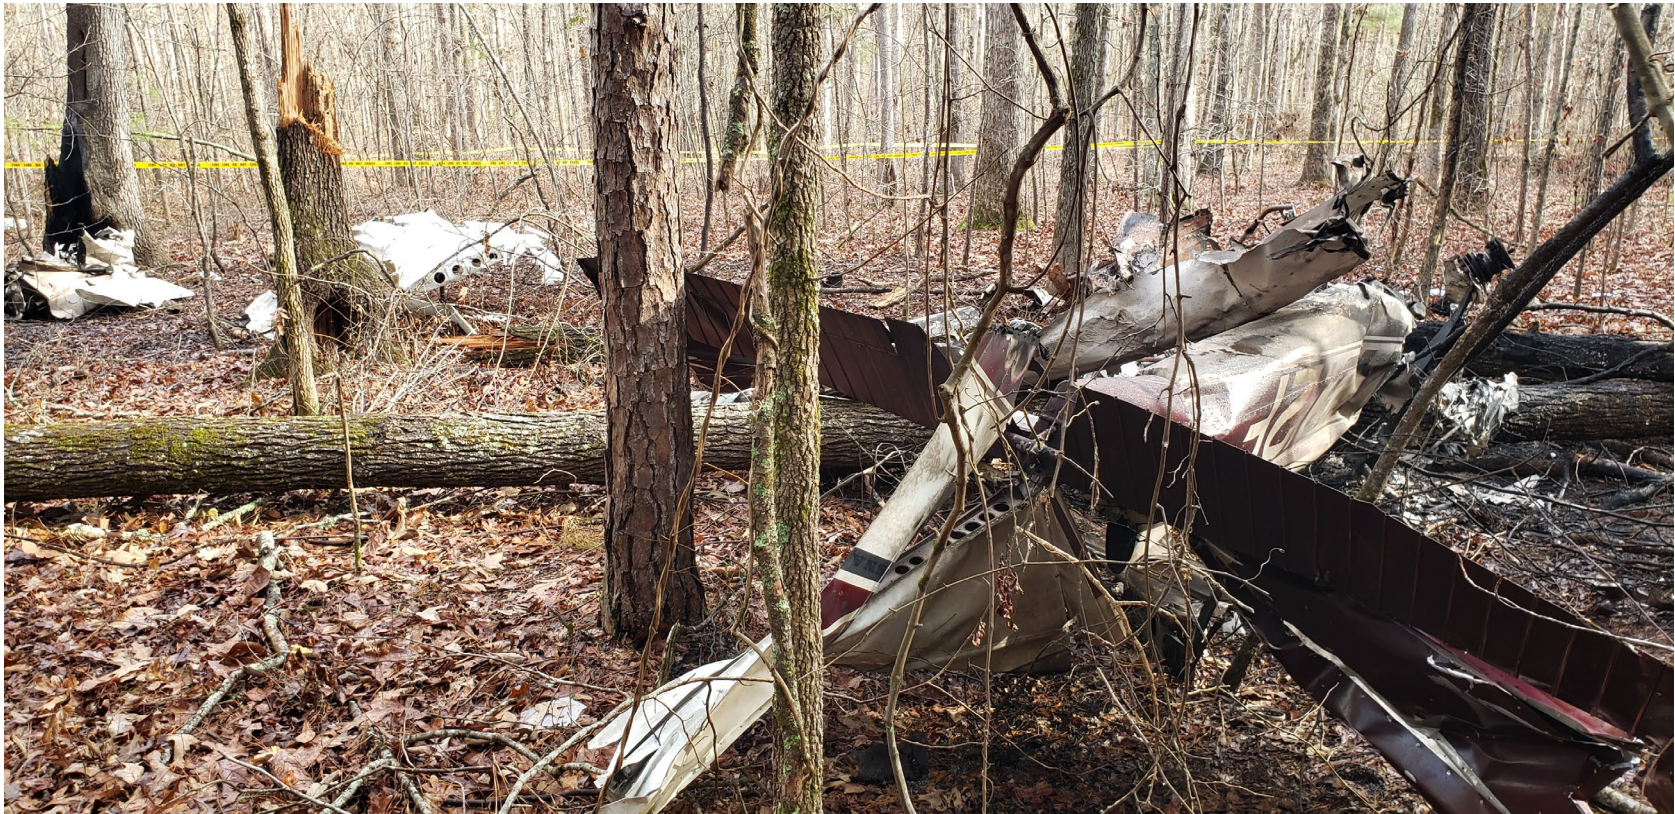
**Photo 4 – Aft view of wreckage.**

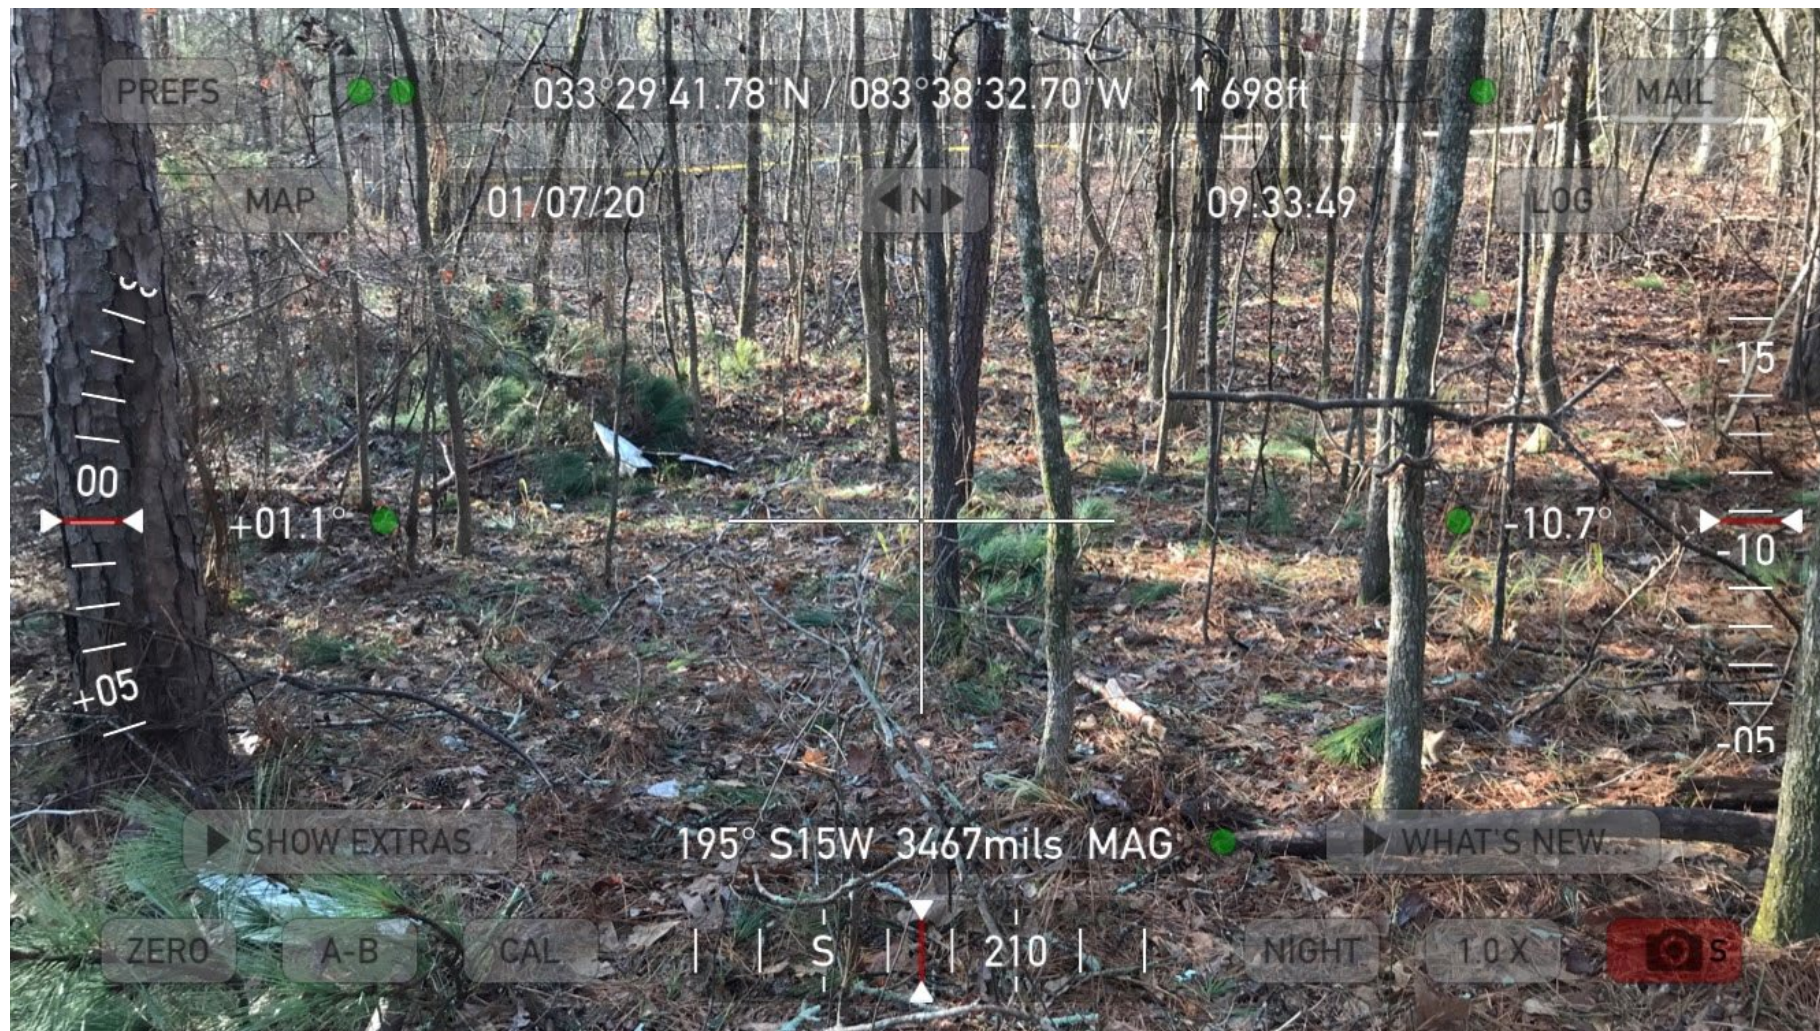
**Photo 5 – Wreckage path and direction of travel. Note airplane debris and broken limbs.**

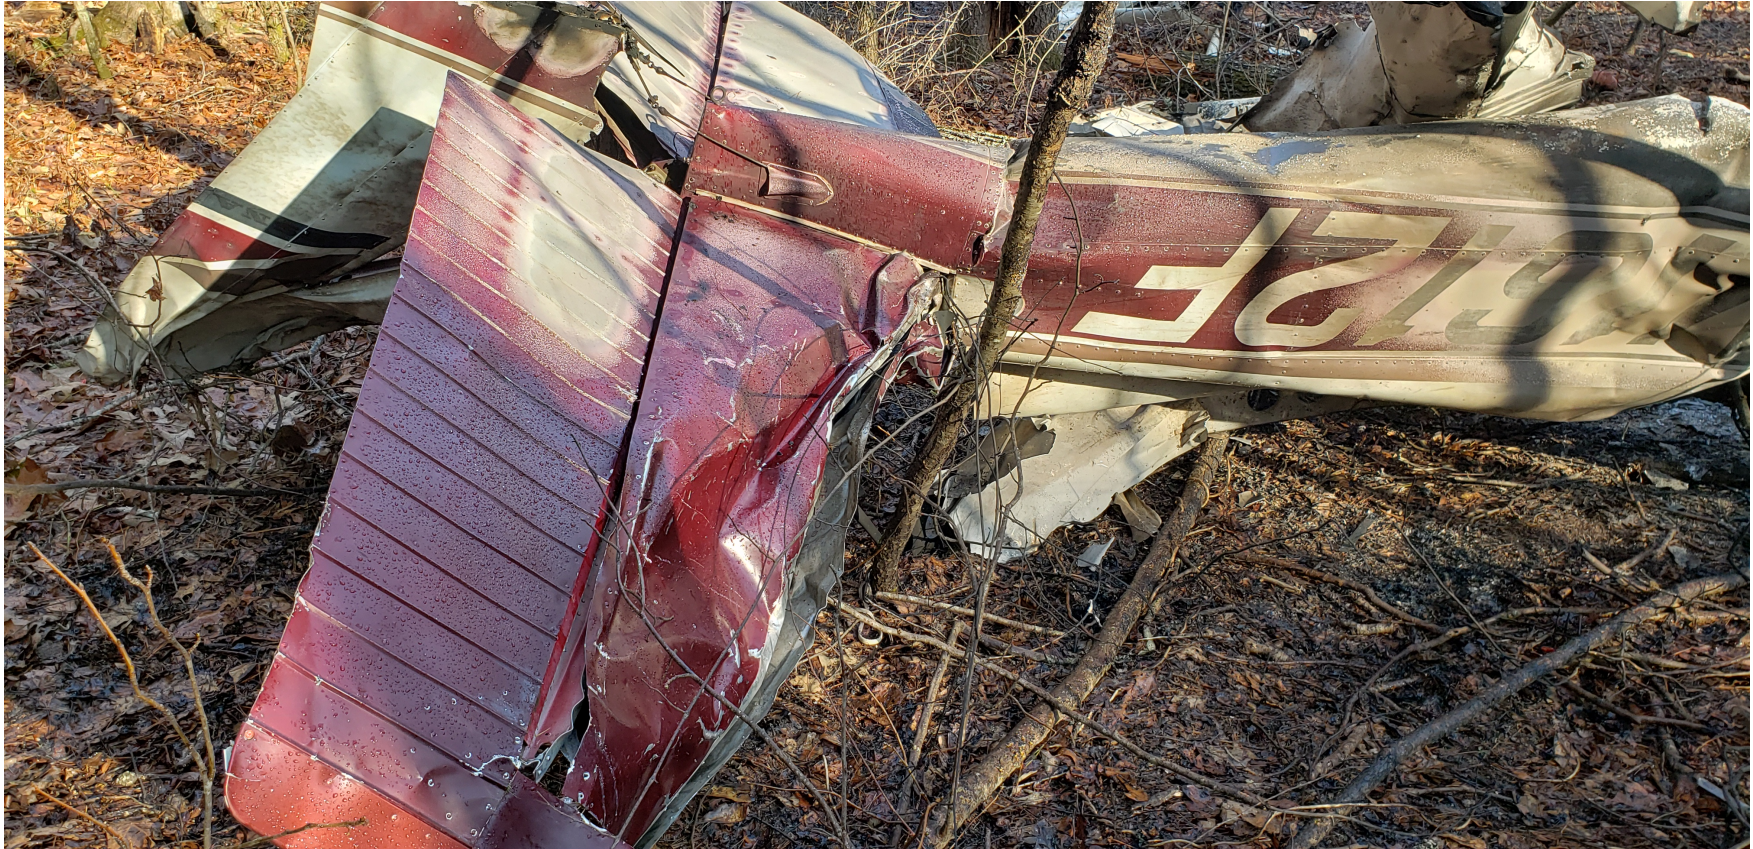
**Photo 6 – Close up view of left side of empennage (inverted) showing damage to horizontal and vertical stabilizer.**

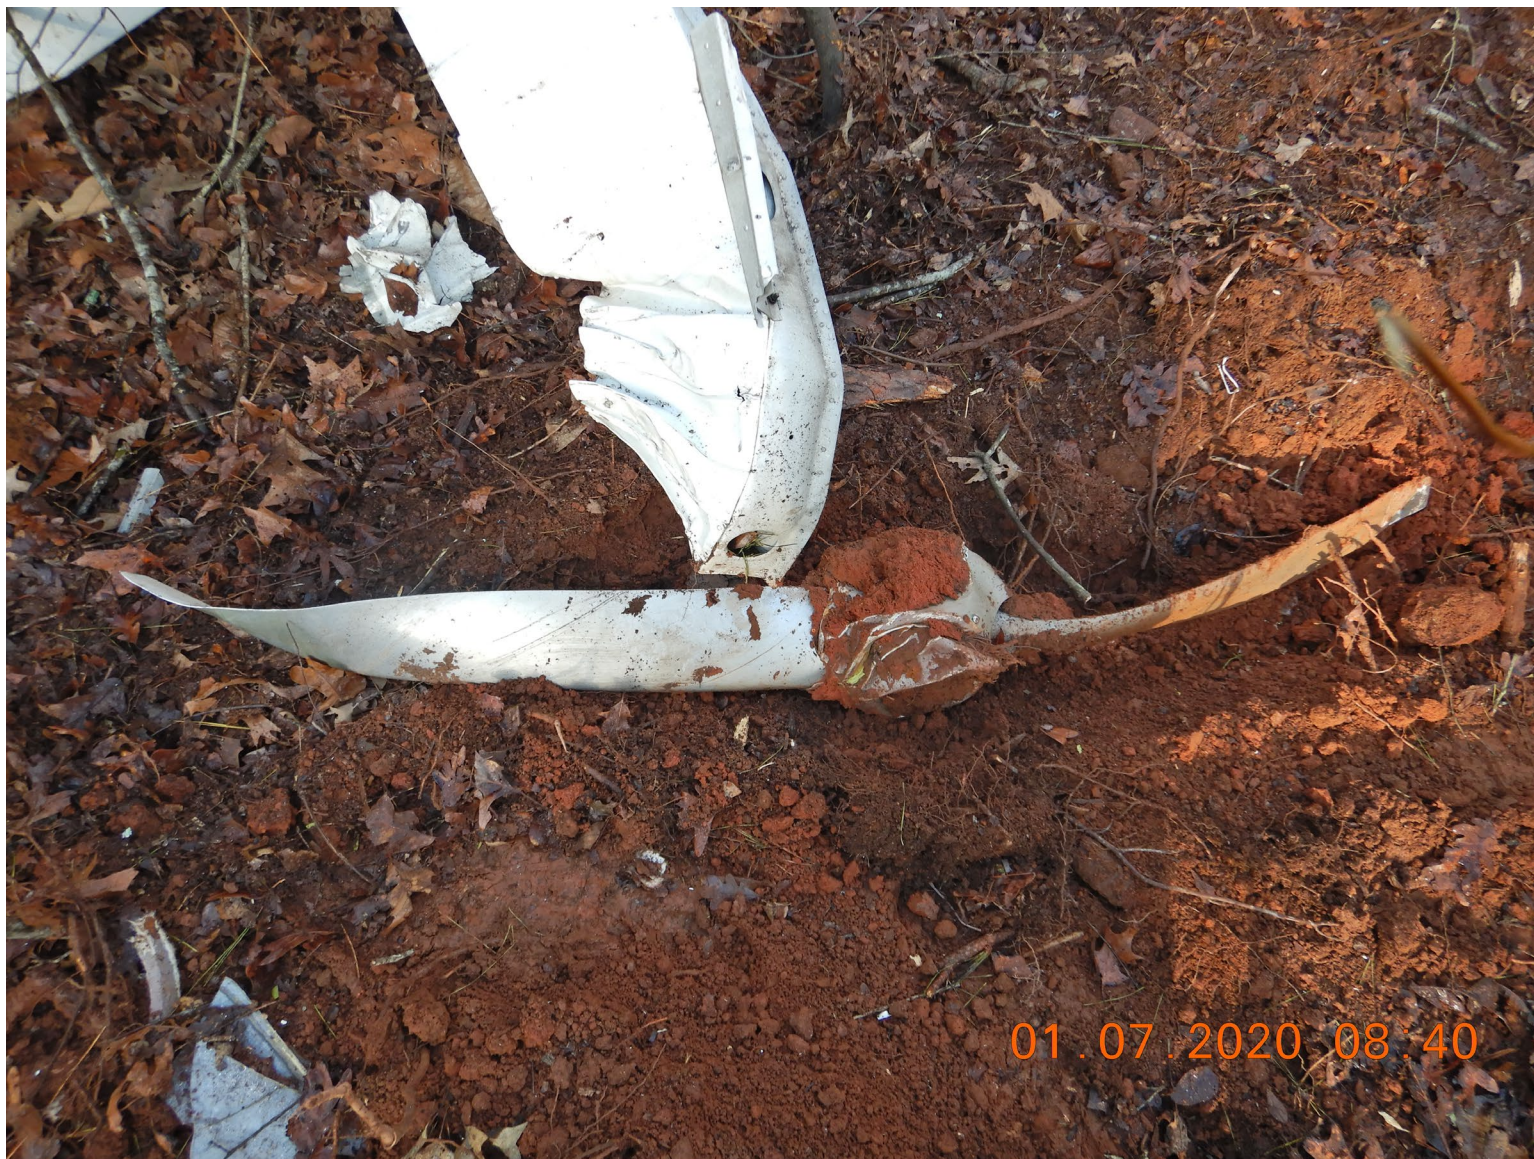
**Photo 7 – View of separated propeller after removal from the ground.**

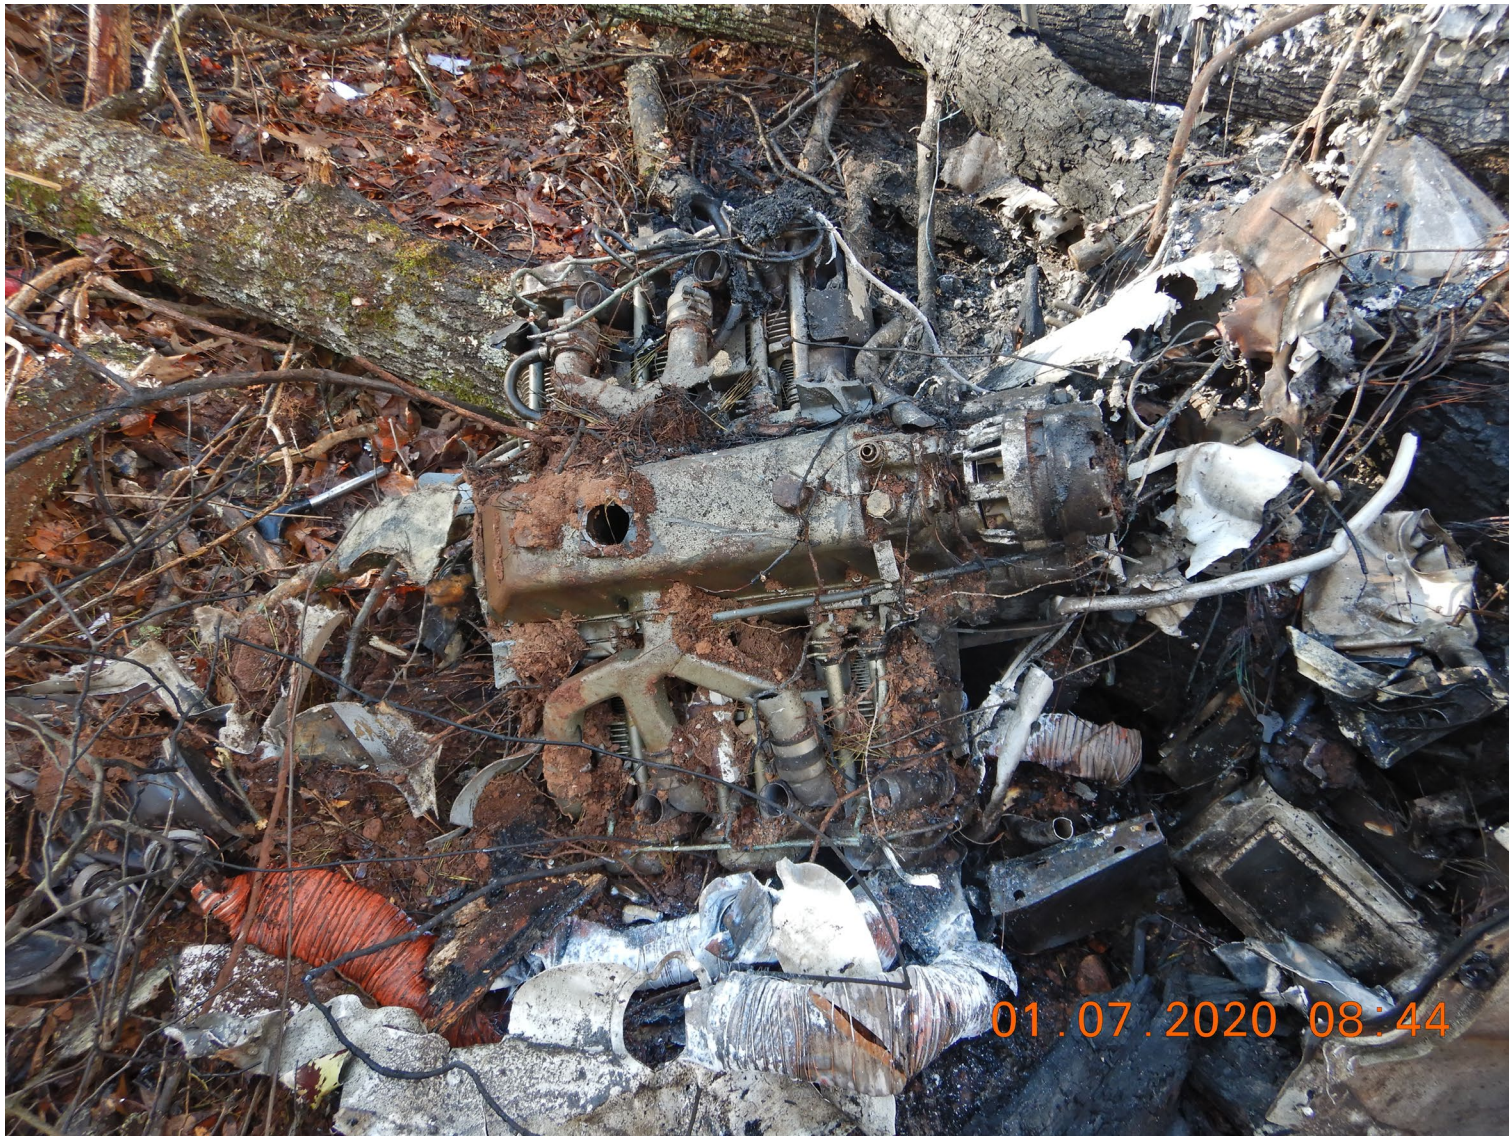
**Photo 8 – View of underside of the engine as discovered at the accident site.**

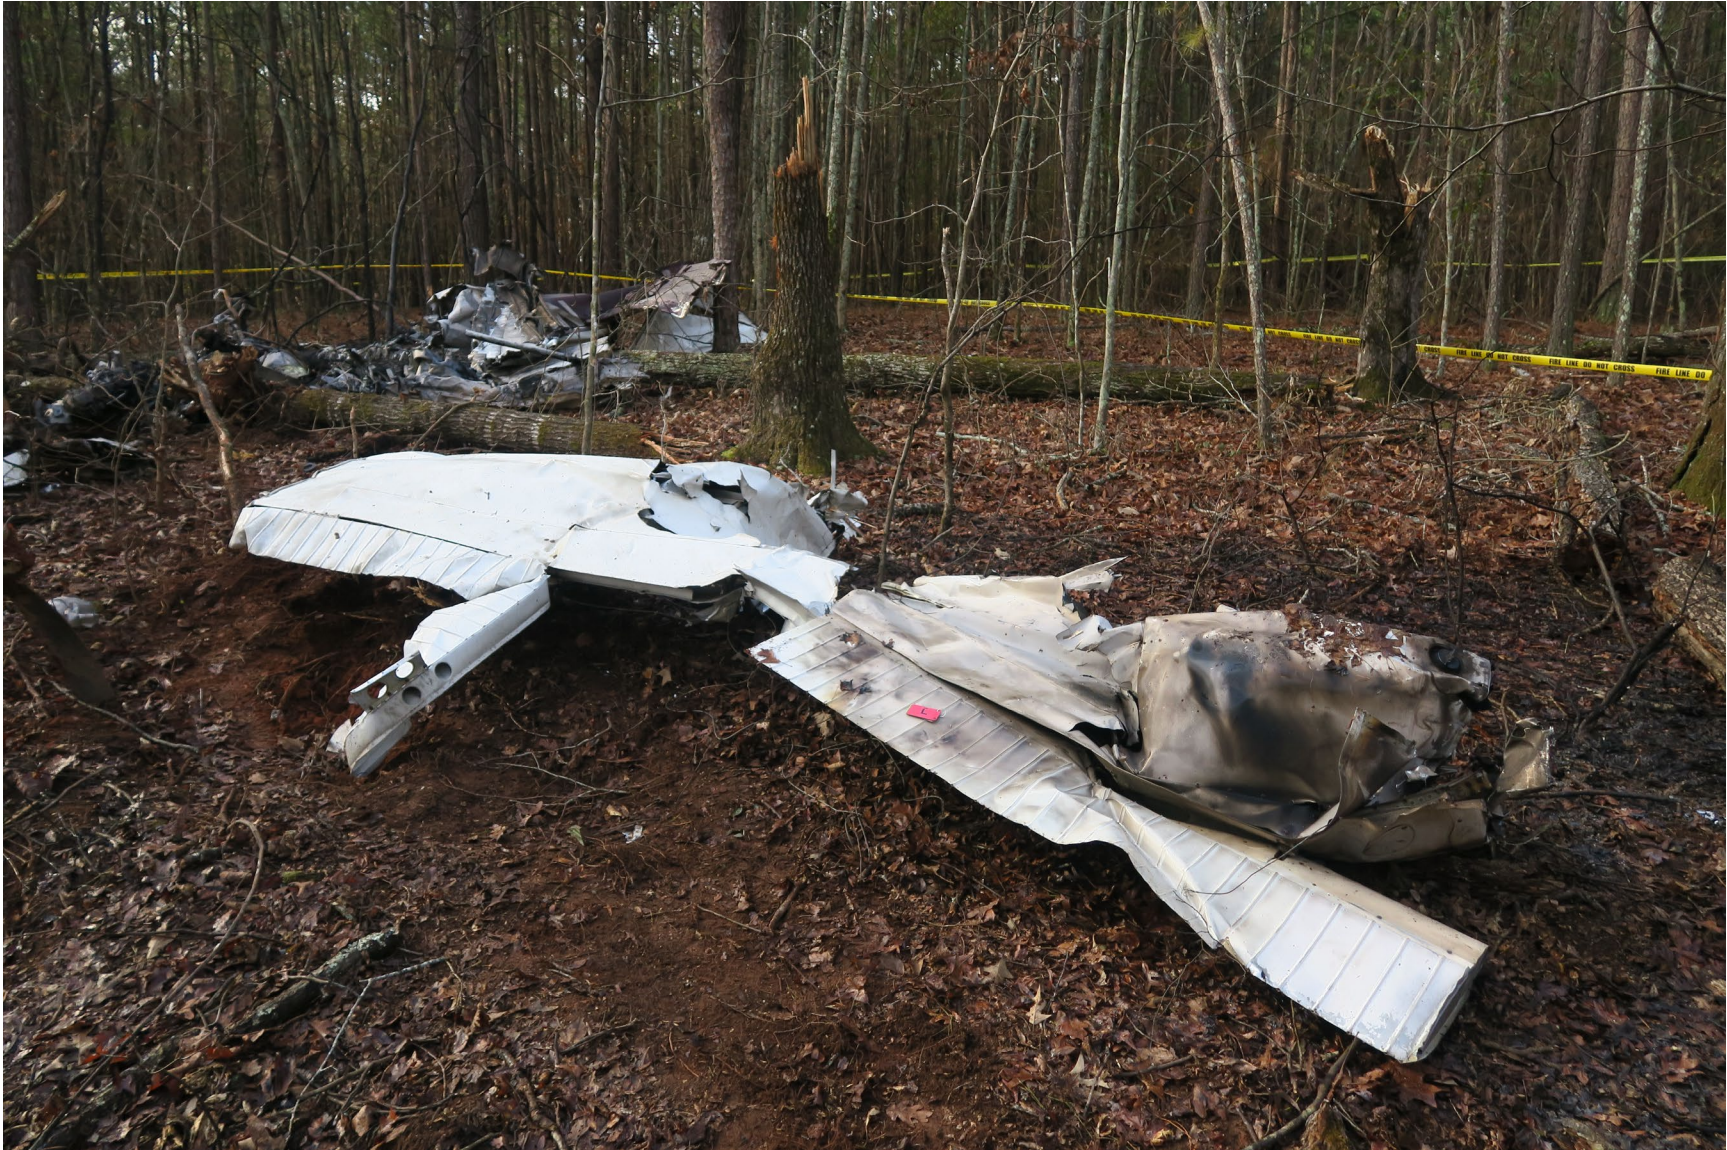
**Photo 9 – View of separated left wing as discovered at the accident site; about 20 feet from the main wreckage.**

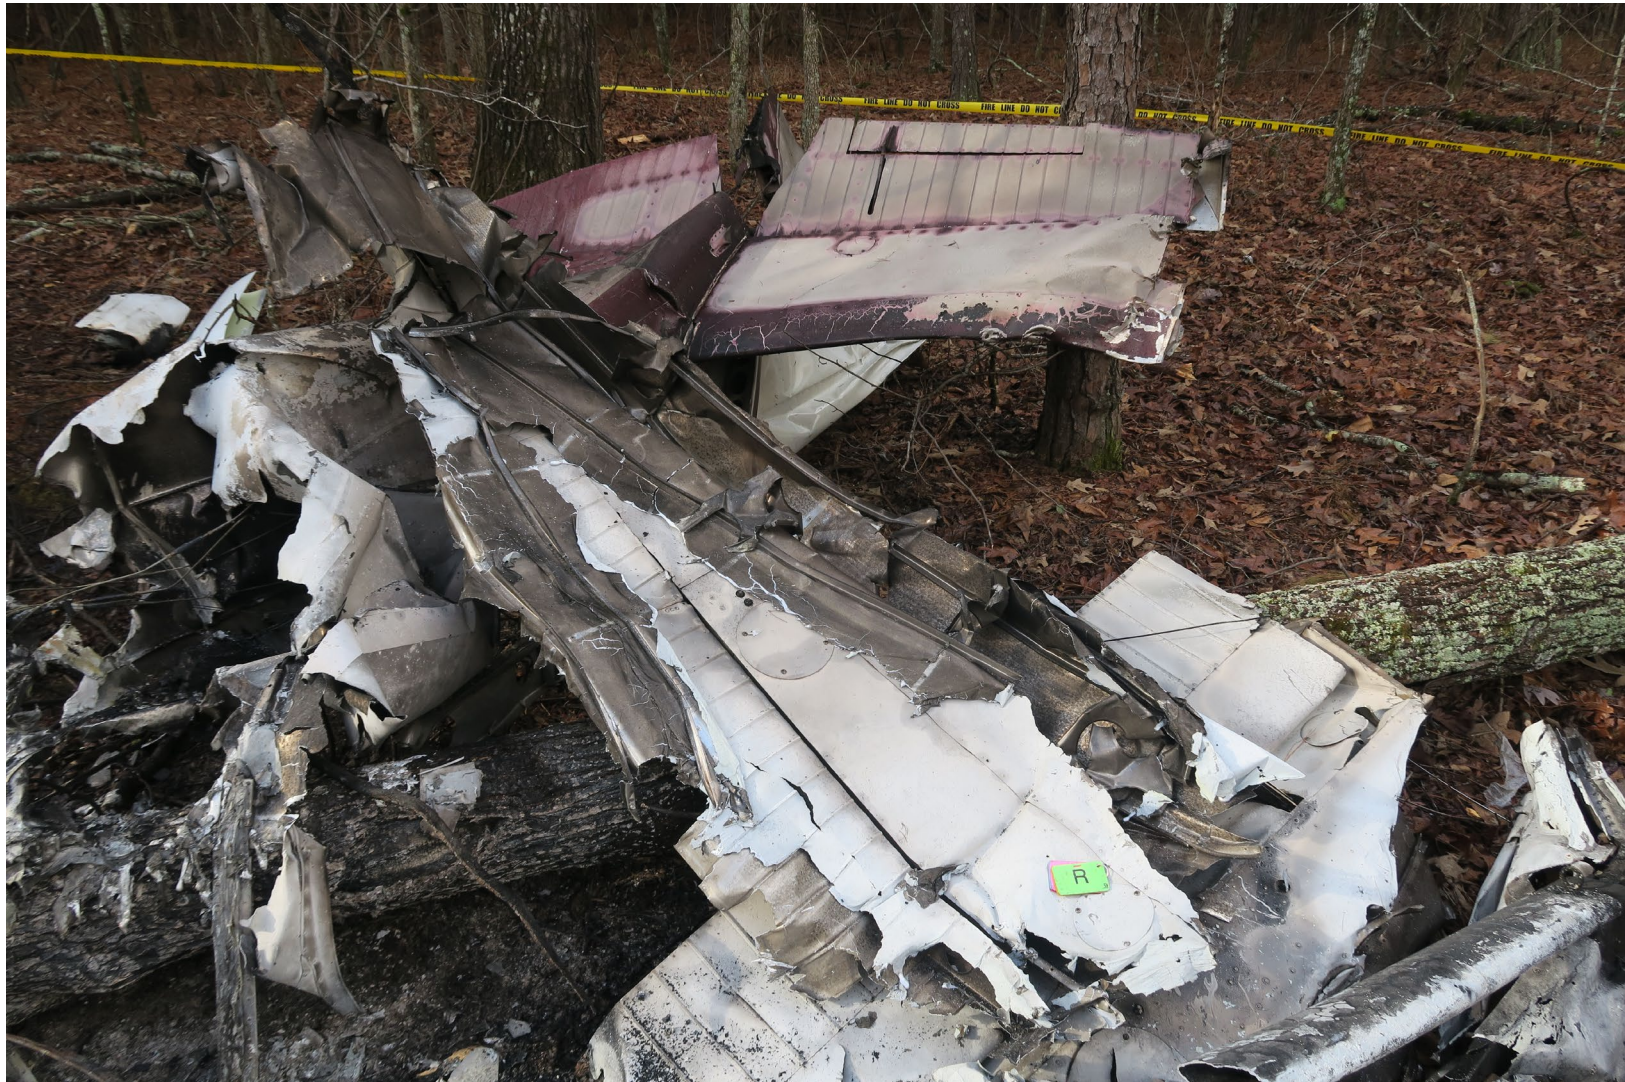
**Photo 10 – View of right wing damage as it lays over top of the fuselage.**

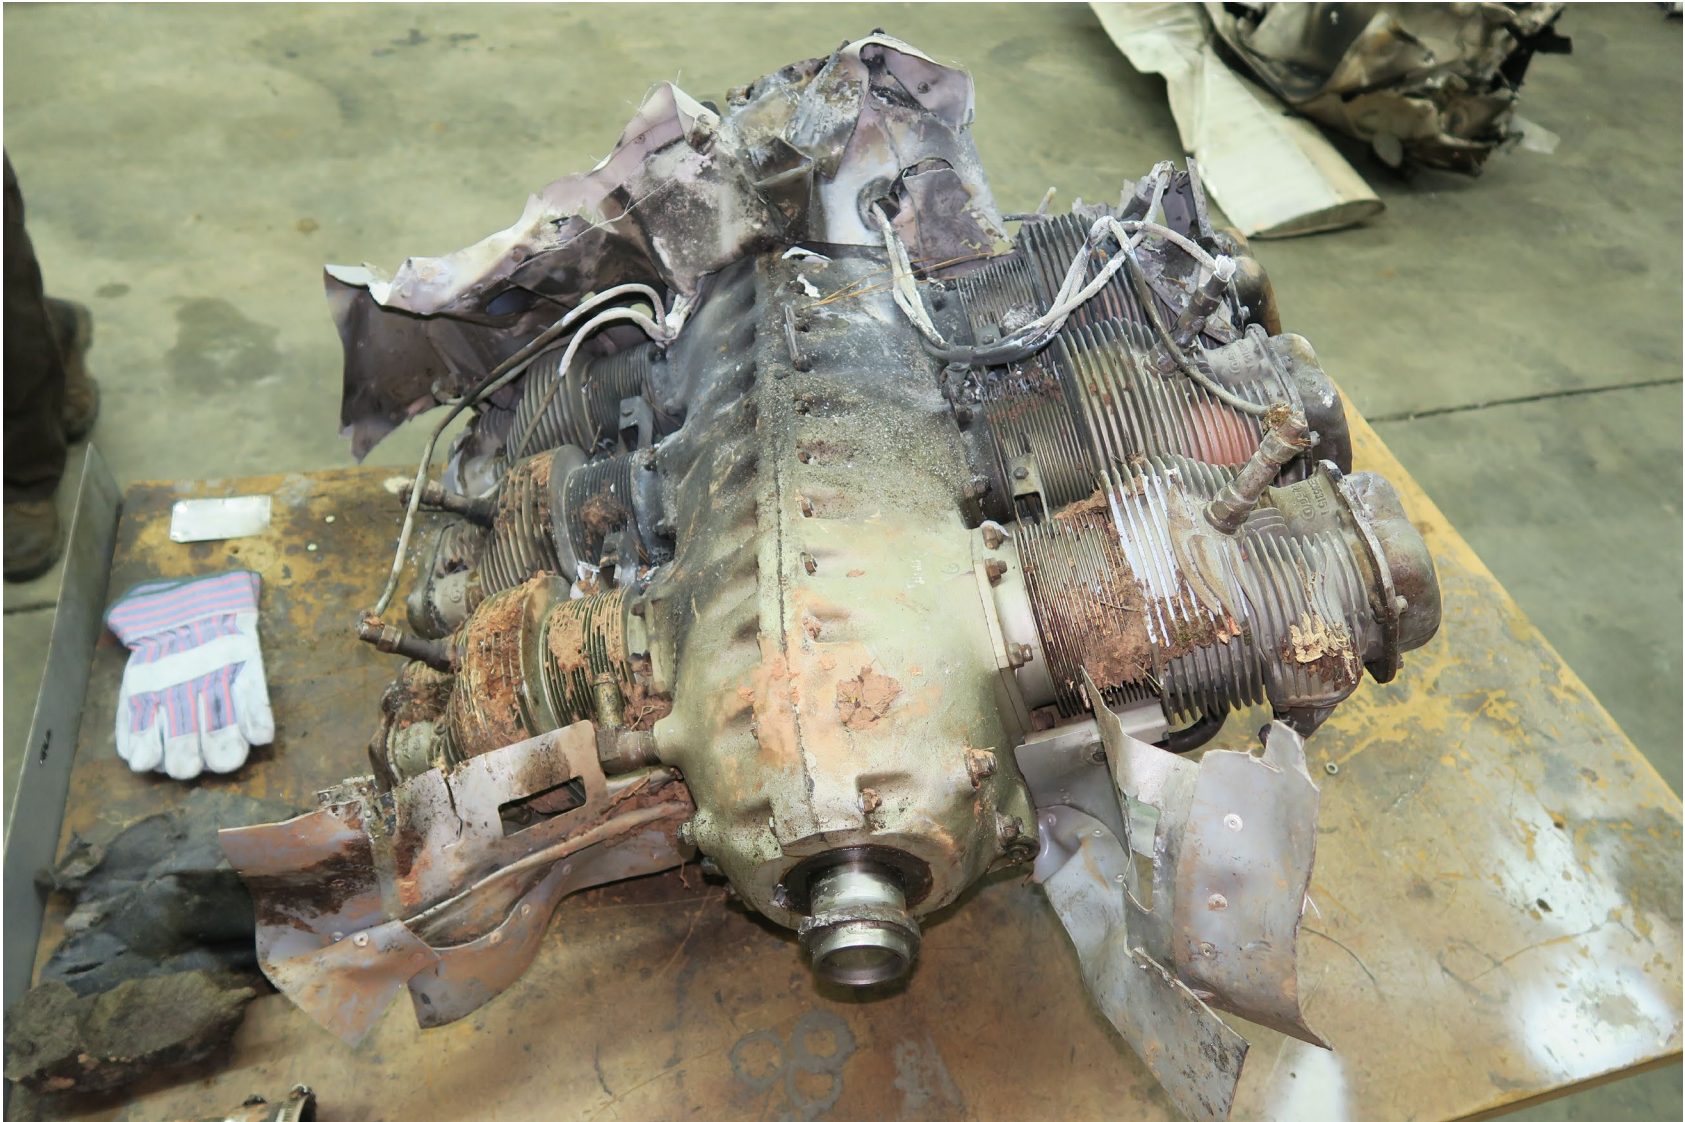
**Photo 11 – View of top side of engine after recovery.**

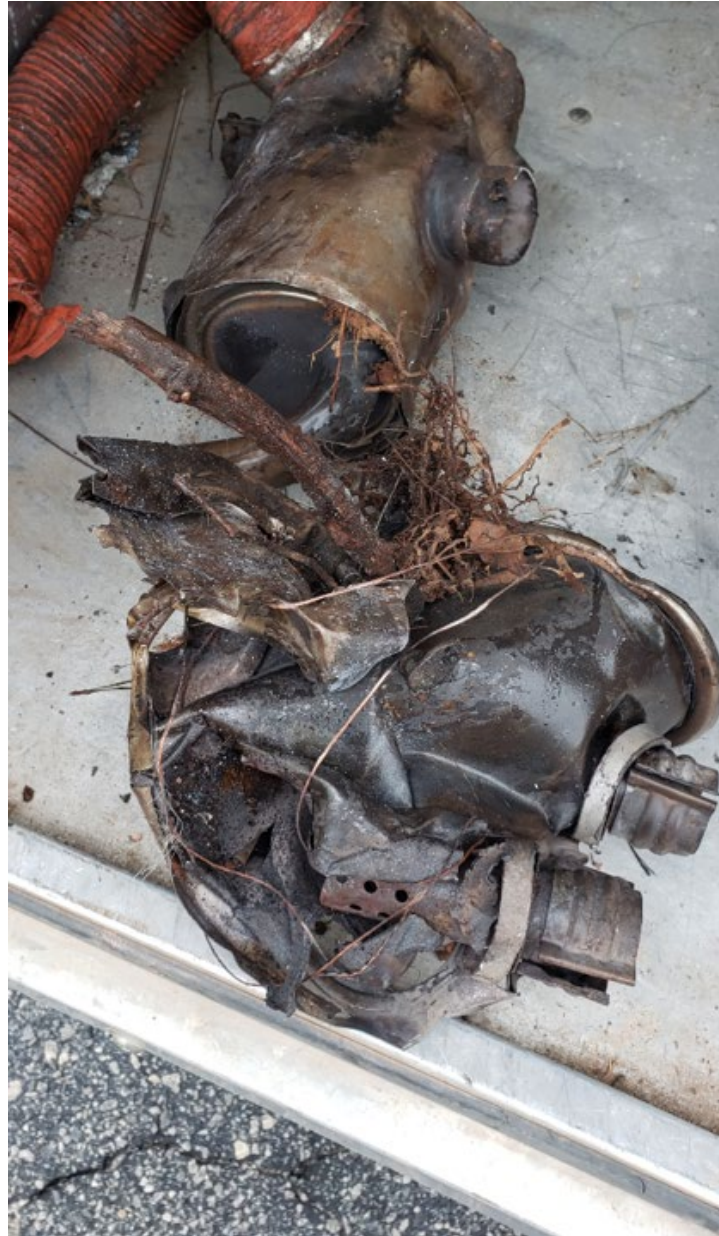
**Photo 12 – View of left and right muffler assemblies after recovery from site.**
