**NATIONAL TRANSPORTATION SAFETY BOARD**

**Computed Tomography Specialist's Factual Report**

ERA20FA074

Location: Mechanicsburg, Pennsylvania  
Date: January 9, 2020  
Time: 2029 eastern standard time  
Airplane: Robinson R66 helicopter, N450MC

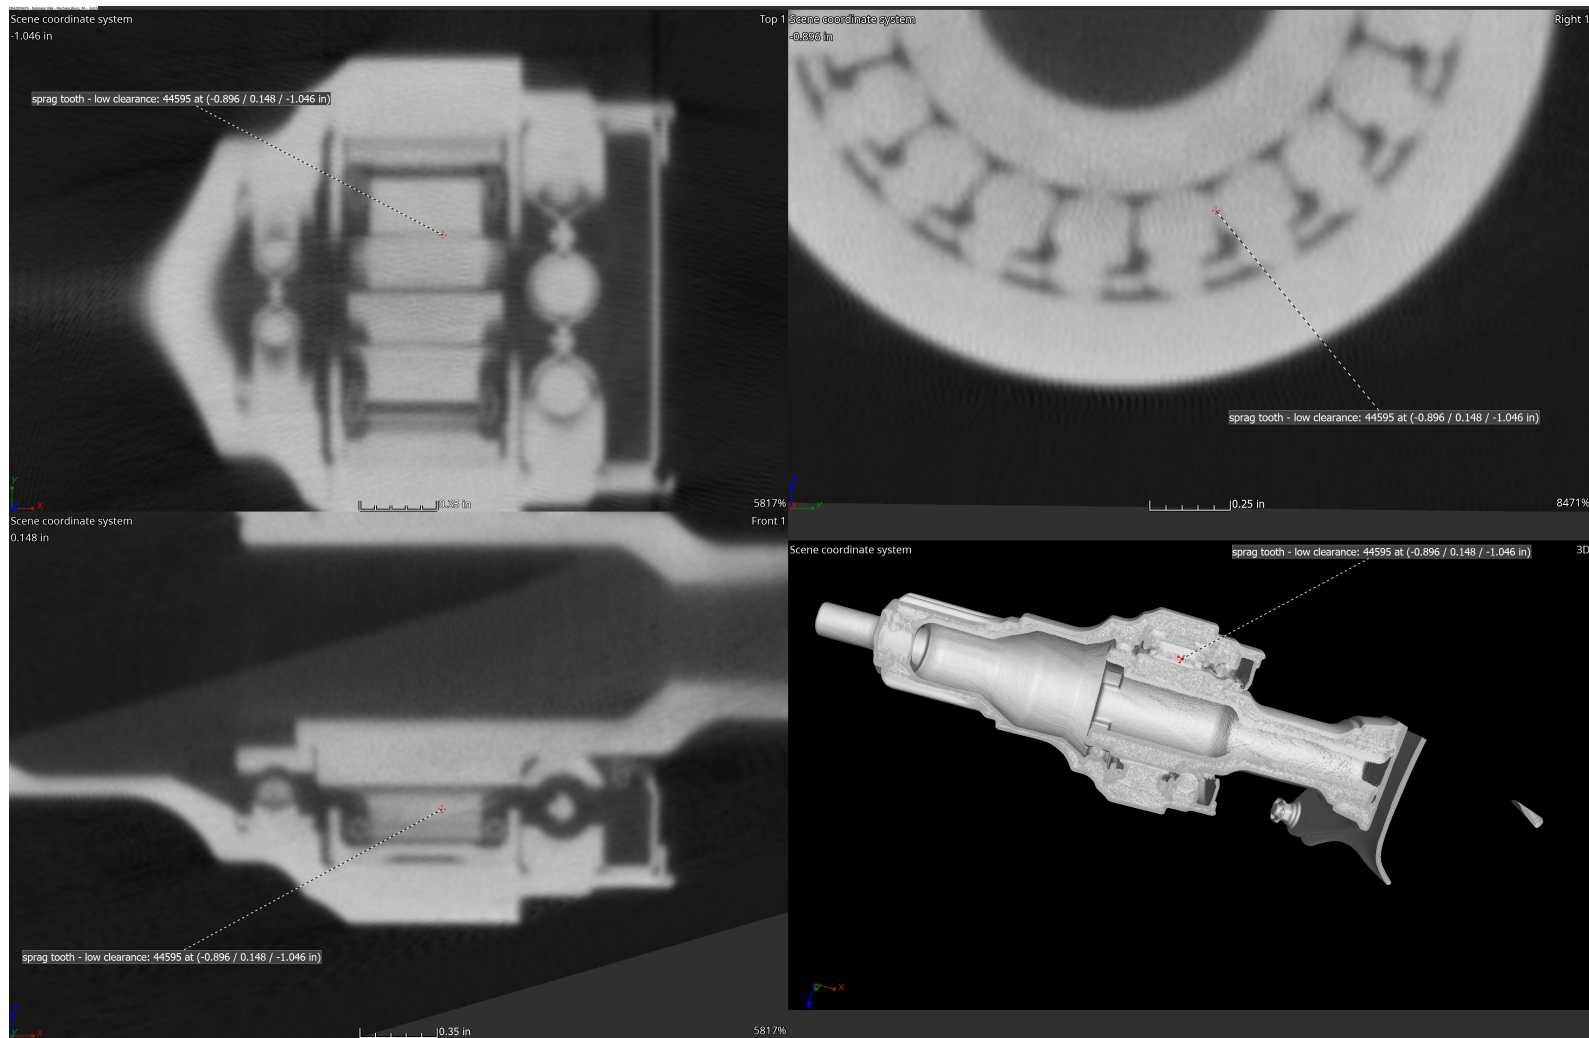
Review of the images determined that, when the scans were conducted, there was one location where there were indications of low clearance distances between two adjacent sprag teeth. There were no other indications of missing or damaged parts, contamination, or any other anomalies.

Figure 10  
Sprag clutch – sprag tooth low clearance point

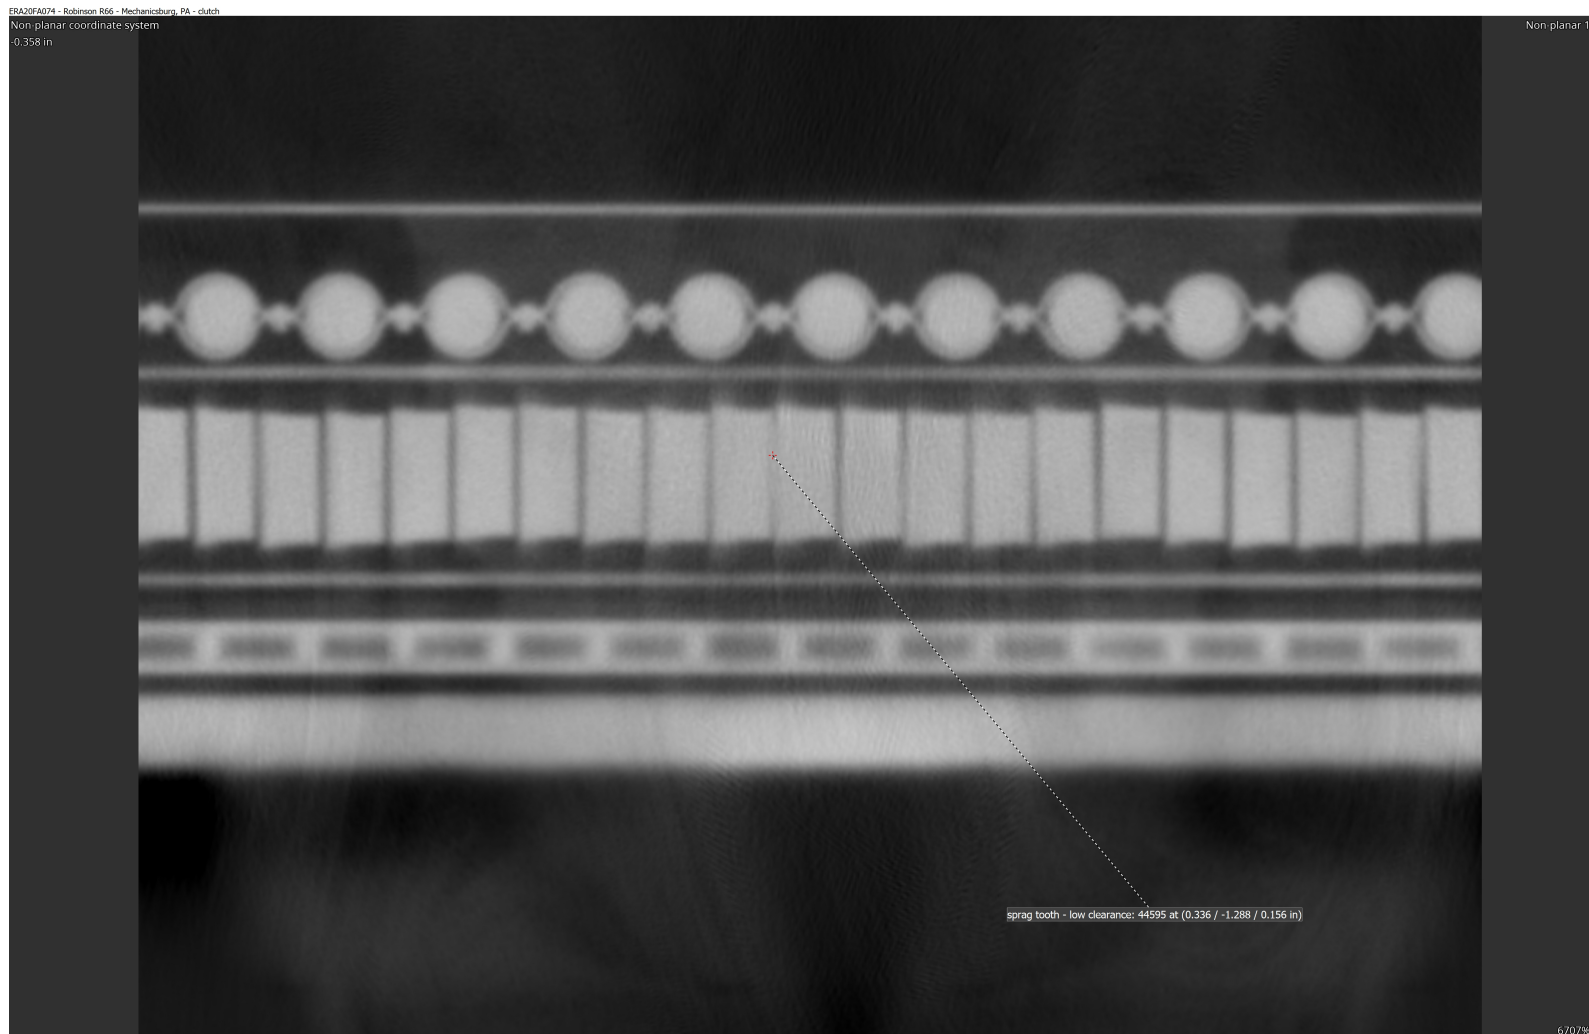
Figure 11  
Sprag clutch – sprag tooth low clearance point - unrolled
