**NATIONAL TRANSPORTATION SAFETY BOARD**  
**Office of Aviation Safety**  
**Washington, D.C. 20594**

**HELICOPTER SPECIALIST'S FACTUAL REPORT**

**NTSB No: ERA20FA074**

Operator: Redmark Capital LLC  
Aircraft: Robinson R66, registration N450MC  
Location: Mechanicsburg, Pennsylvania  
Date: January 9, 2020  
Time: 2029 eastern standard time

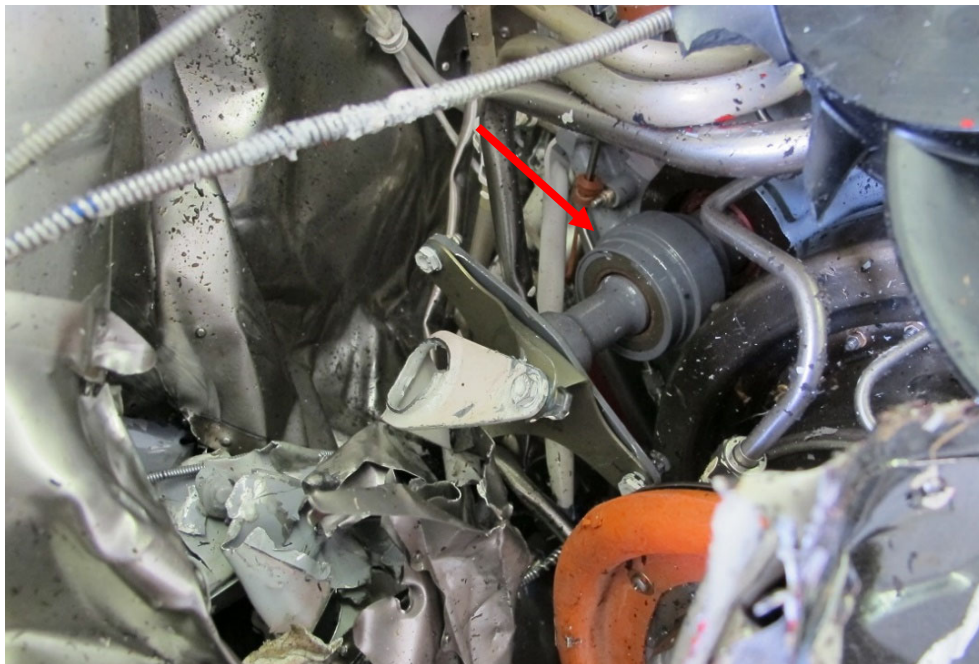
Examination of the sprag clutch assembly, P/N A188-2 and S/N 12635, at the accident site found it remained installed onto the engine accessory gearbox. The engine-to-transmission shaft was fractured at its aft flange with signatures consistent with overload. The aft flange of the engine-to-transmission shaft assembly remained attached to the flange on the forward end of the clutch assembly and exhibited deformation. All attaching hardware between the clutch assembly flange and the engine-to-transmission shaft assembly was present and secure. The freewheeling and driving functionality of the clutch was verified. According to maintenance records, the clutch assembly was original to the helicopter.

**Figure 1. The red arrow points to the sprag clutch as seen in the wreckage. (Image courtesy of Robinson Helicopter Company)**

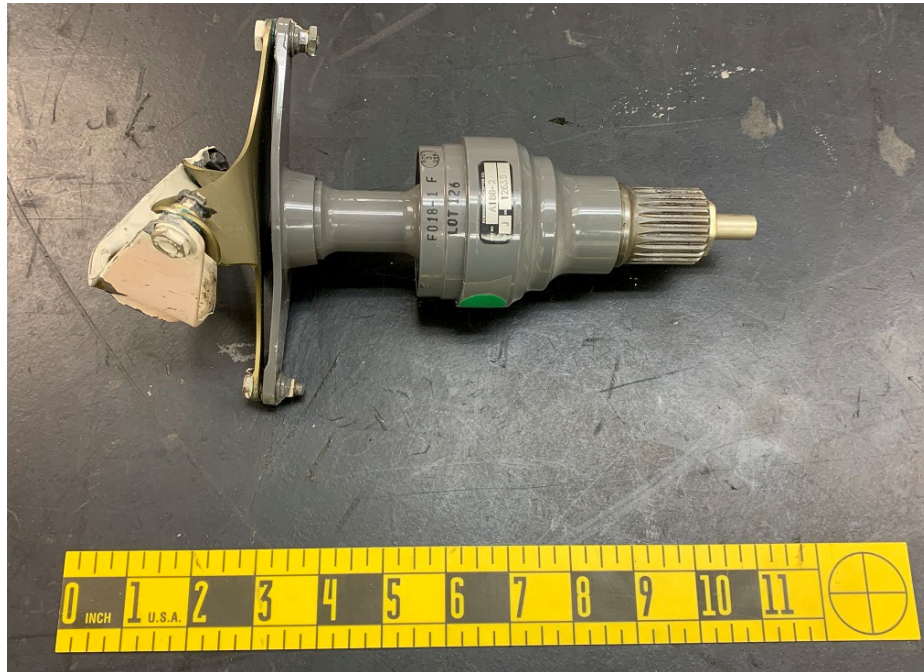
On March 9, 2021, the clutch assembly was examined and disassembled in the NTSB Materials Laboratory in Washington, District of Columbia (**Figure 2**). The clutch assembly's freewheeling functionality was verified. The plug on the spline-end of the clutch assembly was removed and, with the clutch upright (i.e. its rotational axis pointing up), a metal scale was inserted into the clutch assembly. The oil level within the clutch measured about 3.5 inches in height. The drawing required an oil level of about 4.3 inches. The residual oil was poured into a glass jar and had a medium-dark translucent red appearance, but exhibited no evidence of contaminants such as metallic chips or flakes and did not have an acrid odor. About 2.20 fluid ounces of residual oil was collected.

**Figure 2. The recovered sprag clutch assembly.**

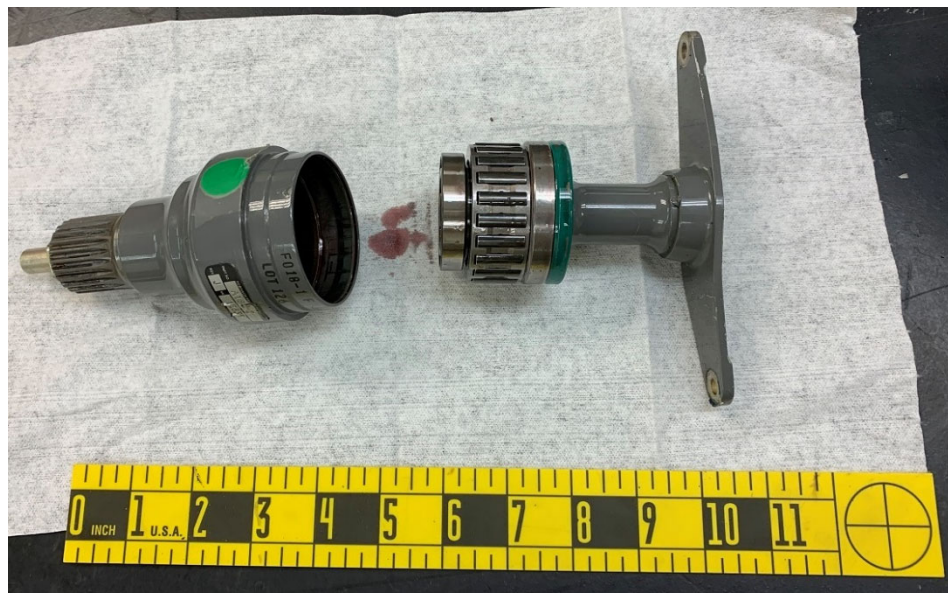
Using a mechanical press, the shaft was separated from the housing. The sprag clutch, seal, and two bearings remained installed on the shaft (**Figures 3-5**). The inner surfaces of the clutch housing did not exhibit anomalous damage. The smaller of the two bearings rotated freely and exhibited no evidence of binding. The larger of the two bearings rotated freely but exhibited a ratchet-like feel when rotated. However, the two bearings did not exhibit thermal damage or other anomalous damage. The sprag elements were all present and did not exhibit evidence of cracks, fractures, galling, or other anomalous damage on its visible surfaces. The clutch was not disassembled further.

**Figure 3. The sprag clutch after separation of the shaft from the housing.**

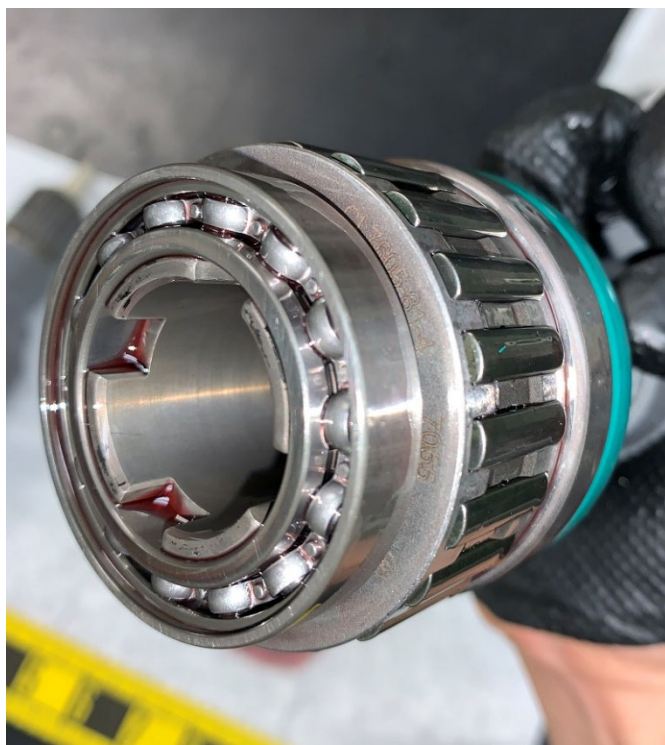
**Figure 4. A view of the sprag elements and a bearing.**

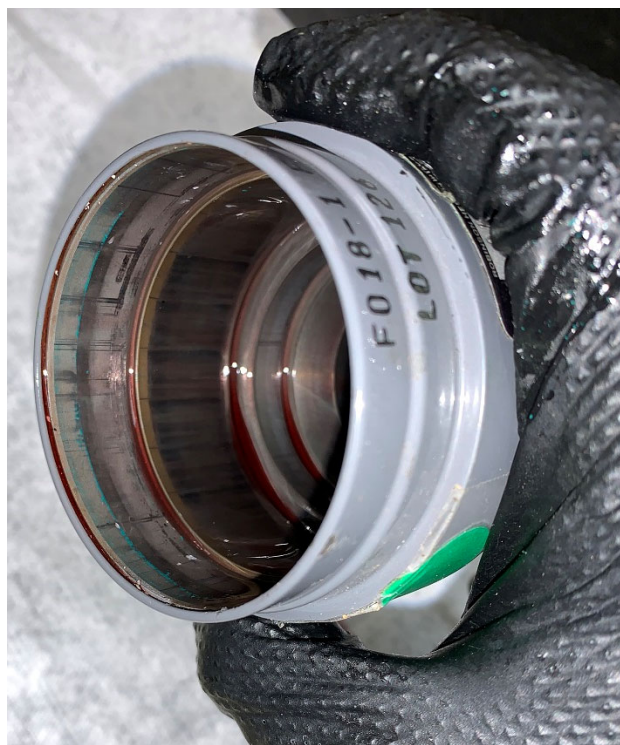
**Figure 5. A view of the clutch outer race.**

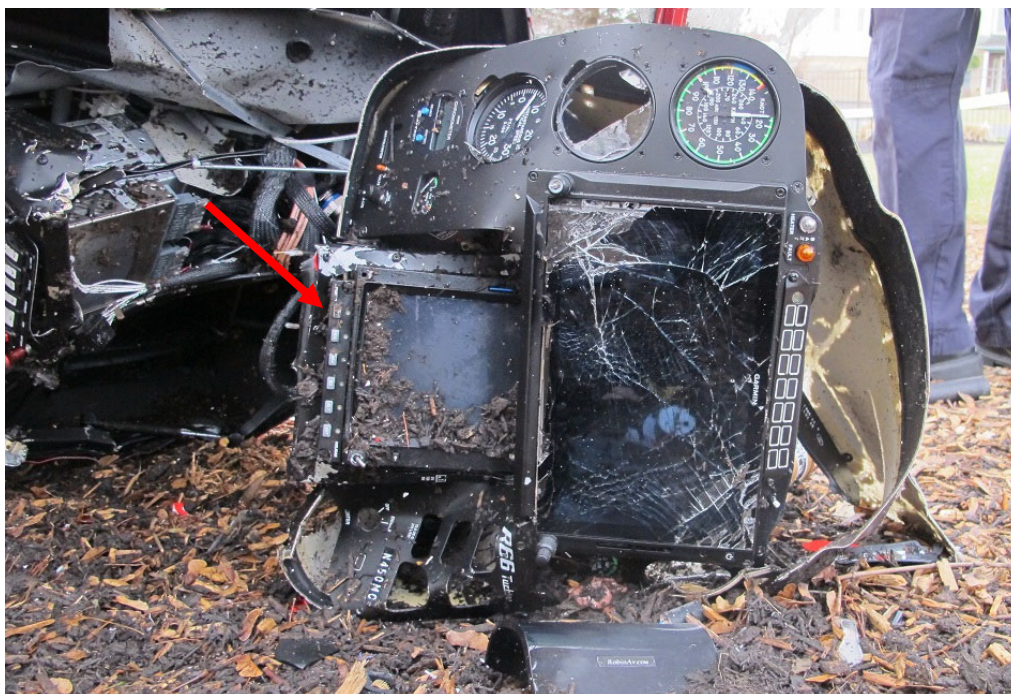
**Figure 5.** The red arrow points to the HCP installed within the instrument panel. (Image courtesy of Robinson Helicopter Company)

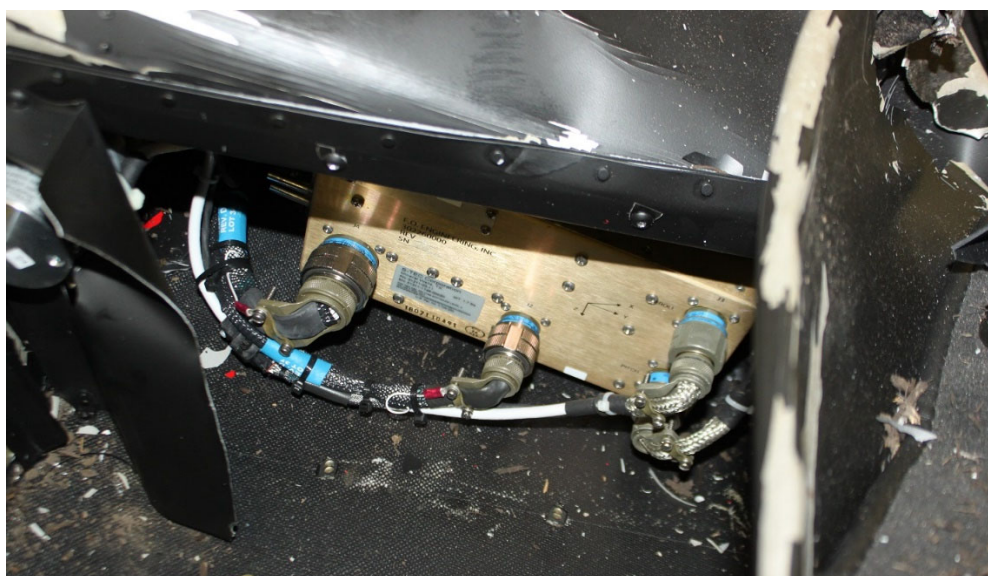
**Figure 6.** The FCC as seen in the wreckage.

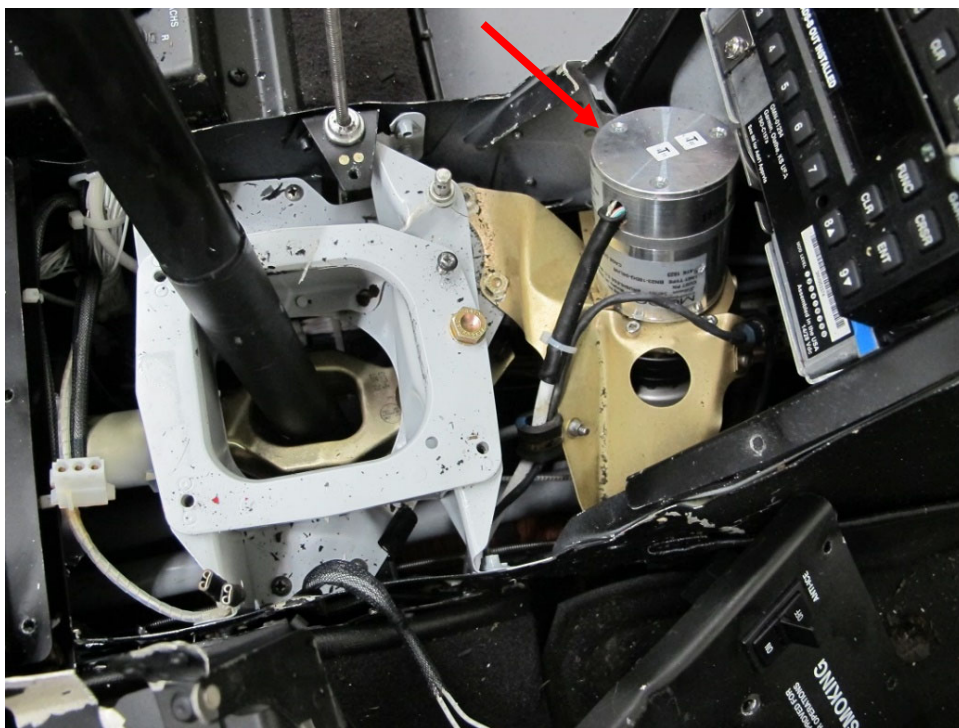
**Figure 7. The red arrow points to the pitch servo-actuator installed in the wreckage. (Image courtesy of Robinson Helicopter Company)**

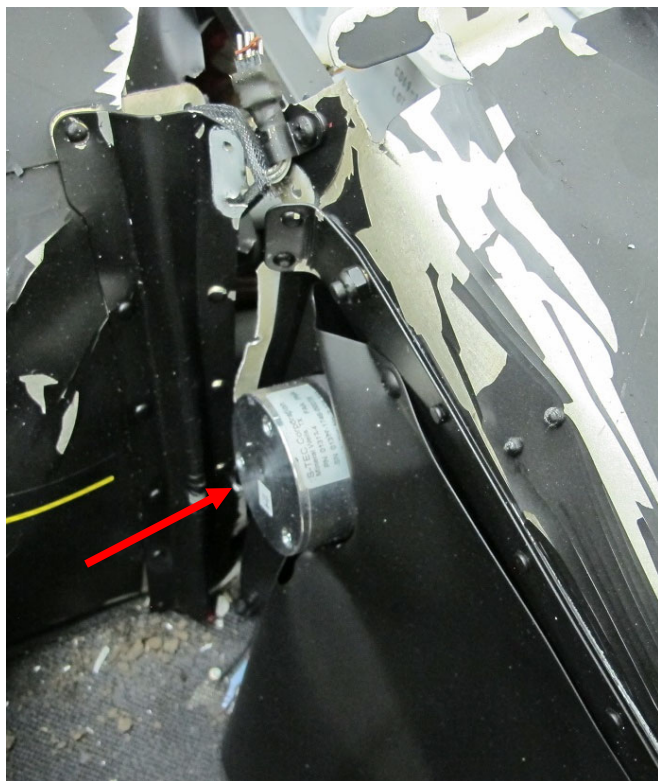
**Figure 8. The red arrow points to the roll servo-actuator installed in the wreckage. (Image courtesy of Robinson Helicopter Company)**

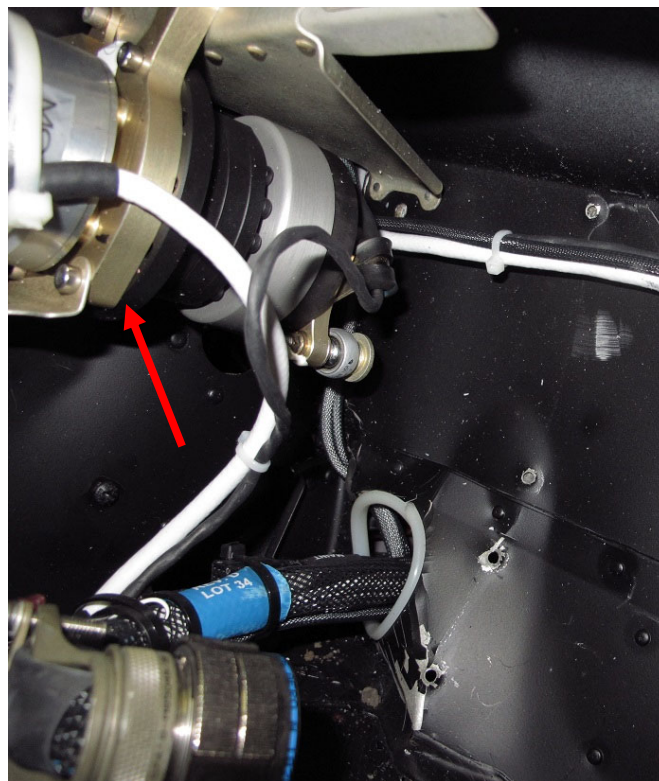
**Figure 9. A different view of the roll servo-actuator (red arrow) installation. (Image courtesy of Robinson Helicopter Company)**

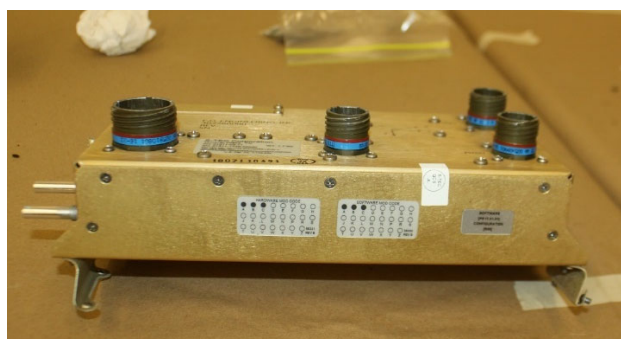
**Figure 10. The recovered FCC.**

On March 18, 2021, the pitch and roll servo-actuators were removed from the wreckage (**Figure 12**). The FCC, HCP, and both pitch and roll servo-actuators were shipped to Genesys Aerosystems in Mineral Wells, Texas to bench test the components for functionality. The FCC and HCP functioned normally. Bench testing of the pitch servo-actuator was not possible, likely due to damage observed on a wire within a wire bundle leading to the motor. Bench testing of the roll servo-actuator was performed and the servo passed the resolver test and the acceptance test protocol. The roll servo-actuator was connected to an FCC and an HCP (both bench units) and a system-level test was performed. The roll servo-actuator failed the system-level test, which included driving the servo clockwise and counterclockwise as well as manually back-driving the servo clockwise and counterclockwise. There was no obvious visual damage to the servo-actuator motor's wire bundle, but internal damage to the wires could result in a failure of the system-level test. On June 14, 2021, the pitch and roll servo-actuators were disassembled at Genesys Aerosystems' facilities in Mineral Wells, Texas.

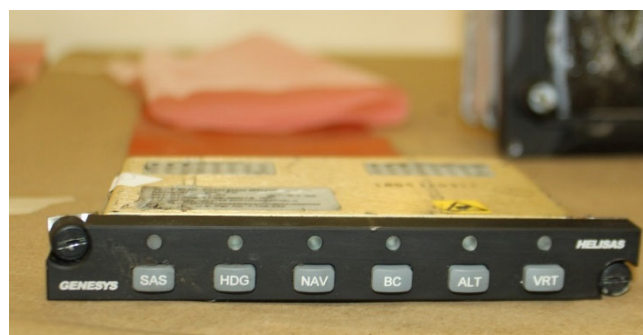
**Figure 11. The recovered HCP.**

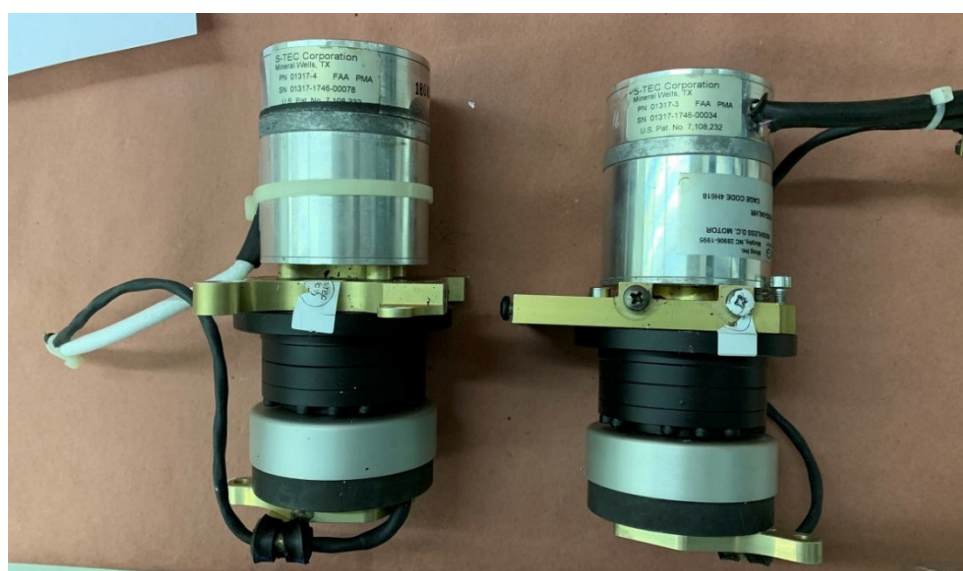
**Figure 12. The roll (left) and pitch (right) servo-actuators after removal from the wreckage.**

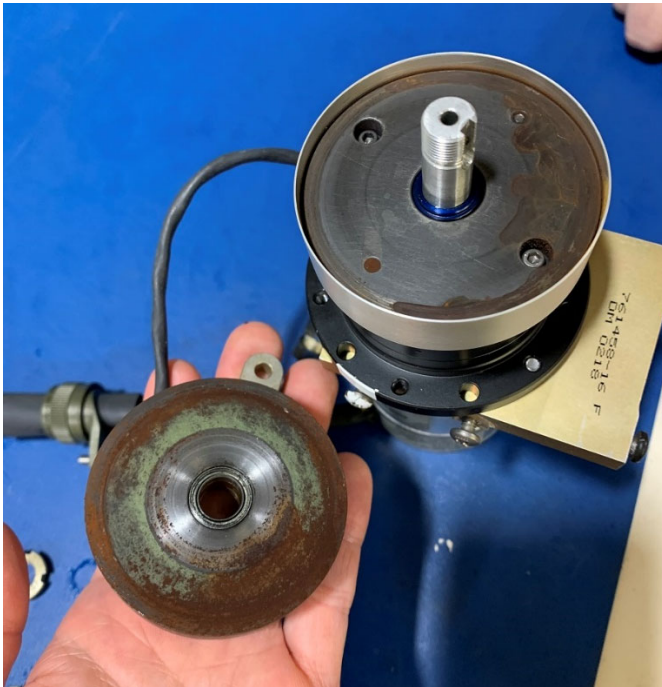
The retaining nut for the clutch remained secured to the tanged washer. The clutch magnet was able to be removed from the friction plate (**Figure 13**). The magnet and friction plate had evidence of surface corrosion.<sup>3</sup> The adapter did not exhibit looseness when removed. Grease was present within the gearbox and had a clean, beige-colored appearance (**Figure 14**). The quantity of grease observed was typical for the component. The bearing was removed, rotated smoothly, and exhibited no anomalous damage. None of the removed screws exhibited evidence of looseness. The motor shaft turned smoothly when rotated by hand. The [shrink-wrapped] wire bundle sleeve was partially dislodged from the motor housing, exposing some of the wiring, one of which was cut. The motor cover was removed and a white-colored sealant was present on the motor wiring, but no other internal damage was observed.

**Figure 13. Pitch servo-actuator magnet and friction plate.**

<sup>3</sup> The pitch servo-actuator was not bench tested and thus surface corrosion would not have been rubbed off during testing.

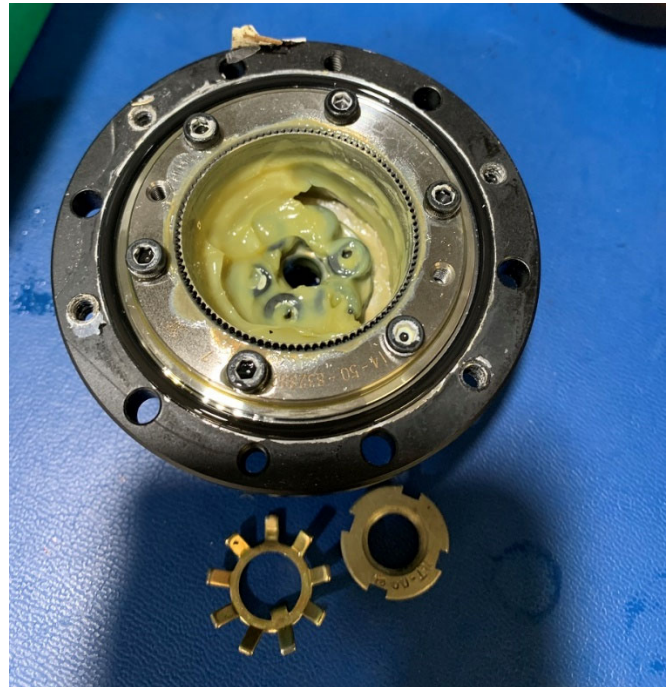
**Figure 14. Pitch servo-actuator gearbox.**

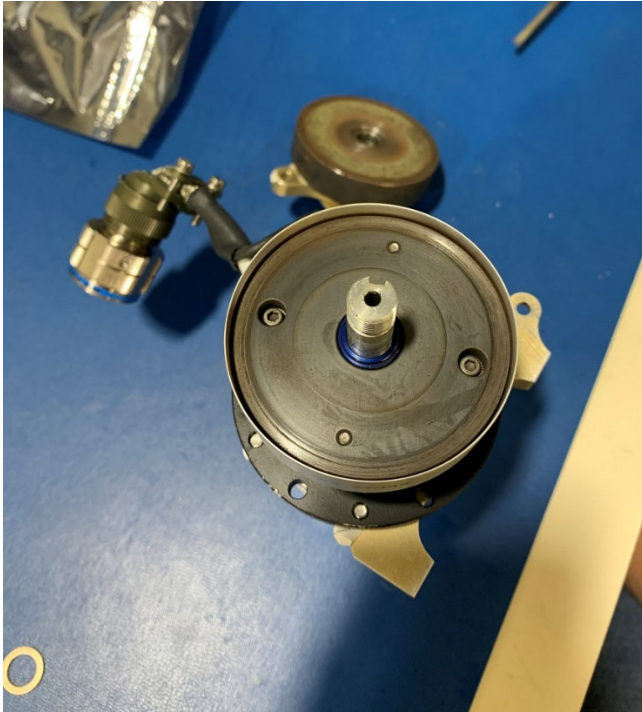
The retaining nut for the clutch was secured to the tanged washer. The clutch was stuck onto the housing and was tapped out. Once removed, the surfaces between the clutch magnet and friction plate did not exhibit anomalous damage (**Figures 15 and 16**). The adapter did not exhibit looseness when removed. Grease was present within the gearbox and had a clean, beige-colored appearance (**Figure 17**). The quantity of grease observed was typical for the component. The bearing was removed and exhibited smooth rotation and no anomalous damage. None of the removed screws exhibited evidence of looseness. The motor shaft turned smoothly when rotated by hand. The cover for the motor was removed and a white-colored sealant was present on the motor wiring. No anomalous damage was observed on the visible internal surfaces. The motor wiring bundle had a sharp bend at the motor housing, but the wiring zip-tie remained secure.

**Figure 15. Roll servo-actuator friction plate.**

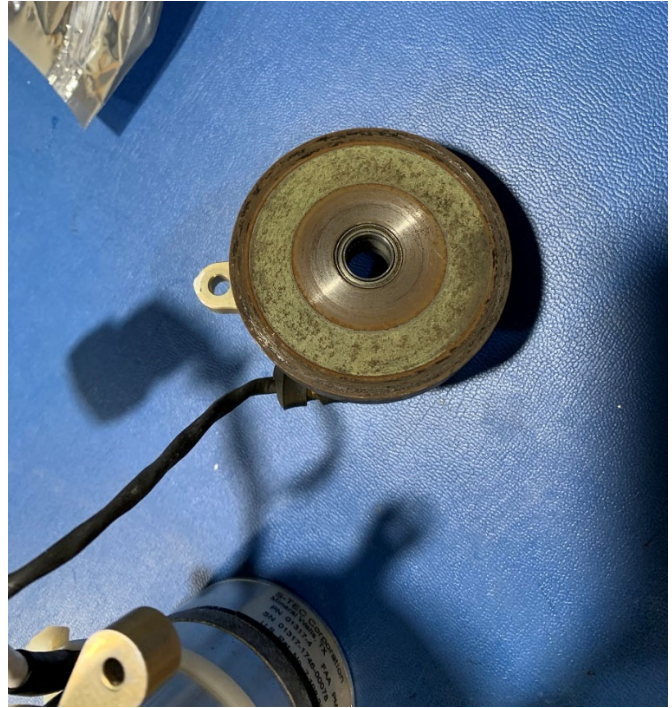
**Figure 16. Roll servo-actuator magnet.**

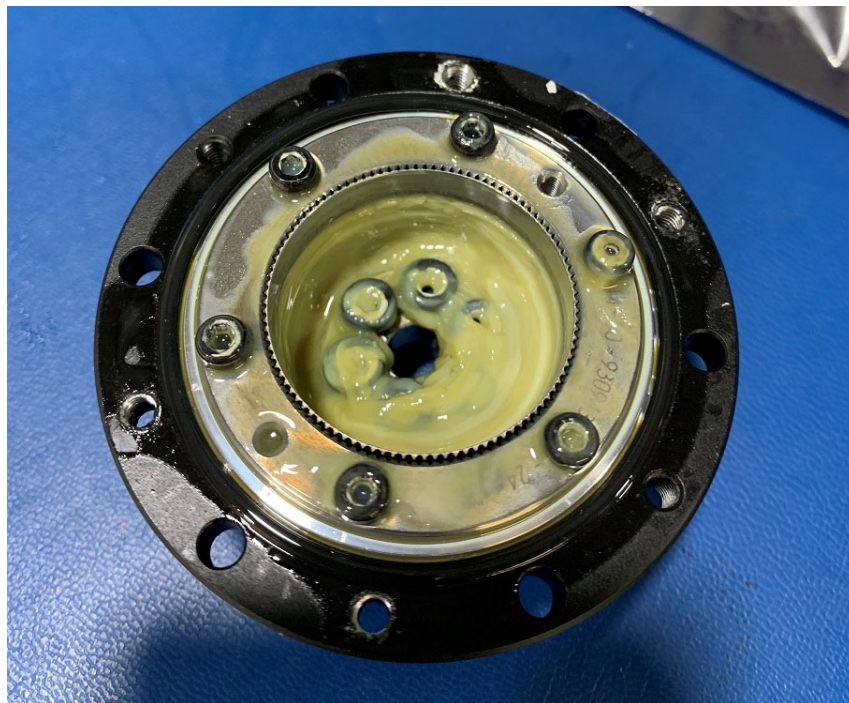
There was no visual damage to the wire bundle, but Genesys Aerosystems' facility did not have the capability to perform electrical testing of the motor and its wire bundle.

**Figure 17. Roll servo-actuator gearbox.**
