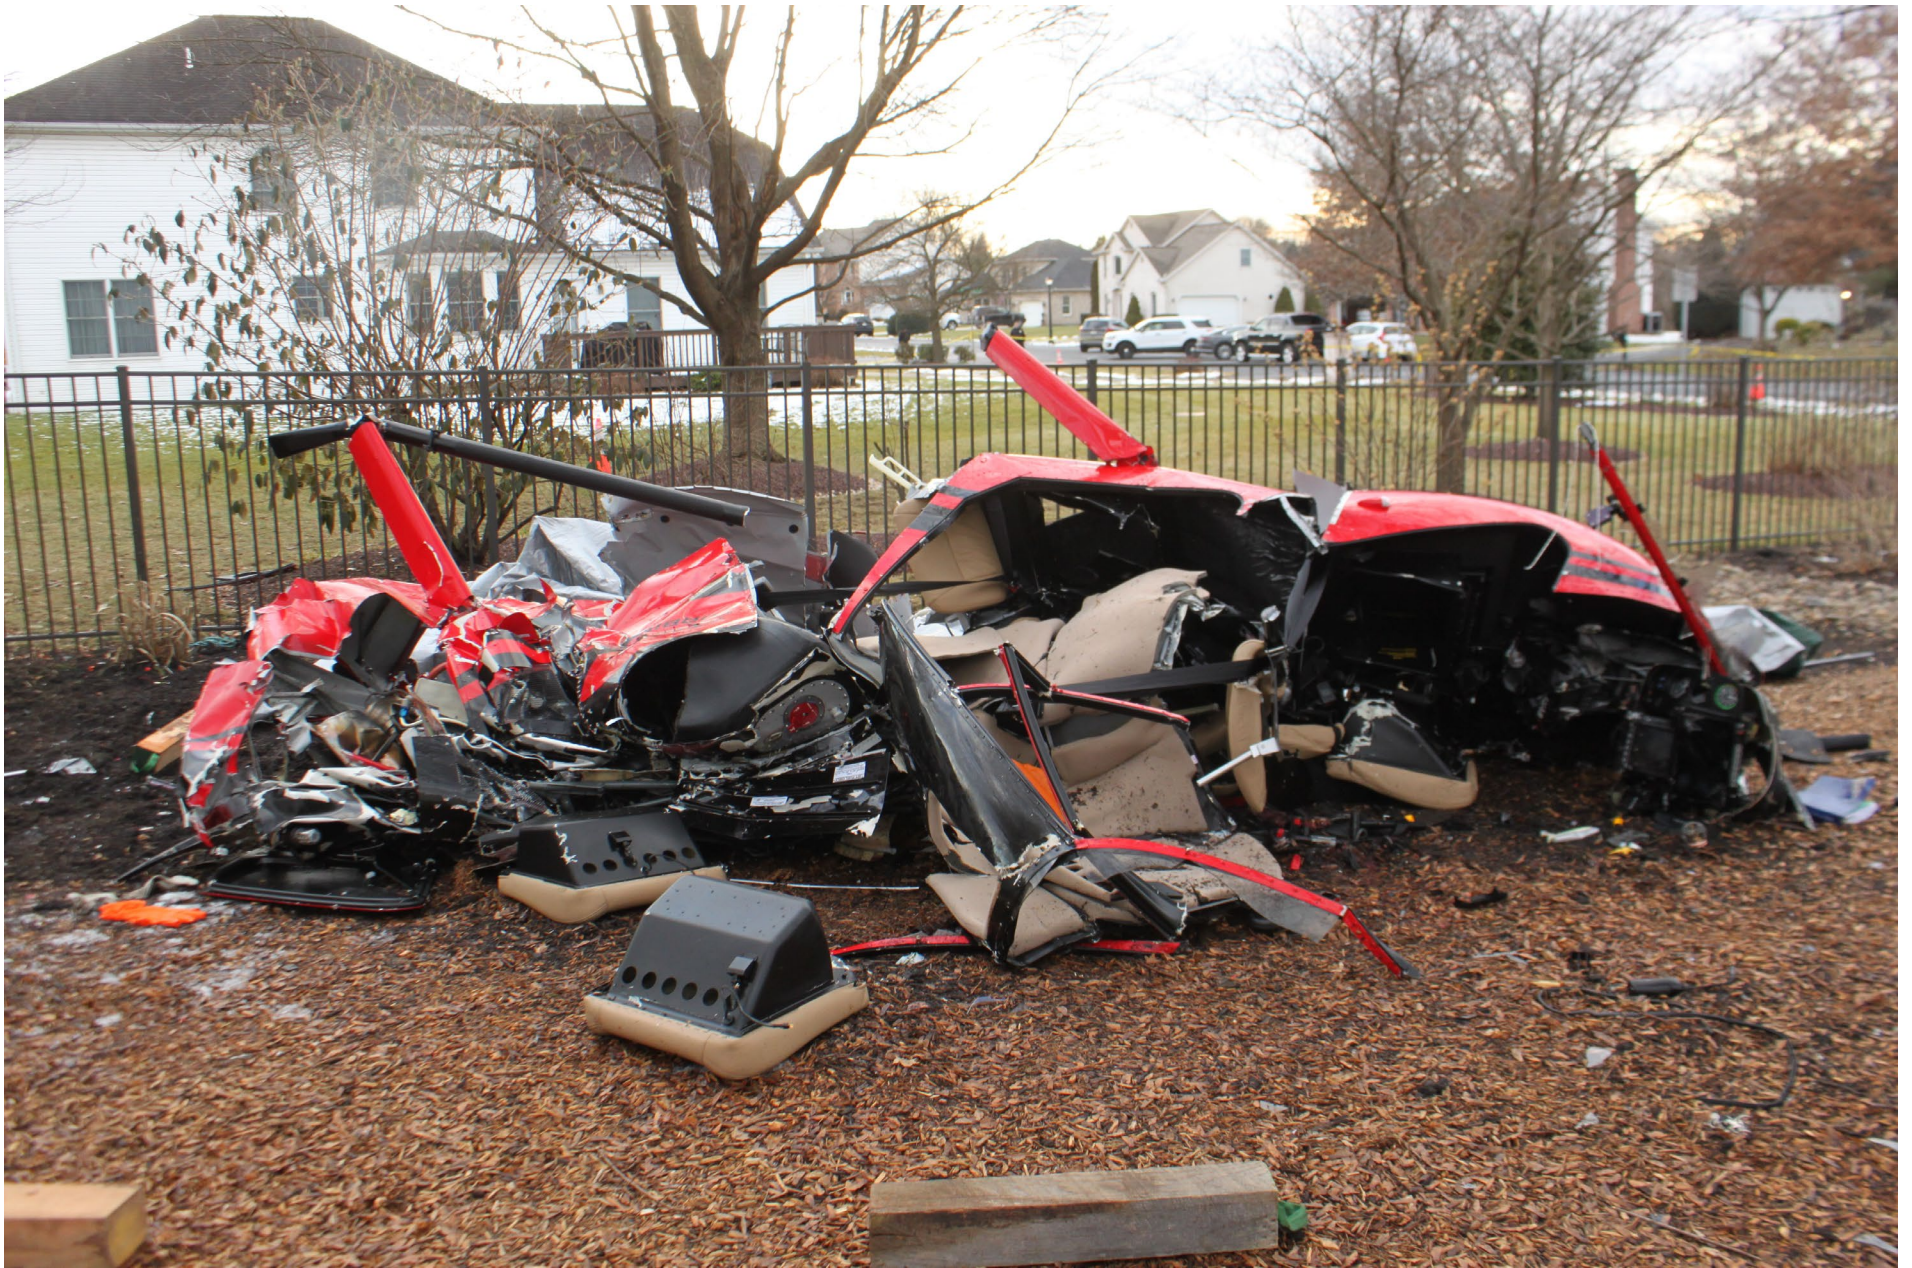
**Photo 1 – NTSB Digital Photograph. View of the Helicopter Fuselage at the Accident Site.**

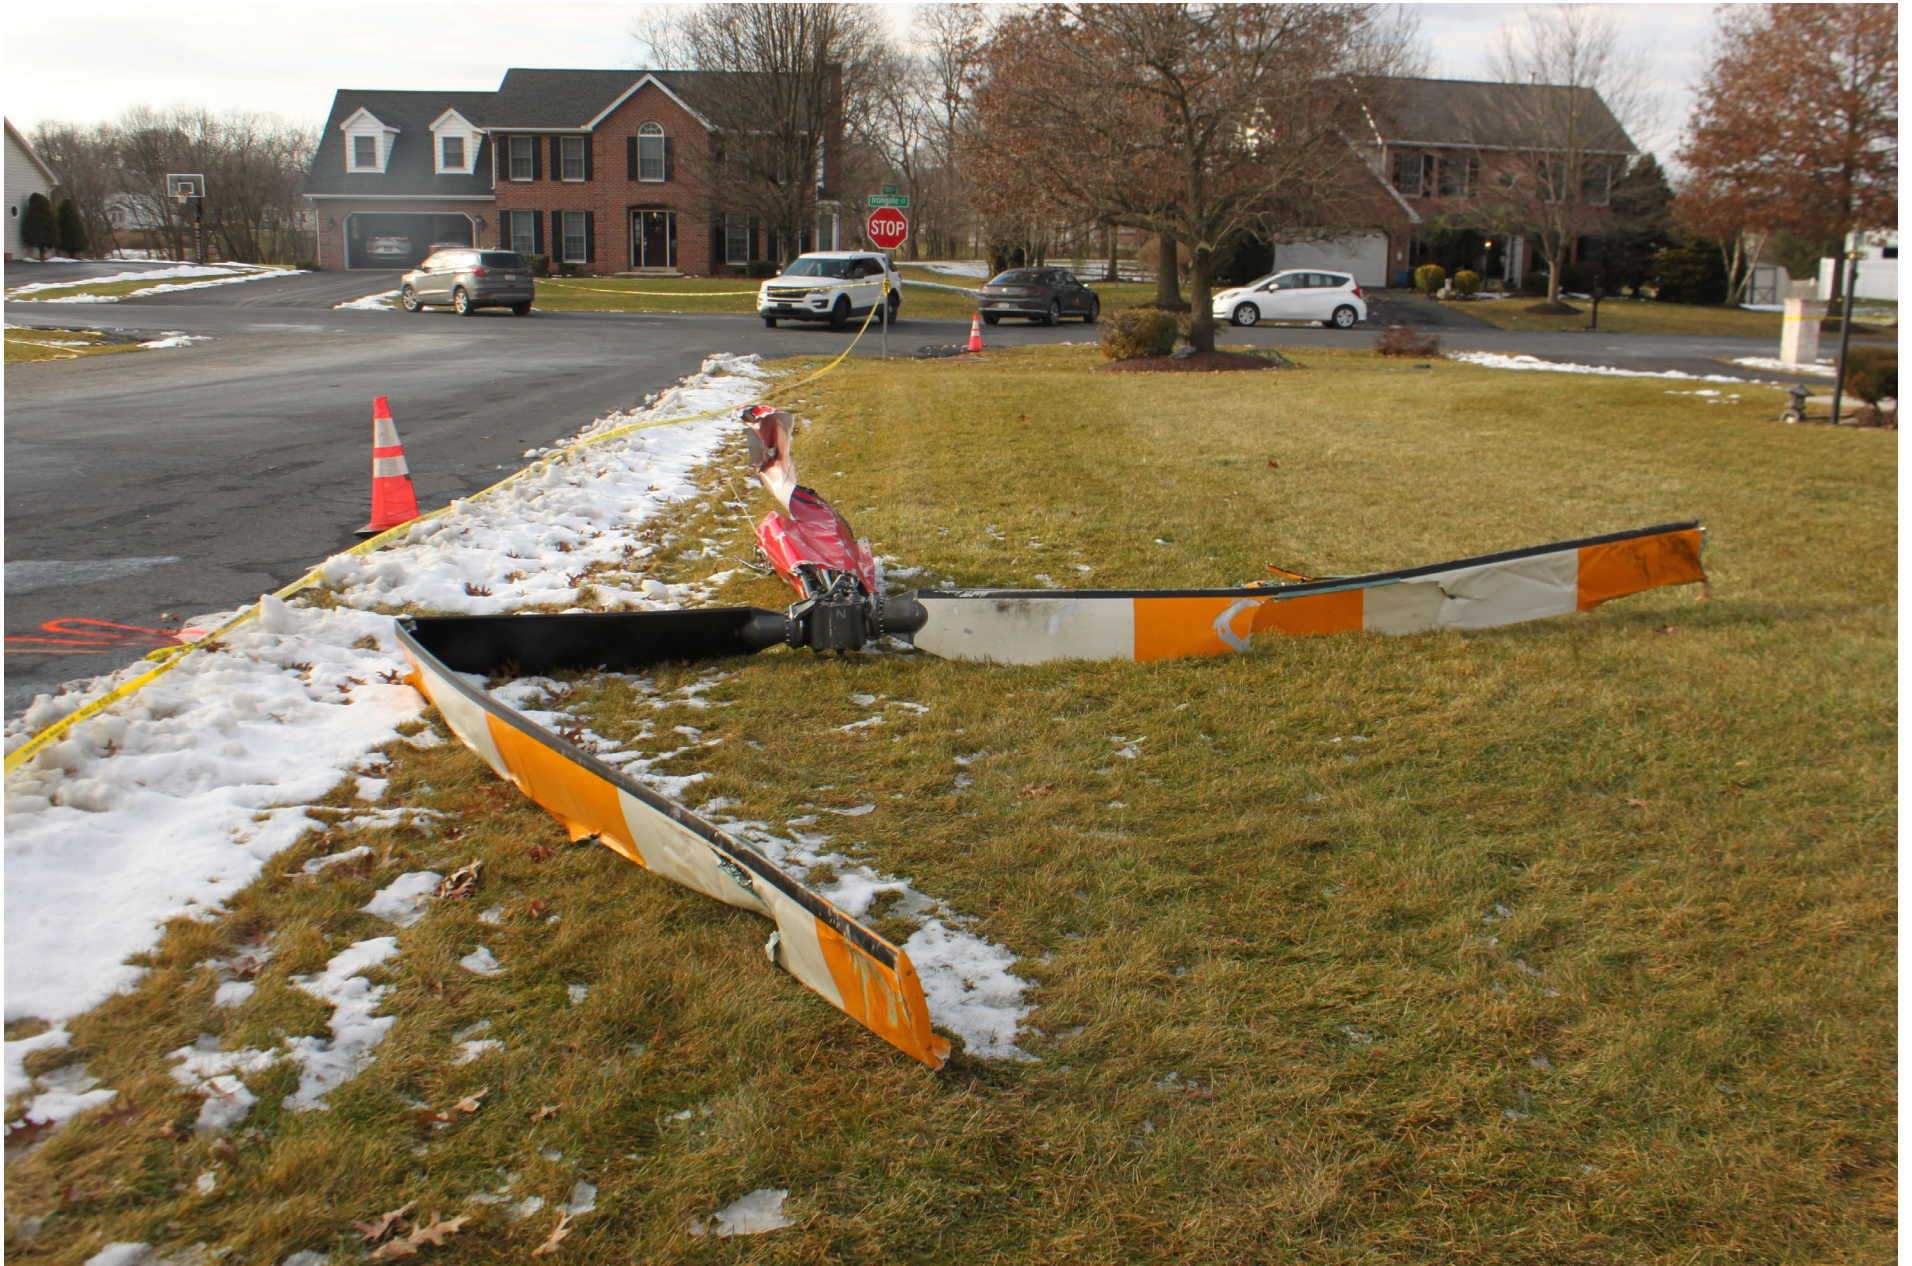
**Photo 2 - NTSB Digital Photograph. View of the Separated Main Rotor Mast with Attached Main Rotor Blades.**

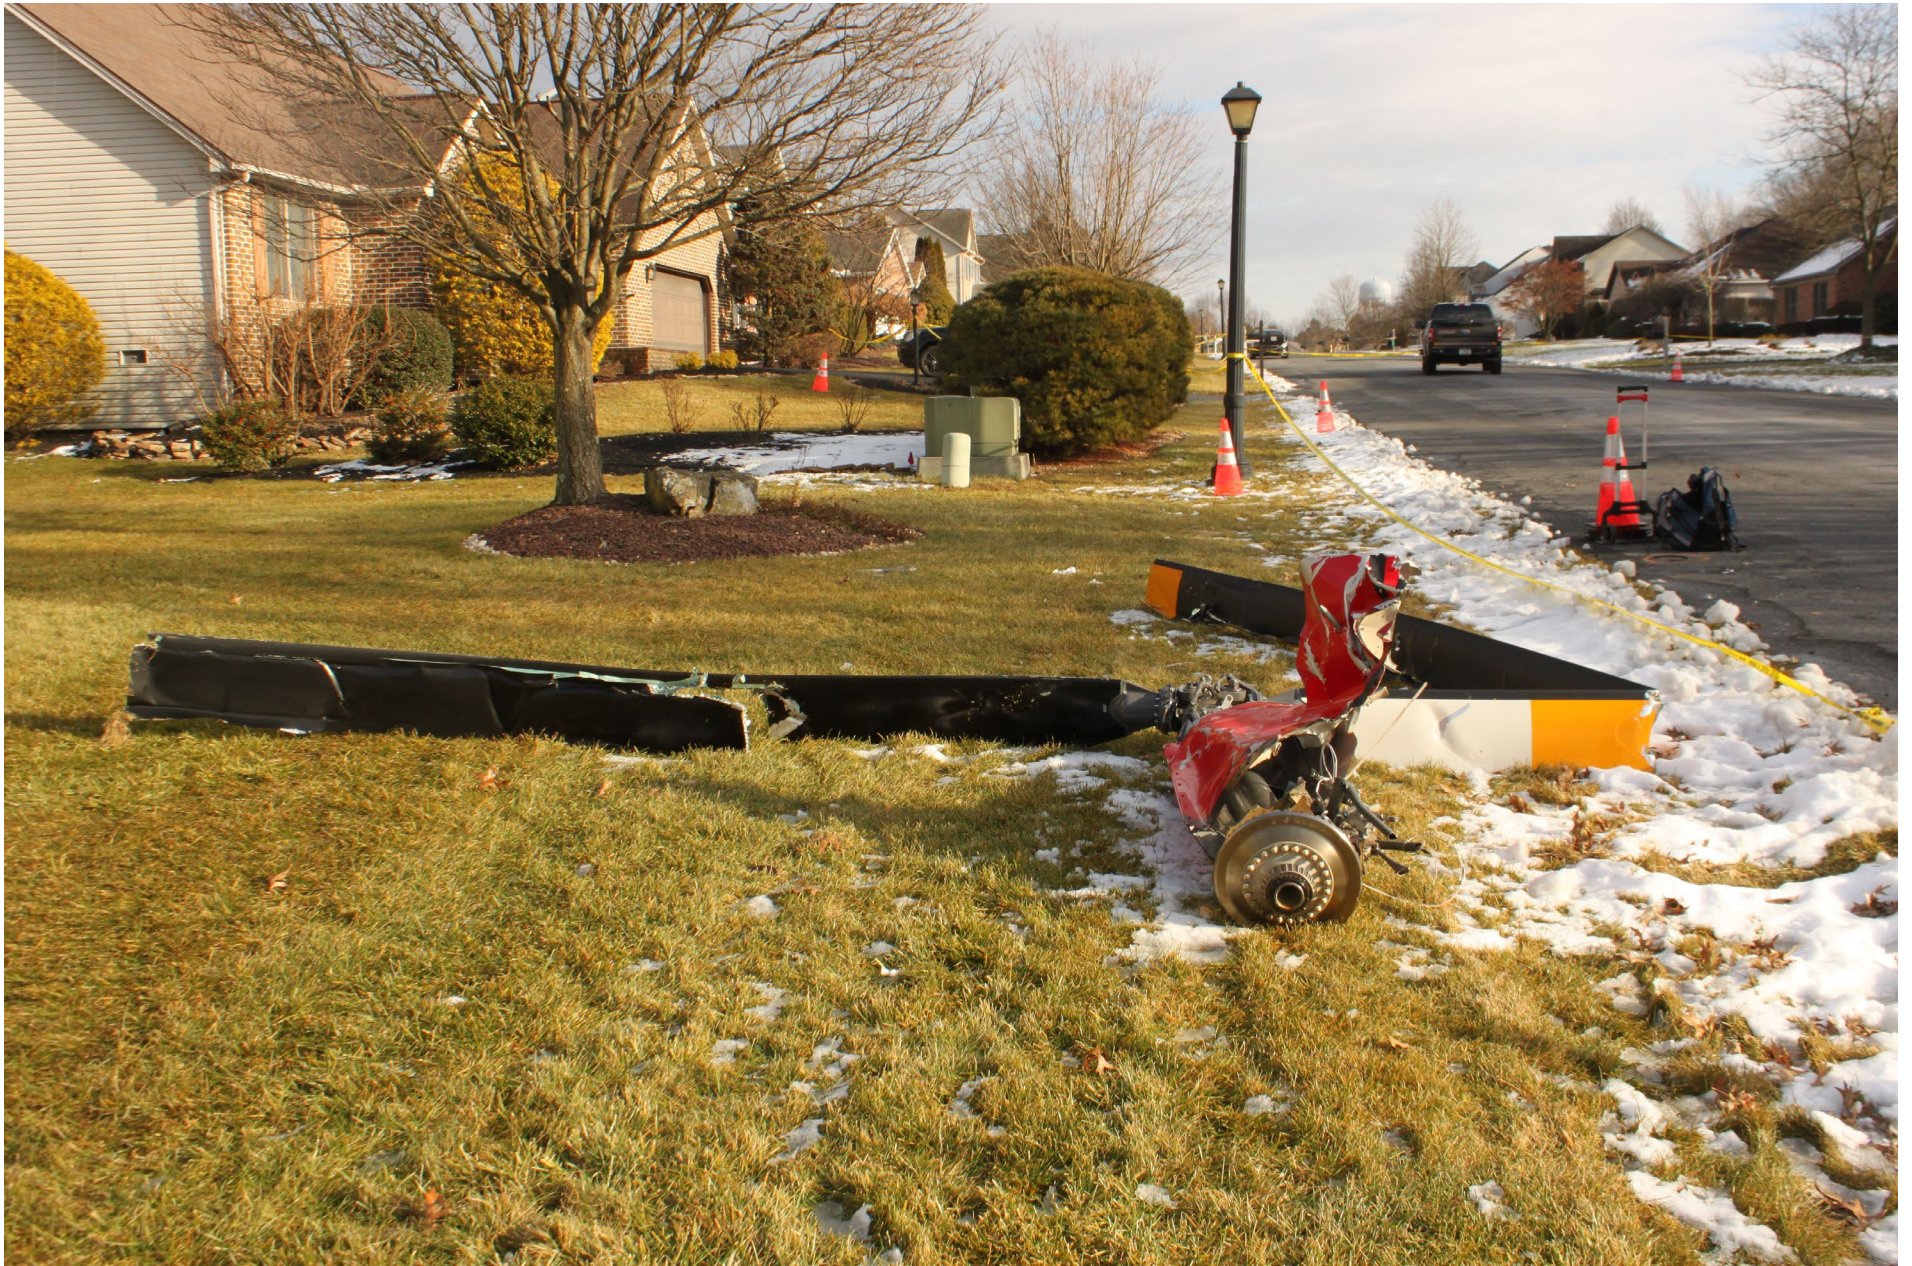
**Photo 3 - NTSB Digital Photograph. Different View of the Separated Main Rotor Mast with Attached Main Rotor Blades.**

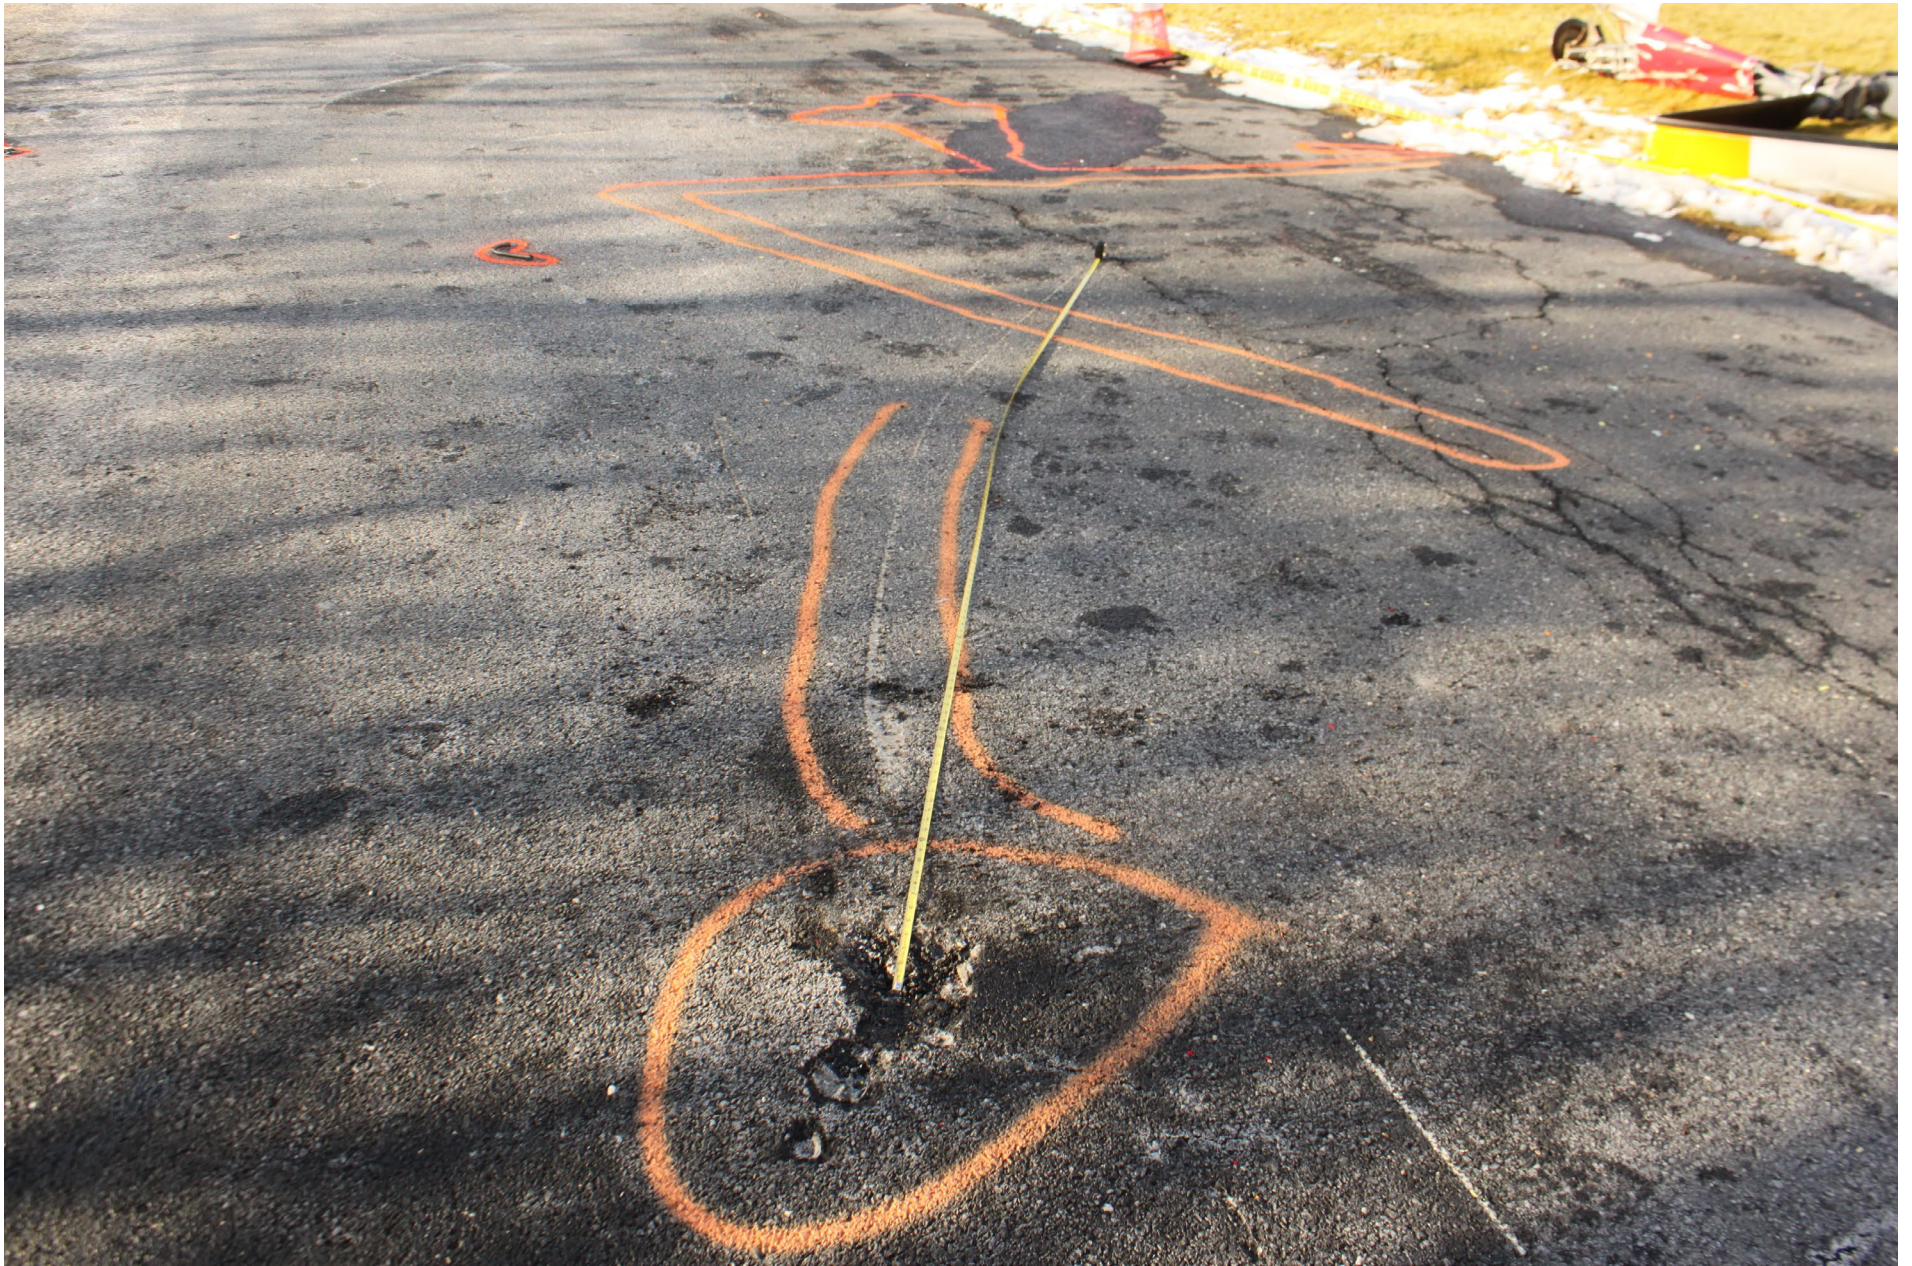
**Photo 4 - NTSB Digital Photograph. View of the Location Where the Main Rotor Mast with Attached Blades was Found Before Being Moved.**

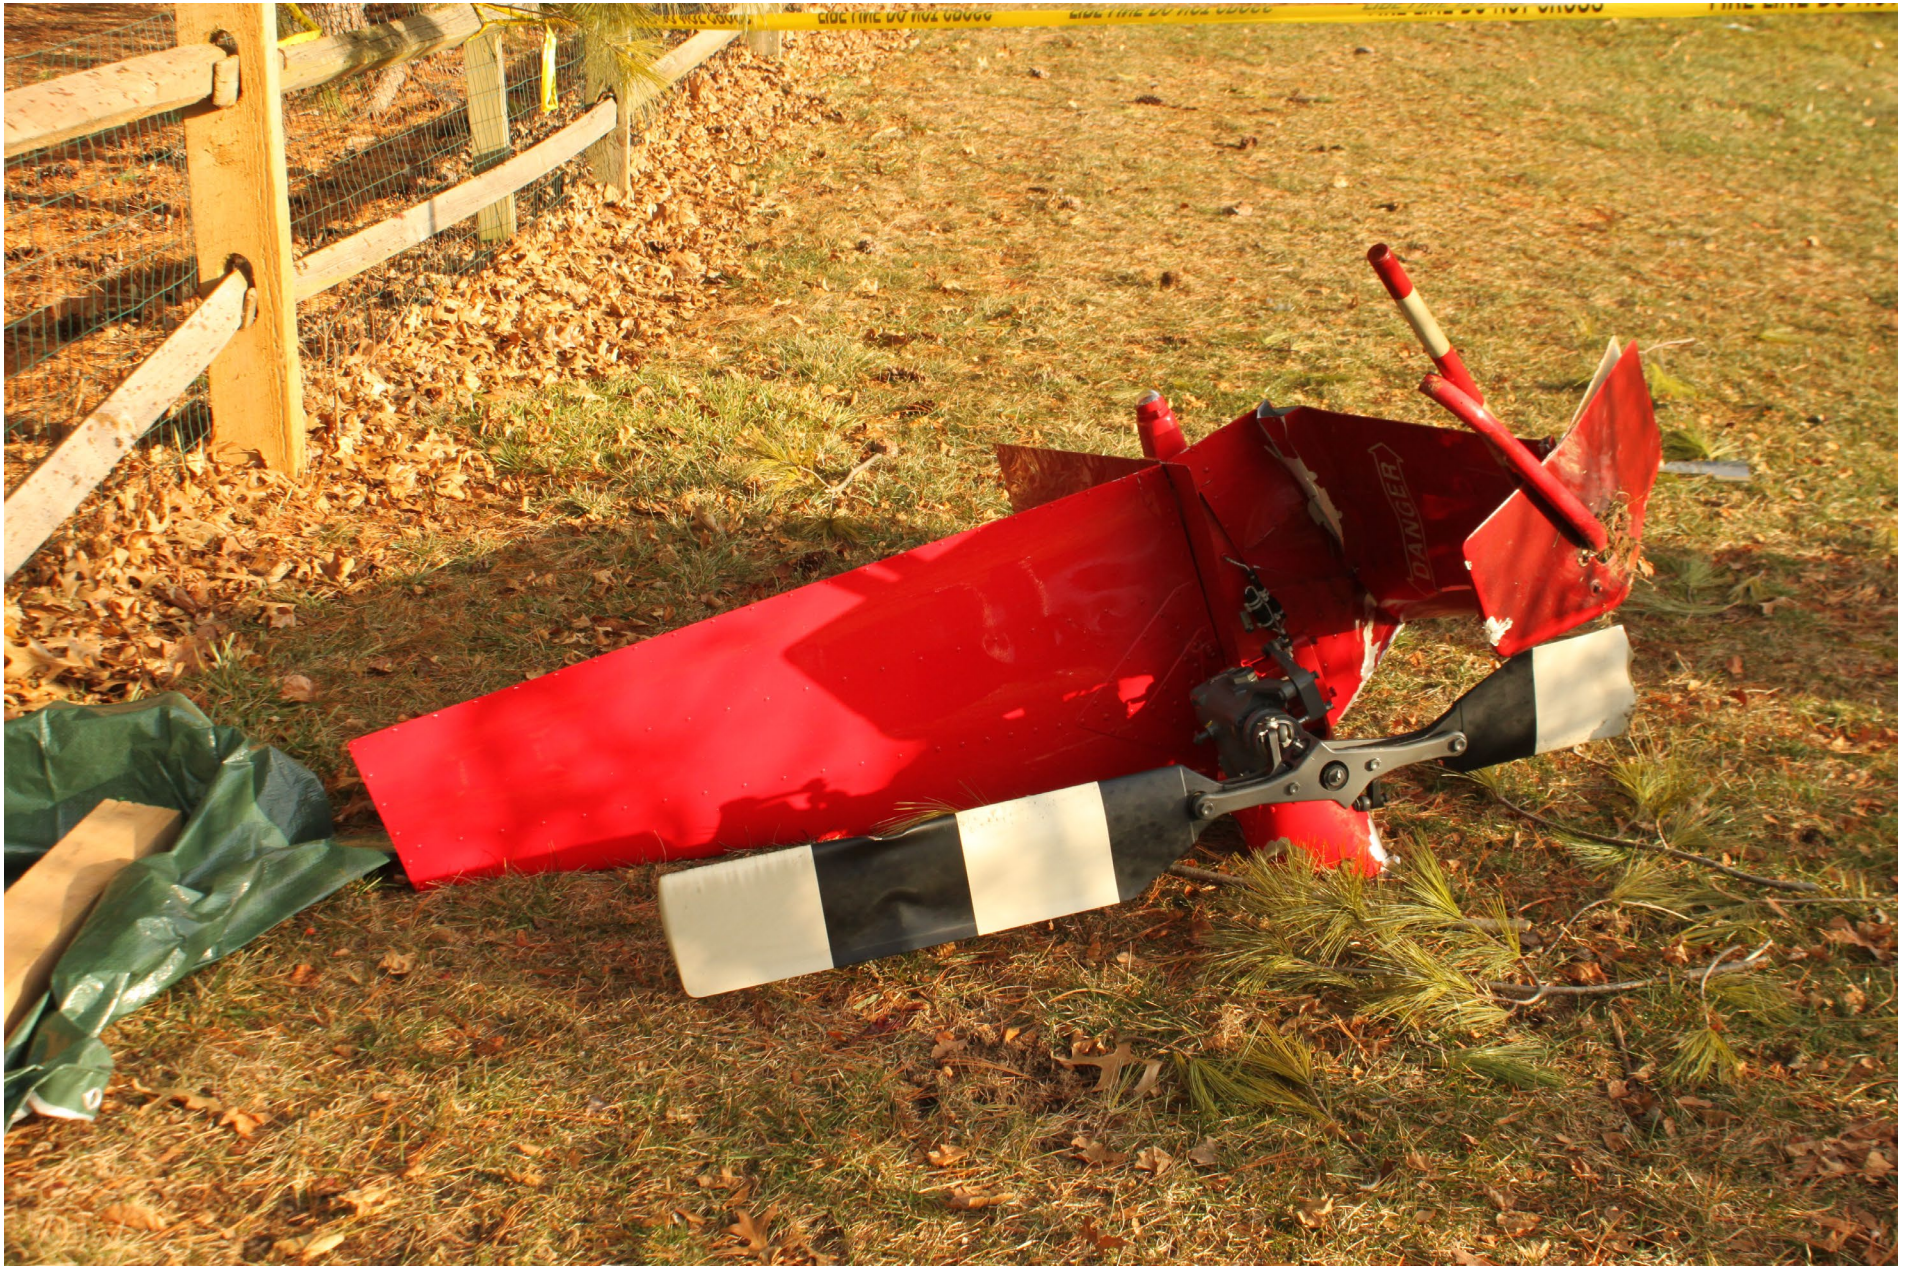
**Photo 5 - NTSB Digital Photograph. View of the Separated Tail Rotor Assembly. Note the fractured Tail Rotor Blade.**

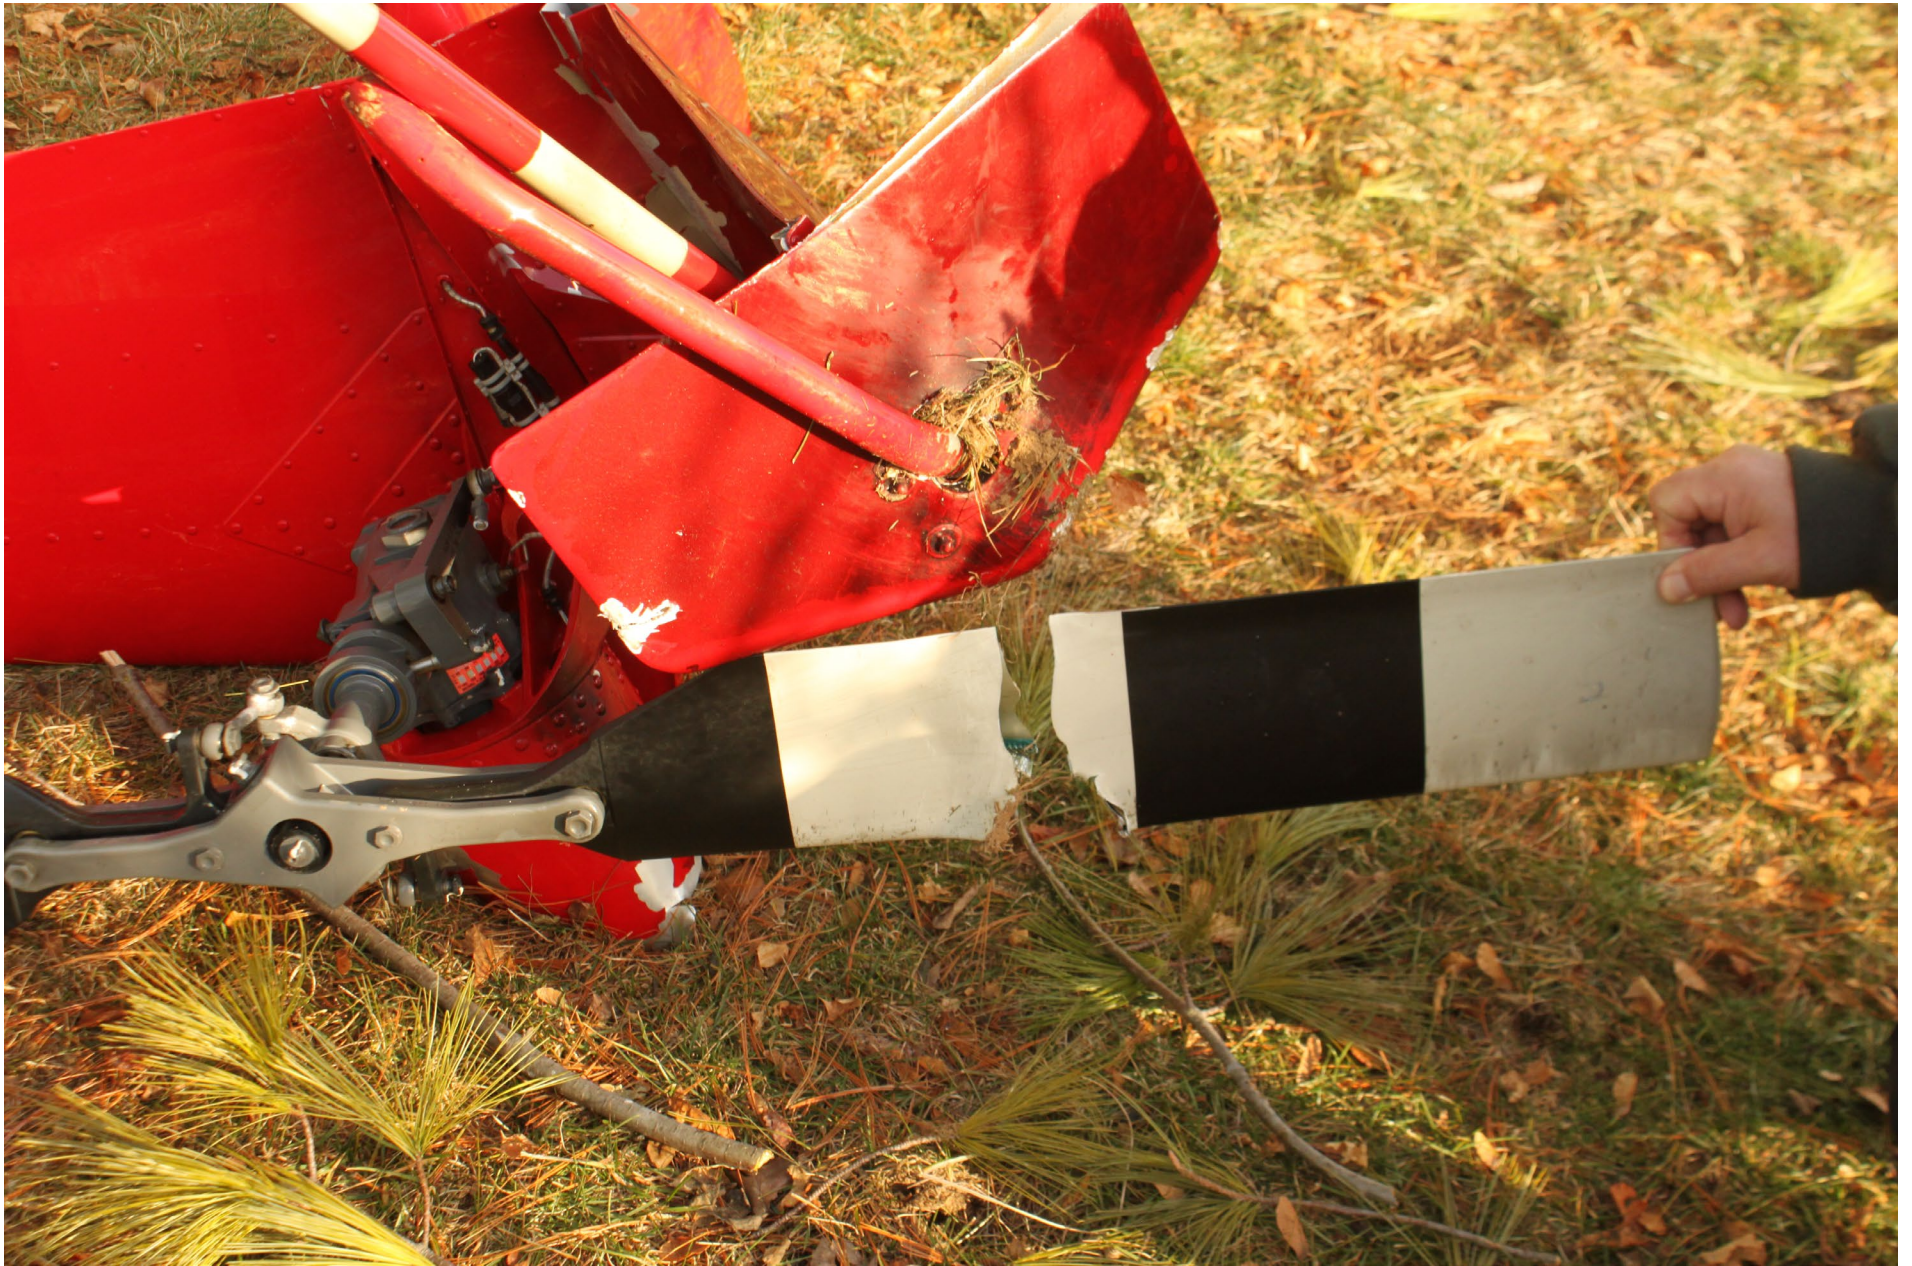
**Photo 6 - NTSB Digital Photograph. Close-Up View of the fractured Tail Rotor Blade Showing the recovered Section of Tail Rotor Blade in the Photograph.**

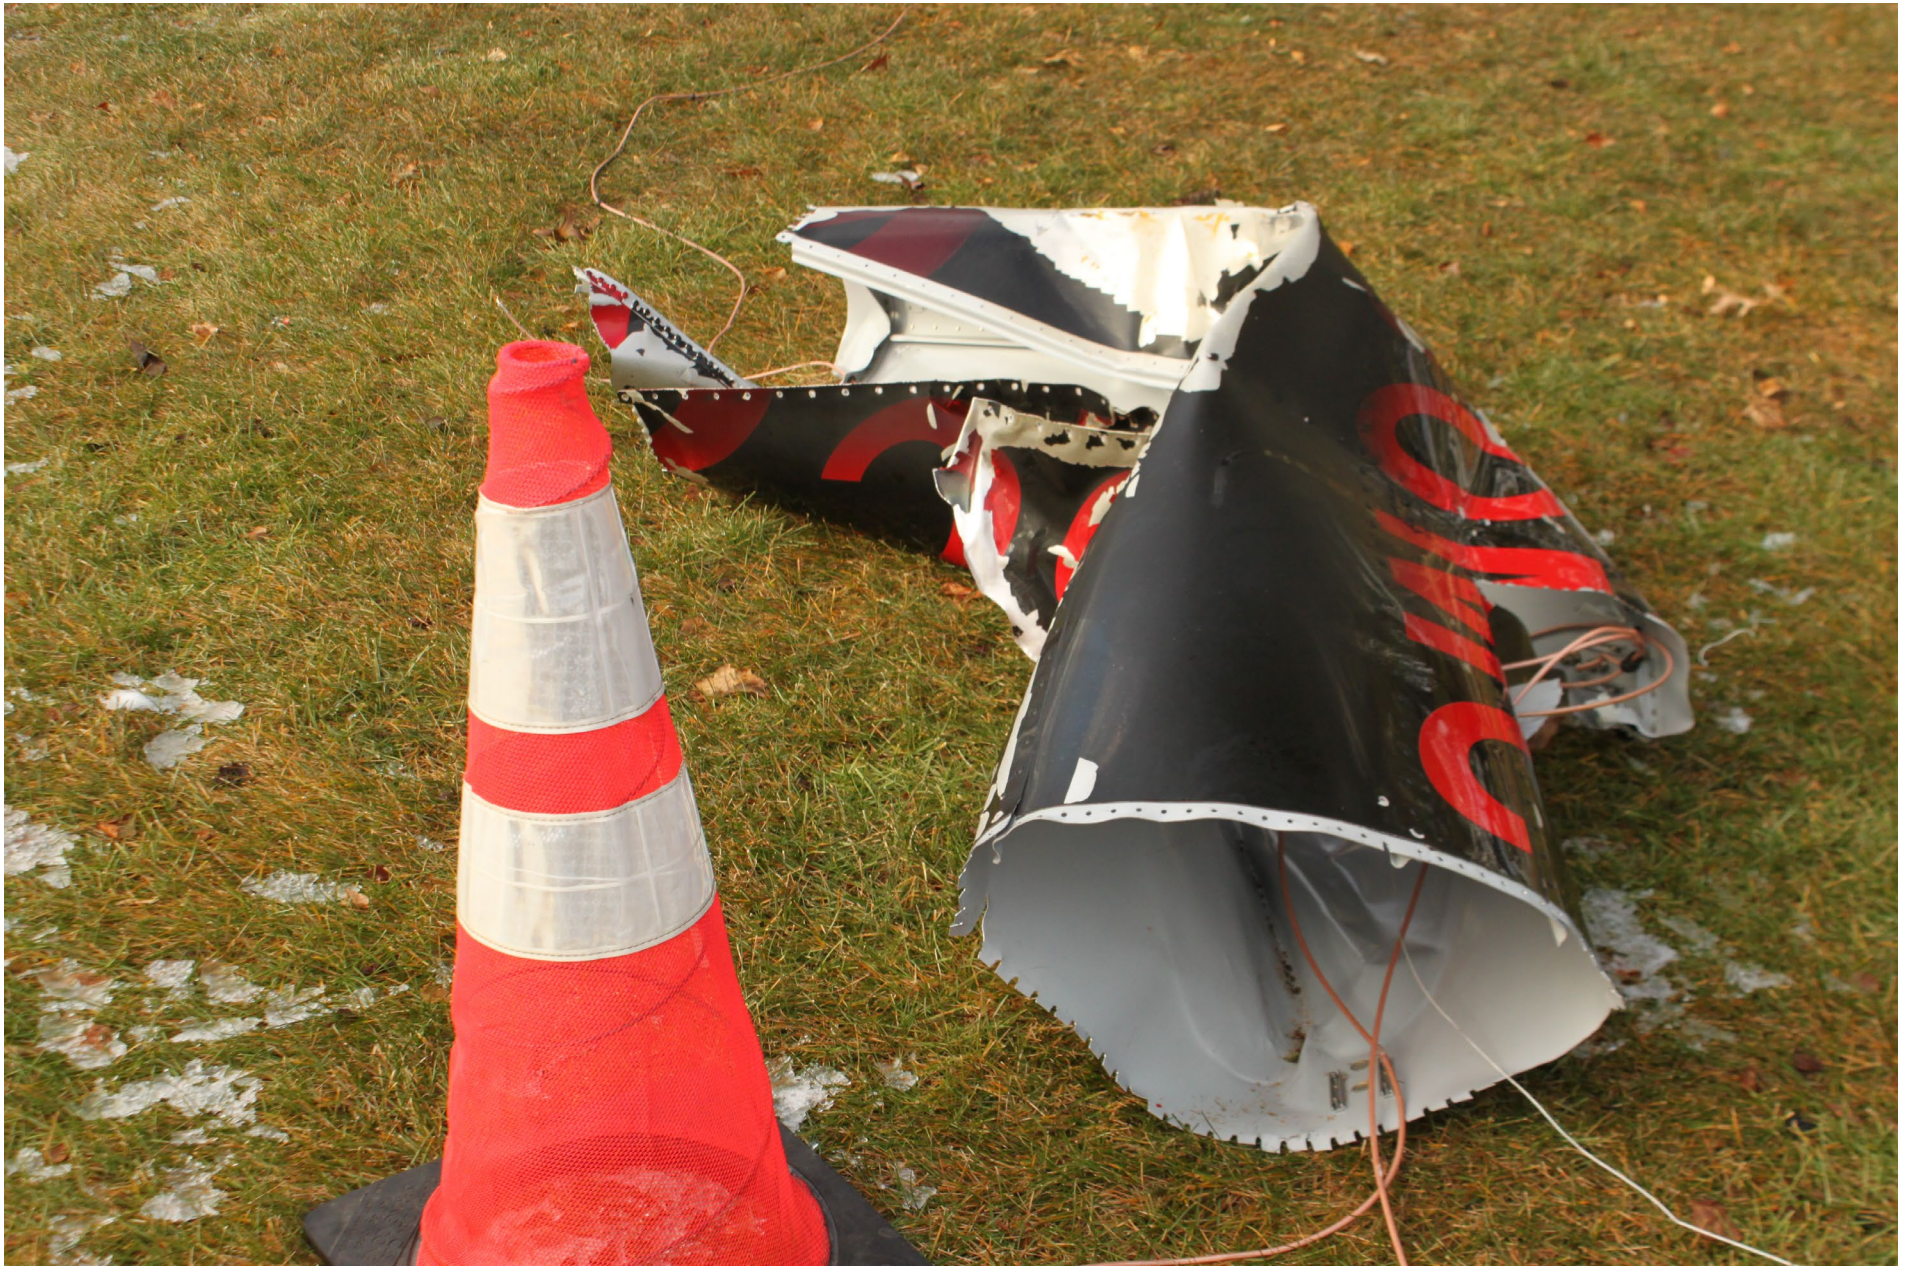
**Photo 7 - NTSB Digital Photograph. View of a Portion of the Separated Tailboom.**

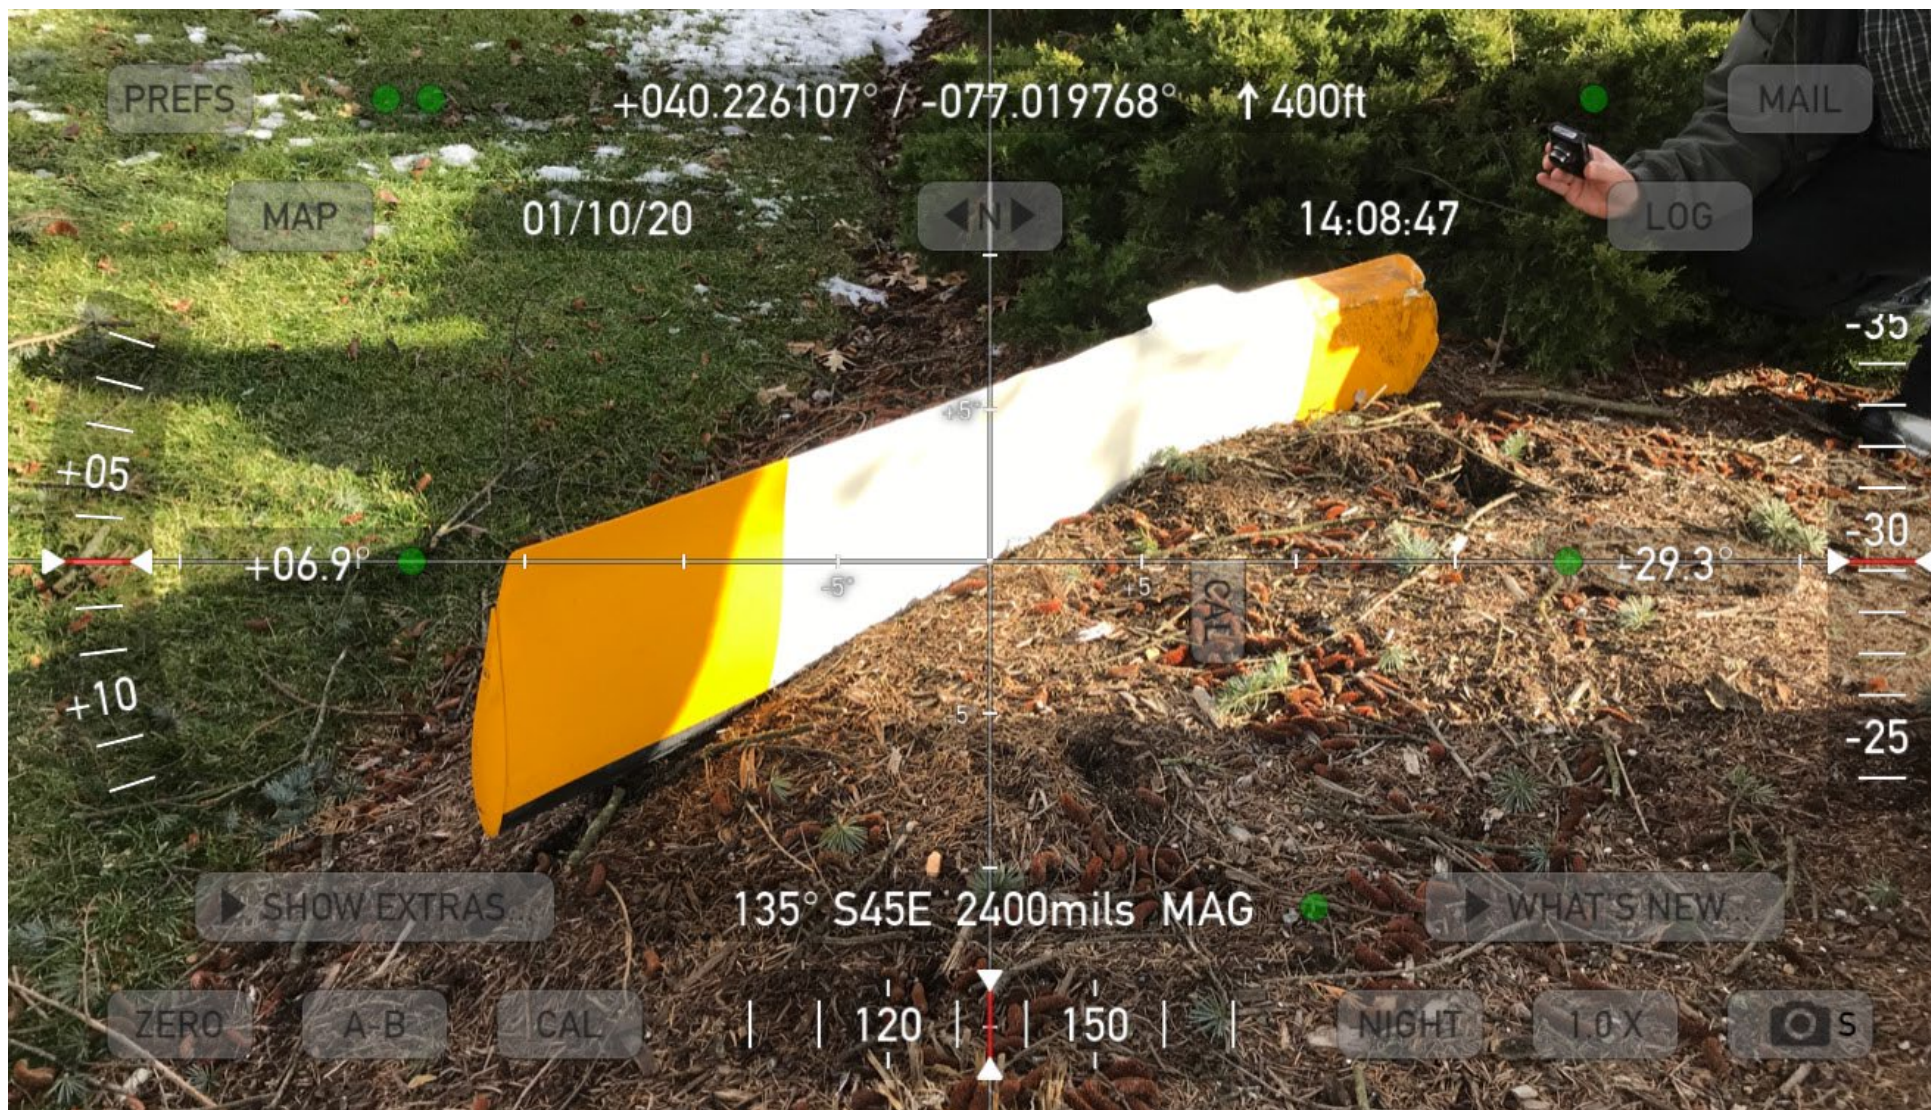
**Photo 8 - NTSB Digital Photograph. View of the Separated Portion of Main Rotor Blade and Corresponding Location.**

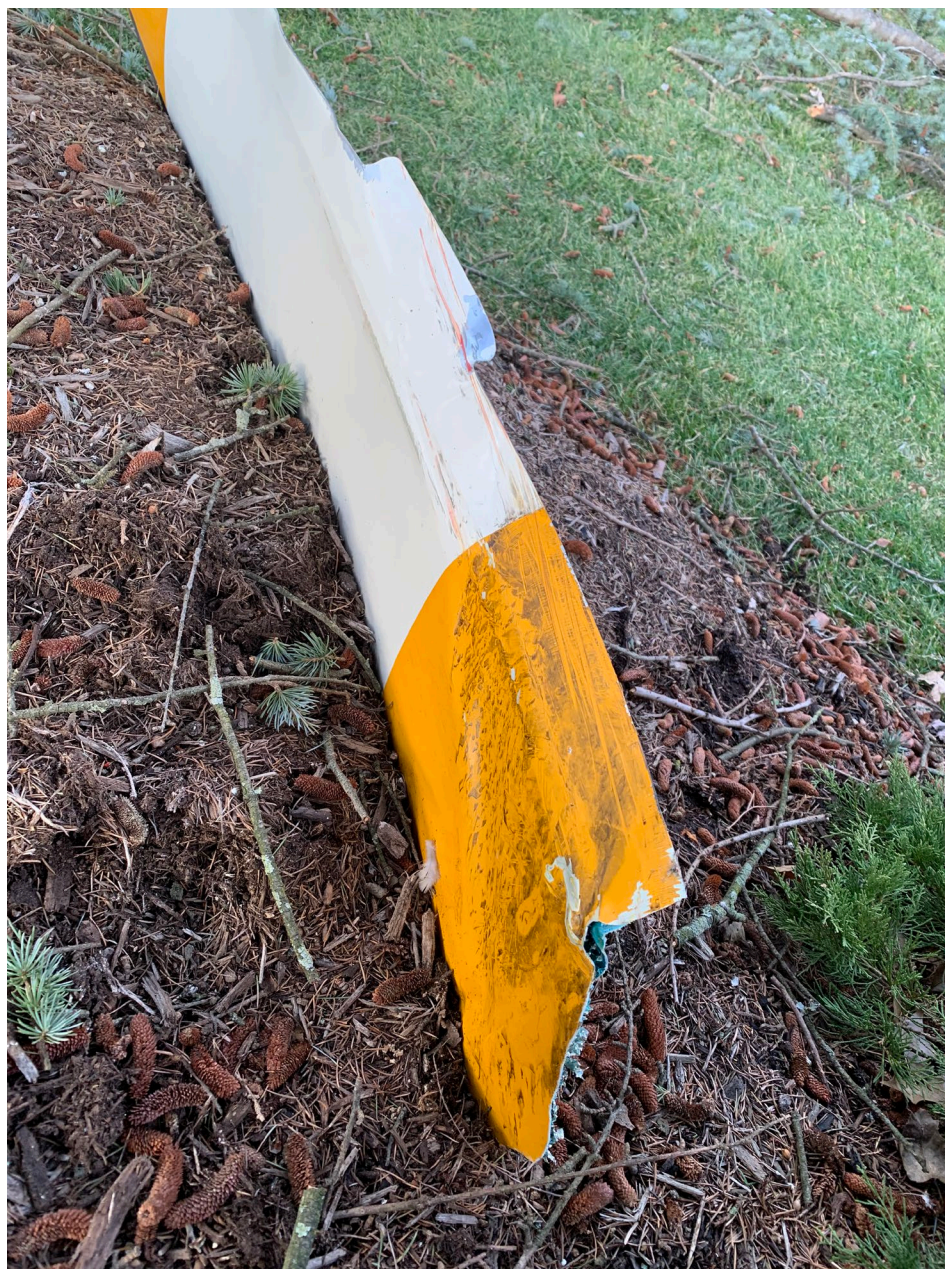
**Photo 9 – FAA Digital Photograph. View of the Inboard Section of the Separated Main Rotor Blade. Note the Feather Adhering to the Upper Surface of the Blade near the Leading Edge.**
