# NATIONAL TRANSPORTATION SAFETY BOARD

## MATERIALS LABORATORY FACTUAL REPORT

Report No. 20-053

Place : Senoia, GA  
Date : January 25, 2020  
Vehicle : Mustang II Experimental (unregistered)  
NTSB No. : ERA20FA086  
Investigator : Robert Gretz (AS-ERA)

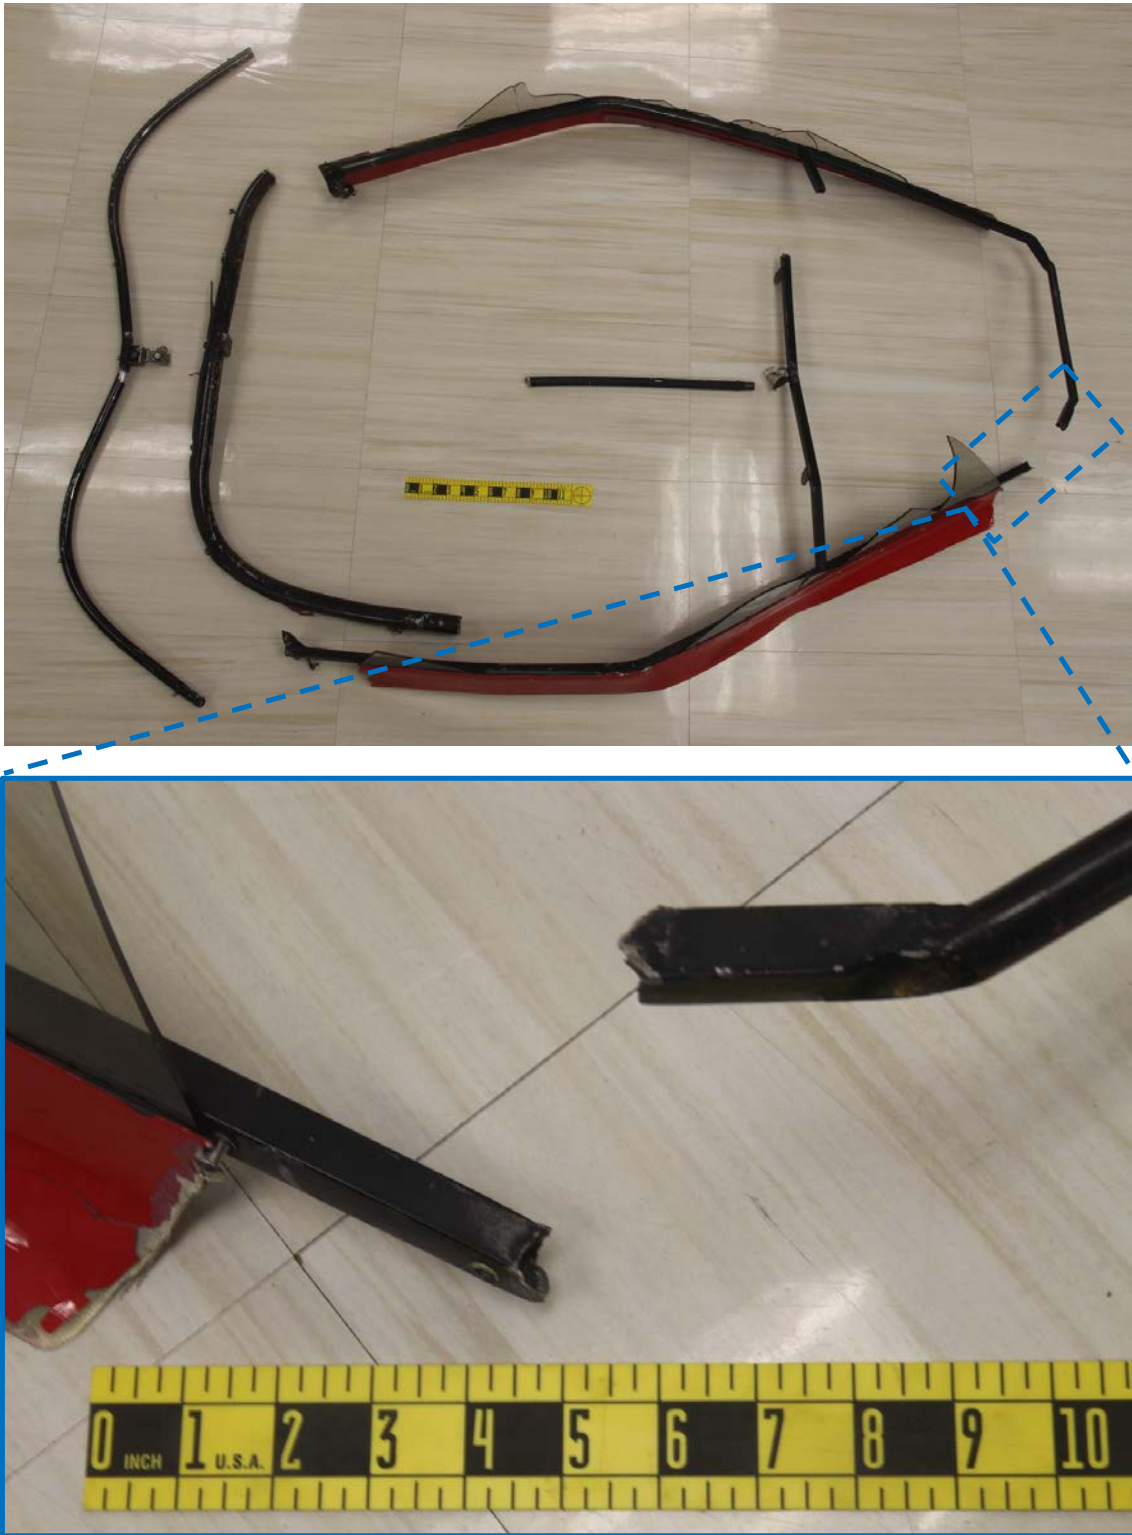
The canopy frame pieces are shown in Figures 1-4. Numerous dents and bends were observed on the canopy pieces. There were separations in the canopy frame near the left aft corner junction and through the horizontal tube near the rear of the frame, as shown in Figures 1 and 2, respectively. The fracture features of both separations were consistent with overstress.

Figure 1: The top shows an overall photo of the canopy frame pieces. The bottom shows a close-up photo of a separation in the canopy frame near the left aft corner junction.

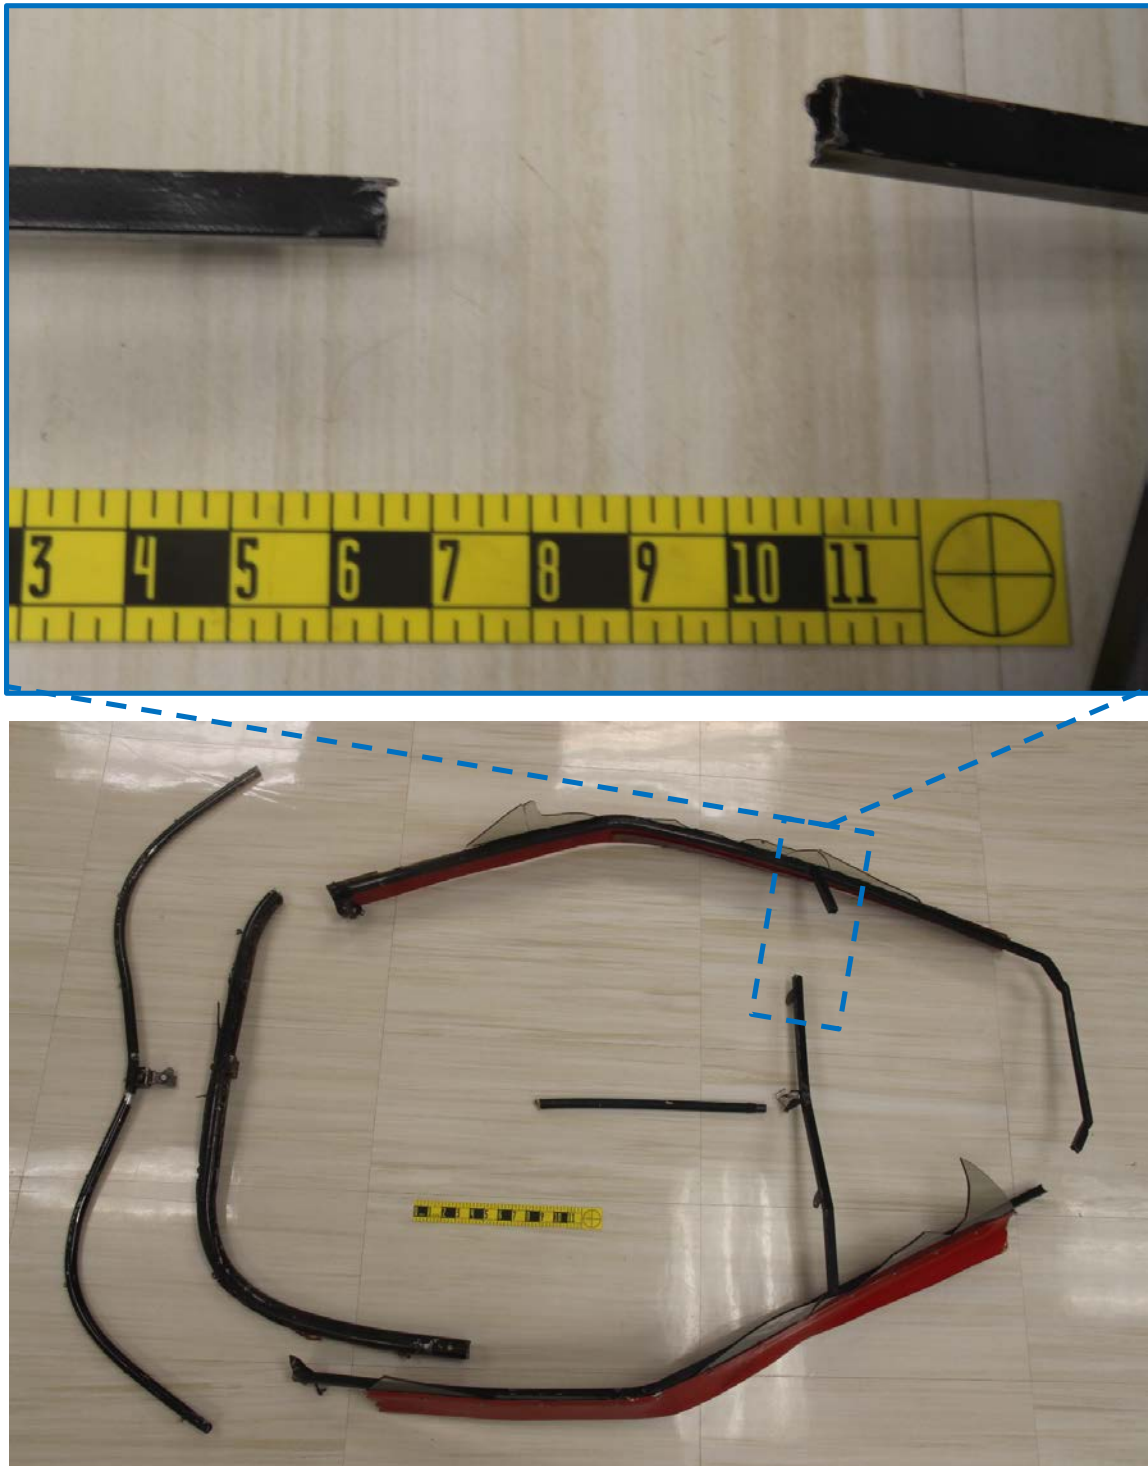
Figure 2: The bottom shows an overall photo of the canopy frame pieces. The top shows a close-up photo of a separation in the canopy frame through the horizontal tube near the rear of the frame.

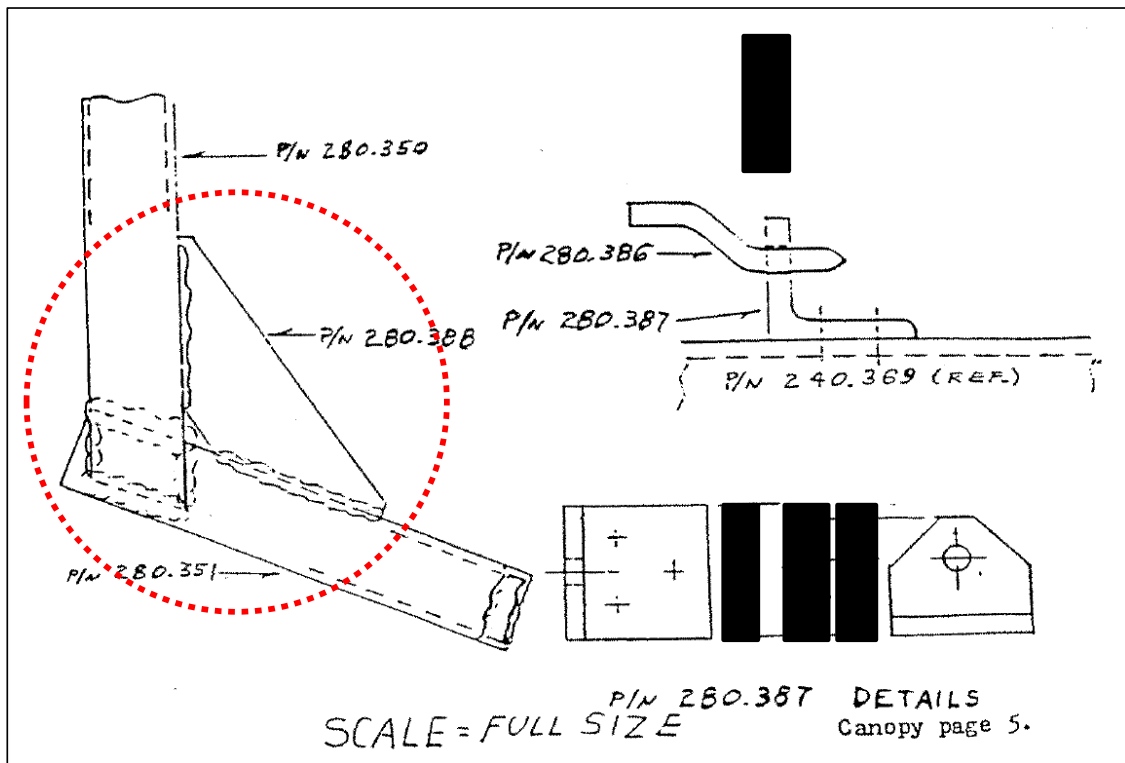
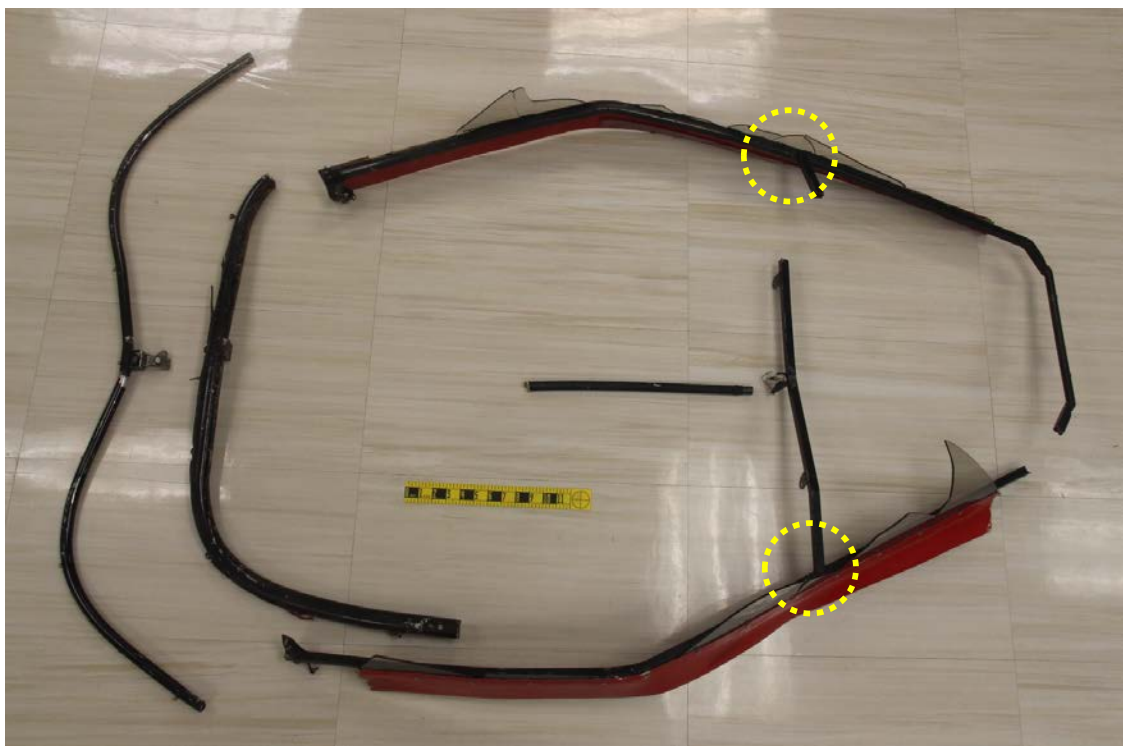
A Mustang II Compendium revised January 3, 2020 outlined, among other items, the placement of gussets in the aft corner junctions of the frame, which were meant to strengthen the canopy framework. As shown in Figure 3, the canopy frame from the accident aircraft did not have gussets in place.

Figure 3: The top image shows a portion of the Mustang II Compendium revised January 3, 2020 with the gusset at the aft junction corners encircled in a red dotted line. The bottom shows an overall photo of the canopy frame pieces, with yellow dotted circles indicating the aft junction corners without gussets installed.

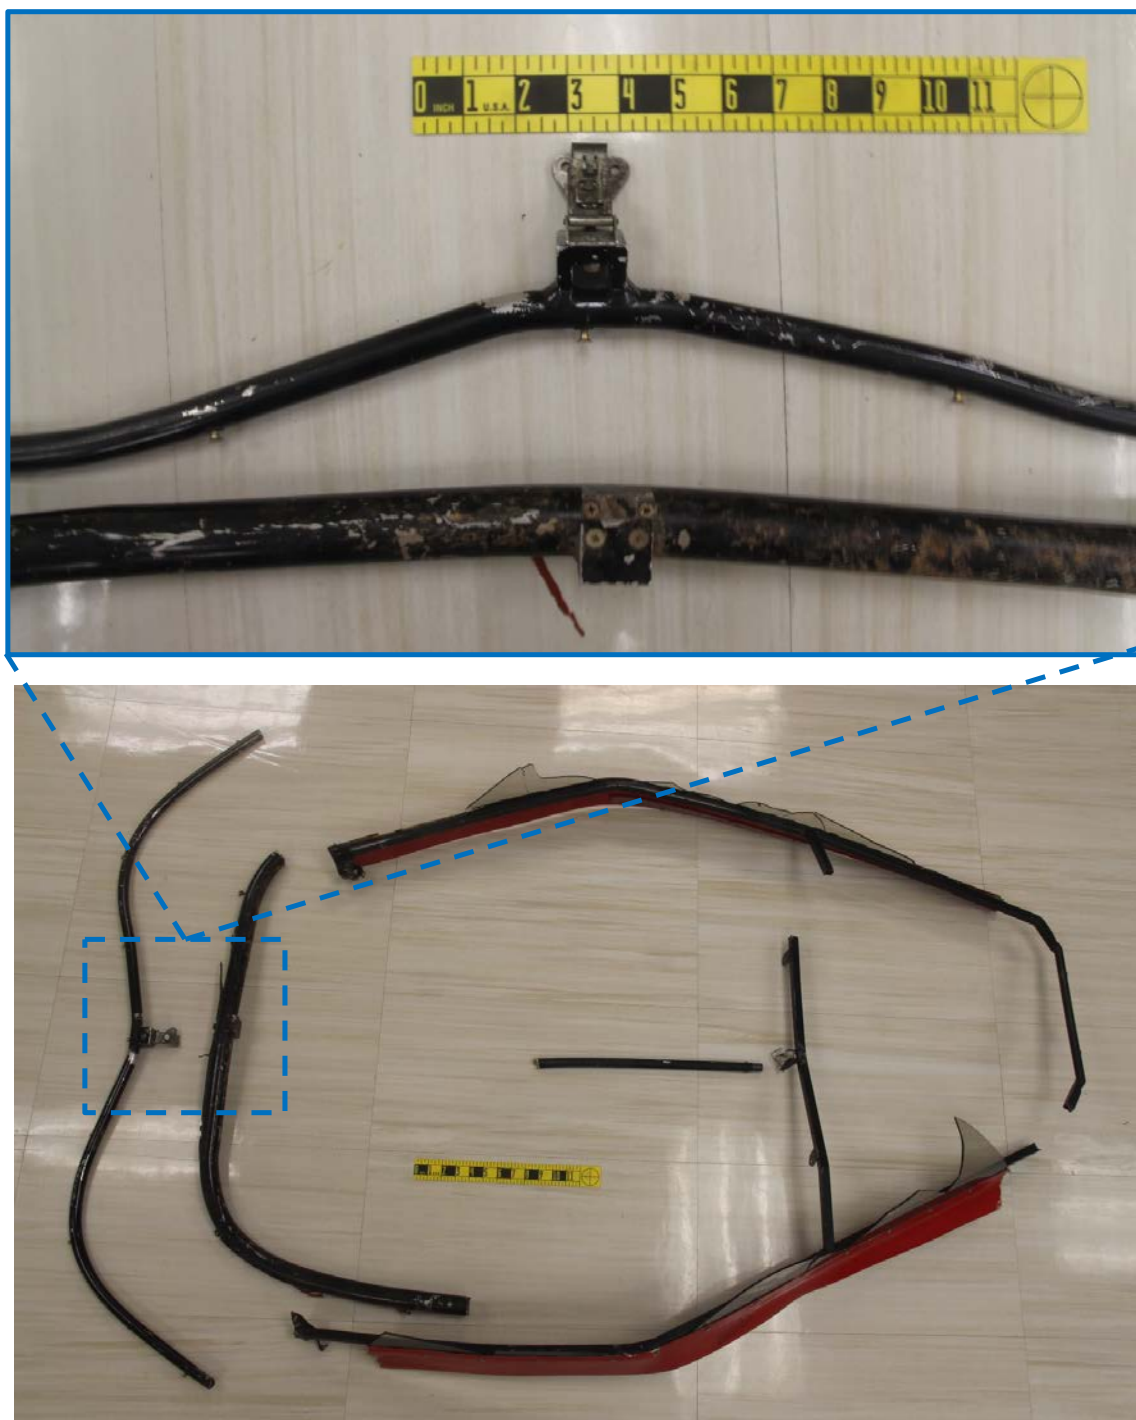
The canopy locking mechanism, shown in Figure 4, was intact, could still be mechanically manipulated, and appeared functional. Figure 5 shows the left and right attachment locations of the forward tube. Yellow arrows point to deformation of the bolt holes in the tube consistent with pull-out of the mating bolts.

Figure 4: The bottom shows an overall photo of the canopy frame pieces, and the top shows a close-up photo of the canopy locking mechanism.

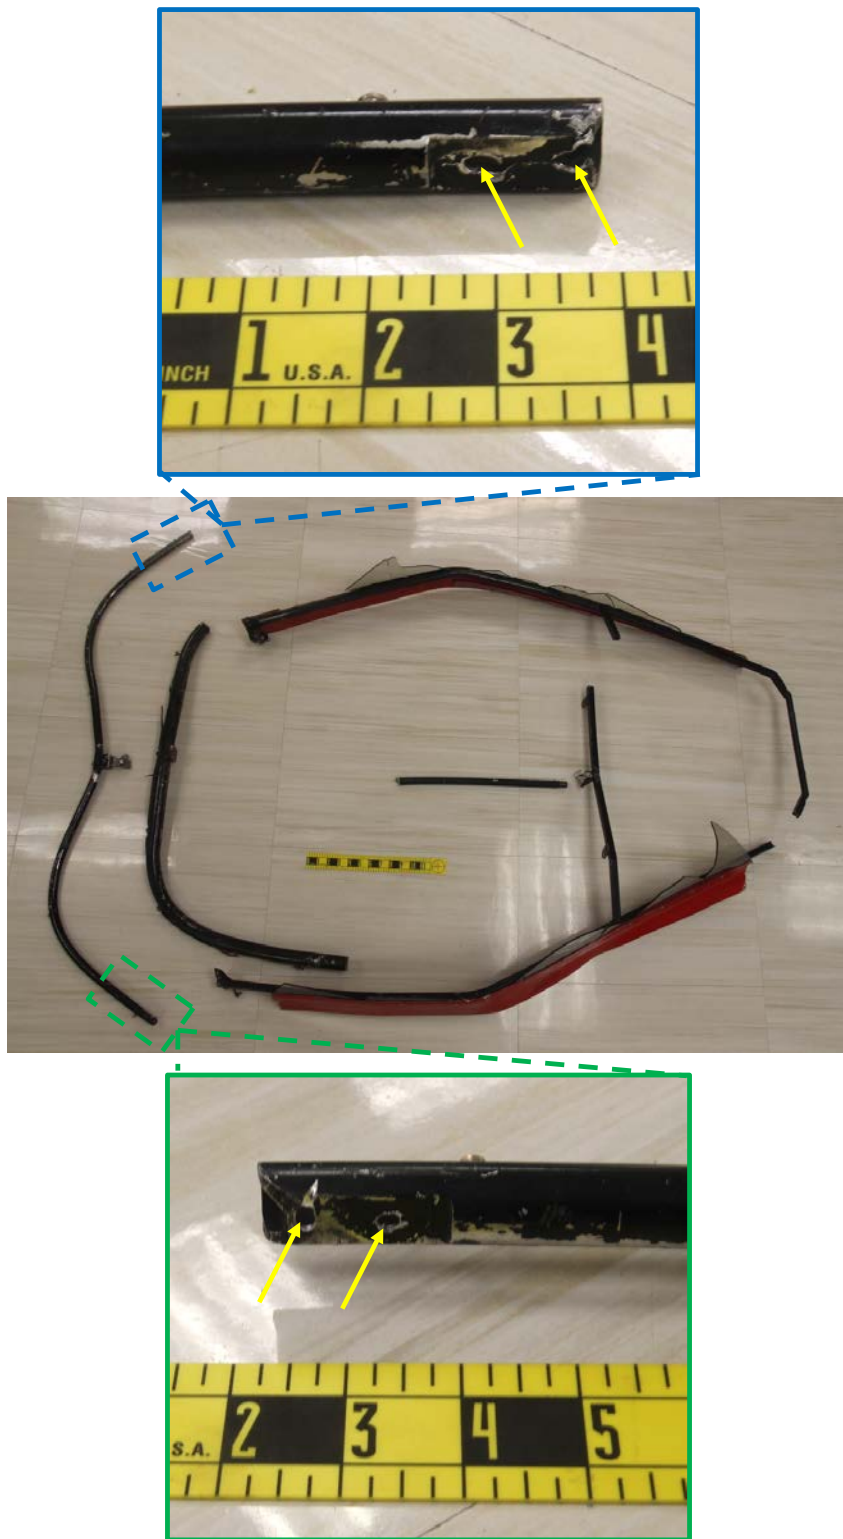
Figure 5: The center shows an overall photo of the canopy frame pieces. The top and bottom photos show the right and left attachment locations, respectively, of the forward tube. Yellow arrows point to deformation of the bolt holes in the tube.

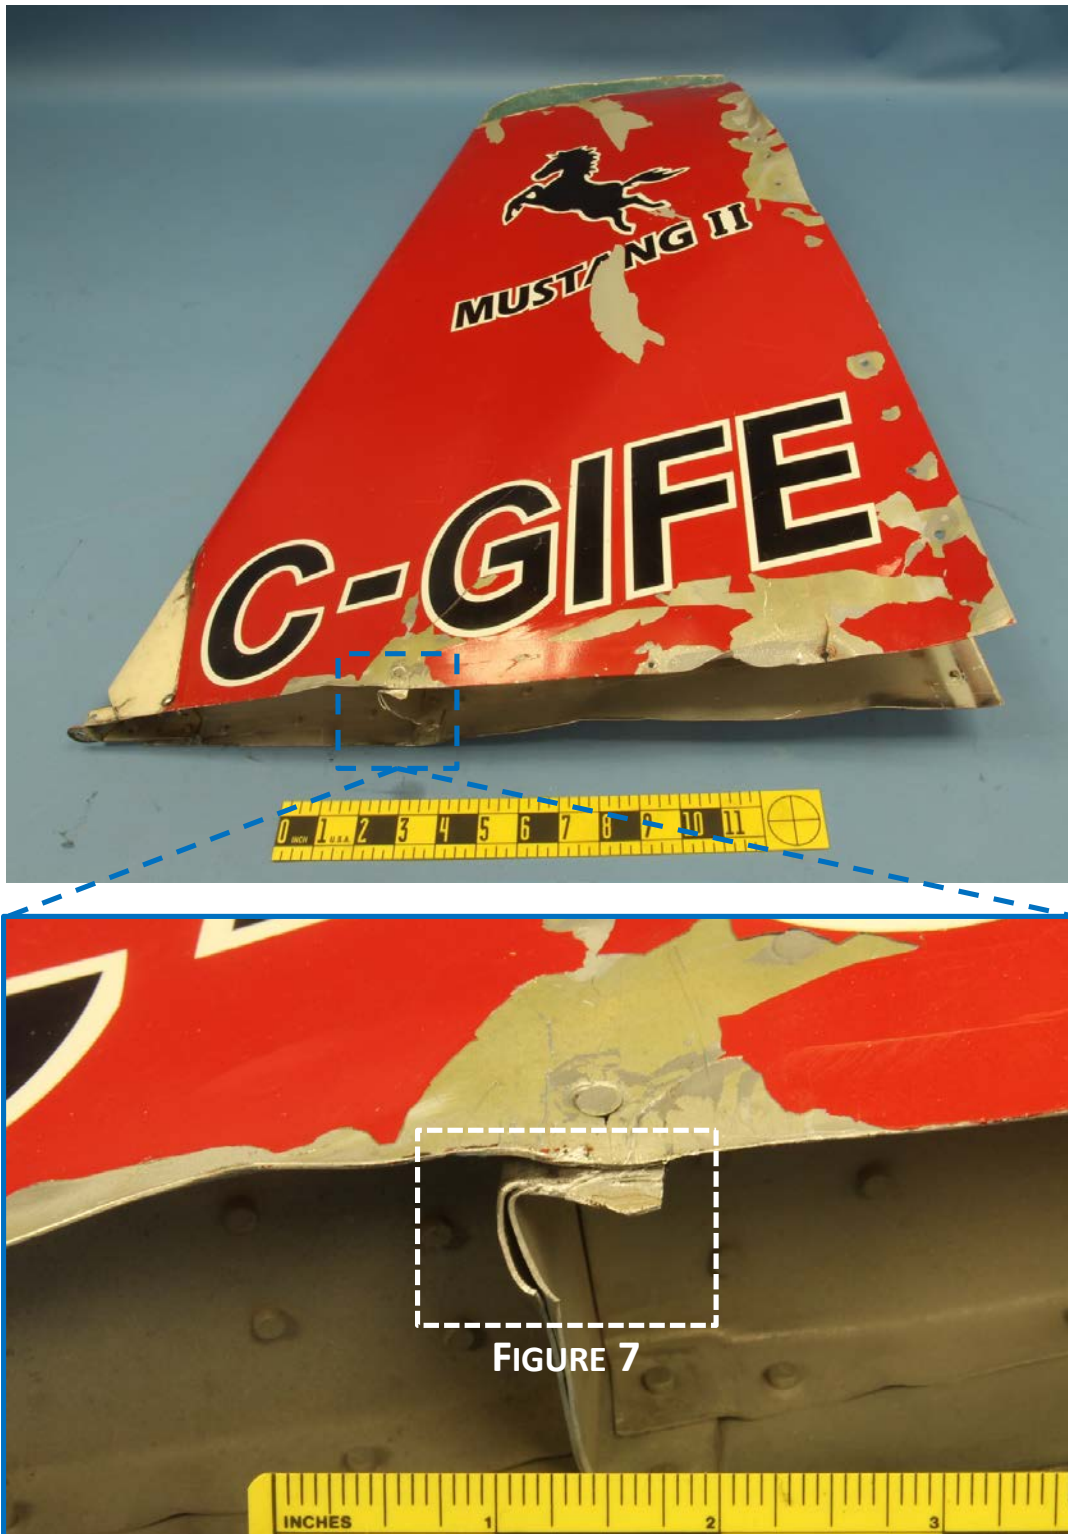
The separated vertical stabilizer is shown in Figure 6. A portion of the doubler for the main rib was missing adjacent to a left attachment rivet. A flat area was observed on the fracture surface at the corner of the doubler, as shown in Figure 7. The flat area was

Figure 6: The top shows an overall photo of the separated vertical stabilizer. The bottom photo is a close-up of the left corner of the main rib doubler.

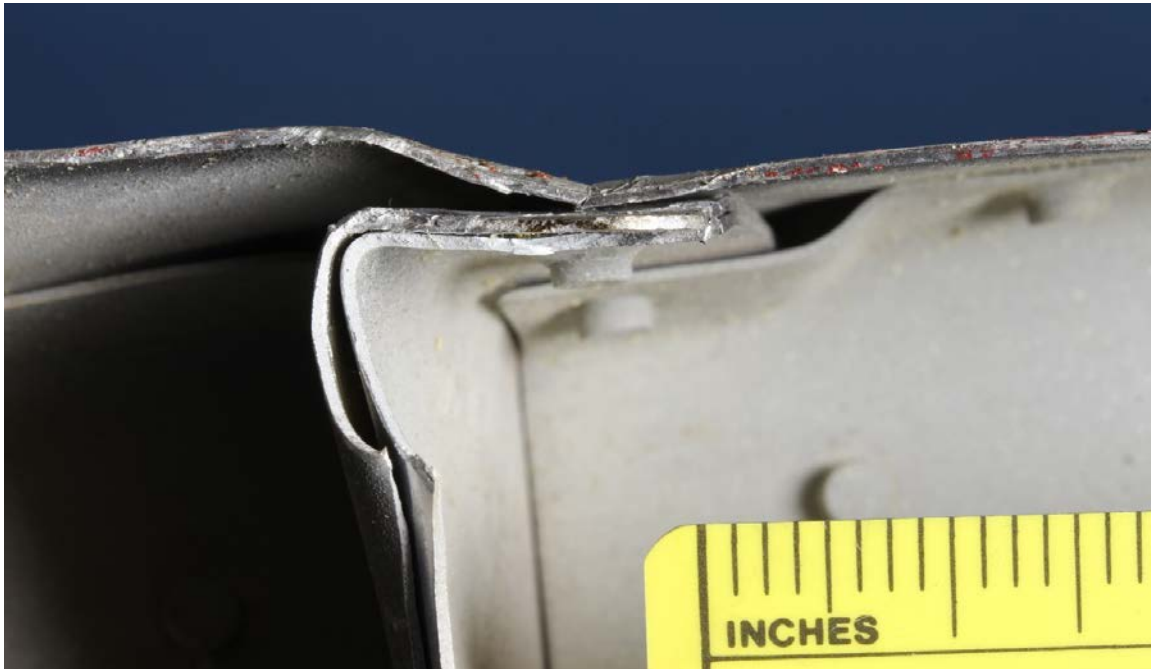
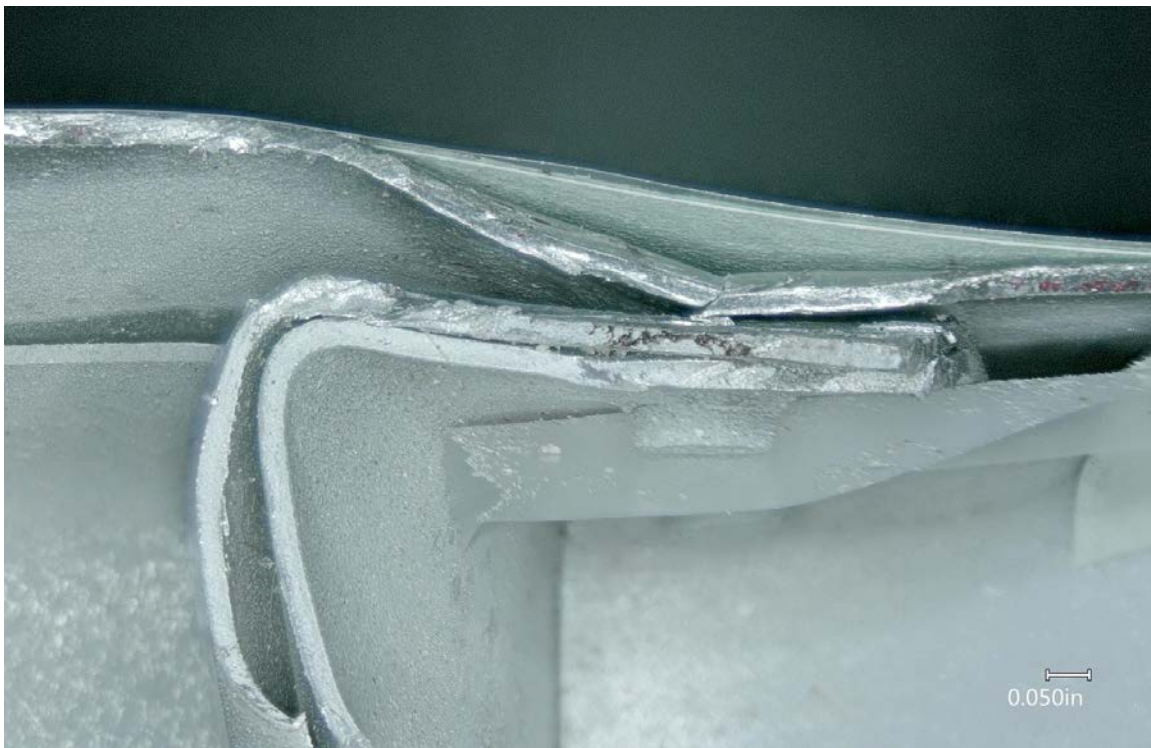
Figure 7: A close-up photo (top) and digital microscope image (bottom) of a flat area on the fracture surface at the corner of the doubler.

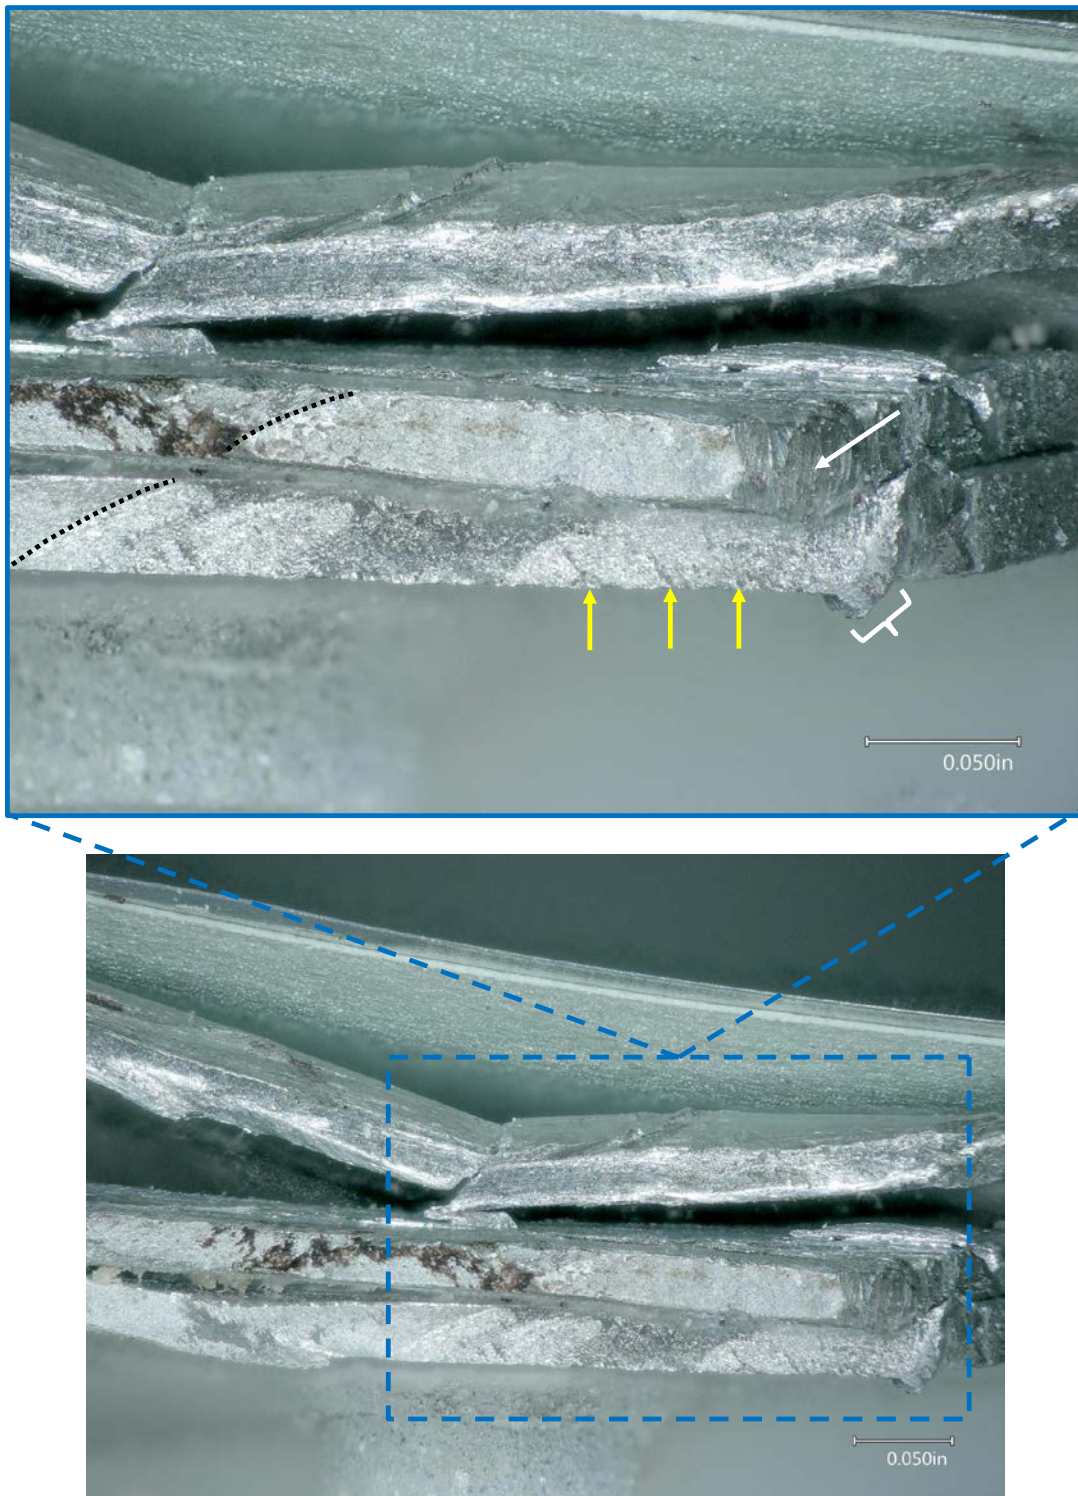
examined using a 5-50x zoom digital microscope. The black dotted line in Figure 8 outlines a thumbnail-shaped pattern observed on the flat area. The thumbnail-shaped pattern was consistent with fatigue cracking emanating from the internal corner of the doubler. Ratchet marks consistent with multiple initiation fatigue cracking were observed along the internal edge of the aft doubler rib. While damage obscured the exact fatigue initiation site, the orientation of the thumbnail-shaped pattern and the location of the ratchet marks indicate the fatigue cracking likely started at the internal corner of the aft doubler rib.

Figure 8: Digital microscope images of the flat area on the fracture surface at the corner of the doubler. The black dotted line outlines the thumbnail-shaped pattern emanating from the doubler corner. The yellow arrows point to ratchet marks along the internal edge of the aft doubler rib. The white bracket and arrow indicate damage obscuring the corners of the doubler ribs.

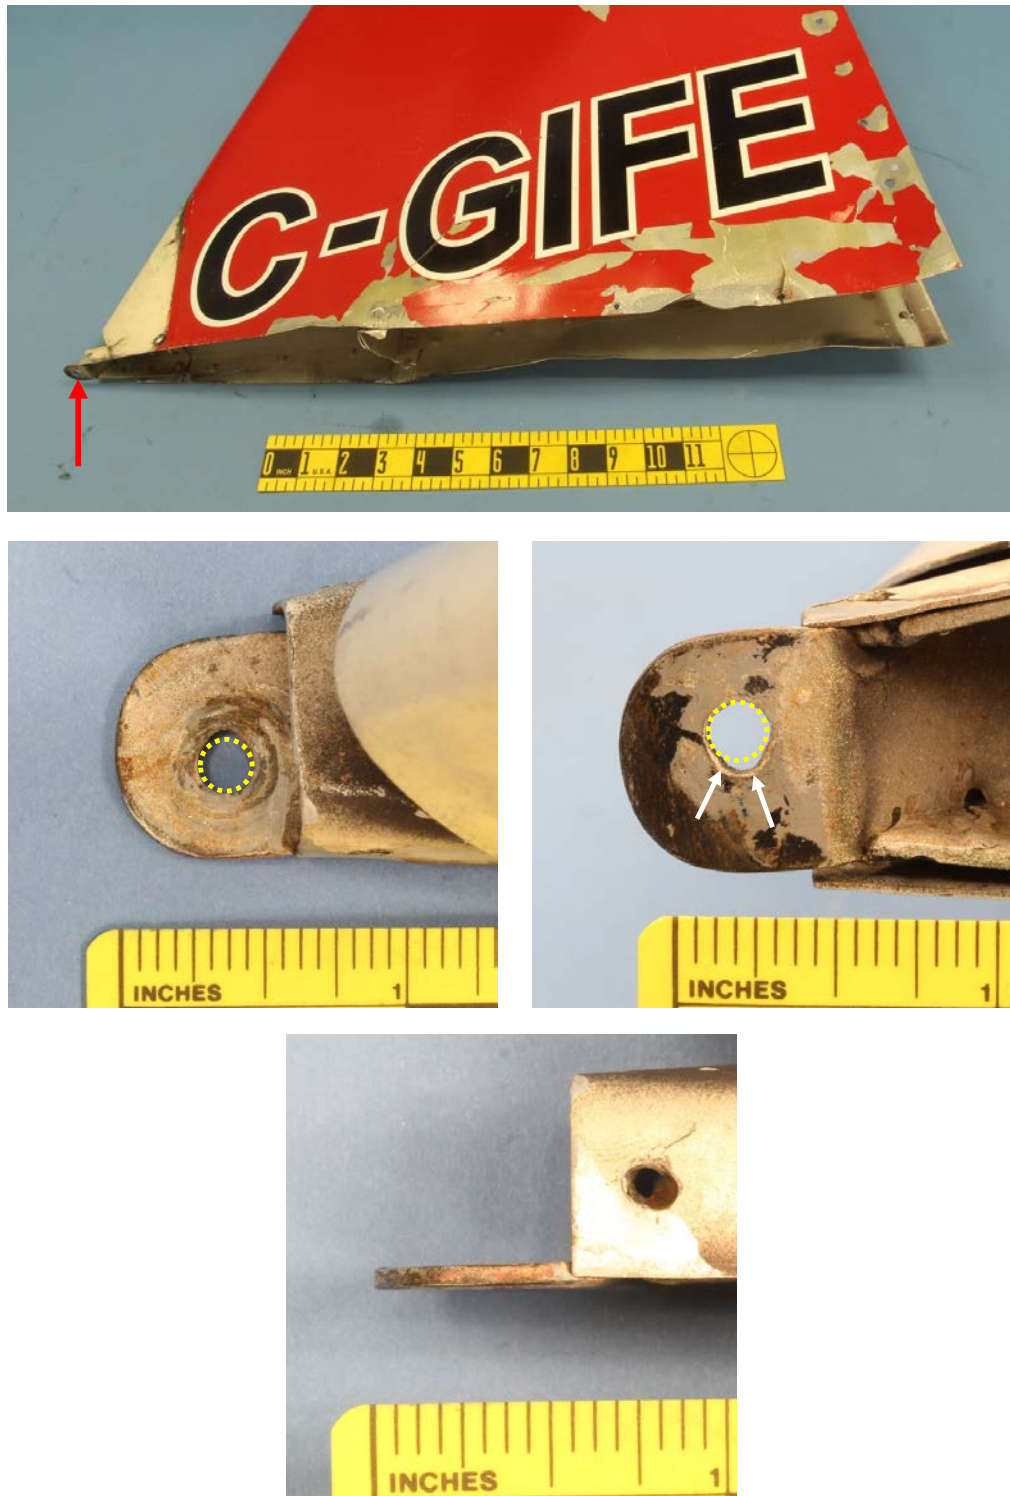
The forward attach point on the vertical stabilizer is shown in Figure 9. The mating bolt was missing when the vertical stabilizer was recovered. Wear was observed on one side of the bolt hole in the attach point, making the hole out of round, as illustrated by the yellow dotted lines. Rolled material was observed on the bottom of the attach point, as indicated by the white arrows. The irregular shape of the bolt hole and the rolled material is constituent with wear that occurred over time. A profile view of the attach point shows it was flat and did not have deformation associated with pull-out of the mating bolt.

Figure 9: Close-up photos of the forward attach point (red arrow, top photo) on the vertical stabilizer. The top and bottom of the attach point bolt hole are shown in the center left and right photos, respectively. The yellow dotted lines illustrate a round bolt hole. The white arrows point to rolled material. The bottom photo shows a profile view of the attach point.

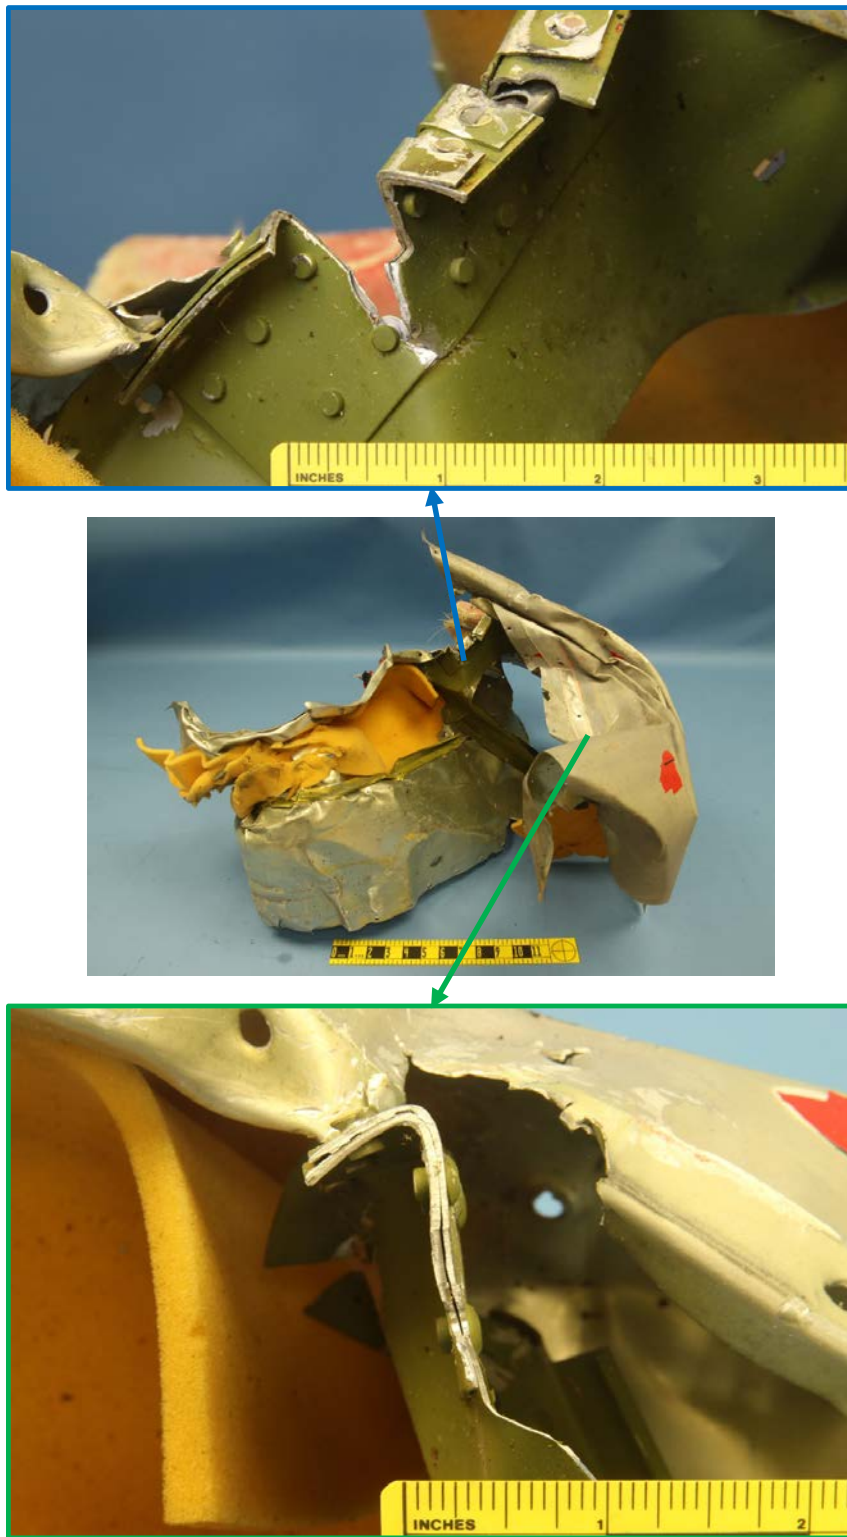
The portion of fuselage skin and internal structure submitted for examination is shown in Figure 10. The fracture features on the skin and structural rib pieces of the fuselage were consistent with overstress.

Figure 10: Overall photo of the submitted fuselage piece is shown in the center. The top and bottom photos show some of the fractures in the ribs of the piece.

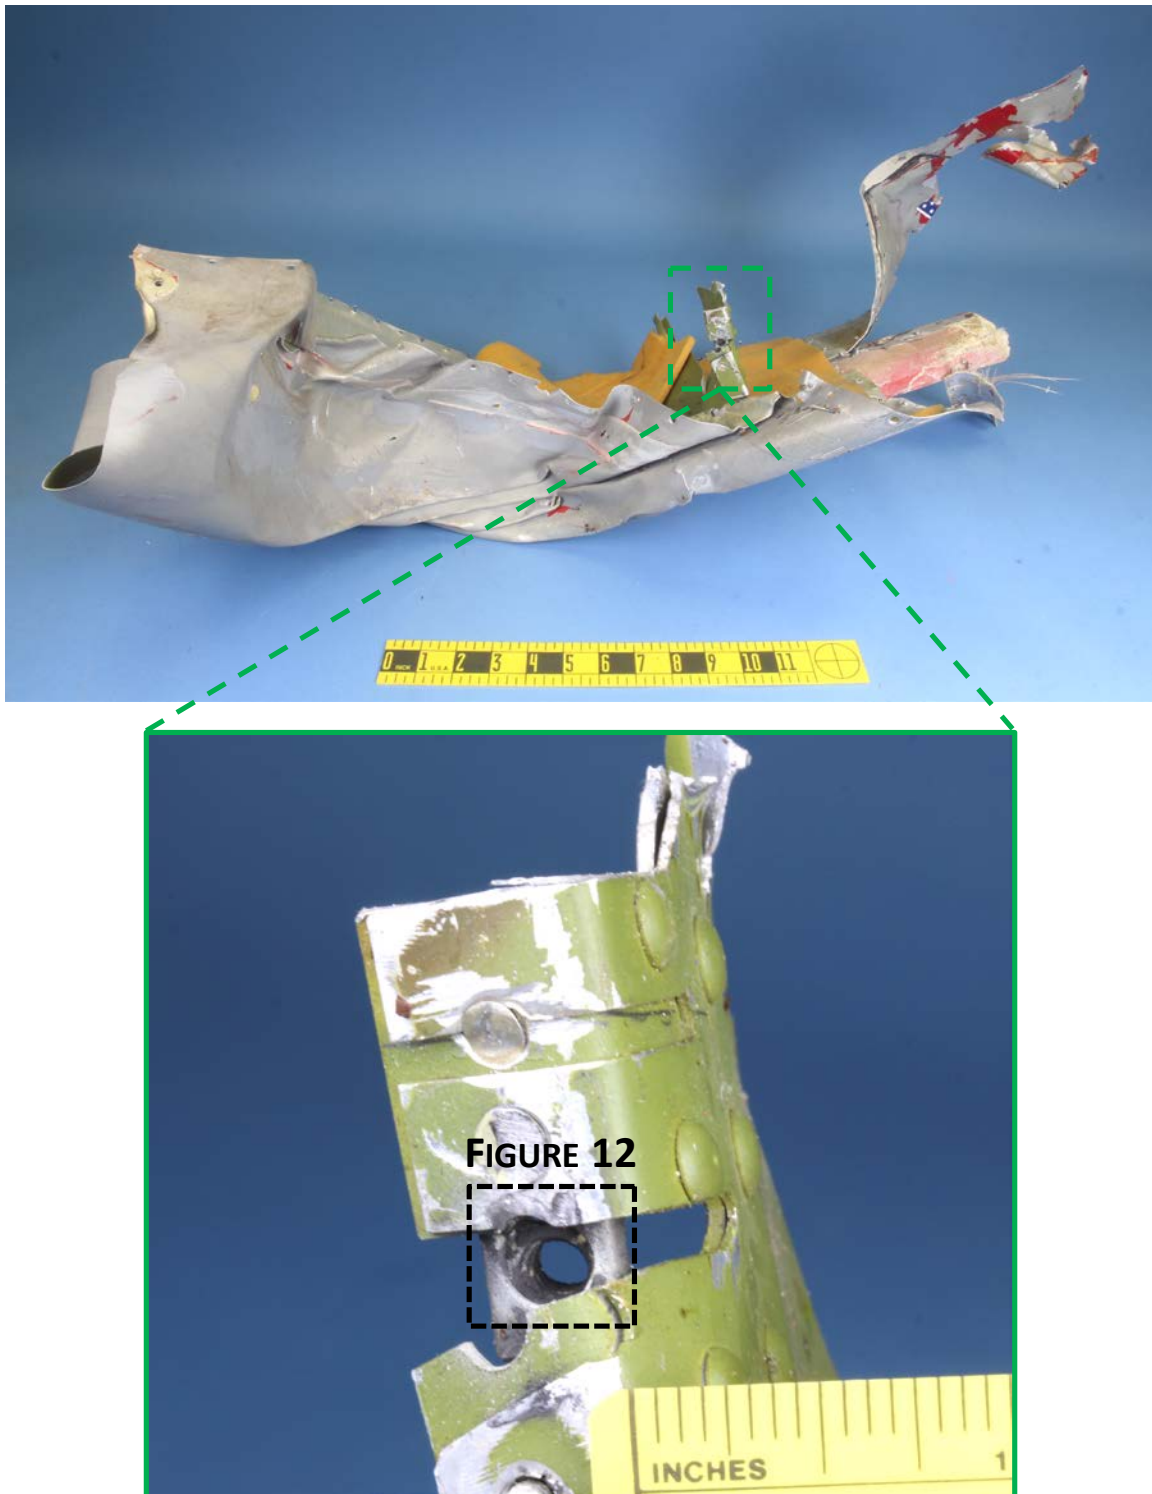
The bolt hole through the rib that mated with the forward attach point of the vertical stabilizer was still attached to the submitted fuselage pieces, as shown in Figure 11. The threads of the bolt hole were examined using a 5-50x zoom digital microscope. Digital microscope images of the threads are shown in Figure 12. The threads had some flattening but were largely intact. Oxidation covered the surfaces of the threads. It could not be determined if the oxidation was a passivation layer formed prior to the accident or was due to exposure of the threads post-accident. No stripping or other thread deformation associated with pull-out of the mating bolt was observed.

Figure 11: Overall (top) and close-up (bottom) photos of the bolt hole through the rib that mated with the forward attach point of the vertical stabilizer.

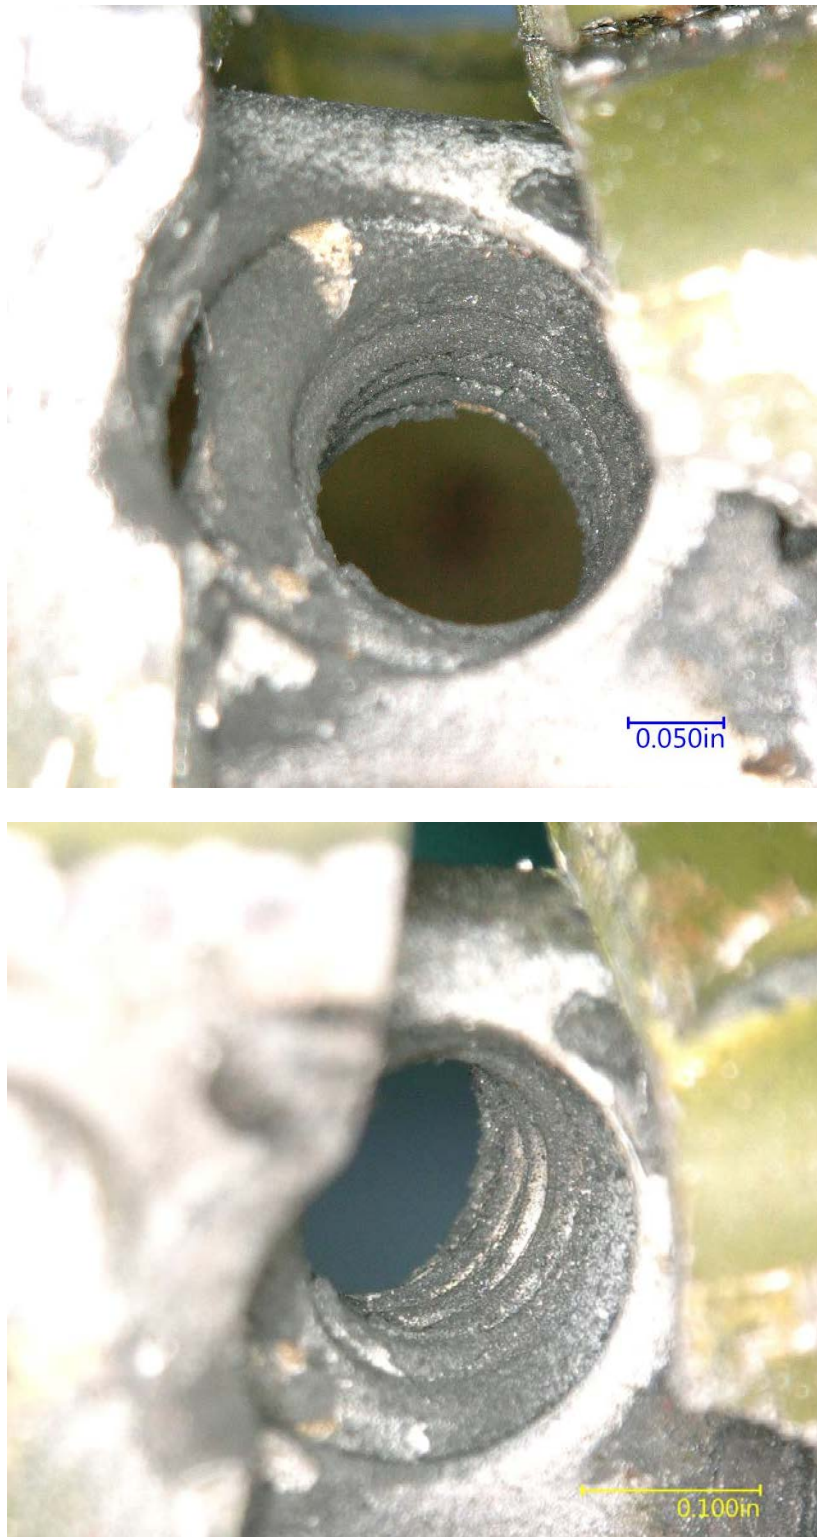
Figure 12: Digital microscope images of the threads in the bolt hole through the rib that mated with the forward attach point of the vertical stabilizer.
