**NATIONAL TRANSPORTATION SAFETY BOARD**

**Image Recorder**

**Specialist's Factual Report  
By Nick Swann**

| NTSB Number: | ERA20FA086 |

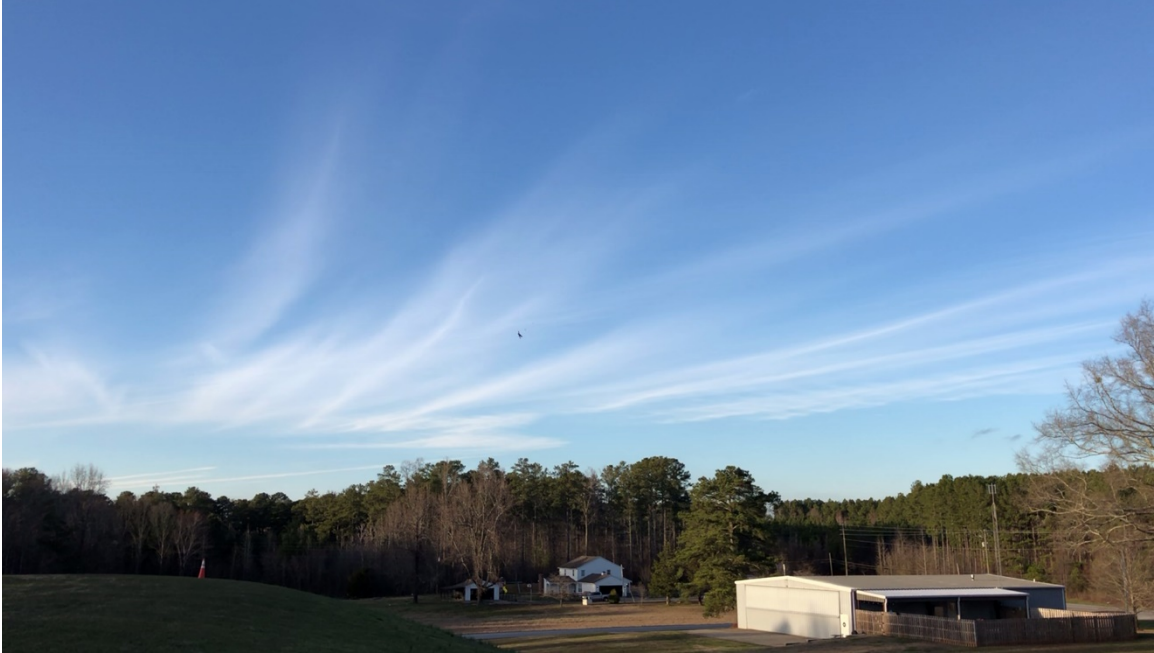
By extracting individual frames from the remainder of the recording, a frame by frame analysis was performed of the airplane breaking up. An example of debris images can be seen below in figure 1 and figure 2. Visible in figure 2 are three distinct pieces of debris; one glinting in the sunlight circled in green, and two other darker pieces circled in red. Due to the resolution of the recording, the compression effects of recorded video, and the distance the camera operator was from the aircraft, the parts of the aircraft that liberated in flight were not able to be identified.

At 02:47, the first piece of debris from the airplane was visible. Just thereafter, the camera autofocus was unable to track the airplane and the camera temporarily lost focus for several frames. When focus returned roughly a second later, four pieces of debris were seen behind the aircraft and the aircraft appeared to be in a sharp nose down attitude. The aircraft continued to descend rapidly toward a tree line in the distance and several frames later, just before 02:49, the fuselage of the aircraft was seen in a sharp nose down attitude and appeared to descend into the trees. At this time, a 5<sup>th</sup> piece of debris was seen liberating from the aircraft.

**Figure 1. Frame captured from video showing debris**
