# National Transportation Safety Board

## Performance Study

### Specialist Report

| NTSB Number: | ERA20FA101 |

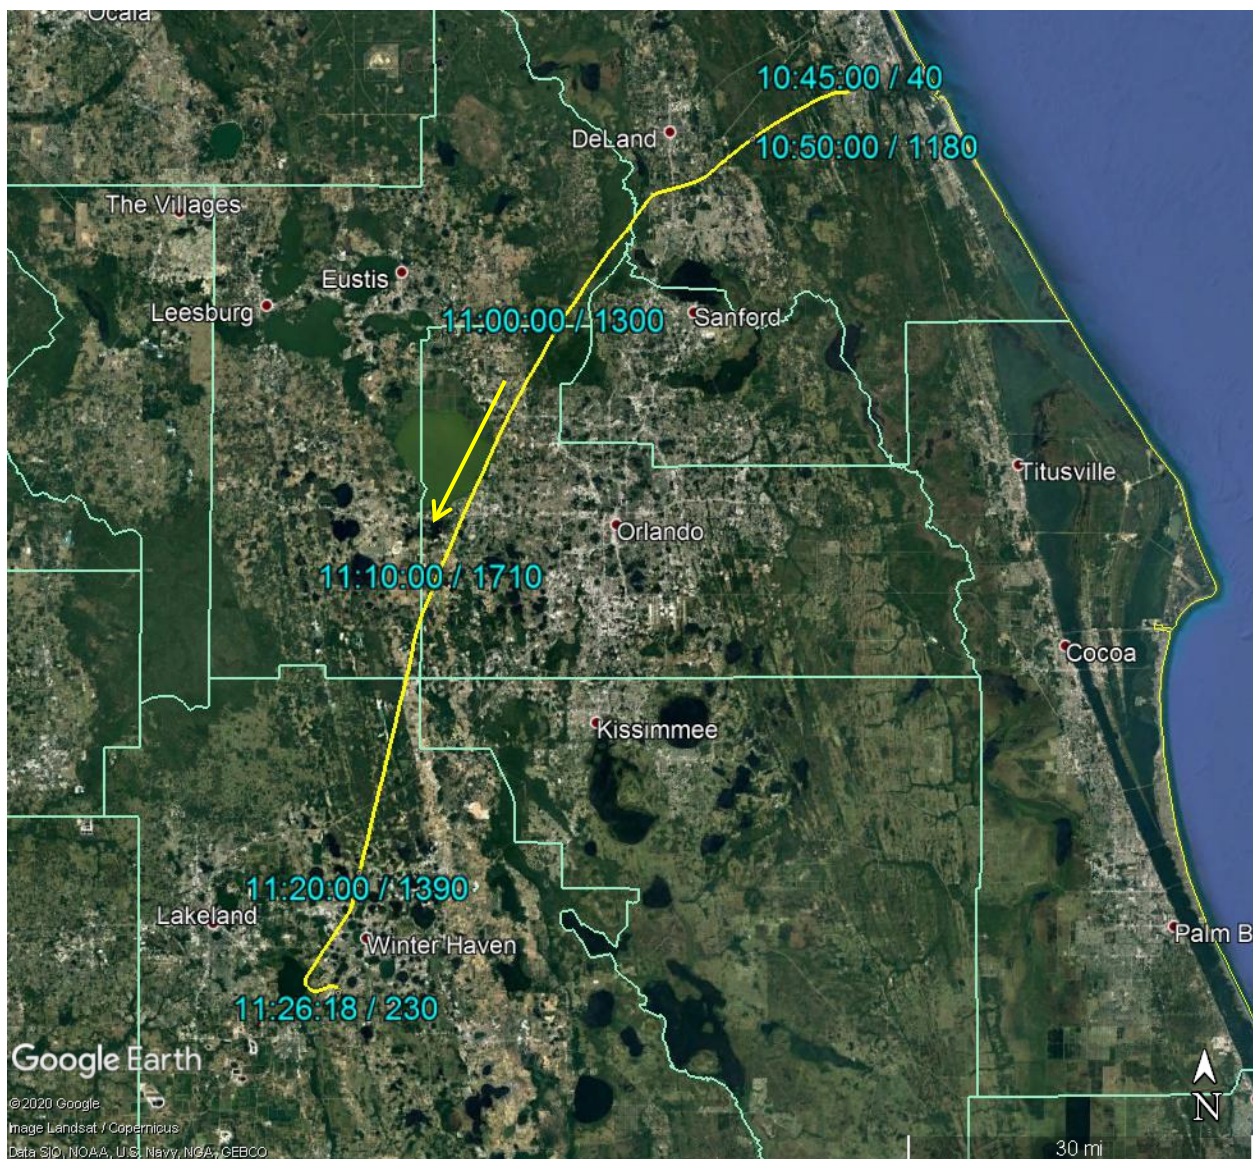
The airplane took off on a south-southeasterly heading from Spruce Creek Airport (7FL6) at about 10:45 (Figure 1). It climbed to 1,300 ft then 1,700 ft msl (mean sea level) while maintaining an airspeed between 120 kts and 140 kts (Figure 2). The airplane began descending at 11:17.

**Figure 1.** Accident flight in yellow with select times and altitudes (msl) annotated in blue.

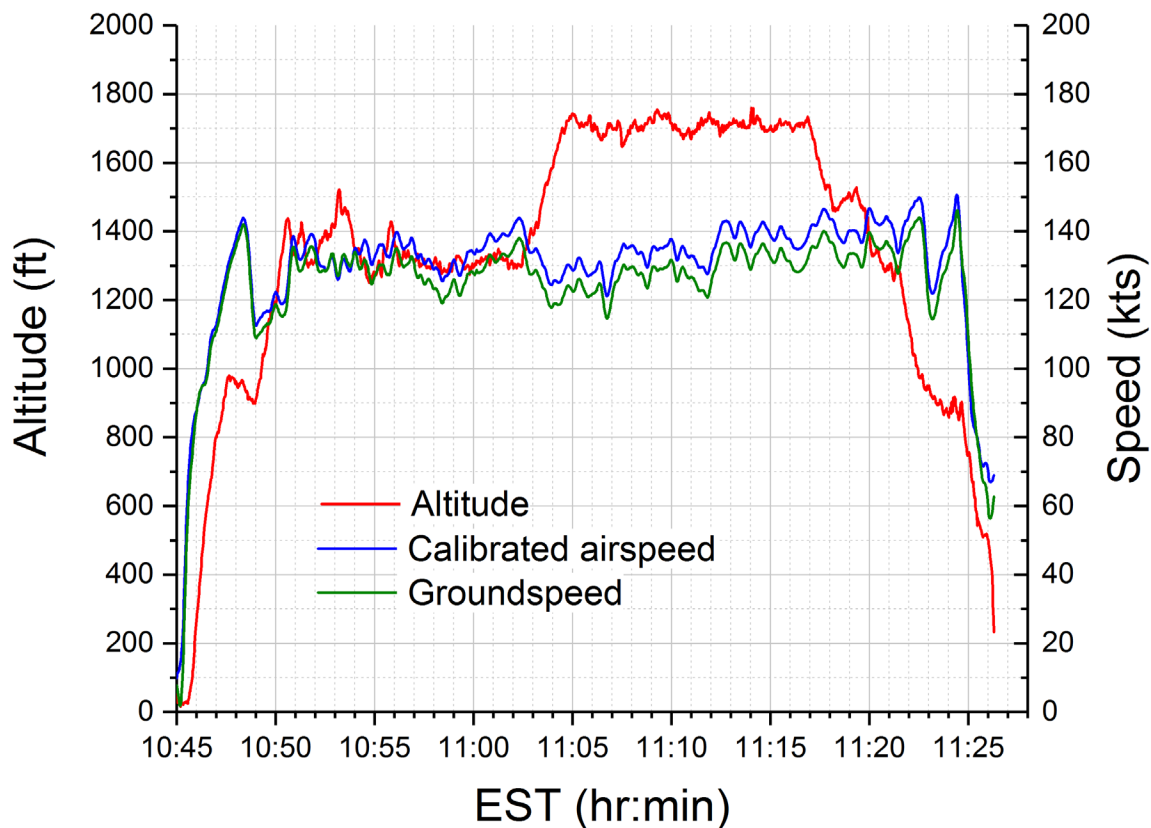
**Figure 2.** Accident flight altitude, msl, and calculated calibrated airspeed and groundspeed.

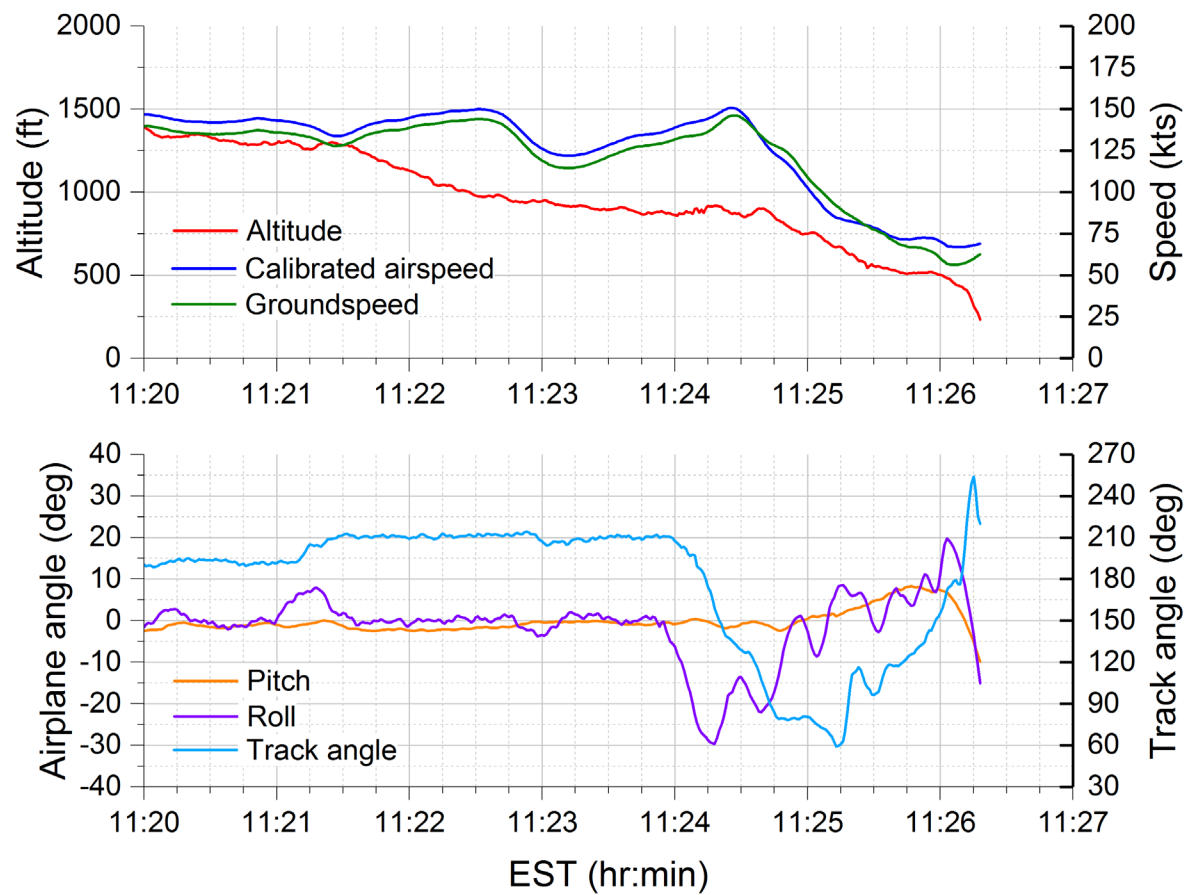
Around 11:22:45, the airplane's speed decreased from 150 kts calibrated airspeed to 120 kts in about 30 seconds before returning to 150 kts by 11:24:30 (Figure 3). During this time the airplane was in a level left turn from a track of 210° to 70° (Figure 4). After 11:24:45, the airplane slowed and descended and at 11:25:15 began a right turn towards runway 23. During the right turn, the airplane's bank angle varied between 5° and 20° right wing down while descending and slowing. From 11:25:45 to 11:26, the airplane leveled off at an airspeed of about 70 kts and an altitude of 500 ft msl<sup>1</sup>. Just after 11:26, its descent rate increased to -1,500 ft/min and the airplane began to pitch down. From 11:26:10 to 11:26:12, the airplane was briefly aligned with runway 23 before continuing to turn right and passing through the runway heading (Figure 5). At 11:26:15 the airplane turned left. The data ended at 11:26:19 when the airplane was about 230 ft msl, 110 ft above ground level, 0.6 NM short of the threshold for runway 23.

**Figure 3.** Accident flight altitude, msl, calculated calibrated airspeed and groundspeed, track angle, and calculated pitch and roll for the end of flight.

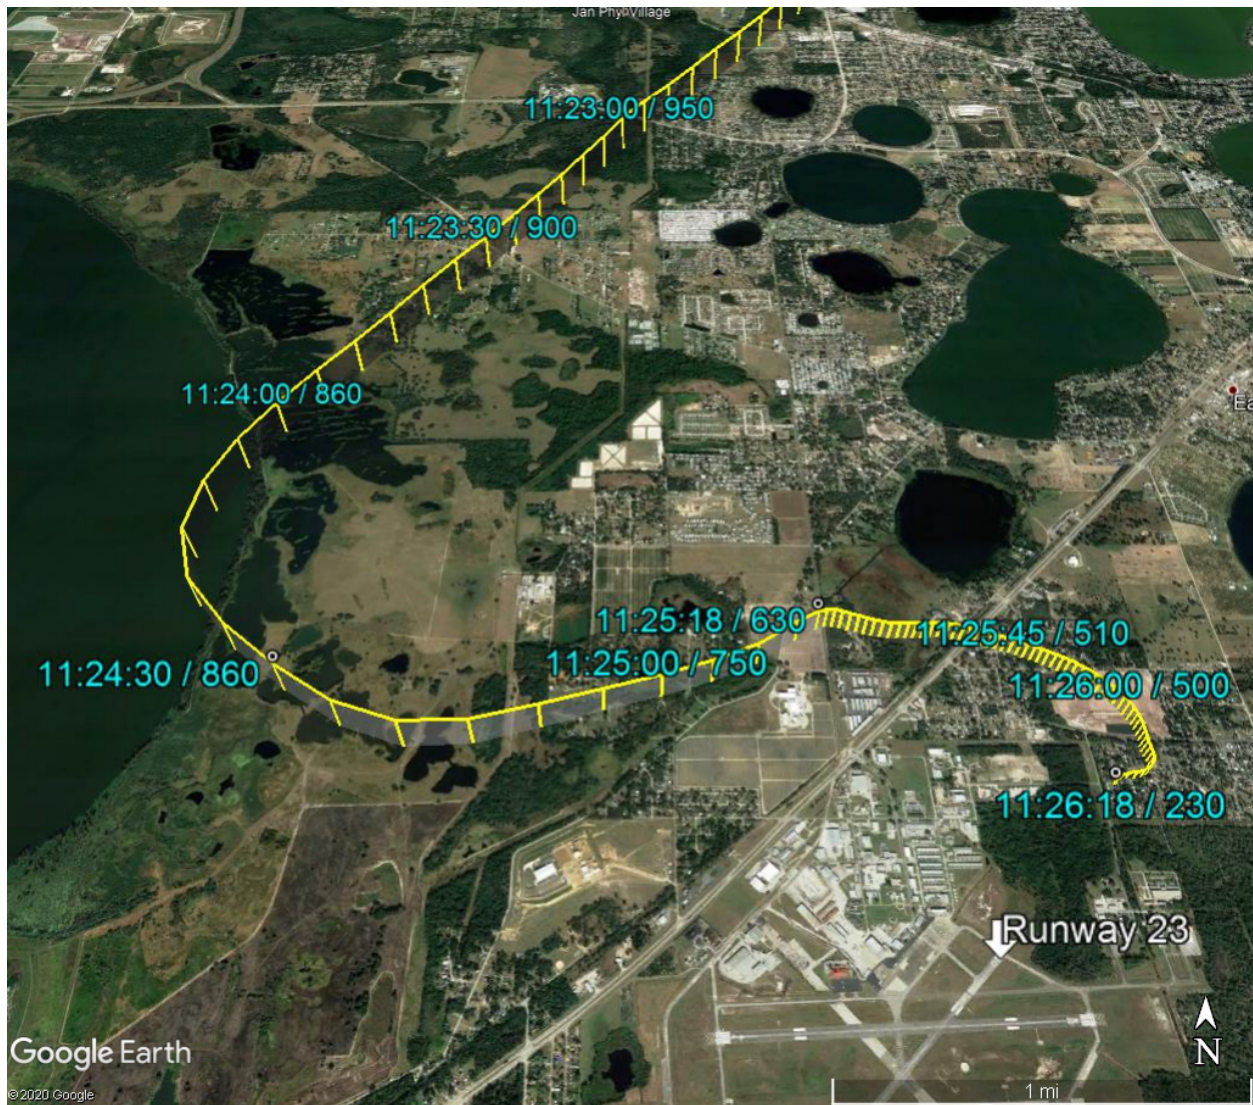
**Figure 4.** End of accident flight path in yellow, selected times and altitudes, msl, in blue.

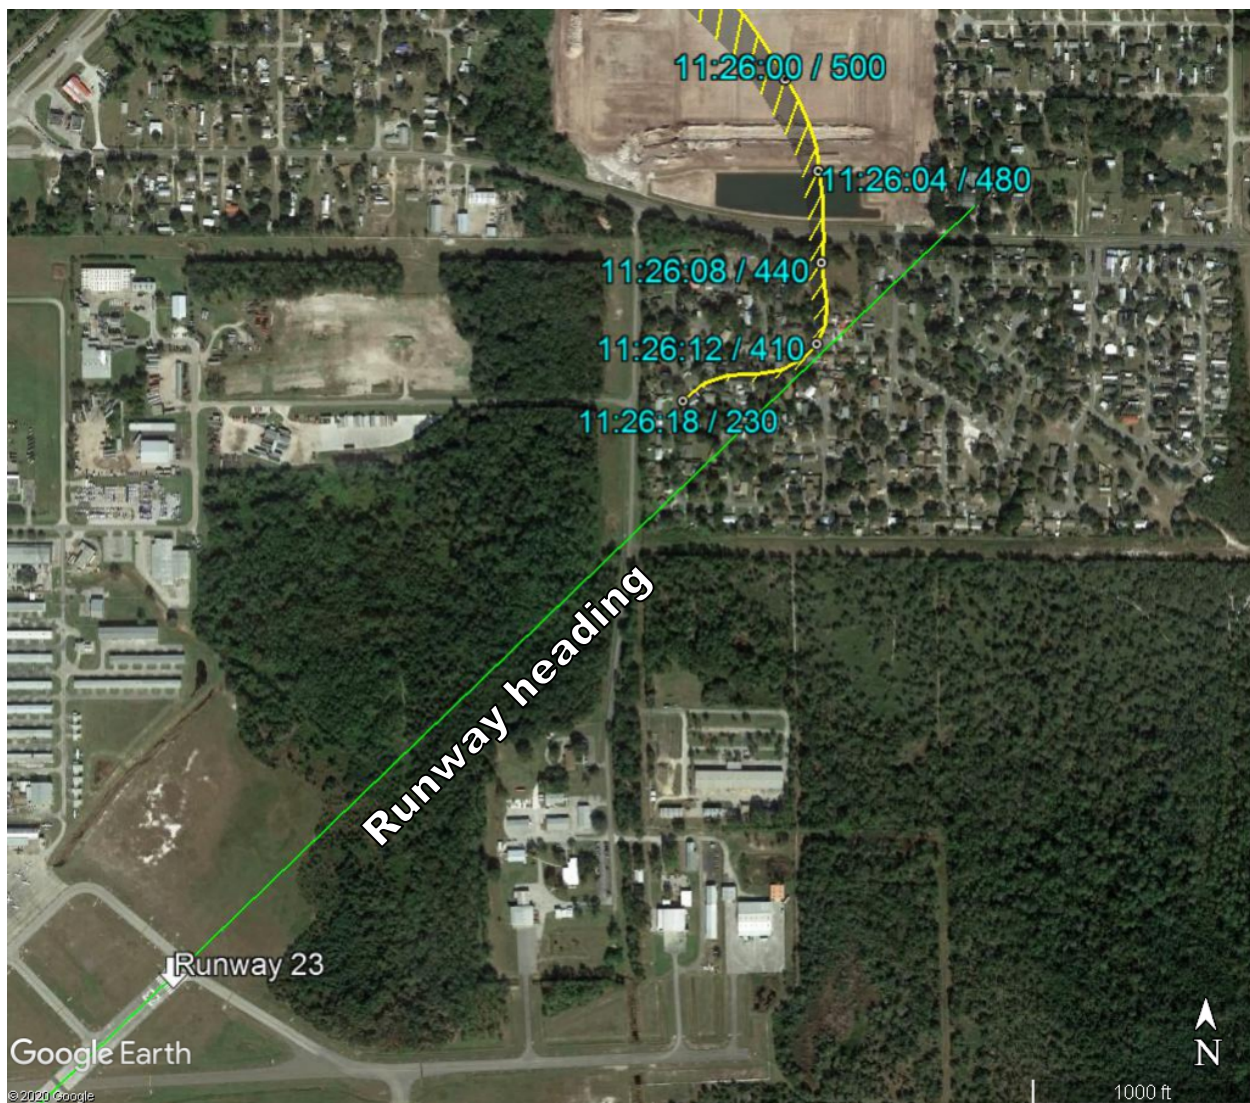
**Figure 5.** End of accident flight path in yellow, selected times and altitudes, msl, in blue. The heading for runway 23 is shown in green.

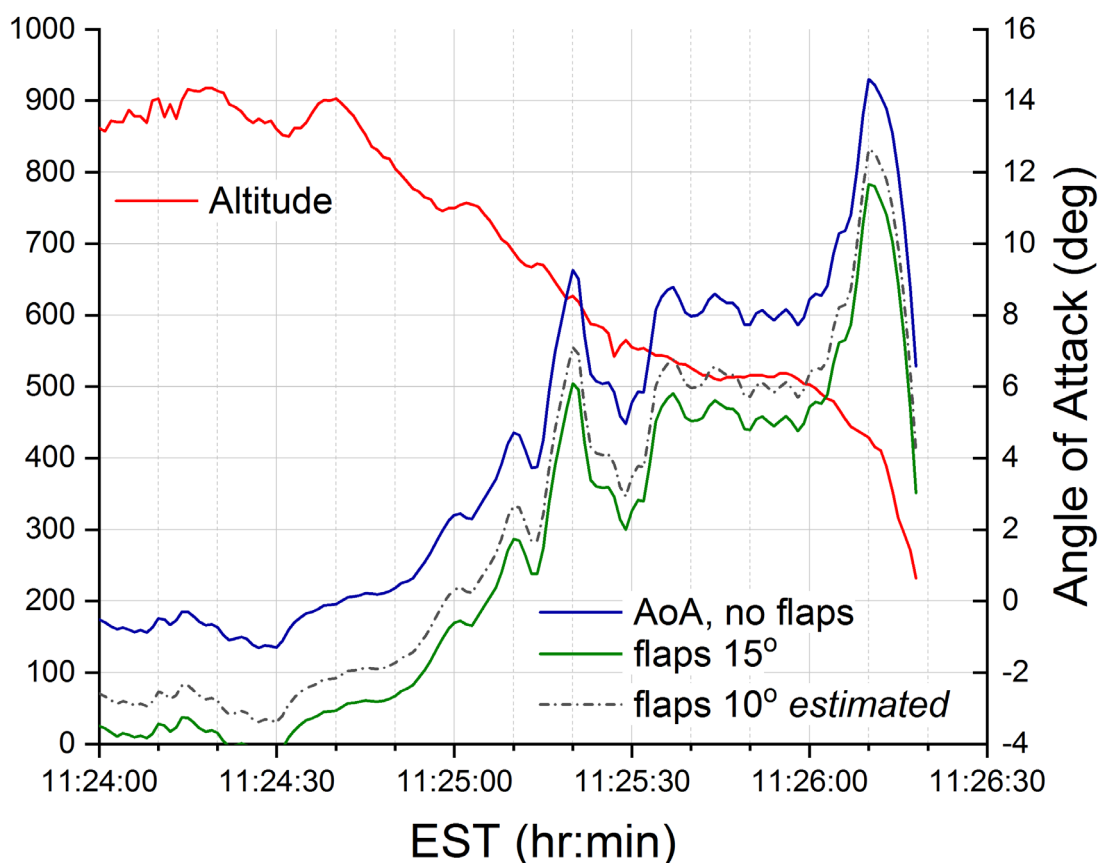
Figure 6 shows the calculated angle of attack of the airplane using the no flaps lift data and the flaps 15° lift data. Also shown is an estimated angle of attack for 10° of flaps assuming a linear relationship between the other flap lift curves. As the airplane slowed and maneuvered on descent, the angle of attack increased. The airplane's maximum angle of attack occurred at 11:26:10 after

which it abruptly dropped, coinciding with the airplane's brief alignment with the runway. The airplane's descent also accelerated from about 500 fpm between 11:26 and 11:26:12 to more than 1,500 fpm after 11:26:12. The maximum angle of attack for the no flaps configuration just exceeds its stall angle at this point and the airplane's final flight path was consistent with aerodynamic stall. The maximum angle of attack for 15° of flaps was not exceeded in the calculations for that configuration and the stall angle for 10° is not known for certain. Nine more seconds of flight data were recorded before impact. While the flaps were documented as 10° in the wreckage, it is not known when flaps were deployed or if they were in transit at the time of impact.

**Figure 6.** Accident flight altitude, msl, and calculated angle of attack (AoA).

The airplane's calculated angle of attack increased to a maximum at 11:26:10. Mooney lift data, the airplane's departure from the runway heading, and increased rate of descent are consistent with the airplane experiencing aerodynamic stall.

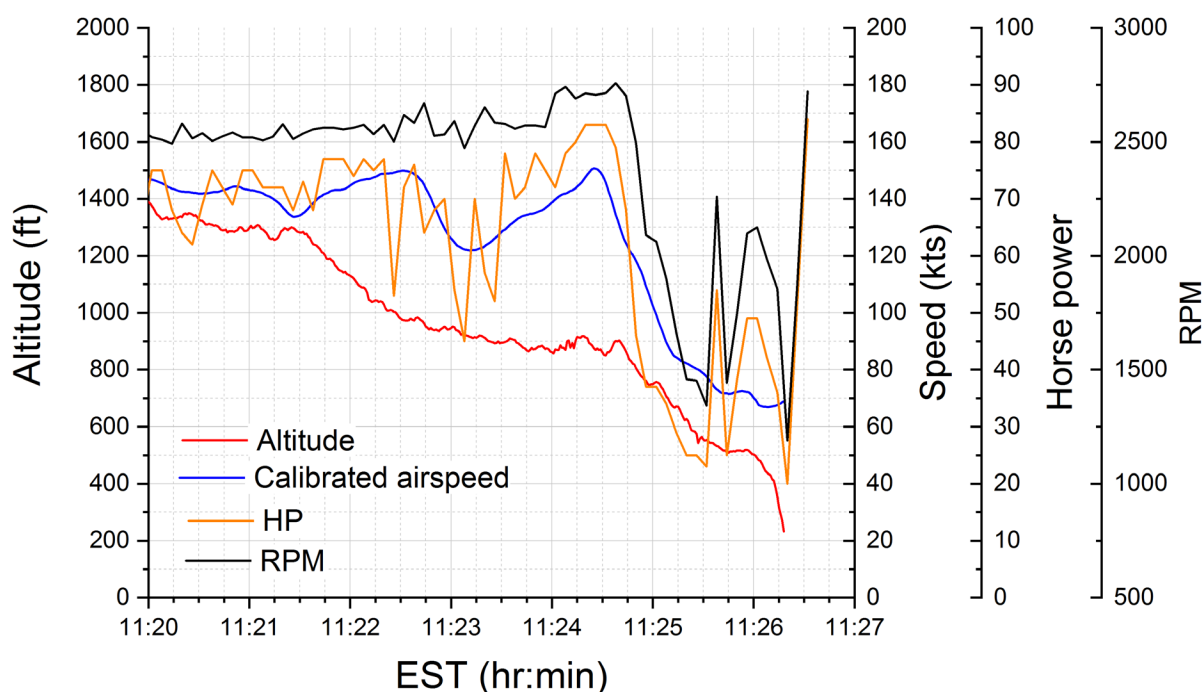
The recorded engine data were time correlated with the position data by matching the increase in horsepower with the take-off roll at the beginning of flight. This engine data ended 13 seconds after the Stratus data. This time correlation shows good agreement between the two data sources. Figure 7 shows the relationship among horsepower, RPM (engine rotations per minute), altitude, and speed at the end of flight. The cylinder and exhaust temperature data from the engine were consistent with each other.

**Figure 7.** End of accident altitude, msl, and airspeed with time-correlated horsepower (hp) and RPM.

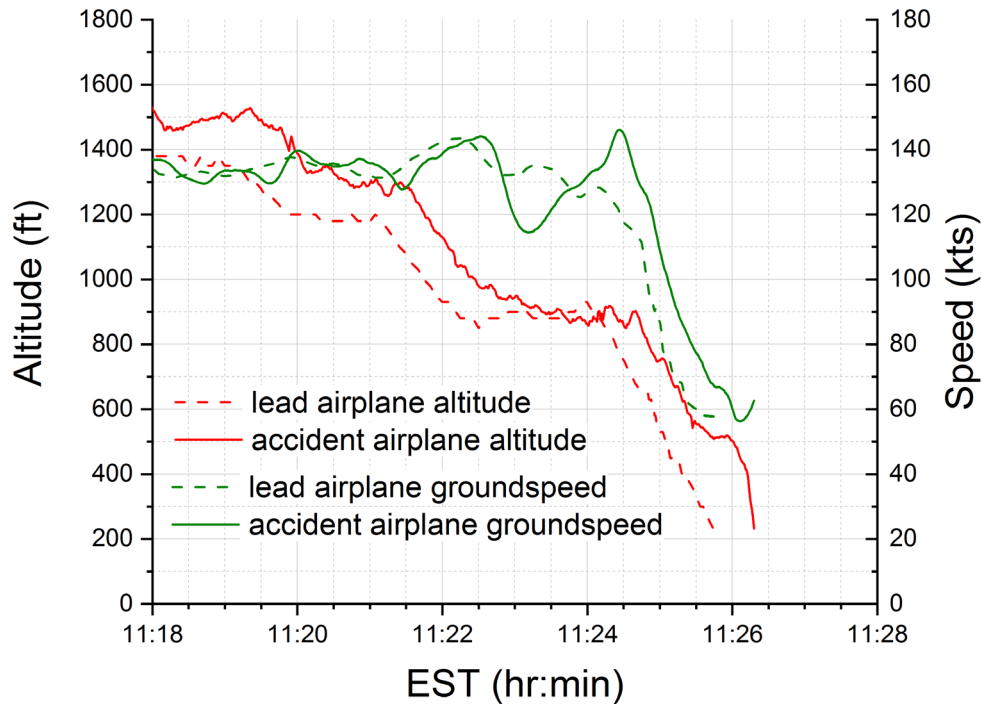
The accident airplane was number 4 in a formation of 4, but only the lead airplane and accident airplane recorded position data. Throughout the flight, the accident airplane's path, altitude, and speed closely followed the lead airplane. However, the accident airplane's speed diverged markedly from the lead airplane (Figure 8) from 11:22:45 to 11:24:30 when it slowed and then sped up rapidly, as discussed in detail earlier in this report.

**Figure 8.** Accident airplane and lead airplane altitude, msl, and speeds.

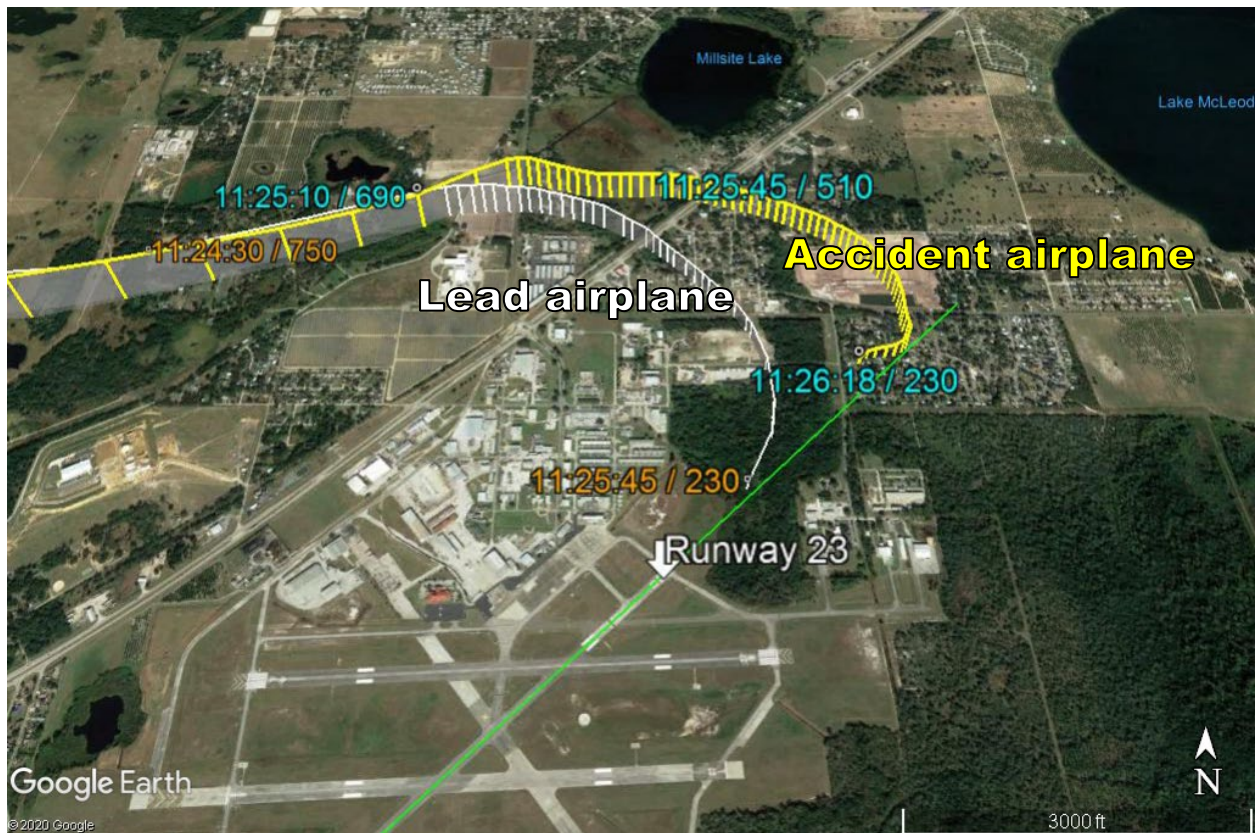
According to the pilot of the lead airplane, each subsequent pilot was to extend their downwind leg from the previous airplane to allow sufficient spacing during landing. While the flight paths of the second and third airplanes are not known, the accident airplane's downwind was only extended an additional 1,500 ft compared to that of the lead airplane. Additionally, the turn onto final was not the expected rectangle shape with rounded corners demonstrated by the lead airplane's flight path (Figure 9). Comparison of the accident and lead airplanes' turns onto final emphasizes the irregular nature of the accident airplane's flight path after 11:25:15. Figure 10 shows the lead and accident airplane's approach to runway 23 and the 3.5° glide slope<sup>3</sup>. The accident airplane briefly captured the glide slope, coincident with lining up with the runway heading, before losing altitude.

**Figure 9.** Lead airplane and accident airplane flight paths, with selected times and altitudes, msl.

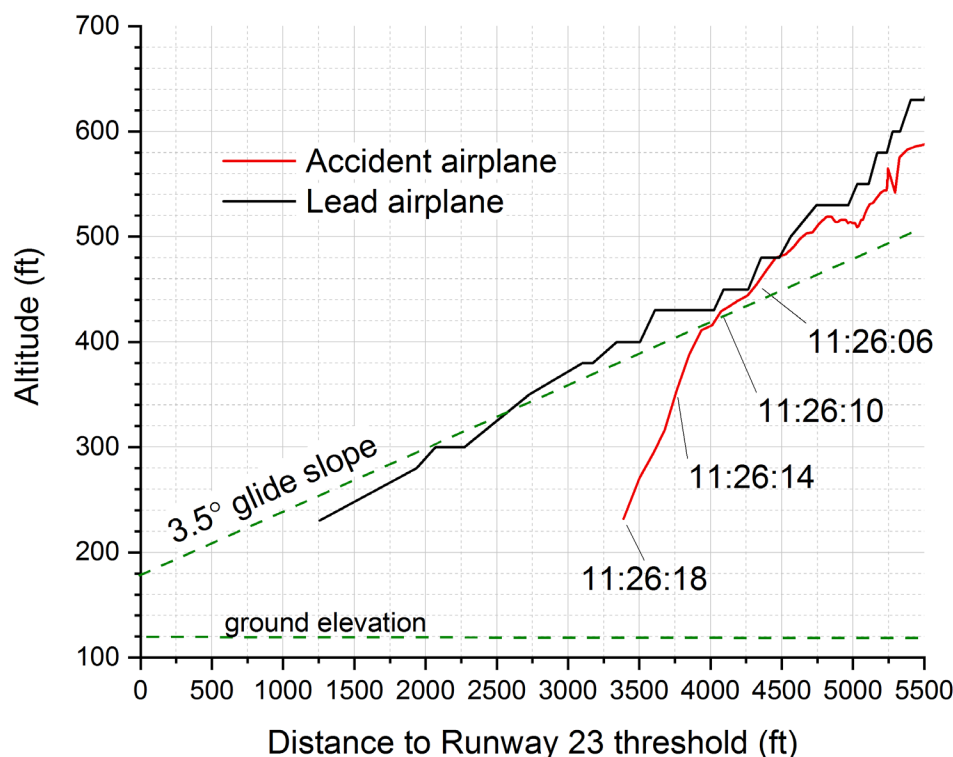
**Figure 10.** Lead airplane and accident airplane altitude, msl, while on approach. Ground elevation is shown at 120 ft above mean sea level.
