**NATIONAL TRANSPORTATION SAFETY BOARD**

**AIRFRAME AND ENGINE EXAMINATION**

**ERA20FA101**

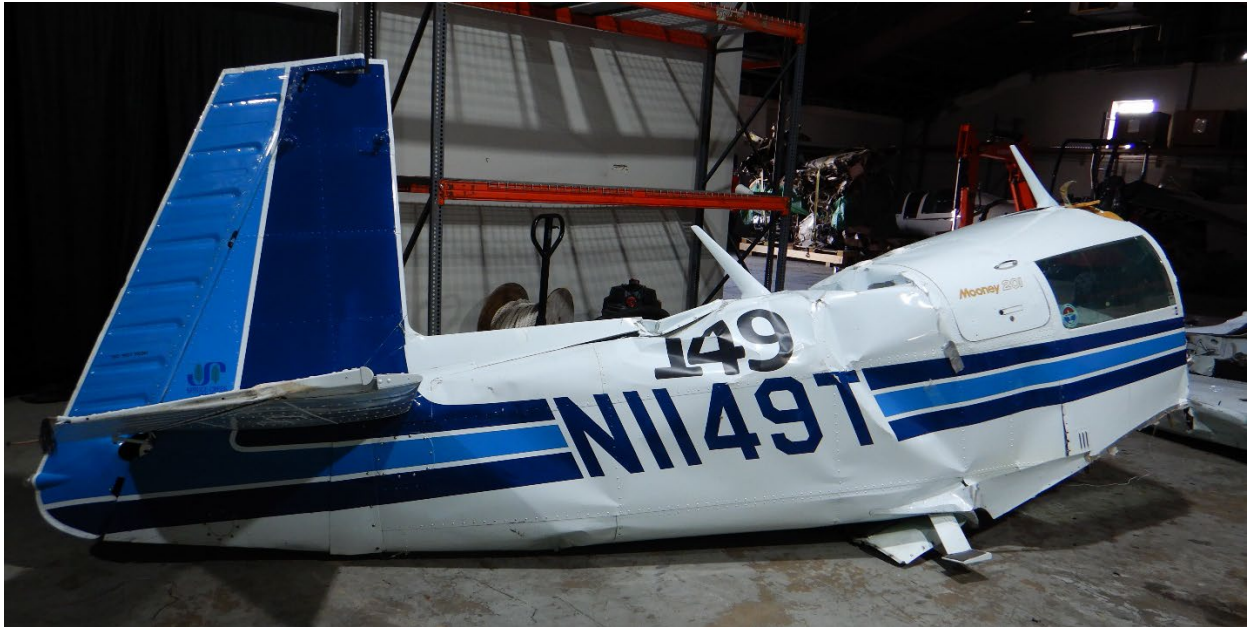
The empennage was fractured in multiple areas with wrinkling noted on the left and right sides. The empennage aft of the right wing displayed crushing from impact with a fence, upon which the wreckage came to rest. The forward most 18 in of the vertical fin fairing rivets were pulled out. The tail section was mostly undamaged.

Photo 1: Airplane from right

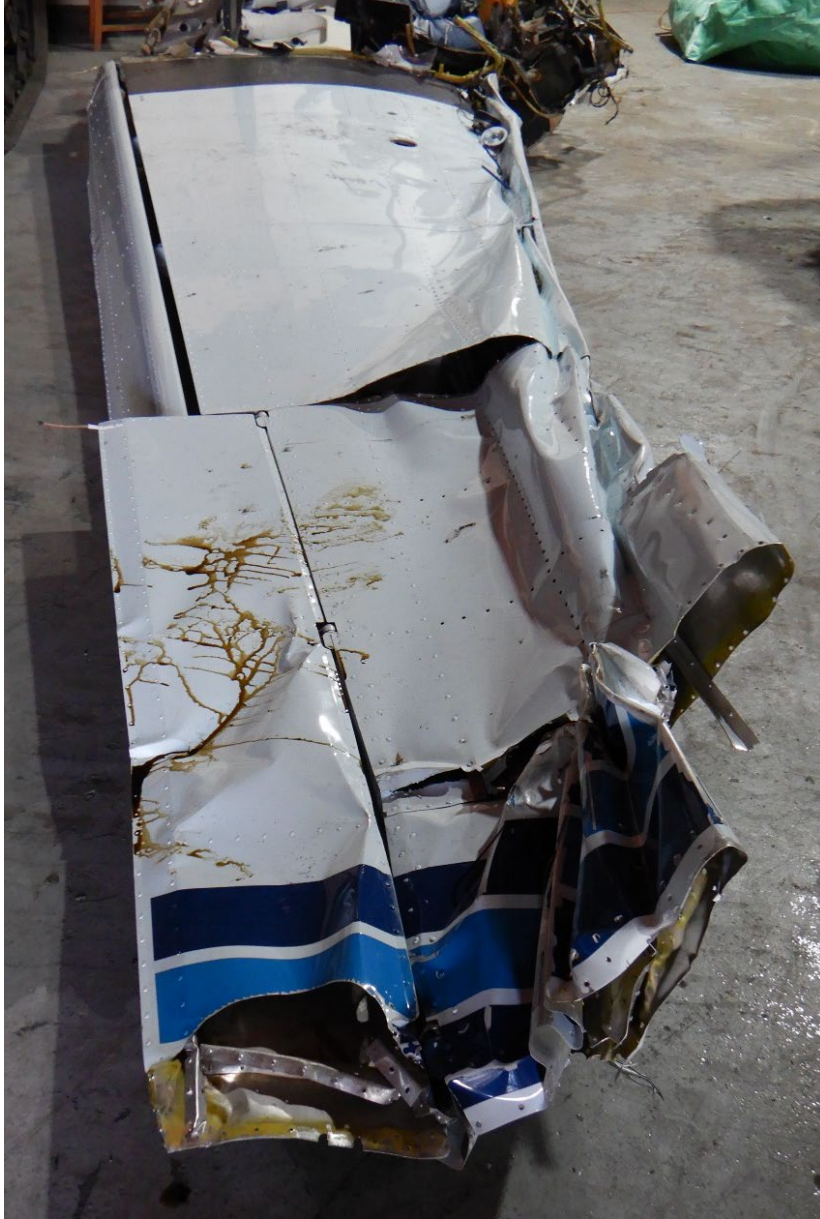
Examination of the right wing revealed the flap and aileron remained connected at all hinge points. The leading edge exhibited full span aft crushing. The outboard several feet of the wing were displaced in a positive direction. The right main landing gear remained in its well. The fuel cap was in-place. No fuel remained in the tank.

Photo 2: Right Wing

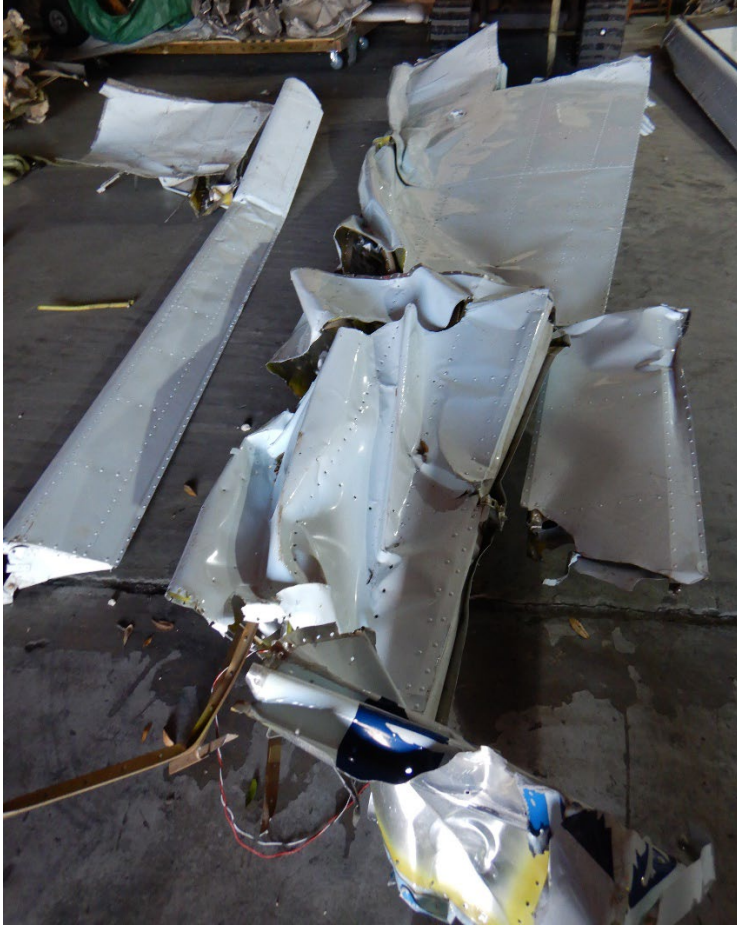
Examination of the left wing revealed that the flap was attached only at the most inboard attach point and was displaced in a positive direction. The left aileron was impact fractured and detached from the wing at all but the innermost attachment point. The entire left wing leading edge was impact crushed aft and upward. No fuel remained in the tank, and the tank was impact ruptured. The inboard panel of the left upper wing surface was torn away where the landing gear, seated in its well, was partially driven through the upper wing surface.

Photo 3: Left Wing and Detached Flap

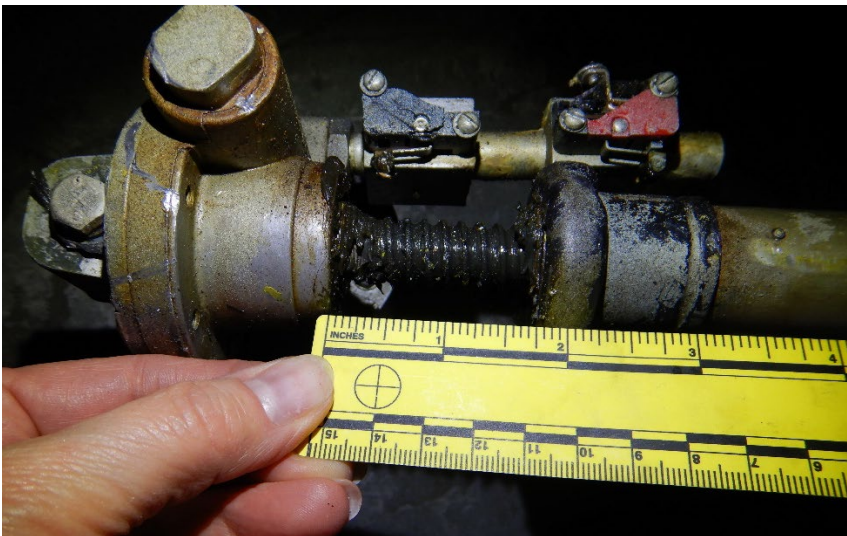
Aileron flight control continuity was confirmed from the left aileron attach point to the cockpit area, and from the right aileron control surface to the cockpit area, although the aileron tubes were bent in several areas, and deformation near the cockpit area was extensive. Elevator control continuity was confirmed from the control surface to a cut made in the tube assembly at the forward empennage area during recovery, and from the cut to the cockpit area. Rudder control continuity was confirmed from the flight control surface to a fracture just aft of the aft spar, and from the fracture to the cockpit area. The fracture surface exhibited evidence of overload failure with no evidence of pre-existing cracks. Examination of the pitch trim flight control system revealed 7 threads were extended from the jackscrew actuator near the aft empennage, and the pitch control tube was fractured just aft of the aft spar. The fracture surface exhibited evidence of overload failure at a connection point in the tube assembly. Examination of flap actuator threads revealed flaps were set to 10°.

Photo 4: Flap Actuator Threads

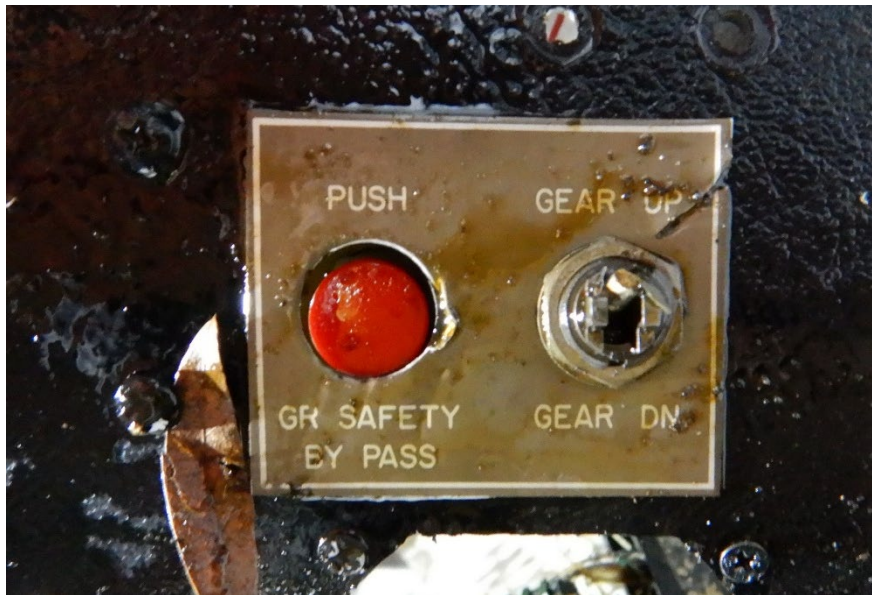
Photo 5: Landing Gear Selector Position

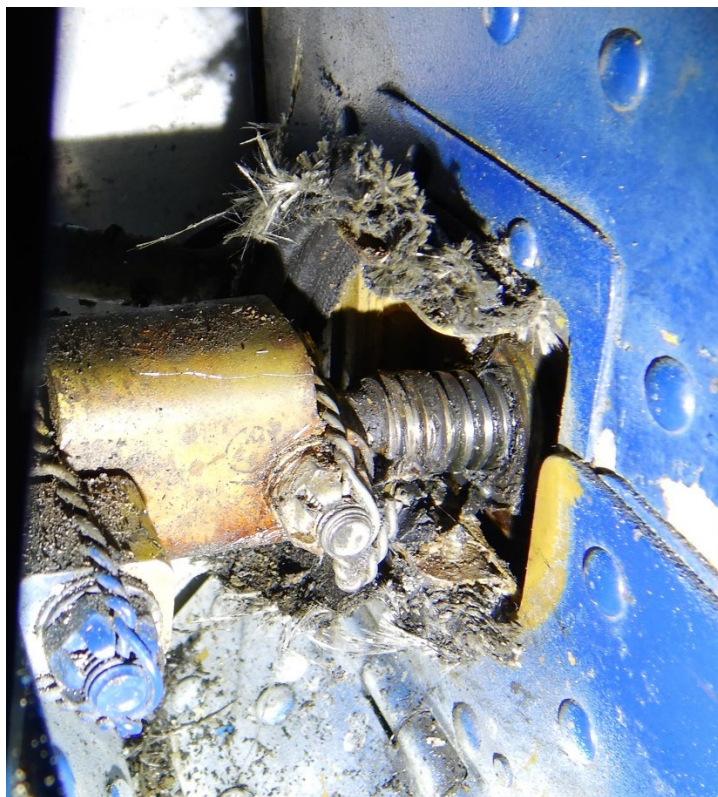
Photo 6: Elevator Trim Actuator

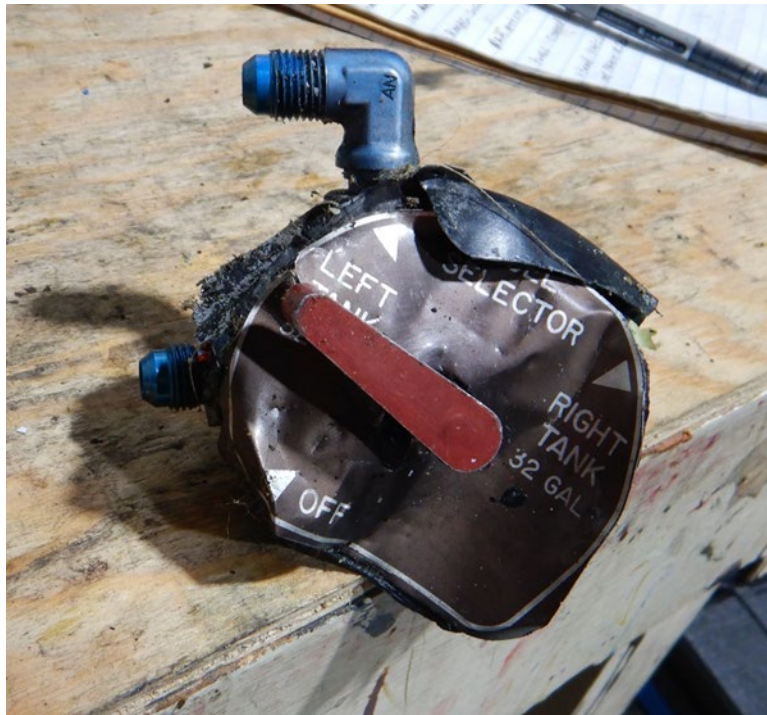
Examination of the airframe fuel system revealed that fuel strainer fuel hoses remained attached to the fuel strainer. The fuel selector was on the left tank position and it was internally free of obstructions. Fuel was noted in the fuel hose from the fuel selector to the fuel strainer, and in the selector valve when the fuel hose from the right tank was removed.

Photo 7: Fuel Selector

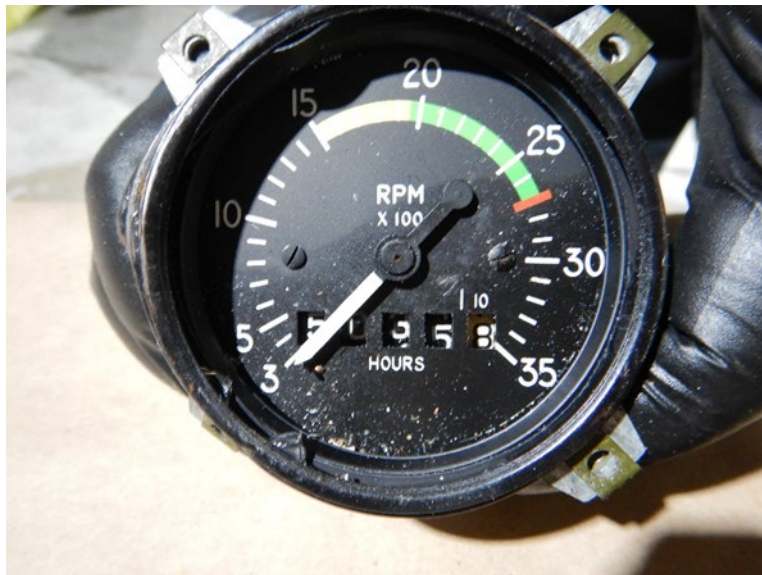
Photo 8: Tachometer

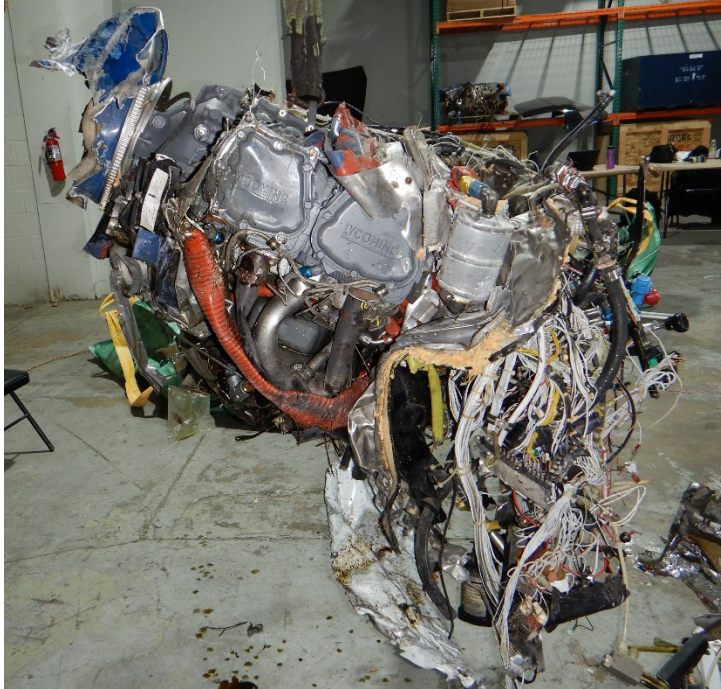
The firewall, wiring and instruments were removed from the engine and the engine was partially disassembled to facilitate the examination. The engine and its accessories were examined. The external engine exam revealed that the exhaust muffler and exhaust pipes were crushed. The

intake pipes were impact damaged. The No. 2 cylinder head was impact damage in the area of the intake valve.

Photo 9: Engine Prior to Teardown

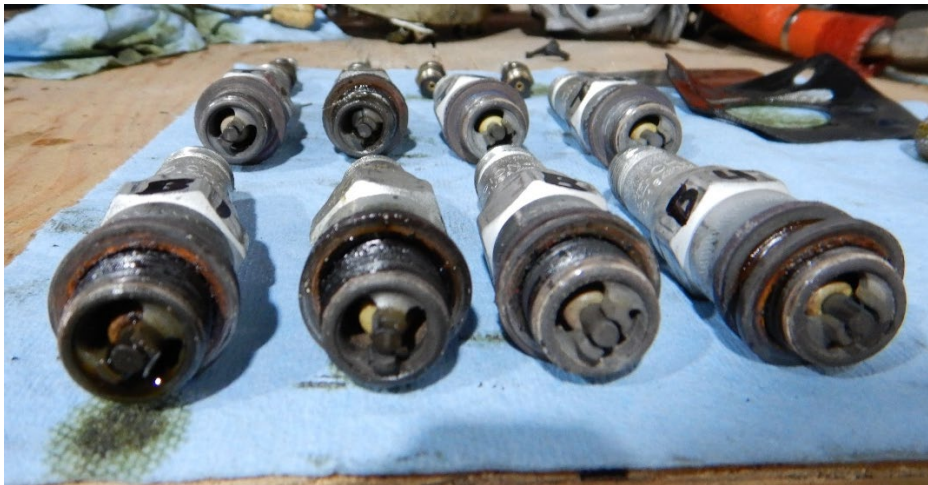
The engine was rotated using a tool inserted in the vacuum pump drive pad. Continuity of the crankshaft to the rear gears and to the valve train was confirmed. Compression and suction were observed from all four cylinders. The interiors of the cylinders were examined using a lighted borescope with no anomalies noted. The No. 2 top spark plug was impact damaged and oily. The Nos. 1 and 2 bottom spark plug electrodes were undamaged but oily. The remaining spark plug electrodes exhibited gray coloration and worn normal condition.

Photo 10: Spark plugs

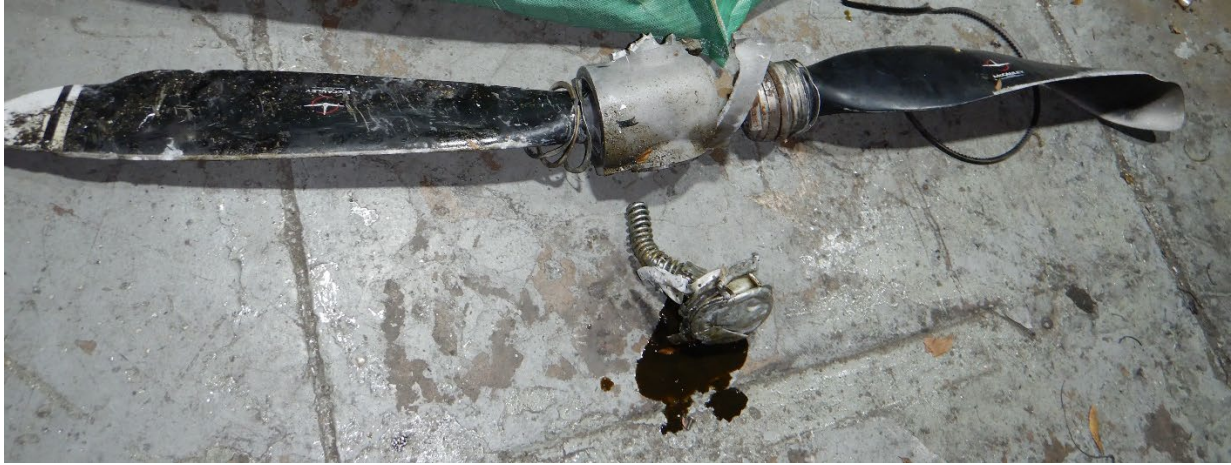
The propeller spinner was crushed, and propeller hub was impact fragmented. The propeller hub mounting flange remained attached to the engine crankshaft flange. The remainder of the hub was impact separated and fragmented. One propeller blade was separated from the hub. That blade exhibited leading edge gouges, chordwise scoring and twisting along the longitudinal axis. The other blade exhibited leading and trailing edge gouges and chord-wise scoring.

Photo 11: Propeller

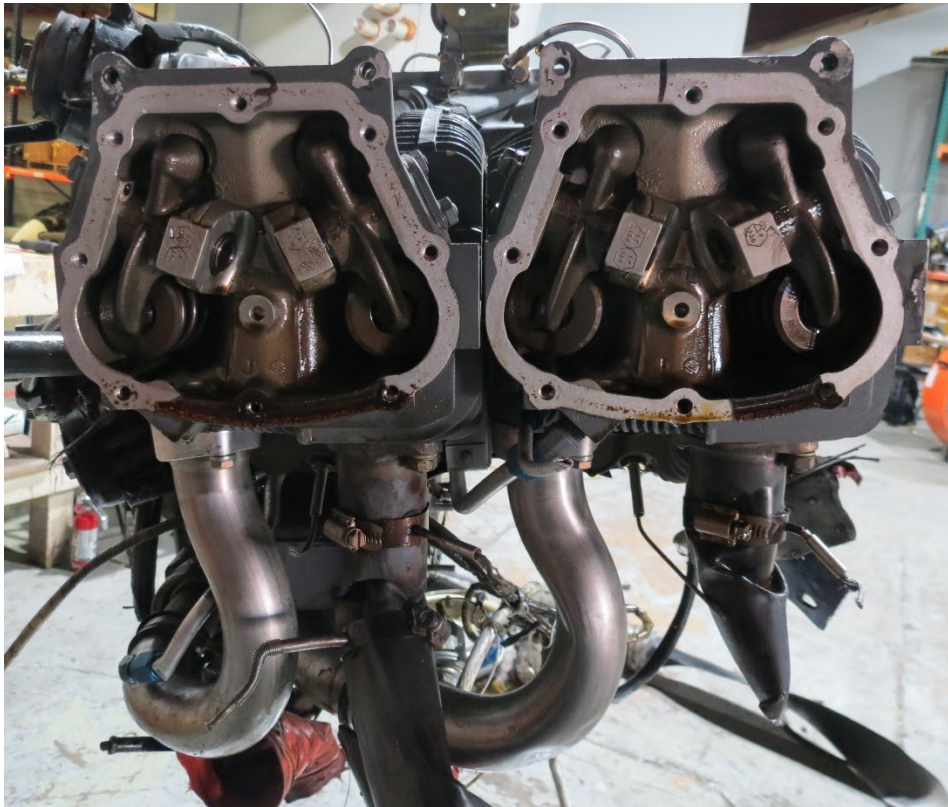
Photo 12: Cylinder Nos. 1 and 3 (Photo Courtesy of Lycoming Engine)

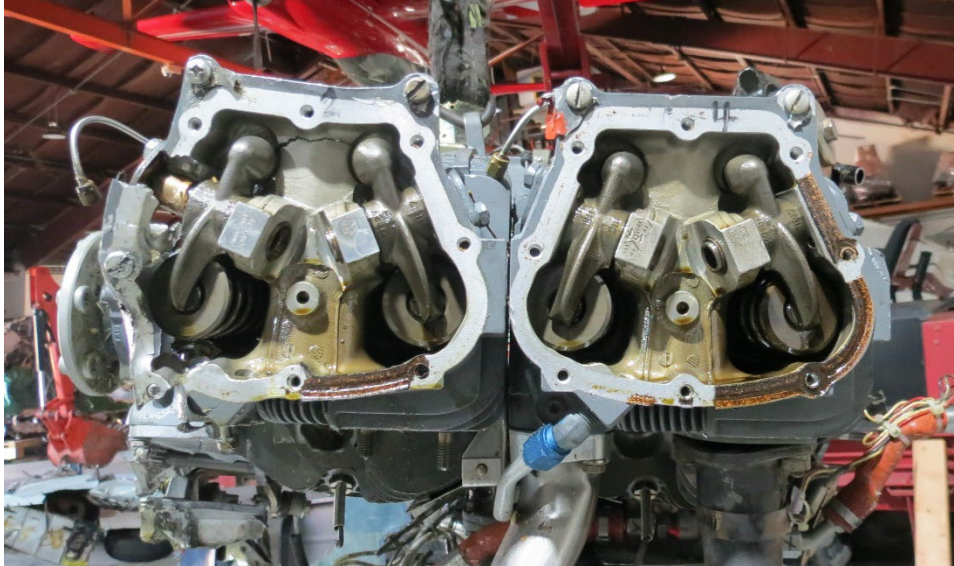
Photo 13: Cylinder Nos. 2 and 4 (Photo Courtesy of Lycoming Engine)
