## **NATIONAL TRANSPORTATION SAFETY BOARD**

### **Group Chairman's Factual Report**

# **AIR TRAFFIC CONTROL**

ERA20FA118

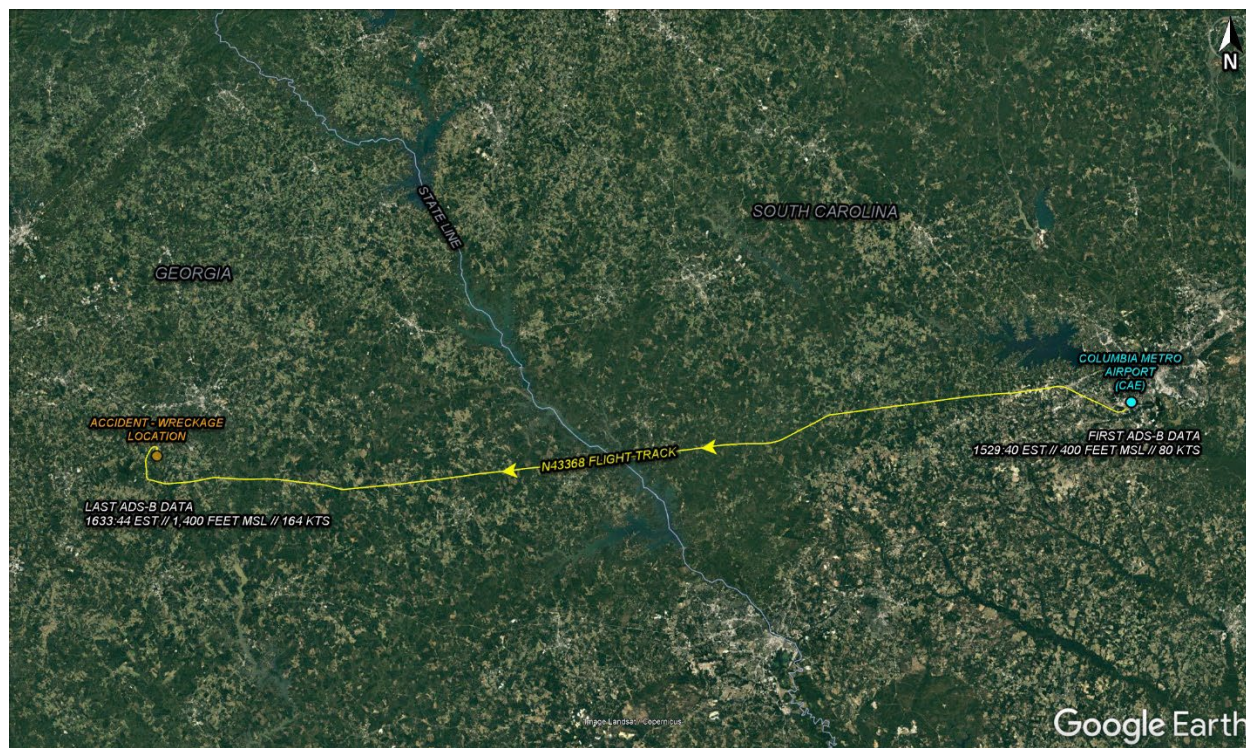
**Figure 1.** Overview of accident flight track - ADS-B Data.

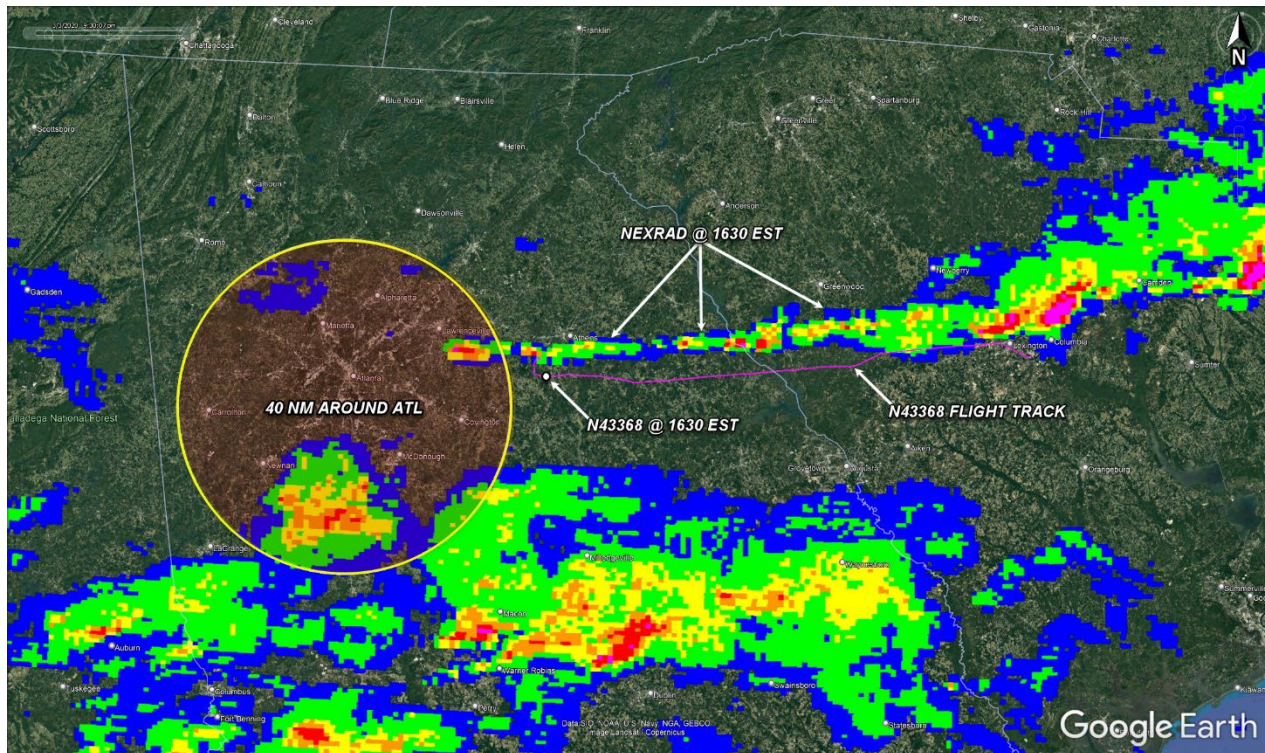
**Figure 2.** Graphical NEXRAD information transmitted by SBS to FIS-B clients at about 1630, with additional mark-ups showing accident flight track, and 40 mile-diameter circle surrounding ATL.

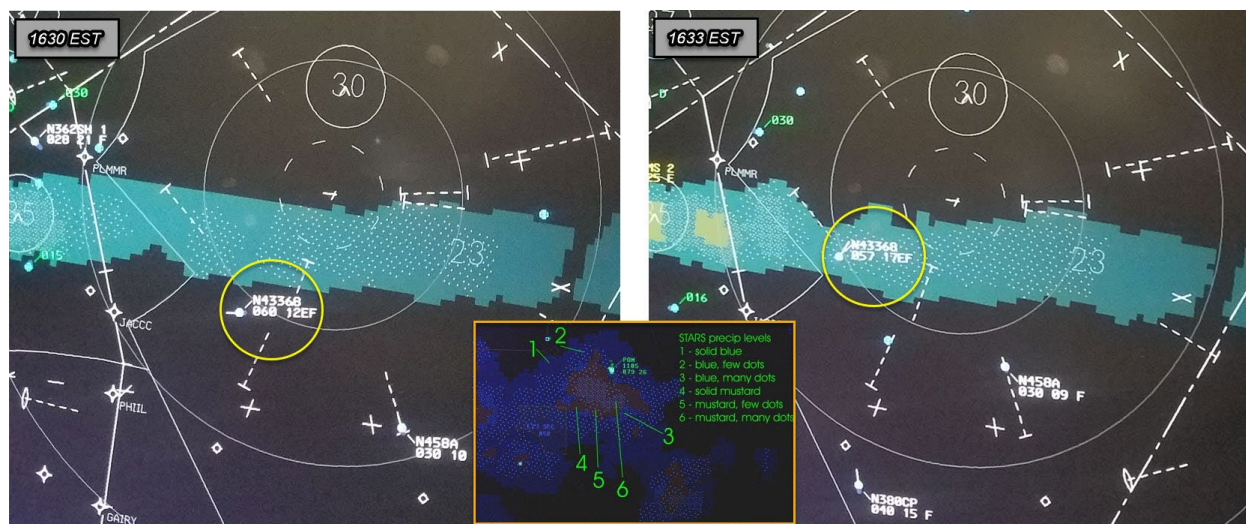
The image on the left shows N43368 (circled in yellow) at 1630 when ATC instructed the pilot to fly heading 300° and the pilot expressed concern that it would take him into thunderstorms.

The image on the right shows N43368 at 1633, when ATC requested the pilot to say flight conditions and the pilot reported "rain." The STARS displayed weather at that time showed the aircraft in an area of level 2 to 3 (moderate precipitation).

**Figure 3.** A comparison of ERAM screen captures taken at 1630 (left) and 1633 (right).
