## **Airframe and Engine Examination Report**

NTSB ACCIDENT NUMBER: **ERA20FA118**

AIRCRAFT REGISTRATION: N43368

AIRCRAFT TYPE: Piper PA-46

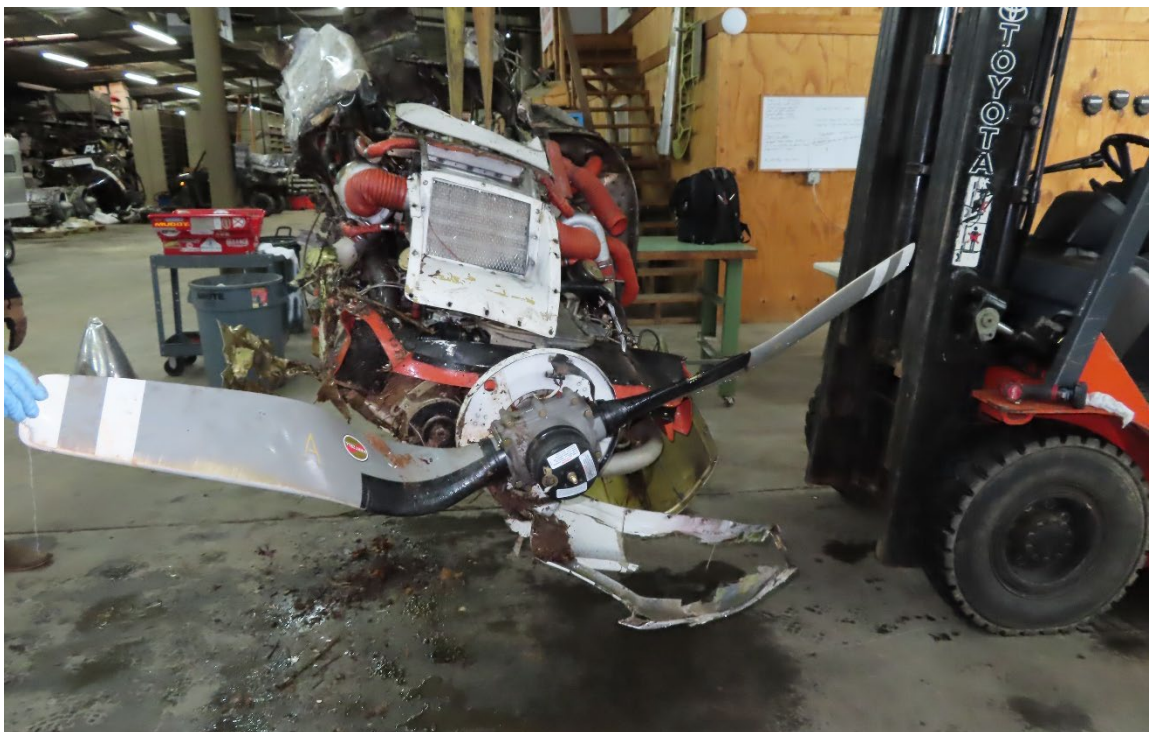
The engine remained with the main wreckage and was destroyed by a post impact fire, it remained attached to the fuselage was lying inverted.

Figure 1: View of the engine during examination. (Photo courtesy of FAA)

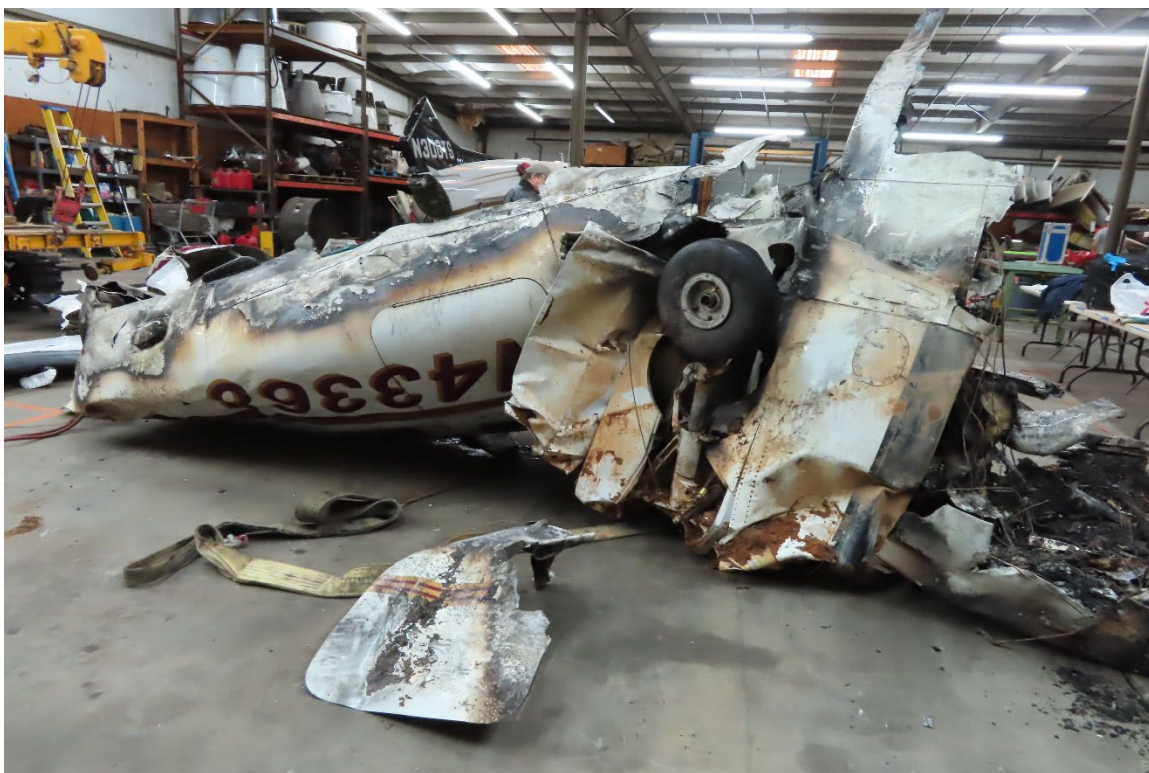
Figure 2: View of the fuselage. (Photo courtesy of Piper)

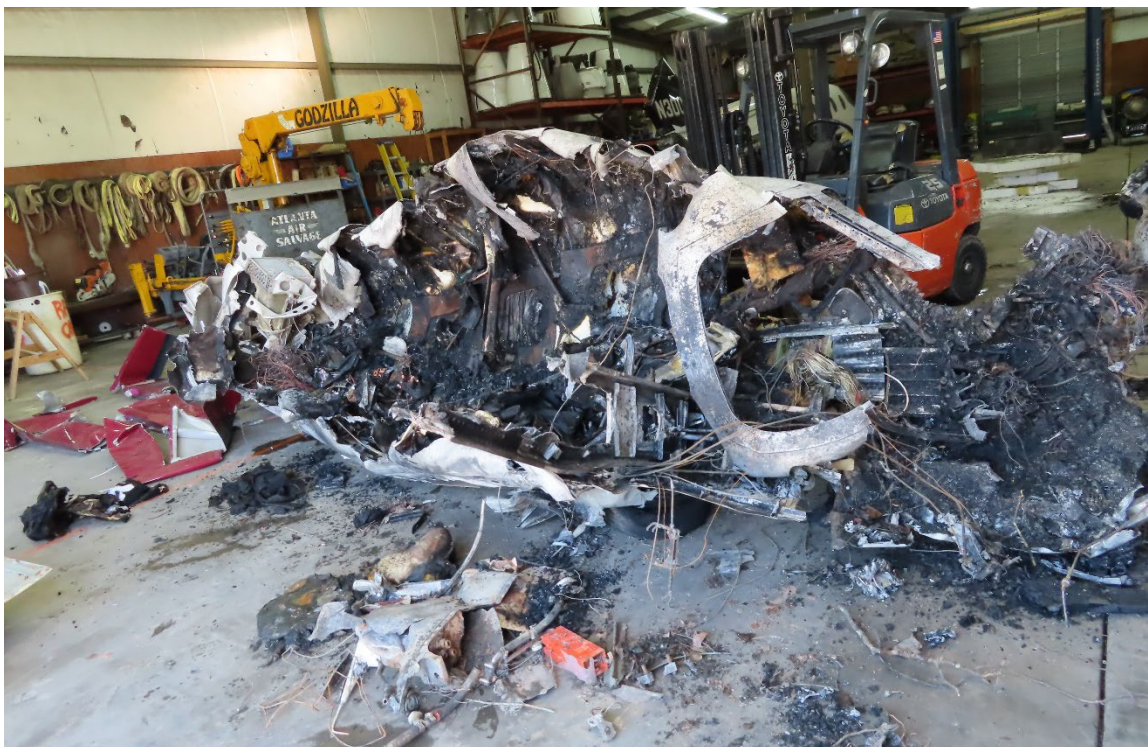
Figure 3: View of the right side of the wreckage. (Photo courtesy of Textron)

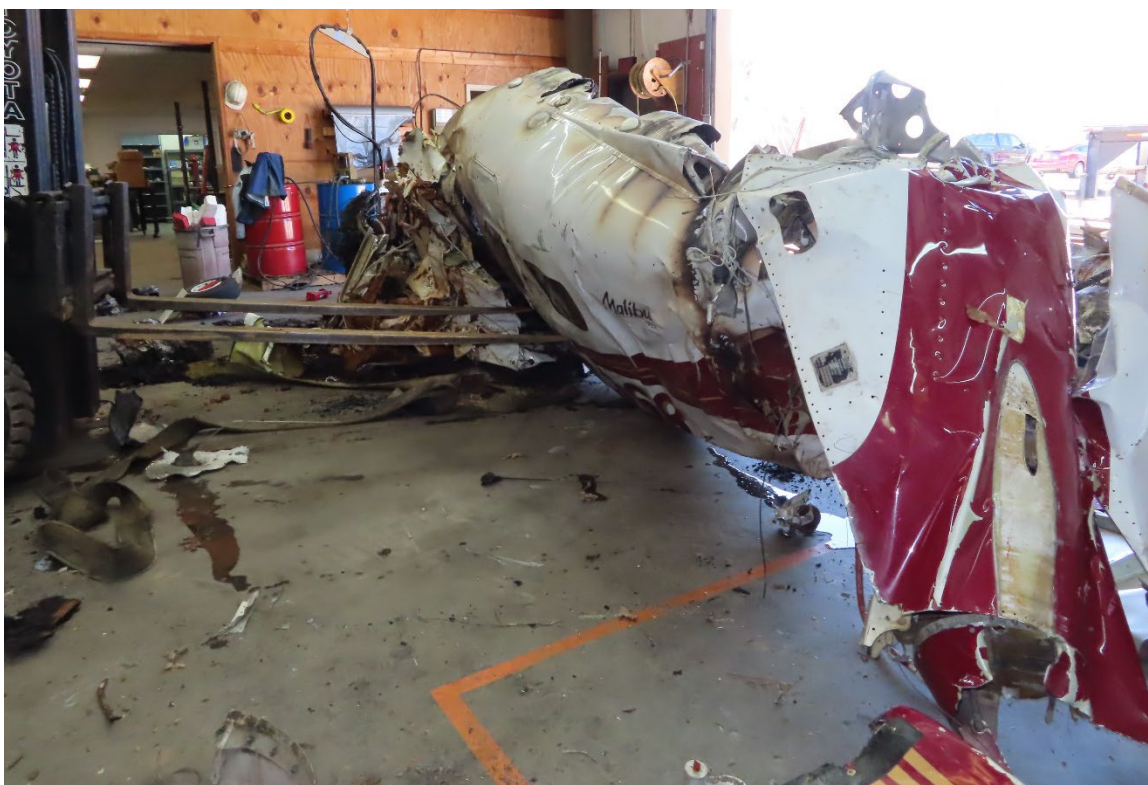
Figure 4: View of the left side of wreckage. (Photo courtesy of Piper)
