**Douglass Brazy**  
**Air Safety Investigator**  
**Eastern Region Aviation**

**March 13, 2020**

**Subject:** NTSB investigation ERA20FA124, Cessna 177RG, N1572H, Sterling, Massachusetts, March 11, 2020, Wreckage Examination

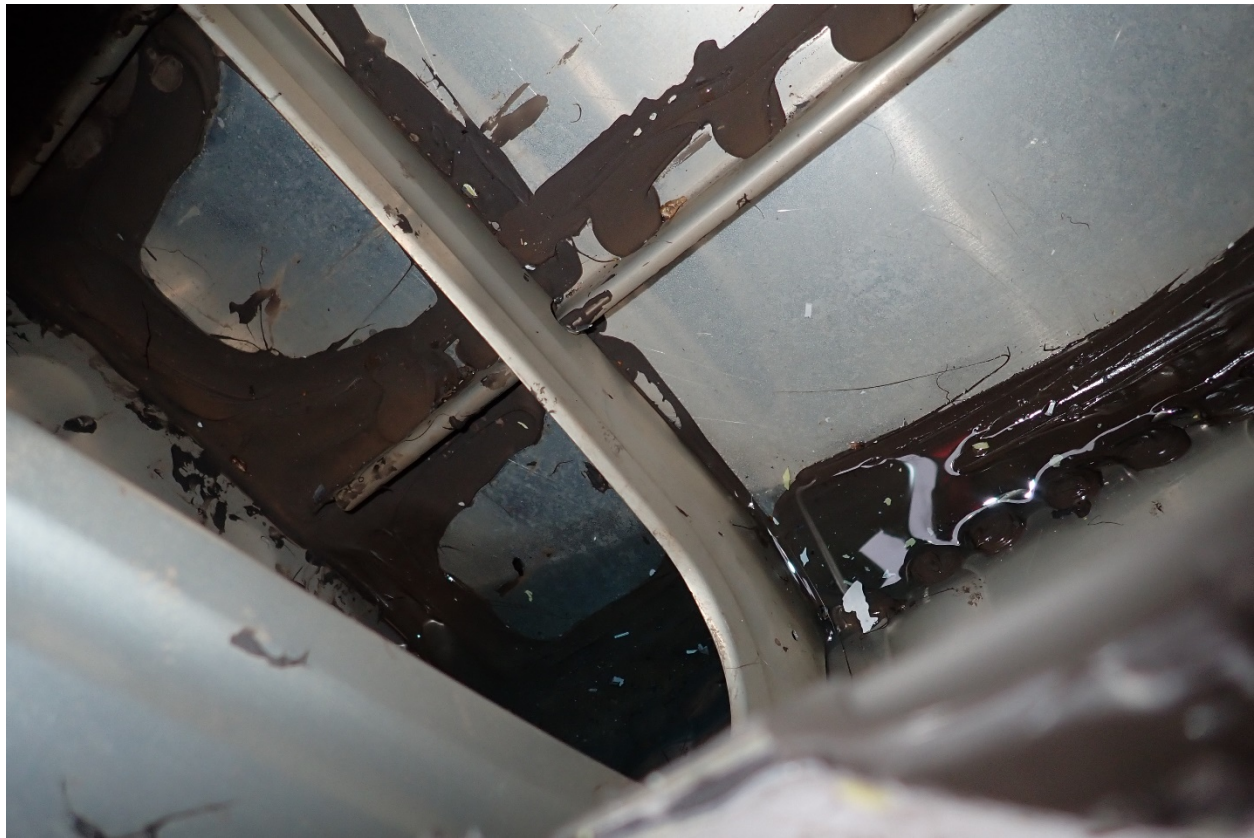
Both fuel caps were in place and undamaged. Both fuel tanks were relatively intact and appeared unbreeched. The access panels holding the fuel caps were removed and inspection holes cut at the low sides of the tanks on the top skin. About 2-3 oz fuel found in each tank against the leading edge. Screens and drains were clear/unobstructed. No staining noted near either drain on underside of wing. Due to the orientation of the airplane (about 50° nose down) the fuel tank pickups, located in the lower rear section of the wings near their roots, were elevated above the fuel found near the leading edge of the tanks.

*Figure 1 – Inside of Left Wing Fuel Tank - Lowest Corner*

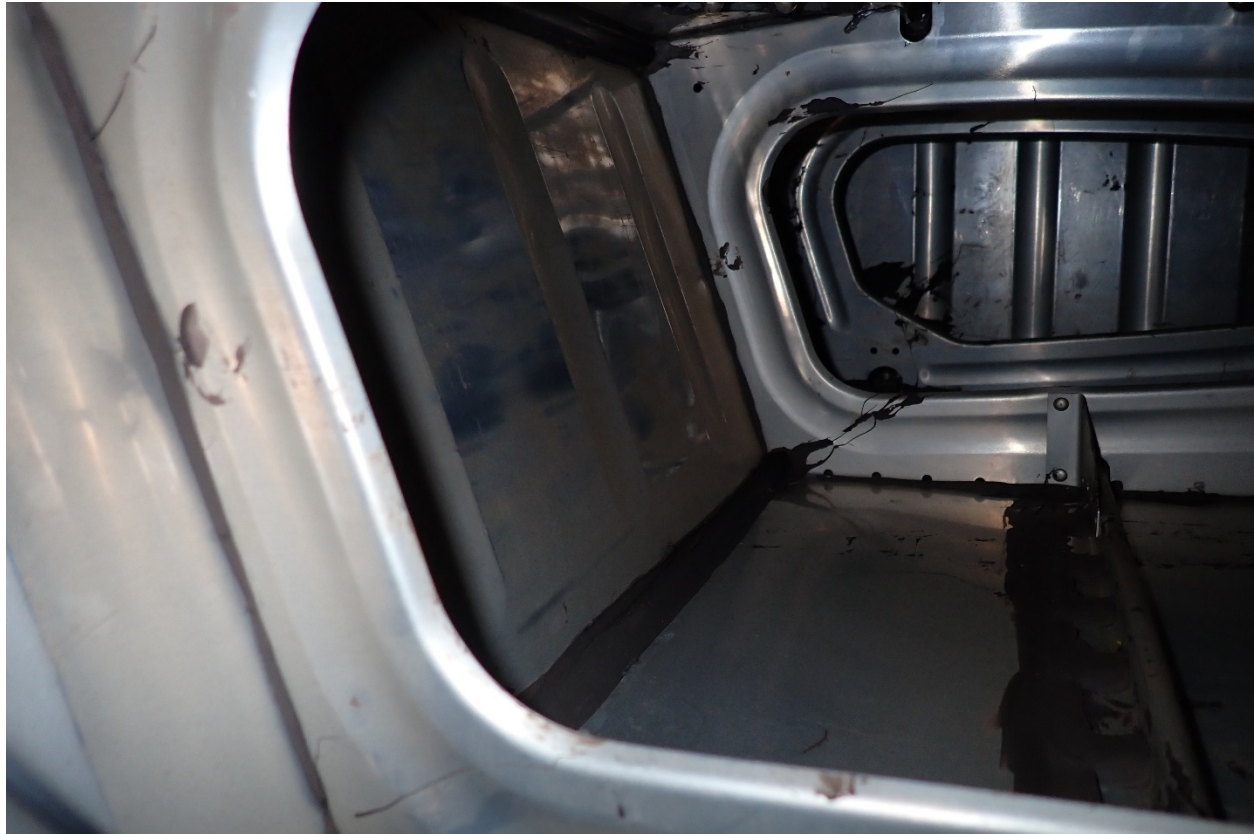
*Figure 2 Inside of Right Wing Fuel Tank - Lowest Corner*

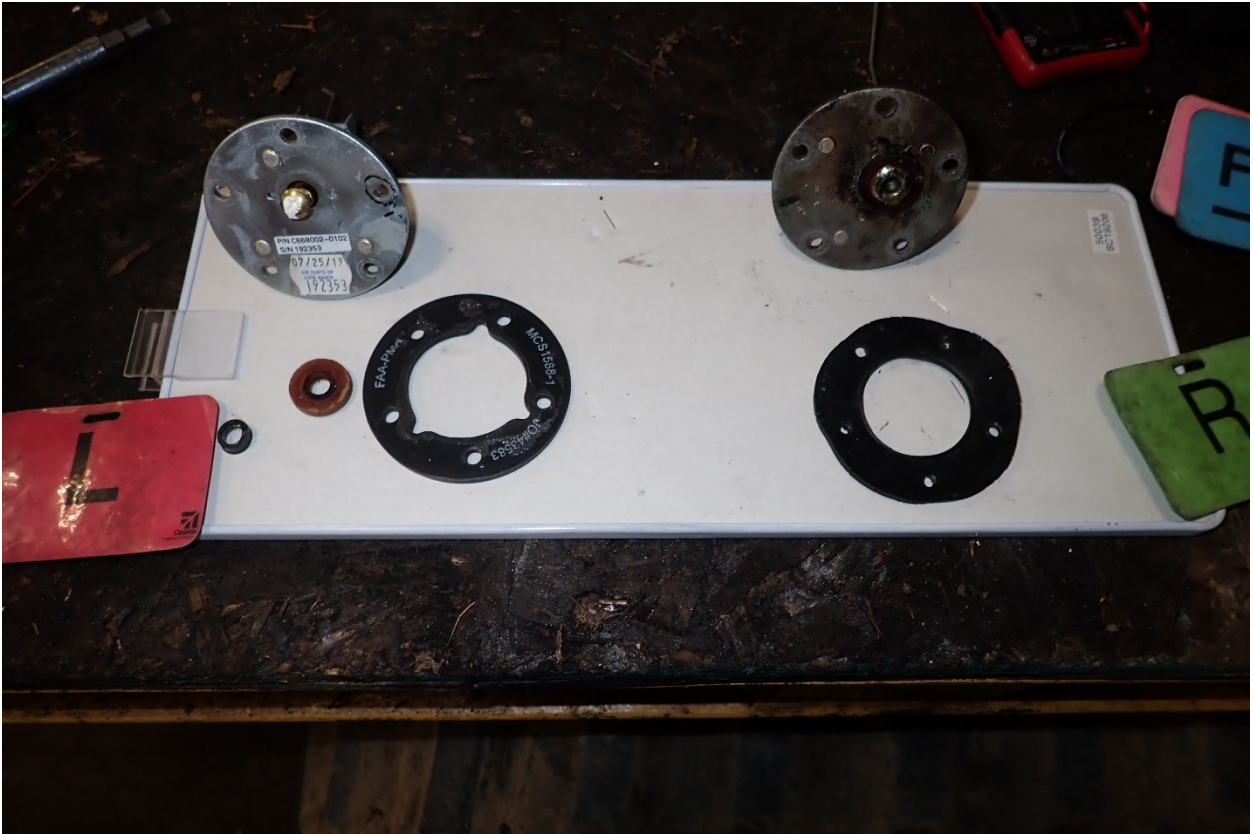
Left Transmitter (P/N C668002-0102): measured 87 ohms in the empty position, and 31 ohms in the full position.

Right Transmitter (P/N C668002-0102): measured 238 ohms in the empty position, and 20 ohms in the full position.

The specification drawing for the fuel transmitter indicated that the empty value should be between 240 and 260 ohms, and the full value should be between 31.5 and 35.5 ohms.

Both fuel transmitters were removed from the wings. The left transmitter had a sticker on it which read "Air Parts of Lock Haven" and a date of 7/25/19. The right transmitter had no markings and appeared to be the originally installed unit.

When the center post screw of the left transmitter was rotated, the resistor mount rotated as well. When the left transmitter center post screw was removed, the resistor mount fell into the transmitter body. The right transmitter resistor mount did not rotate with the center post screw, and the resistor mount remained in place when its center post screw was removed.

The left transmitter was reassembled and re-tested. After reassembly, the resistance was measured at 262 ohms in the empty position, and 54 ohms in the full position.

Based on the on-wing testing of the fuel transmitters, with both the fuel tanks at or near empty, the left fuel gauge should have indicated more fuel than actually present in the fuel tank. The right fuel gauge should have indicated at or near empty. With full or nearly full tanks, the left fuel gauge should have properly indicated a full tank, the right fuel gauge should have indicated at/near a full tank.

*Figure 3 Left and Right Fuel Level Transmitters*

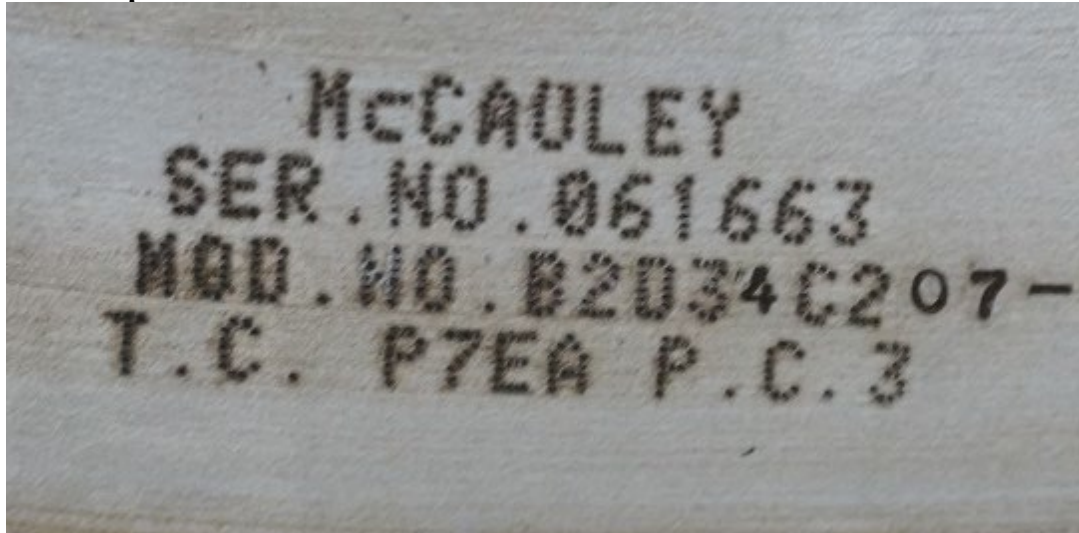
Figure 4 – Propeller Hub Markings

Undamaged

No damage

Slight aft bend about 1/3 span from hub. No other damage
