# NATIONAL TRANSPORTATION SAFETY BOARD

## MATERIALS LABORATORY FACTUAL REPORT

Report No. 21-087

Place : Sterling, MA  
Date : 03/11/2020  
Vehicle : Cessna 177RG, N1572H  
NTSB No. : ERA20FA124  
Investigator : Doug Brazy

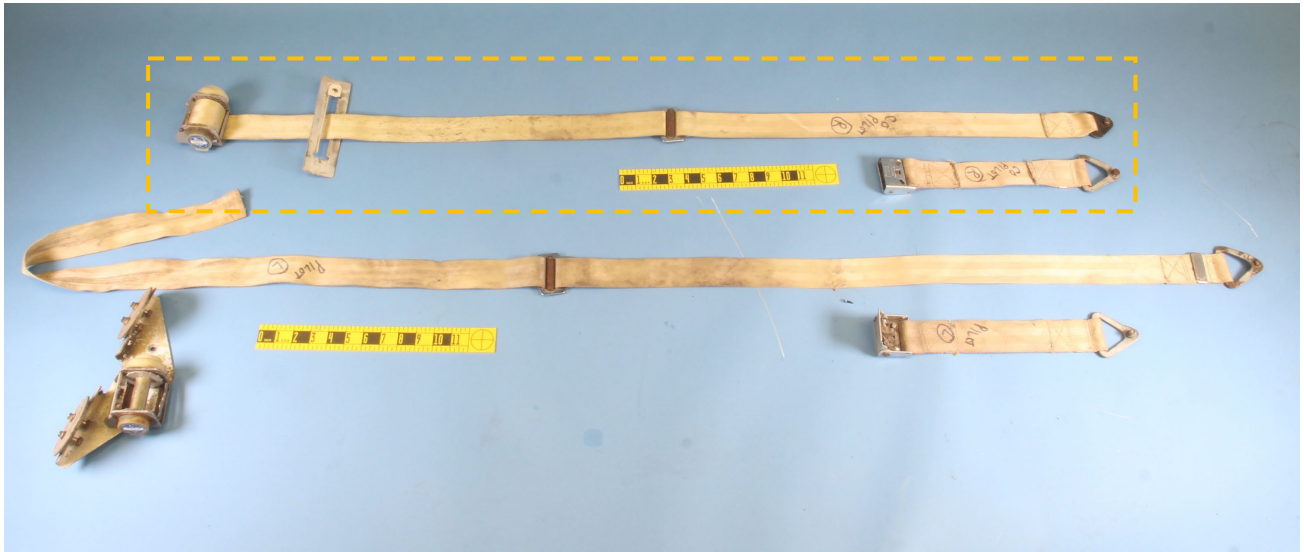
Pilot's and Co Pilot's seat belt assemblies as received (Figure 1).

Figure 1: Seat belt assemblies as received. The Co-pilot's seat belt assembly is within the dashed outline.

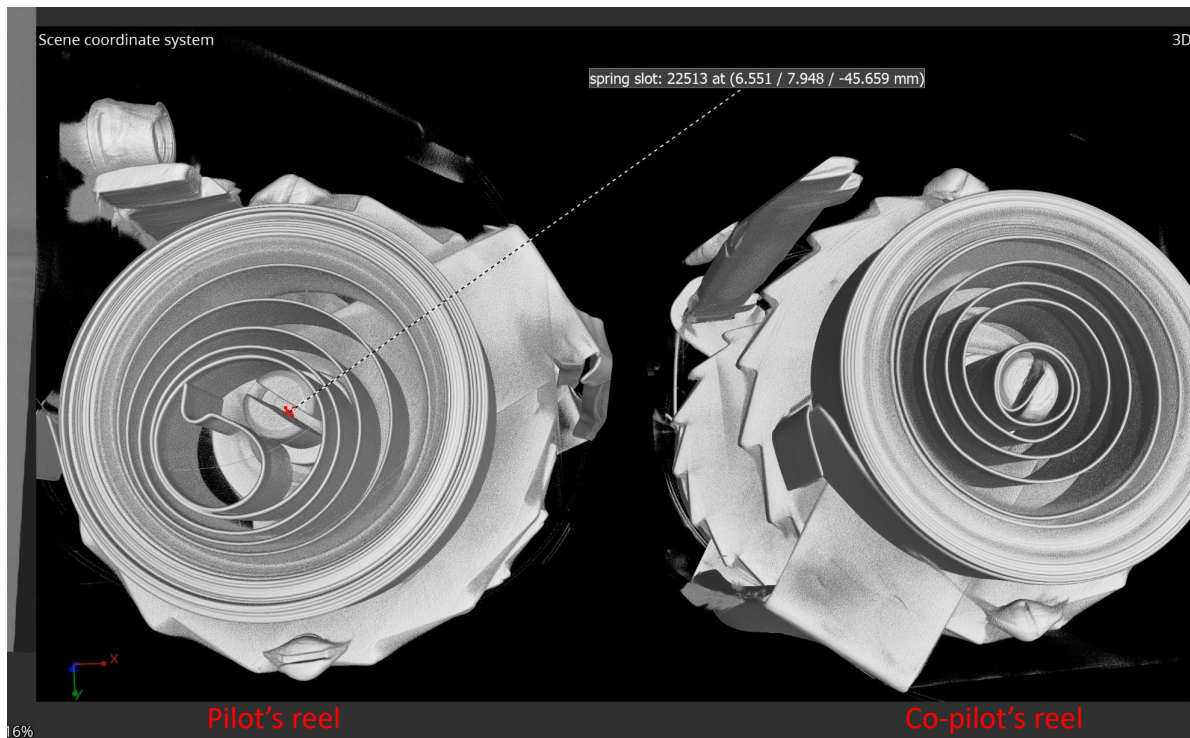
Prior to testing the inertial locking mechanisms on both seat belt reels the reel assemblies were sent to an outside lab for Computed Tomography (CT) scanning. Both reels were CT scanned at the same time and the images were examined side by side to identify any differences between the two units while also looking for any signs of internal damage. The CT scans did not reveal any damage to the inertial locking mechanism on either of the two reels. The CT scan did reveal that on the pilot's reel the spool retraction springing that would retract the seat belt webbing back onto the spool after an extension was not properly connected to the axle running through the spool (Figure 2). The end of the retraction spring would normally pass through a spring slot on the end of the axle running through the spool. A dog leg on the end of the retraction spring would prevent the spring from pulling through the slot on the end of the axle. The CT images indicated that the end of the retraction spring did not pass through the slot on the end of the axle but instead was laying next to the spring slot on the end of the axle.

Figure 2: Pilot's and co-pilot's seat belt reel retraction springs.

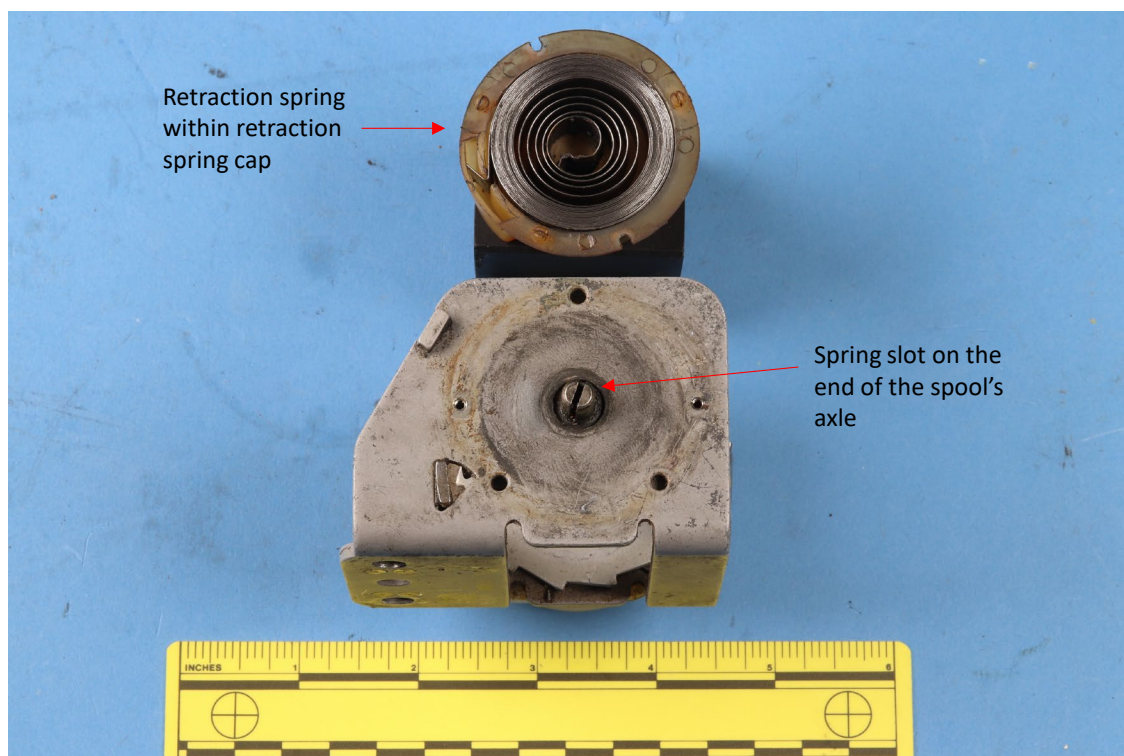
After the seat belt reel assemblies were returned from CT scanning, they were functionally tested in the Materials Laboratory. The co-pilot's reel assembly functioned as designed allowing extension and retraction of the webbing from the spool and locking when given a sudden tug. In order to functionally test the pilot's reel assembly, the cover of the retraction spring was removed (Figure 3) to properly engage the retraction spring into the spring slot on the end of the spool's axle after the webbing had been wound onto the spool. After reassembling the pilot's seat belt reel assembly, the reel allowed extension and retraction of the seat belt webbing and exhibited lockup when given a sudden tug.

In summary, the only anomaly identified with the pilot's seat belt reel assembly was the disconnected retraction spring identified from the CT images prior to disassembly. Once the retraction spring was properly connected to the spool spring slot after the seat belt webbing had been wound up the seat belt reel and inertial locking mechanism functioned as designed. A lack of clearance between the retraction spring cap and the retraction spring in the assembled position would not have allowed the retraction spring to come out of the spring slot on the end of the spool's axle without removing the spring cap. The dog leg on the end of the retraction spring would not have allowed the retraction spring to pull through the spring slot under normal circumstances.

Figure 3: Pilot's seat belt reel with retraction spring and spring cap removed.

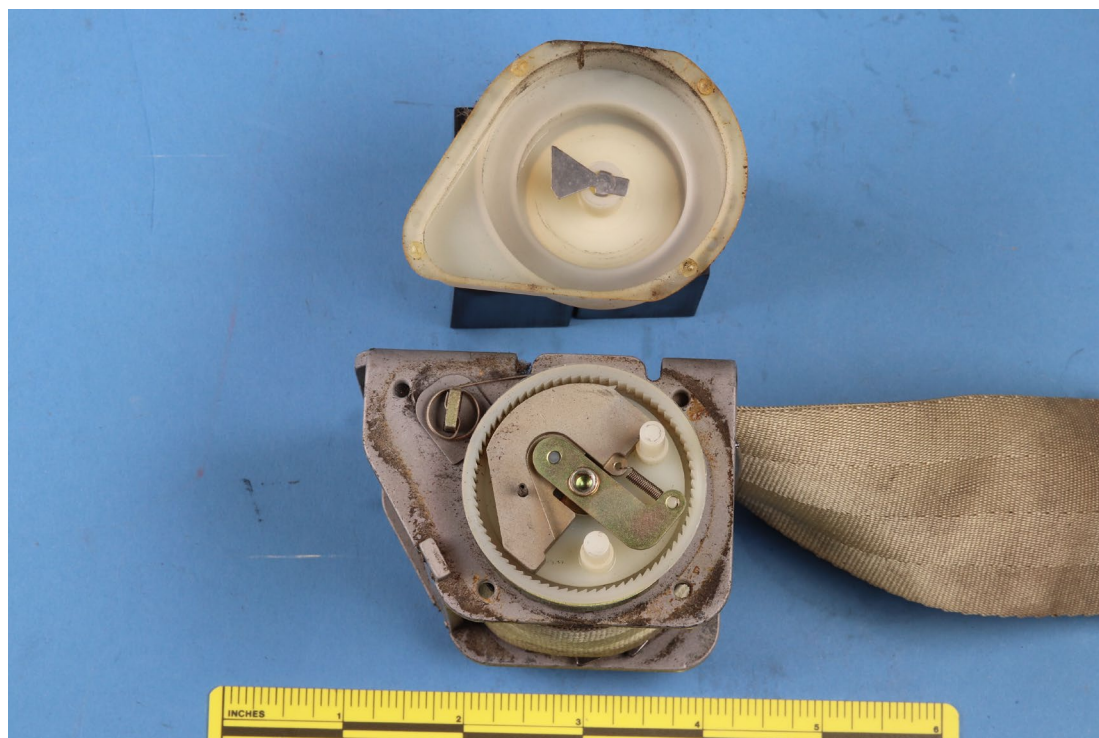
After the functional testing did not reveal any anomalies with the performance of the inertial locking mechanism on the pilot's seat belt reel assembly the cover of the inertial locking mechanism was removed for examination (Figure 4). The internal components of the inertial locking mechanism did not exhibit any anomalies such as missing gear teeth on the ring gear or any problems with the engagement of the pawl with the ring gear (Figure 5). Functional tests of the inertial locking mechanism were conducted with the inertial locking mechanism's cap removed to observe the movement of the internal components. All the components in the inertial locking mechanism moved freely and functioned as intended.

Figure 4: Pilot's seat belt reel with inertial locking mechanism cover removed.

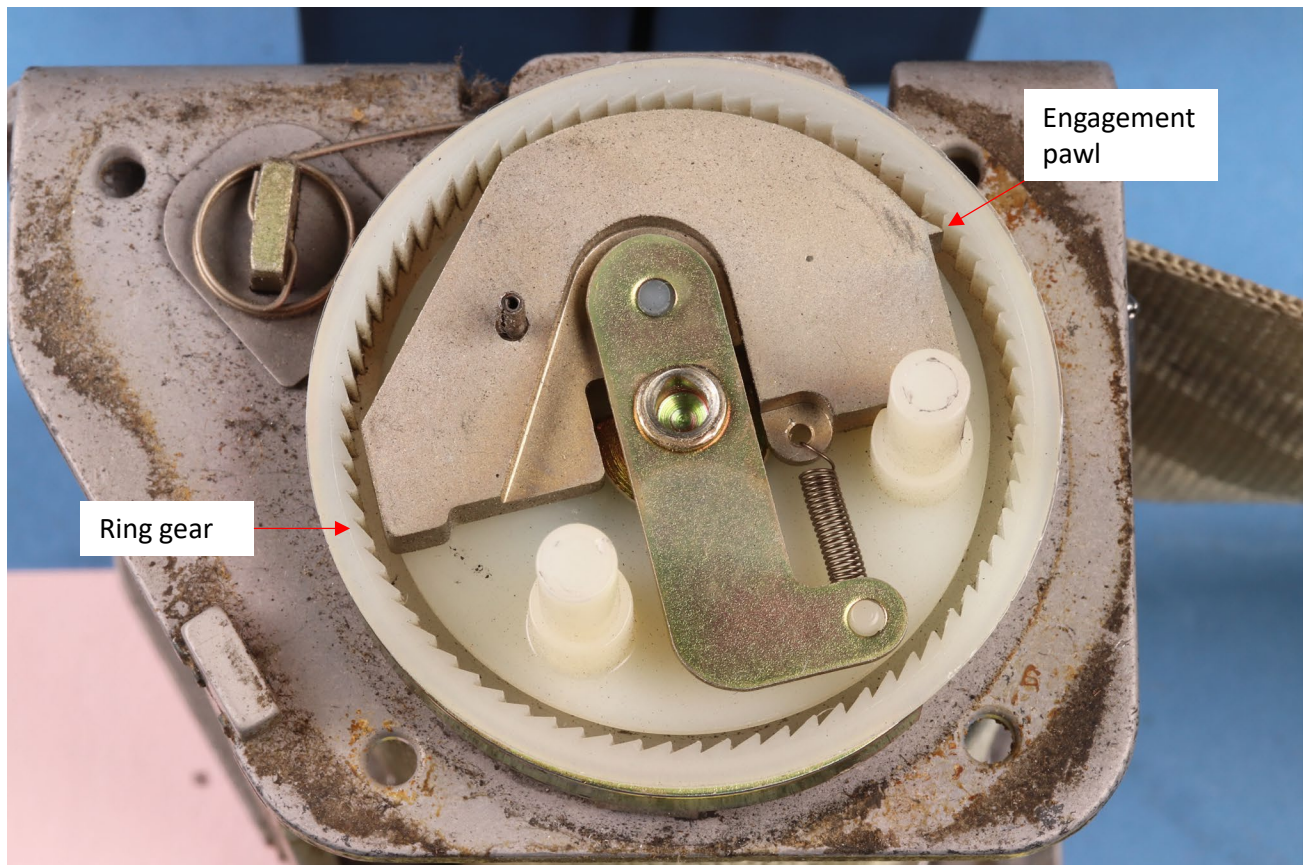
Figure 5: Close up of pilot's reel inertial locking mechanism internal components.
