# Continental Motors

## ENGINE RUN REPORT

| ENGINE MODEL | TSIO-550-C (1B) |

| EXAMINATION | | ACCIDENT DATA | |
|---|---|---|---|
| DATE | 3-12-2020 | NTSB ACCIDENT # | ERA20LA011 |

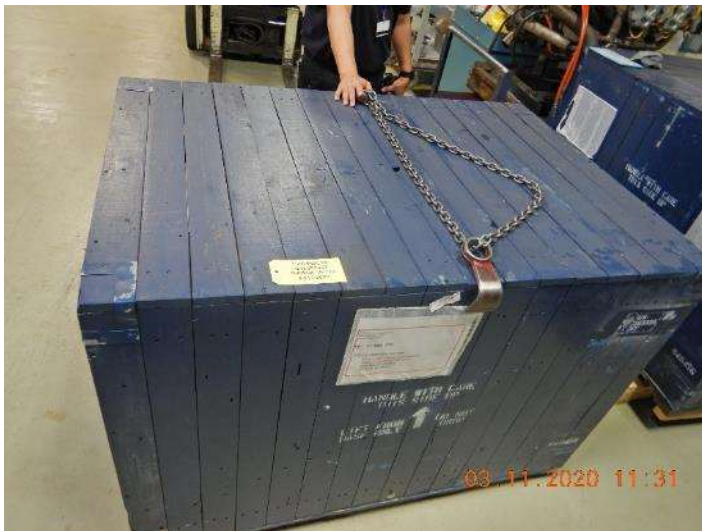
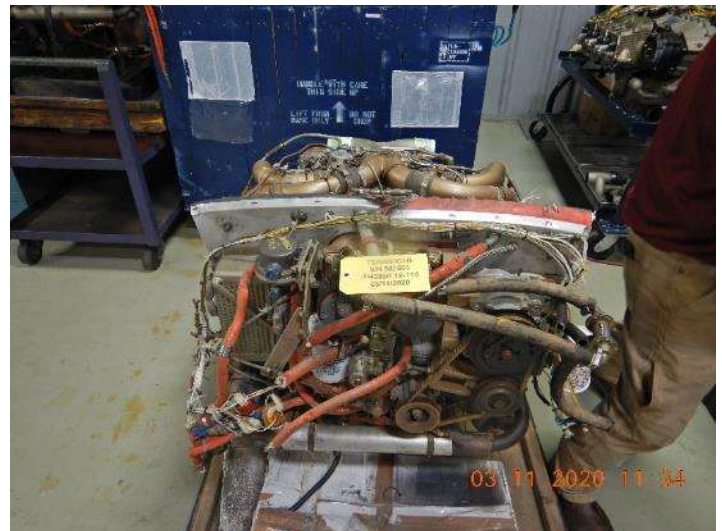
The engine was removed from the shipping crate in the presence of the NTSB Investigator and a visual inspection indicated that the engine exhibited surface corrosion on all cylinder cooling fins, both alternators and the left and right turbo chargers. A cardboard box was shipped with the engine which contained induction tubes, over boost valve, muffler and inner coolers.

This engine had been submerged in the Susquehanna River near Harrisburg, PA for 13 days before being recovered. The recovery crew drained the crankcase of oil and water and filled all cylinders and crankcase with diesel fuel to preserve the engine. No impact damage was noted.

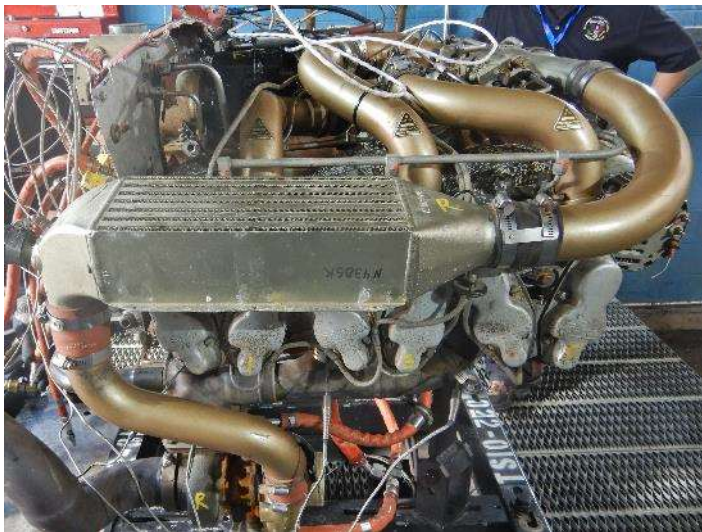
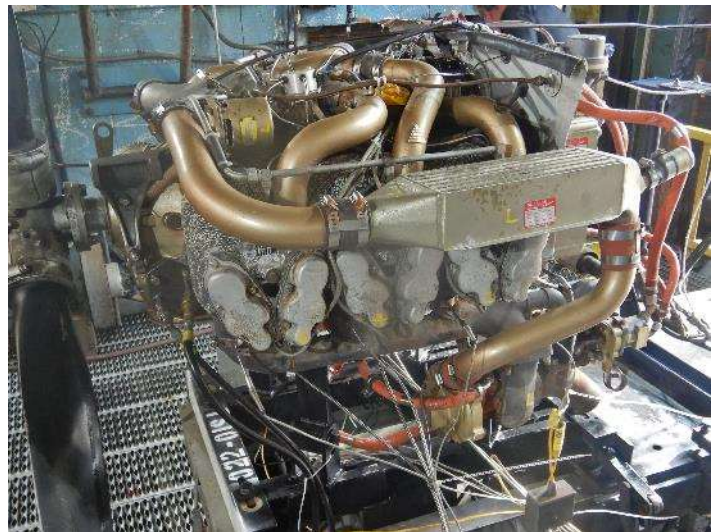
The engine did not start on the first attempt. No fuel flow was observed from the manifold valve to the fuel injectors. The fuel manifold was found to be contaminated with water and corrosion from being submerged in a river for several days prior to recovery. The manifold valve diaphragm assembly was stuck in the body which prevented the flow of fuel to the nozzles. The fuel manifold valve was disassembled, cleaned and reassembled. The engine then experienced a normal start without hesitation or stumbling in observed RPM. The engine RPM was advanced in steps for warm-up in preparation for full power operation. The engine throttle was advanced to 1200 RPM and held for five (5) minutes to stabilize. The engine throttle was advanced to 1600 RPM and held for five (5) minutes to stabilize. The engine throttle was advanced to 2450 RPM and held for five (5) minutes to stabilize. The engine throttle was advanced to full open position and held for five (5) minutes to stabilize. The engine throttle was rapidly advanced from idle to full throttle five times where it performed normally without any hesitation, stumbling or interruption in power.

Throughout the test phase, the engine accelerated normally without any hesitation, stumbling or interruption in power and demonstrated the ability to produce rated horsepower.
