**ERA20LA011**

**Piper, PA46-310P – N4385K**

**NTSB ENGINE EXAMINATION REPORT**

**March 12, 2020**

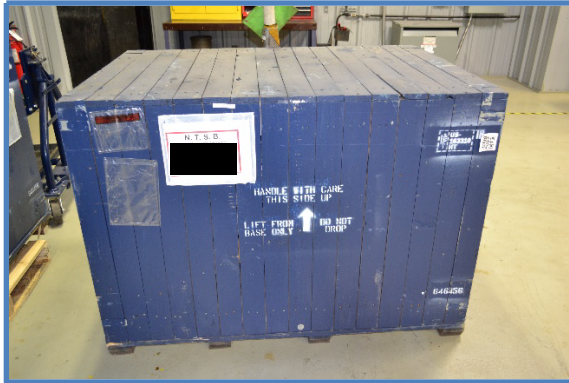
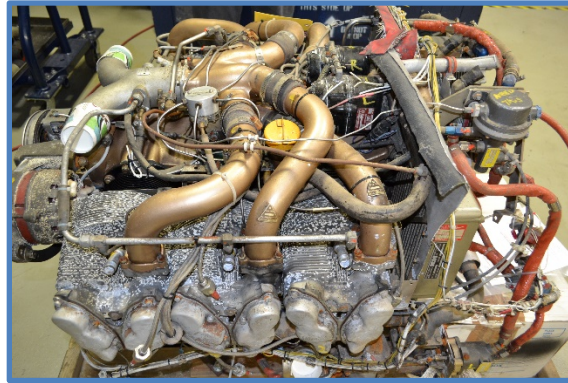
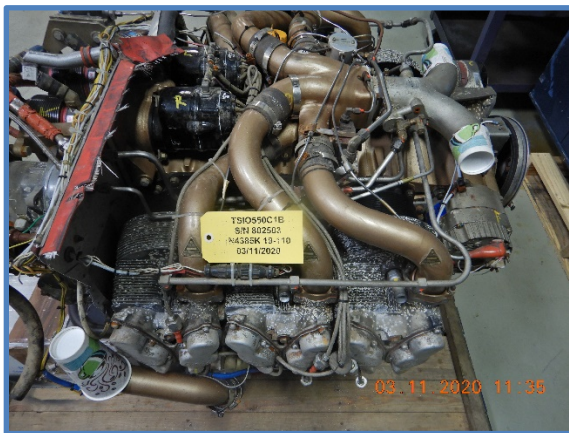
- Corrosion on both turbos
- The right turbo had impact damage to the bottom
- The cylinder heads exhibited corrosion to the aluminum cooling fins due to water submersion.

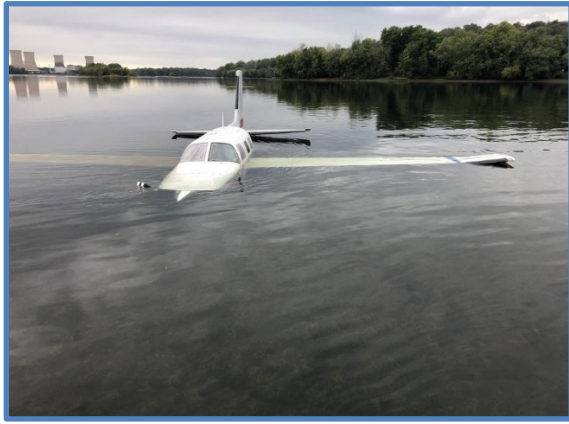
Picture 2. View of airplane in water

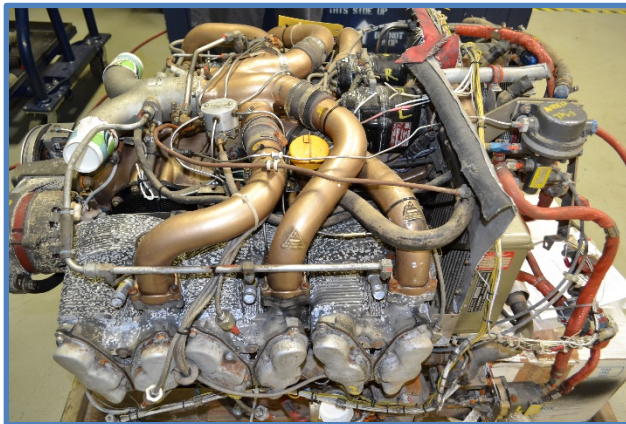
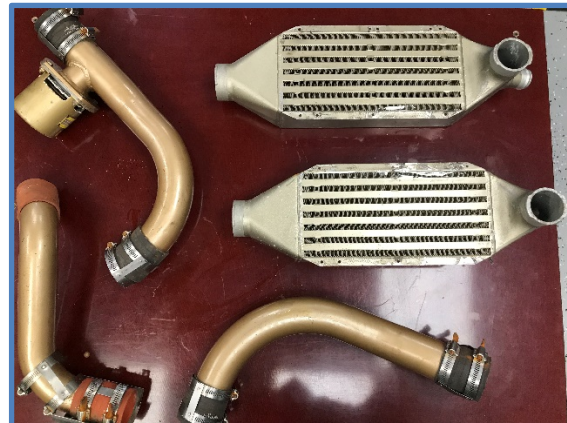
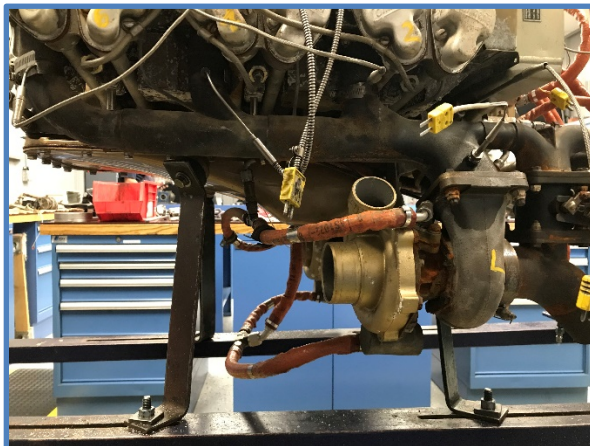
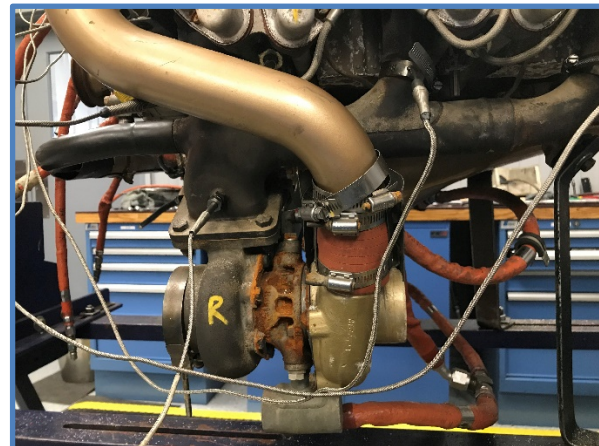
The air induction and exhaust tubes remained attached to the engine. The right turbo had impact damage to the bottom, but not enough to necessitate a substitute, it could be manually rotated. The intercoolers, both turbos, cross over tube and exhaust tubes remained attached to the engine to facilitate examination.

Picture 3. Intake and Exhaust Systems

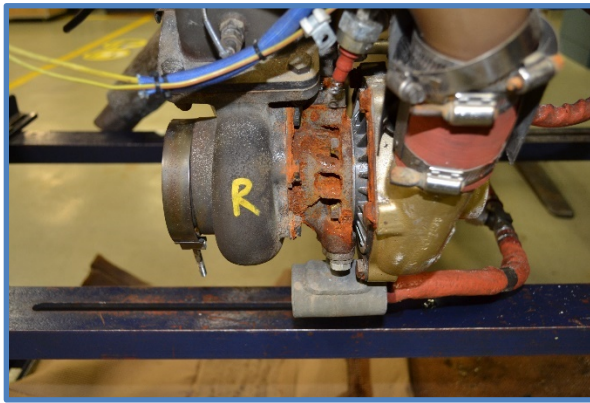
Picture 4. View of corrosion on right turbo

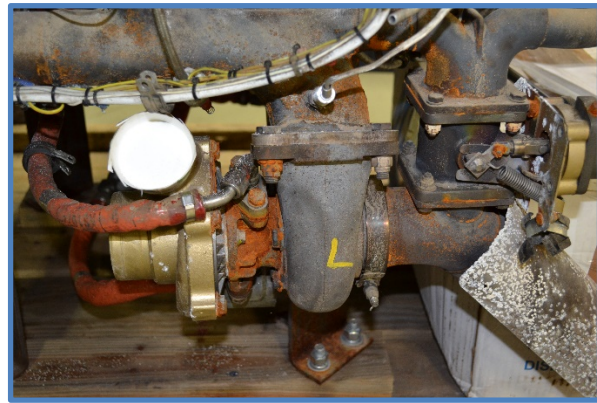
Picture 5. View of corrosion on left turbo

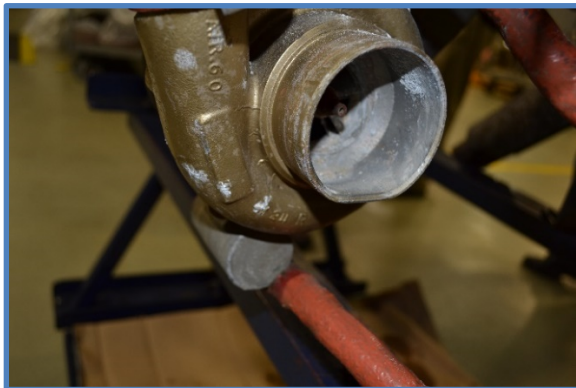
Picture 6. View damaged right turbo

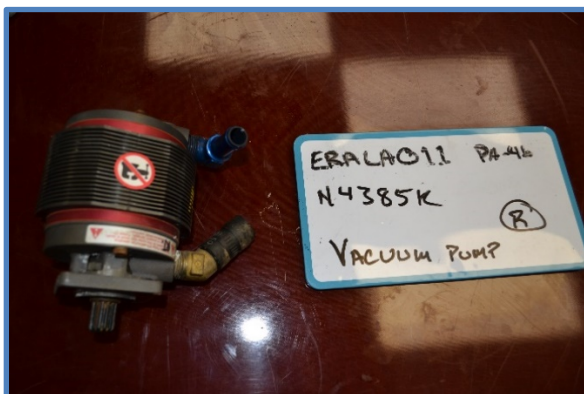
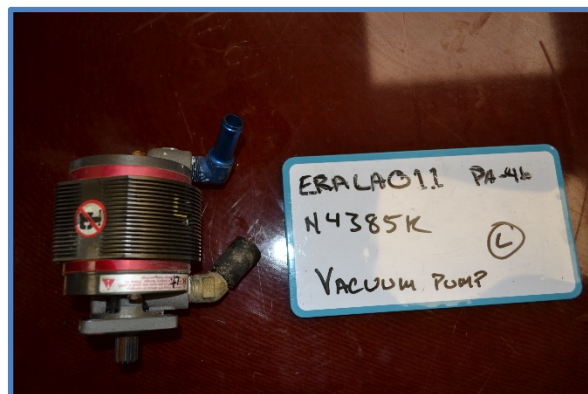
Picture 7. Vacuum Pumps

The vacuum pumps (instrument air pumps) were removed from the engine to facilitate examination. Both instrument air pumps could be manually rotated, and no apparent damage was noted.

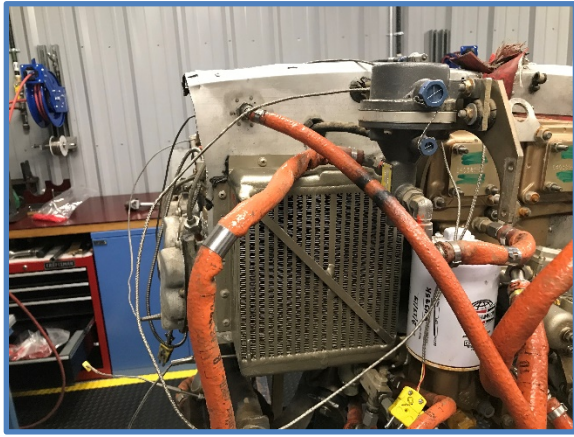
The engine oil cooler was examined, no apparent damage was noted.

Picture 8. View of oil cooler.

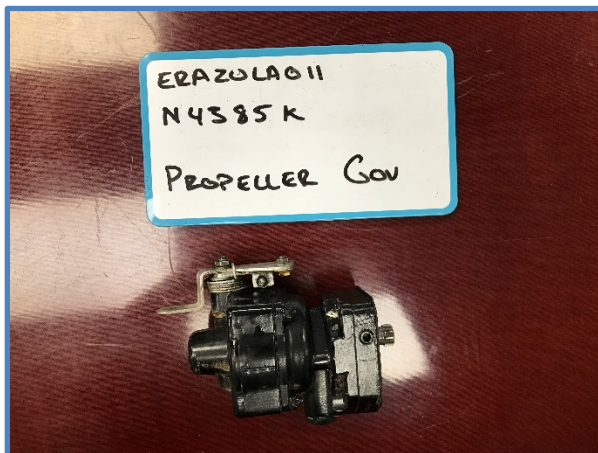
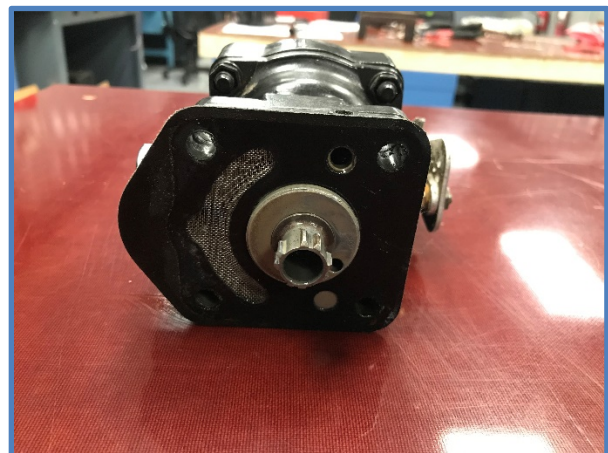
Picture 9. View of Propeller Governor.

The propeller governor was removed from the engine and rotated by hand. When it was rotated oil was pumped through the governor.

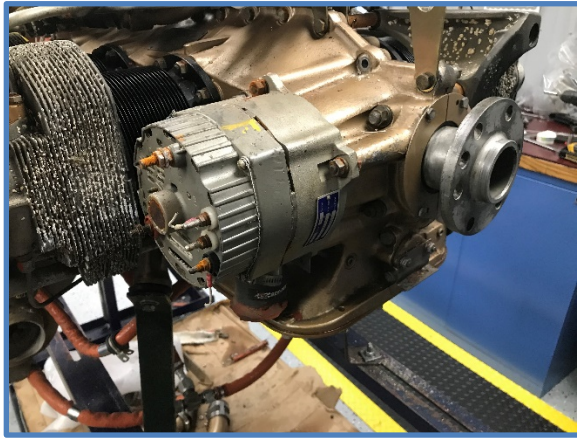
Picture 10. Alternator

The alternator #1 remained attached to the engine, no apparent damage was noted. Alternator #2 was removed to facilitate examination.

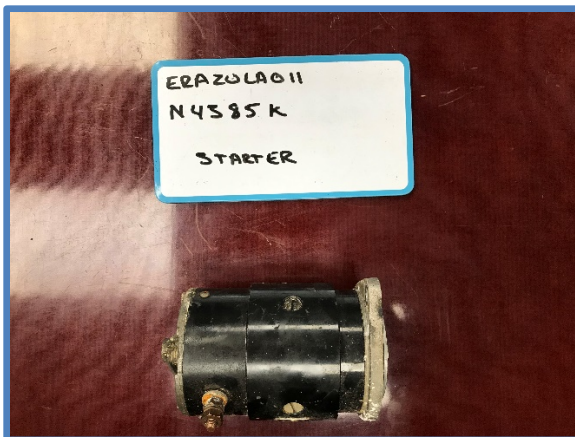
Picture 11. Starter

The starter was removed from the engine and examined, the starter contained water and was binding. As a precautionary measure the starter was substituted to facilitate examination.

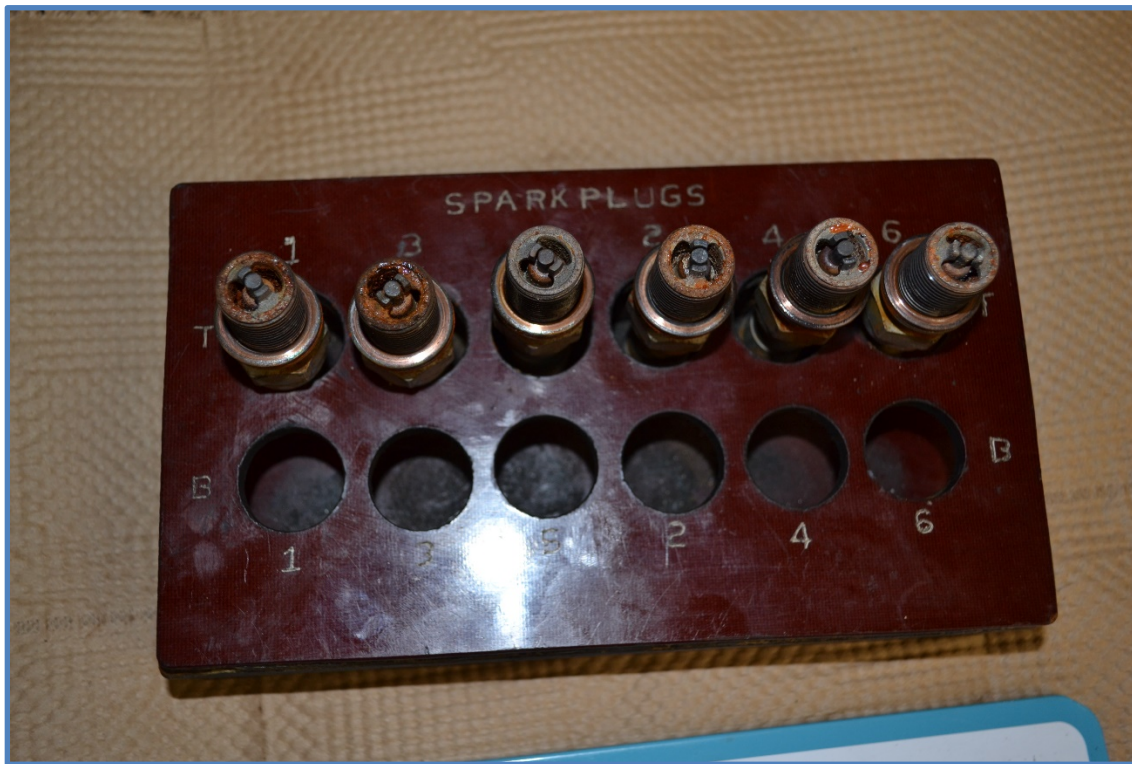
Picture 12. View of top Spark Plugs

The top sparkplugs were removed and inspected. The condition was normal and the color was normal but with corrosion due to water submersion. The engine was manually rotated, and thumb compression was achieved on all six cylinders.

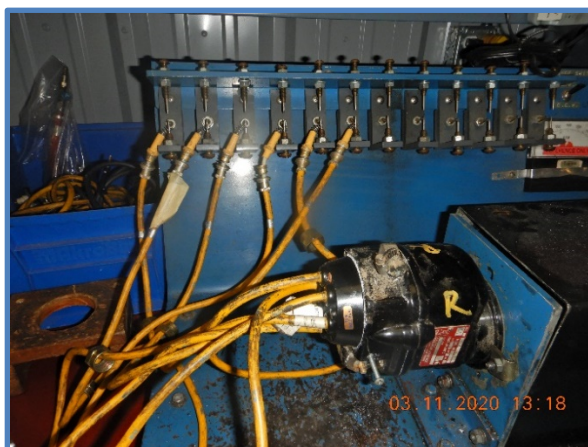
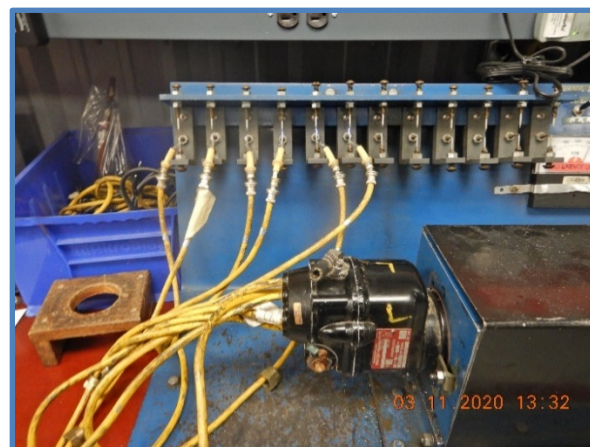
Picture 13. Magnetos on Test Stand

The magnetos remained attached to the engine and were removed. They were both mounted to a test stand and produced spark on all towers.

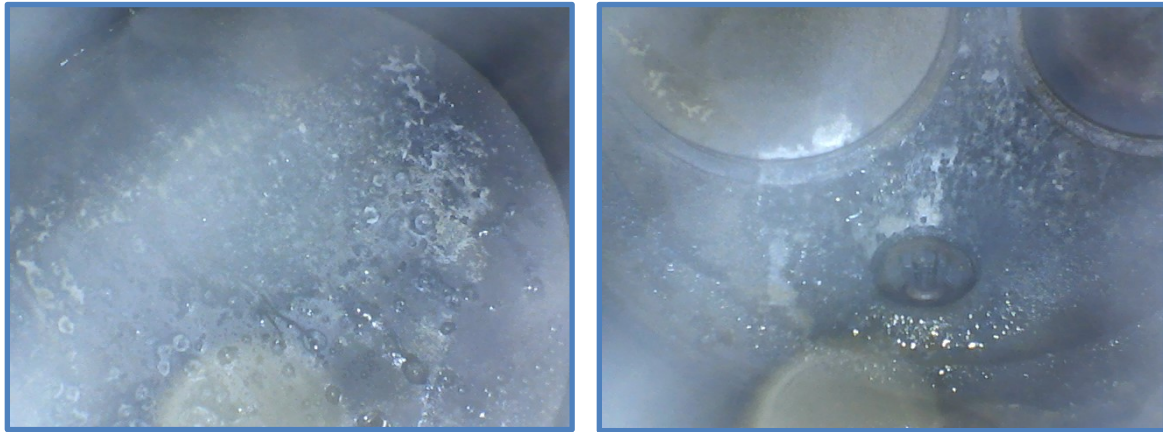
Picture 14. View electronic lighted borescope examination of cylinder 1

During the accident recovery exam, an electronic borescope inspection was performed on each cylinder. All intake and exhaust valves were intact and exhibited normal combustion deposits. Each piston crown exhibited normal combustion deposits and cross hatching was visible on cylinder bores.

A cold compression check of the cylinders resulted in the number # 1 = 3/80, # 3 = 25/80, # 5 = 32/80 and the # 2 = 40/80, # 4 = 27/80 and # 6 = 34/80.

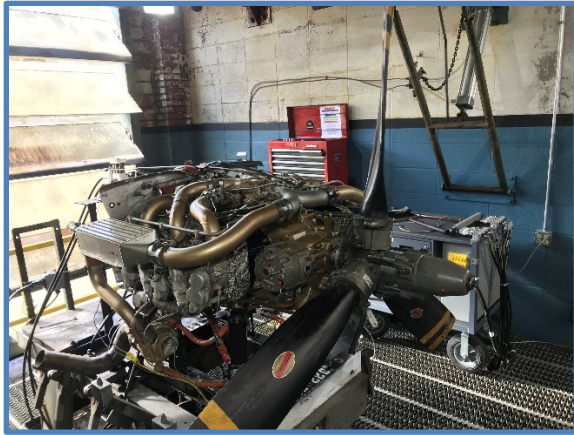
Picture 20. View of engine in test cell

The engine was mounted on a stand and prepared for the test run, installing the appropriate fuel connections, exhaust pipes, test equipment and propeller. During the first attempt to start, the engine would not start. Further examination of the fuel system identified a stoppage at the fuel manifold valve. Removal and examination of the fuel manifold valve identified water and

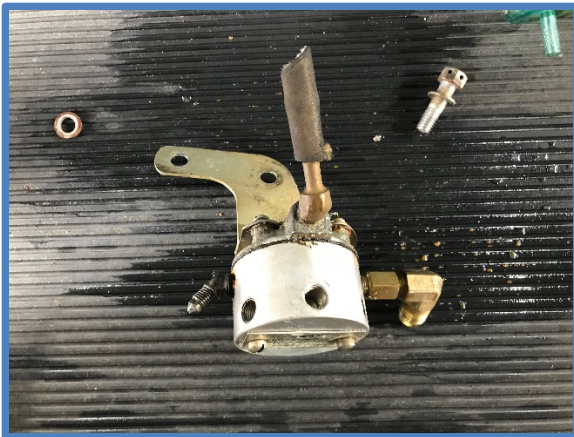
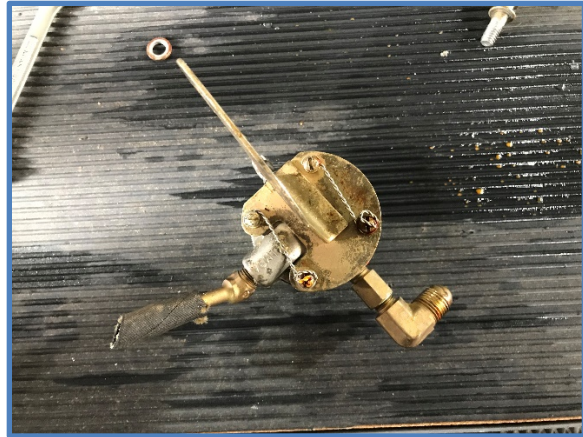
Picture 21. View of fuel manifold valve

corrosion inside the fuel manifold valve, consistent with the engine being submerged in water. The fuel manifold valve was cleaned, reassembled and utilized to complete the engine test run. The remaining engine starts and performance test were completed with no further discrepancies.

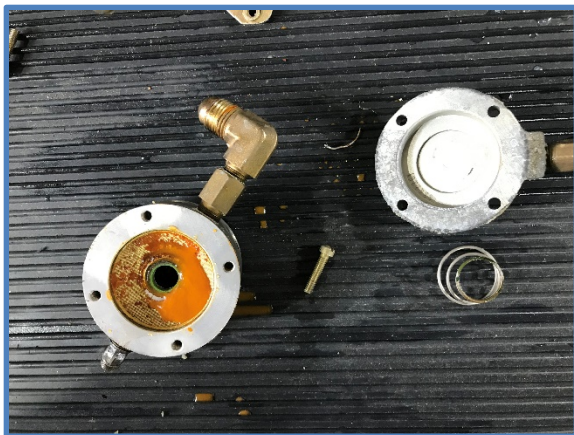
Picture 22. View of corrosion and water in fuel manifold valve
