**ERA20LA039**

**West Liberty, Kentucky**

**Rans S7 – N831RS**

**NTSB ENGINE EXAMINATION REPORT**

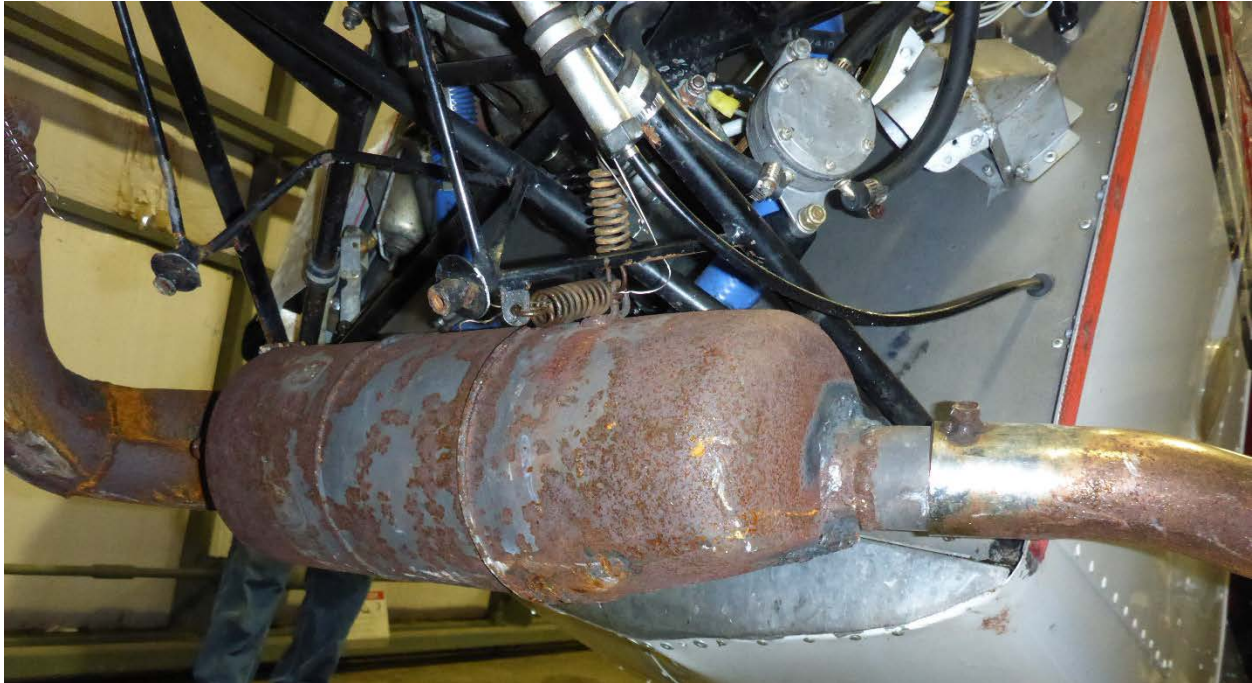
The exhaust system was partially separated from the engine. It exhibited corrosion and was removed for further examination. There were no obstructions in the exhaust system.

Figure 1. View of exhaust system.

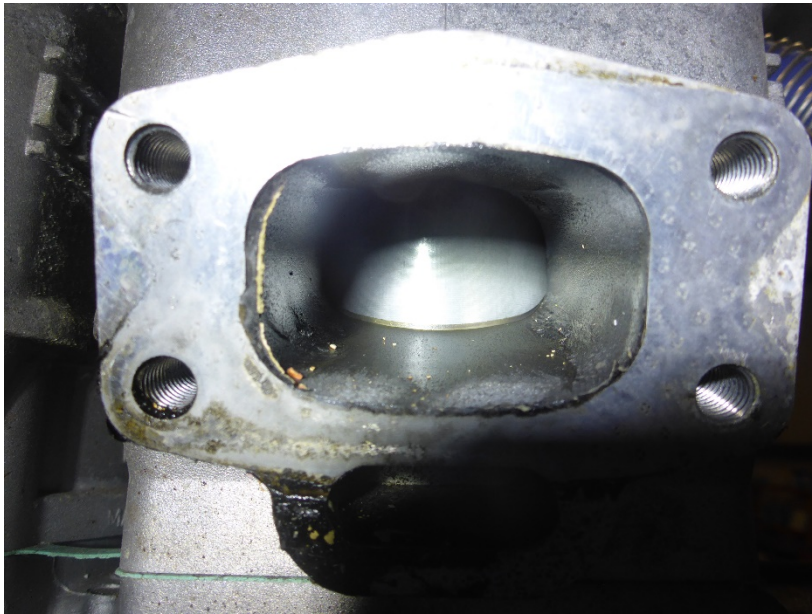
Compression was observed on both cylinders when rotating the propeller through by hand. The exhaust Y-pipe was removed to examine the interior of the cylinders. The magneto side piston exhibited vertical scoring and had no lubrication. The PTO side piston exhibited a small amount of lubrication and a minor amount of scoring was noted.

Figure 2. Front piston (PTO Side)

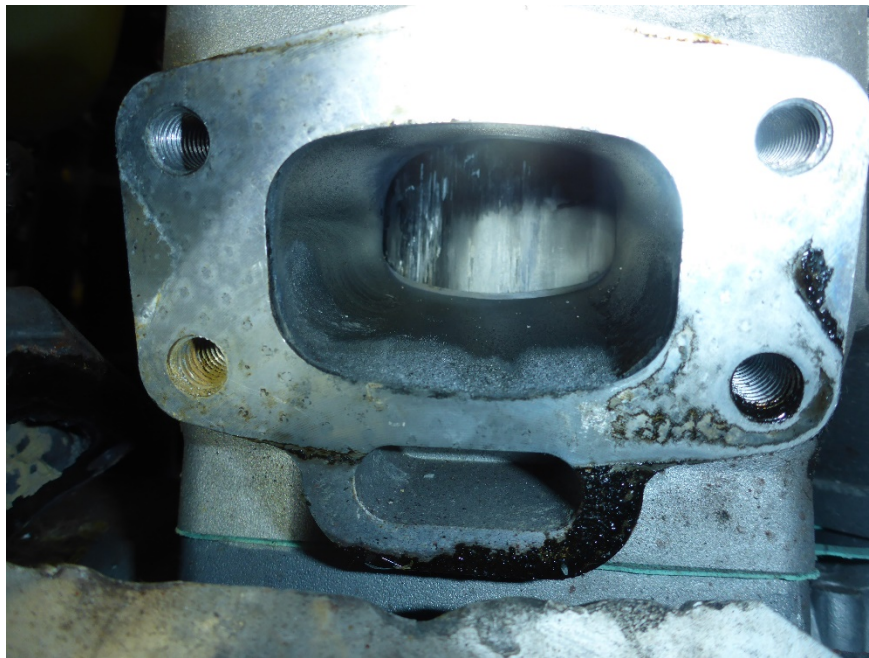
Figure 3. Aft piston (magneto side)

The examination revealed that the aft (magneto side) piston seized during flight as a result of lack of lubrication as seen by the vertical scoring on the piston and lack of oil in the oil injection tank.

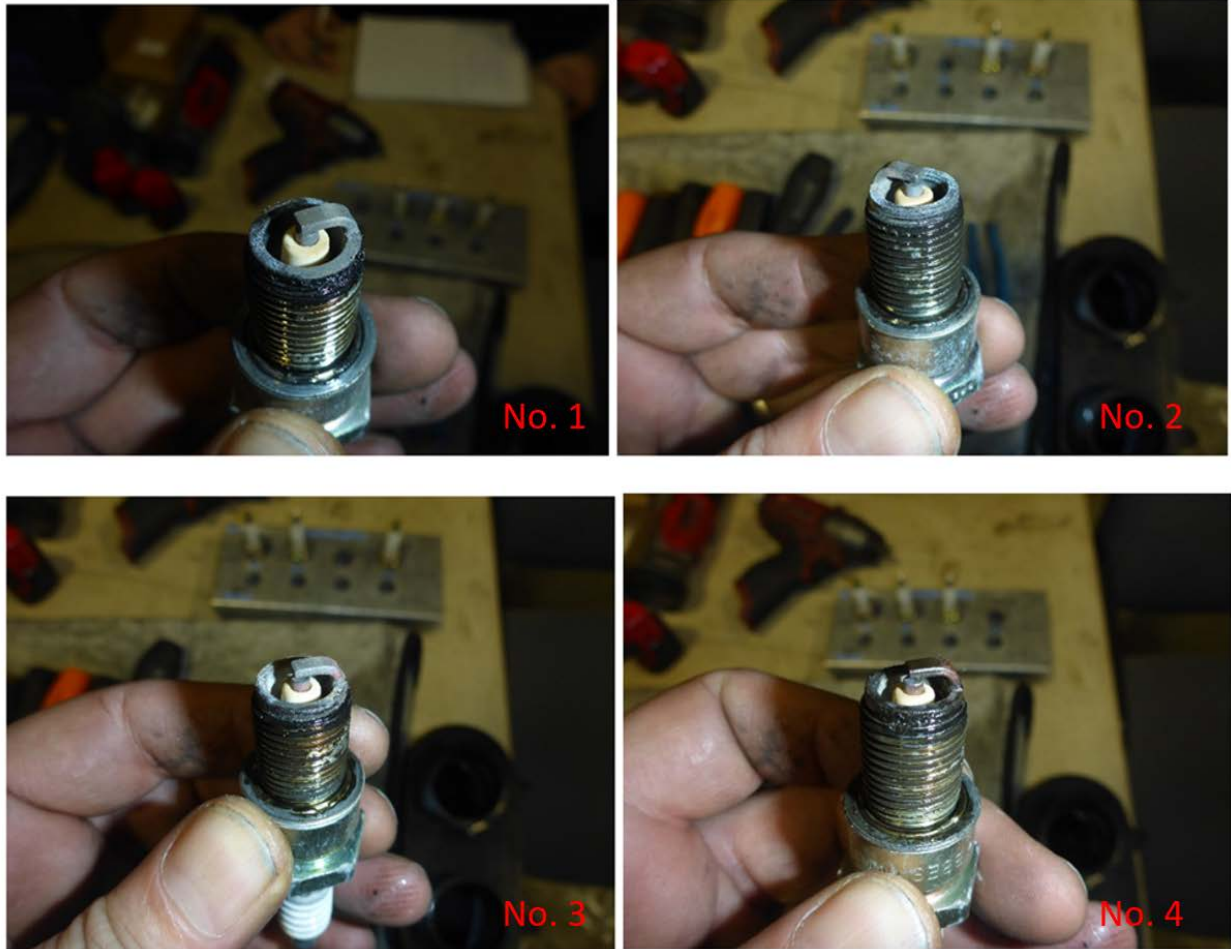
The spark plugs were removed from the engine and exhibited normal wear. They were not oil soaked. The power takeoff (PTO) side No. 2 and magneto side No. 3 spark plugs had removable caps. The PTO No. 1 and Magneto No. 4 spark plugs had non-removable plugs.

Figure 4. View of Spark Plugs

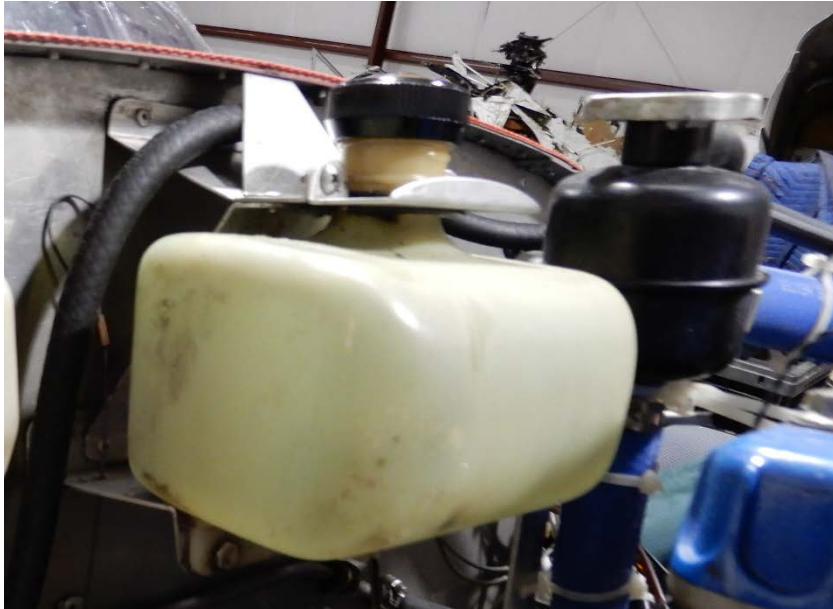
The oil injection tank did not contain oil in it. The oil tank was a gravity fed system, and the oil line went slight “uphill” before getting to the engine. The oil tank was not a Rotax product. No

Figure 5. View of oil injection tank as found. Note: no oil.

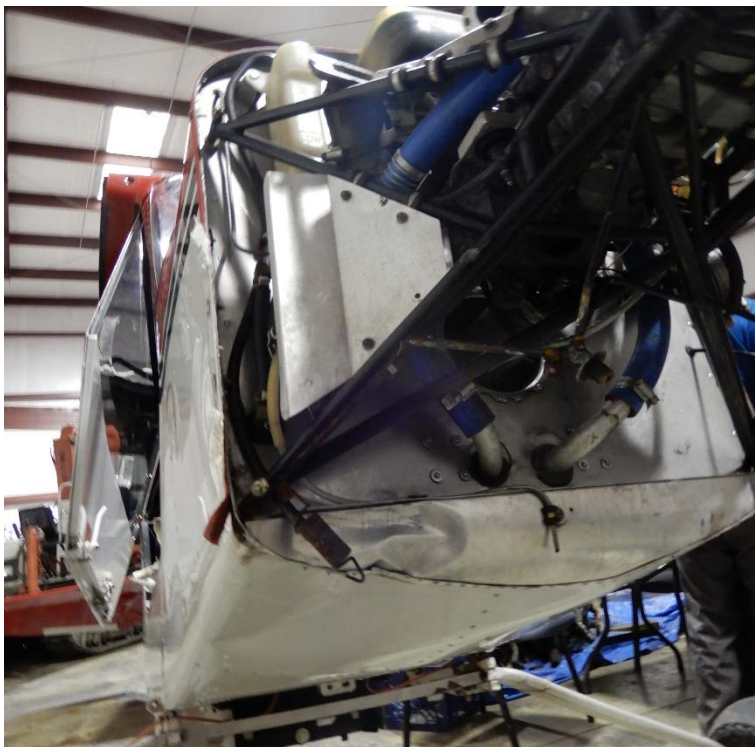
There was no oil streaking noted on the airframe.

Figure 6. View of underside of airframe. Note: No oil streaks.

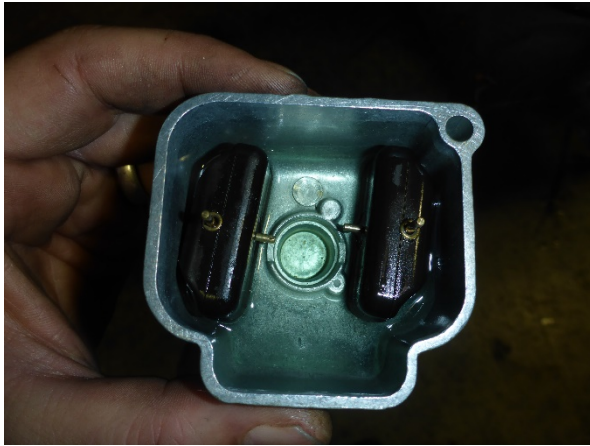
The PTO carburetor float bowl was removed and fuel was noted in the bowl. There were no anomalies with the floats. The PTO carburetor main jet was removed and not obstructed. The fuel filter screen was examined, no debris was noted, and was not crushed.

Figure 7. View of PTO Carburetor bowl.

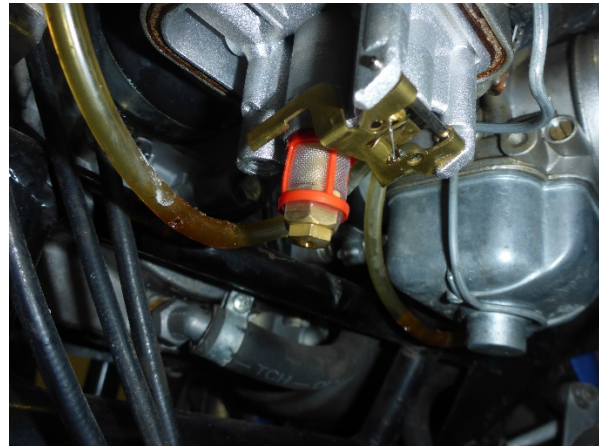
Figure 8. View of PTO Carburetor Fuel Filter Screen.

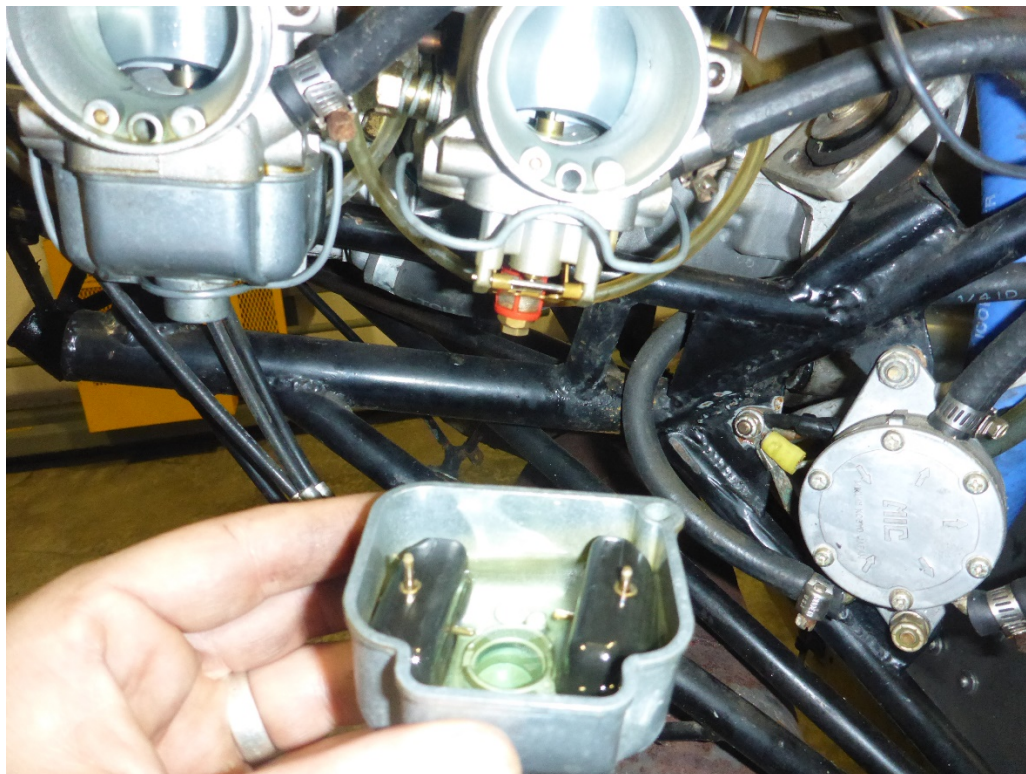
The magneto side carburetor bowl was removed and fuel was noted in the bowl. There were no anomalies with the floats. The magneto side carburetor main jet was removed and not obstructed. The fuel filter screen was examined, no debris was noted, and was not crushed.

Figure 9. View of aft (magneto) carburetor with fuel filter screen in background.
