**NATIONAL TRANSPORTATION SAFETY BOARD**  
**Office of Aviation Safety**  
**Washington, D.C. 20594**

**HELICOPTER SPECIALIST'S FACTUAL REPORT**

**NTSB No: ERA20LA054**

Operator: Alamo Helicopter Tours San Antonio LLC  
Aircraft: Robinson Helicopters R-44  
Location: San Antonio, TX  
Date: December 14, 2019  
Time: 1656 CST

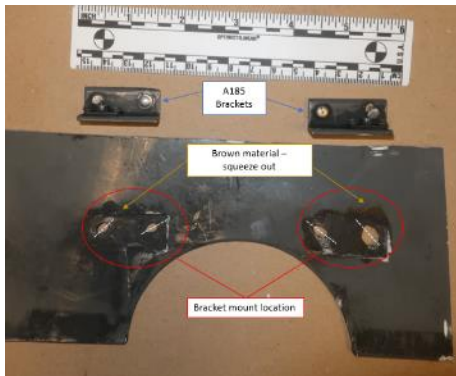
**Photo 1 - Upper scroll section and brackets.**

The upper brackets (A185) were separated from the scroll (photo 1). Both rivets in each bracket appeared to be sheared flush with the contact face of the bracket. Both bracket contact surfaces and sheared rivets had a shiny bright surface. Three of the four rivet heads appeared not to be installed using approved standards (rivet heads smeared). All 4 holes were elongated on the mating surface of the upper scroll (photo 1 & 2), and the surface was worn under each bracket and the inside back plate. The two upper scroll back plates were not recovered on-scene. Brown

SB-94, dated 8 June, 2017 is addressed to R44 series owners, Operators, and Maintenance Personnel. The bulletin directs the inspection of the A185 brackets for evidence of fretting or looseness. Loose brackets can allow lower bearing to misalign resulting in belt-tension actuator damage.

SL-61A, dated 21 July, 2017 is addressed to R44 series owners, Operators, and Maintenance Personnel. The service letter directs actions to be performed whenever looseness of an A185 bracket is detected and whenever the upper or lower scroll is removed. To comply with SL-61A a third middle rivet is to be placed on each upper bracket.

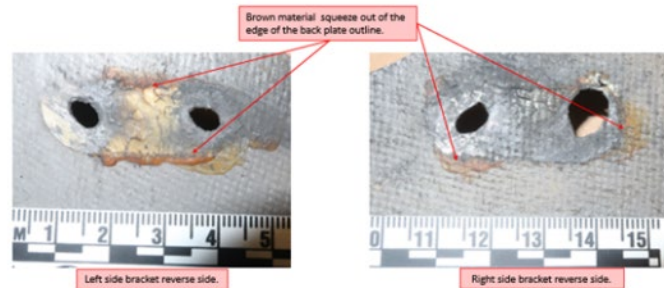
**Photo 2 - Upper scroll (reverse side) closeup.**

colored material was observed on the surface of the fiberglass scroll around the outline of the back plates. The brown material appeared to be squeezed out from between the scroll and the back plate (photo 2).

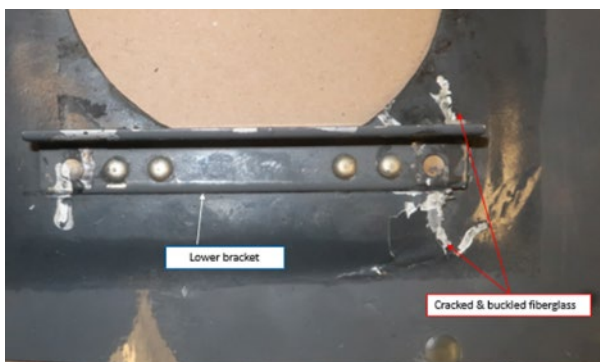
**Photo 3 - Lower bracket on lower scroll section.**

The lower bracket remained attached to the lower scroll (photos 3 & 4). Fiberglass damage was evident on the left side of the bracket (photo 3). Non factory back plates were used on the back side (photo 4). The scroll area around the lower bracket appeared to have been repaired (fiberglass repair). The paint surface on the upper portion of the bracket (bracket to bearing housing surface) had worn through on the inboard edge. Maintenance logbook entry dated November 24, 2017, noted Service Bulletin 94 (SB94) had been complied with in accordance with Service Letter 61 (SL61); however, SB94 and SL61 required a third rivet to be installed on the upper brackets which was not performed.

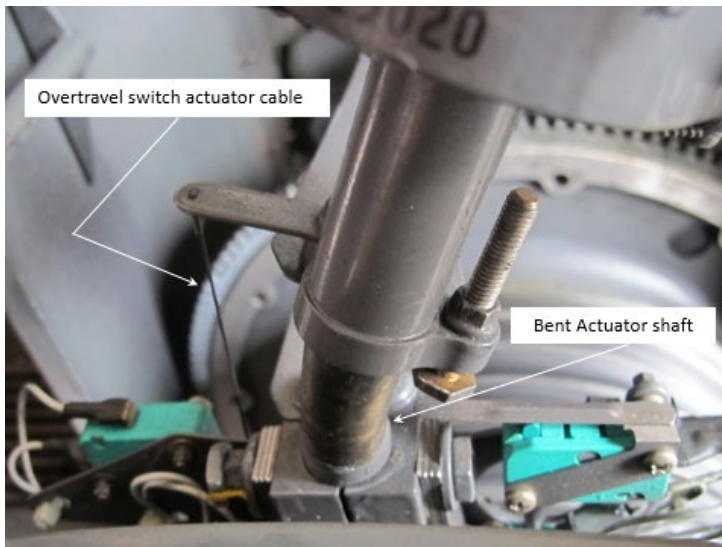
**Photo 5 - Belt tension actuator**

On-scene documentation of the belt tension actuator showed the actuator connected to the lower bearing and drive shaft assembly. The actuator screw tube was bent, and the actuator over-travel safety shutoff switch was engaged (photo 5).

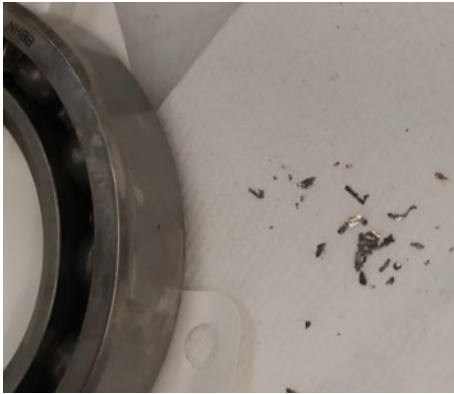
The clutch drain plug was removed. Brownish oil drained from the clutch and was passed through a 190-micron paper filter and collected (photos 6 & 7). One flake (aprox 0.10 in. in length) was observed to react to a magnet. One long black piece of debris (approx. 0.30 in long, similar to 0.5 pencil lead) also captured, and was not reactive to magnet. Multiple dark “specs” captured by filter that reacted to magnet. Oil was filtered a second time through a 190-micron filter, and numerous specs were identified visually, none of which reacted to a magnet.

**Photo 6- Particles collected from the forward support bearing.**

RHC MM Maintenance schedule requires the performance of clutch assembly lubricant inspection and servicing per §7.210 every 500 hours. The lubricant inspection involves the straining of the lubricant thru a 180-200 micron filter/strainer and inspecting for metal debris trapped by the filter. If metal debris is captured by the filter, the clutch assembly is to be replaced or overhauled.

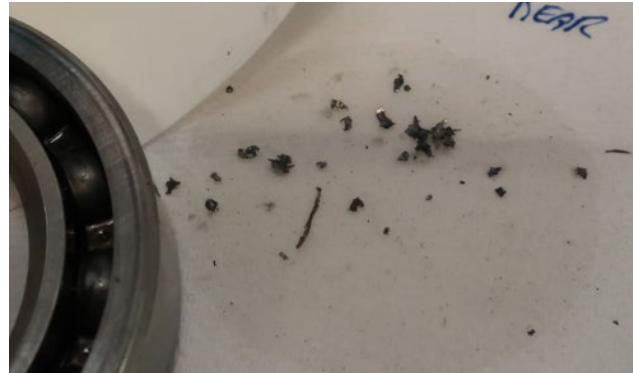
**Photo 7 - Particles collected from the rear support bearing.**
