# NATIONAL TRANSPORTATION SAFETY BOARD

## MATERIALS LABORATORY FACTUAL REPORT

Report No. 20-061

Place : San Antonio, TX  
Date : December 14, 2019  
Vehicle : Robinson R44, N440AH  
NTSB No. : ERA20LA054  
Investigator : Van McKinney (AS-40)

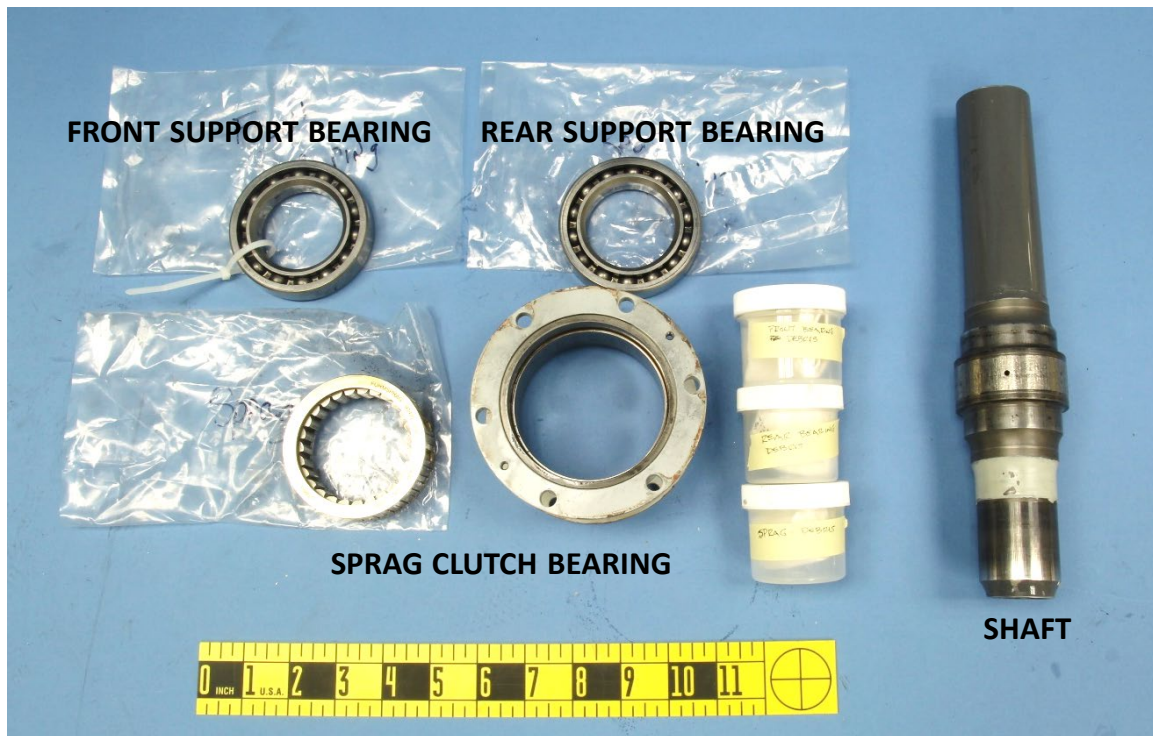
The clutch assembly was submitted in disassembled condition, with the front and rear support bearings and the sprag clutch bearing removed from the shaft. The components, as well as containers of particulates collected during disassembly, are shown in Figure 1.

Figure 1: Overall photo showing the submitted components from the sprag clutch assembly.

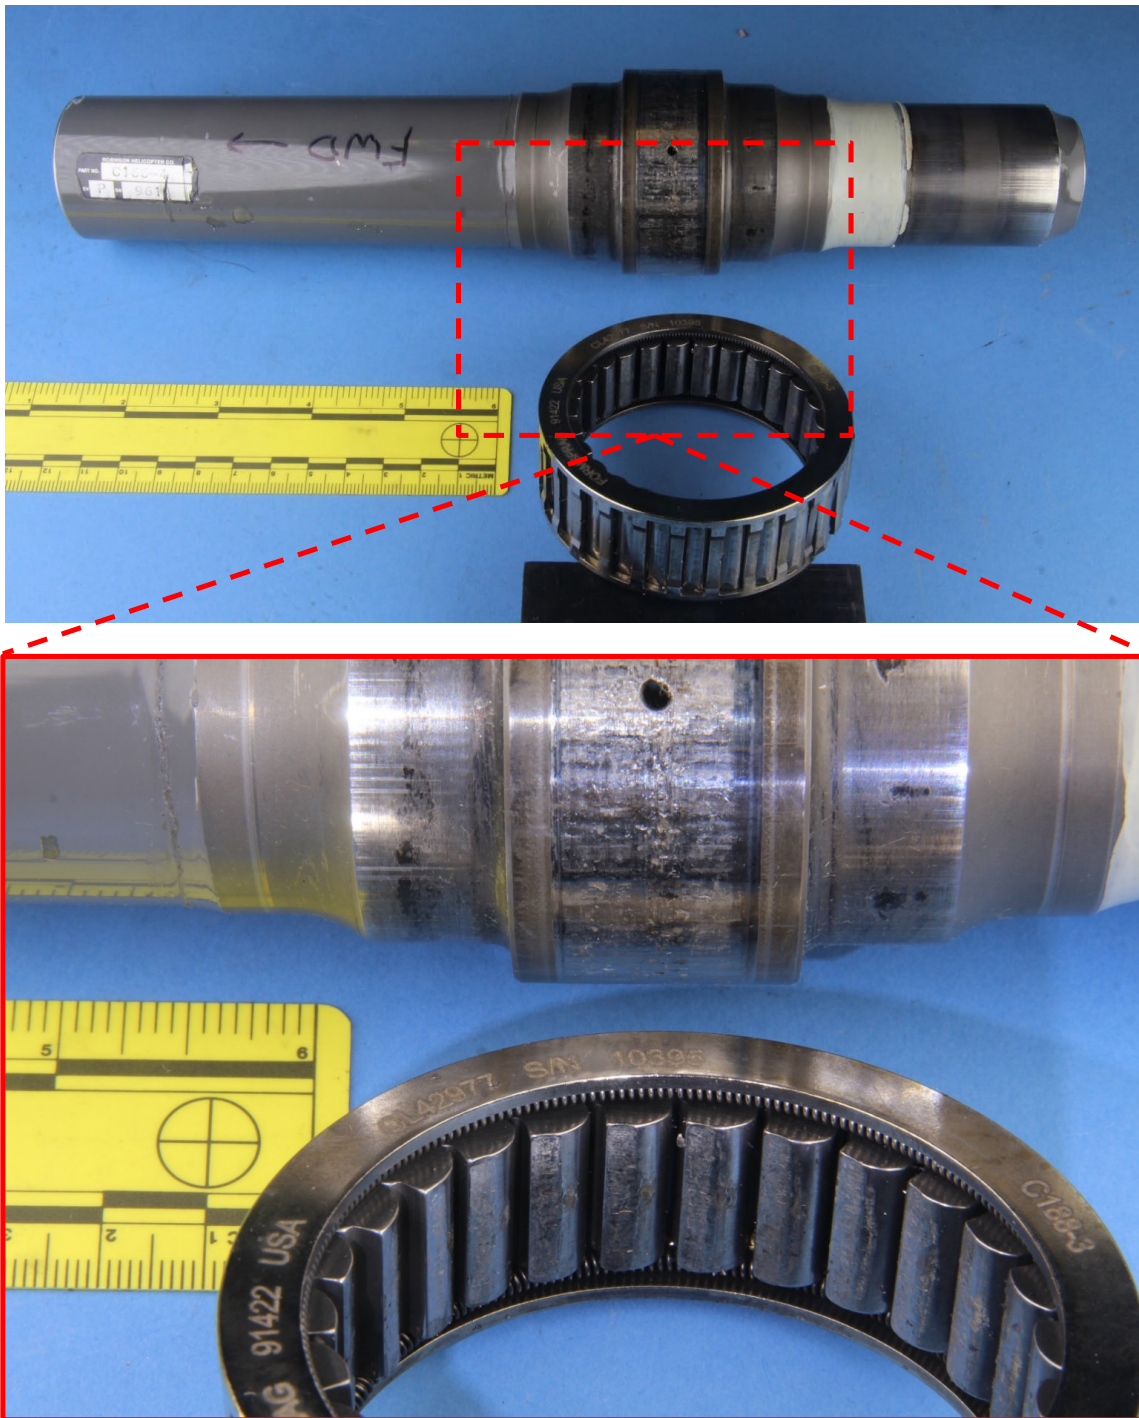
The parts were examined visually and with a 5x to 50x digital microscope. The race on the shaft that mated to the sprag clutch had extensive damage, as shown in Figures 2 and 3. Smearing and galled material were observed on the race. Impressions on the race, outlined by yellow dotted lines in Figure 3, matched the profile of the inner surfaces of the mating sprags.

Figure 2: Overall (top) and close-up (bottom) photos showing the shaft race and inner surfaces of the sprags.

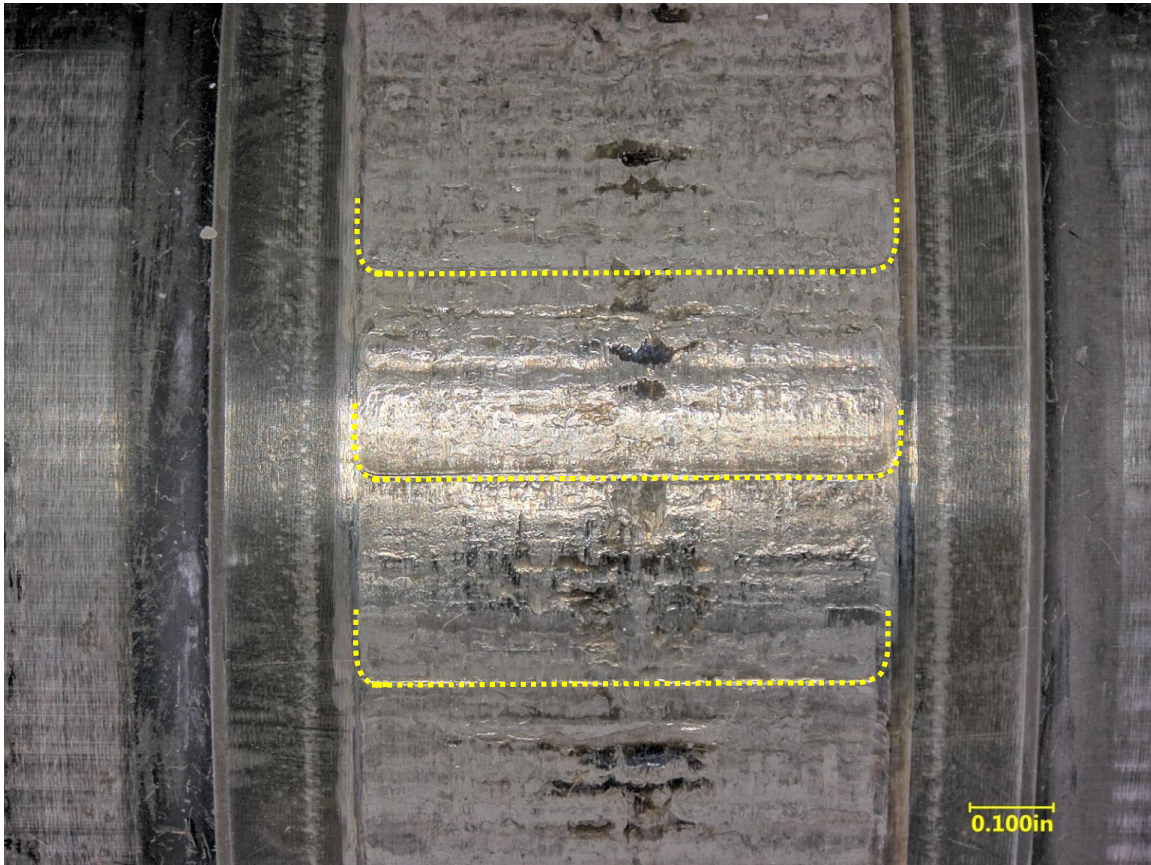
Figure 3: Digital microscope image of the race on the shaft that mated to the sprag clutch bearing. The yellow dotted lines outline impressions on the race.

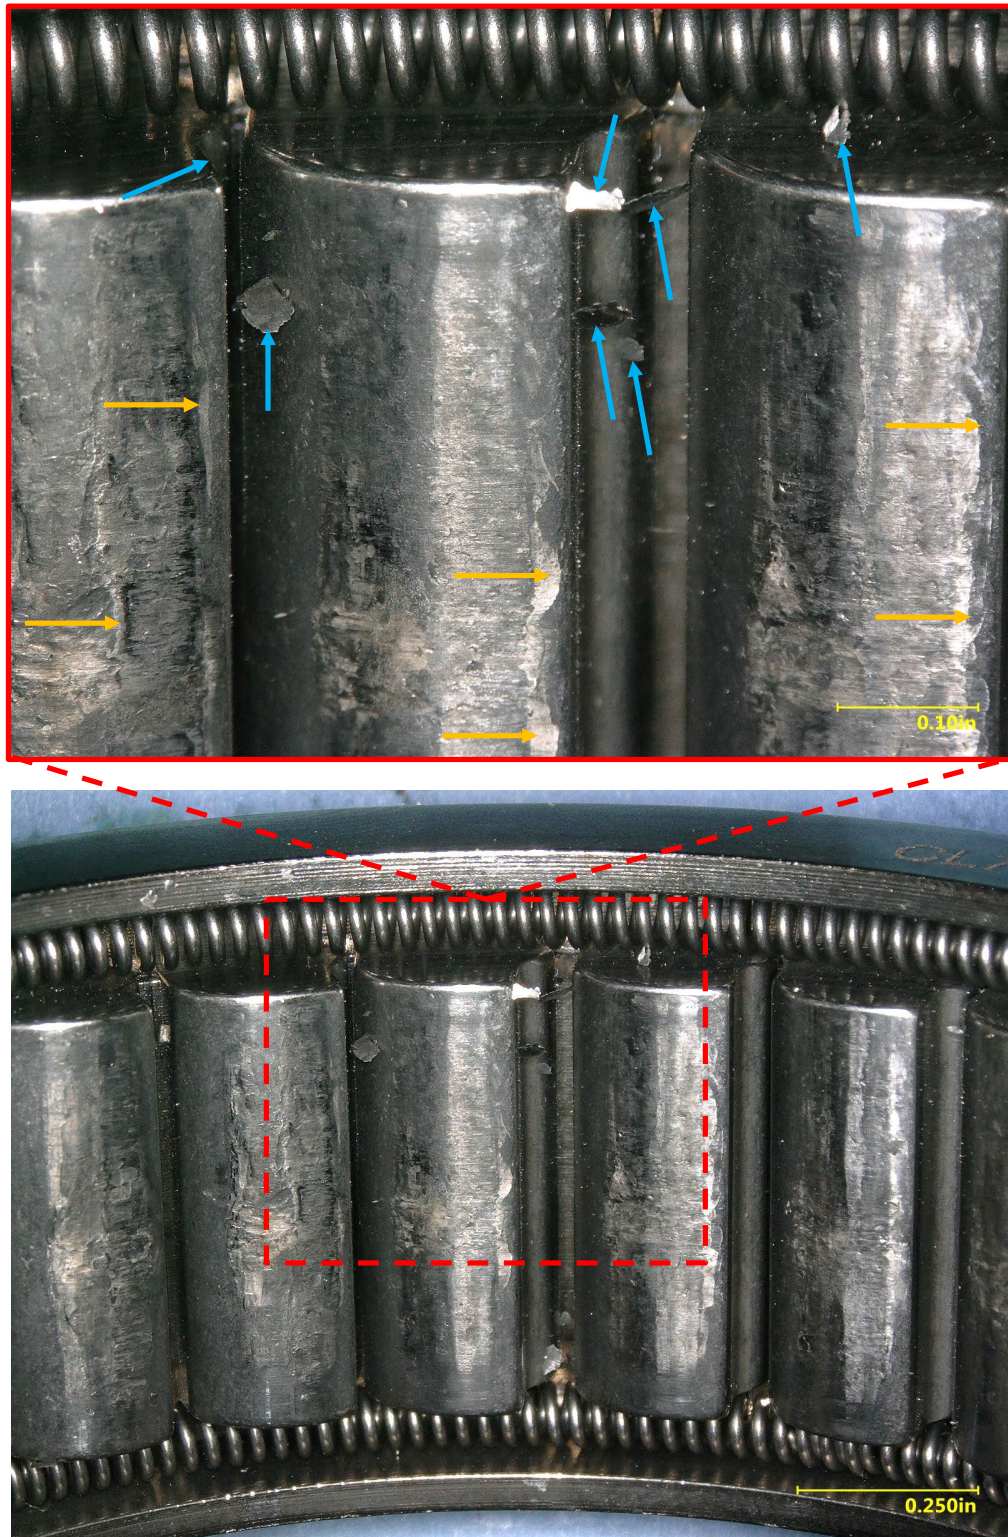
The inner surfaces of the sprags also had heavy smearing damage, as shown in Figure 4. Orange arrows point to material that was pushed to the edges of the sprags in the direction of rotation of the bearing. Damage to the outer surfaces of the sprags was less extensive than compared to the inner surfaces, with light smearing and some gouges, as shown in Figure 5. Numerous metallic particles were observed in the gaps between the cage and the sprags of the sprag clutch bearing (blue arrows).

Figure 4: Digital microscope images of the inner surfaces of the sprags. The orange arrows point to material pushed to the edges of the sprags. Blue arrows point to metallic particles in the gaps between the cage and the sprags.

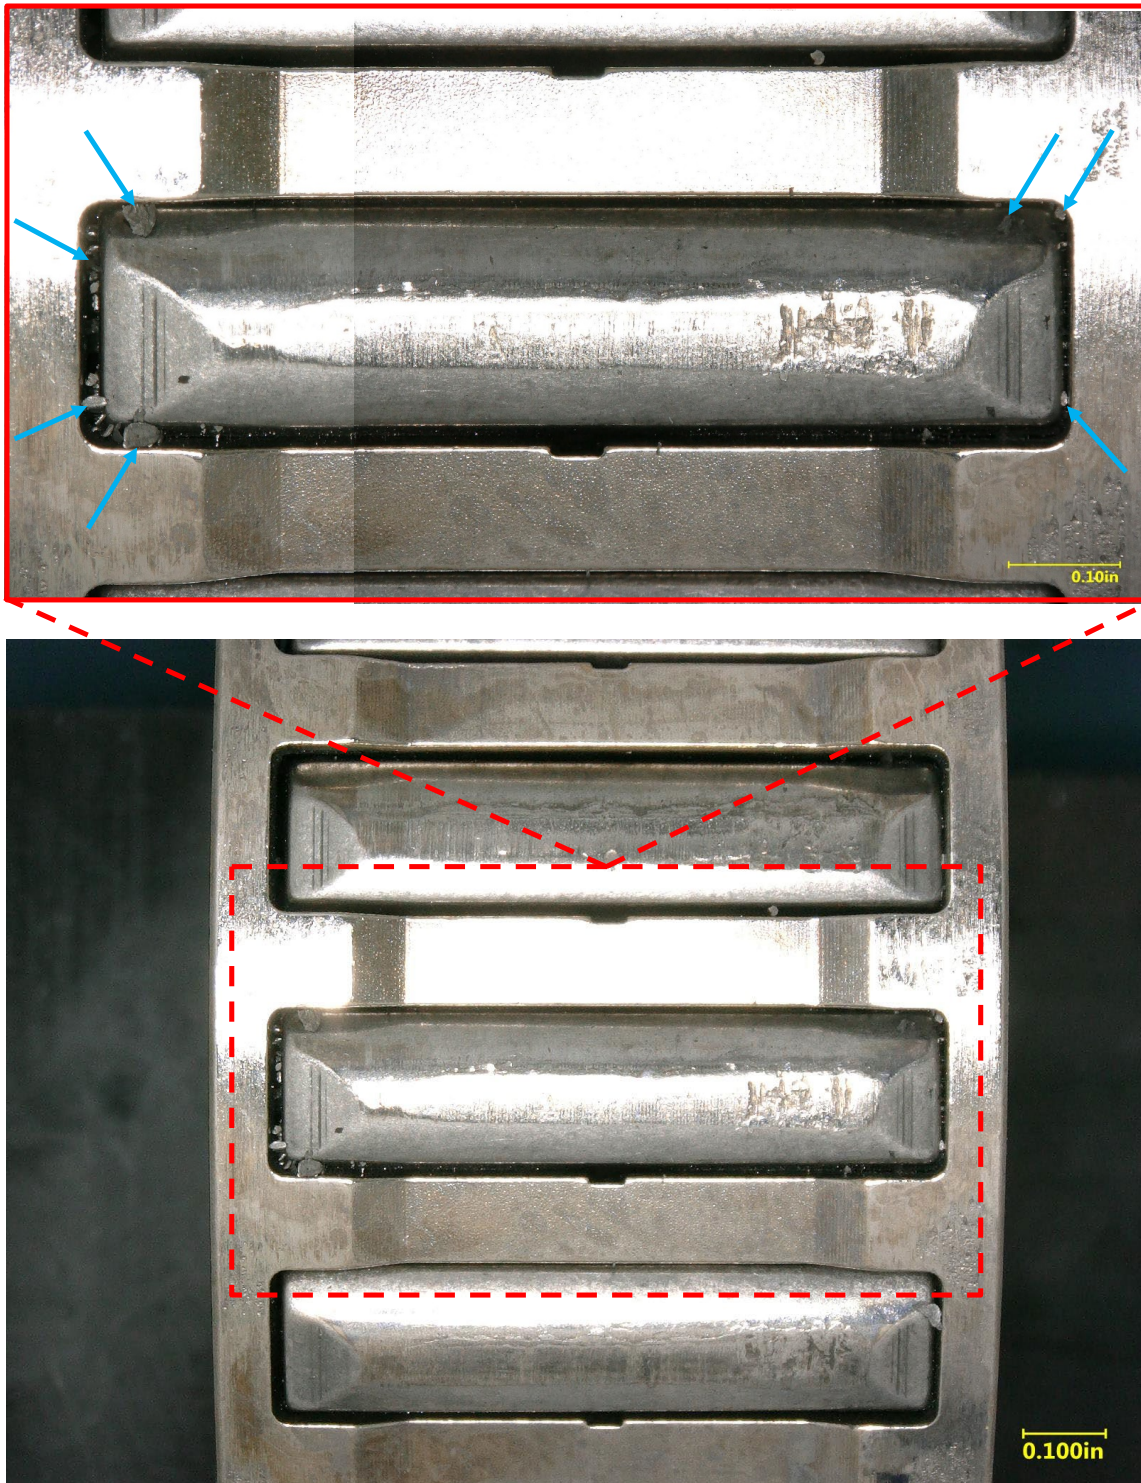
Figure 5: Digital microscope images of the outer surfaces of the sprags. Blue arrows point to metallic particles in the gaps between the cage and the sprags.

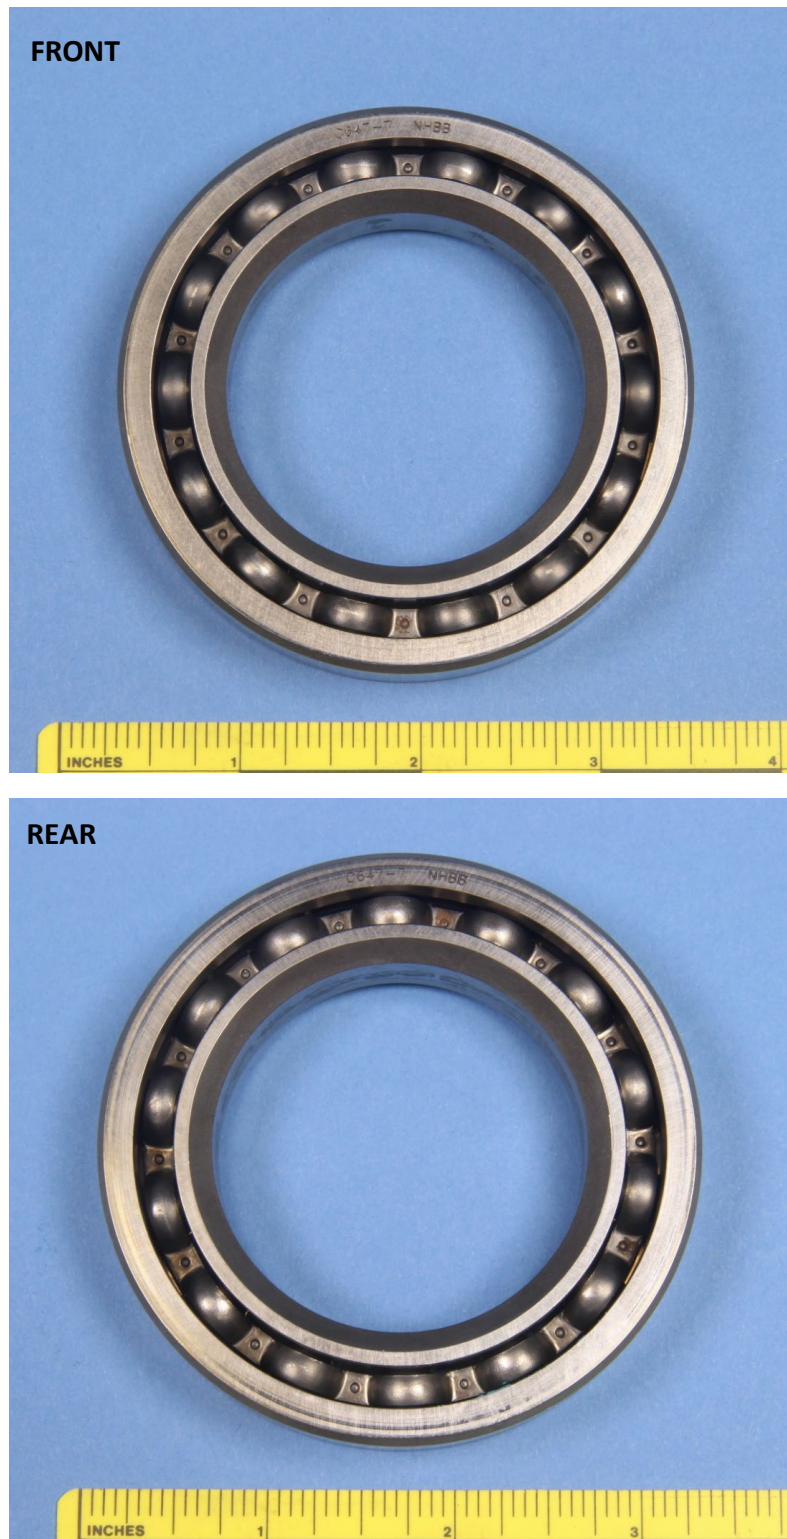
The front and rear support bearings are shown in Figure 6. The bearings were examined with a 5x to 50x digital microscope prior to disassembly. Small areas of damage were visible on the races of the bearing rings. A few metallic particles were observed inside both bearings, as indicated by the blue arrows in Figure 7.

Figure 6: Overall photos showing the front (top) and rear (bottom) support bearings.

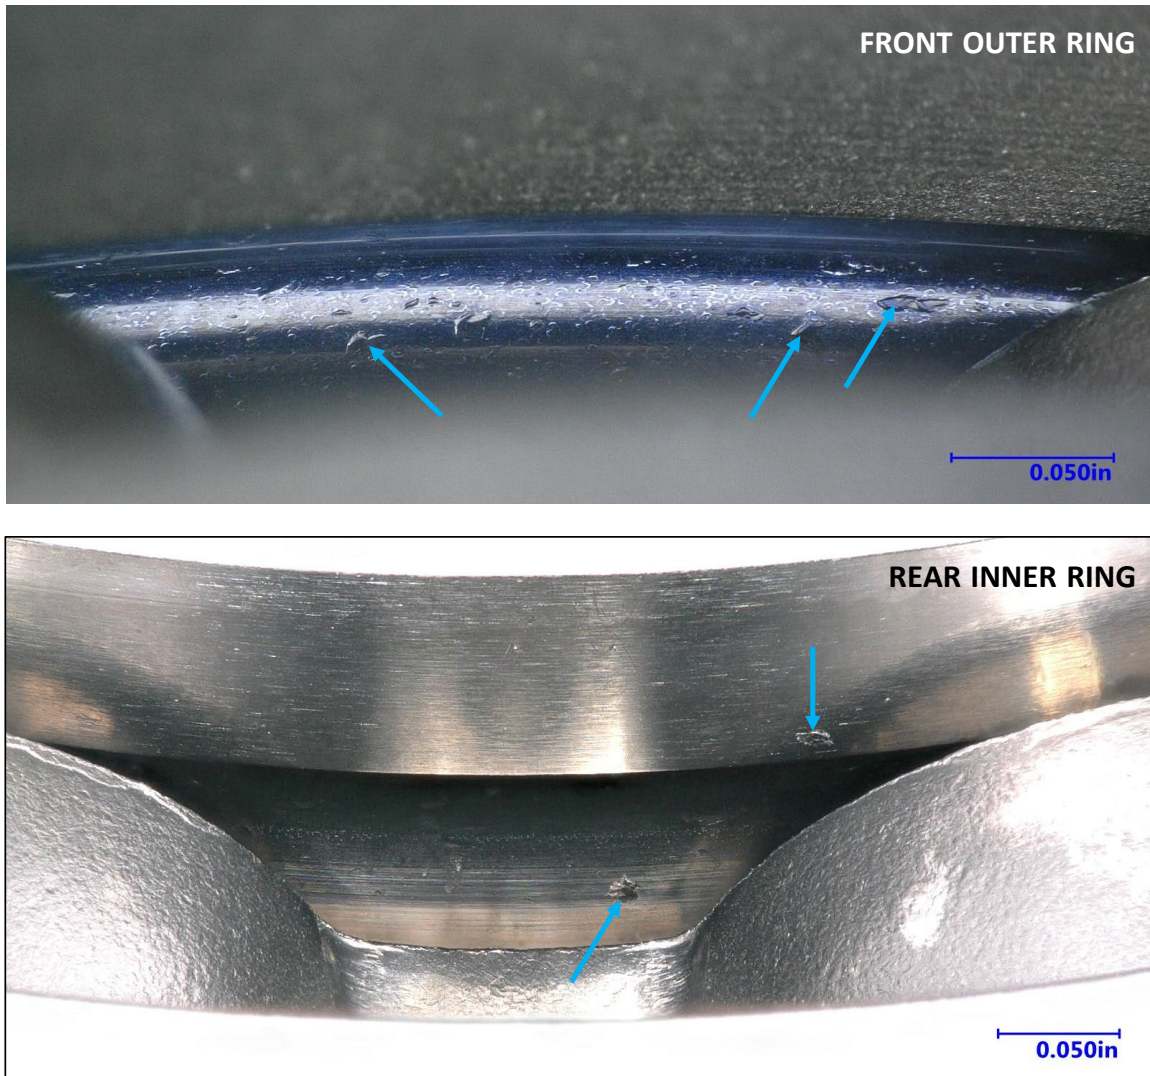
Figure 7: Digital microscope images of the inside of the front (top) and rear (bottom) support bearings. Blue arrows point to metallic particles inside the bearings.

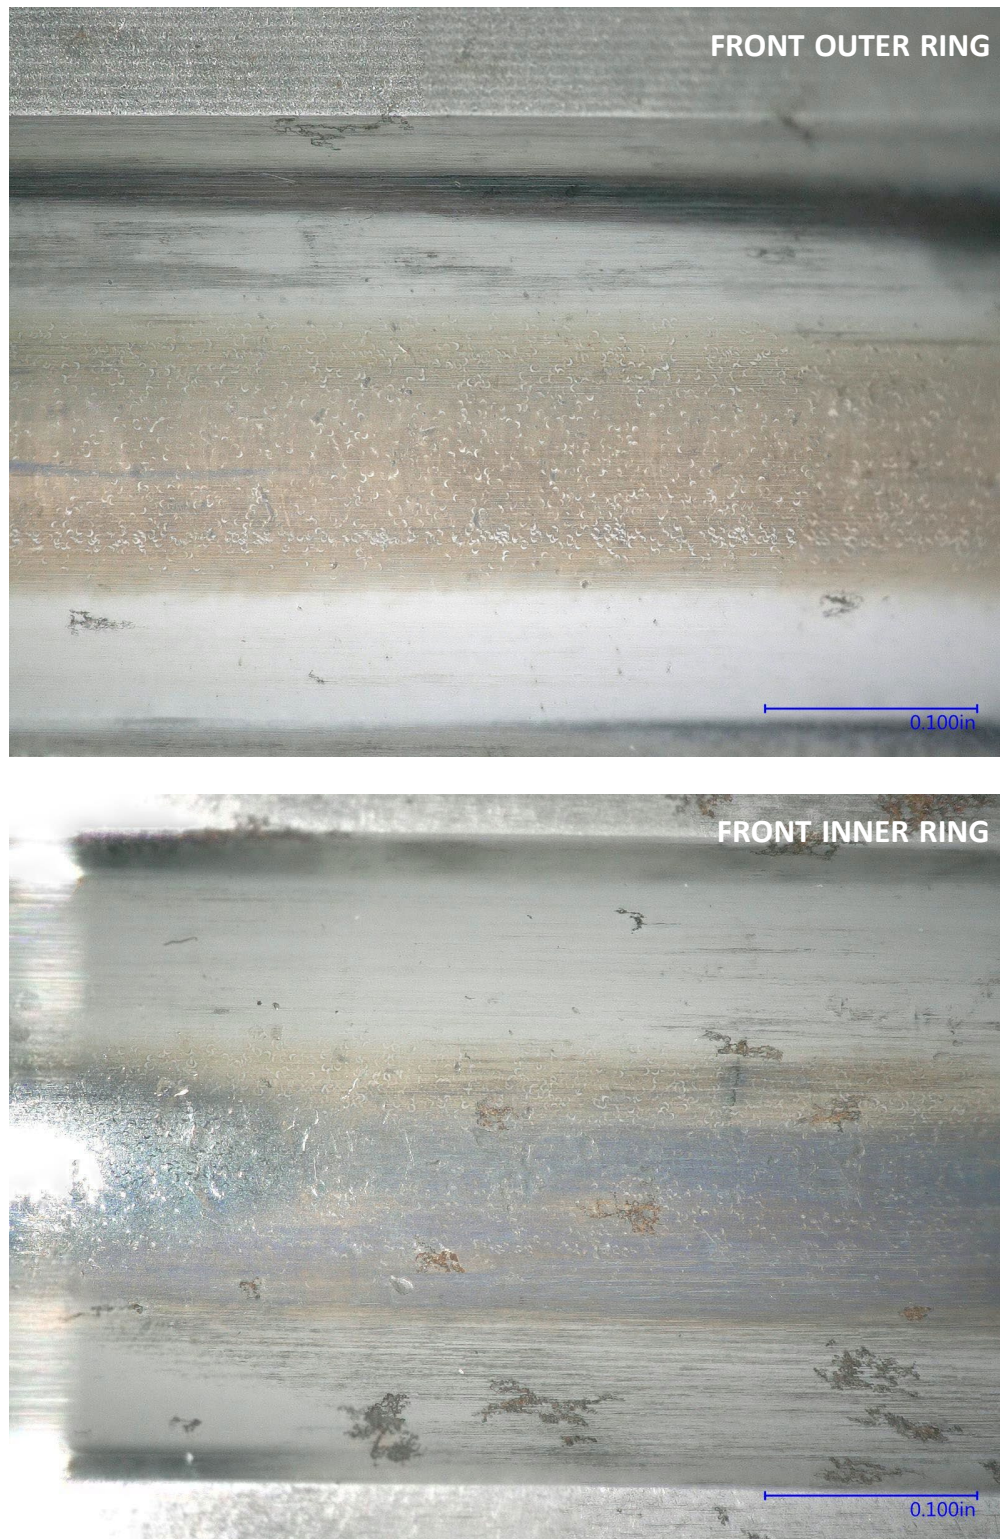
The front and rear support bearings were cross-sectioned, disassembled, cleaned, and re-examined. The races of inner and outer rings from both bearings had several areas of damage, as shown in Figures 8 and 9. The mating balls had some light scratches.

Figure 8: Digital microscope images of the races on the outer (top) and inner (bottom) rings of the front support bearing.

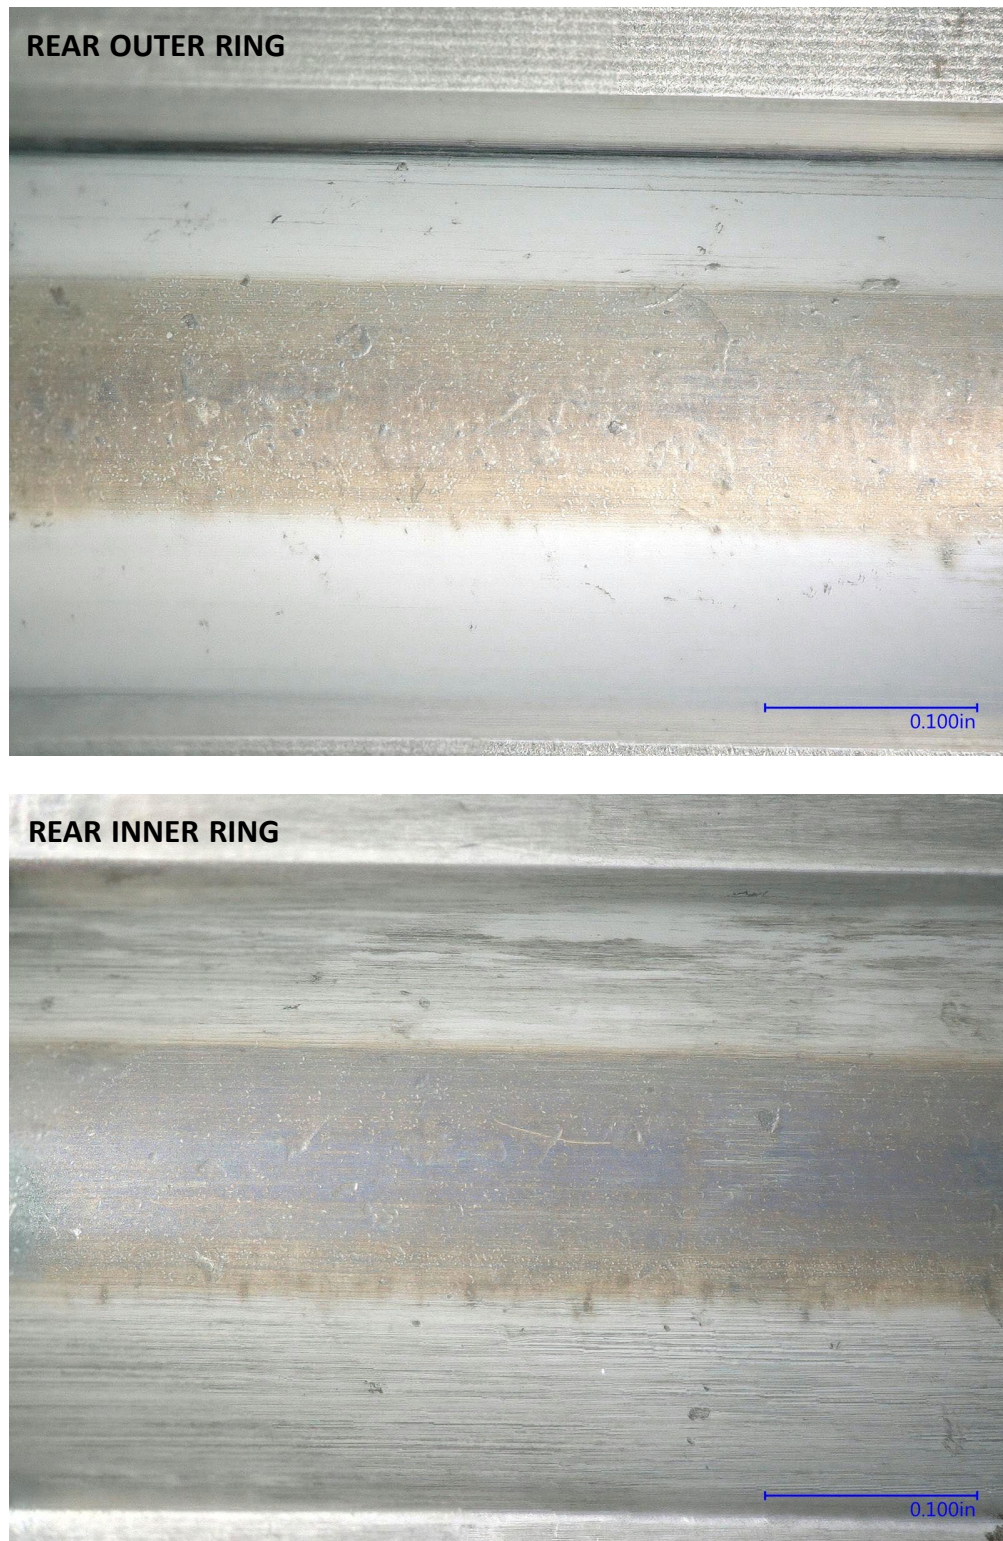
Figure 9: Digital microscope images of the races on the outer (top) and inner (bottom) rings of the rear support bearing.

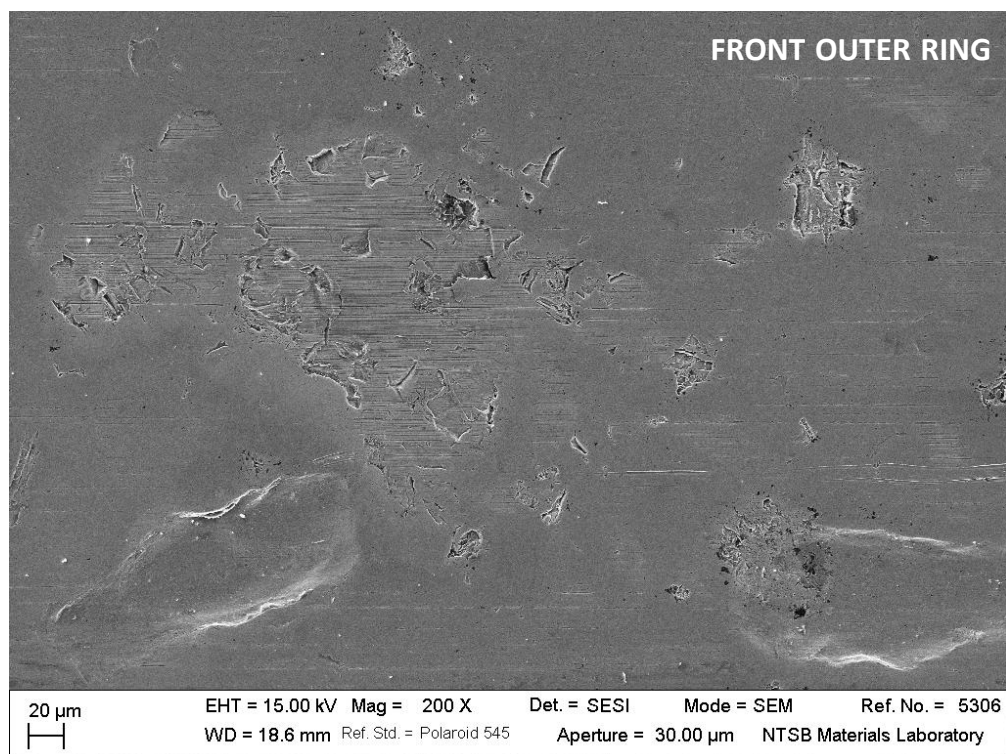
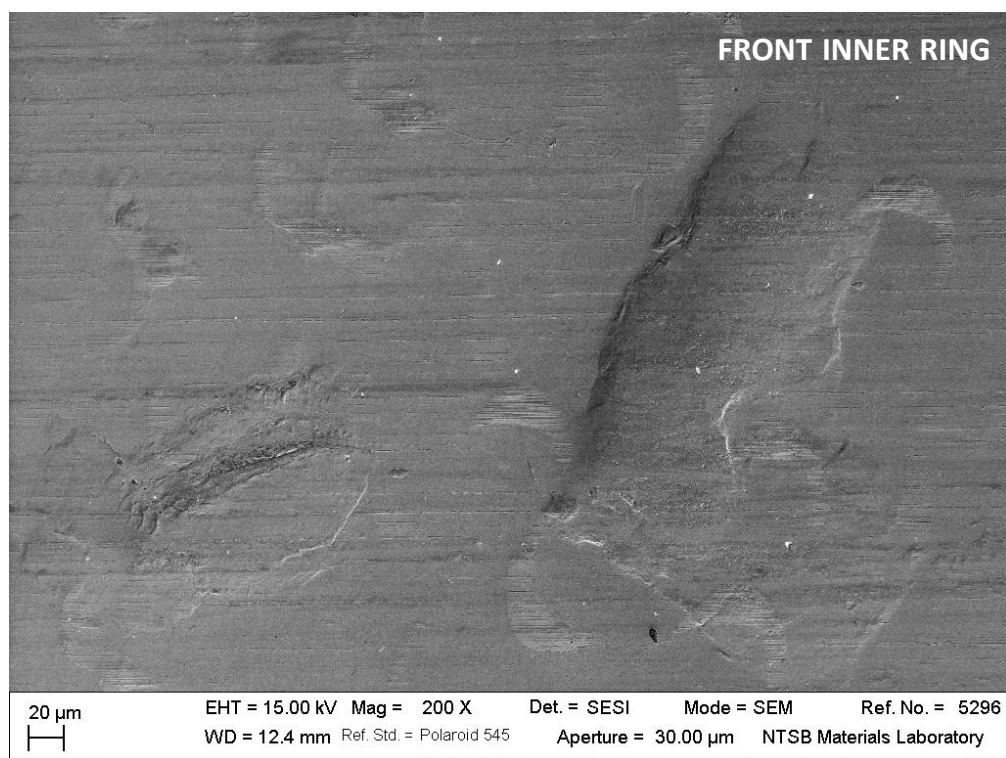
The damage on the support bearing races was examined using a using a Zeiss Auriga 40 field emission (FE) scanning electron microscope (SEM). Dents and some gouges were observed on the races of the bearing rings. The damage was consistent with particle ingestion. No evidence of rolling contact fatigue was observed on the front or rear support bearing ring races.

Figure 10: Secondary electron SEM images of the races on the outer (top) and inner (bottom) rings of the front support bearing.

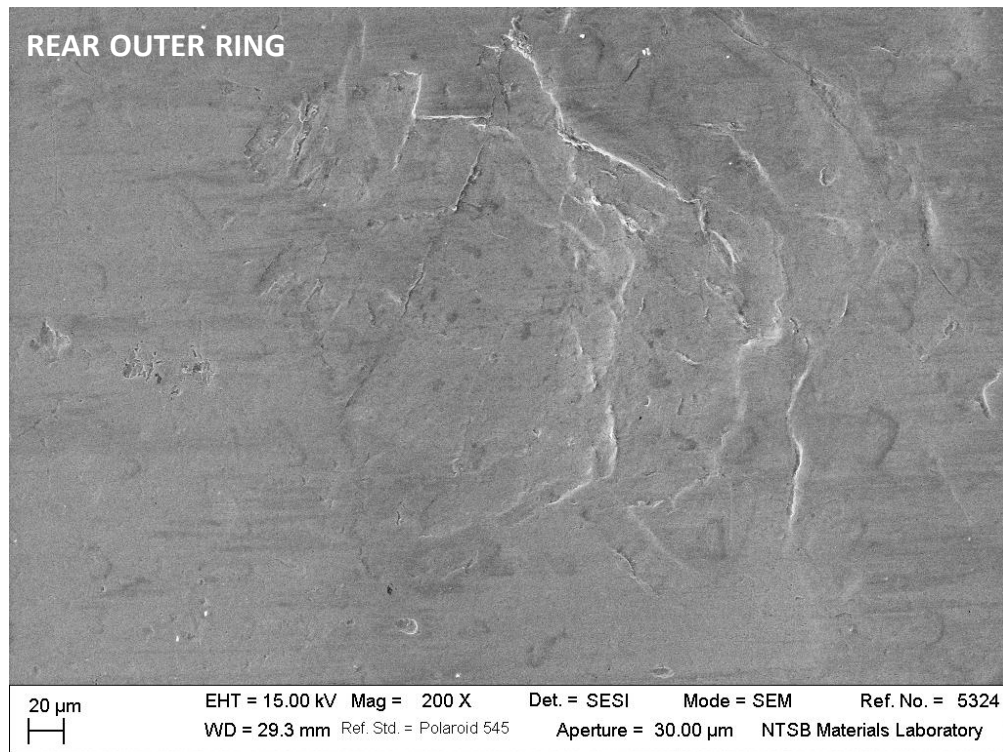
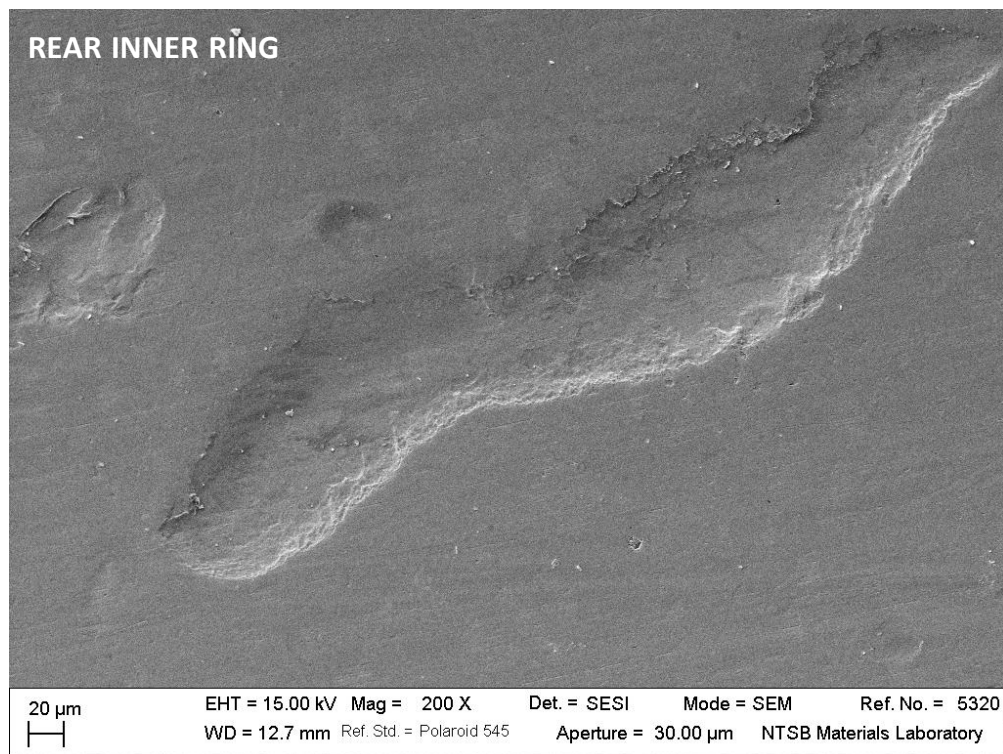
Figure 11: Secondary electron SEM images of the races on the outer (top) and inner (bottom) rings of the rear support bearing.
