## Investigative Photographs

ERA20LA054

**Peter Wentz**  
**Air Safety Investigator**  
**Eastern Region Aviation**

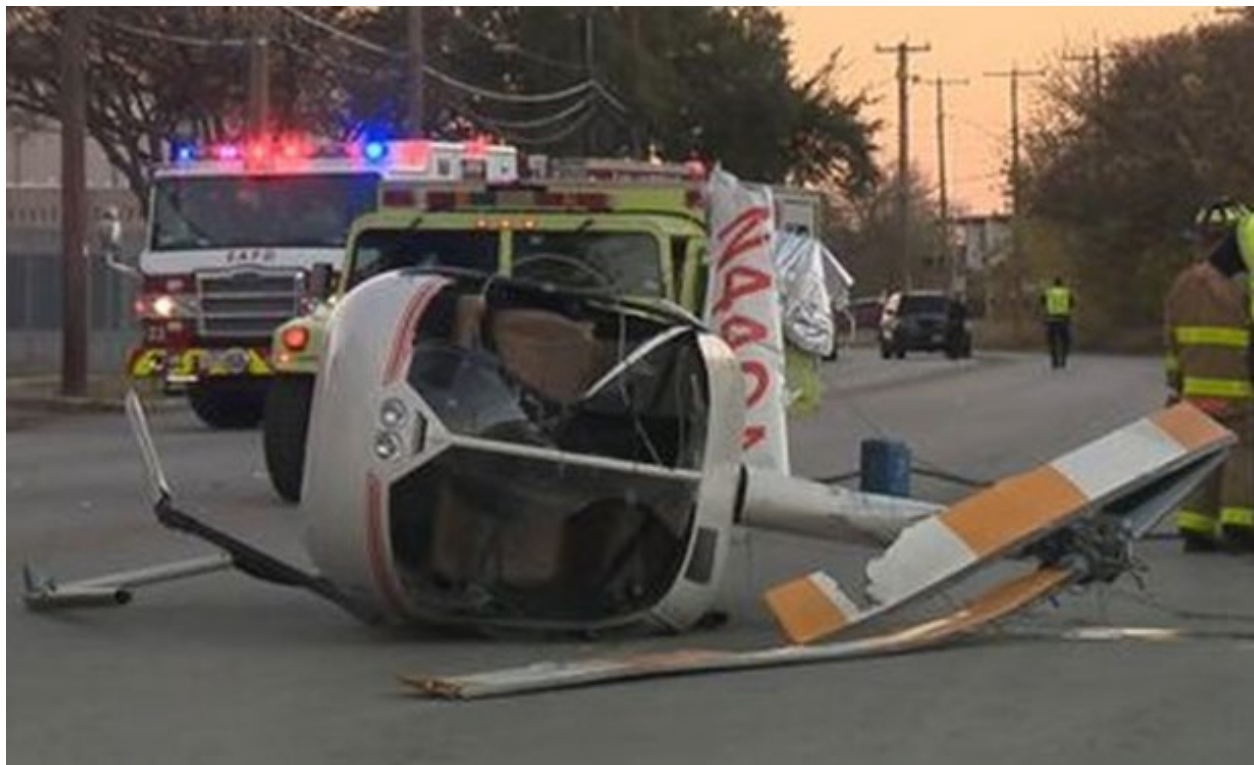
**Photograph 1 – Accident helicopter – front view.**

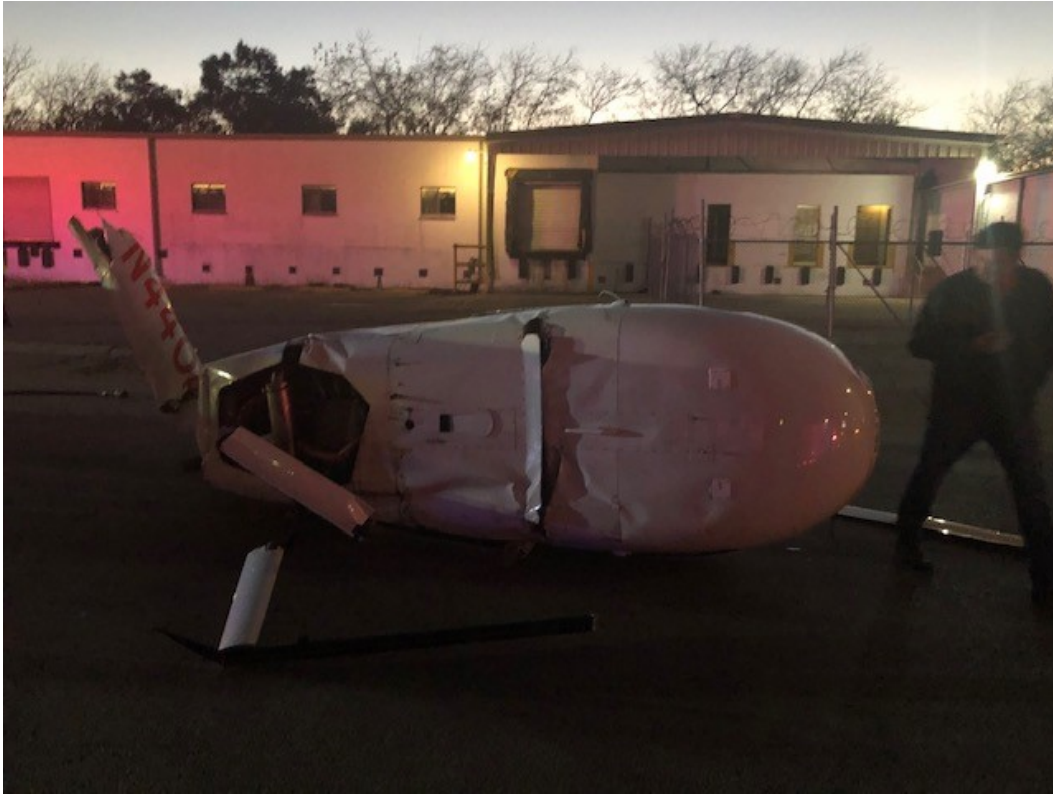
**Photograph 2 – Accident helicopter – underside view.**

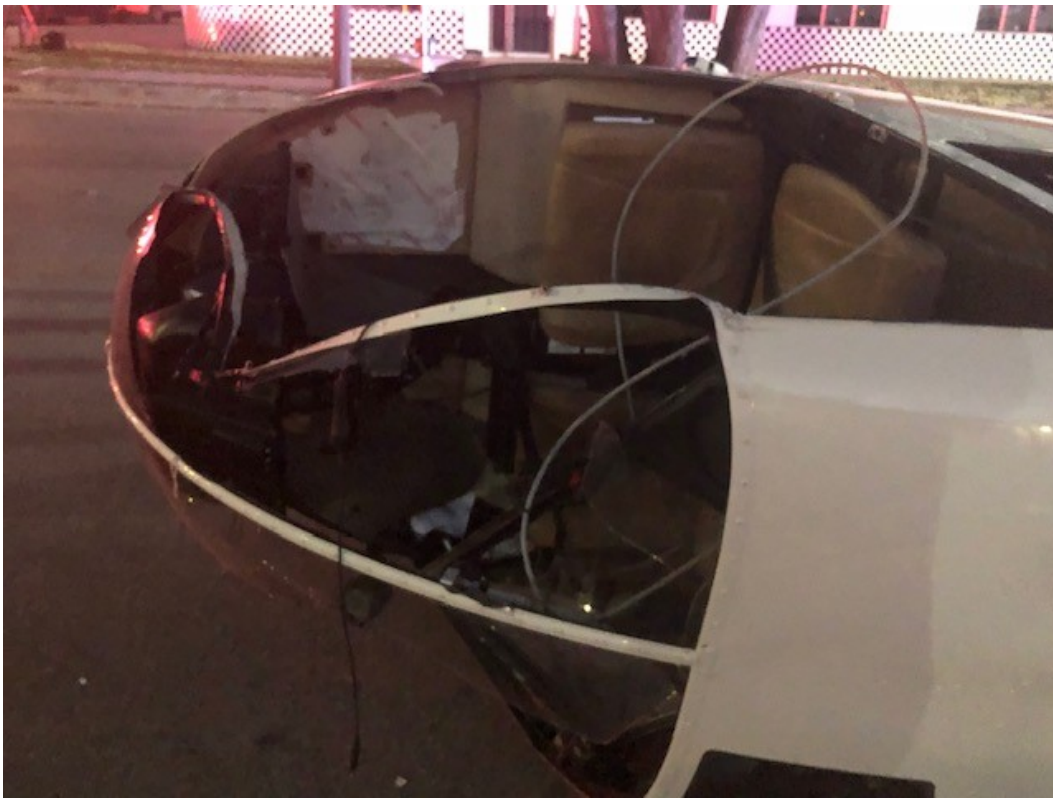
**Photograph 3 – Accident helicopter – photo of front seat.**

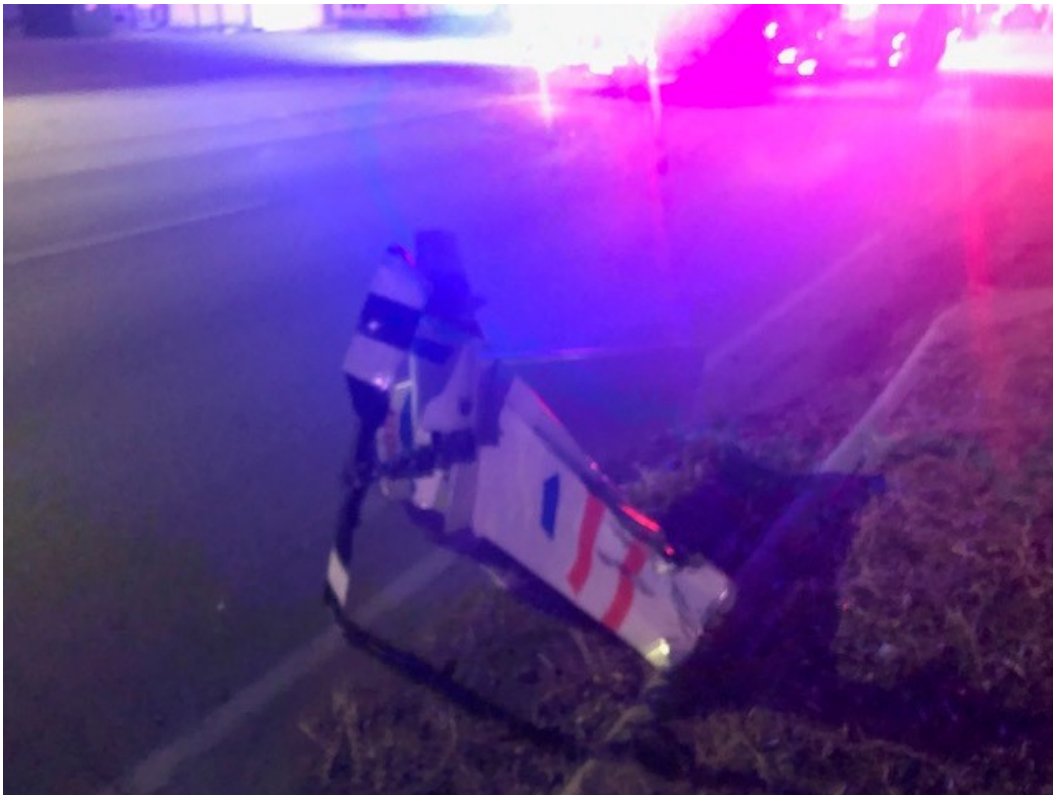
**Photograph 4 – Accident helicopter – tail rotor.**

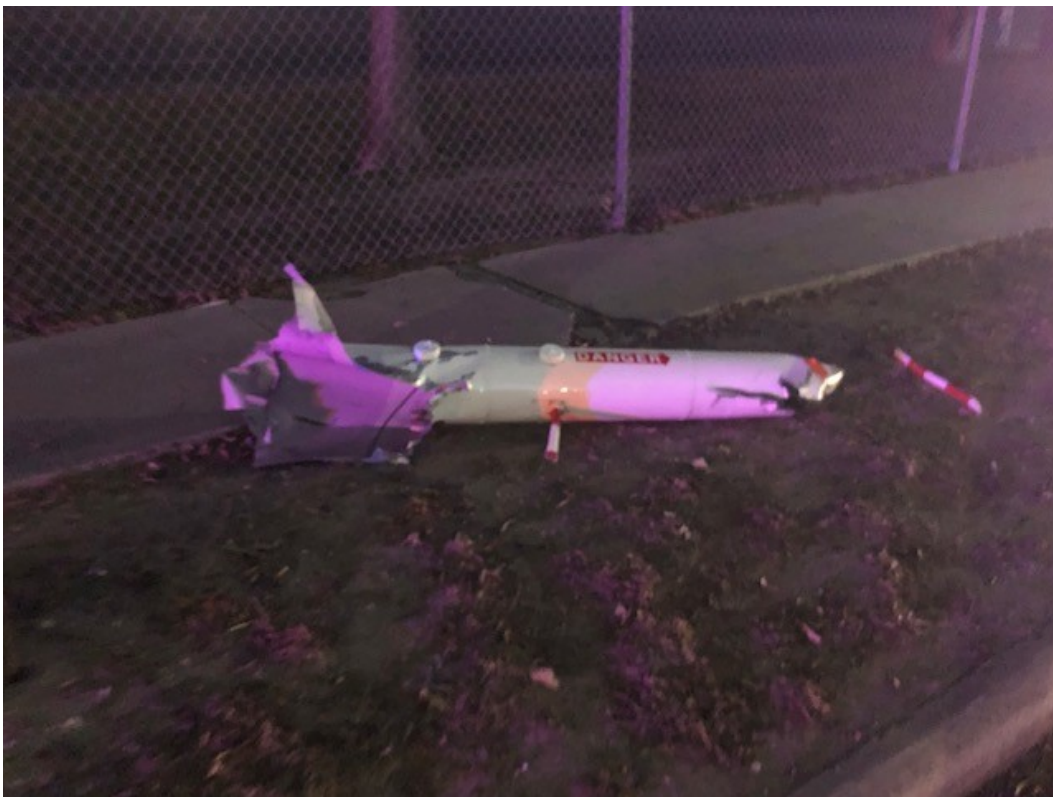
**Photograph 5 – Accident helicopter – tail boom.**

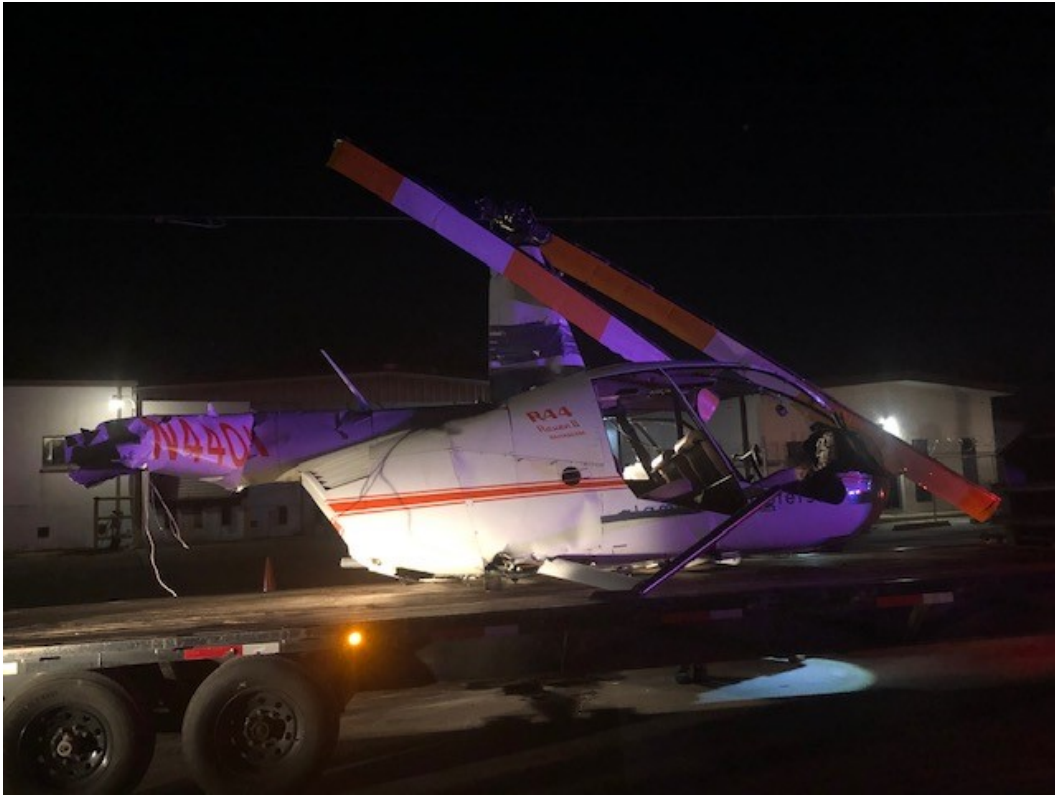
**Photograph 6 – Accident helicopter recovered to flatbed.**
