**R22 SERVICE BULLETIN SB-112**

**R44 SERVICE BULLETIN SB-94**

**SUBJECT:** Actuator Lower Bearing A185 Brackets

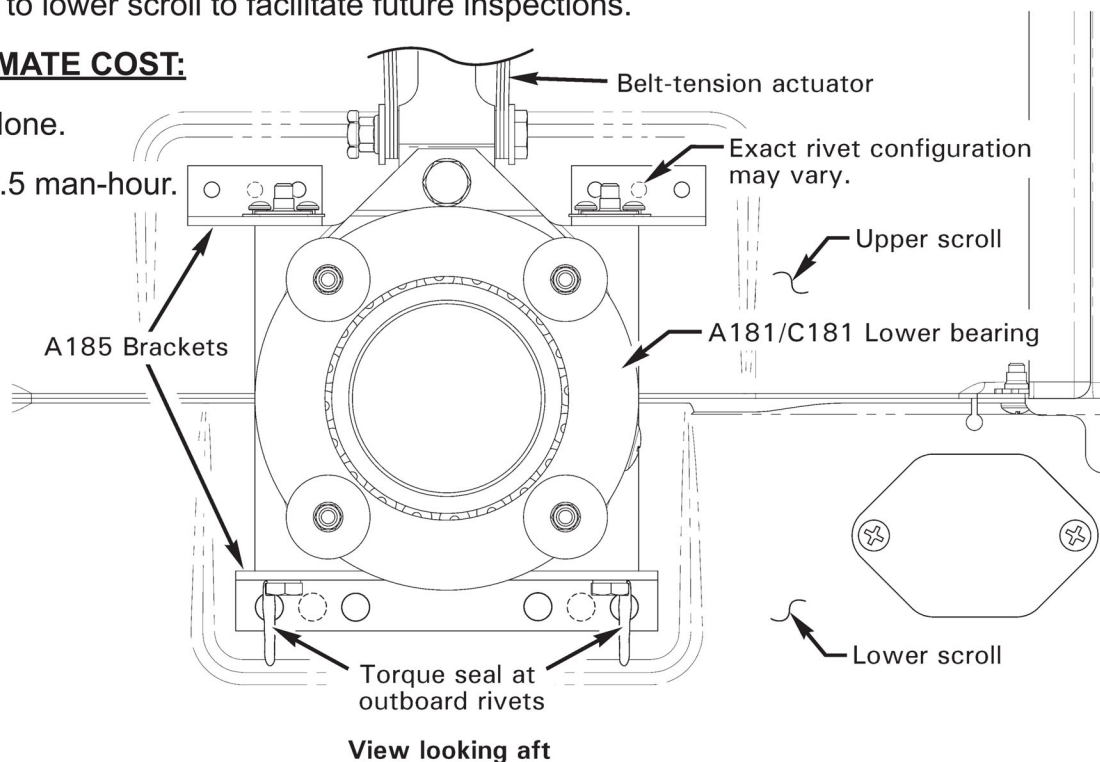
**BACKGROUND:** RHC has received reports of loose A185 brackets. Loose brackets may have allowed lower bearings to misalign resulting in belt-tension actuator damage.

1. Visually inspect A185 brackets and attaching rivets for evidence of fretting or looseness. If evidence of looseness is found, contact RHC Technical Support for repair instructions.
2. On lower A185 bracket, apply torque seal in a vertical stripe across both outboard rivets to lower scroll to facilitate future inspections.
