# NATIONAL TRANSPORTATION SAFETY BOARD

## MATERIALS LABORATORY FACTUAL REPORT

Report No. 20-047

Place : Fletcher, North Carolina  
Date : December 28, 2019  
Vehicle : Piper PA-32RT-300, N27GB  
NTSB No. : ERA20LA062  
Investigator : Todd Gunther, AS-ERA

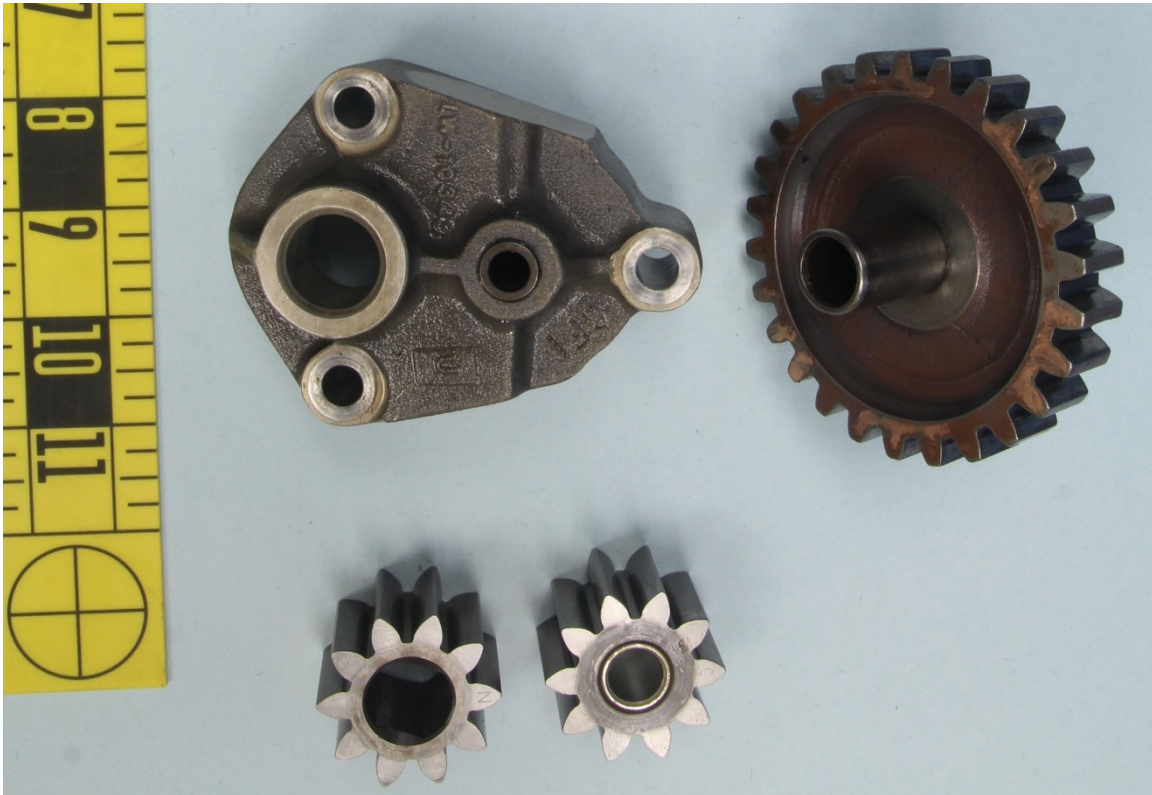
Figure 1 and Figure 2 show the oil pump components, as received. These include half of a pump case, two impeller gears, one larger gear with a shaft, and the drive gear, which was comprised of a shaft with a gear on one end. Two of the teeth of the drive gear had fractured and are pictured in Figure 2.

Figure 1 – The oil pump case half, impellers, and large gear, as received.

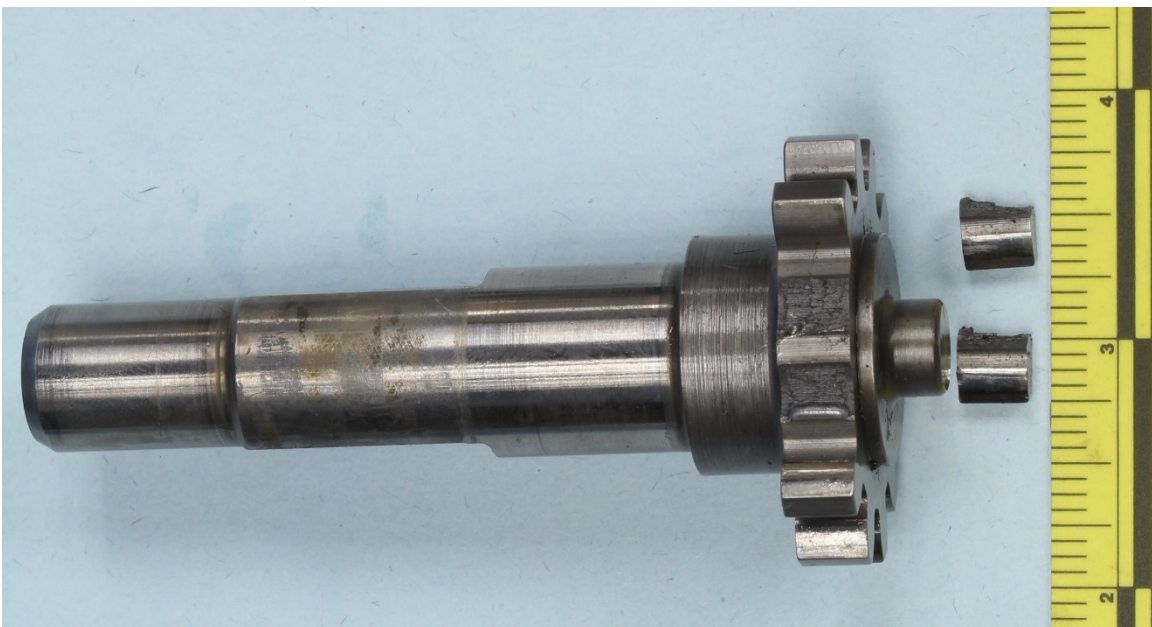
Figure 2 – The geared drive shaft with two fractured gear teeth, as received.

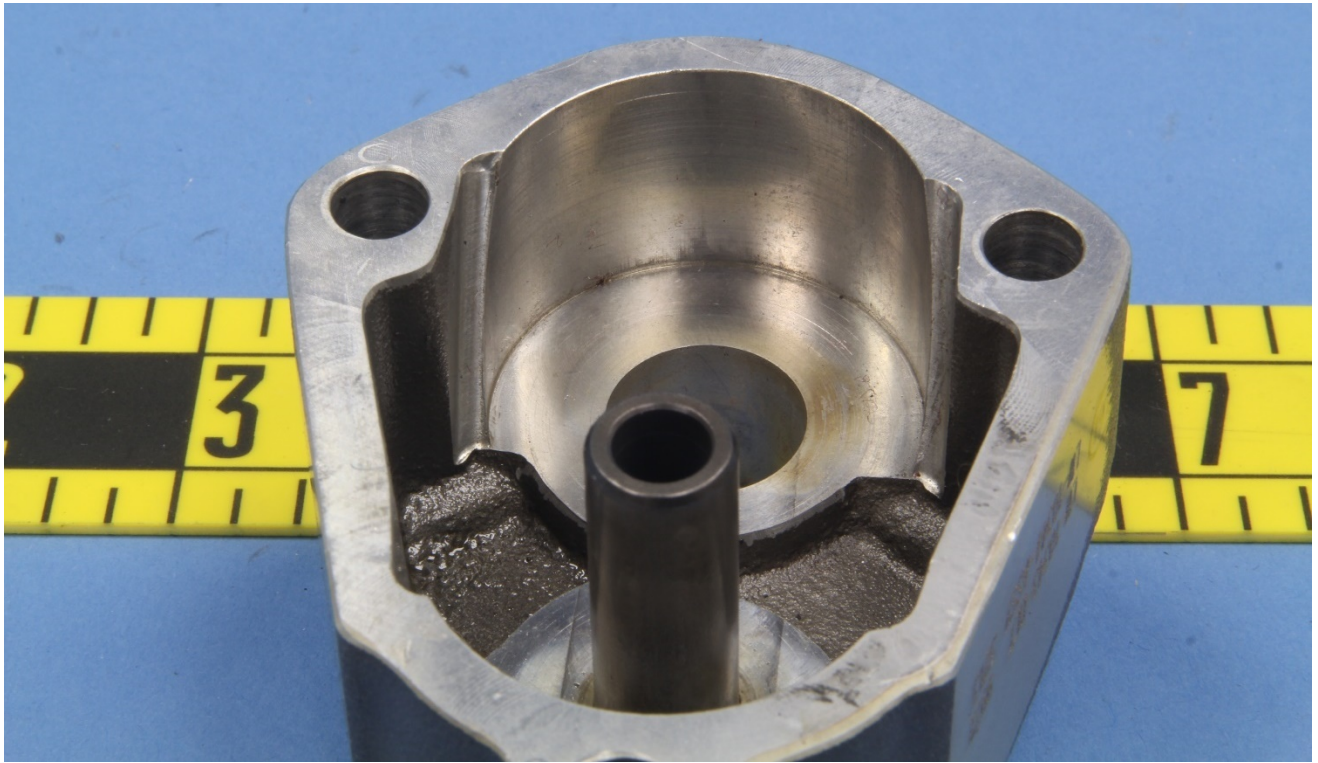
The inner surfaces of the pump case are shown in Figures 3 through 5. The surfaces were smoothed and generally reflective, consistent with having been machined. Many of these surfaces exhibited circumferential wear marks, consistent with rotational wear of the internal impeller gears. The position of these gears is shown inside the case in Figure 6. The wear marks present on the internal surfaces of the case half were consistent with typical rotational wear under lubricated conditions—there were no indications of abrasive wear, spalling, galling, or gouges on the faying surfaces.

Figure 3 – View of the internal impeller surfaces of the case.

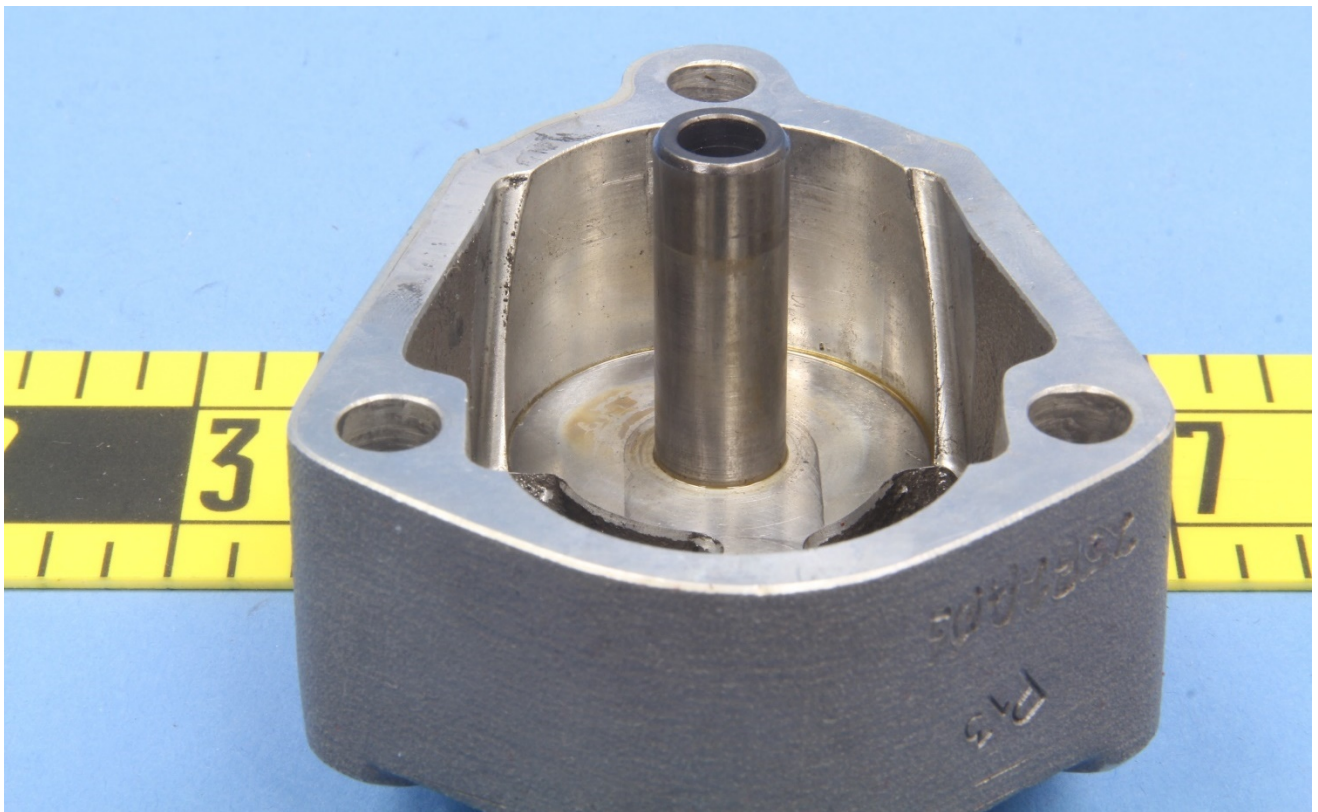
Figure 4 – View of the internal impeller surfaces of the case, opposite side from Figure 3.

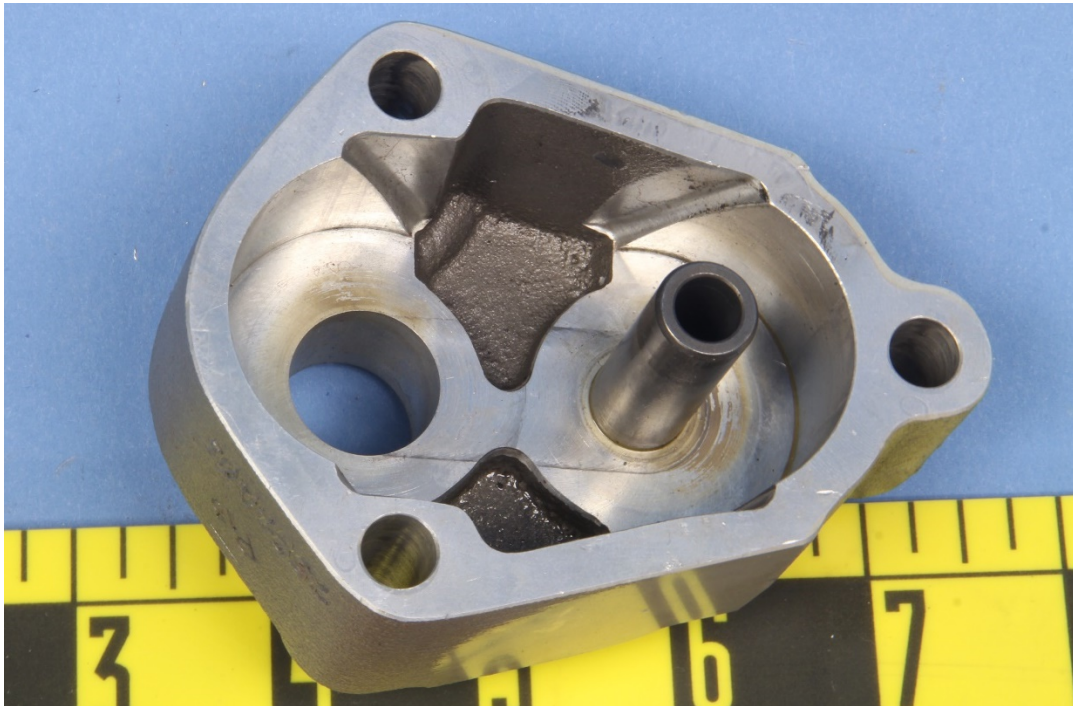
Figure 5 – View of the internal surfaces of the oil pump case.

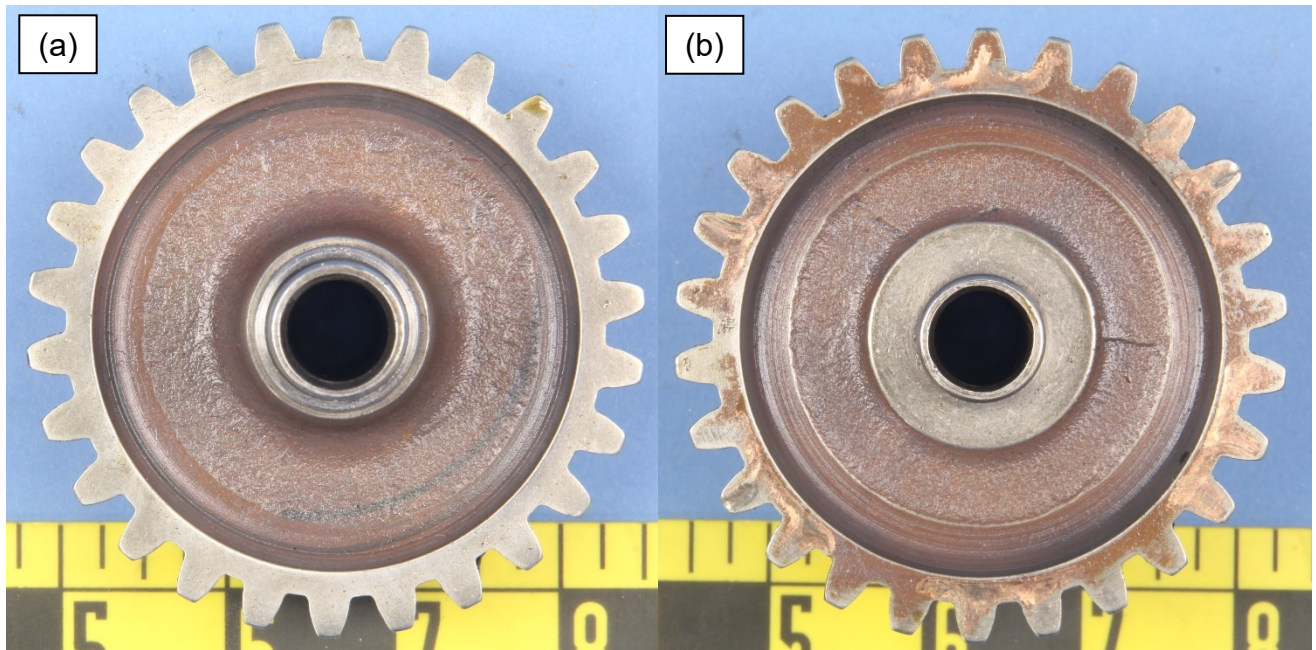
Figure 7 and Figure 8 show the larger gear from the oil pump, viewed from the opposite faces and the gear teeth. The gear exhibited a brownish-red color. However, as shown in Figure 8, this color had been mostly worn away on the gear teeth top lands—this color was consistent with a coating such as a paint on the gear surface. This gear also had a hollow cylindrical shaft attached to it through the center, as shown in Figure 8. The teeth of this gear were intact, and they did not exhibit any indications of plastic deformation.

Figure 7 – View of the faces of the large gear from (a) the necked shaft side and the (b) flat shaft side.

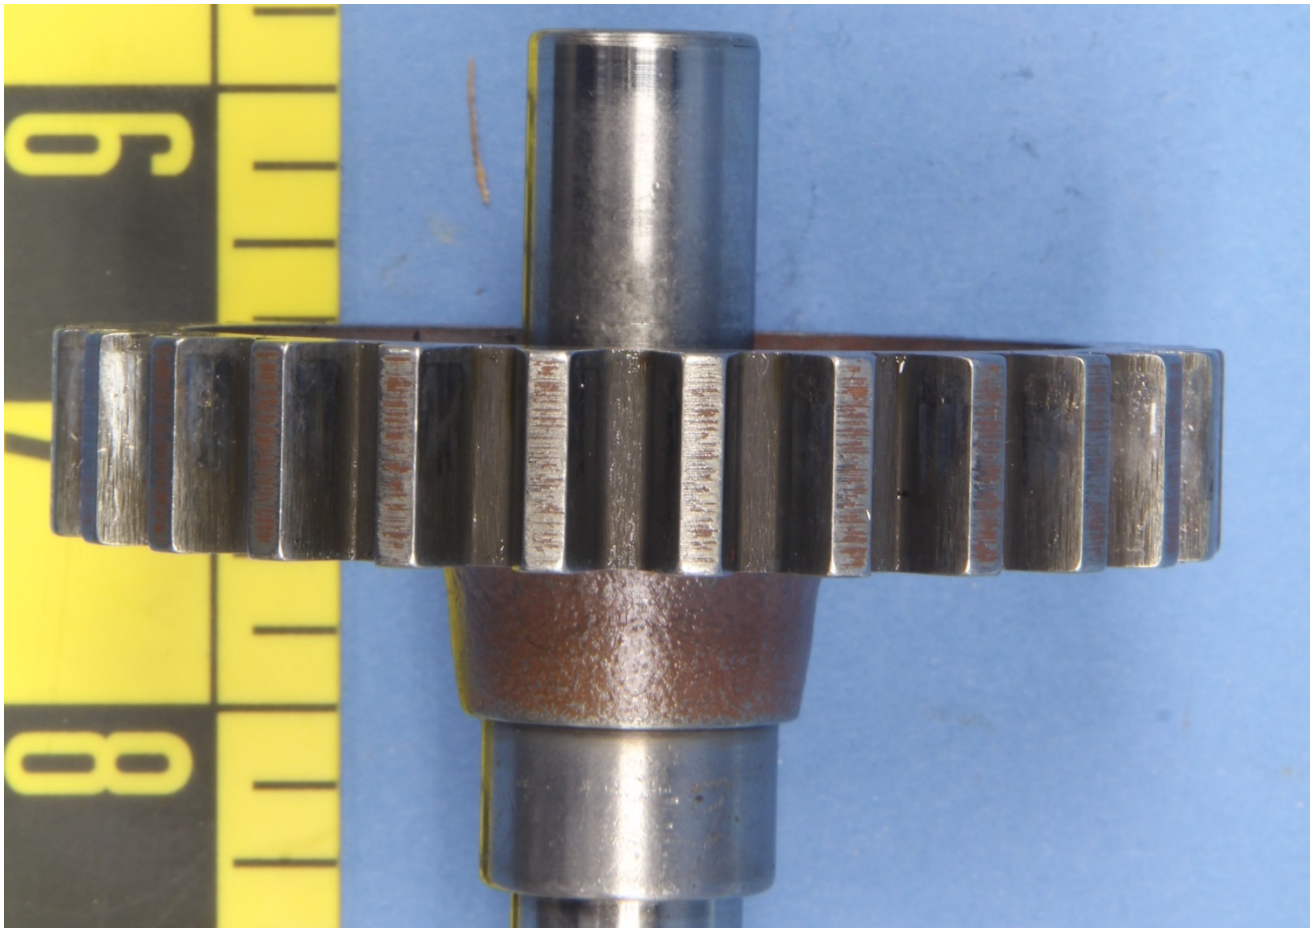
Figure 8 also shows the contact areas on the faces of many of the large gear teeth. While the teeth lands did exhibit a lack of paint consistent with rotational wear, there were still paint remnants present, which would be inconsistent with severe wear conditions. Likewise, the faces of the gear teeth exhibited some longitudinal wear marks and rectangular reflective regions, consistent with contact with mating gear teeth. None of this wear was severe enough to manifest as gouging, deformation, or material loss on the gear, and was consistent with typical contact between gear teeth.

Figure 8 – Typical view of the gear teeth and roots from the side of the large gear.

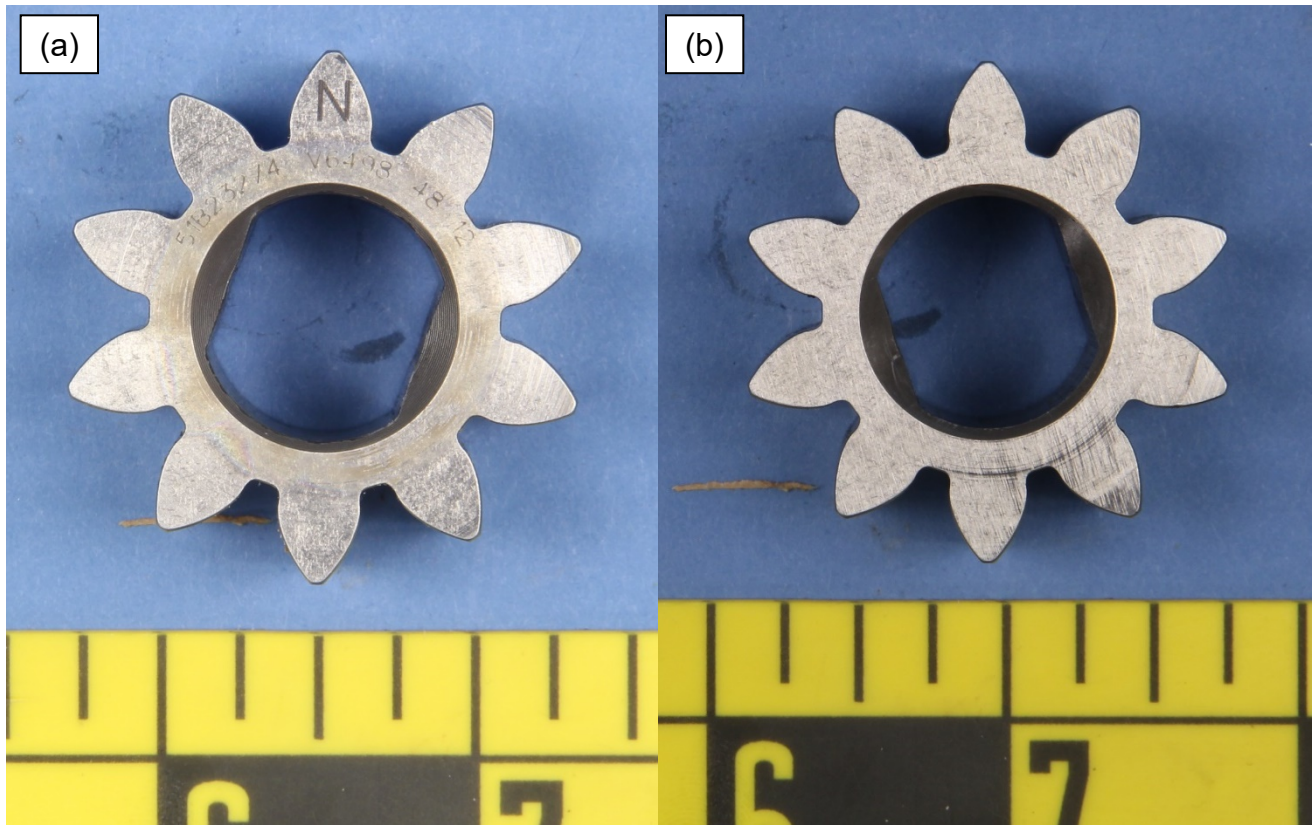
Figures 9 and 10 show one of the impeller gears. This gear exhibited a hollow slotted center, such that the flat portion of the shaft of the drive gear fit inside. One of the faces, shown in Figure 9a, exhibited markings. One marking was a stamp on the gear stating "N", and the other was a stamp located around the gear face stating, "51B232/4 V6498 48/12".

Figure 9 – The (a) marked and (b) unmarked faces of the slotted impeller gear.

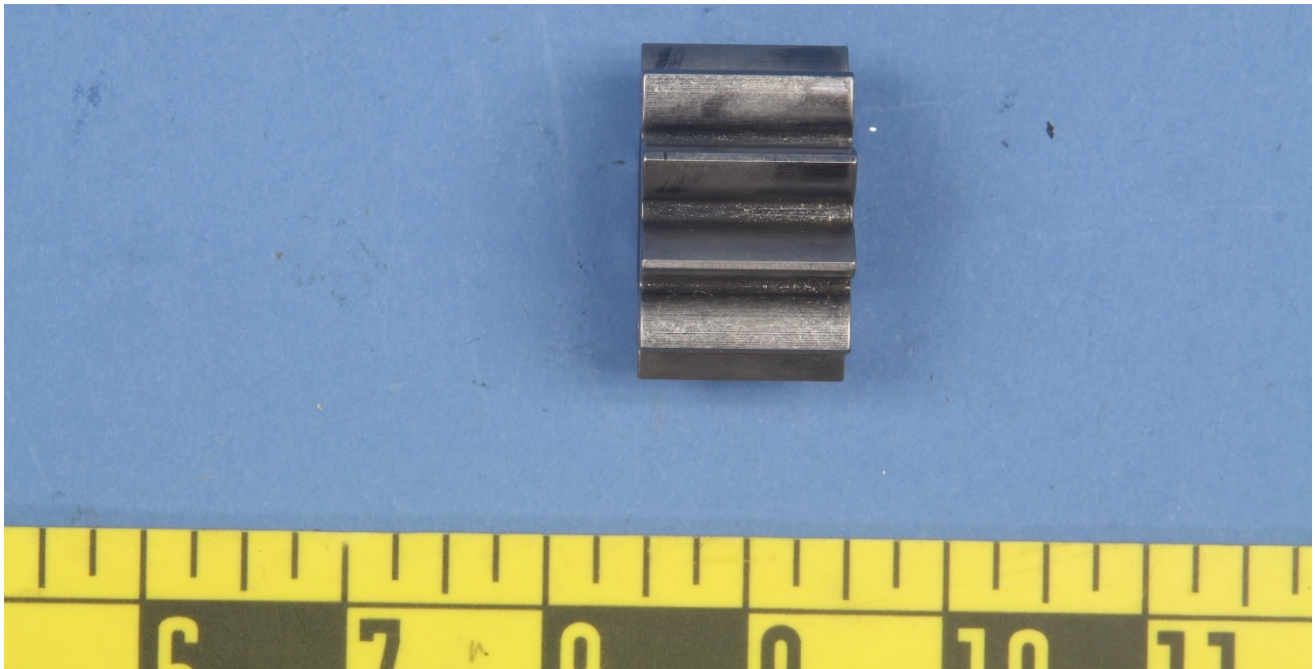
Figures 10 and 11 show several of the slotted impeller gear teeth from an oblique and angled view, respectively. While the contact faces of the teeth did exhibit imprints, these were consistent with typical contact marks with the mating teeth of the other gear. There were no indications of severe wear, missing material, or plastic deformation. The edges and rounded surfaces of the internal slot did exhibit longitudinal wear marks and

Figure 10 – View of the impeller gear teeth, from the side.

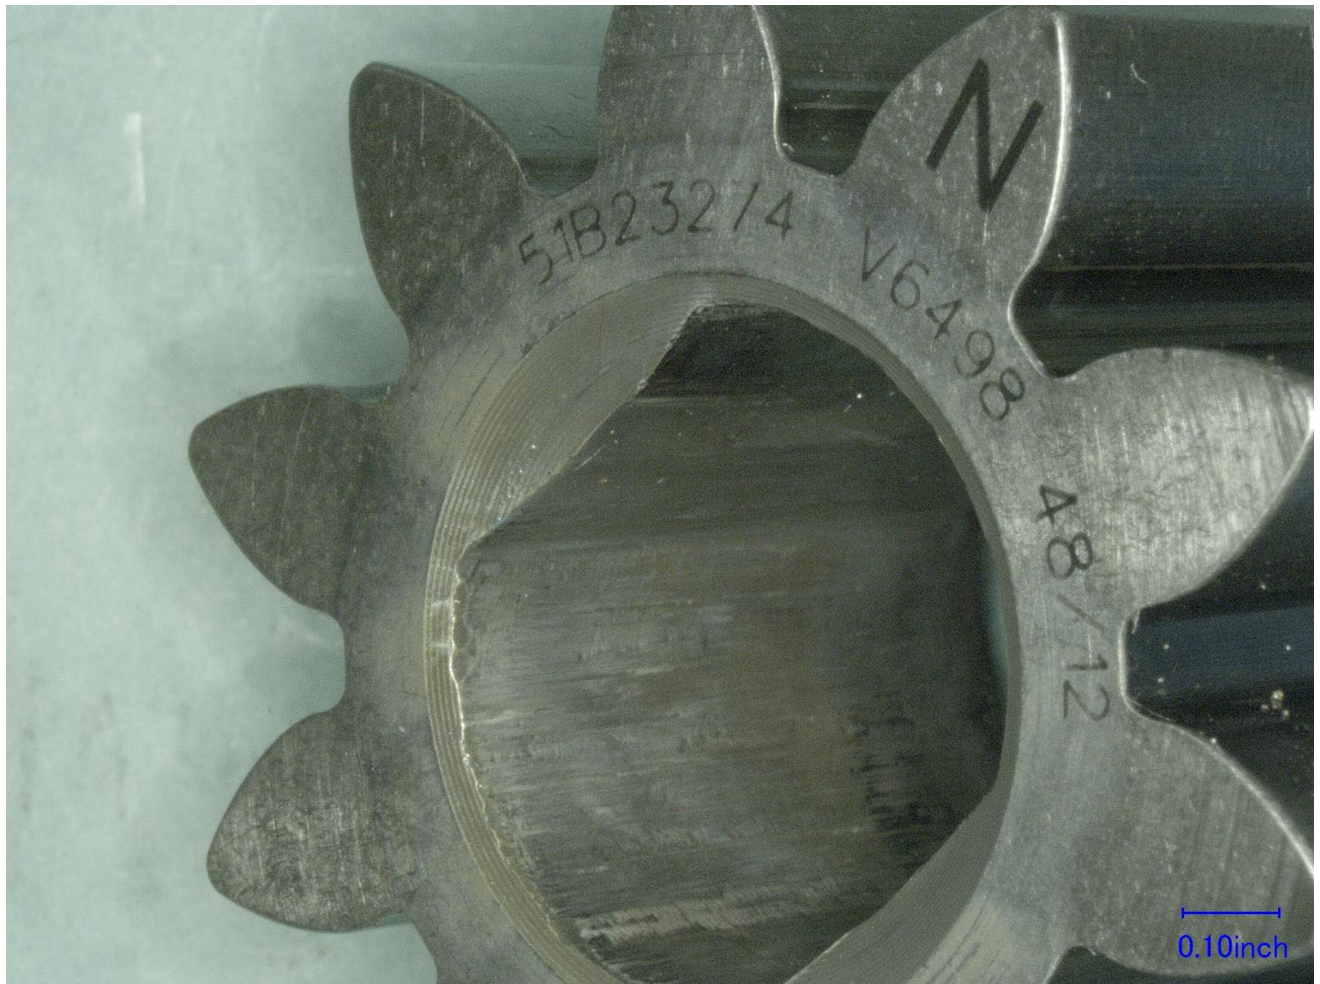
Figure 11 – Angled view of the marked face, teeth, and internal cavity of the slotted impeller gear.

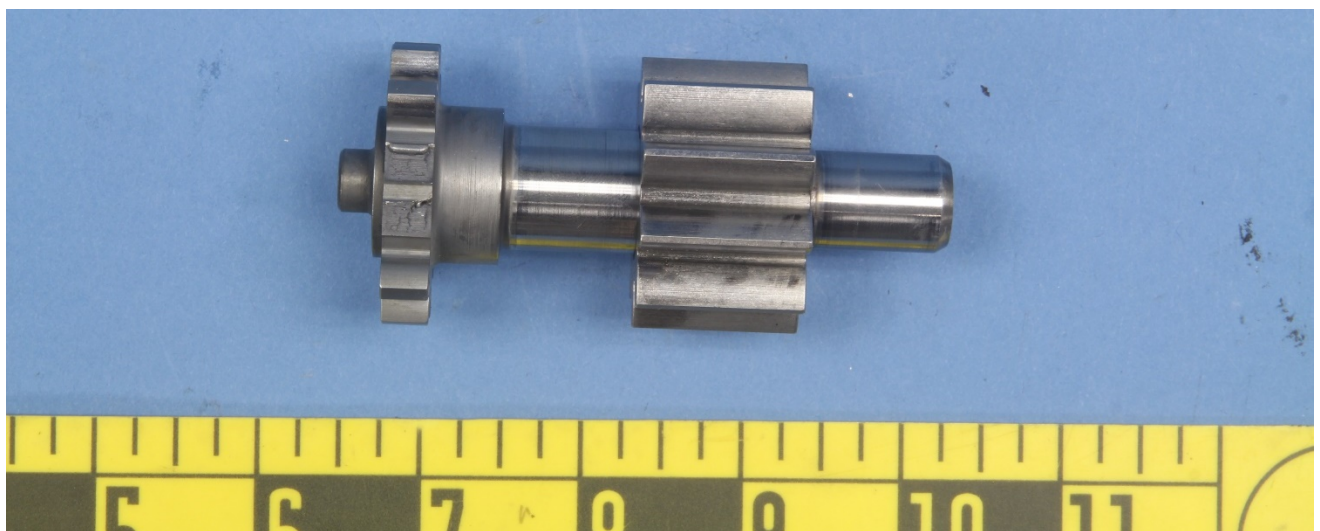
some deformation on the edge. These were consistent with the sliding against the flat shaft surfaces of the drive gear (as illustrated in Figure 12). However, in the position displayed in Figure 12, there was no indication of a loose fit or rotational slippage, indicating the wear to be typical of service conditions.

Figure 12 – Repositioning of the slotted impeller gear on the gear drive shaft.

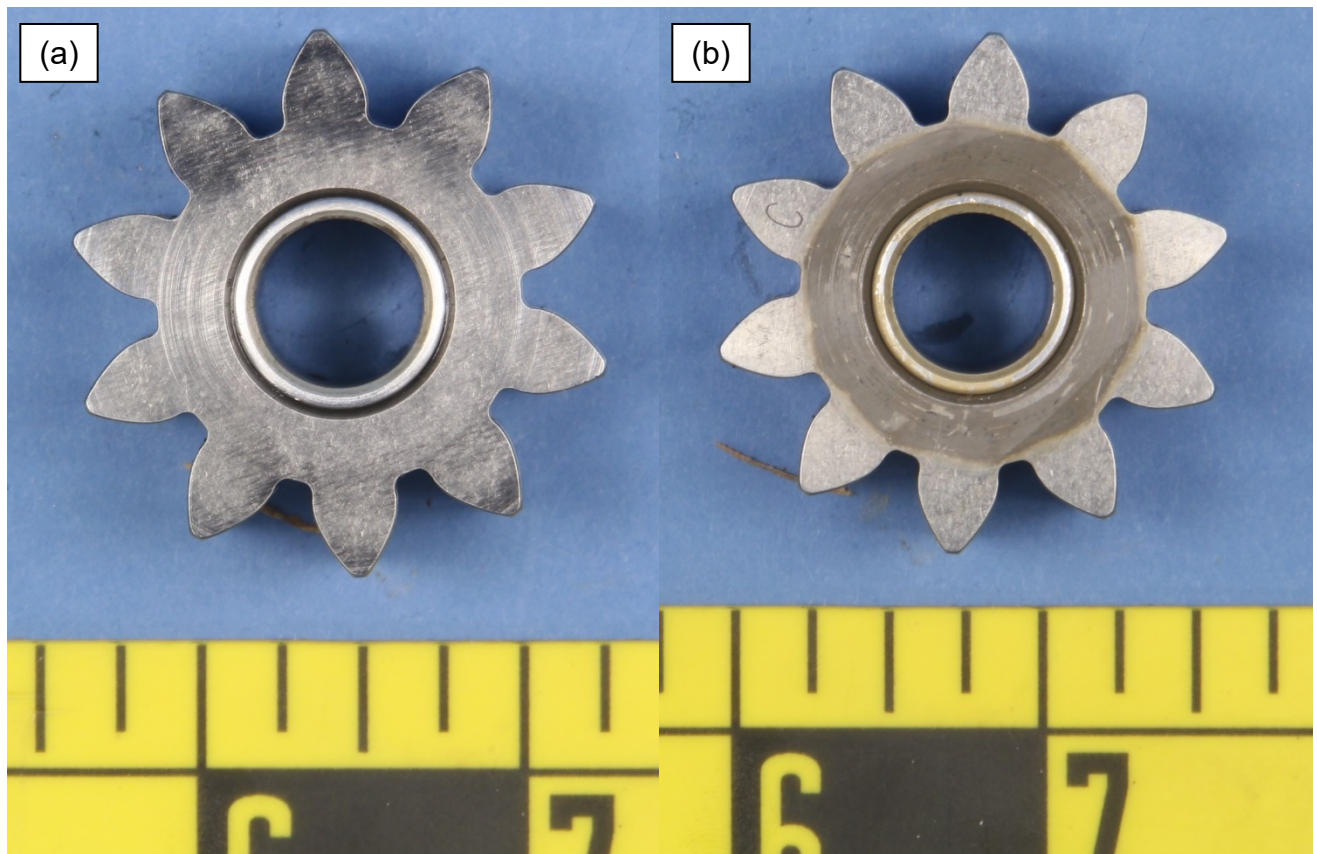
Figure 13 and Figure 14 show the other impeller gear, which exhibited a circular hollow bore that was not slotted. This component exhibited few indications of damage, except for the face shown in Figure 13b. This face had been marked with “C” on one of the teeth. The face of the impeller on this side exhibited circumferential wear marks in a ring pattern significant enough to darken part of the face, consistent with material loss and wear. There were no indications of wear or material loss on the teeth of the gear.

Figure 13 – The (a) unmarked and (b) marked faces of the circular impeller gear.

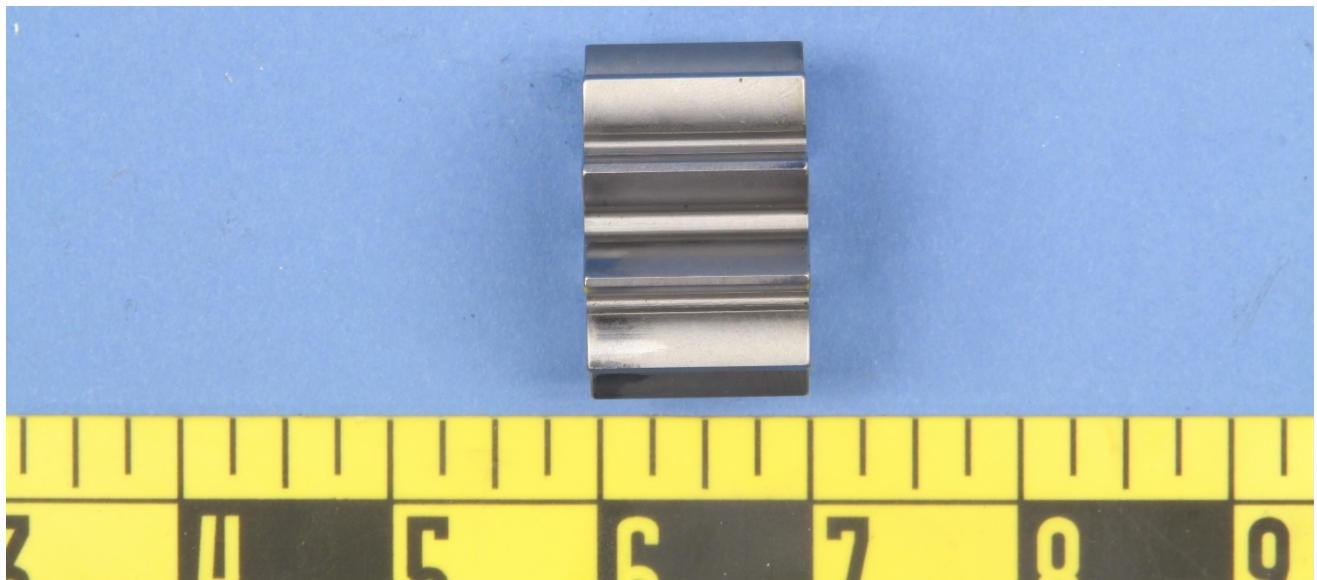
Figure 14 – View of the circular impeller gear teeth, from the side.

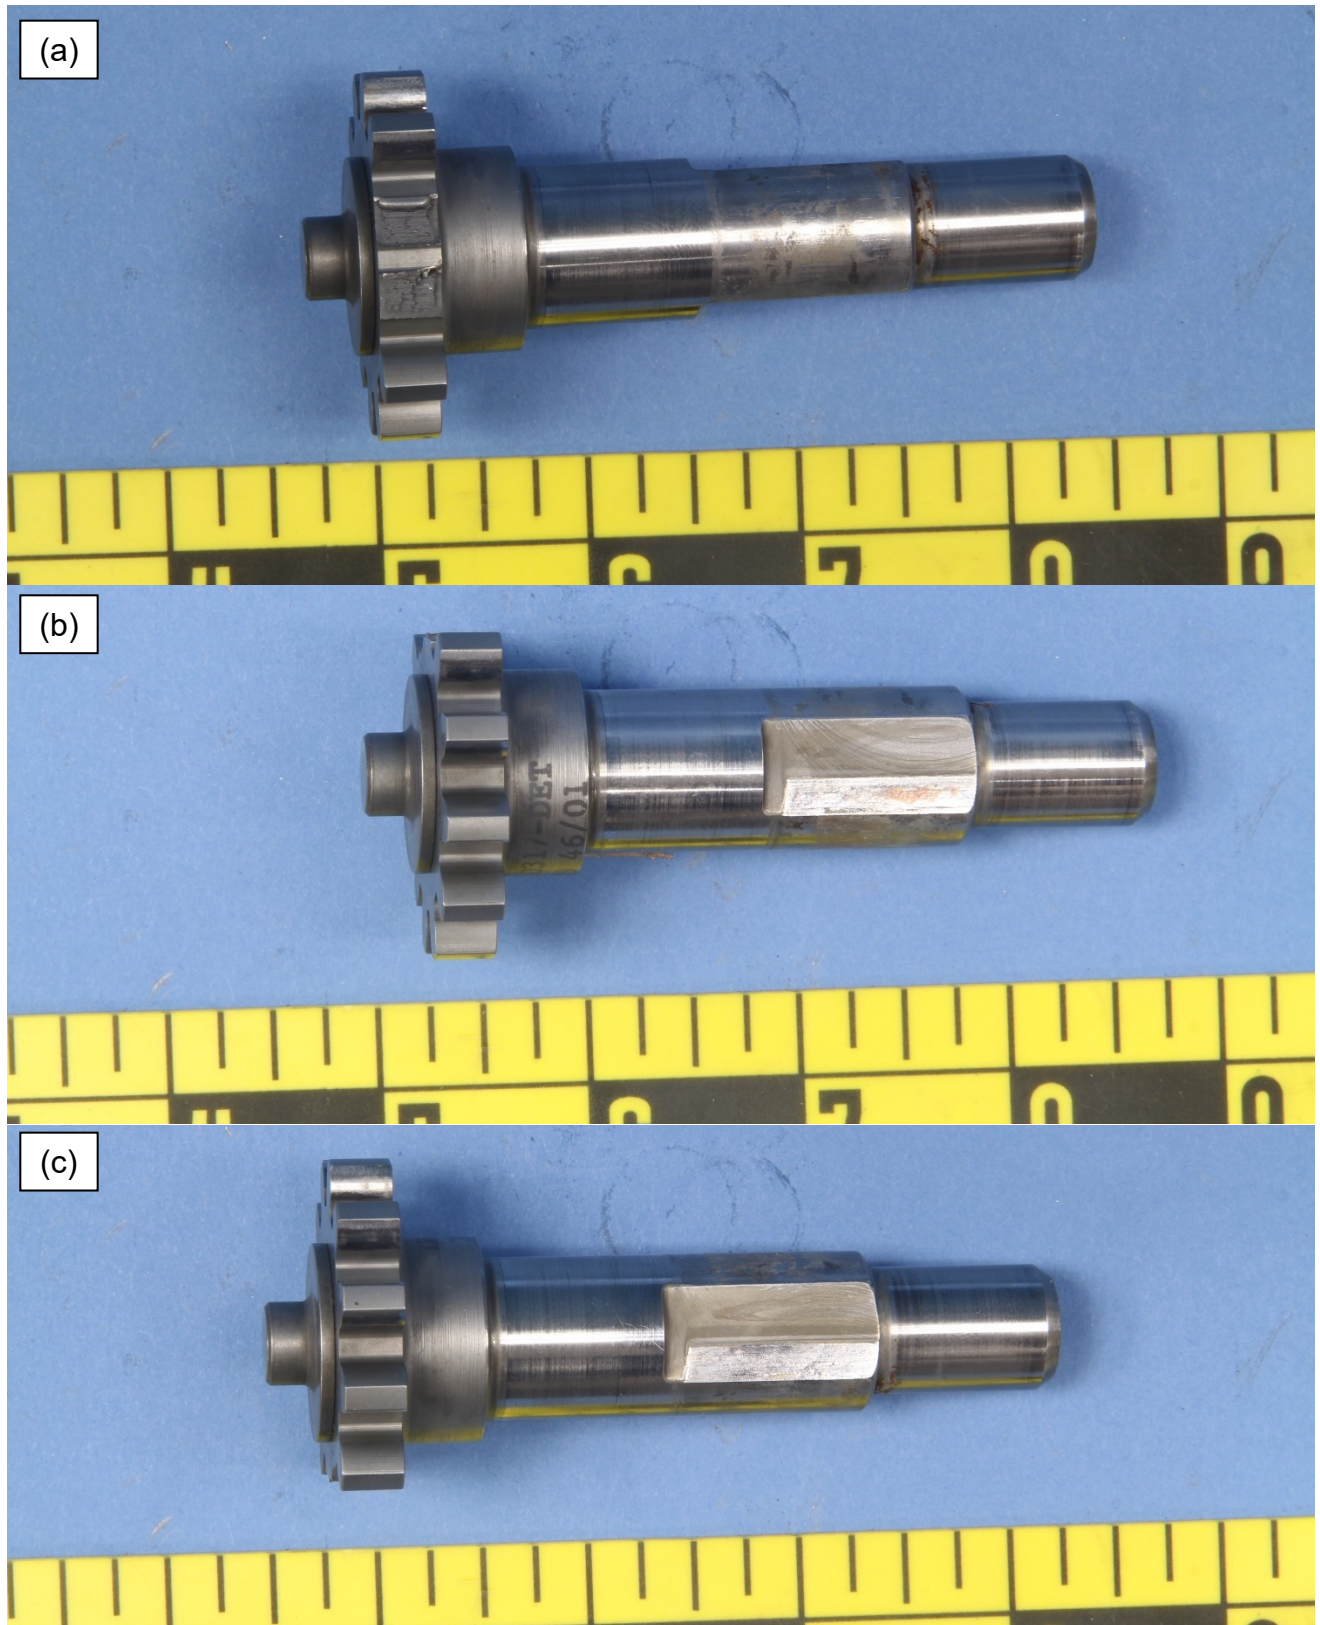
Figure 15 shows the drive gear shaft from three different angles, representing the damage to the part. Of note was the fracture of two gear teeth, as highlighted in Figure 16. There were also witness marks along the slotted portion of the shaft, shown Figure 15b and 15c. There were a variety of markings on the part, as shown on the gear face in Figure 16a: “LW-10318 ASSY MFR30620”. The other markings were on the shoulder of the shaft, stating, “LW-10317-DET 7189 46/01”.

Figure 15 – View of the fractured drive gear shaft from (a), (b), (c) three sides, rotated  $\sim 60^\circ$ .

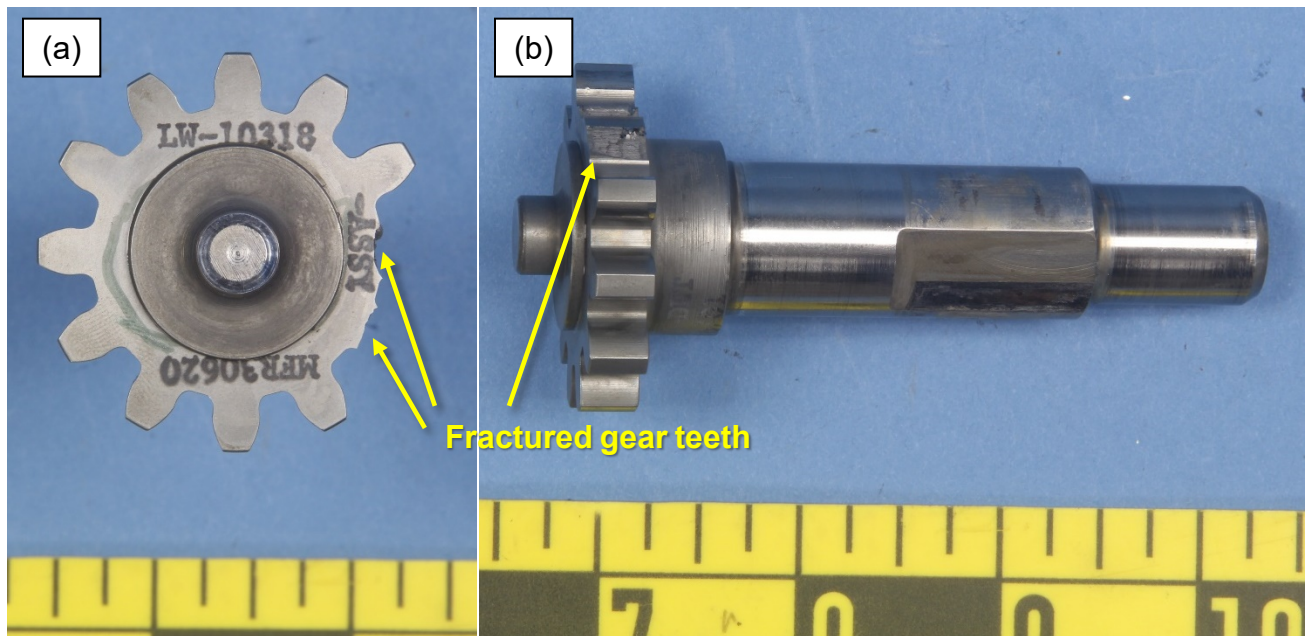
Figure 16 – The drive gear shaft from (a) the gear face with markings and (b) from an angled side view.

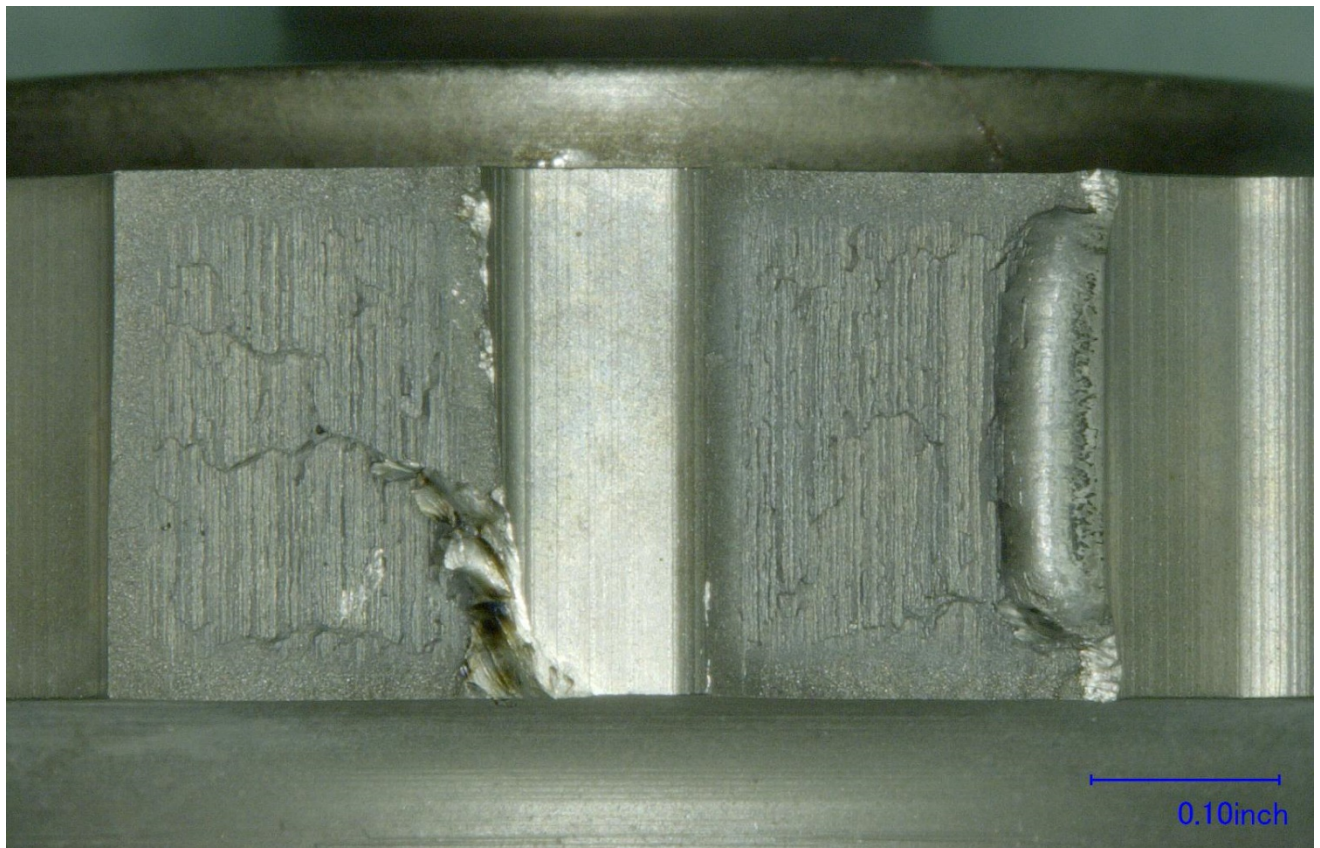
Figures 17 and 18 highlight the fracture surfaces of the gear teeth, from the gear side. The fractures were generally flat, although they were actually somewhat concave when viewed from the side. The fractures were located near the roots of the gear teeth, above the fillet radii, generally along the clearance circle.

The fracture surfaces themselves were generally dull, rough, and fibrous in nature. The fracture surfaces in Figures 17 and 18 both exhibited shinier, smoother regions on the left of the figures, consistent with post-fracture damage such as smearing. The fractures in Figure 18 can be contrasted with the intact teeth adjacent to the fractured teeth, shown in Figure 19. The left tooth face in Figure 19 displayed wear marks, consistent with the driven side of the gear (see Figure 20). The worn areas of the teeth exhibited upward-oriented wear marks on the upper quarter of the tooth, with more randomly oriented marks along the curved part of the tooth face. The fracture surfaces and the wear marks on the intact teeth were consistent with gear rotation from right to left in Figures 18 and 19.

Figure 17 – View of the fractured gear teeth from the gear drive side.

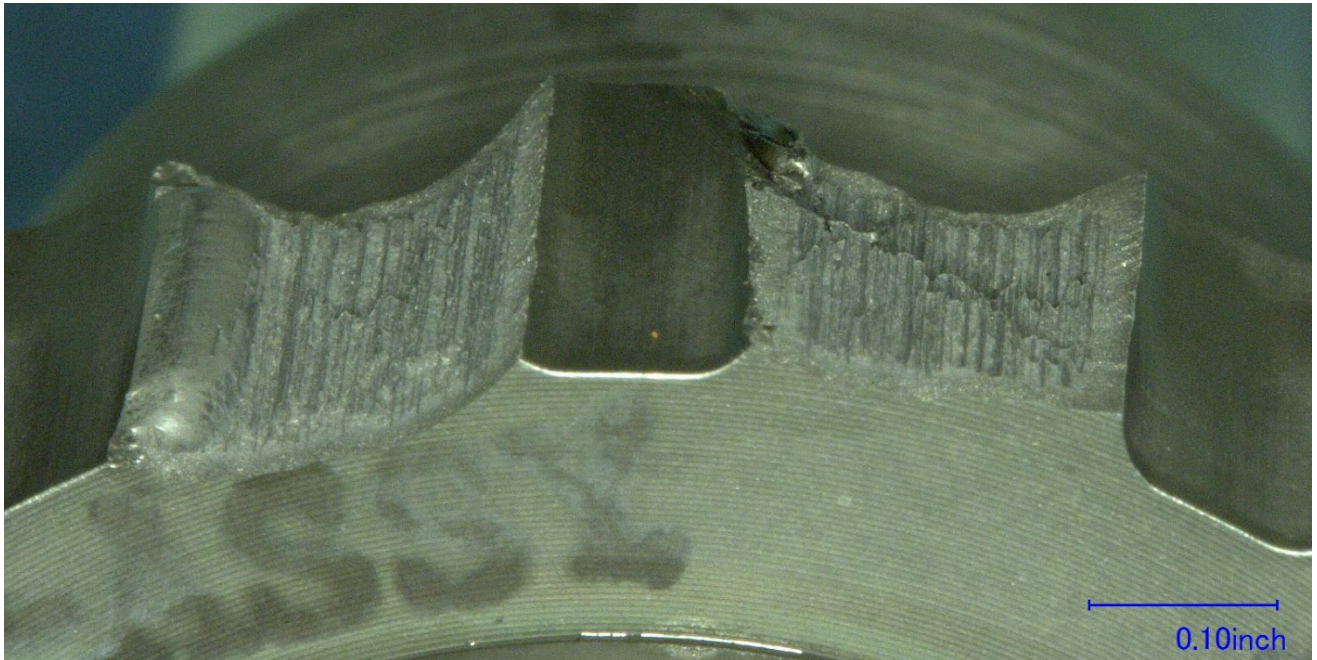
Figure 18 – Angled view of the fractured gear teeth from the drive gear.

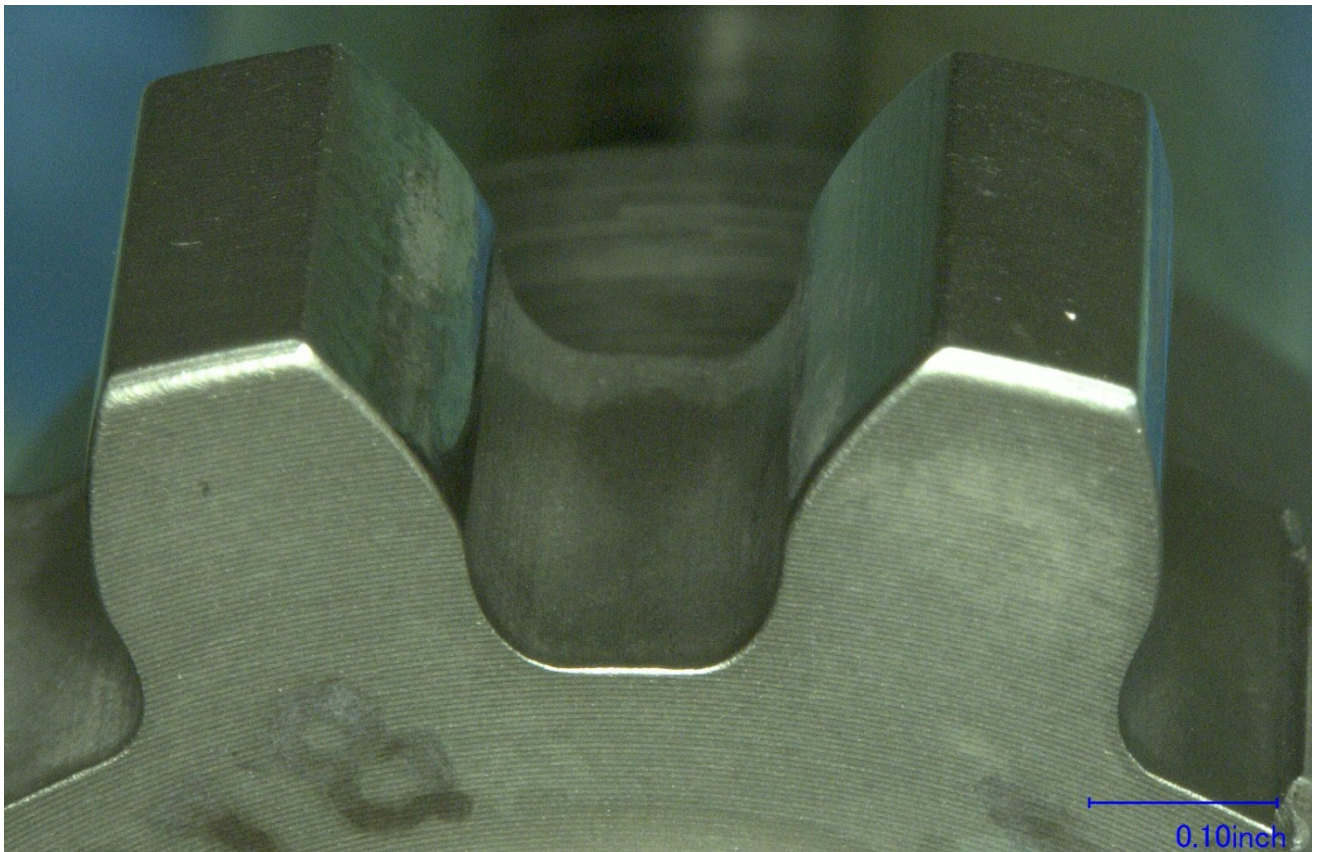
Figure 19 – View of the intact gear teeth from the drive gear, shown in the same orientation as the fractured teeth in Figure 18.

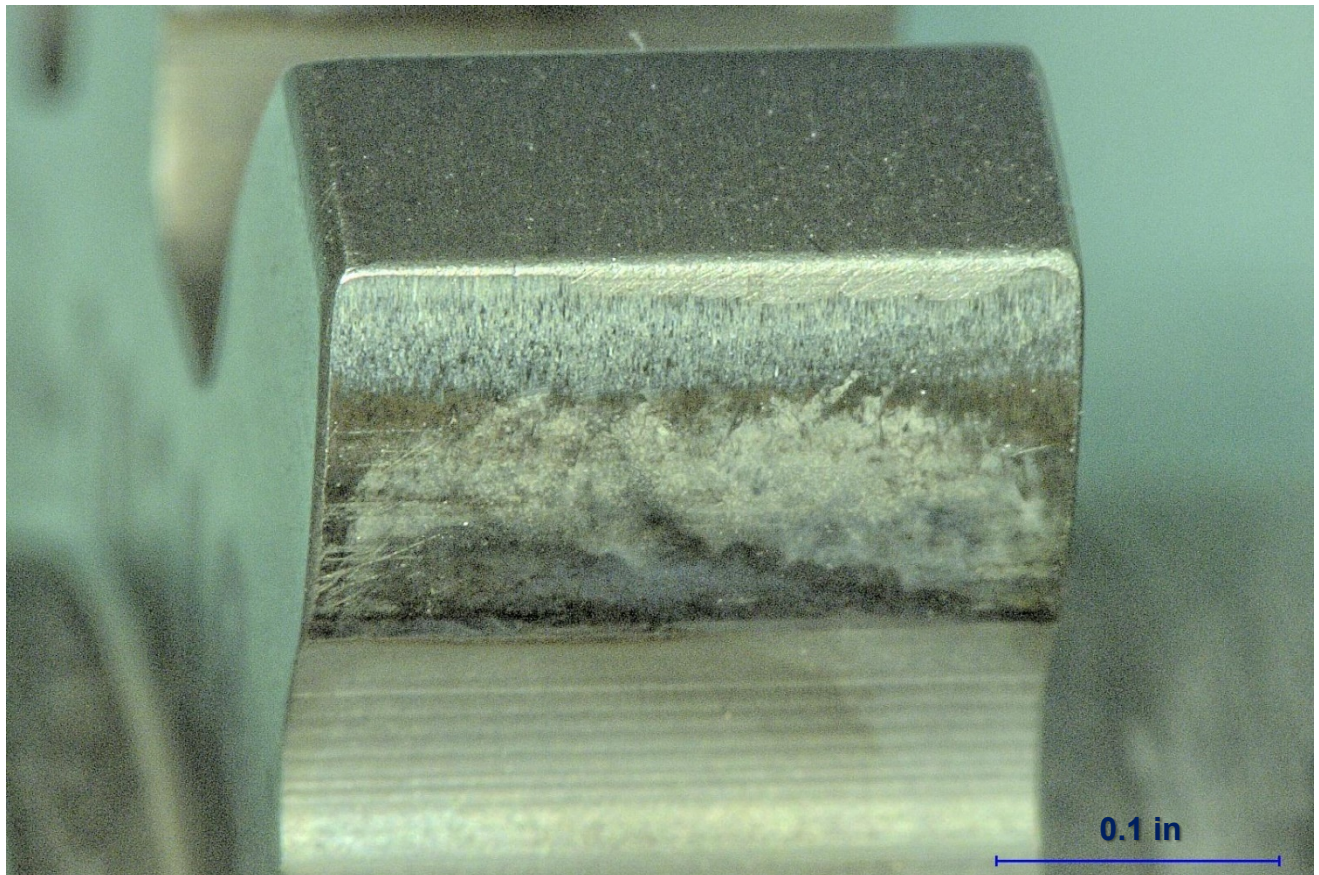
wear patterns as the intact gear tooth shown in Figure 20. One of the gear teeth exhibited local plastic deformation on the face, shown in Figure 23 and 24. This deformation was oriented outward and horizontal to the flank direction in the figure. In addition, Figure 23 shows a small corner indentation near the tooth top land. These damage features were consistent with post-fracture impact damage, typical of liberated pieces impacting rotating metallic components.

Figure 20 – View of the contact areas of the gear teeth adjacent to the fractured teeth on the drive gear.

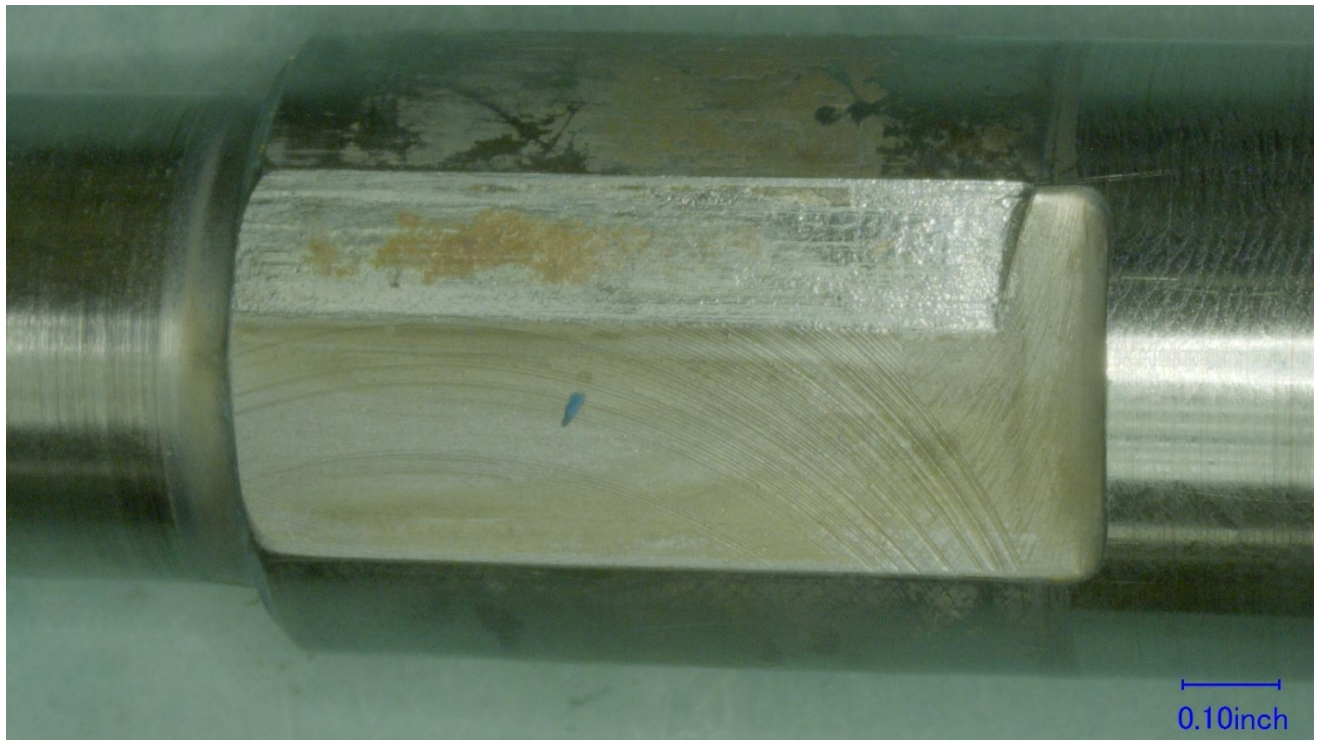
Besides the wear marks on the gear teeth faces, the flat portion of the shaft on the gear drive exhibited a rectangular impression, consistent with adhesive wear against an adjacent faying surface—the interior bore of the slotted impeller. The wear marks, present but reversed on the opposite side, were consistent with the rotation direction of the gear. There were also some rotational marks on the smooth rounded side of the shaft adjacent to the flattened area. These areas exhibited indications of a brownish-colored compound, consistent with iron oxide. None of these surfaces exhibited damage in the form of abrasion, material loss, or deformation.

Figure 21 – View of the wear patterns on the contact face of the drive gear shaft.
