# NATIONAL TRANSPORTATION SAFETY BOARD

## MATERIALS LABORATORY FACTUAL REPORT

Report No. 20-047

Place : Fletcher, North Carolina  
Date : December 28, 2019  
Vehicle : Piper PA-32RT-300, N27GB  
NTSB No. : ERA20LA062  
Investigator : Todd Gunther, AS-ERA

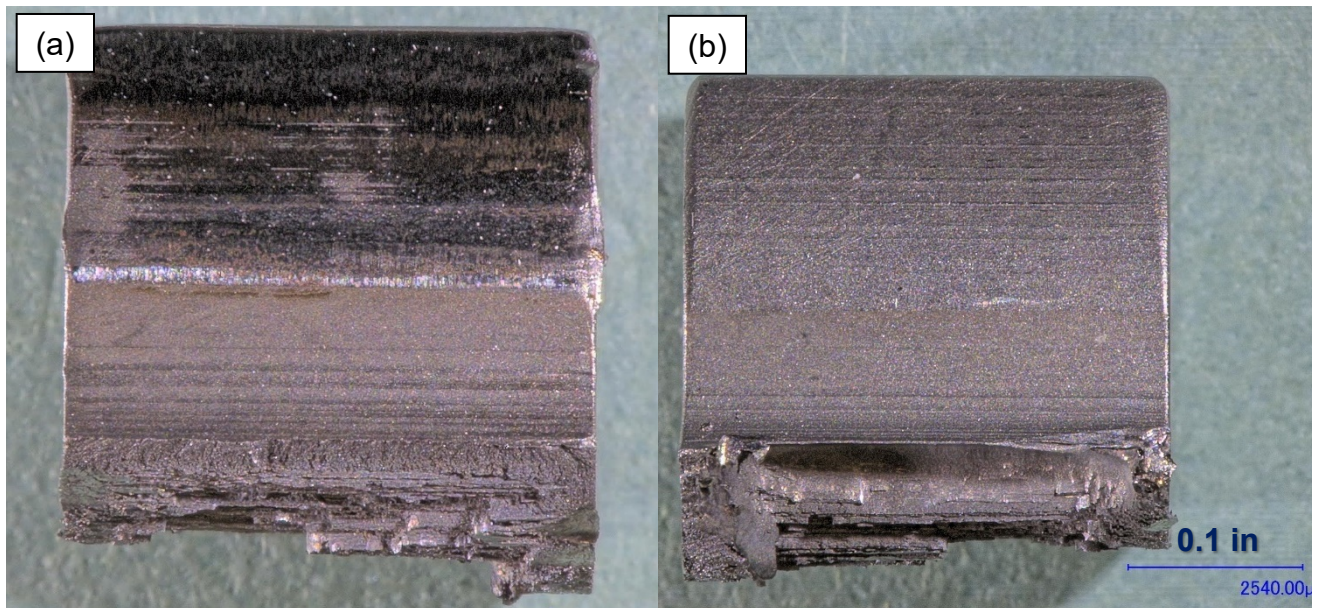
Figures 22 through 25 show the two fractured and liberated gear teeth from different views. The gear teeth had fractured near the roots above the fillet radii, consistent with the mating fracture surfaces from the drive gear. The driven faces of the teeth exhibited similar

Figure 22 – View of one of the fractured gear teeth from (a) (b) each side.

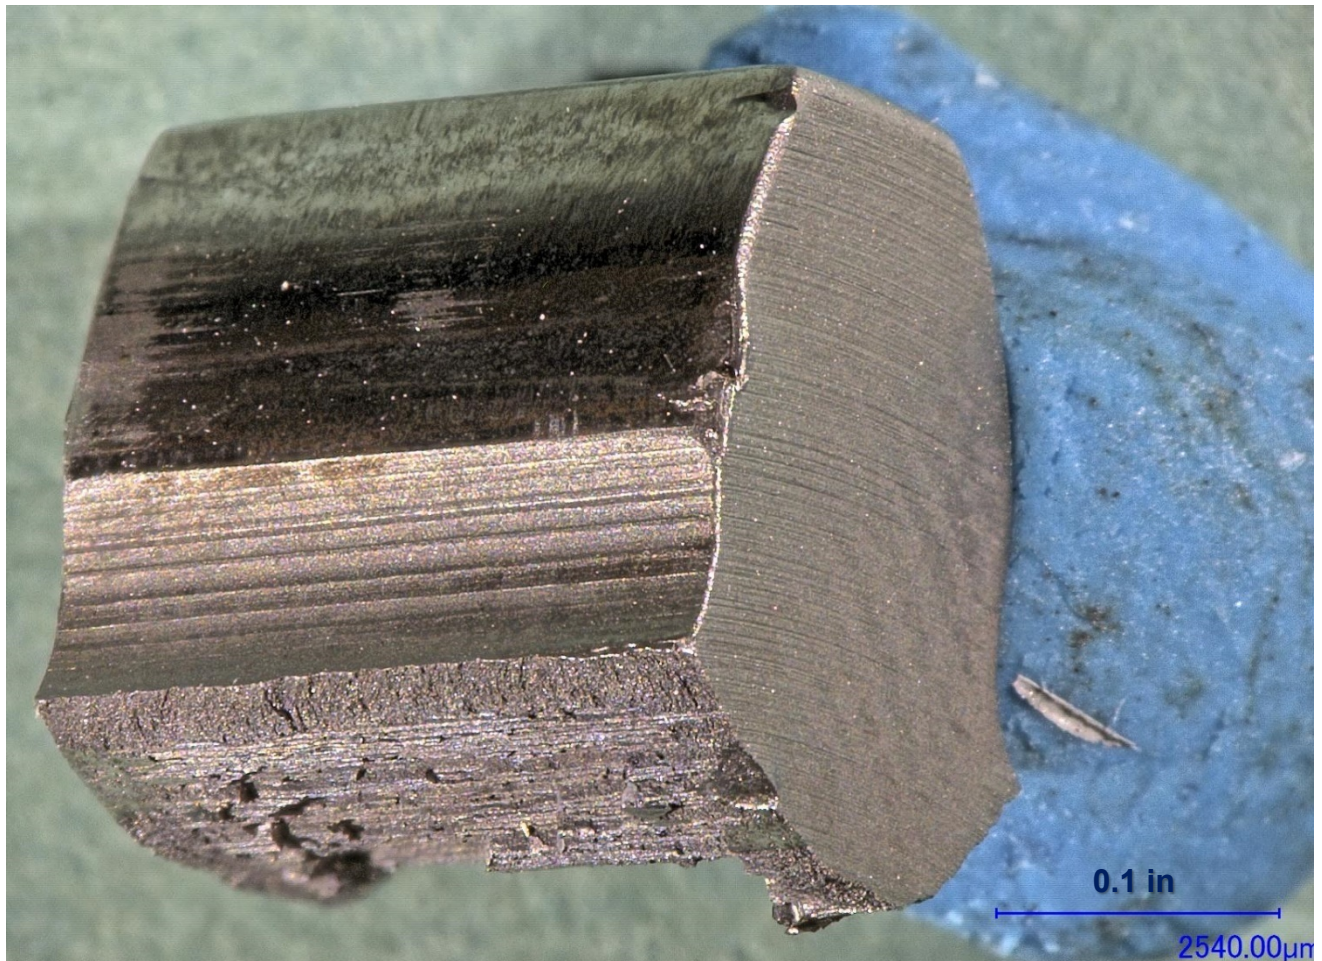
wear patterns as the intact gear tooth shown in Figure 20. One of the gear teeth exhibited local plastic deformation on the face, shown in Figure 23 and 24. This deformation was oriented outward and horizontal to the flank direction in the figure. In addition, Figure 23 shows a small corner indentation near the tooth top land. These damage features were consistent with post-fracture impact damage, typical of liberated pieces impacting rotating metallic components.

Figure 23 – Angled view of one of the fractured view, showing the fracture surface, the contact surfaces and the edges.

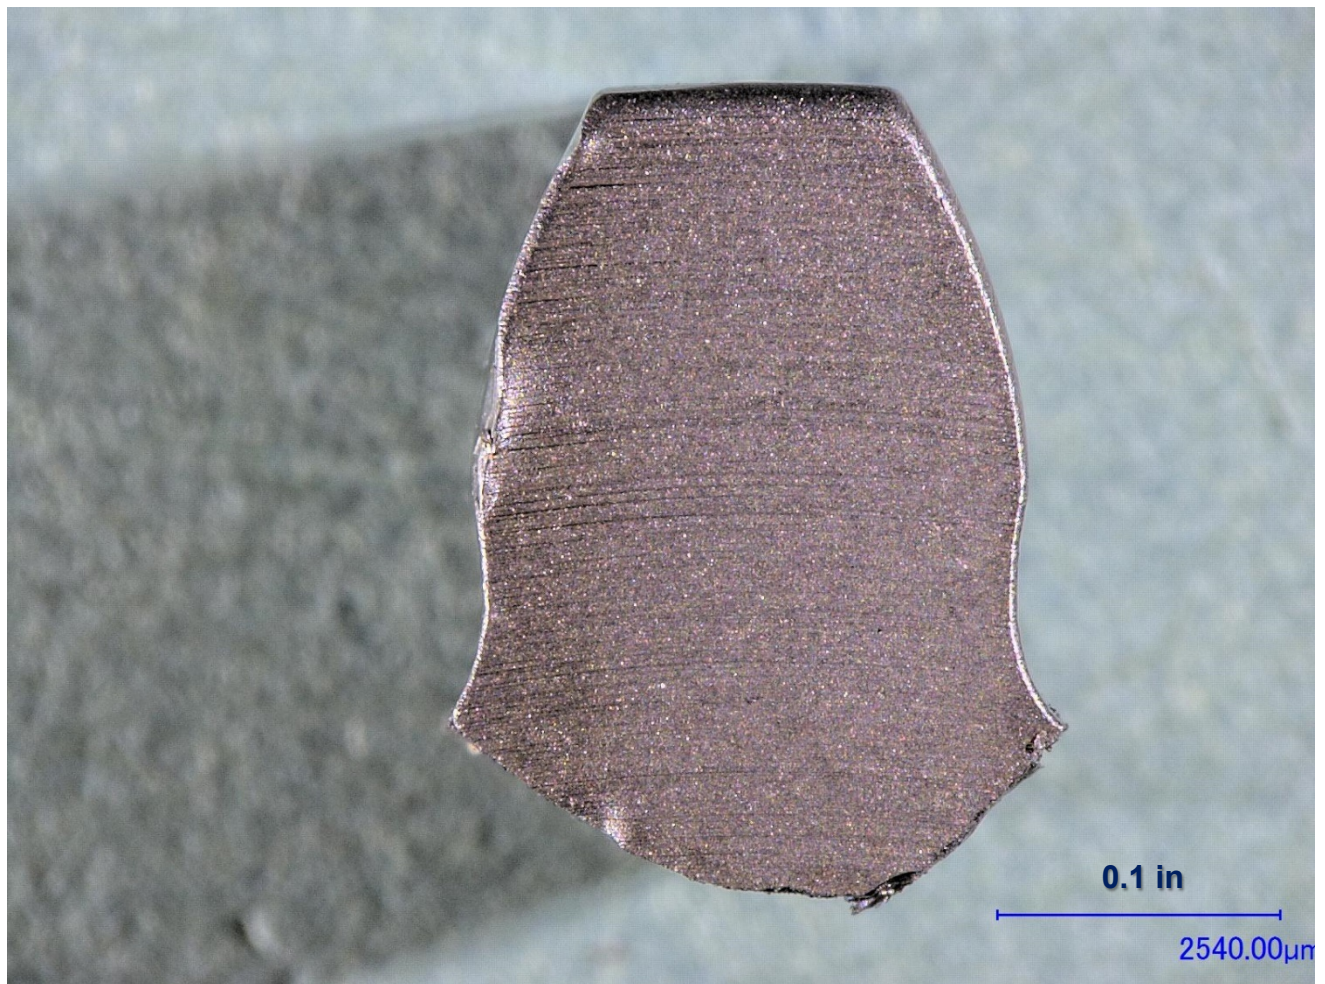
Figure 24 –The flat face of the fractured gear tooth.

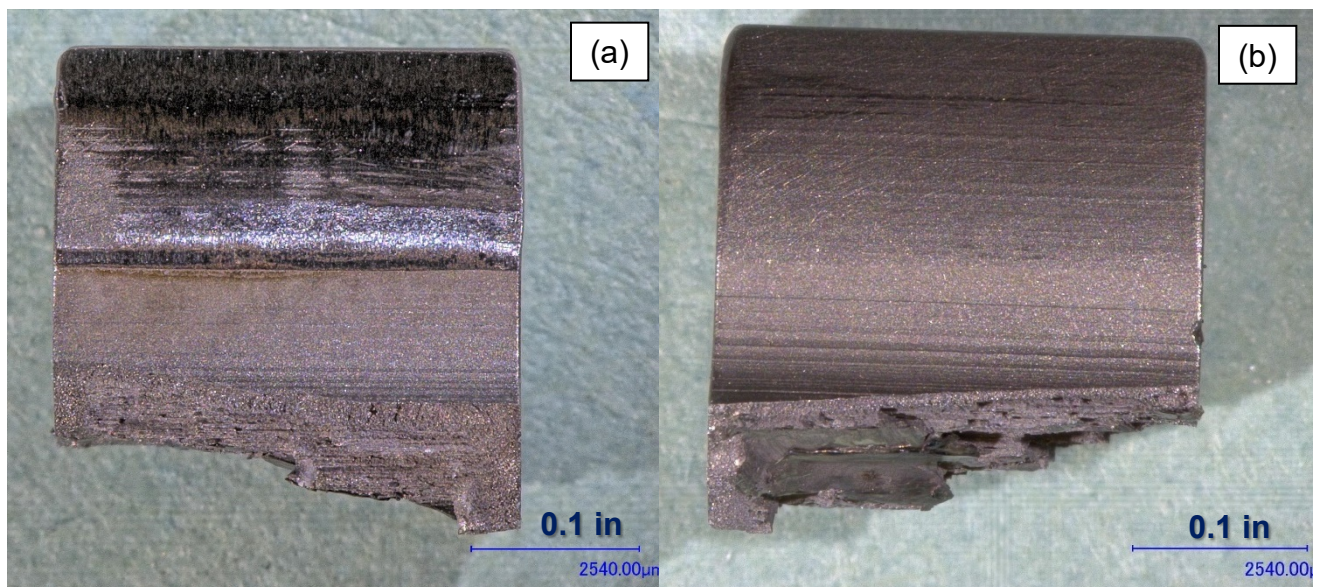
Figure 25 – Opposite views of the other fractured gear tooth.

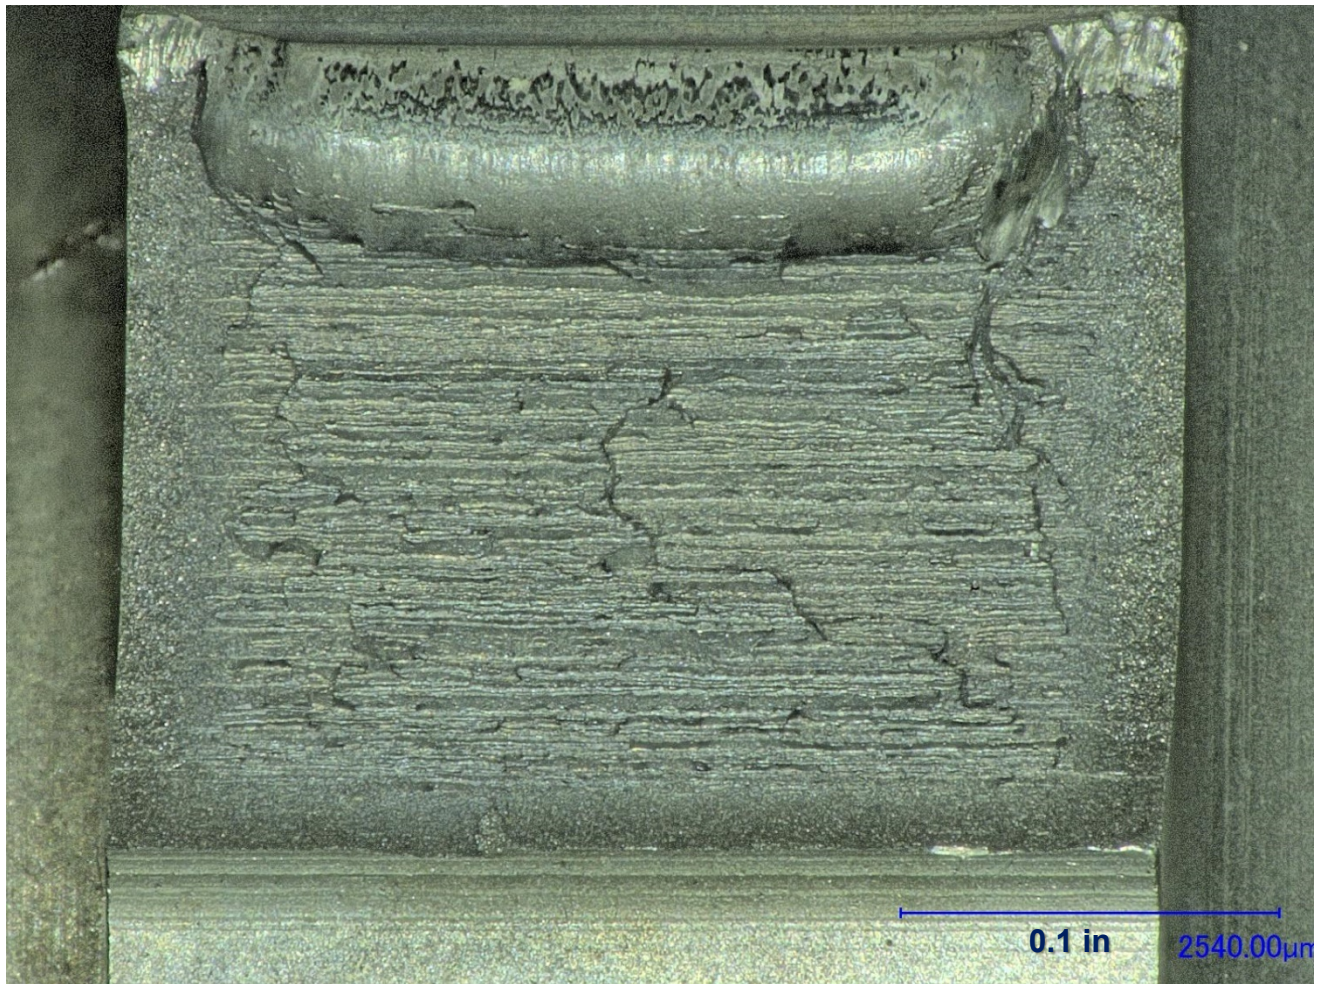
Figure 26 shows a closer view of the less damaged gear tooth fracture surface from the gear drive side. The central region of the fracture surface exhibited a fibrous morphology, with features oriented in a parallel, horizontal manner in the figure. The outer portions, though, exhibited a finer morphology. This gear was examined using a scanning electron microscope (SEM) as illustrated in Figure 27. This figure demonstrates the difference in fracture surface morphologies between the outer and core regions.

Figure 26 – Closer view of one of the fractured gear tooth fractured surfaces from the drive gear.

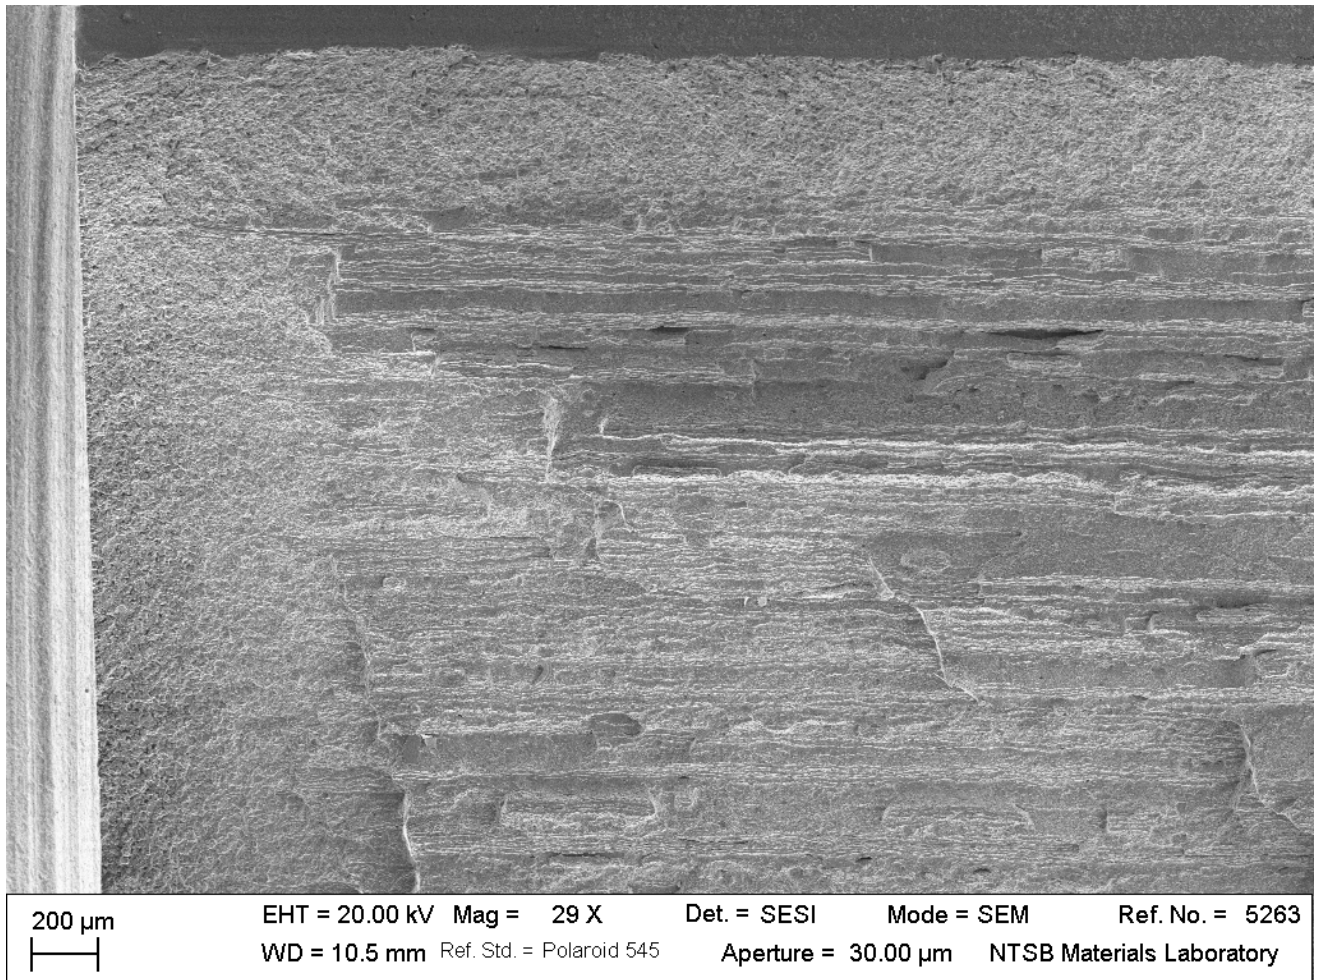
Figure 27 – Secondary electron (SE) of the corner of the gear tooth fracture surface, showing two distinct fracture regions.

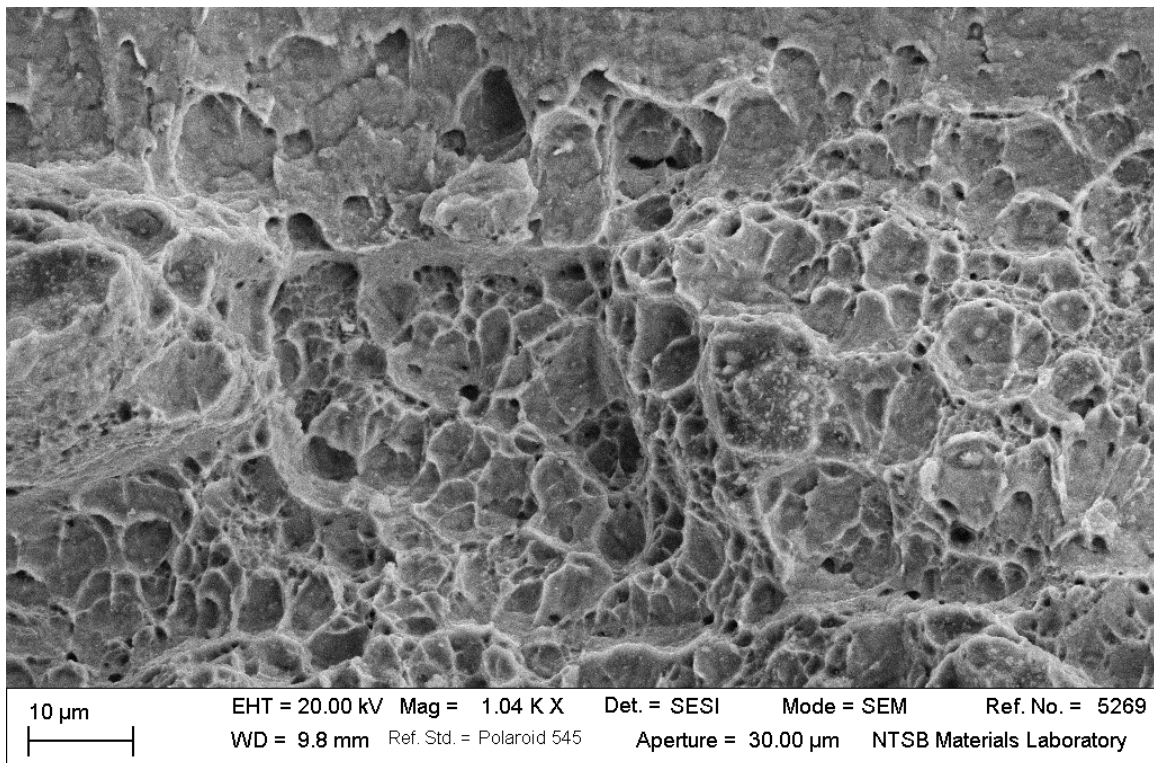
Figure 28 shows a closer view of a typical area of the core region of the fracture surface. The features were consistent with dimpled rupture, typical of overstress fractures of ductile materials. The outer region is typified in Figure 29, showing intergranular fracture features. Some areas of the outer, intergranular region adjacent to the surface edge exhibited a darker contrast in the SEM, as typified in Figure 30.

Figure 28 – SE micrograph of dimpled rupture on the interior of the fracture surface.

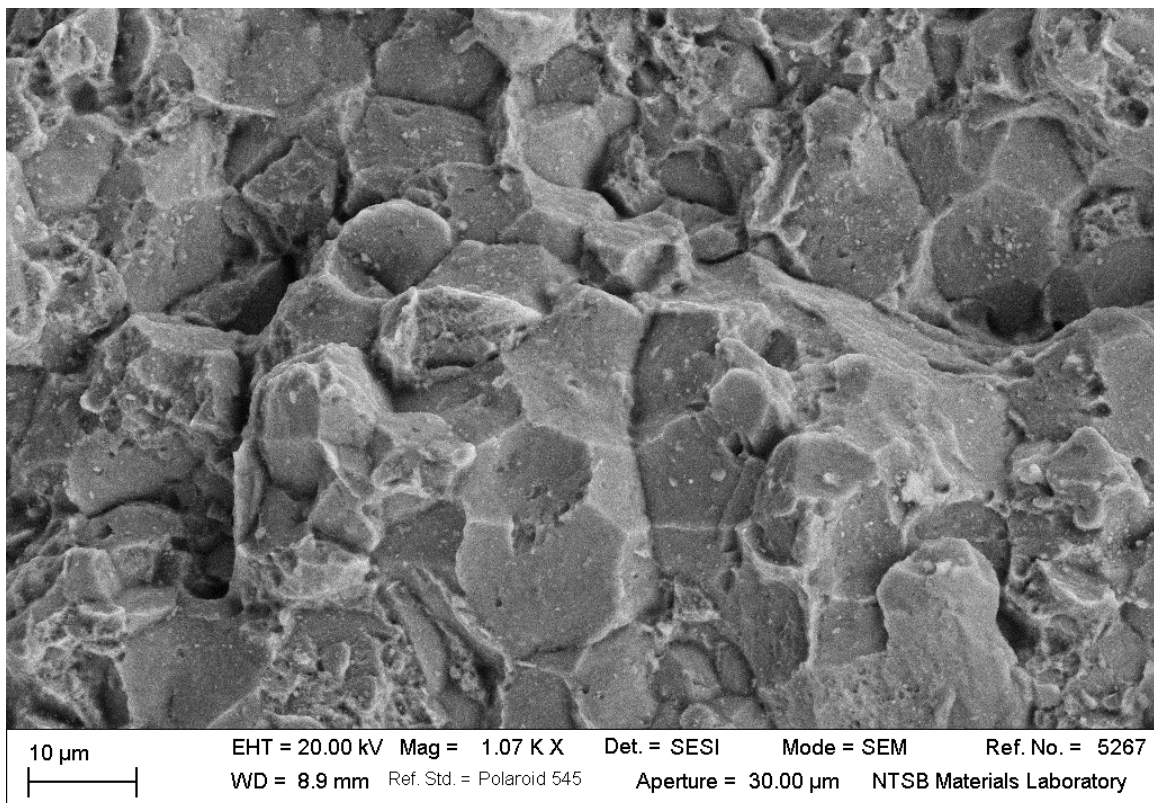
Figure 29 – SE micrograph of intergranular fracture on the periphery of the fracture surface.

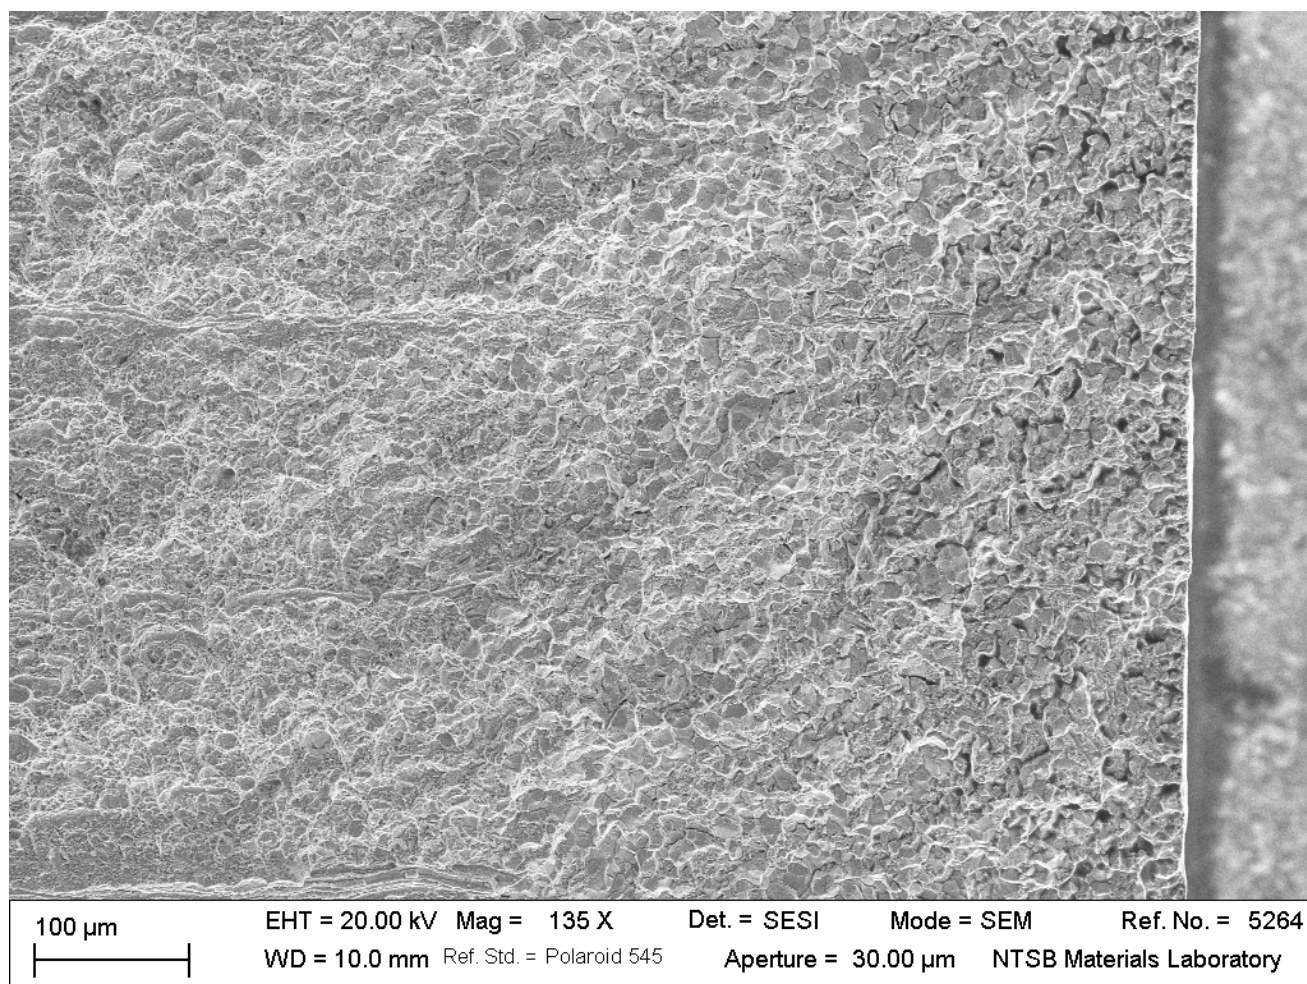
Figure 30 – SE micrograph of the exterior of the intergranular regions of the fracture.

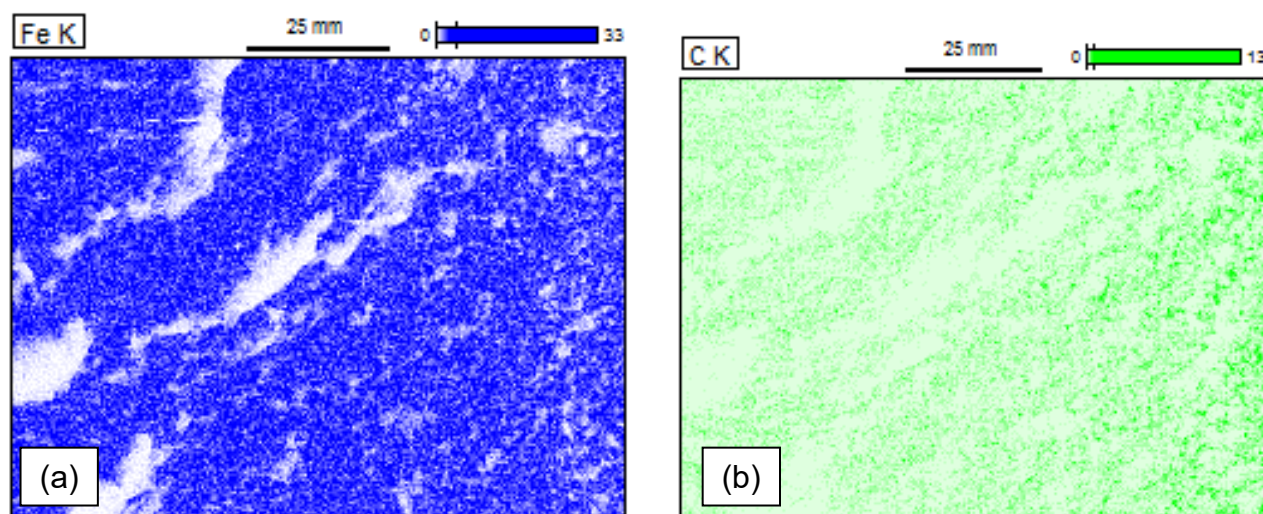
These regions were examined using x-ray mapping from energy dispersive x-ray spectroscopy (EDS). As shown in the maps in Figure 31, the intergranular regions of the fracture surface corresponded to areas of higher carbon content. These features were consistent with a carburizing surface treatment of the gear. Figure 32 shows a closer view of the carbon-rich region, again exhibiting intergranular fracture, with some limited areas of dimpled rupture along the grain boundaries. All these features were consistent with overstress fracture of the two gear teeth during rotation.

Figure 31 – X-ray maps of Figure 30, showing (a) high levels of Fe and (b) high levels of C.

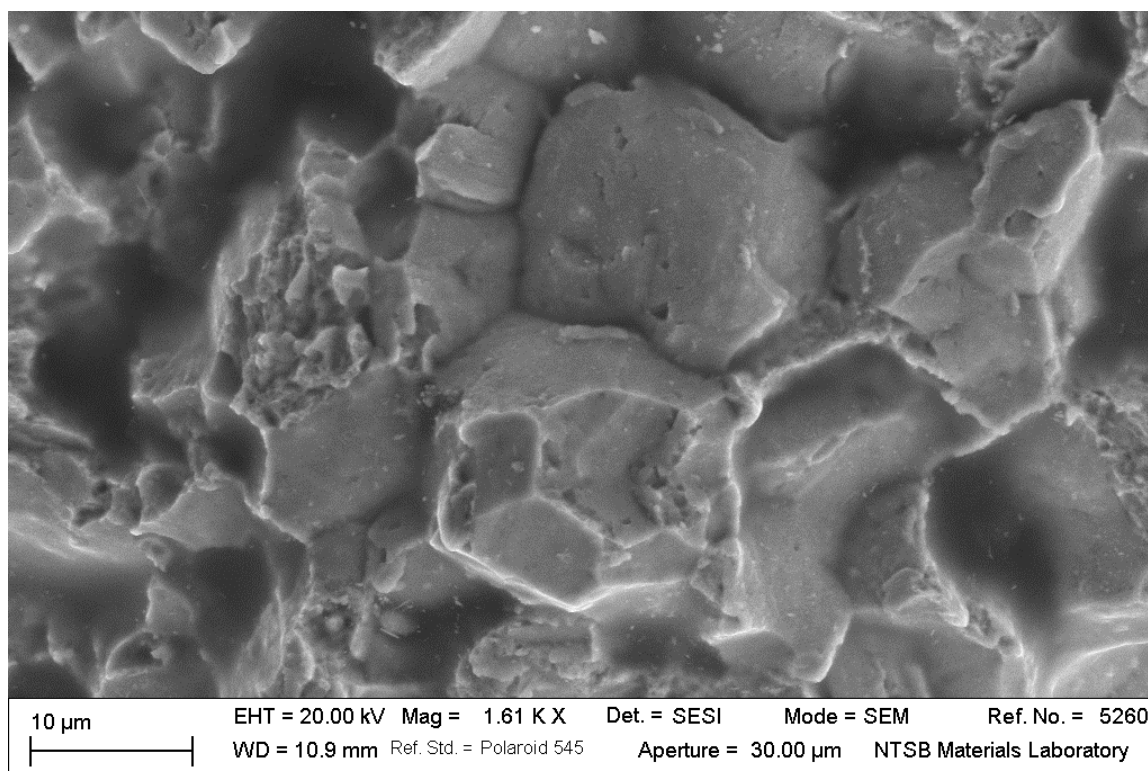
Figure 32 – SE micrograph of intergranular fracture in the area of highest C in Figure 30.

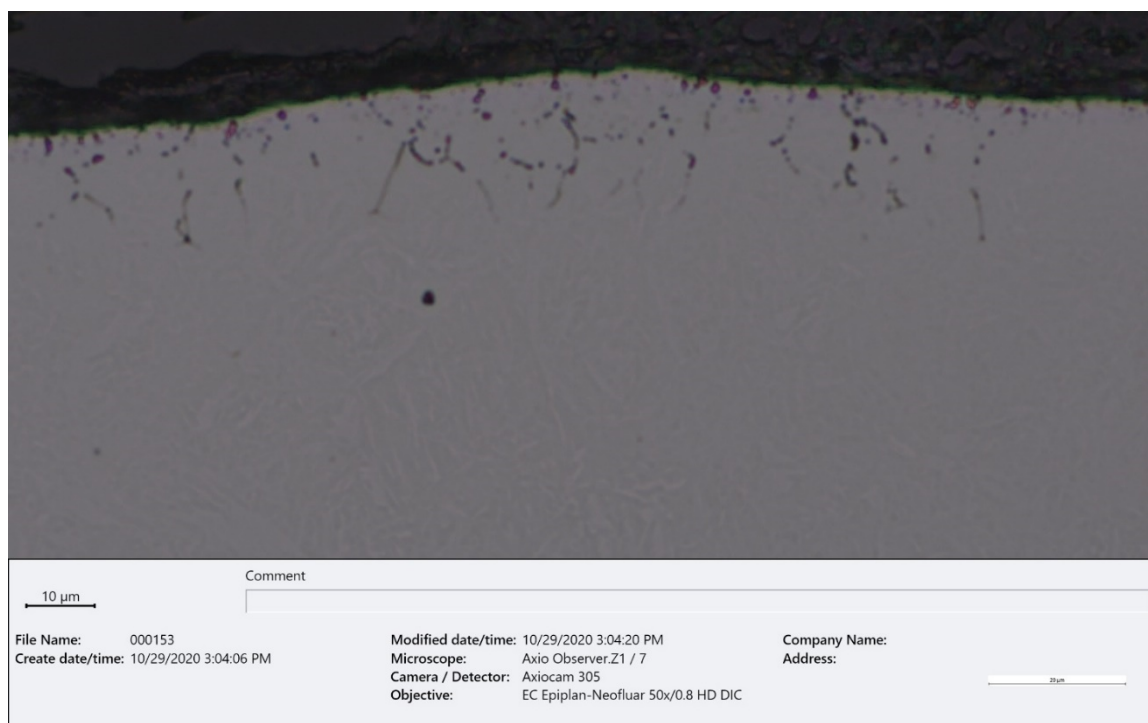
One of the fractured gear teeth was mounted, polished, and etched for metallographic examination. Of note was the area closest to the surface, as illustrated in Figure 33. The region 20  $\mu\text{m}$  ( $8 \times 10^{-4}$  inches) closest to the surface exhibited intergranular cracking, as demonstrated by the dark regions in Figure 33. This cracking was present along the prior austenite grain boundaries along the cross sectioned faces, flanks, and land surfaces. No cracking was seen in other areas away from the surface, or along the fracture surface.

Figure 33 – Bright-field (BF) optical micrograph of the surface of the cross-sectioned fractured gear tooth, showing intergranular cracks (~1000X, as-polished).

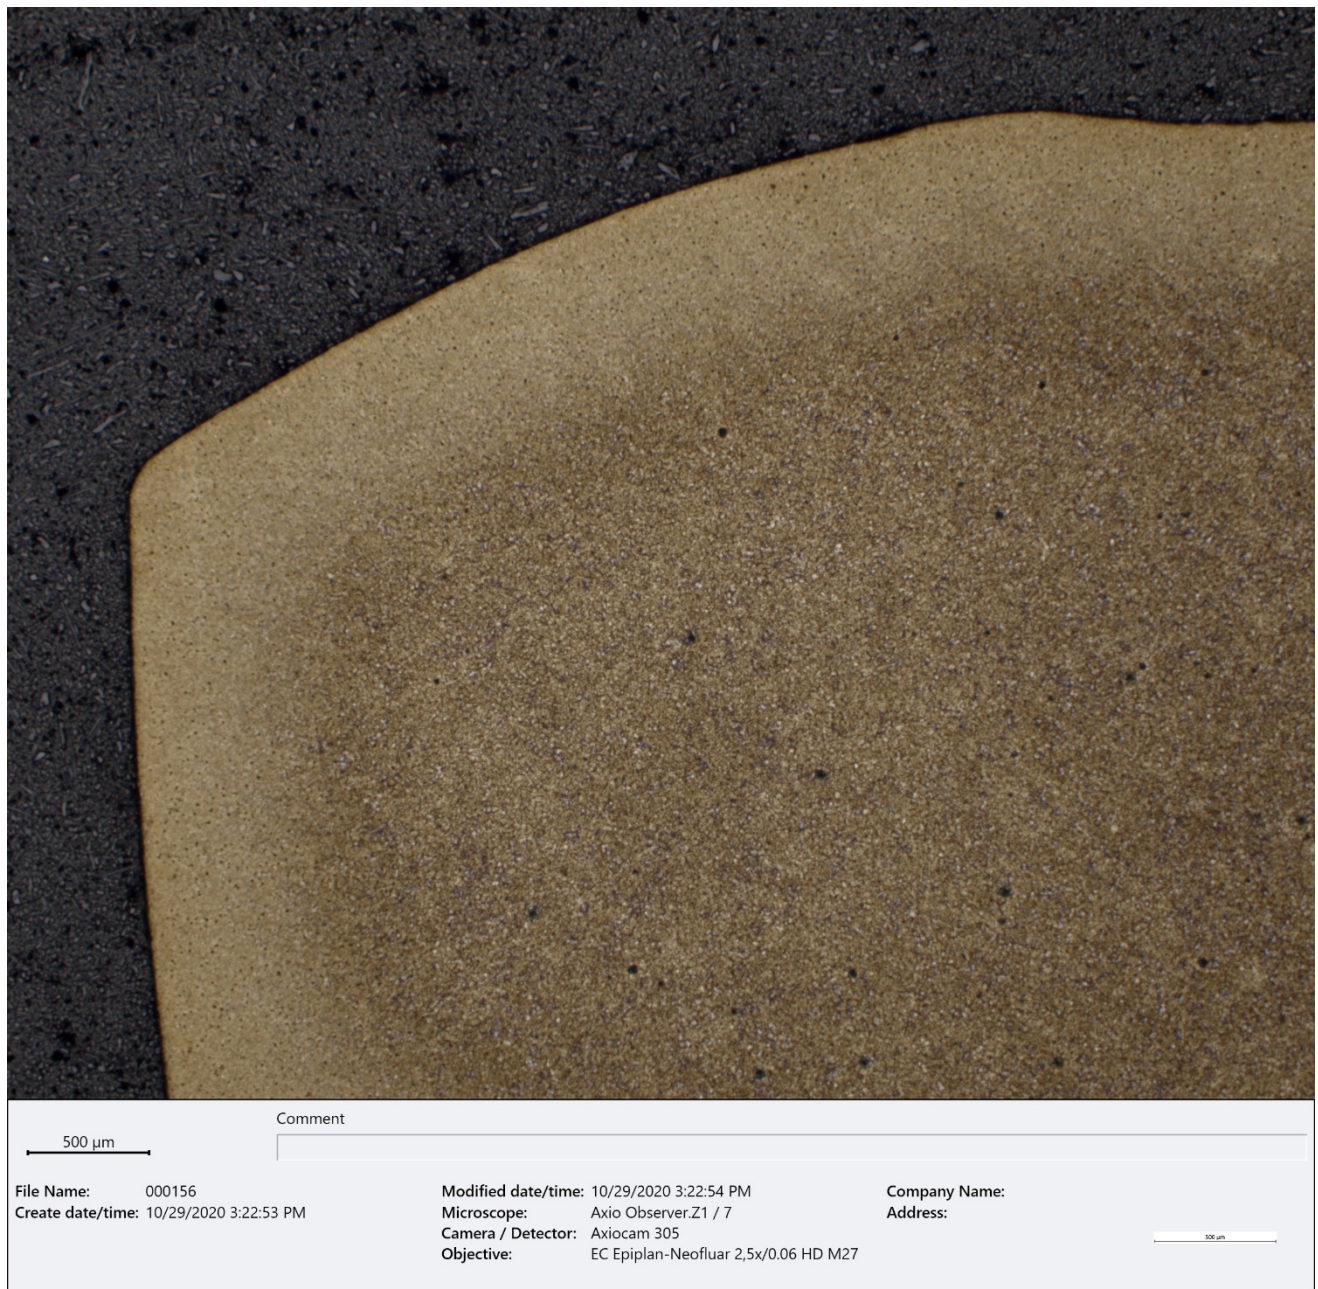
Figure 34 shows an area of the corner of the cross-sectioned gear tooth, after etching with a 2% Nital solution.<sup>2</sup> There was a clear visual contrast between the outer areas near the surface and the core regions. Figure 35 shows a closer view of the core microstructure, which was consistent with a tempered martensitic microstructure exhibiting a general lath morphology. This area did not exhibit any incipient spheroidal carbides or similar constituents. In contrast, the surface microstructure, shown in Figure 36, exhibited a martensitic structure with a more plate-like morphology, consistent with higher carbon content. There was no visual evidence of retained austenite in the surface region.

Figure 34 – BF optical micrograph of the surface corner of the cross sectioned fractured gear tooth, showing a different etching response from the surface and core regions (~25X, etched 2% Nital).

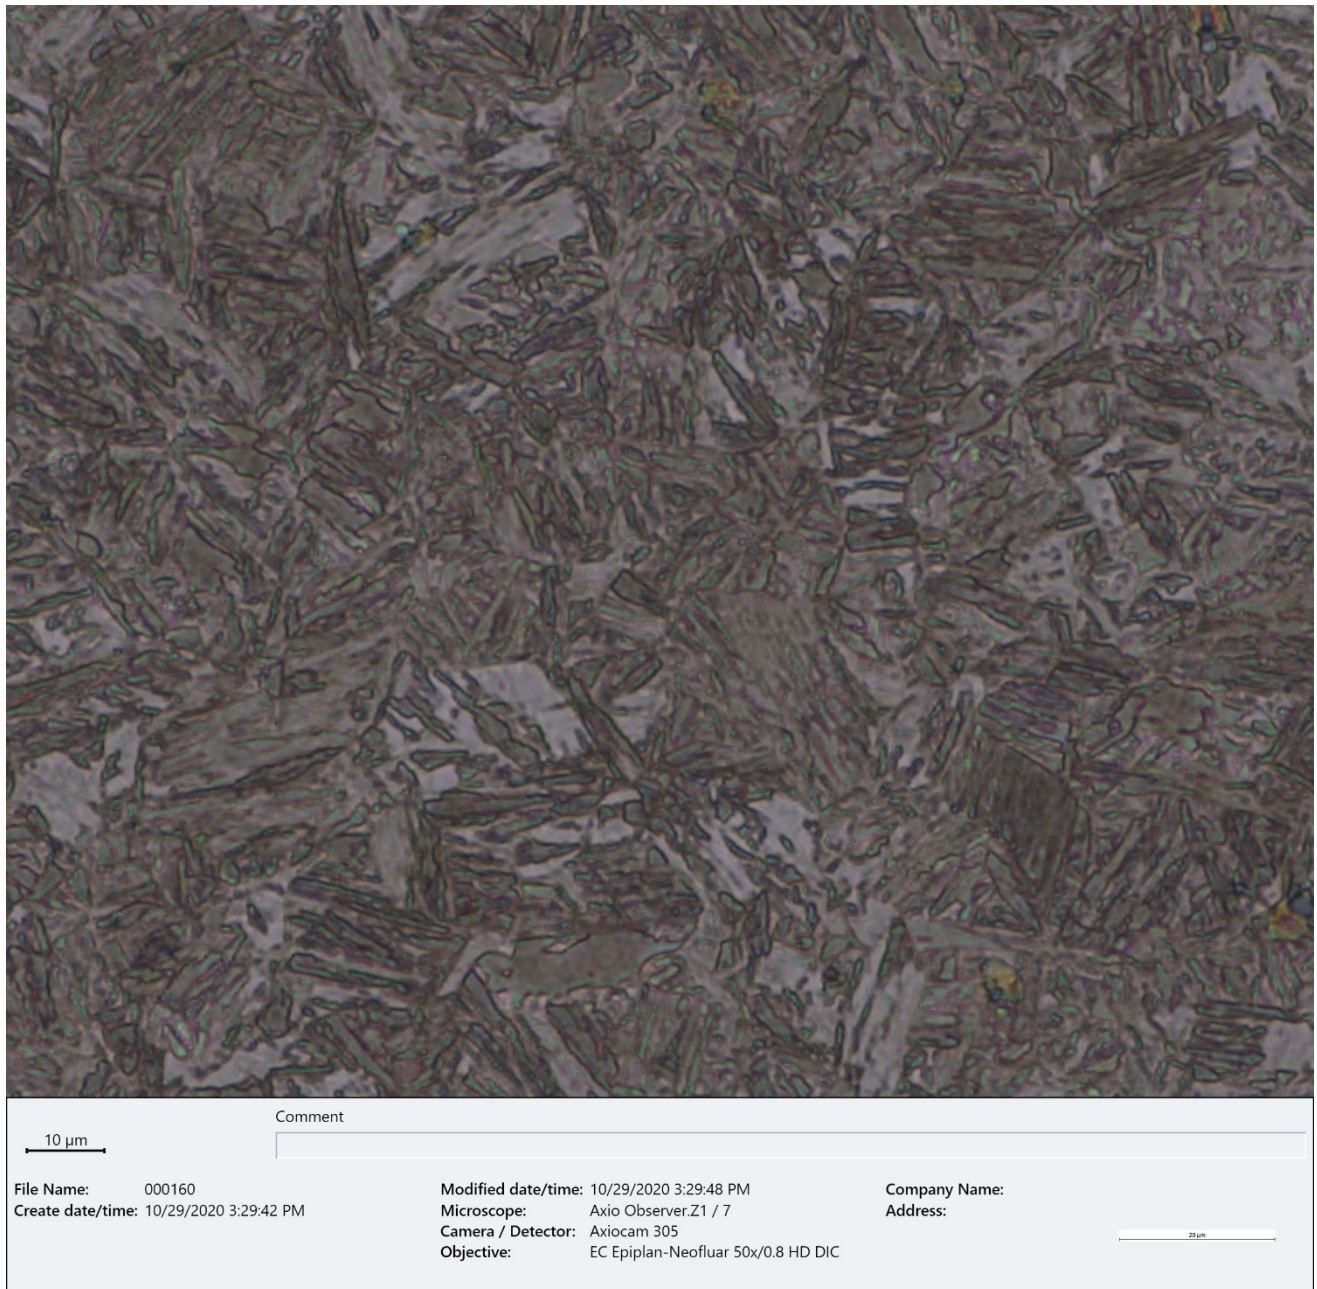
Figure 35 – BF optical micrograph of the core microstructure of cross sectioned fractured gear tooth (~1000X, etched 2% Nital).

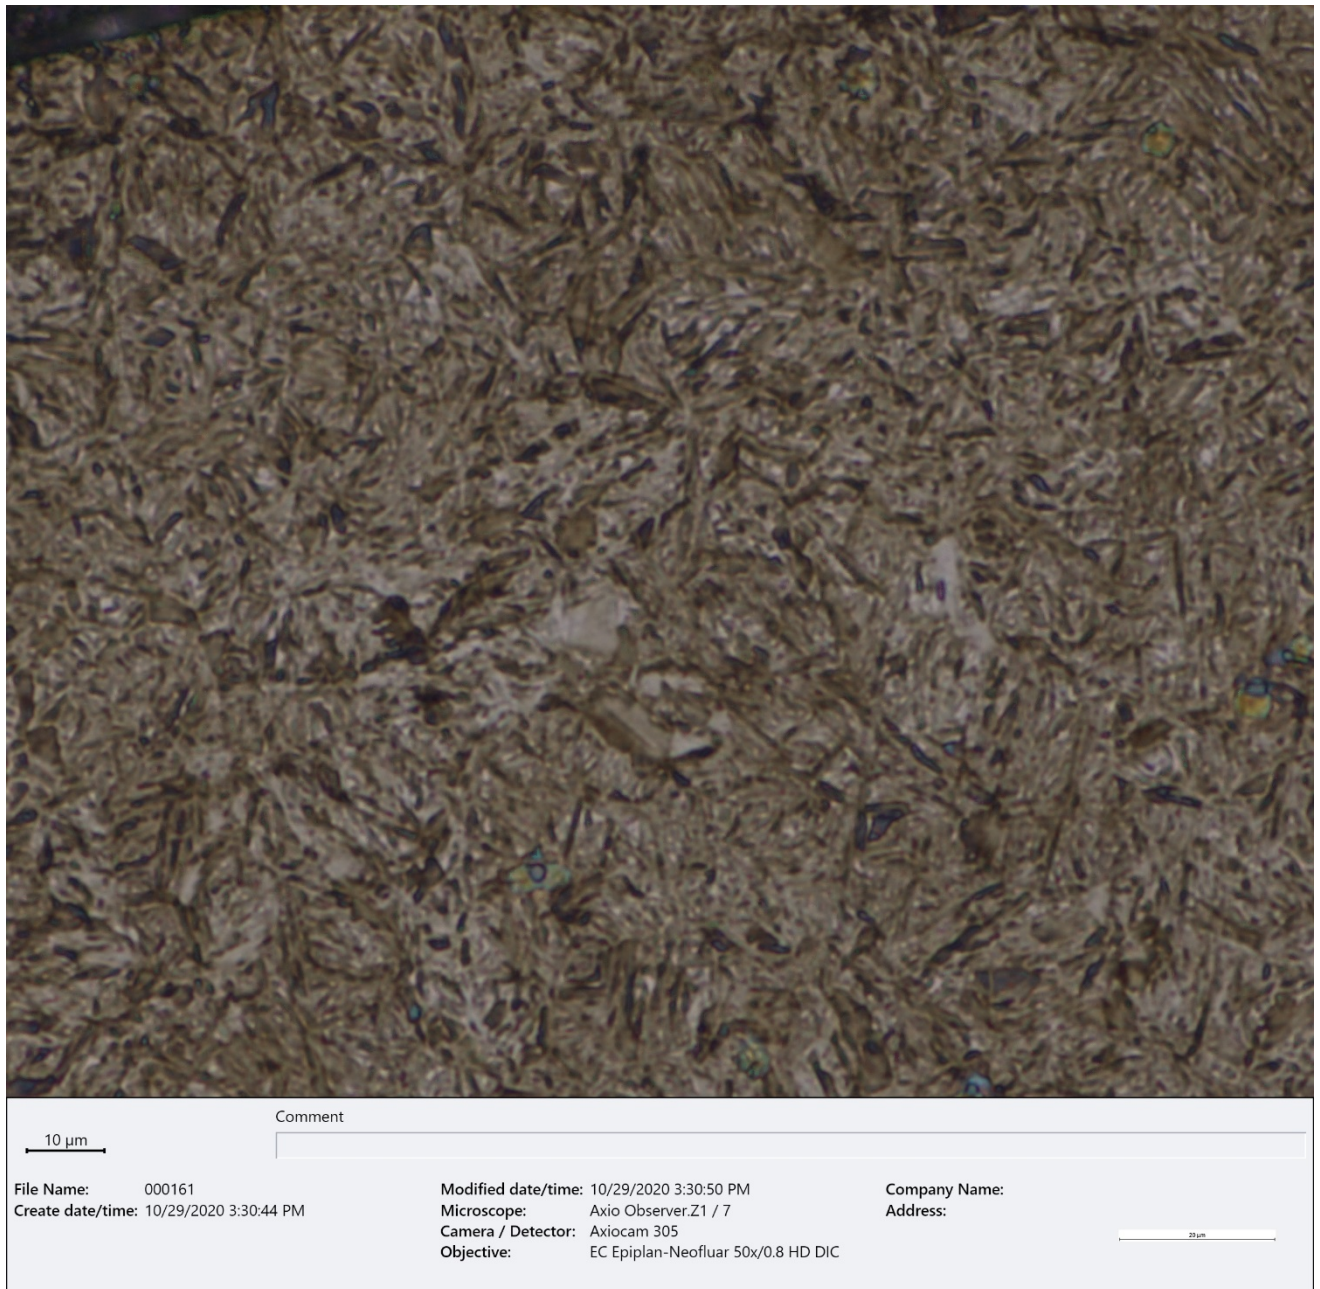
Figure 36 – BF optical micrograph of the surface microstructure of cross sectioned fractured gear tooth (~1000X, etched 2% Nital).

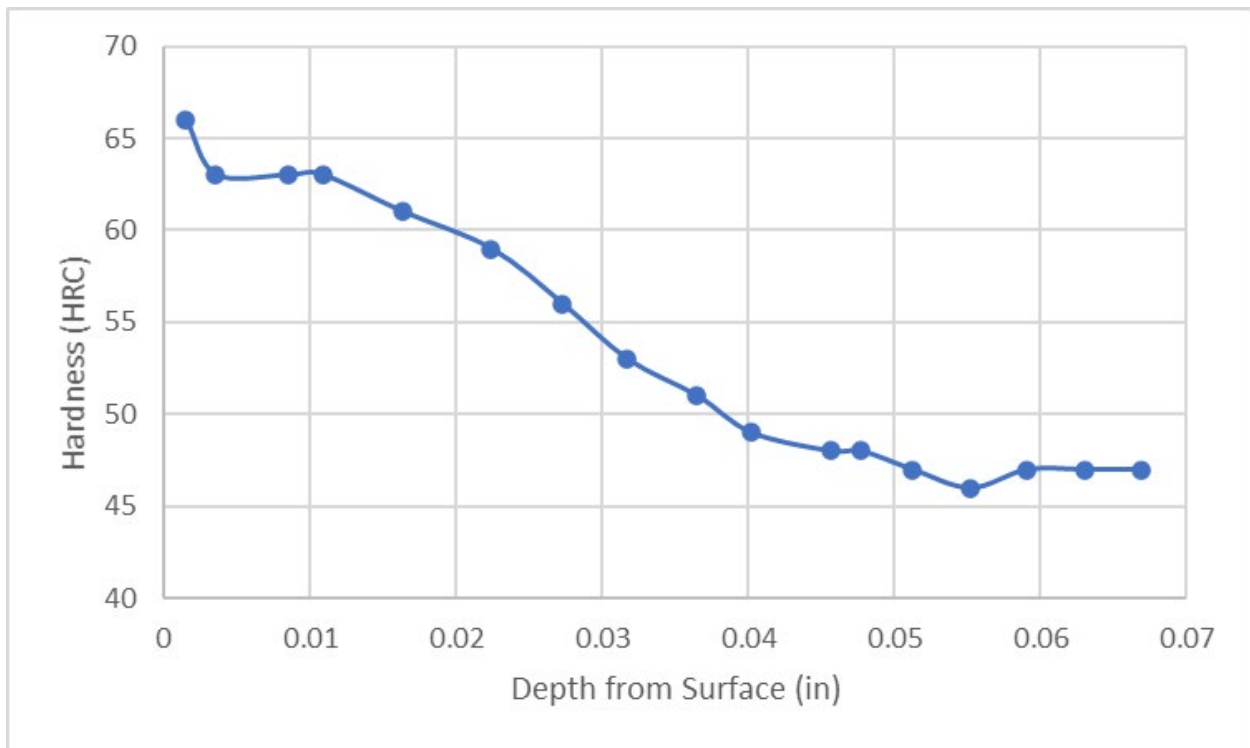
Hardness data were taken on the cross sectioned and polished gear specimen from the surface to the core using microindentation hardness testing per ASTM E384.<sup>3</sup> The hardness data exhibited a change in hardness dependent on the depth from the surface, consistent with a case hardening such as carburization. The core hardness was 47 HRC (474 HV<sub>500</sub>), with an effective case depth of 0.037 inches. The highest hardness at the surface was found to be 66 HRC (850 HV<sub>500</sub>). Figure 37 shows a graph of the hardness data.

Figure 37 – Graph of the microindentation hardness data (in HRC converted from HV500) from the surface inward of the mounted and polished fractured gear tooth.
