# NATIONAL TRANSPORTATION SAFETY BOARD

## MATERIALS LABORATORY FACTUAL REPORT

Report No. 21-078

Place : Kenansville, North Carolina  
Date : January 2, 2020  
Vehicle : Cirrus SR22, N323SR  
NTSB No. : ERA20LA064  
Investigator : Adam Gerhardt, AS-ERA

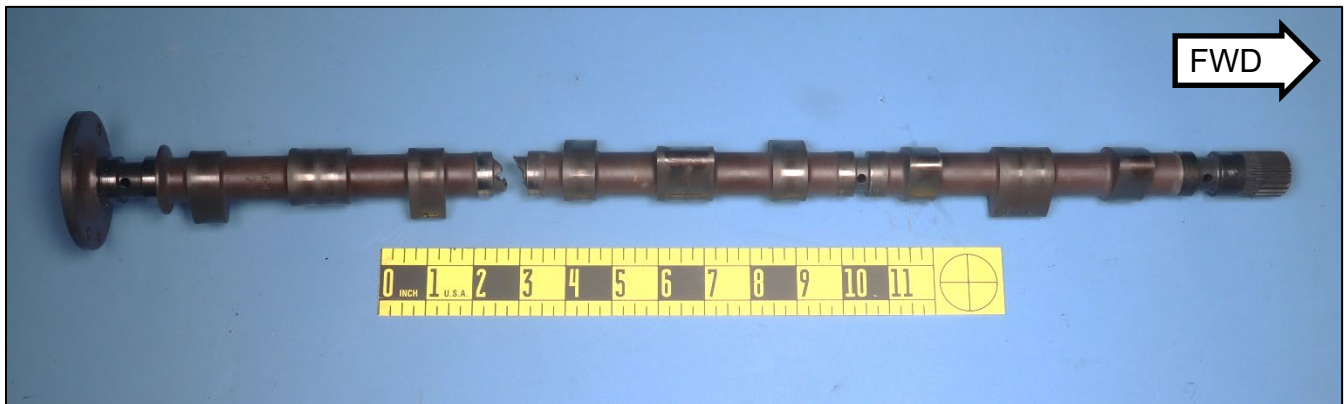
An overall view of the submitted camshaft is shown in figure 1. The camshaft was fractured between lobes associated with the number 2 and number 3 cylinders, intersecting oil transfer holes as shown in figure 2. The fracture plane was angled relative to the transverse plane consistent with fatigue fracture under torsion loading.

Figure 1. Overall view of the submitted camshaft.

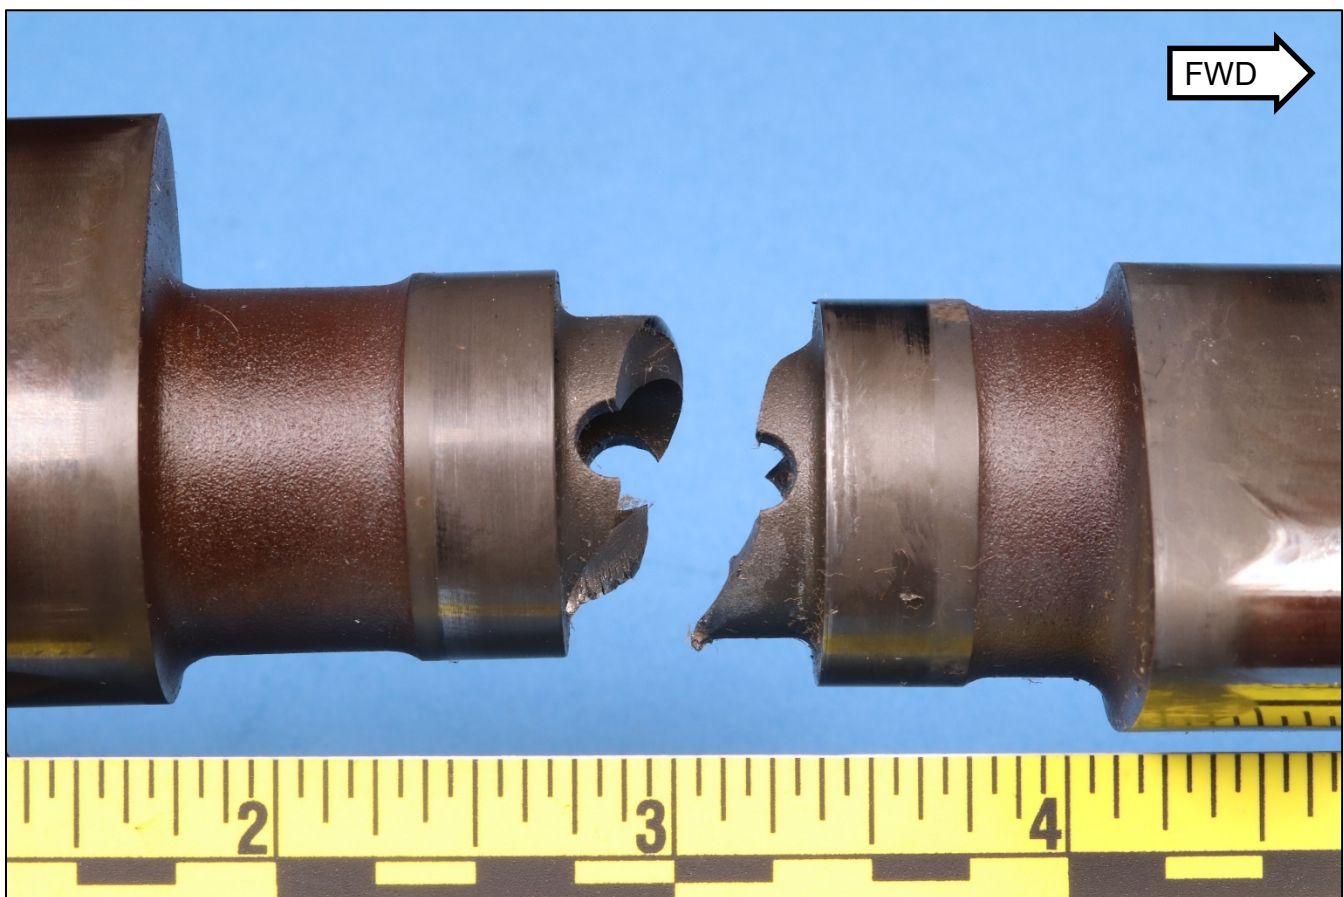
Figure 2. Side view of the camshaft fracture.

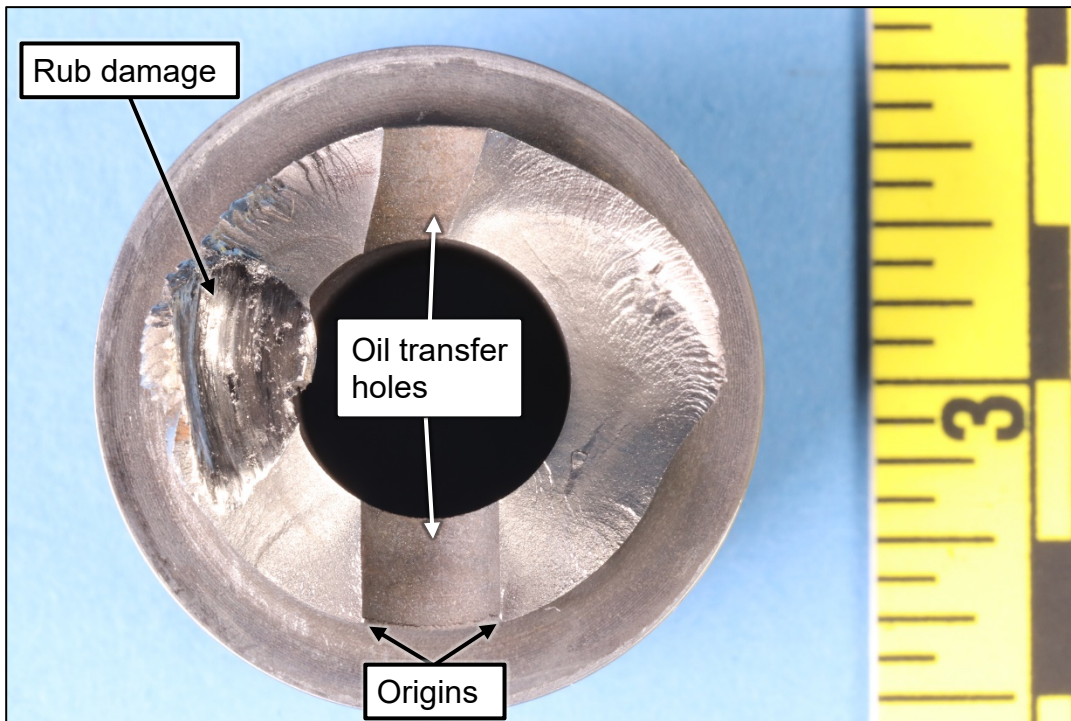
After an initial examination, a transverse cut was made through the camshaft aft of the fracture location to facilitate further examination of the fracture. After cutting, the fracture surface was submerged in acetone and cleaned using an ultrasonic cleaner. A view of the fracture surface on the sectioned and cleaned piece is shown in figure 3. Relatively smooth fracture features with curving crack arrest lines were observed on the fracture surface, features consistent with fatigue. Crack arrest lines emanated from origins at the corner of the oil transfer hole where it intersected the camshaft exterior surface as indicated in figure 3. Fatigue features were observed around most of the fracture surface, intersecting the oil transfer hole at the opposite side of the camshaft. A portion of the fracture had post-fracture rub damage that obliterated the fracture features in the area indicated in figure 3.

Figure 3. Aft side of the camshaft fracture after sectioning and cleaning.

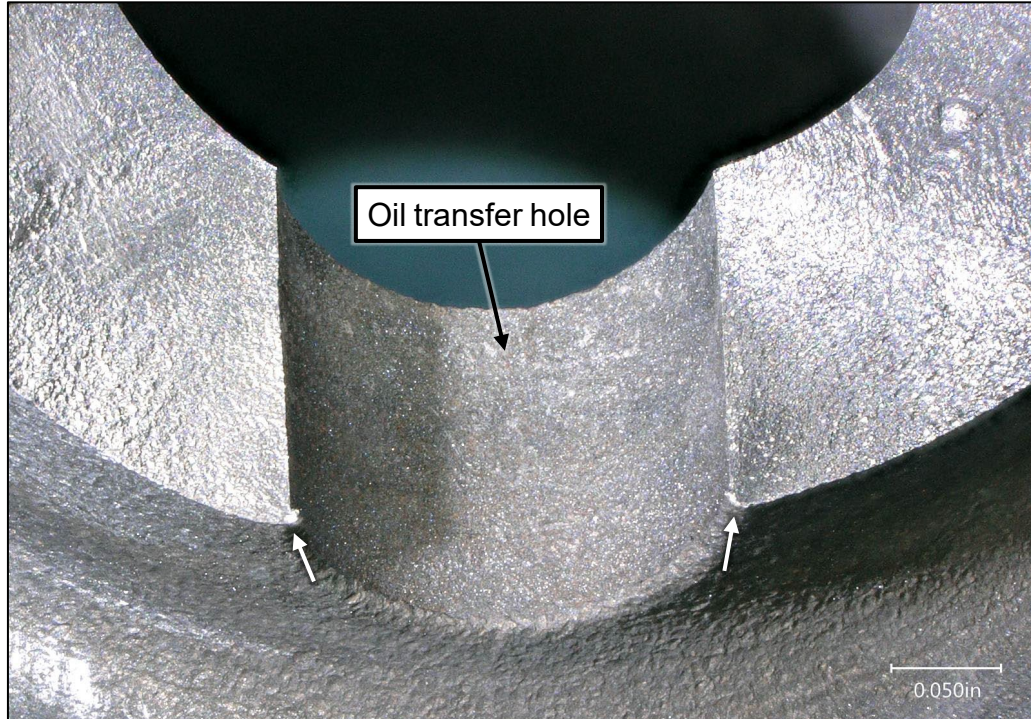
An oblique view of the origin area is shown in figure 4. The exterior surface of the camshaft had a dimpled appearance, consistent with a shot-peened surface treatment. The corner of the oil transfer hole was deformed inward, forming a burr. Dimple features were also observed on the surface of the burr consistent with peening deformation.

Figure 4. Oblique view of the aft side of the fatigue origin area. Unlabeled arrows indicate origins at the outer corner of the oil transfer hole.

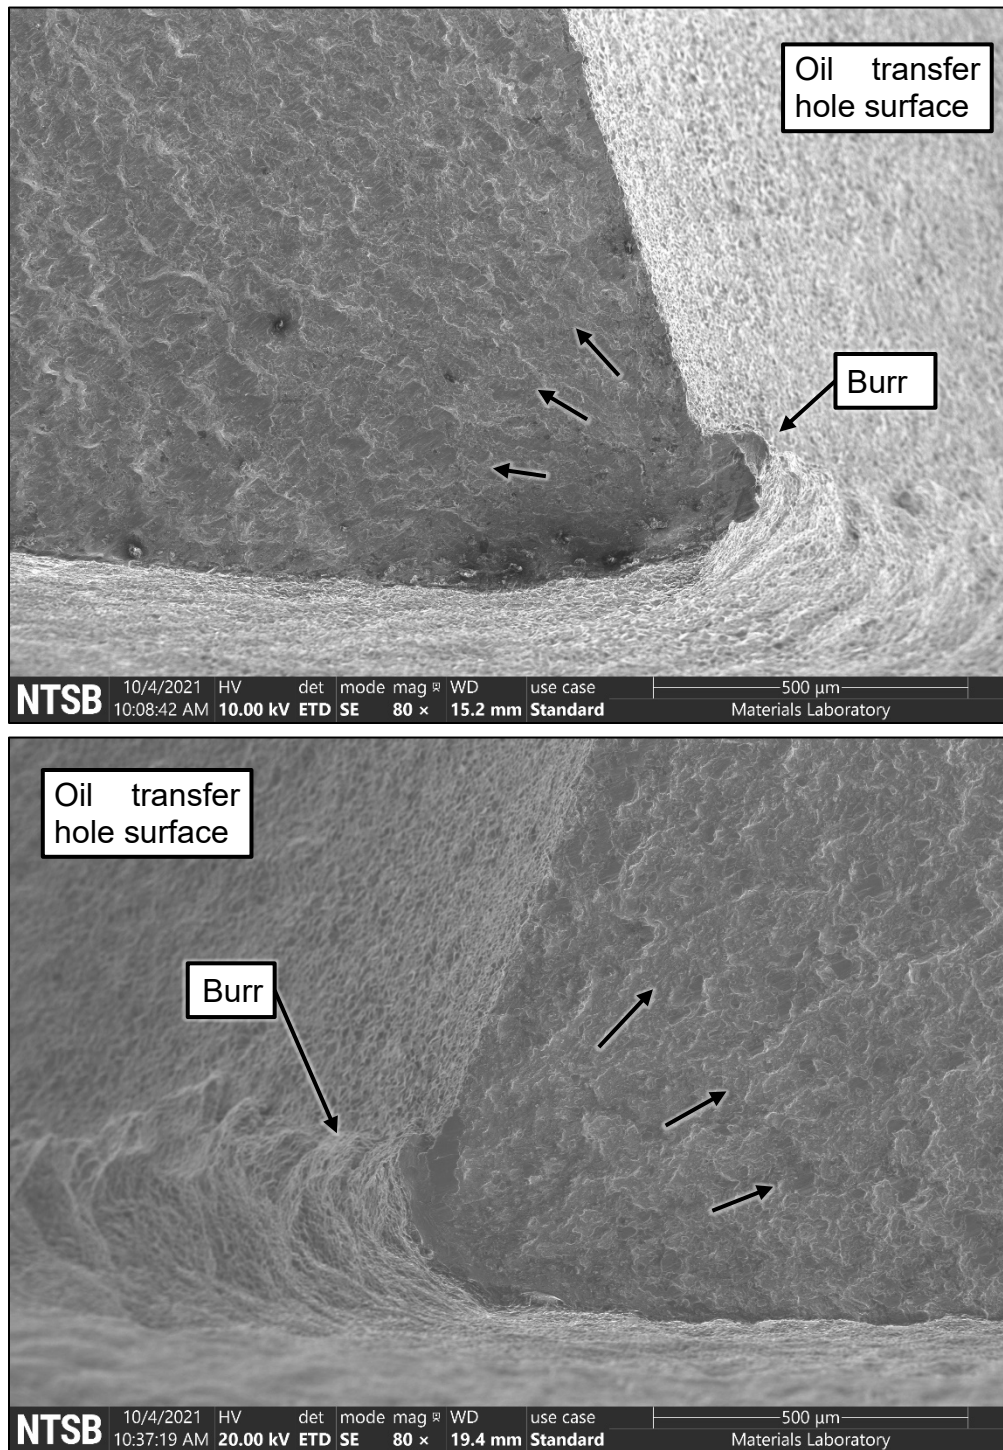
The fracture surface shown in figure 4 was examined using a scanning electron microscope (SEM), and images of the fatigue origins are shown in figure 5. Fine fatigue features were obscured or obliterated by fracture surface recontact damage and

oxidation. However, radial features at each origin area emanated from the oil transfer hole corner where the burr was observed. Unlabeled arrows in figure 5 indicate the local directions of fatigue crack propagation away from the corner.

Figure 5. SEM images of fatigue origins at the corner of the oil transfer hole. Unlabeled arrows indicate the direction of fatigue propagation away from the burr at the hole corner.

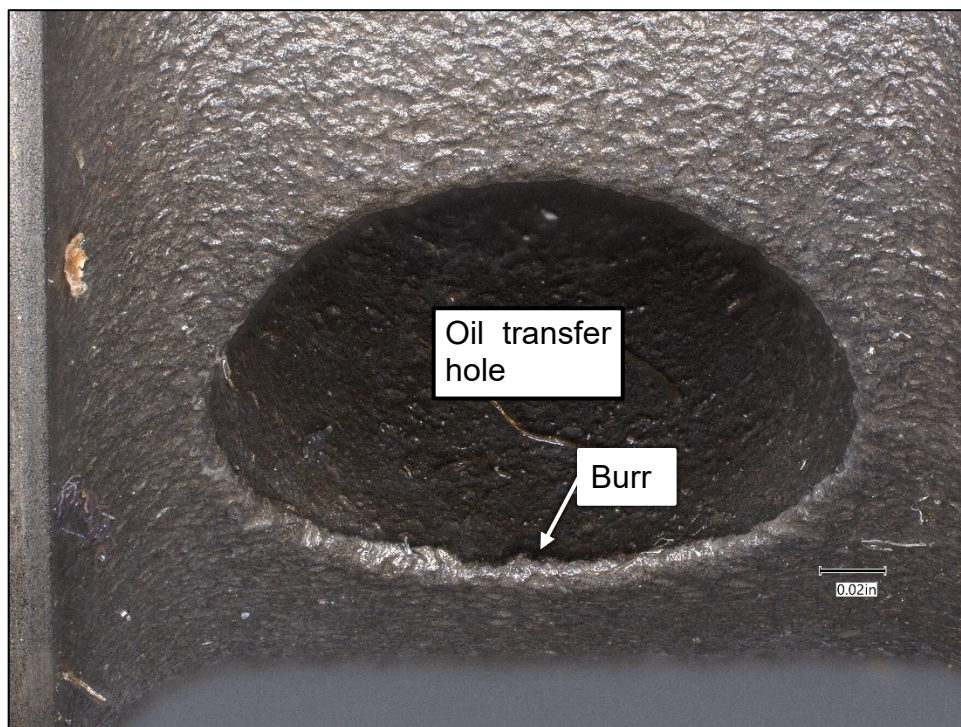
The oil transfer hole between lobes associated with the number 4 and number 5 cylinders is shown in figure 6. A burr was observed at the corner of the hole as shown, but no crack was observed upon examination with an optical stereomicroscope. Next, a transverse cut was made through the hole shown in figure 6 along with another parallel cut to produce a section that could be mounted, polished, and etched for metallurgical examination. A metallographic image of the hole corner on the polished and etched cross-section is shown in figure 7. The etched microstructure was consistent with tempered martensite. At the corner where the burr was observed, the microstructure had an elongated texture consistent with surface deformation associated with the burr formation.

Figure 6. Optical image of another oil transfer hole showing a burr at the corner of the hole.

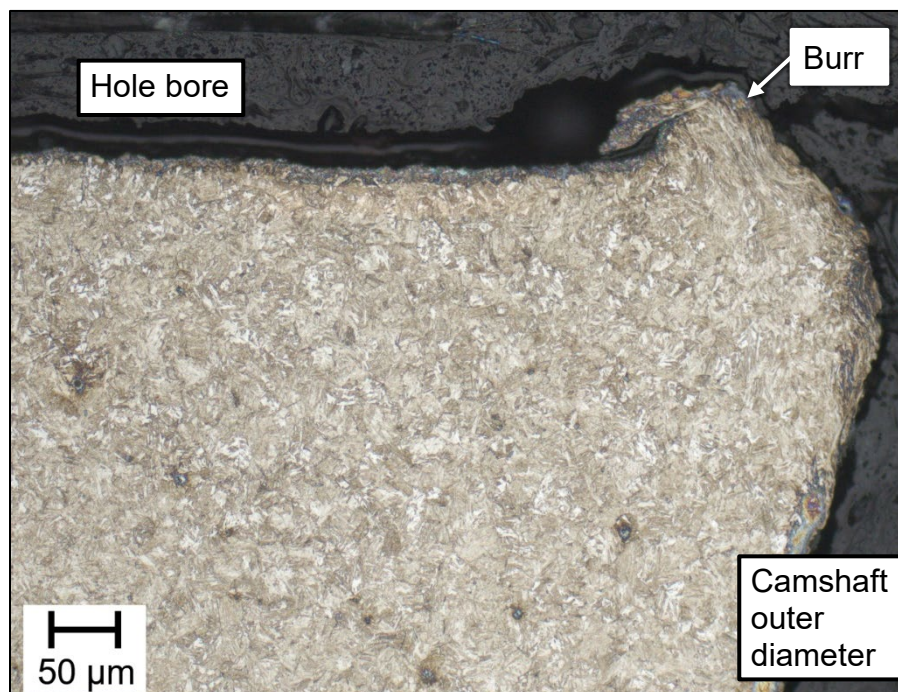
Figure 7. Metallographic image of the hole corner for the oil transfer hole shown in figure 6 (etched with 2% nital).
