| Report number: <b>ML1034300</b> | |
| <p><b>METALLURGICAL REPORT</b></p> | <p><u>Distribution</u></p> <p>1] Phillip Grice</p> |
| Subject: Camshaft fracture IO550N43B S/N: 1034300 | |

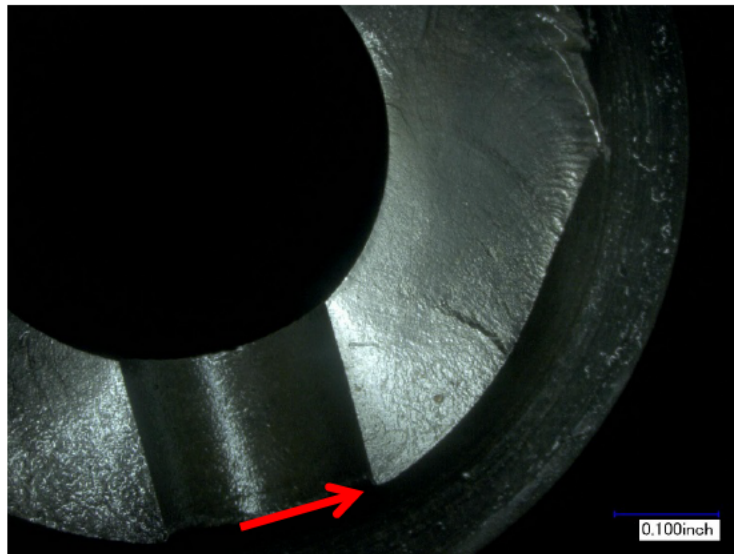
The fractured camshaft from the above serial engine (PN 654084 rev P, shop order 357472) was presented for analysis. The fracture occurred at one of the central oil grooves at the oil transfer hole. Figure 1 and 2 show the fatigue crack started at the surface and moved around the groove. Figures 3 and 4 show the edge where the fracture initiated. The edge of the hole was broken.

- 1] The fracture initiated at the intersection of the oil groove outer diameter and the oil transfer hole.
- 2] The edge of the hole was broken.

*Figure 1 Fracture origin at edge of hole*

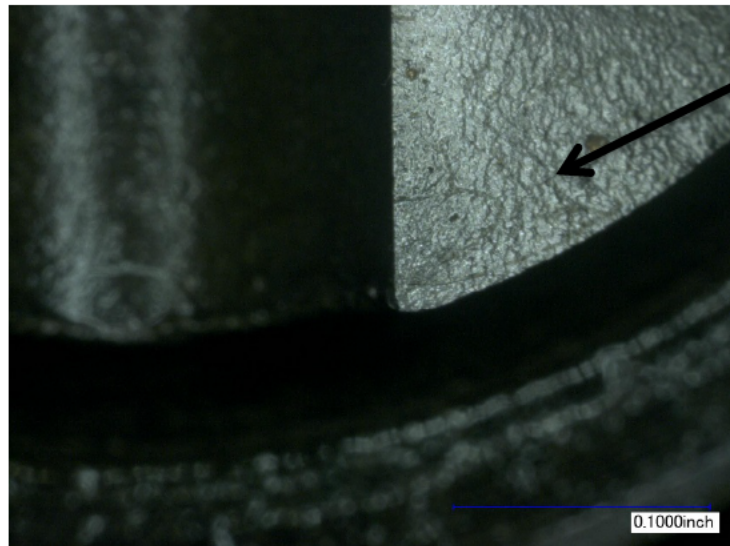
*Figure 2 Beachmarks coming from origin of fracture*

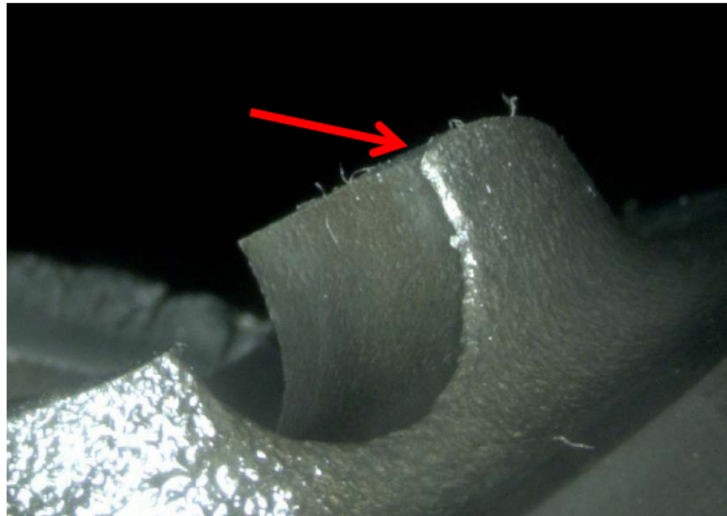
*Figure 3 Side view of fracture origin*

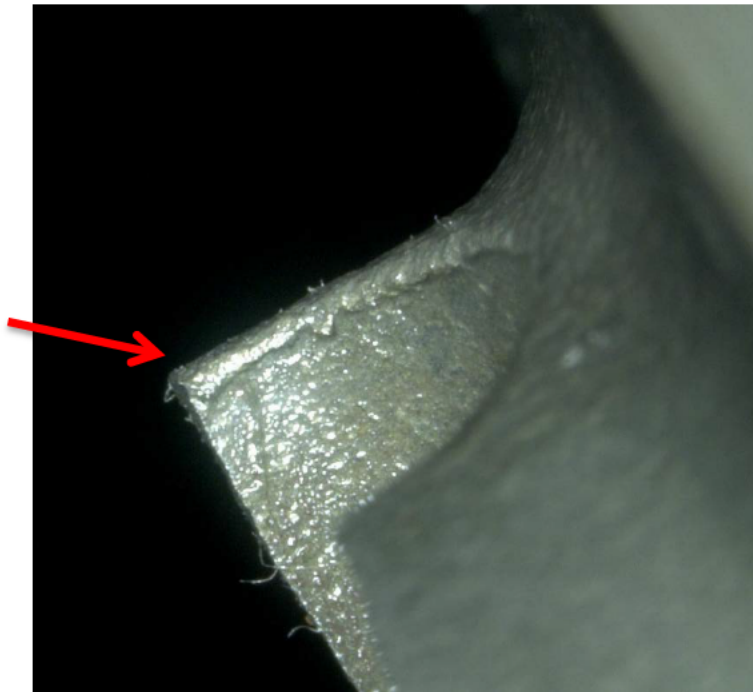
*Figure 4 Edge of origin*
