## **Engine Investigation Report**

**Rolls-Royce Corporation  
Model 250-C20B  
Engine CAE-836941**

**US Dept. of Agriculture – OH-6A  
Weston, Georgia**

**Accident date: 8 January 2020  
Wreckage exam date: 16 January 2020  
Engine exam date: 4-5 January 2020  
Report date: 13 March 2020  
NTSB Case: ERA20LA071**

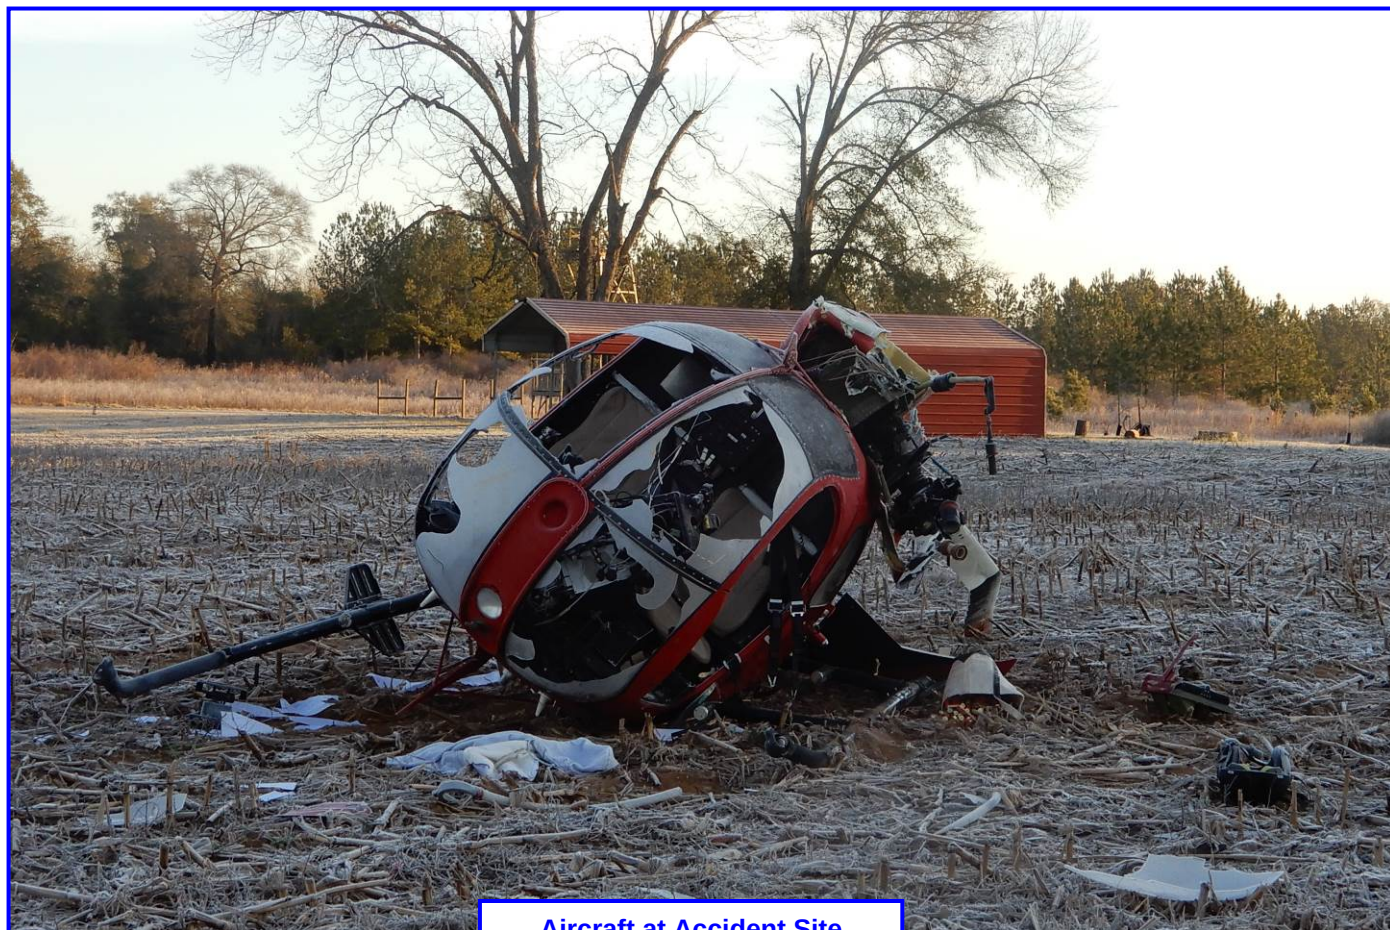
The aircraft contacted the ground apparently with the tail stinger first and with some amount of forward speed. The tail boom had been fracture separated approximately 12-15" forward of the vertical stabilizer and was laying a distance away from the main wreckage. The aircraft touched down and nosed over allowing the main rotor blades to contact the ground. The aircraft rotated approximately 180° from its original direction of flight. The pilot stated that the engine appeared to have run at idle or less for about 3 seconds. He doesn't recall if he shut off fuel or if the engine had FOD'd itself out.

Aircraft at Accident Site

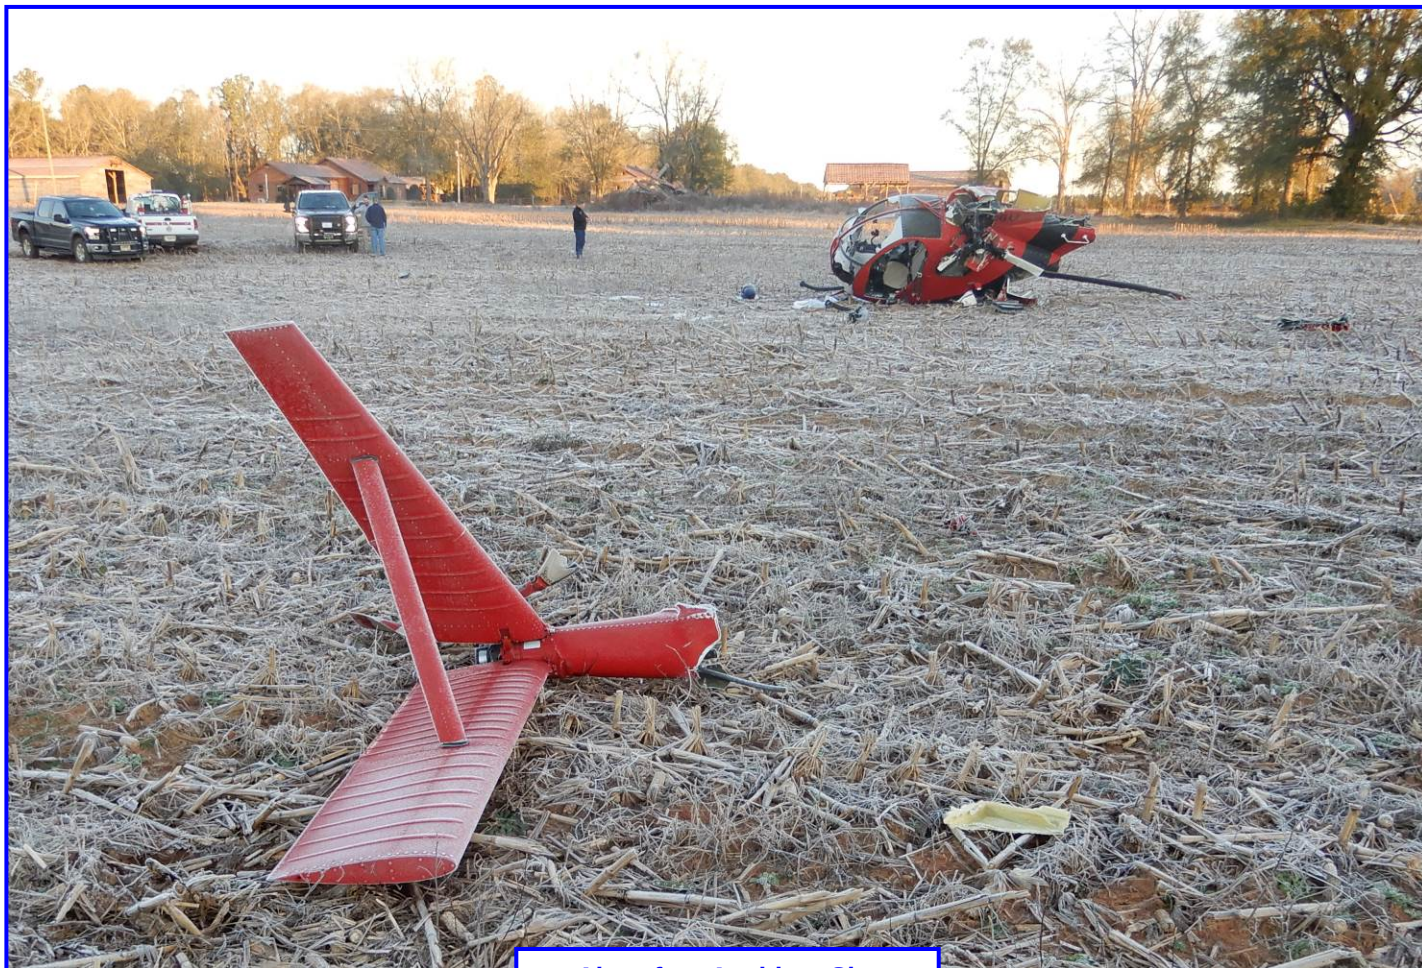
Aircraft at Accident Site

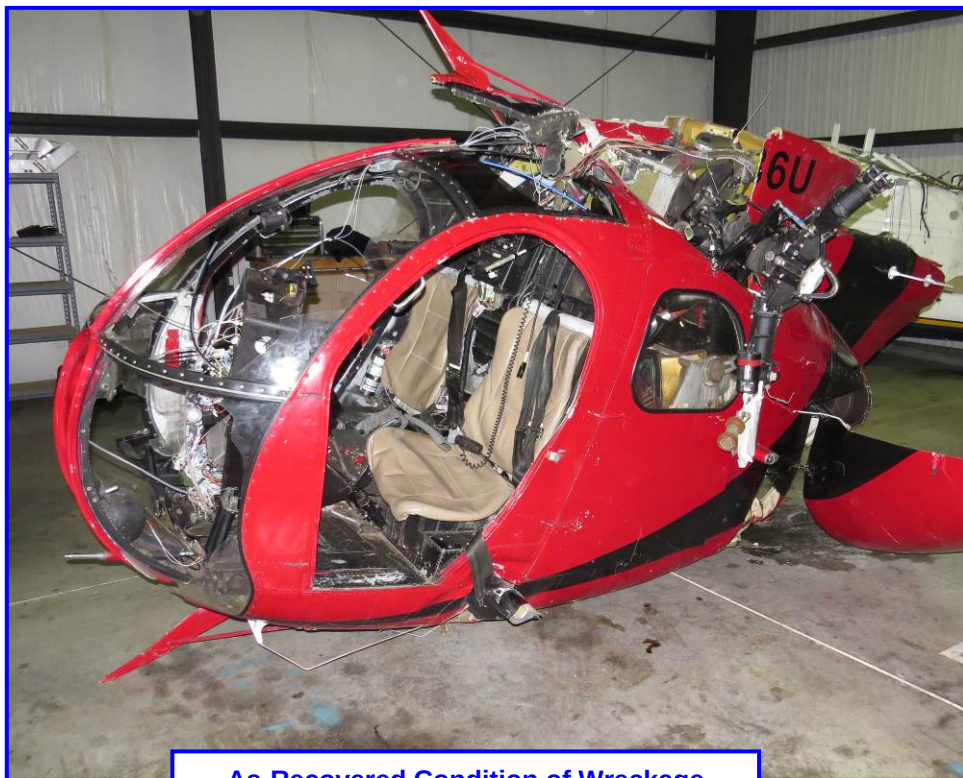
The aircraft sustained substantial damage upon impact fracturing the entire left hand skid and strut assembly. The windscreen was heavily fragmented.

The airframe also sustained major damage to the main rotor and transmission area as well as the surrounding fairing structure. The right hand skid was cut off to allow the fuselage to sit level for the purposes of the examination.

The tail-boom and tail rotor driveshaft were severed forward of the tail-boom's attachment point with the fuselage.

As-Recovered Condition of Wreckage

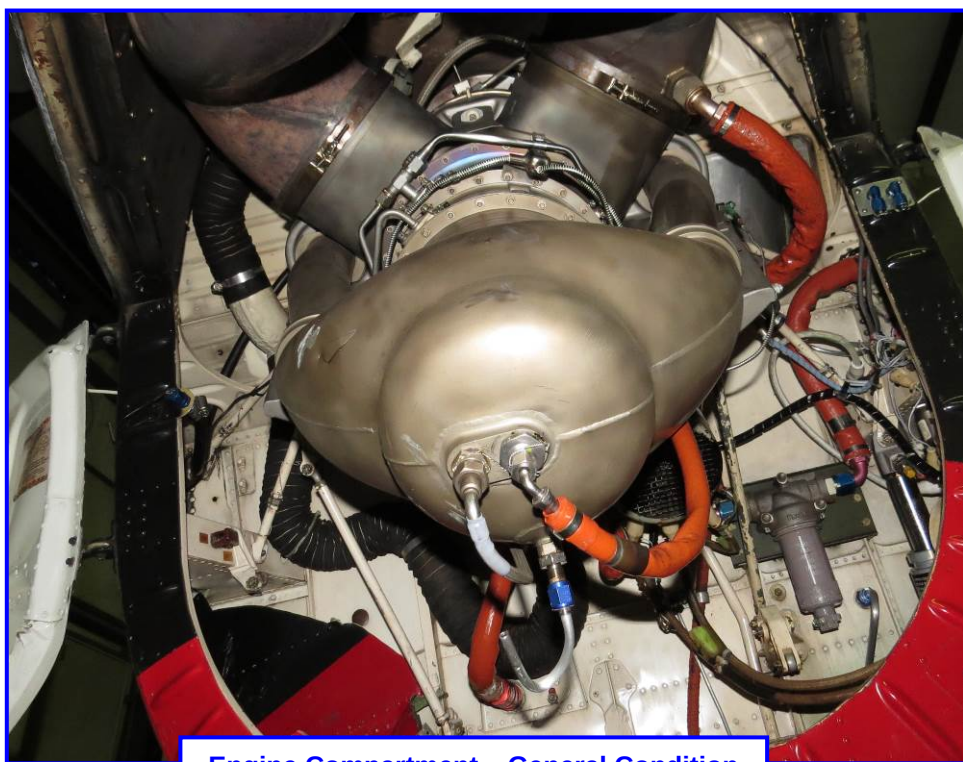
Engine Compartment – General Condition

The control linkage providing movement of the Power Turbine Governor (PTG) was disabled due to fracture at the rod end and bell-crank support bracket at the firewall. Full stop-to-stop travel of the control arm was confirmed at the PTG.

With the exception of minor impact damage to the left rear side of the Outer Combustion Case (OCC – described later in this report) and a bent/deformed burner drain valve extension tube, the engine exterior did not reveal any obvious additional signs of damage from impact forces, internal engine failure, or evidence of fire.

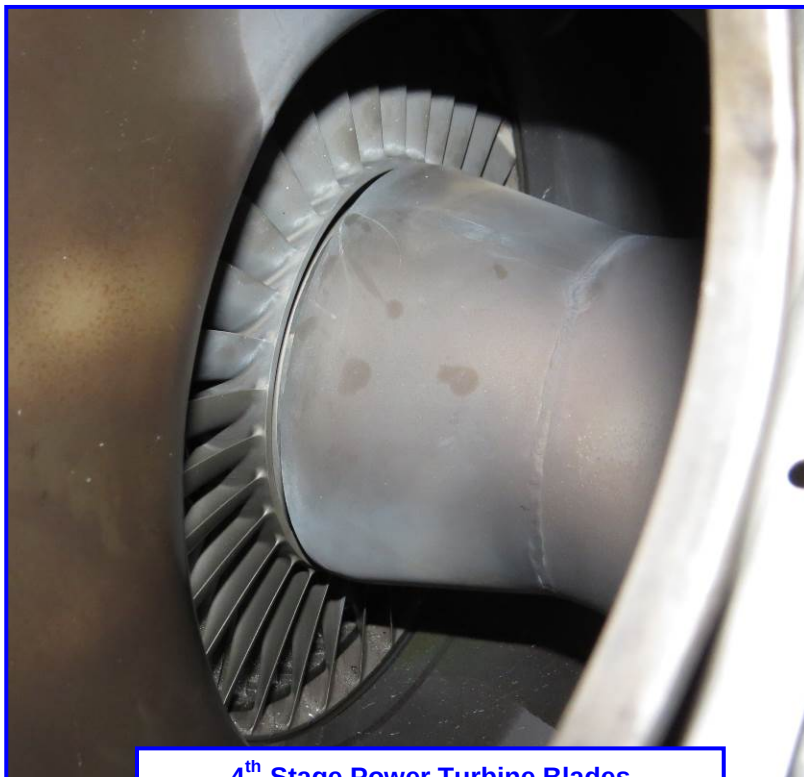
The 4<sup>th</sup>-stage turbine blades appeared undamaged when inspected as did the surrounding turbine sections and exhaust plenum.

4<sup>th</sup>-Stage Power Turbine Blades

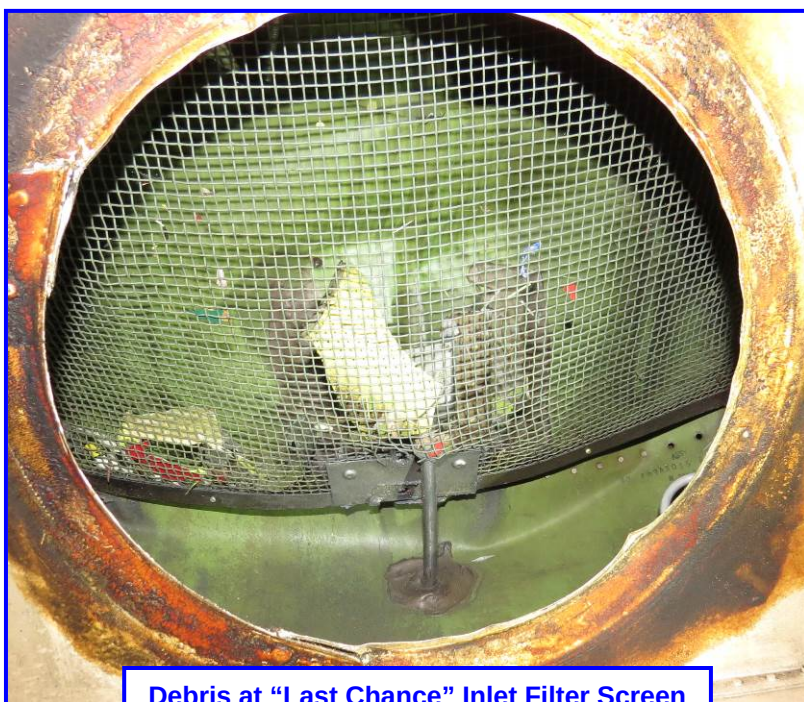
Following removal of the engine, a large amount of random liberated airframe debris from surrounding cowlings & nacelle fairing structure was noted on the inlet (last chance) coarse screen forward of the compressor inlet.

Debris at "Last Chance" Inlet Filter Screen

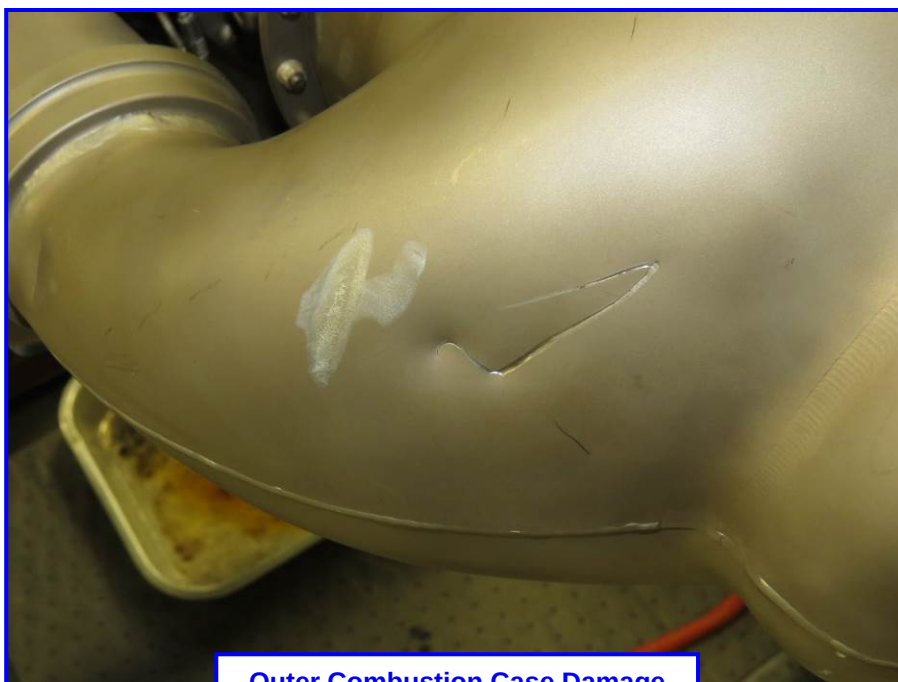
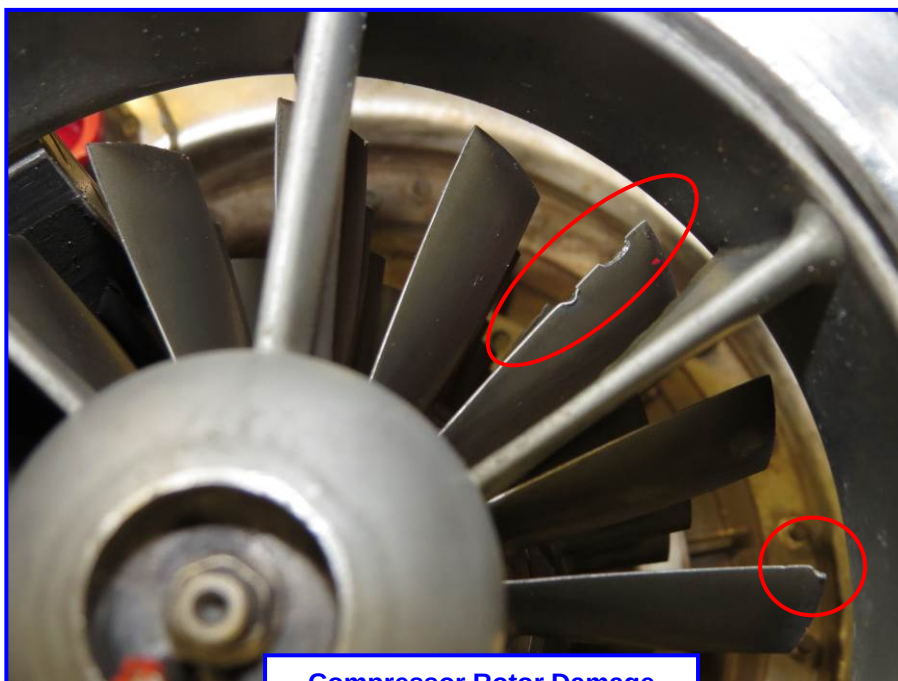
The compressor front support and inlet guide vanes appeared undamaged. Several 1st-stage compressor blades contained areas of missing material from impact damage. The damage appeared jagged and was isolated primarily to the outer  $\frac{1}{2}$  to  $\frac{1}{3}$  of the airfoil leading edge. Borescope inspection revealed damage to a lesser extent back to the 4th-stage blades.

A compressor case half was removed in order to inspect the extent of damage throughout the compressor. The static vanes appeared mostly undamaged. Small bits of vegetation debris were noticed in the compressor.

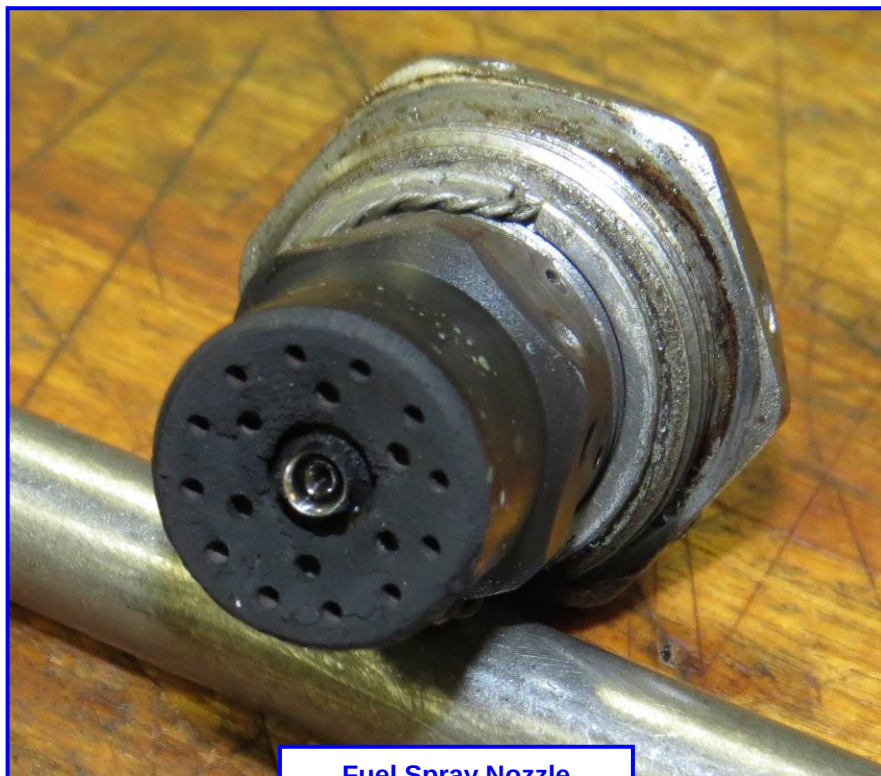
The fuel supply line was removed from the fuel spray nozzle; about 1-1/2 teaspoons of clean, bright fuel drained from the line. The fuel spray nozzle was removed and examined. There was no evidence of obstruction in the fuel spray nozzle inlet. The spray face exhibited a light, uniform carbon and soot appearance. There did not appear to be any blockage within the air distribution holes. The nozzle was not disassembled prior to the engine run.

Fuel Spray Nozzle

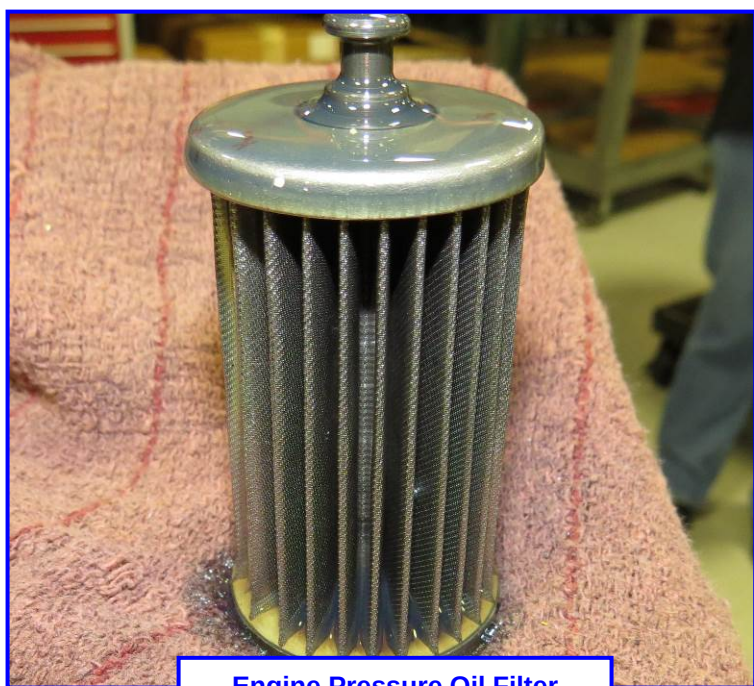
The engine pressure oil filter was removed and inspected clean of ferrous metal, foreign debris, or similar contamination. Approximately 1 tablespoon of clean oil was in the bottom of the gearbox oil filter housing. The engine fuel pump filter was removed and inspected. A few very small bits of black debris were noted between adjacent pleats that were visible when shining light from the inside. The filter was refitted to the pump housing as is.

Engine Pressure Oil Filter

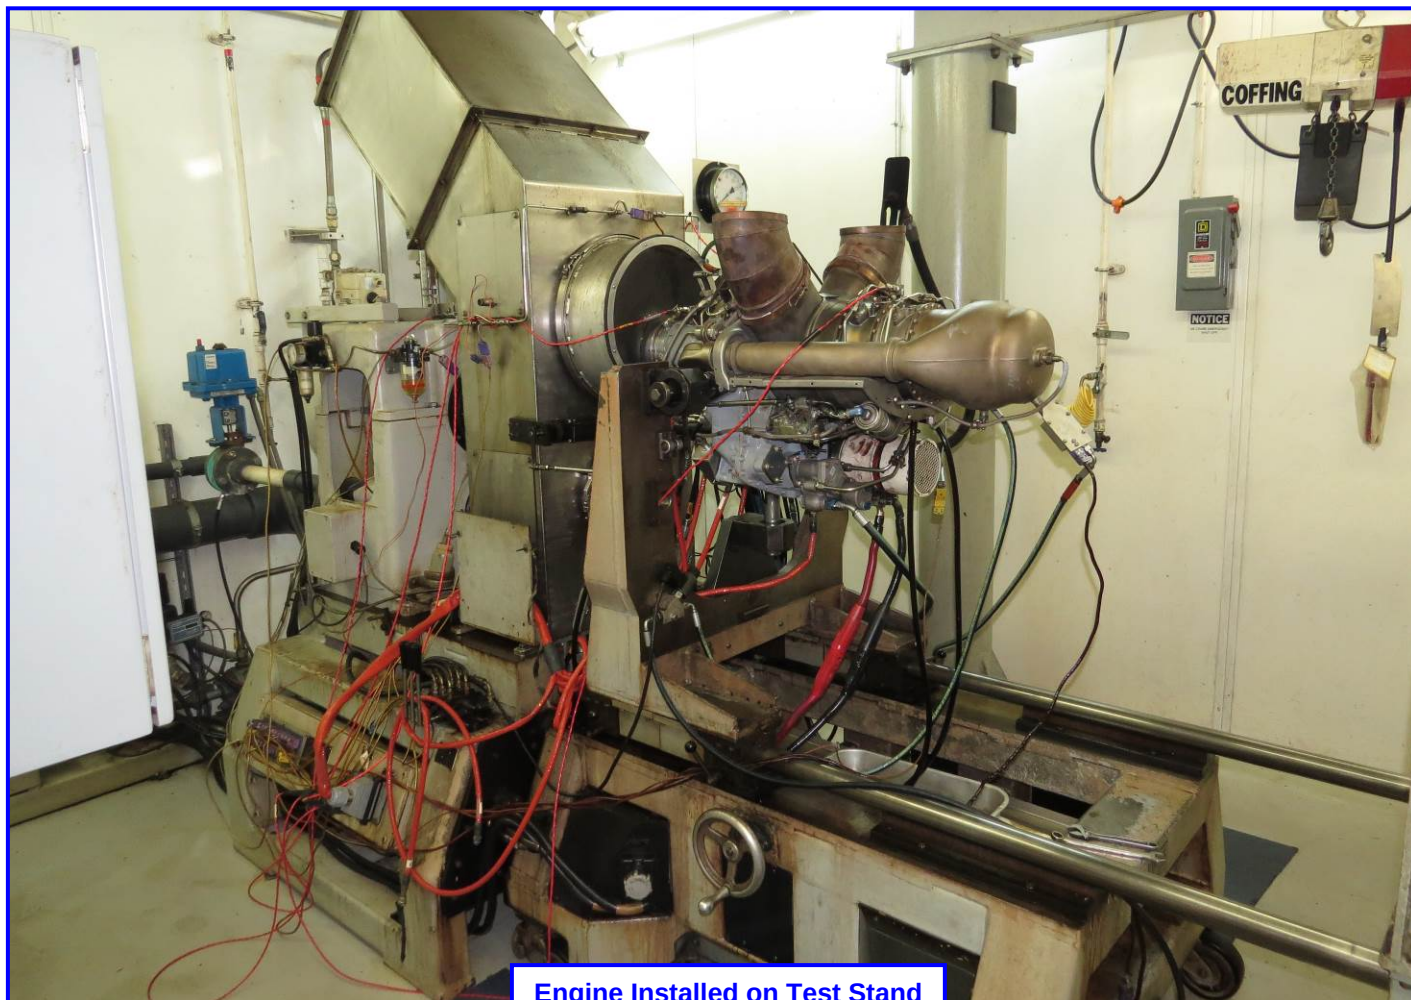
Engine Installed on Test Stand

During coast down following the seal run-in run the engine began to rock back and forth on the stand, essentially pivoting about the side mounts on the gearbox. This condition repeated itself during a motoring attempt but to a lesser extent given the comparatively low N1/N2 rotor speeds. Troubleshooting revealed that the lower engine mount attachment to the gearbox had come loose. The lower test stand mount contains a triangular shaped pad that is held to the gearbox with 3 bolts. Keystone mechanics typically only use 2 bolts for this connection. During the troubleshooting it was noted that 1 of the 2 bolts had fallen out completely and the 2<sup>nd</sup> bolt was backed off the mount by approximately 1/8-3/16". Further testing of the engine was not pursued given the uncertainty as to the cause for the lower mount issue.

Lack of additional running prevented the ability of performing the full test procedure including the power calibration, governor droop, and accel/decel checks. The limited amount of test stand running did produce acceptable results. When corrected for standard atmospheric conditions, the engine yielded performance +8.3% above new-production standards at "low cruise" (300 horsepower), +7.8% above new-production standards at normal cruise (370 horsepower), and +16.2% above new-production standards at maximum (Take-Off) power (420 horsepower).

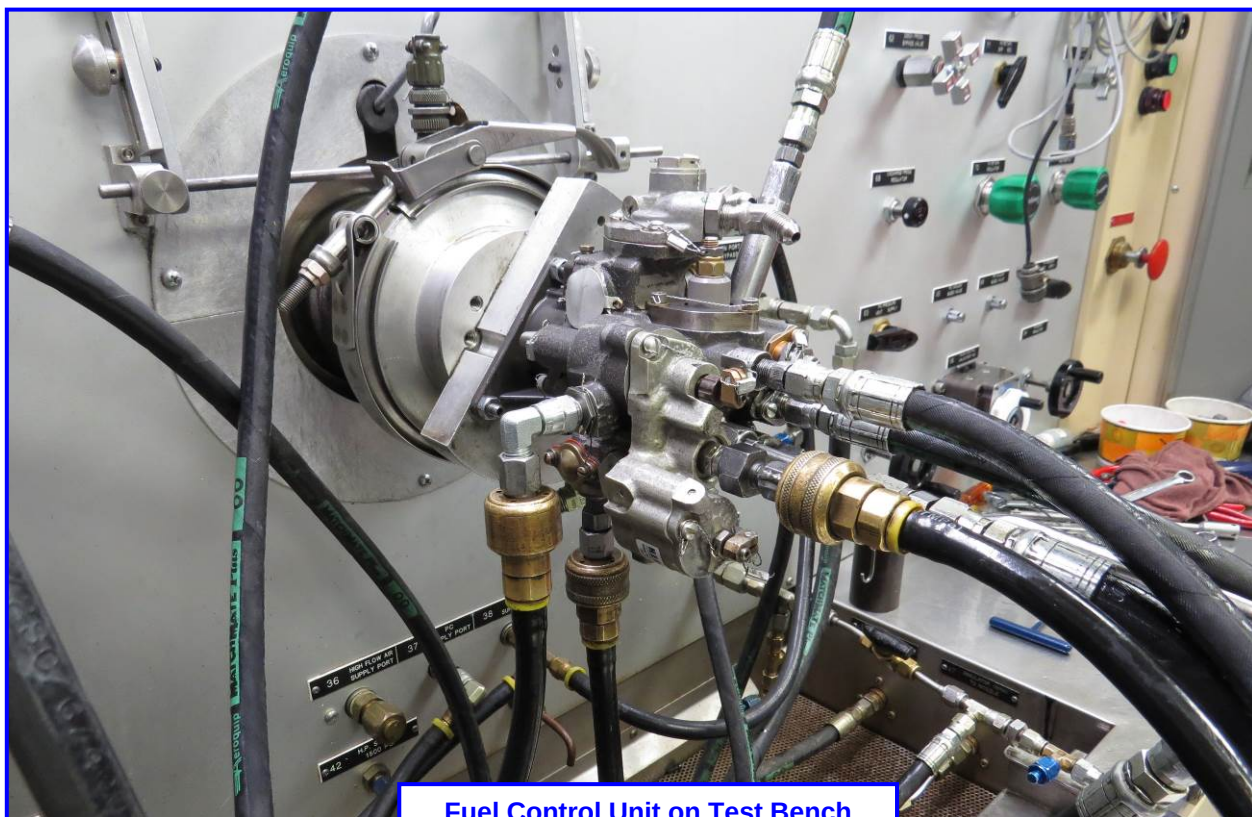
The FCU was tested two separate times due to an anomaly with the minimum fuel flow set point. It was later determined that the Px air fitting (test stand component) was slightly leaking. This condition was corrected and the FCU performed satisfactorily. The FCU internal fuel filter was removed and inspected clean & free of blockage and debris.

Fuel Control Unit on Test Bench

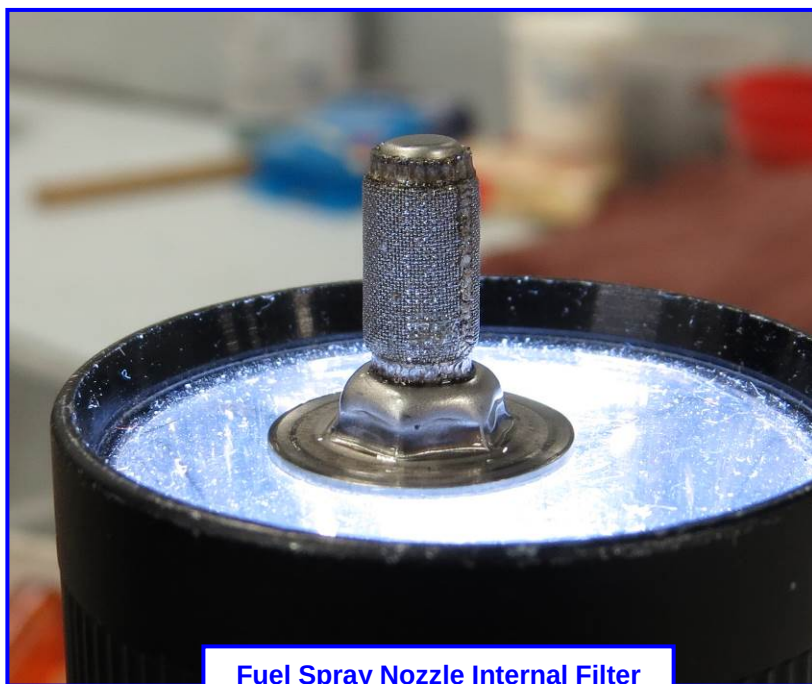
The fuel spray nozzle displayed minor streaking at the high flow test point. The nozzle was disassembled and the internal screen was void of debris or evidence of collapse.

Fuel Spray Nozzle Internal Filter

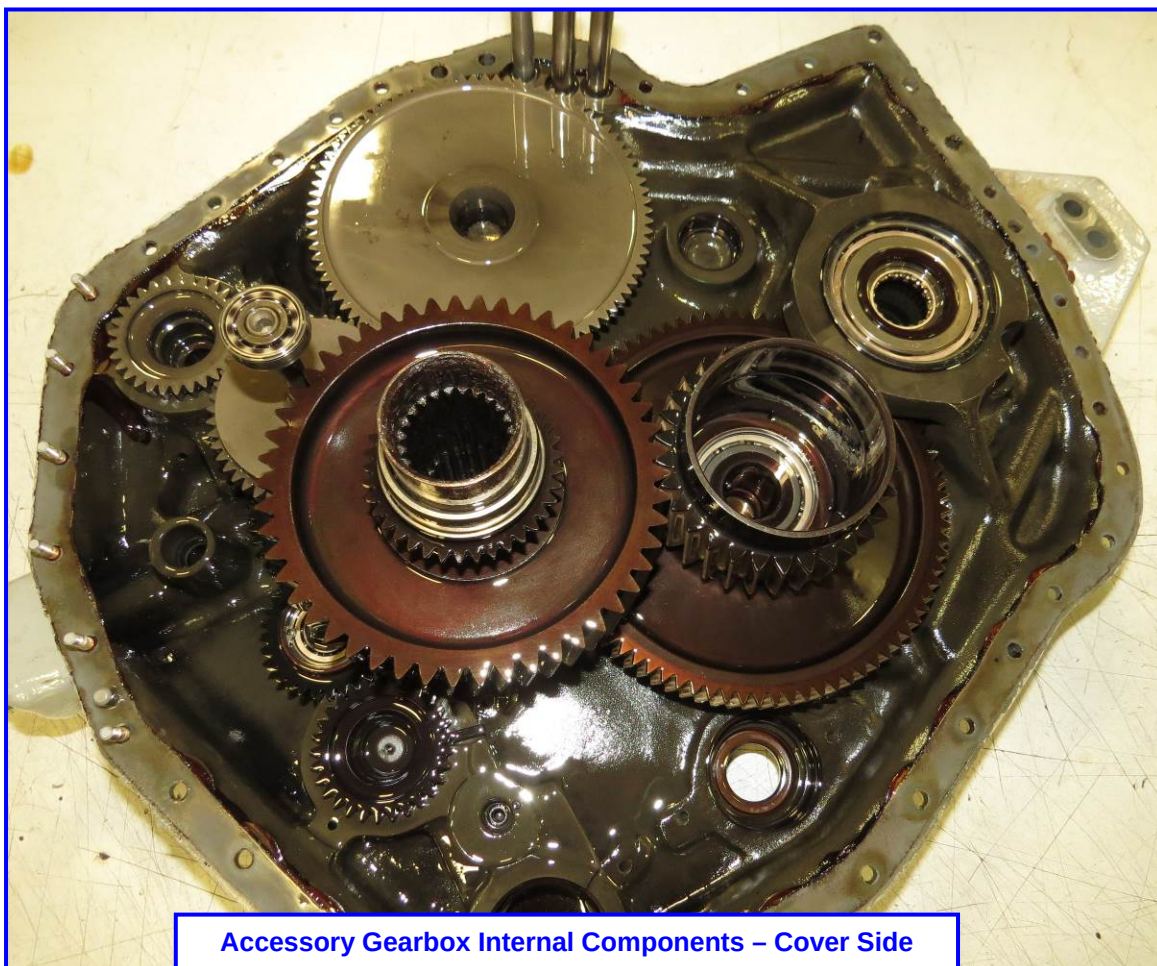
Following completion of the accessories testing the gearbox assembly was opened to expose the internal gearing and components. The magnetic chip detectors were also removed following the engine test. Both MCDs appeared clean. The gearbox and internal components were oil wetted, void of suspended metallic debris, and visually unremarkable.

Accessory Gearbox Internal Components – Cover Side

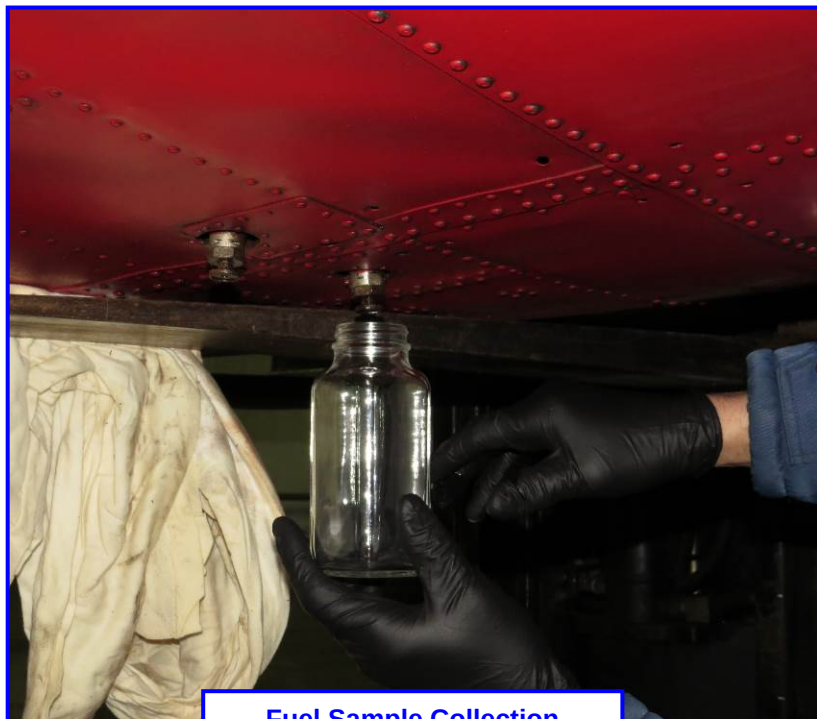
The fuel cell panels were removed allowing access to the internal bladder of the main tank. Prior to defueling the aircraft, a fuel sample (~ ½ liter) was collected via the petcock drain valve from the bottom of the fuselage. The sample was retained by the USDA for shipment to an external lab for further analysis. Test results appeared normal for the parameters measured by the lab; specifically water, bacteria, & fungus. Approximately 25 gallons of clean, clear fuel was subsequently drained from the tank.

**Fuel Sample Collection**

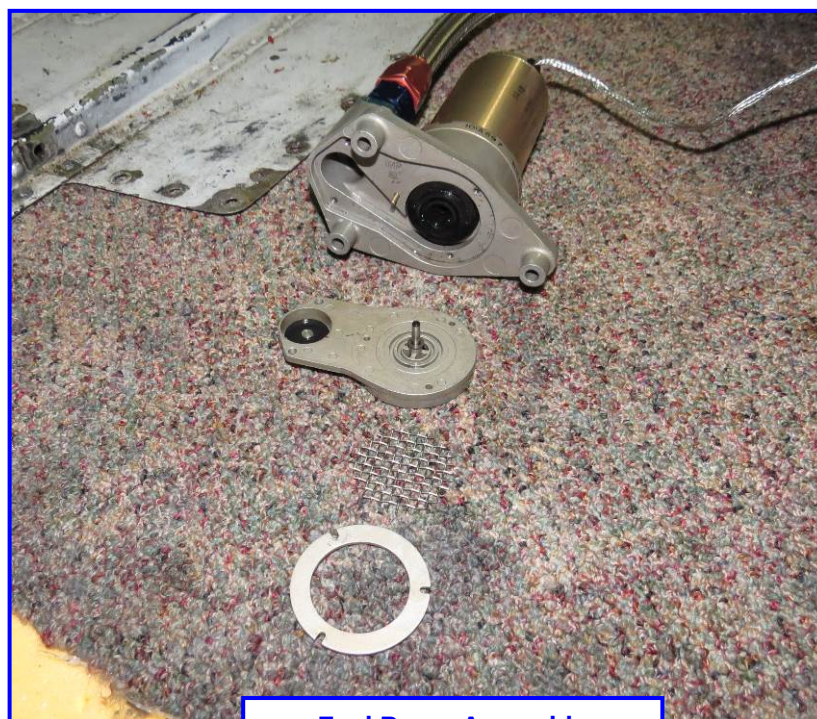
The fuel pump was removed and tested using a spare 28-volt battery and a supply of drained fuel collected in a bucket. The pump operated normally. The boost pump was partially disassembled following the test to inspect for any signs of debris, blockage, or other abnormalities. The pump appeared unremarkable.

**Fuel Pump Assembly**
