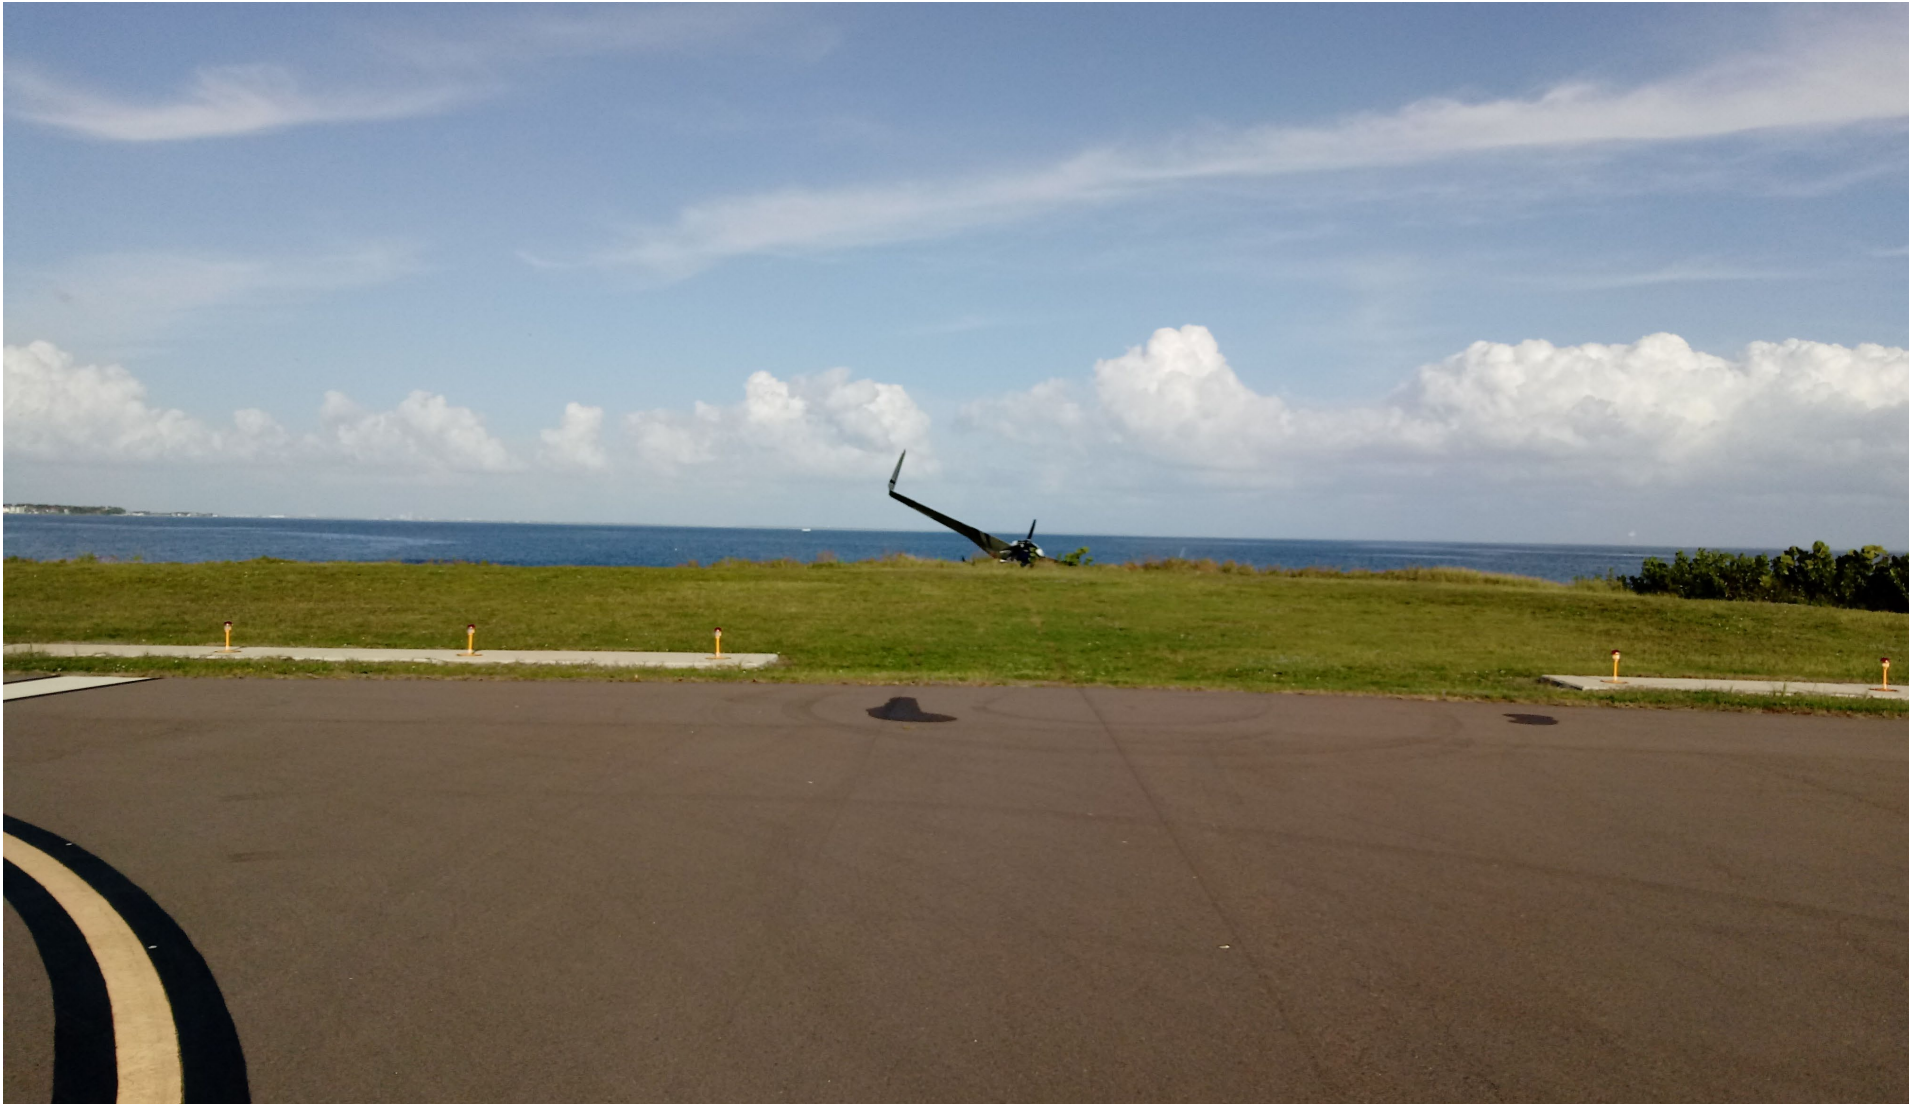
**Photo 1 – Accident Site – Courtesy of City of St. Petersburg**

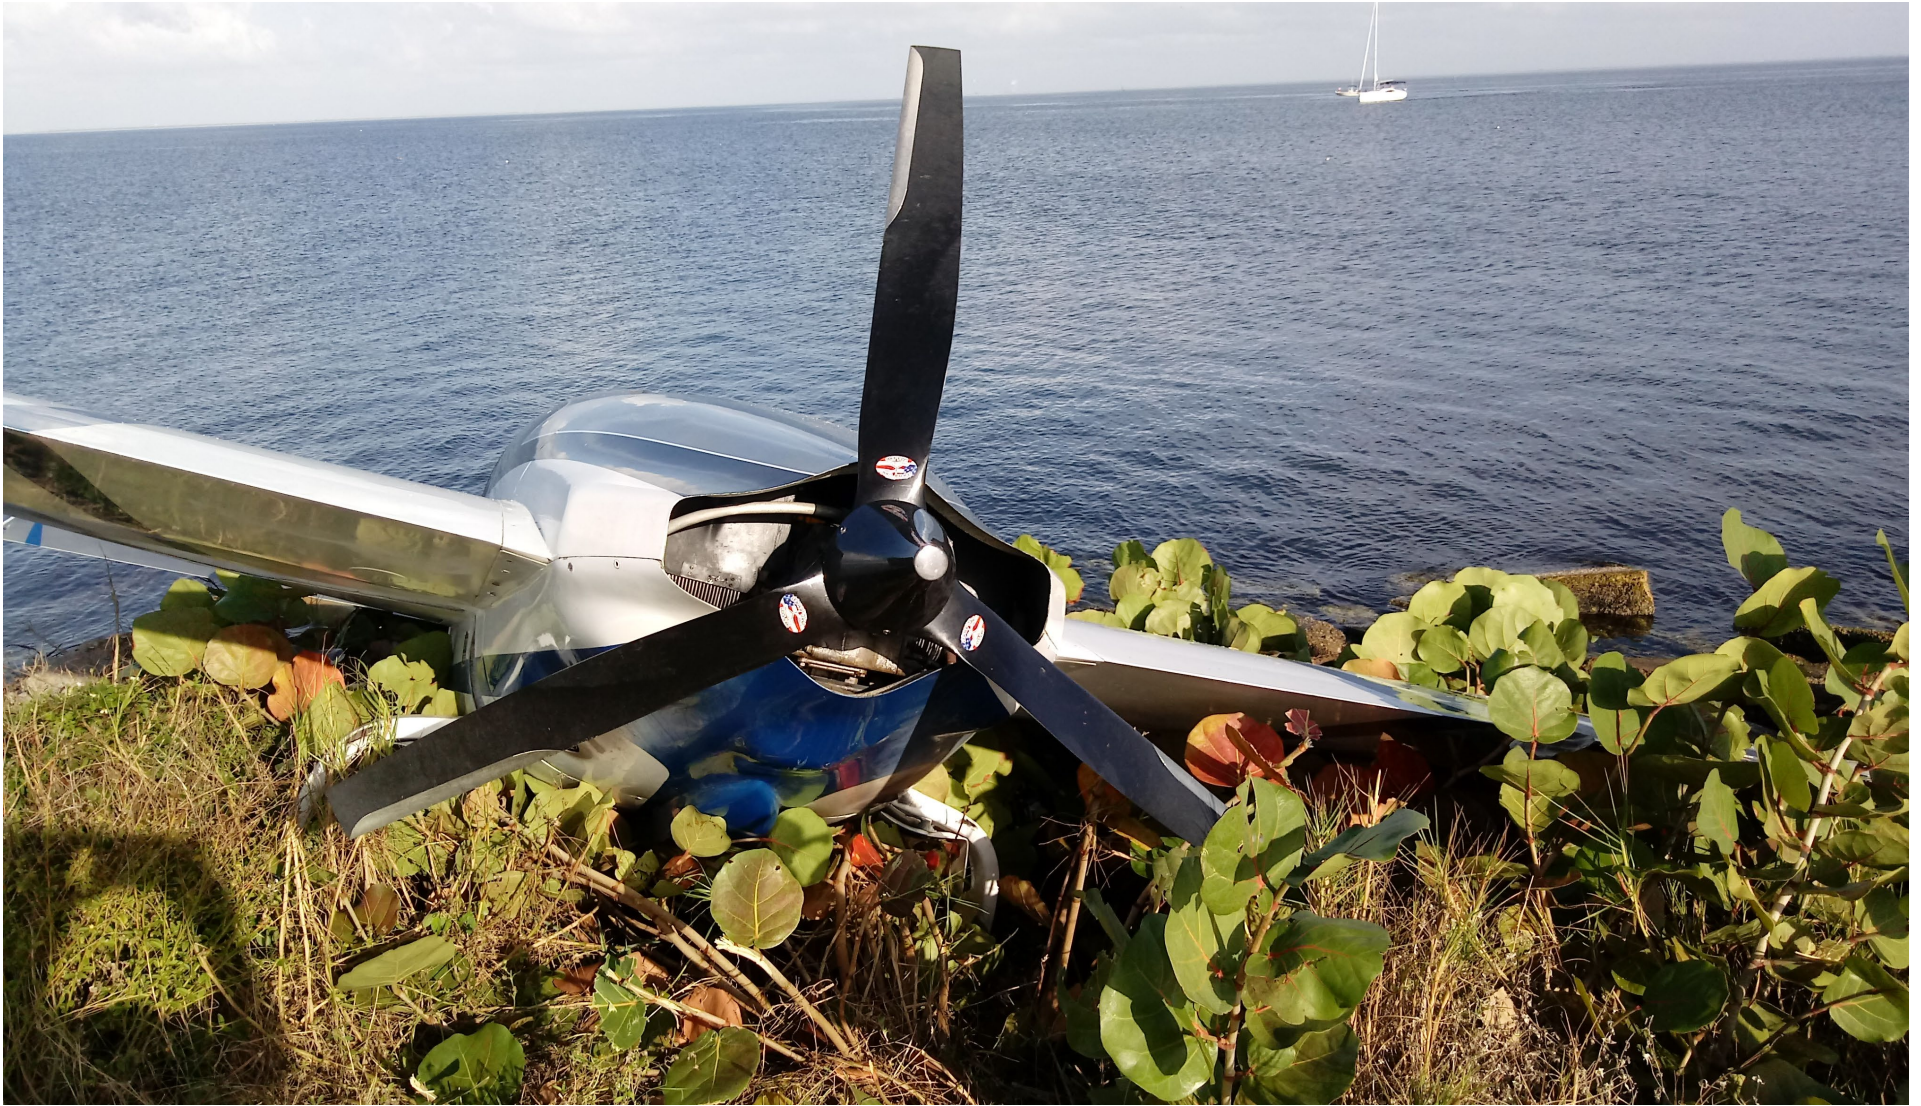
**Photo 2 – Main Wreckage - Accident Site – Courtesy of City of St. Petersburg**

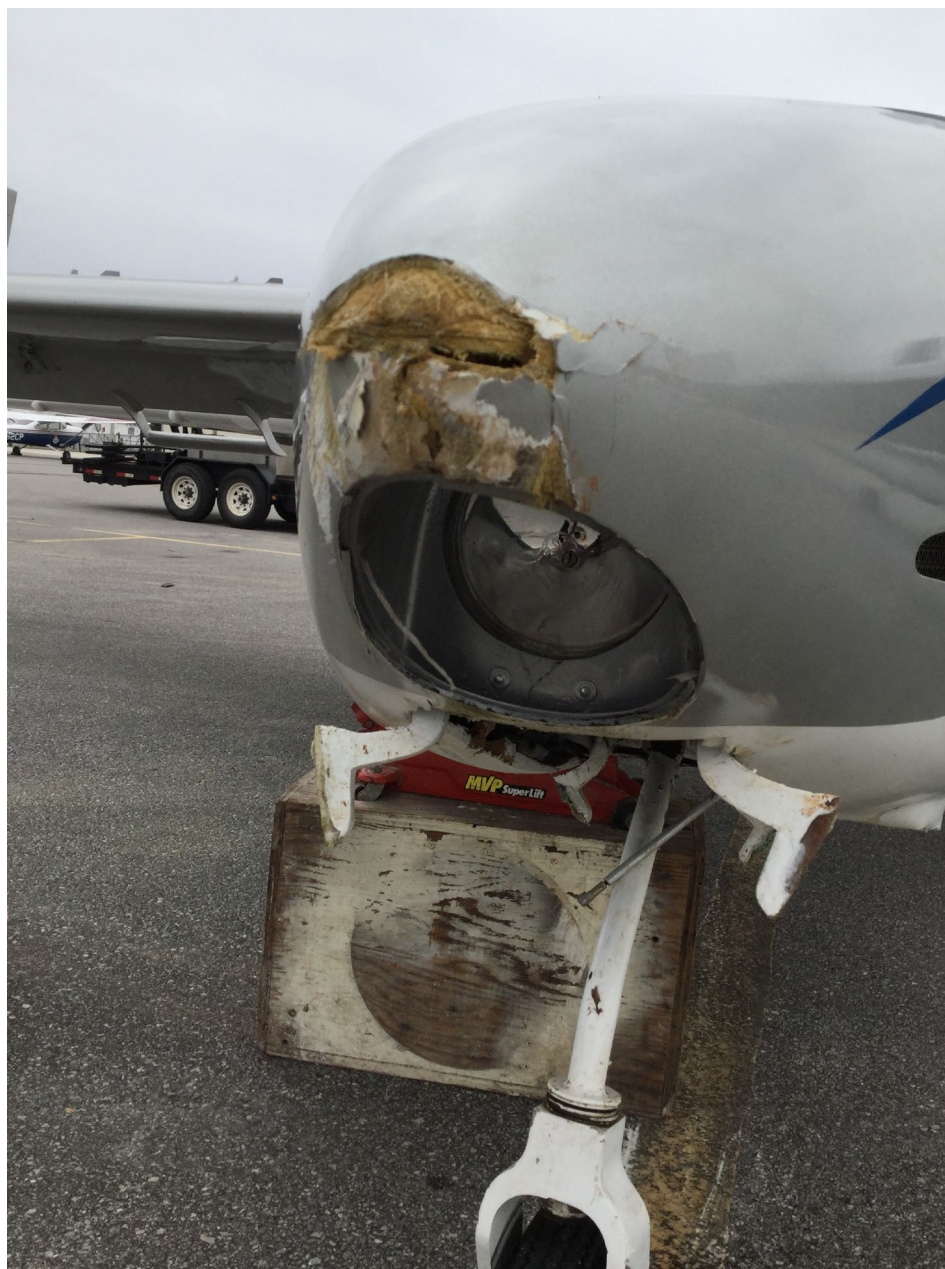
**Photo 3 – Nose Section – Courtesy of FAA**

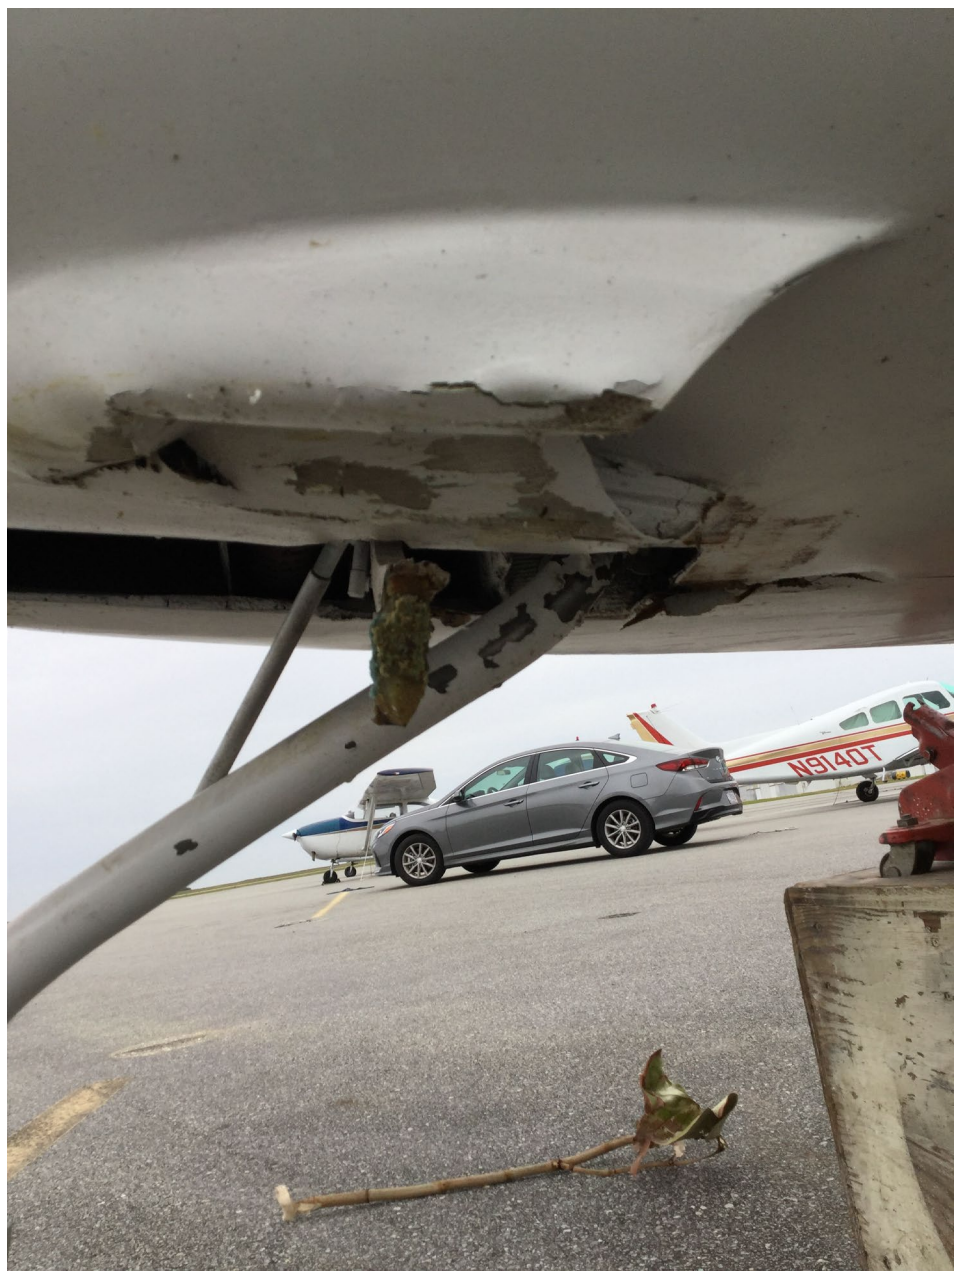
**Photo 4 – Nose Gear Well – Courtesy of FAA**

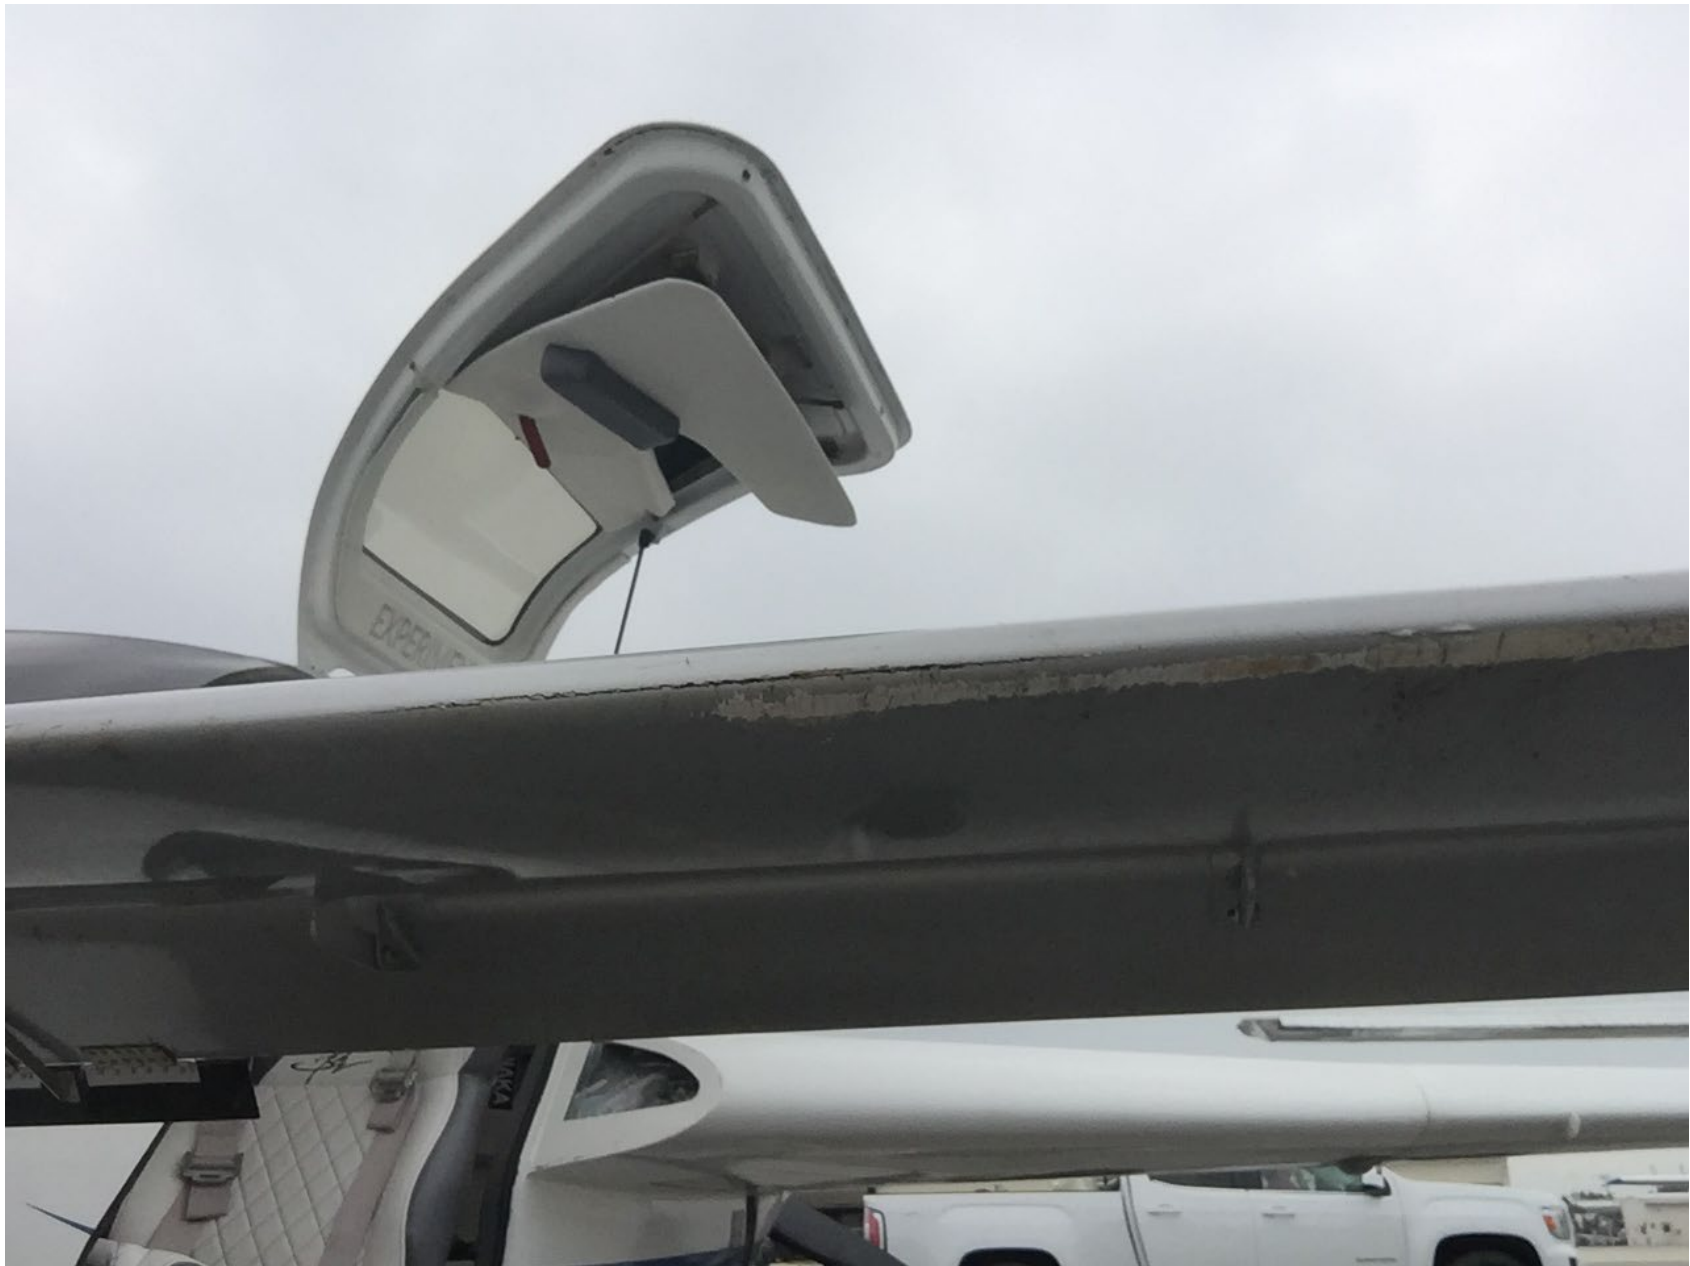
**Photo 5 – Left Canard – Courtesy of FAA**

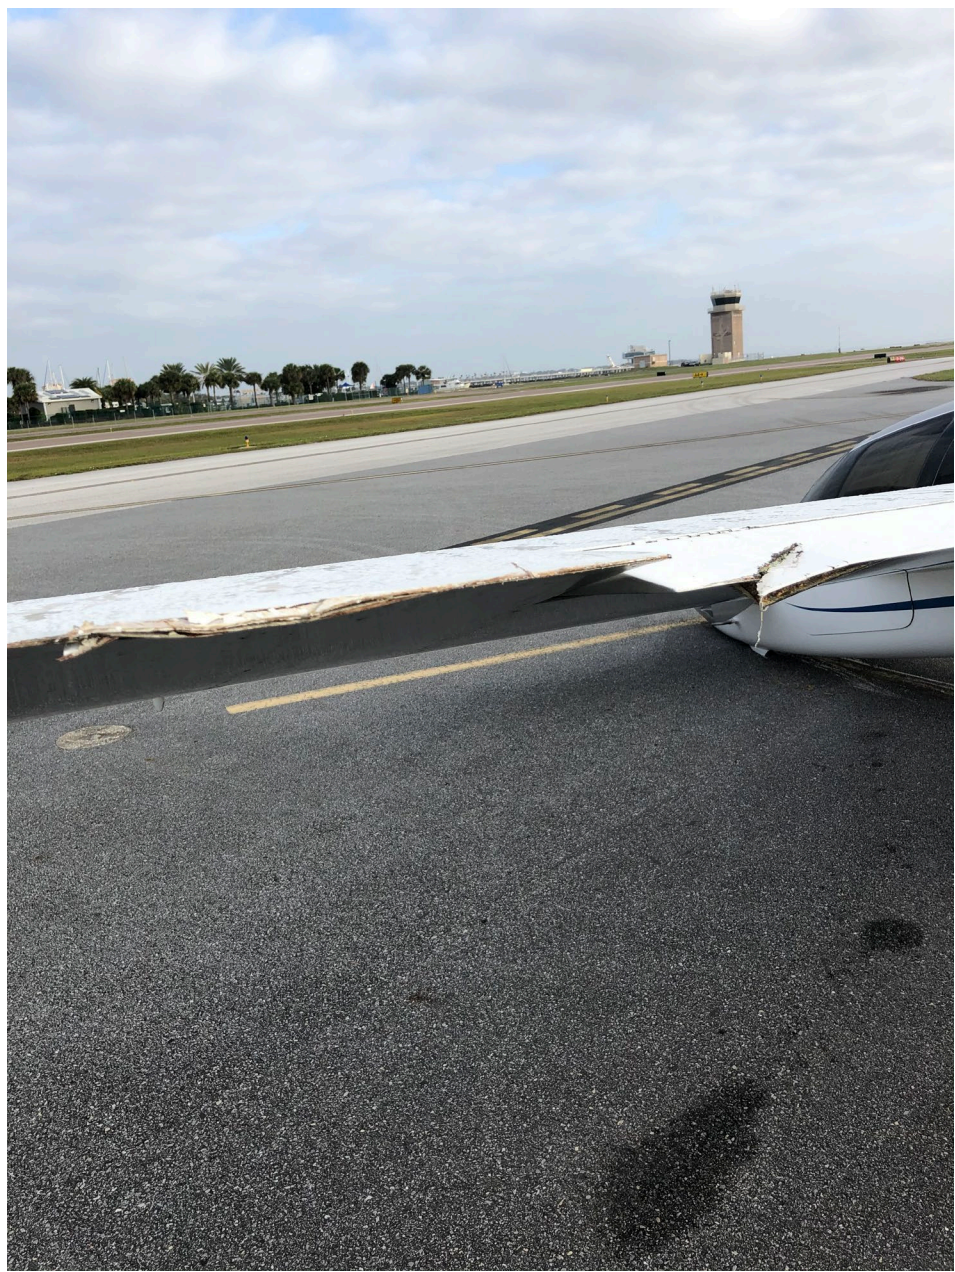
**Photo 6 – Left Wing Trailing Edge - Courtesy of FAA**

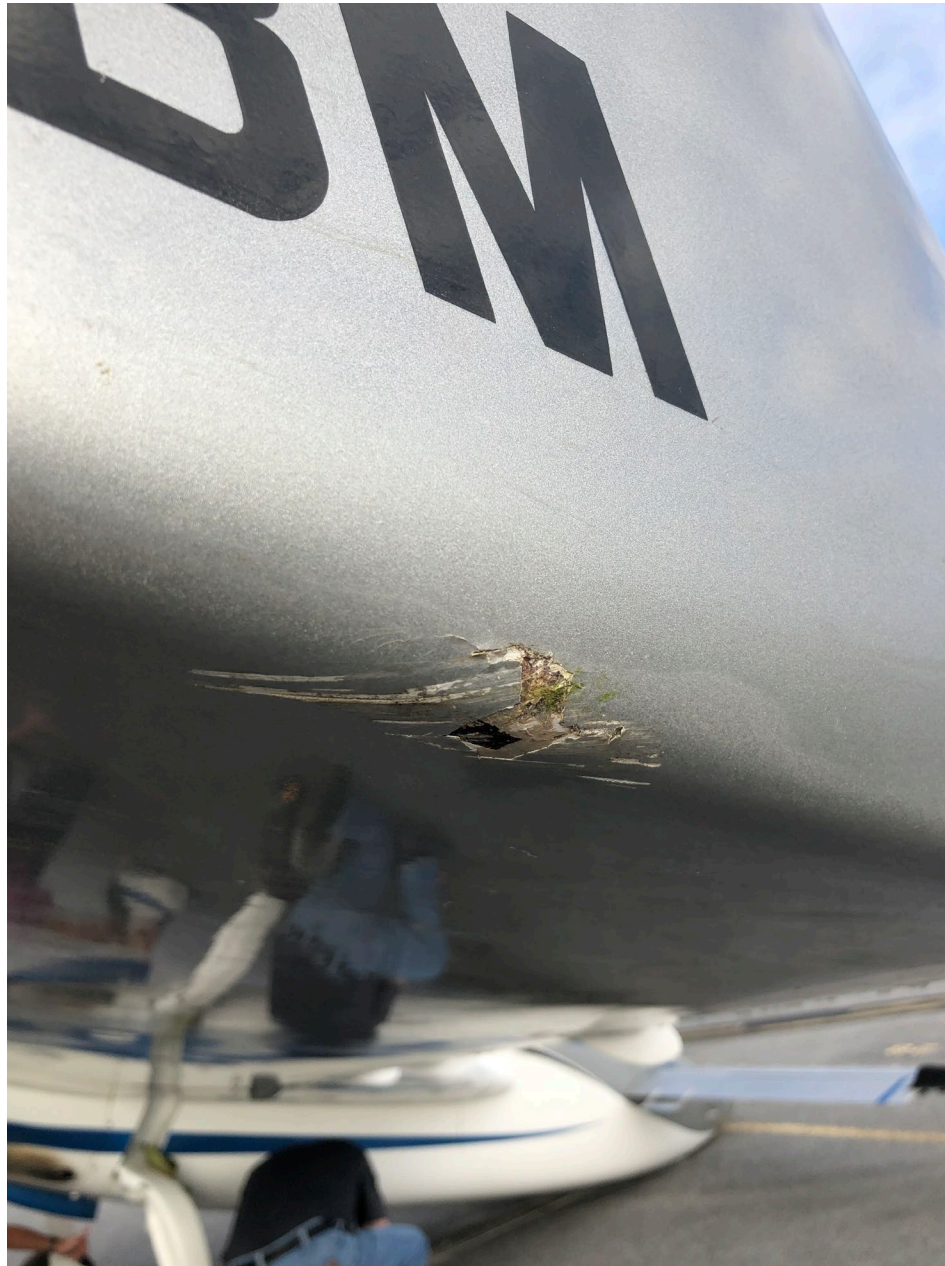
**Photo 7 – Right Wingtip – Courtesy of FAA**

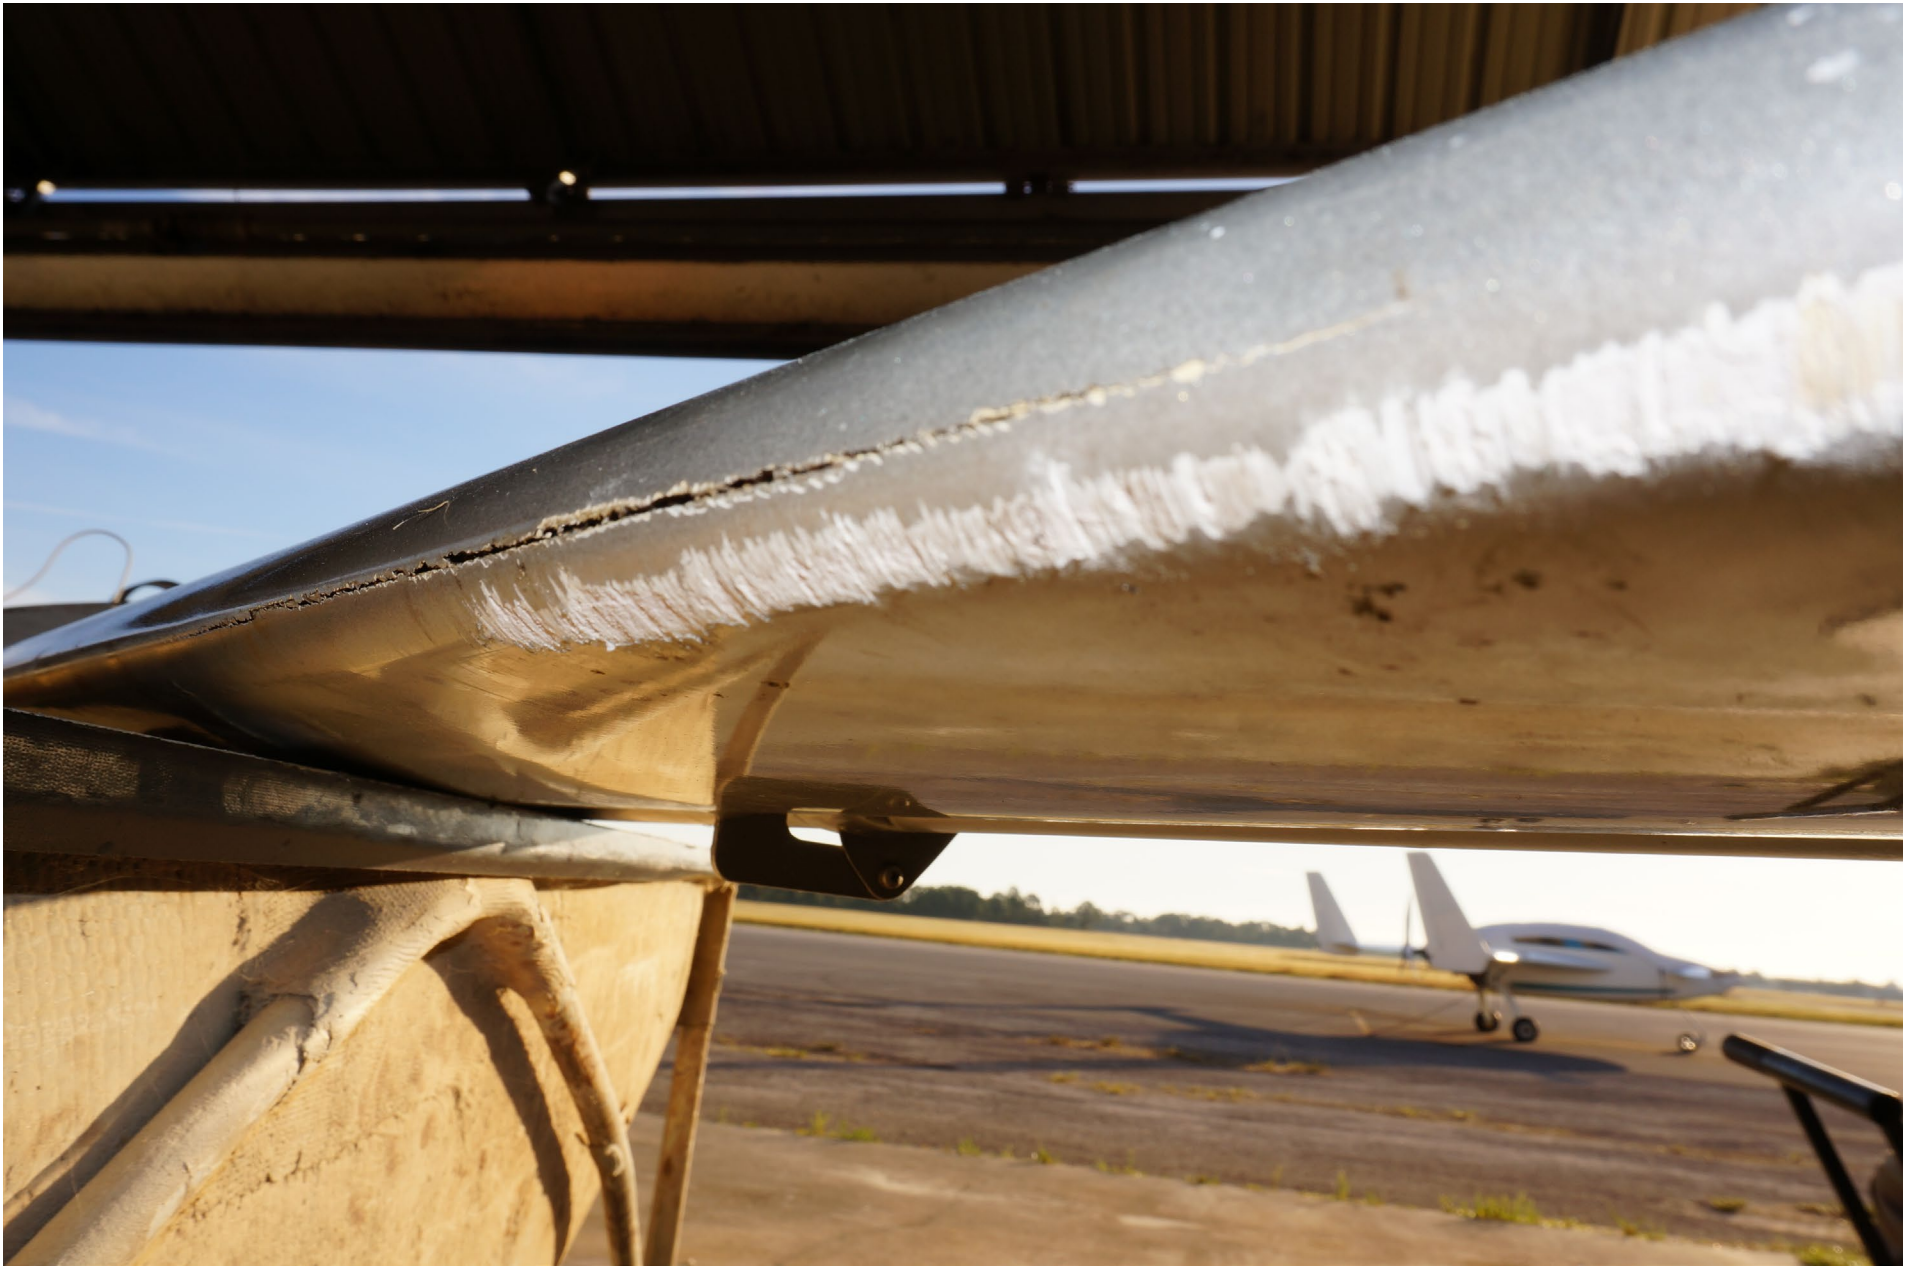
**Photo 8 – Close Up of Left Canard Leading Edge**

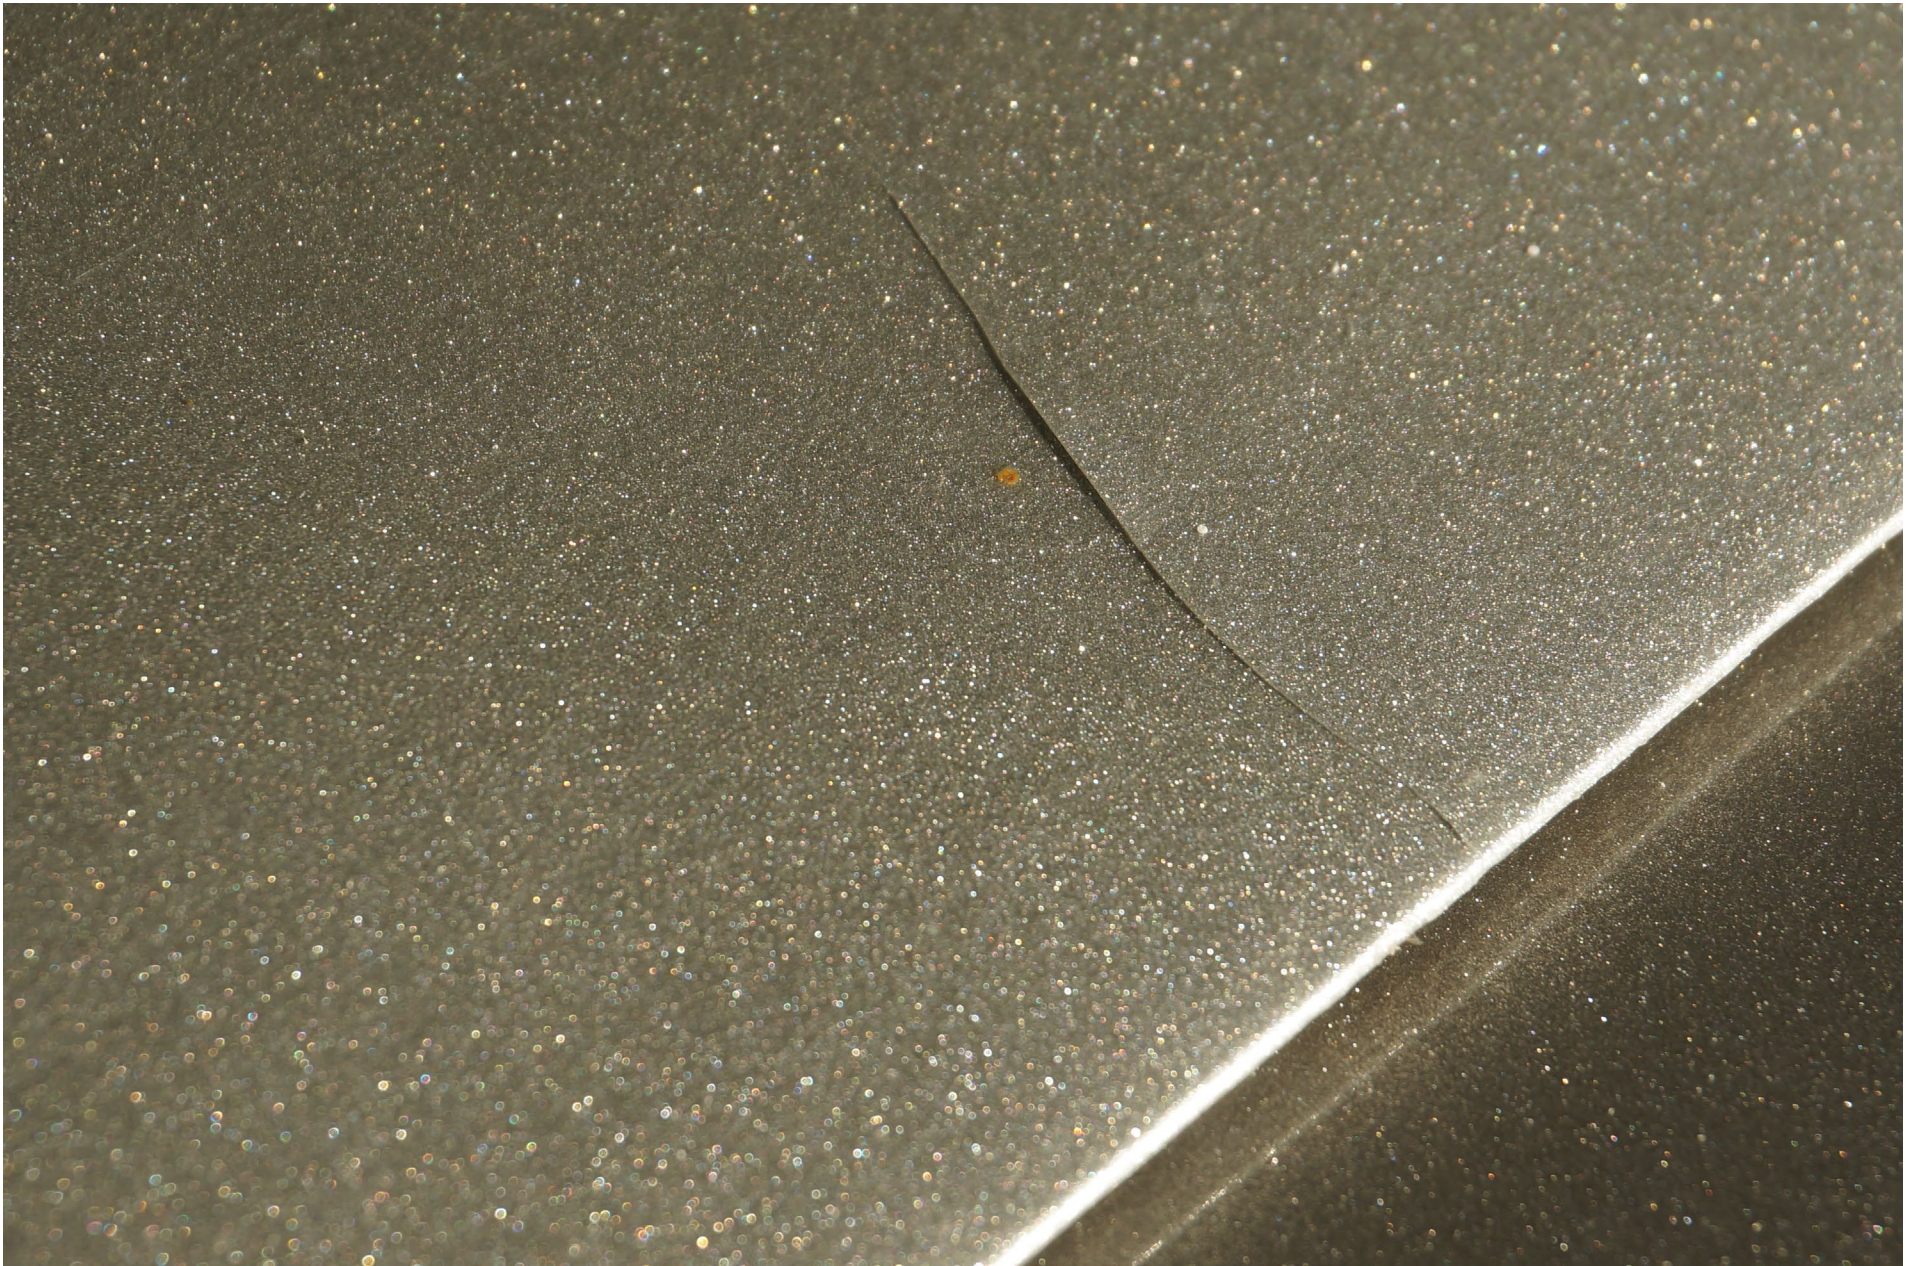
**Photo 9 – Left Canard Trailing Edge**

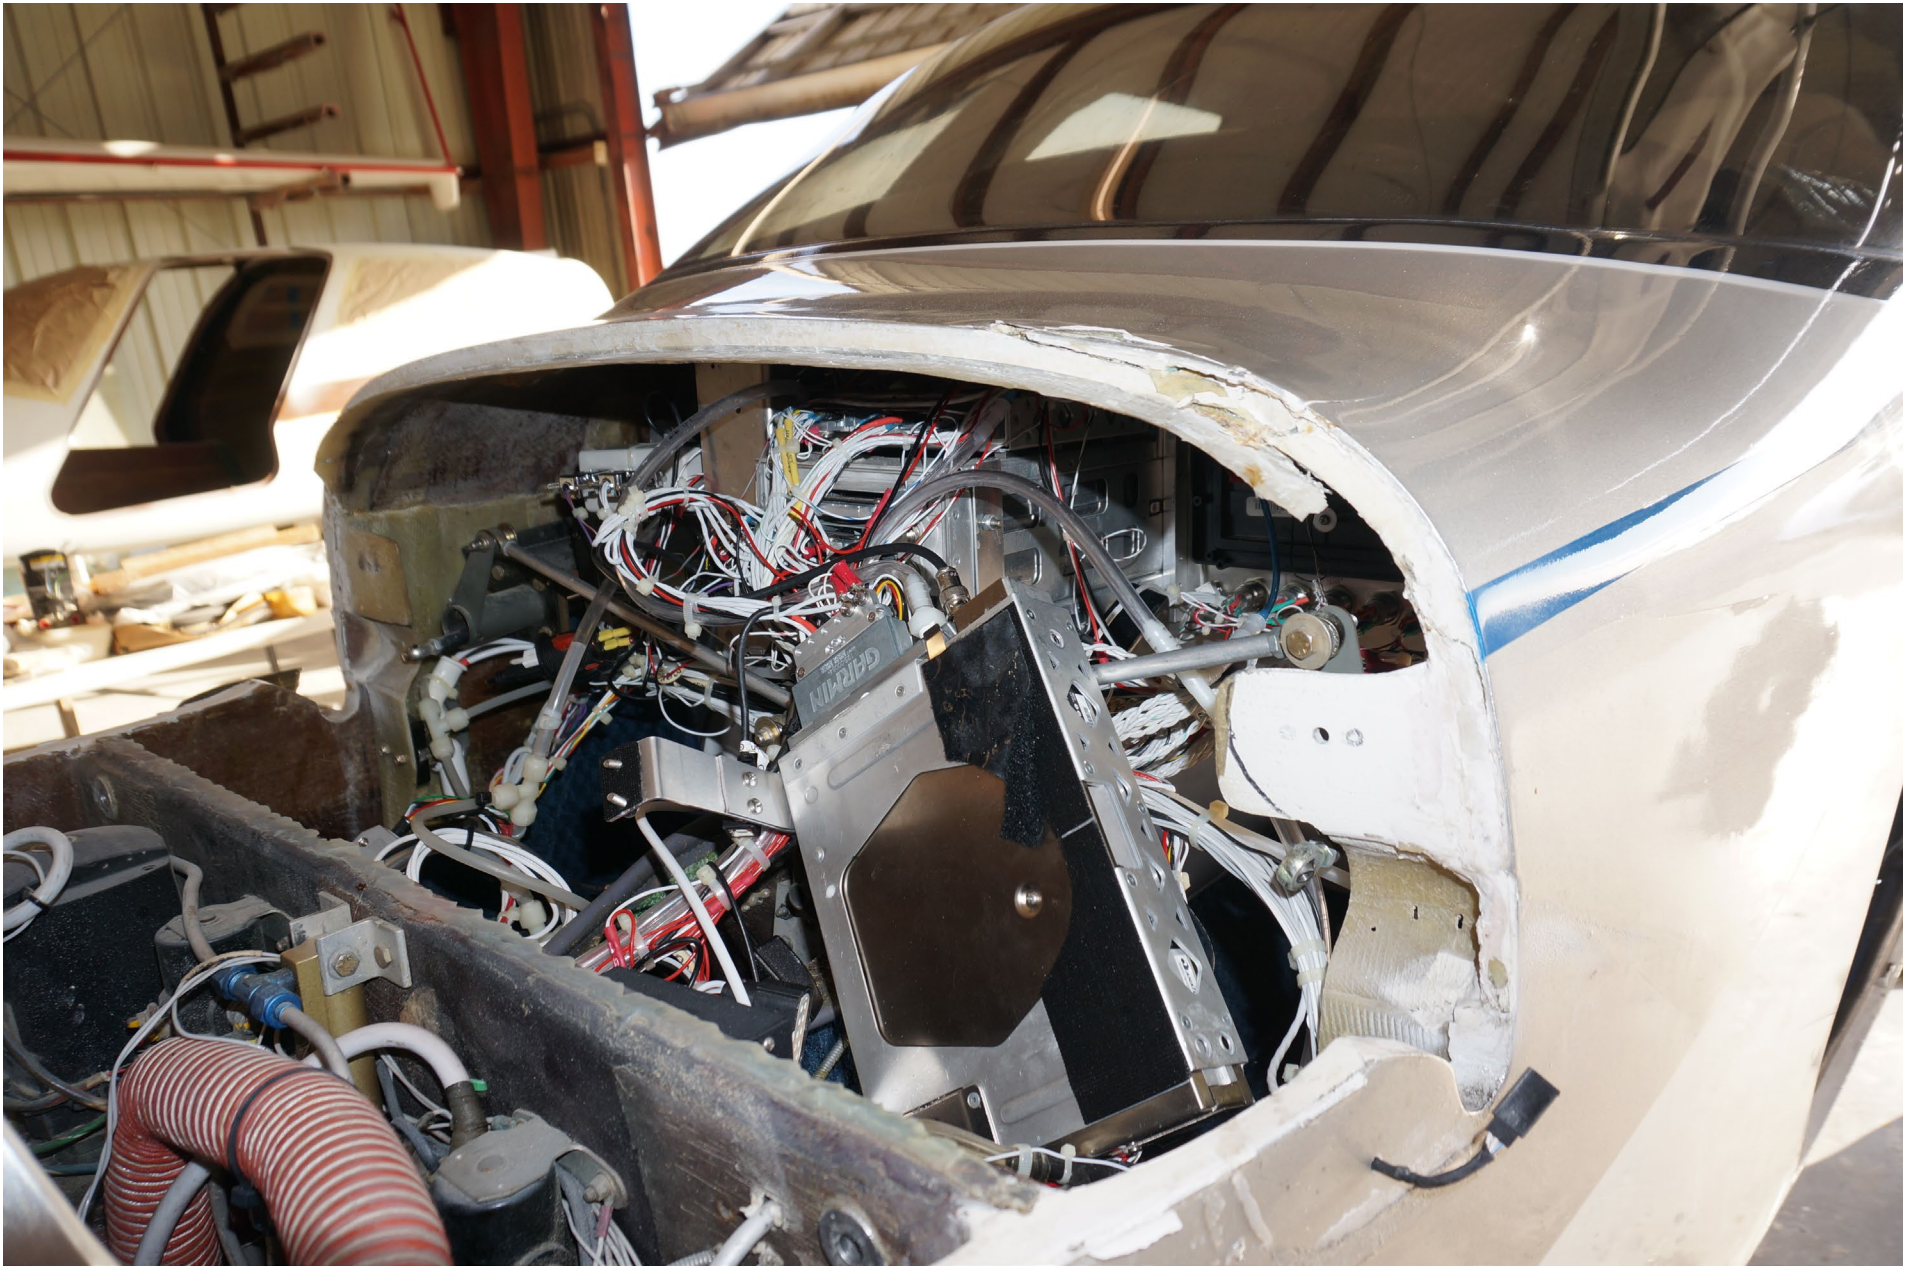
**Photo 10 – Upper Fuselage Damage Forward of Windshield**

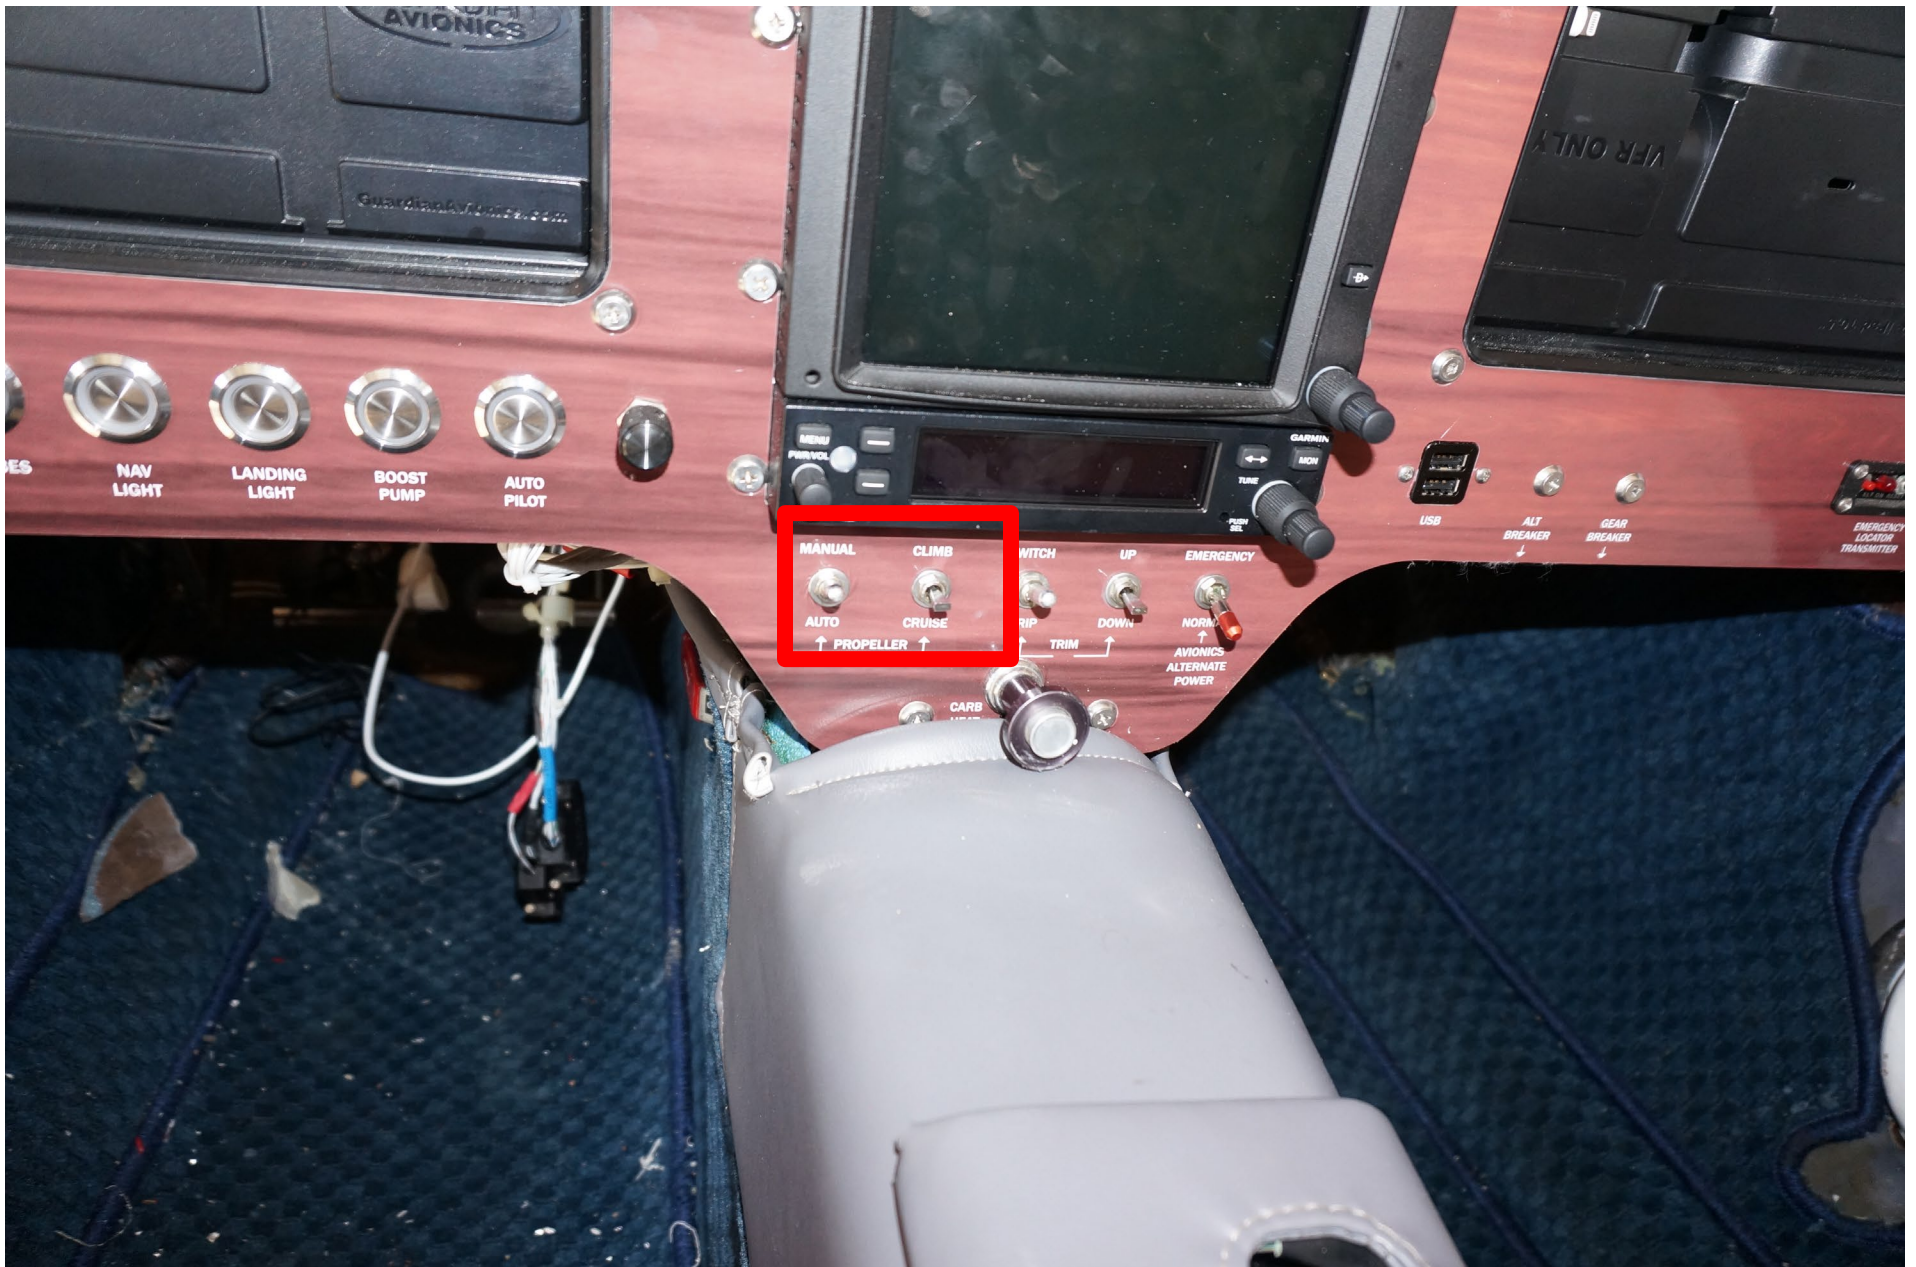
**Photo 11 – Propeller Control Switches**
