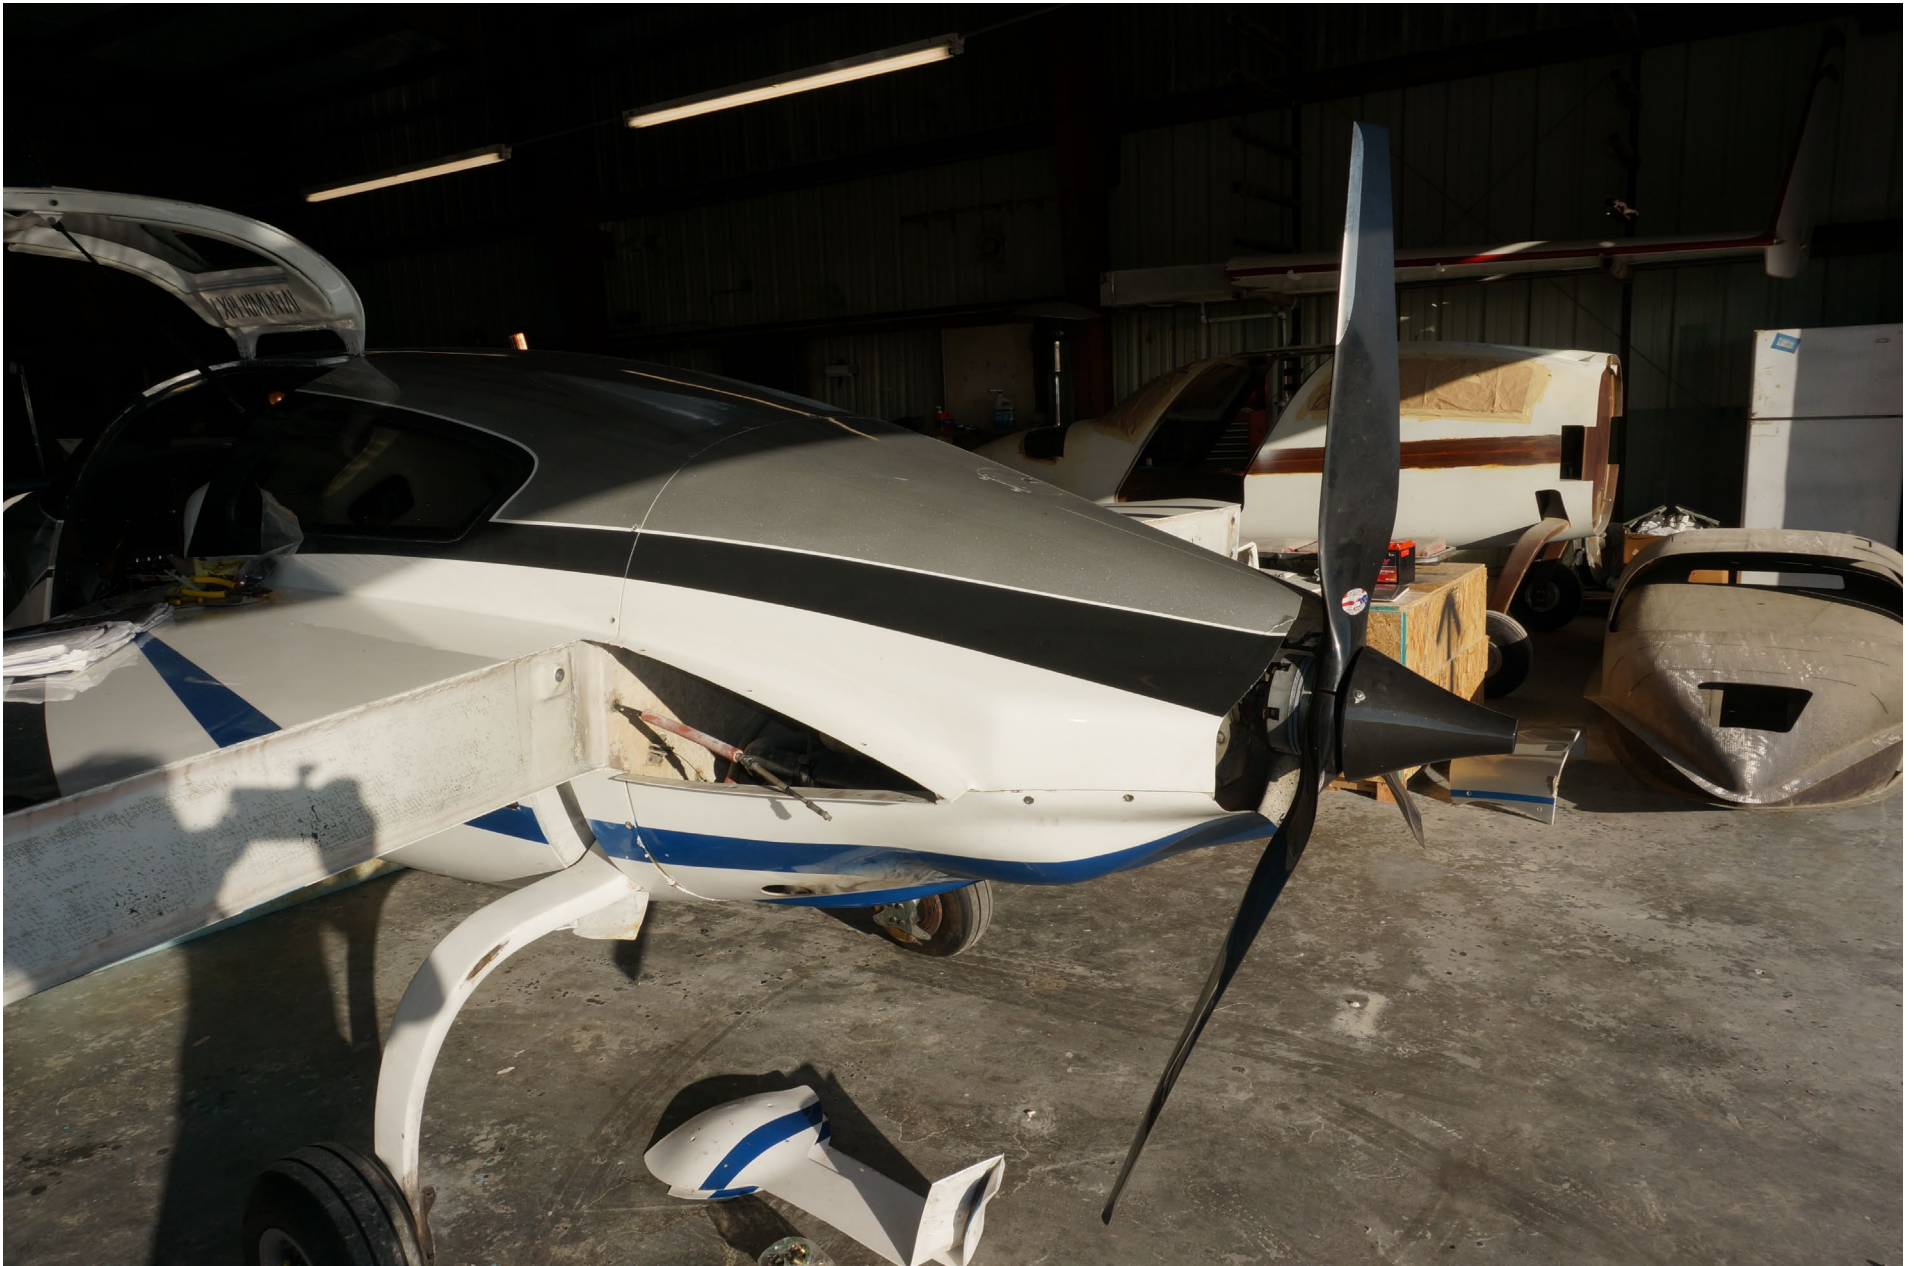
**Photo 12 - Propeller**

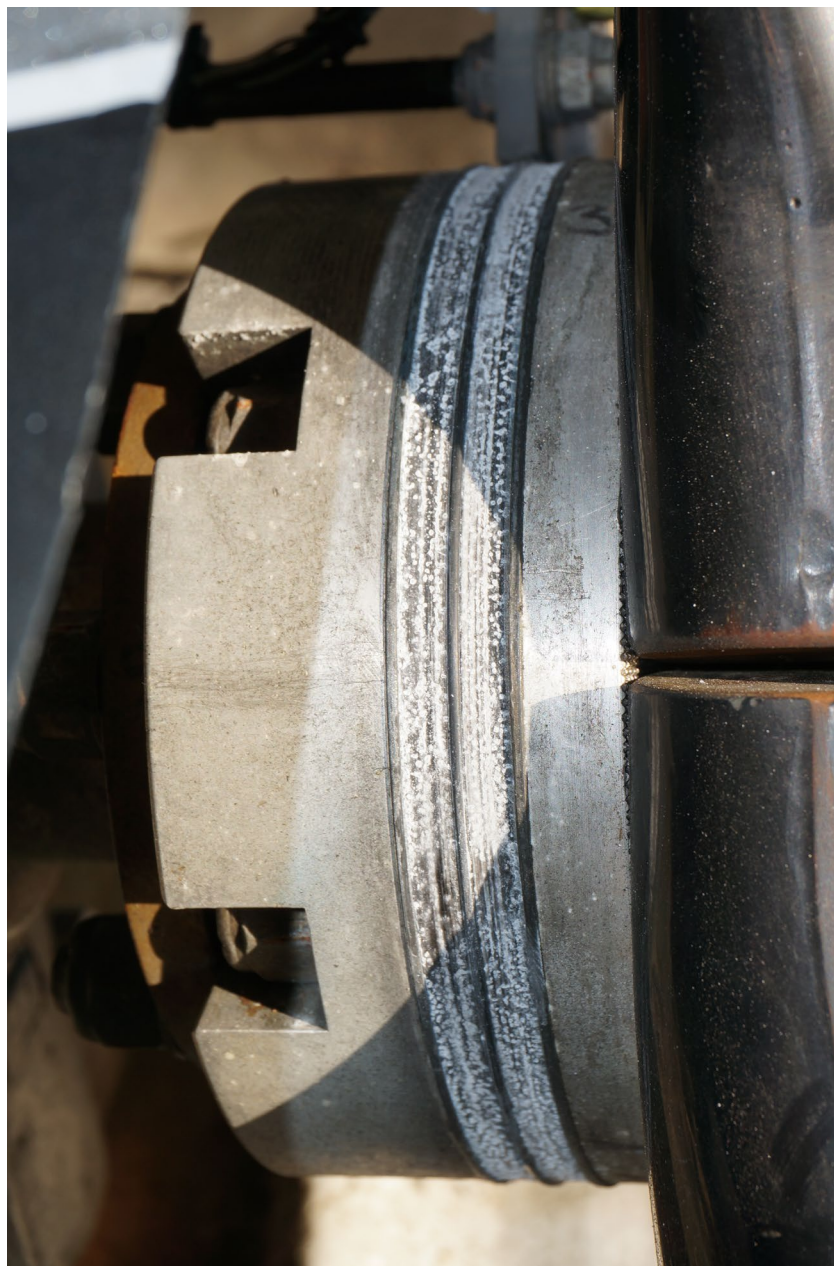
**Photo 13 – Propeller Slip Rings**

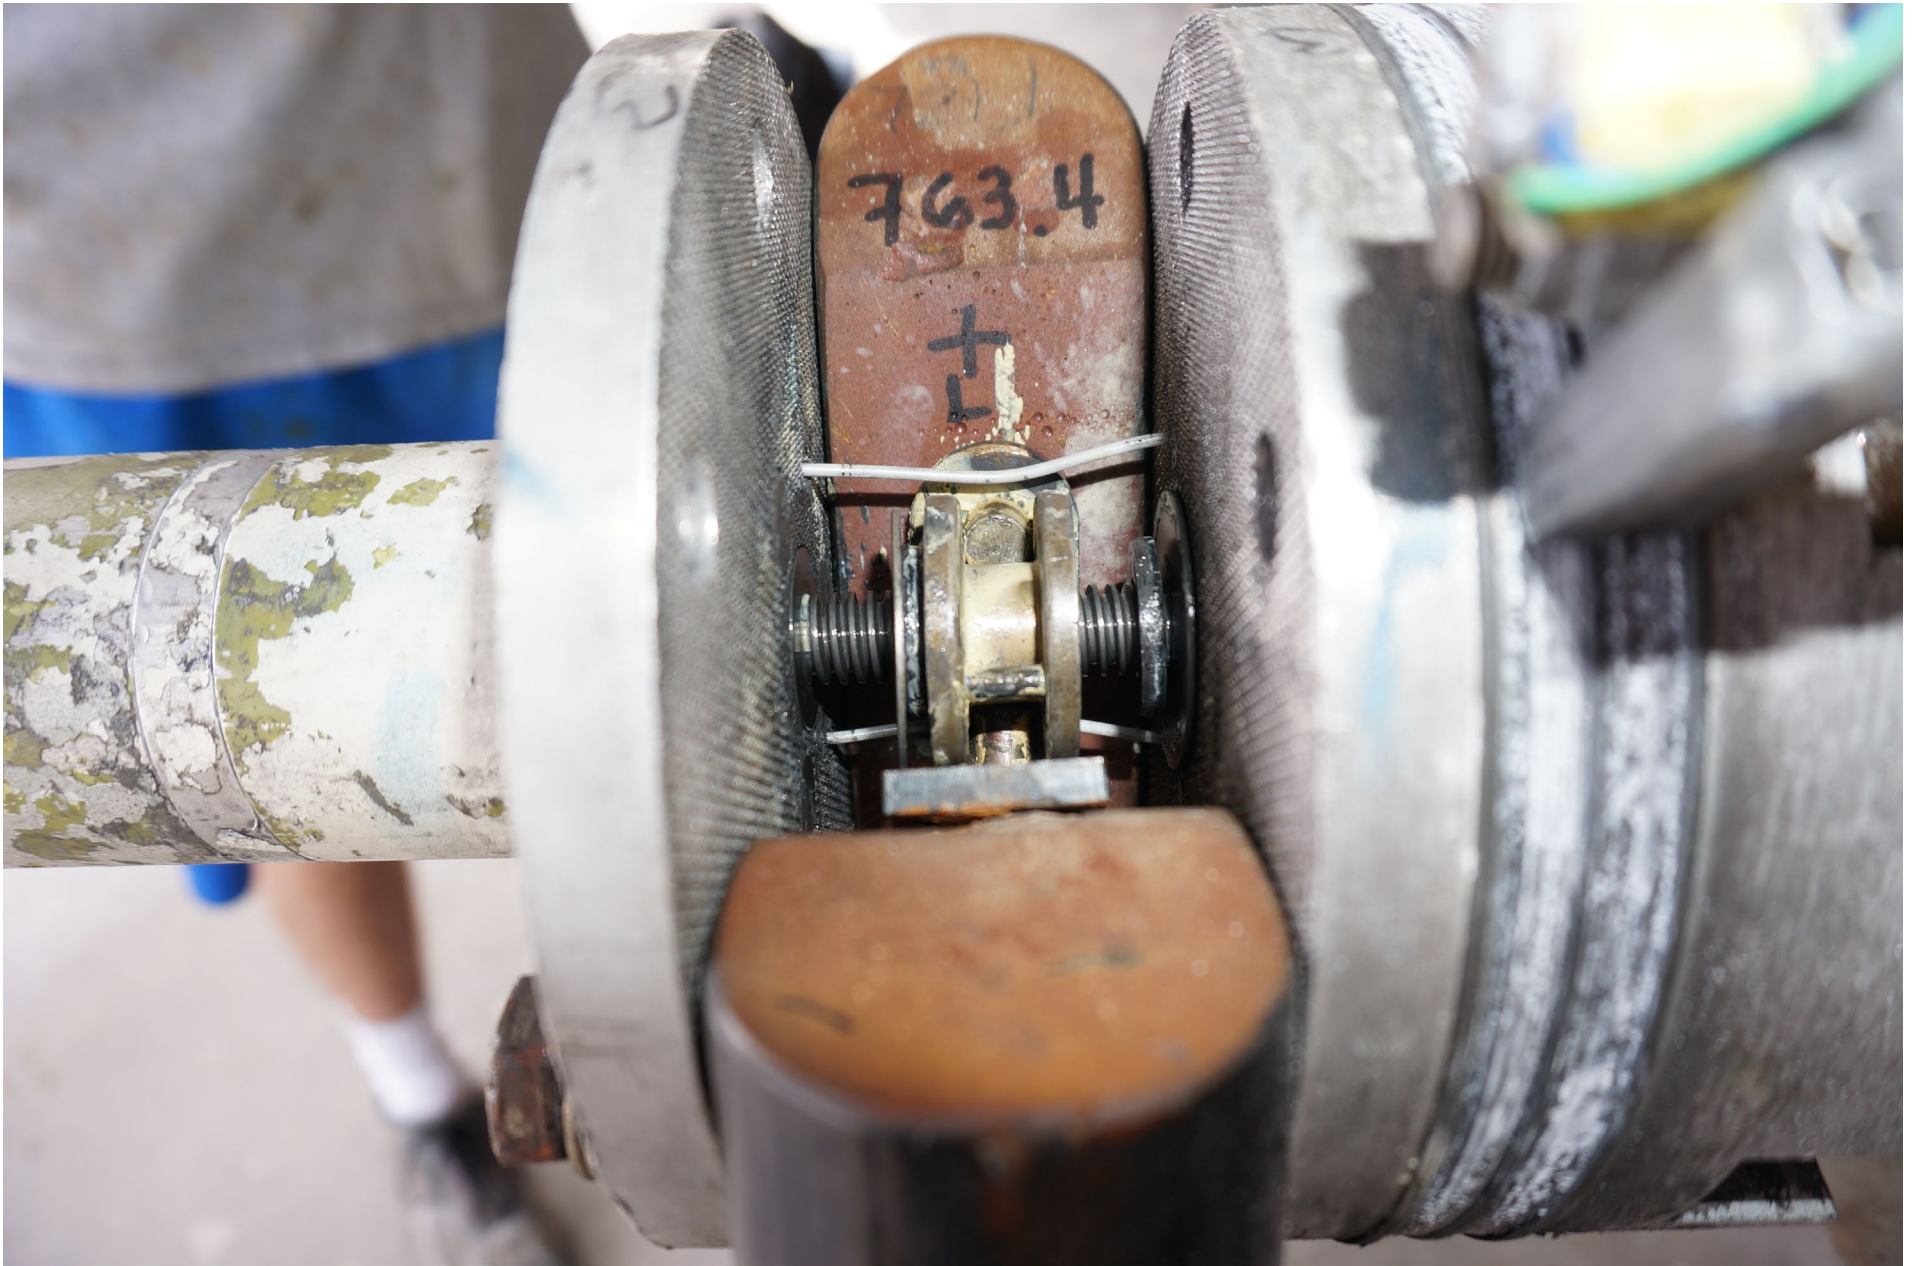
**Photo 14 - Propeller Pitch Spool in Approximately Mid-Range Pitch Position**
