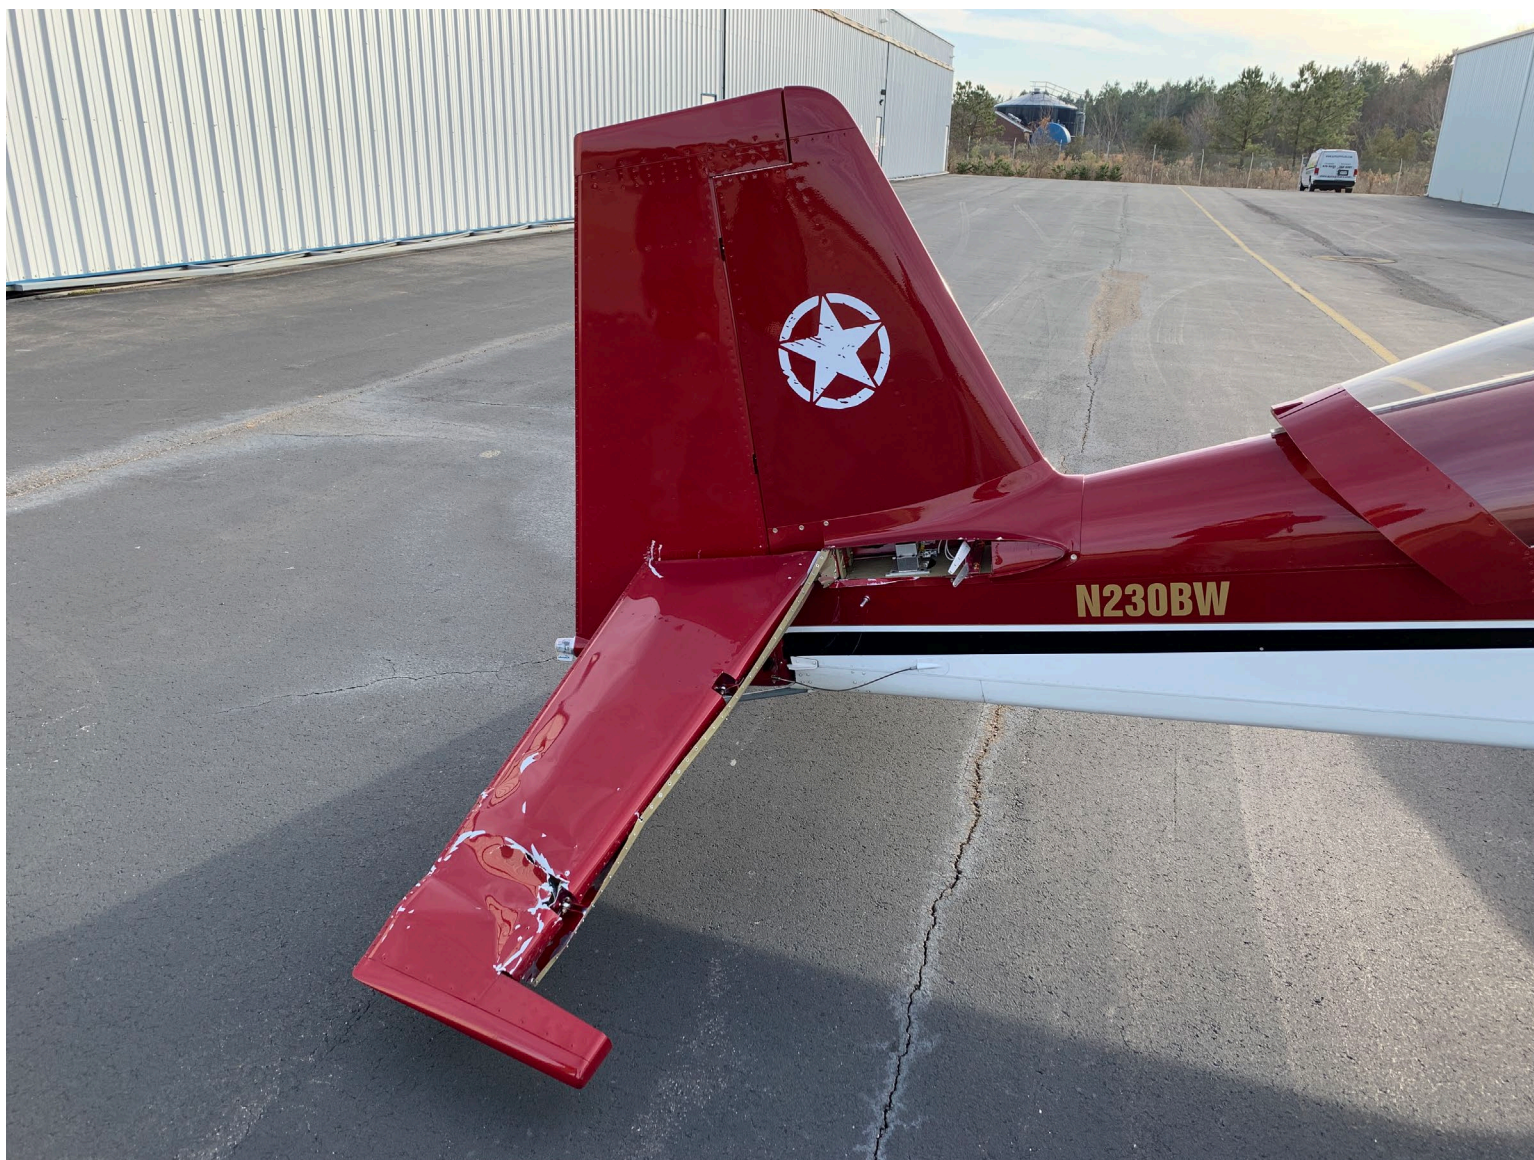
**Photo 1 – View of right side tail damage. Right stabilizer missing. Right elevator bent down and damaged. (Courtesy of Owner)**

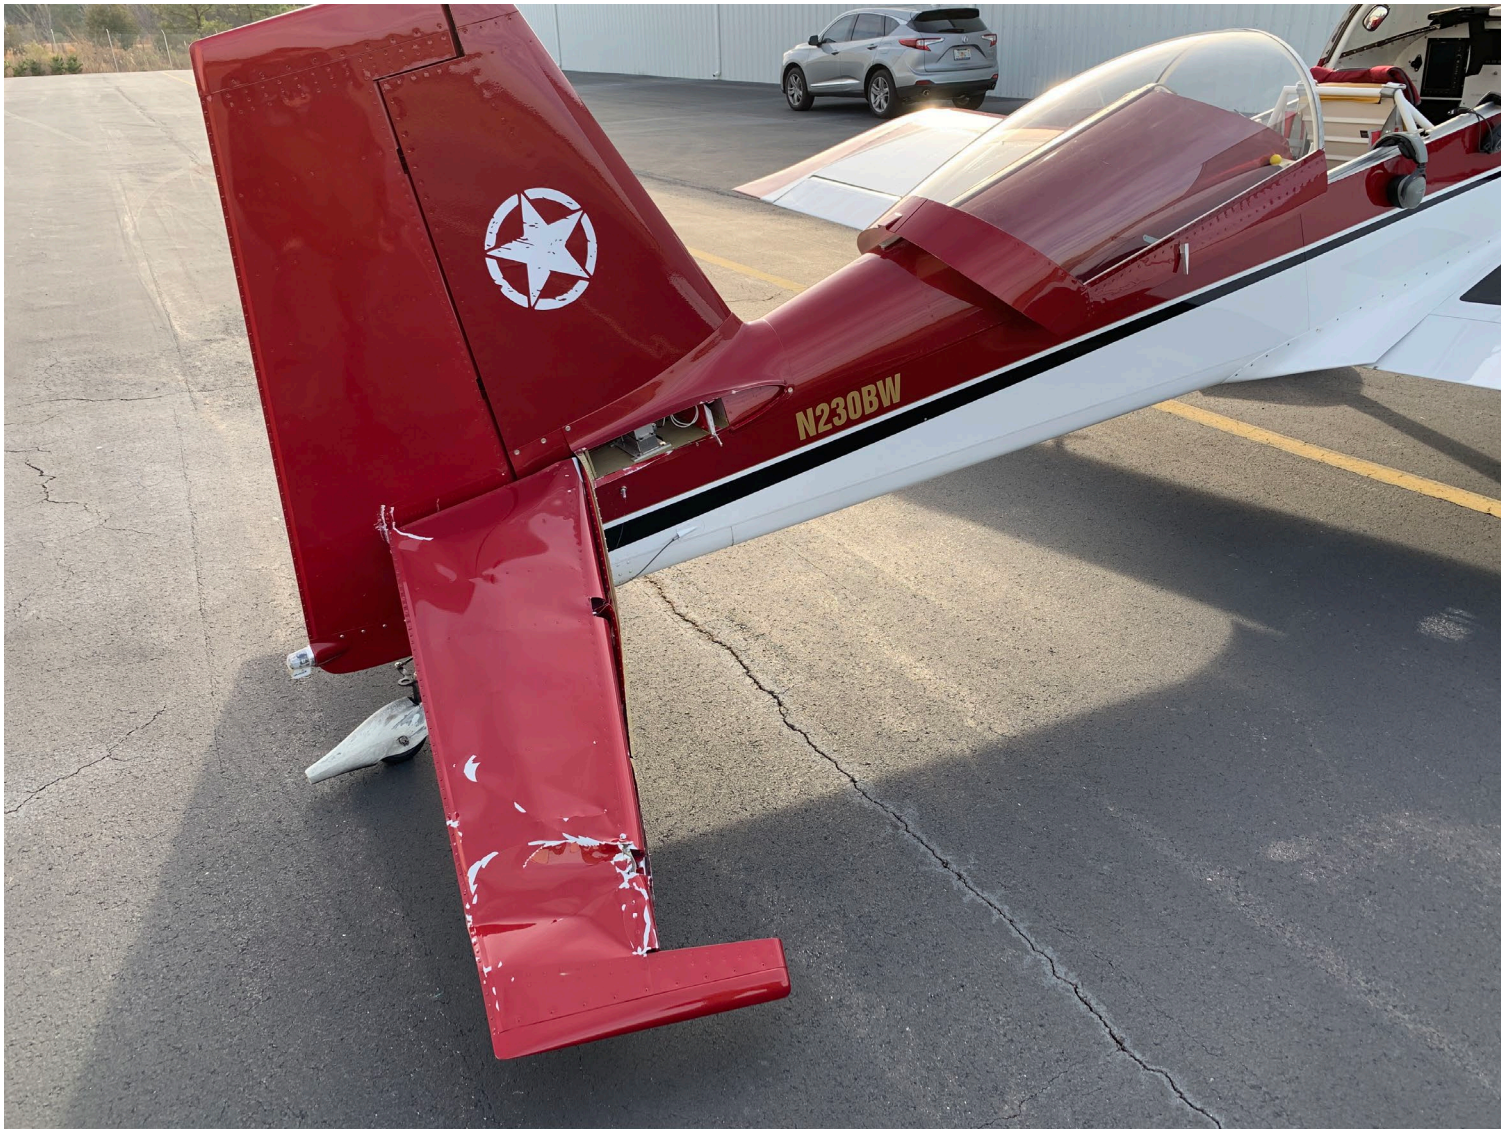
**Photo 2 – Close up view of right elevator damage. Note the stabilizer is missing and entire structure is bent down.  
(Courtesy of Owner)**

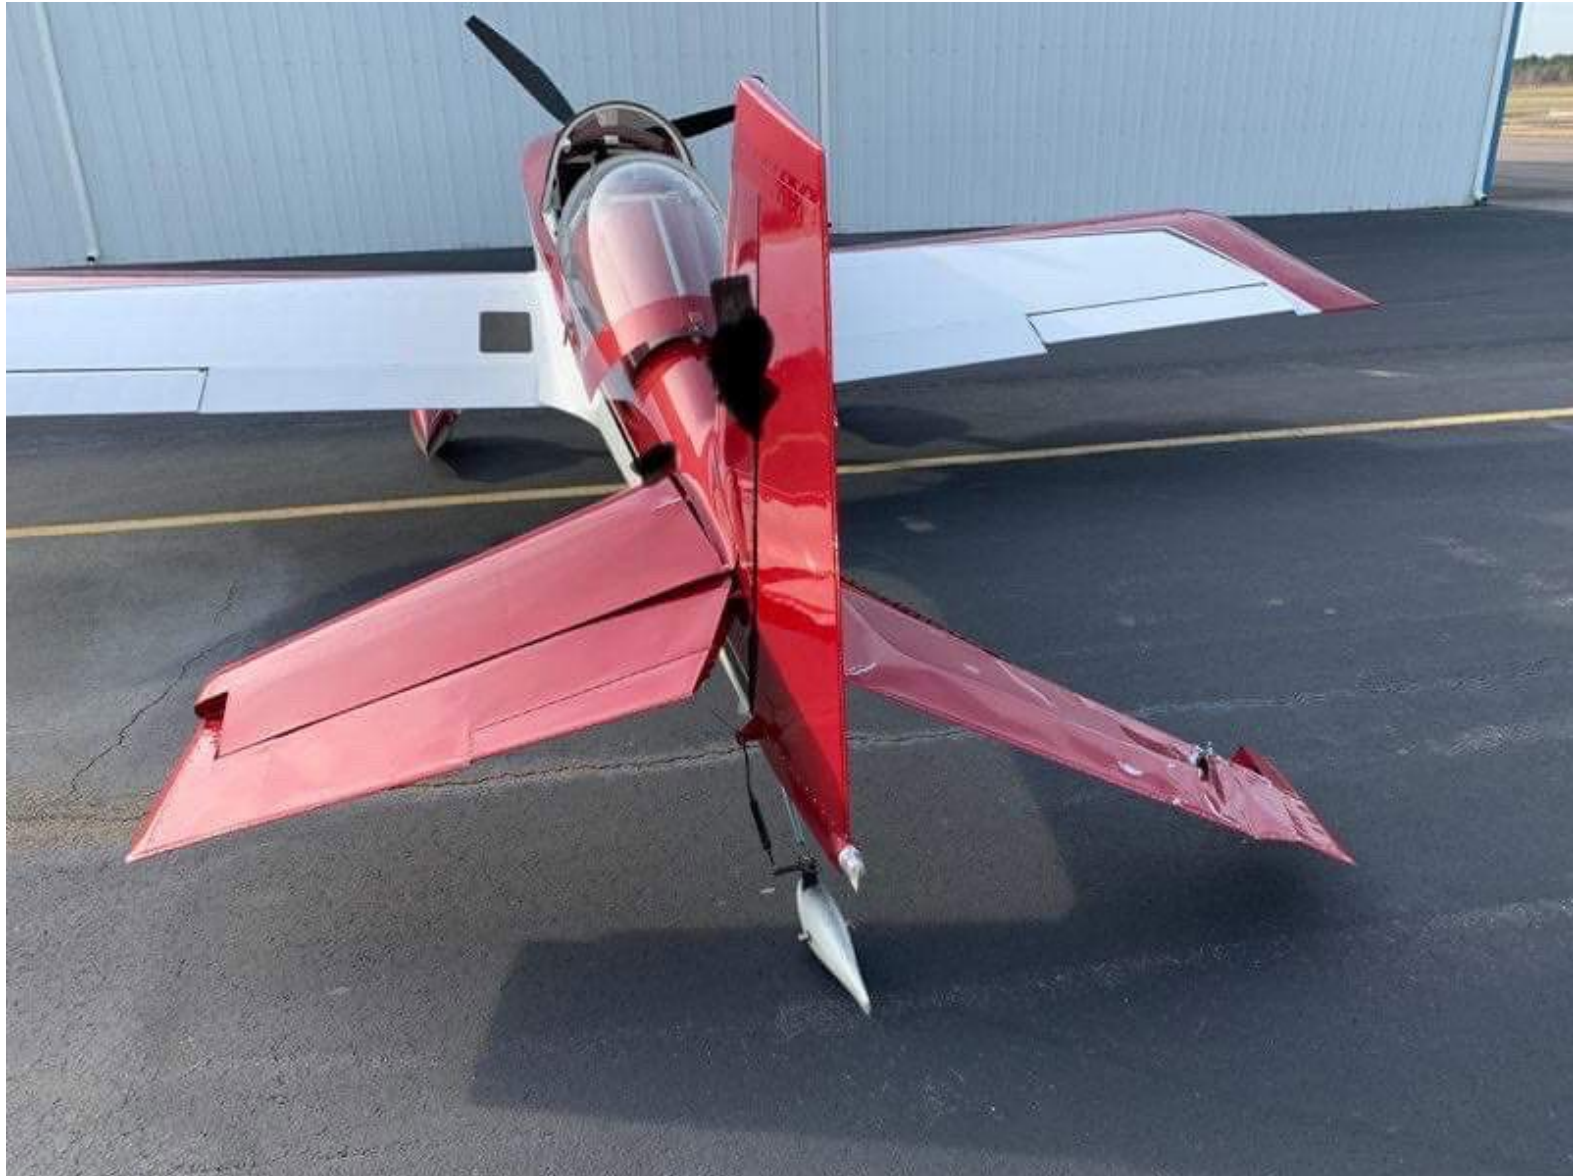
**Photo 3 – View of empennage looking forward. Both left and right sides bent down. Right side missing stabilizer.  
(Courtesy of Owner)**

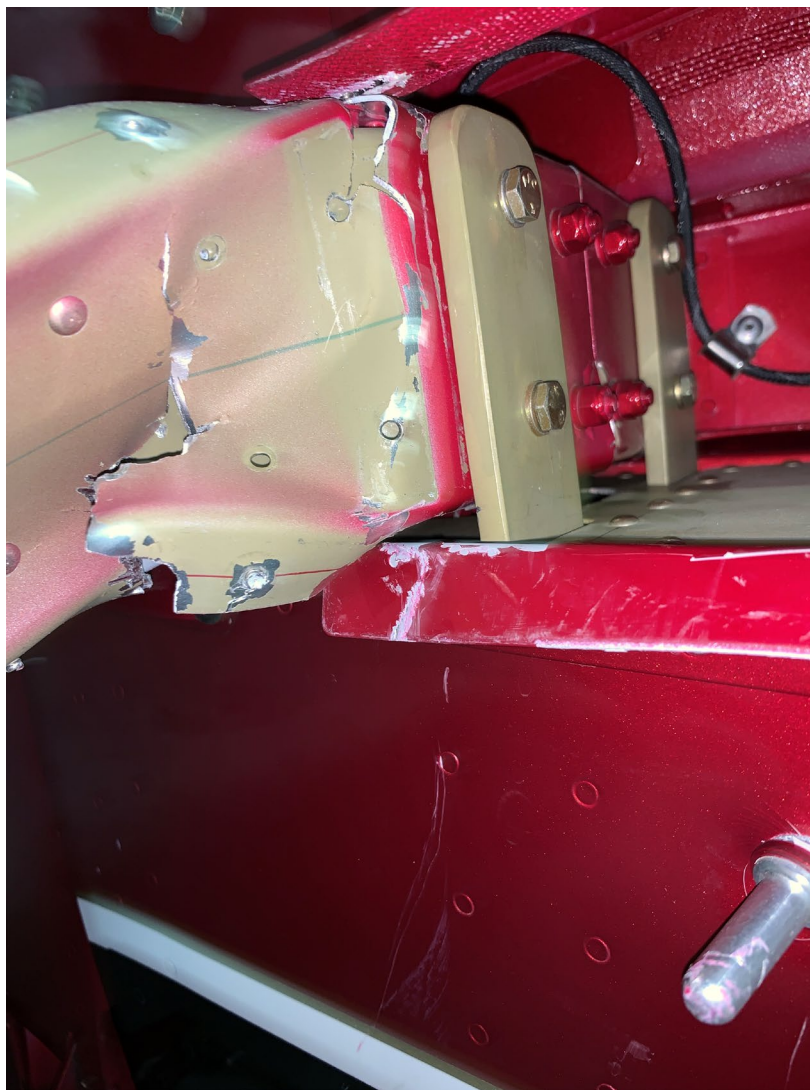
**Photo 4 – View of right horizontal stabilizer failed aft spar and flange. (Courtesy of Owner)**

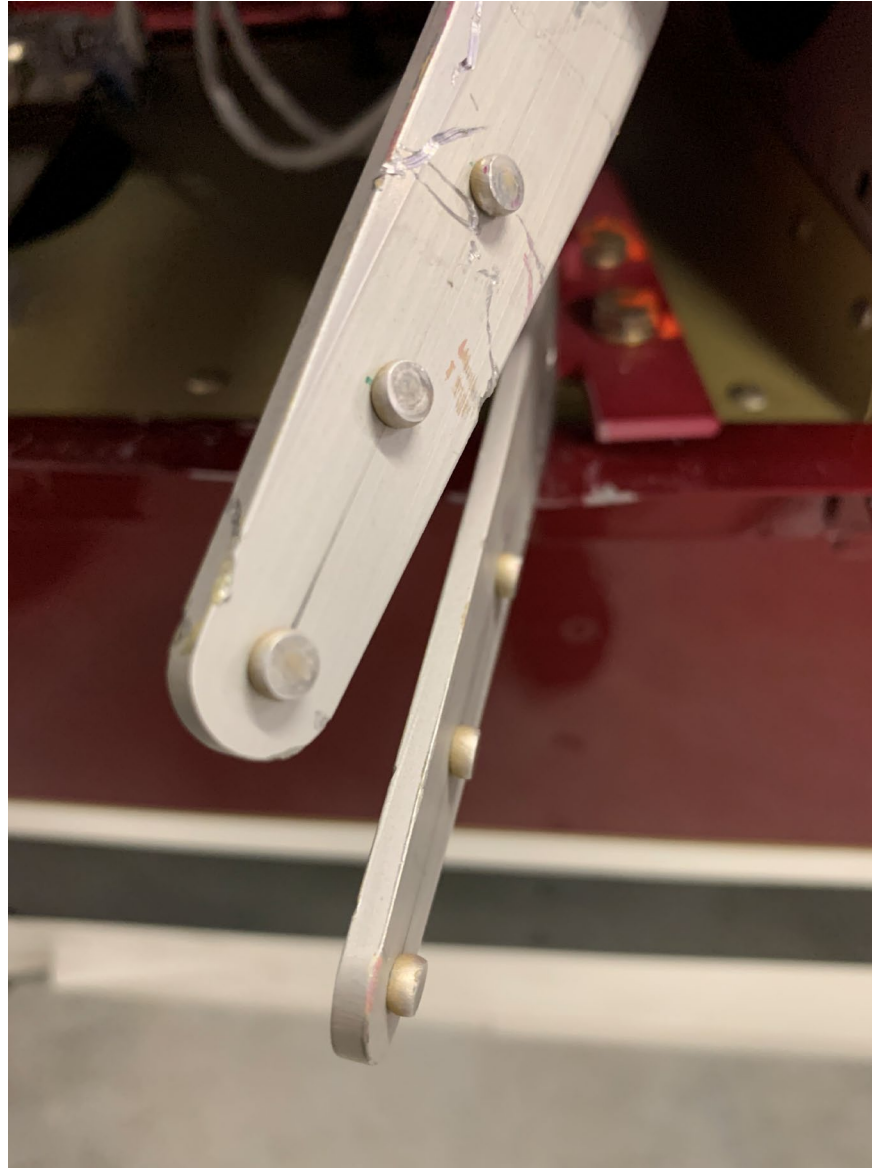
**Photo 5 – Photo of forward spar inboard attachment straps/rivets. Note they are bent down and aft. (Courtesy of Owner)**

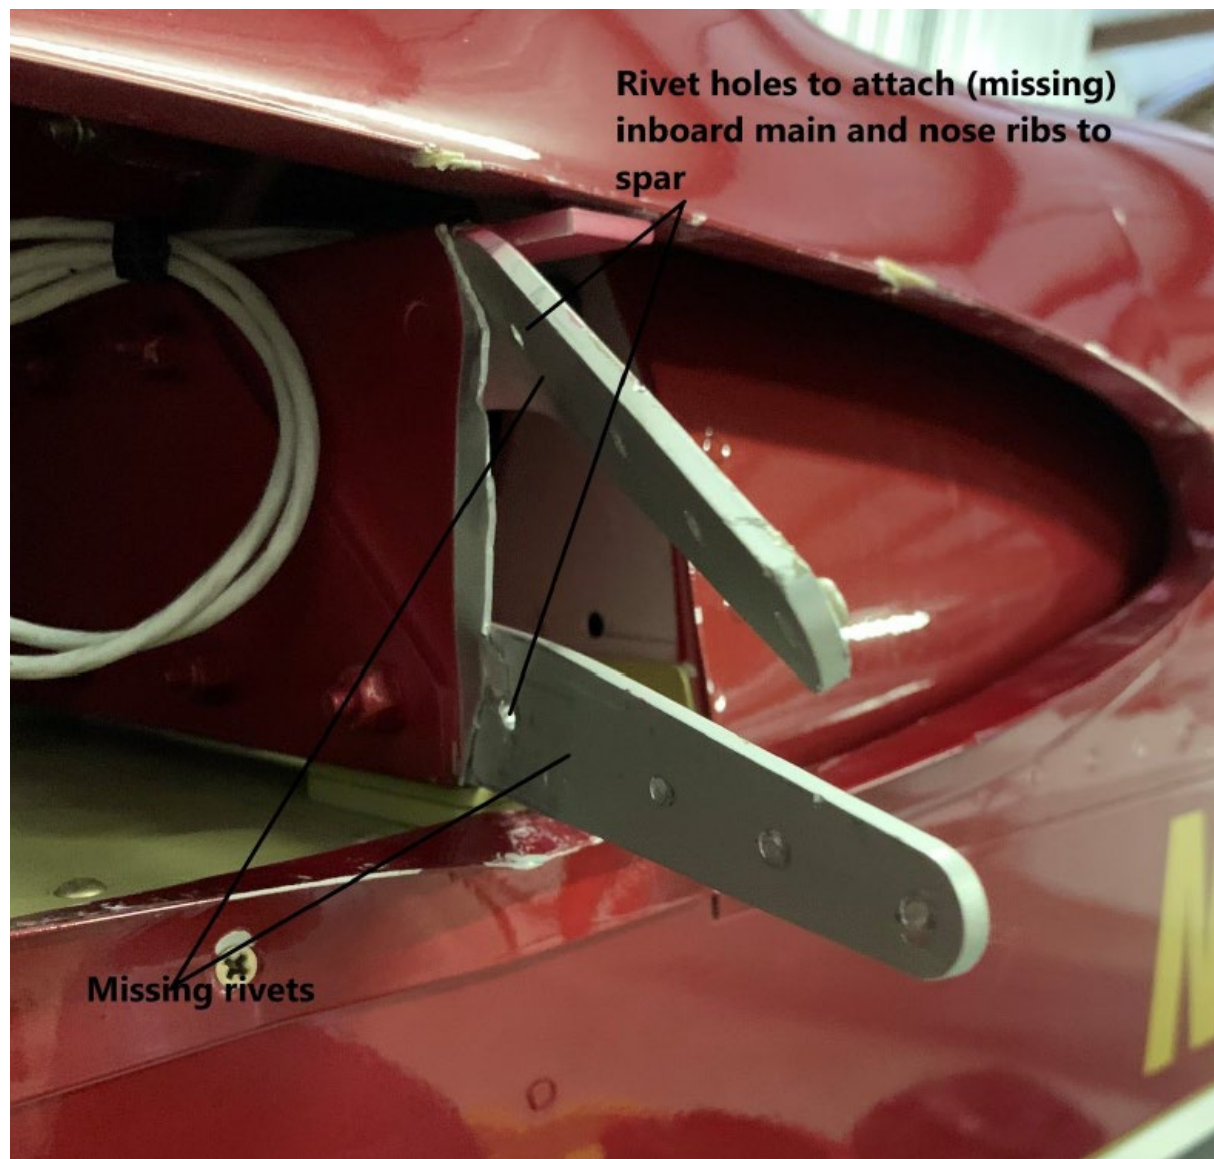
**Photo 6 – Closeup of forward spar attachment straps missing rivets inboard. (Courtesy of Paul Romano)**
