# N230BW Accident Report

## Introduction

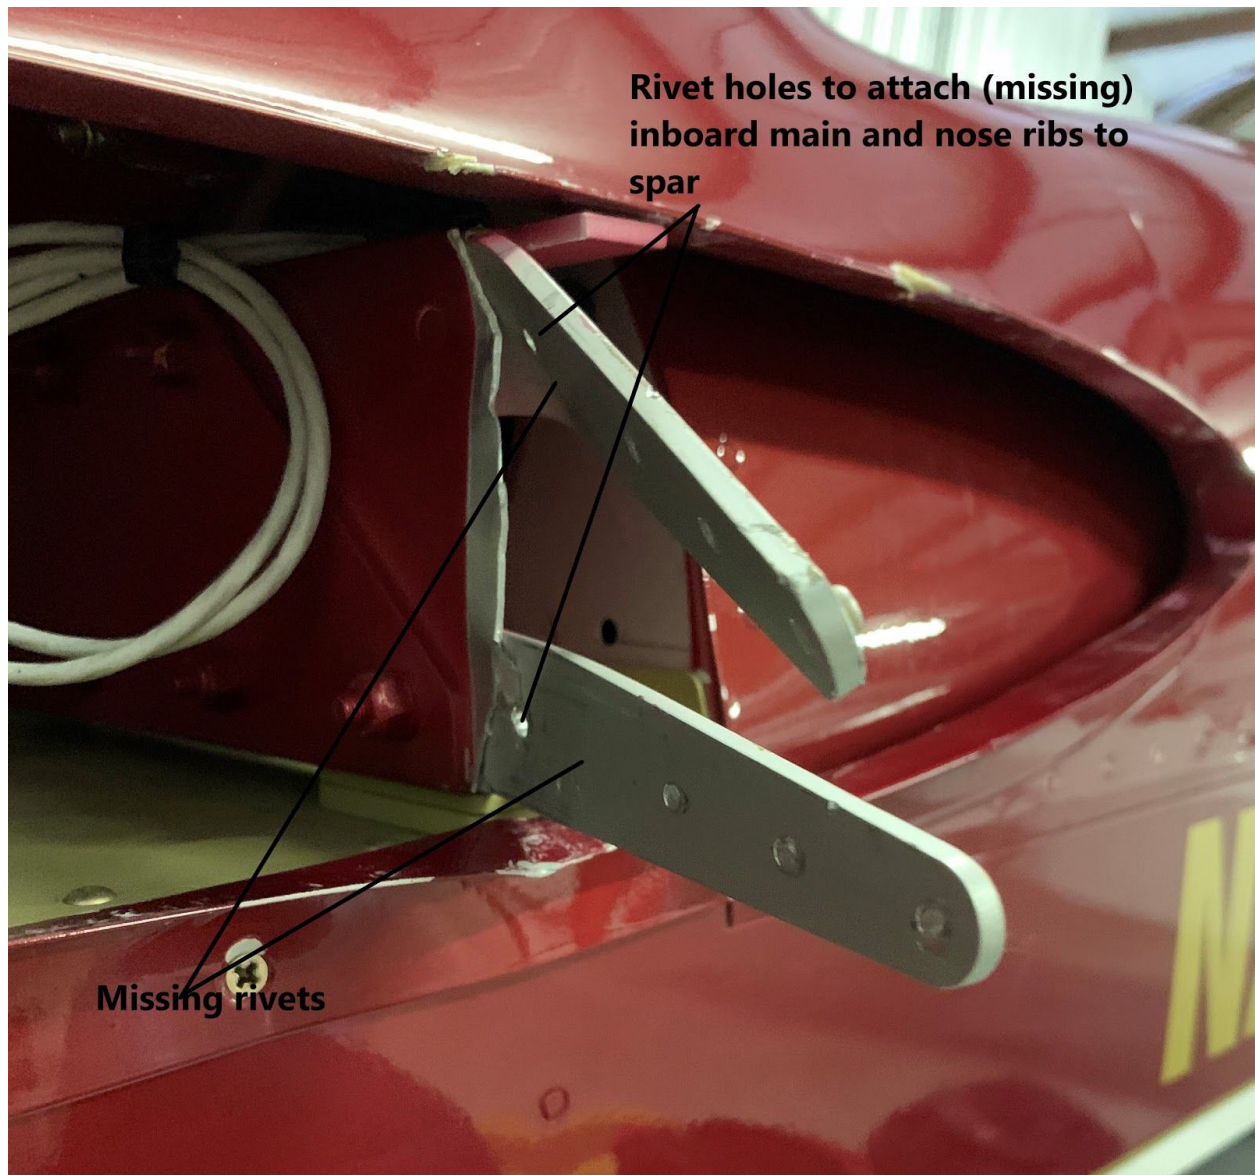
Figure 1 shows the failure of the HS 002 front spar, and the bent legs of the HS 014 spar caps. The failure occurred at the HS 002 bend area as the tapering HS 002 front spar merges with the fuselage.
