# N230BW Accident Report

On 12/24/2019 an F1 Rocket with a MK I empennage, manned by a crew of 2, sustained a structural failure to the horizontal stabilizer while maneuvering. The failure resulted in the majority of the starboard stabilizer departing the aircraft. The starboard elevator remained attached to heavily damaged rear spar and to the port elevator through the hinge points and the control horns. The starboard HS that departed the aircraft has not been recovered.

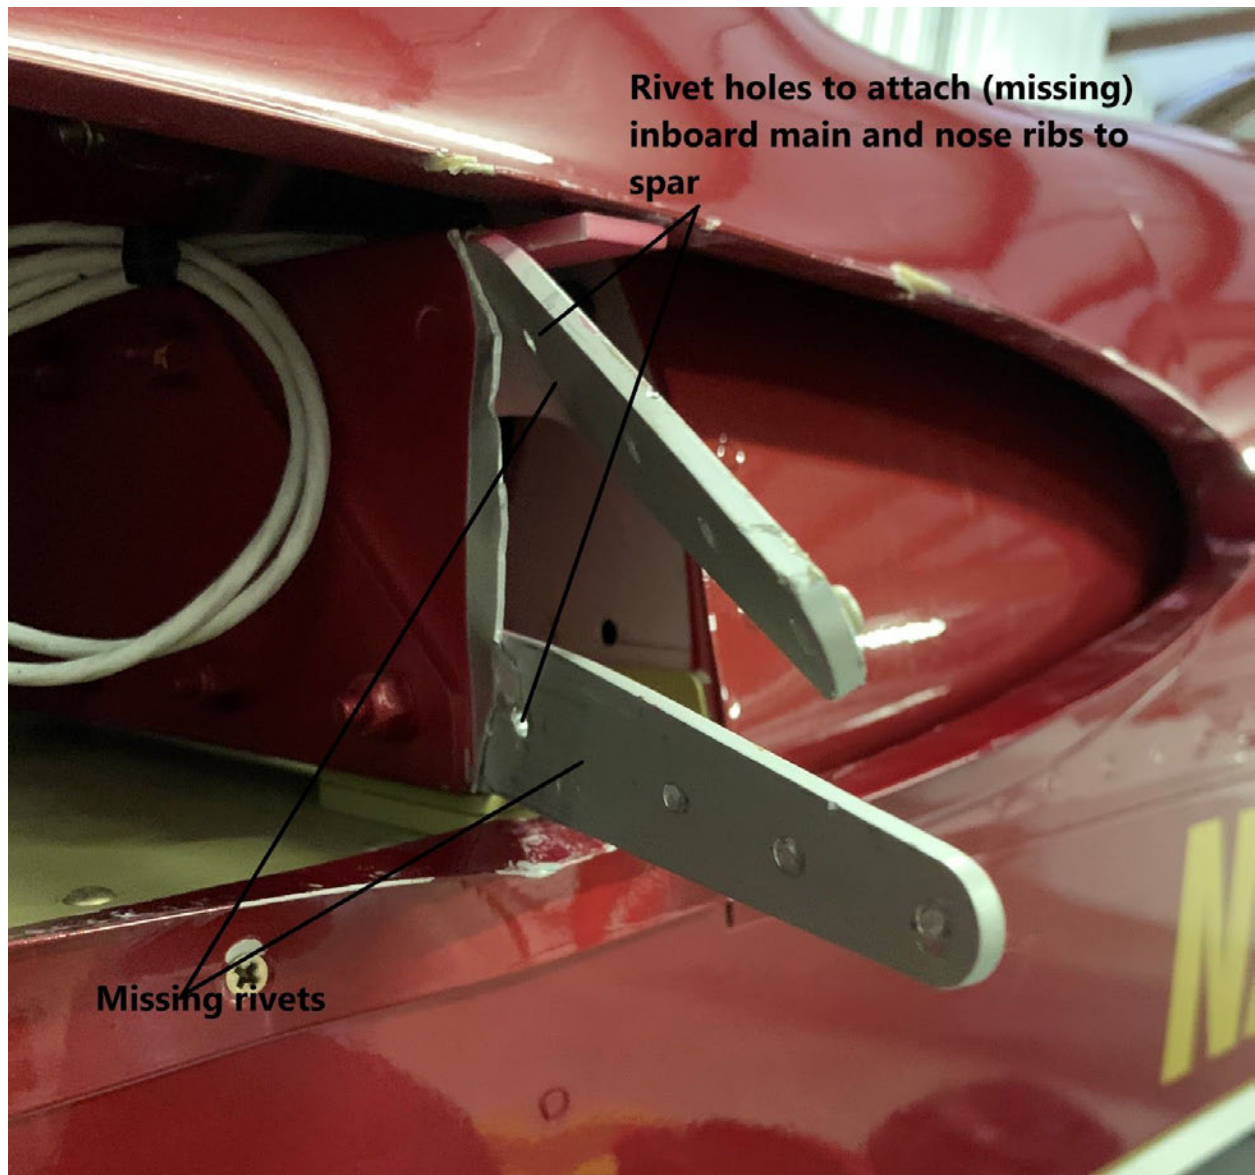
Figure 1 shows the failure of the HS 002 front spar, and the bent legs of the HS 014 spar caps. The failure occurred at the HS 002 bend area as the tapering HS 002 front spar merges with the fuselage.

In general, construction appeared to be excellent. However, there was one significant discrepancy in the build of the stabilizer. One rivet was missing on each of the four spar cap bent legs. There should be five AN470AD4 rivets in this line of fasteners, and there are only four on this build. A total of 4 rivets were never installed, nor were their corresponding holes drilled.

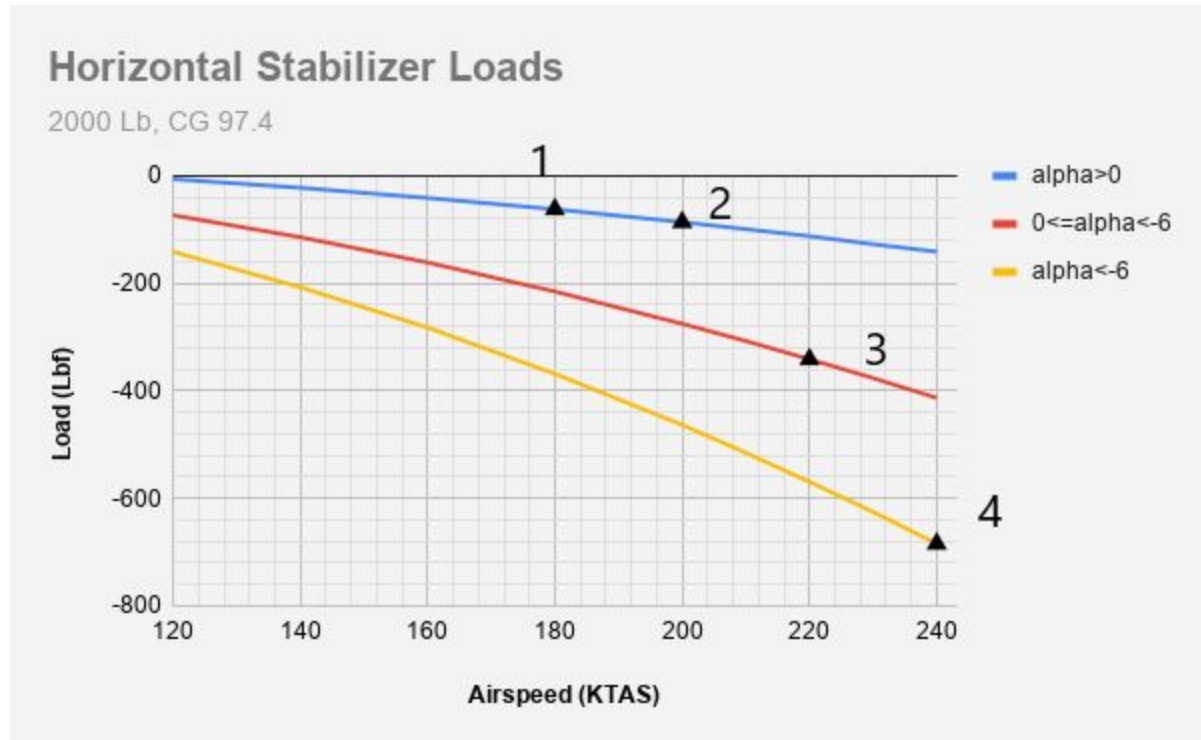
For positive angles of attack, the loading of the stabilizer is moderate, even up to  $V_{ne}$ . At 180 KTAS (1), the load is 62 lbf, at 200 KTAS (2) it is 86 lbf. However, the load rapidly builds at negative angles of attack.

A typical Rocket with a stock IO 540 will cruise at 180 KTAS on 10 gph. At 180, the load on the horizontal stabiliser is -62 lbf. Pushing the throttle to best power will generally yield about 200 KTAS and a stabilizer load of -86 lbf. However, if any negative angle of attack maneuvering is attempted at these speeds, the loads rapidly build up. A pushover to descend that is faster than

the aircraft can stabilize (and this does not have to be an abrupt pushover) on a new descending trajectory will yield a load of 341 lbf at 220 KTAS (3) at a moderate negative angle of attack of only -5 degrees. Continuing the descent by pushing even a degree or two harder will yield loads of 684 lbf at 240 KTAS (Vne).

The curves shown in Figure 4 will become steeper, with higher loading at the same air speed as the CG moves forward. For example, the 341 lbf load at 220 KTAS discussed above becomes 436 lbf when the CG moves forward to 91". The 684 lbf at 240 KTAS becomes 780 lbf when the CG is at 91".

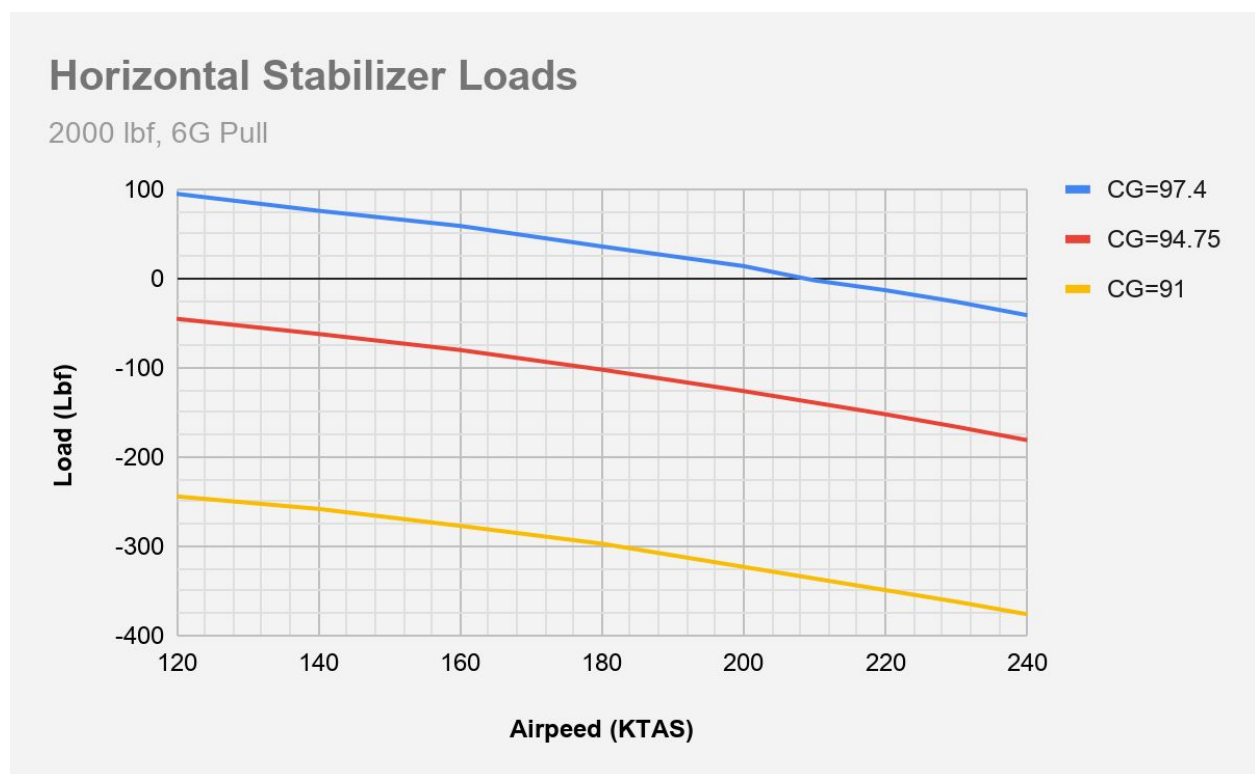
Figure 5 illustrates the effect of CG on the horizontal stabilizer tail load. The curves were generated assuming a 6 G pull at three different CG locations. At aft CG (97.4") the loads are moderate, varying between 95 and -41lbf. At the aerodynamic center (94.75") the loads vary

between -41 lbf and -181 lbf. At a CG of 91" the loads are considerably higher, varying between -244 lbf and -376 lbf. It must be stressed that these are the loads required for equilibrium in a 6 G pull, once the pull was established. The pilot will be modulating the stick in such a way to maintain the forces shown in the figure.

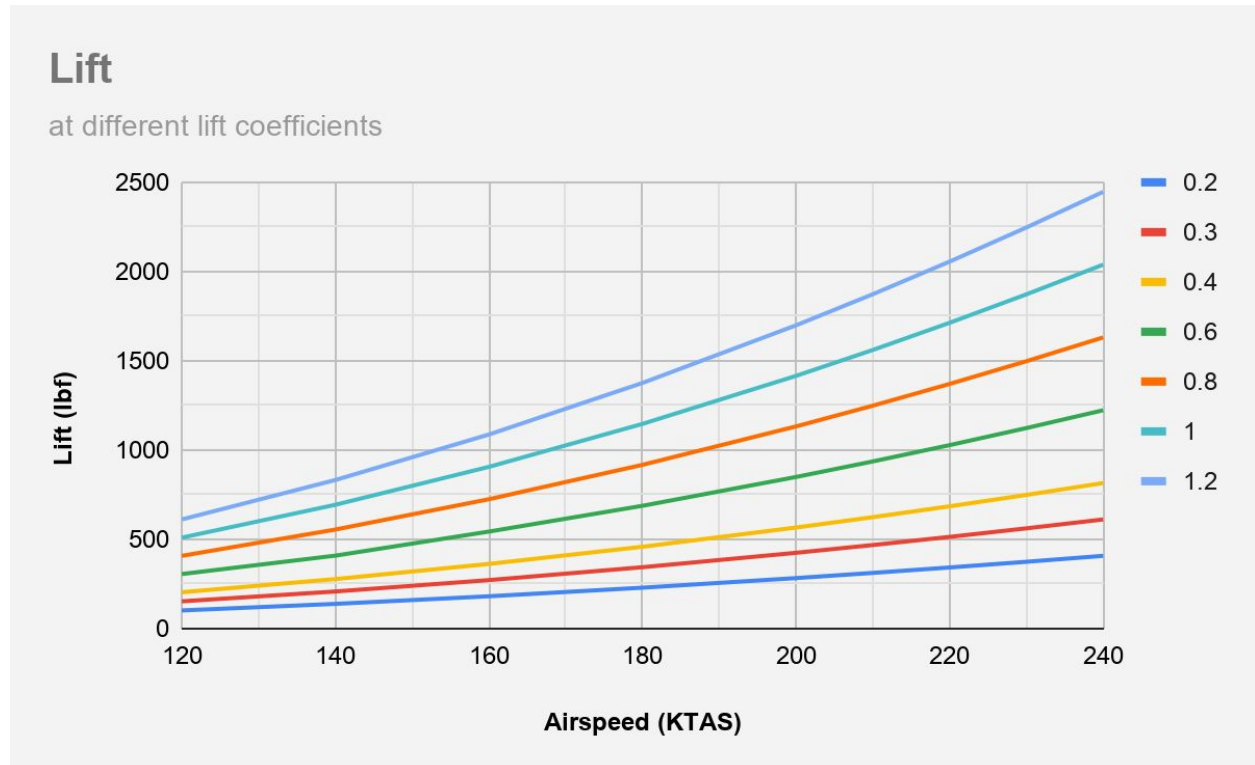
Figure 6 illustrates the loads the stabilizer can create at different lift coefficients (a combination of AoA and elevator deflection). For a 6 G pull, a 2000 lb aircraft needs to generate at least 12000 lbs. Since the wing incidence is about 2 degrees, this will require an AoA of 12 degrees. Assuming the elevator is deflected 10 degrees with an AoA of 12 degrees, the lift coefficient is about 1.2, and the immediate load on the stabilizer semispan is 2500 lbs at 240 KTS. There will be no opportunity to even reach equilibrium before the structure fails.

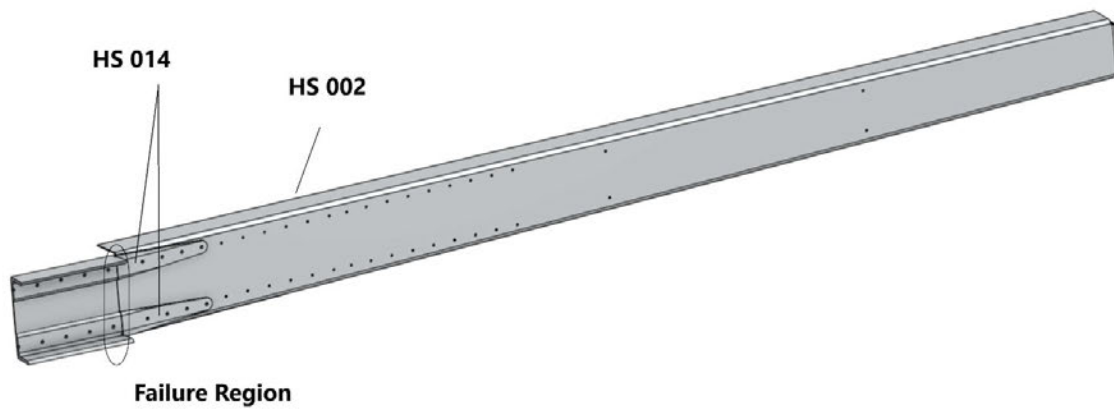
The failure region on the accident aircraft is at the bend in the HS 002 where the root rib, HS 002 and the HS 014s intersect.

Figure 9 illustrates the region of interest without the root ribs in place. The HS 002 was originally manufactured with 2024 T3 .032" aluminum. Approximately 20 to 25 of the MK I designs were manufactured before transitioning to the MK II design that had an extensive spar assembly added to the back of the HS 002 in addition to the HS 014s. It is believed that either part way through the production of the MK I, or at the start of the MK II production a transition was made to .040" 2024 T3 for the HS 002.

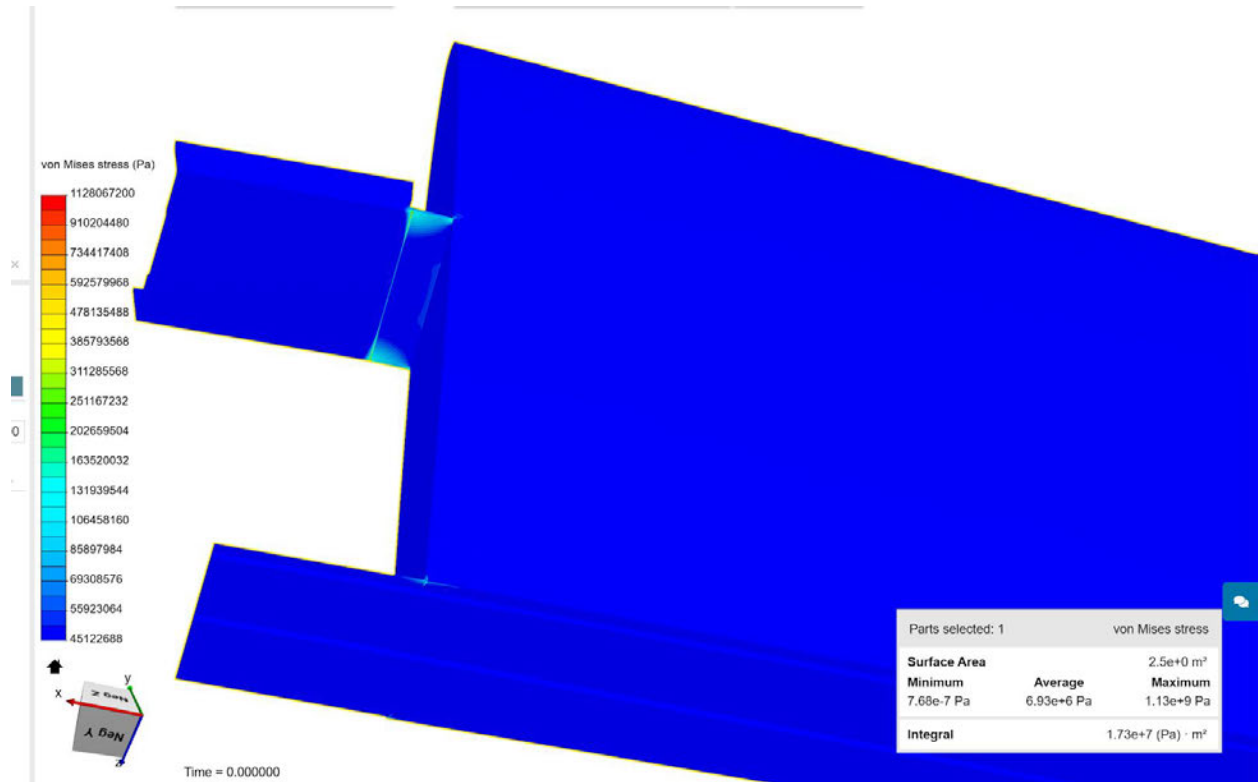
Figure 12 illustrates the Von Mises stress concentration in the bend area. The stress field in the stabilizer has been filtered to show stresses between 45 MPa and 1130 MPa. Note that the average stress level is only 7 MPa, and the nature of the stress concentration at the top and bottom of the HS 002 points to bending loads and not shear or potential buckling loads as the major problem.

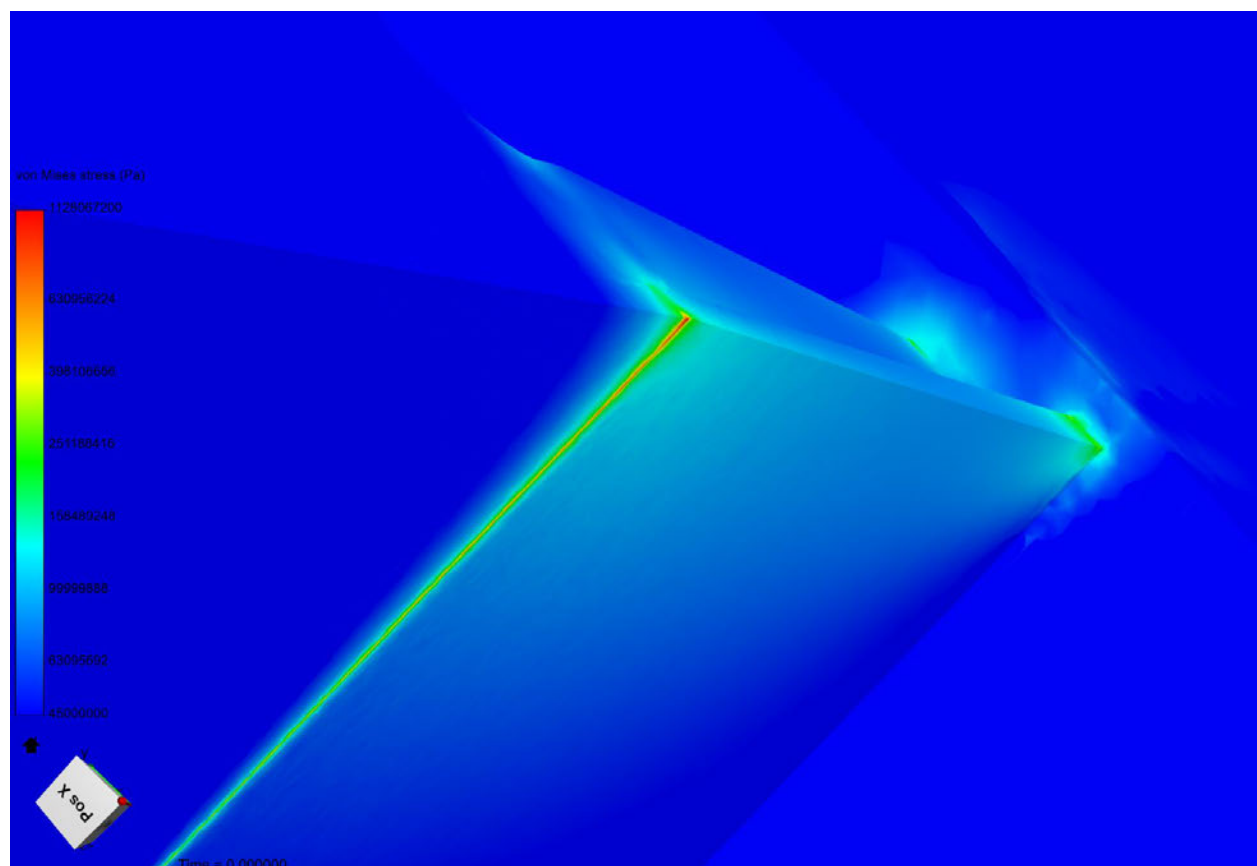
Figure 13 is a closer view of the affected area and shows that in the rivet area the part is fairly lightly loaded but in the bend area the stresses are over twice the limit load (470 MPa) of 2024 T3 aluminum.

The FEA model is a simplified version of the actual part in order to facilitate the computations. A more detailed model of the area in question would refine the peak numbers, and would possibly be lower than shown. The result, however, would be similar. This area is significantly more stressed than any other part of the stabilizer, and given the nature of any bends in highly loaded 2024 T3, this area is prone to cracking.
