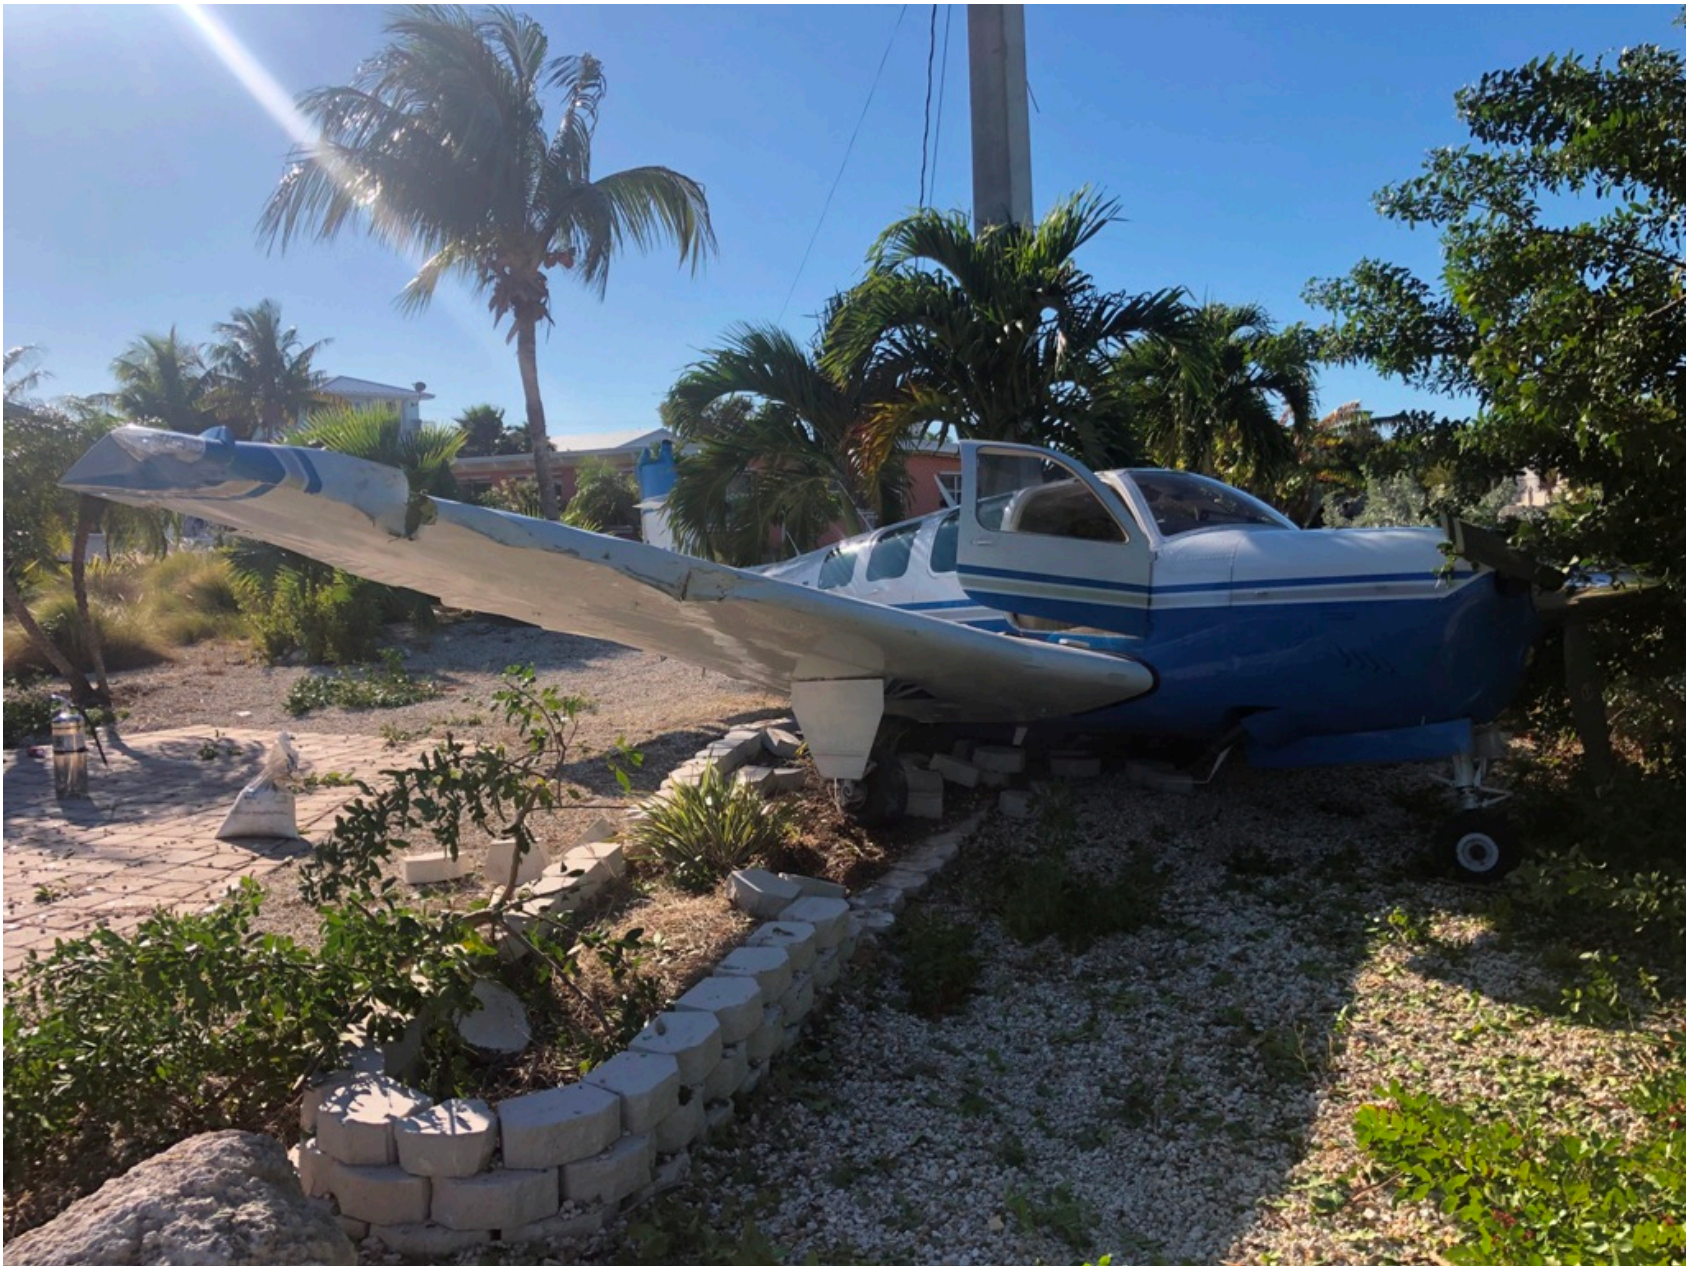
**Photo 1 – Digital Photograph From Airport Manager. Right Side View of the Airplane at the Accident Site. Note the Damage to the Right Wing.**

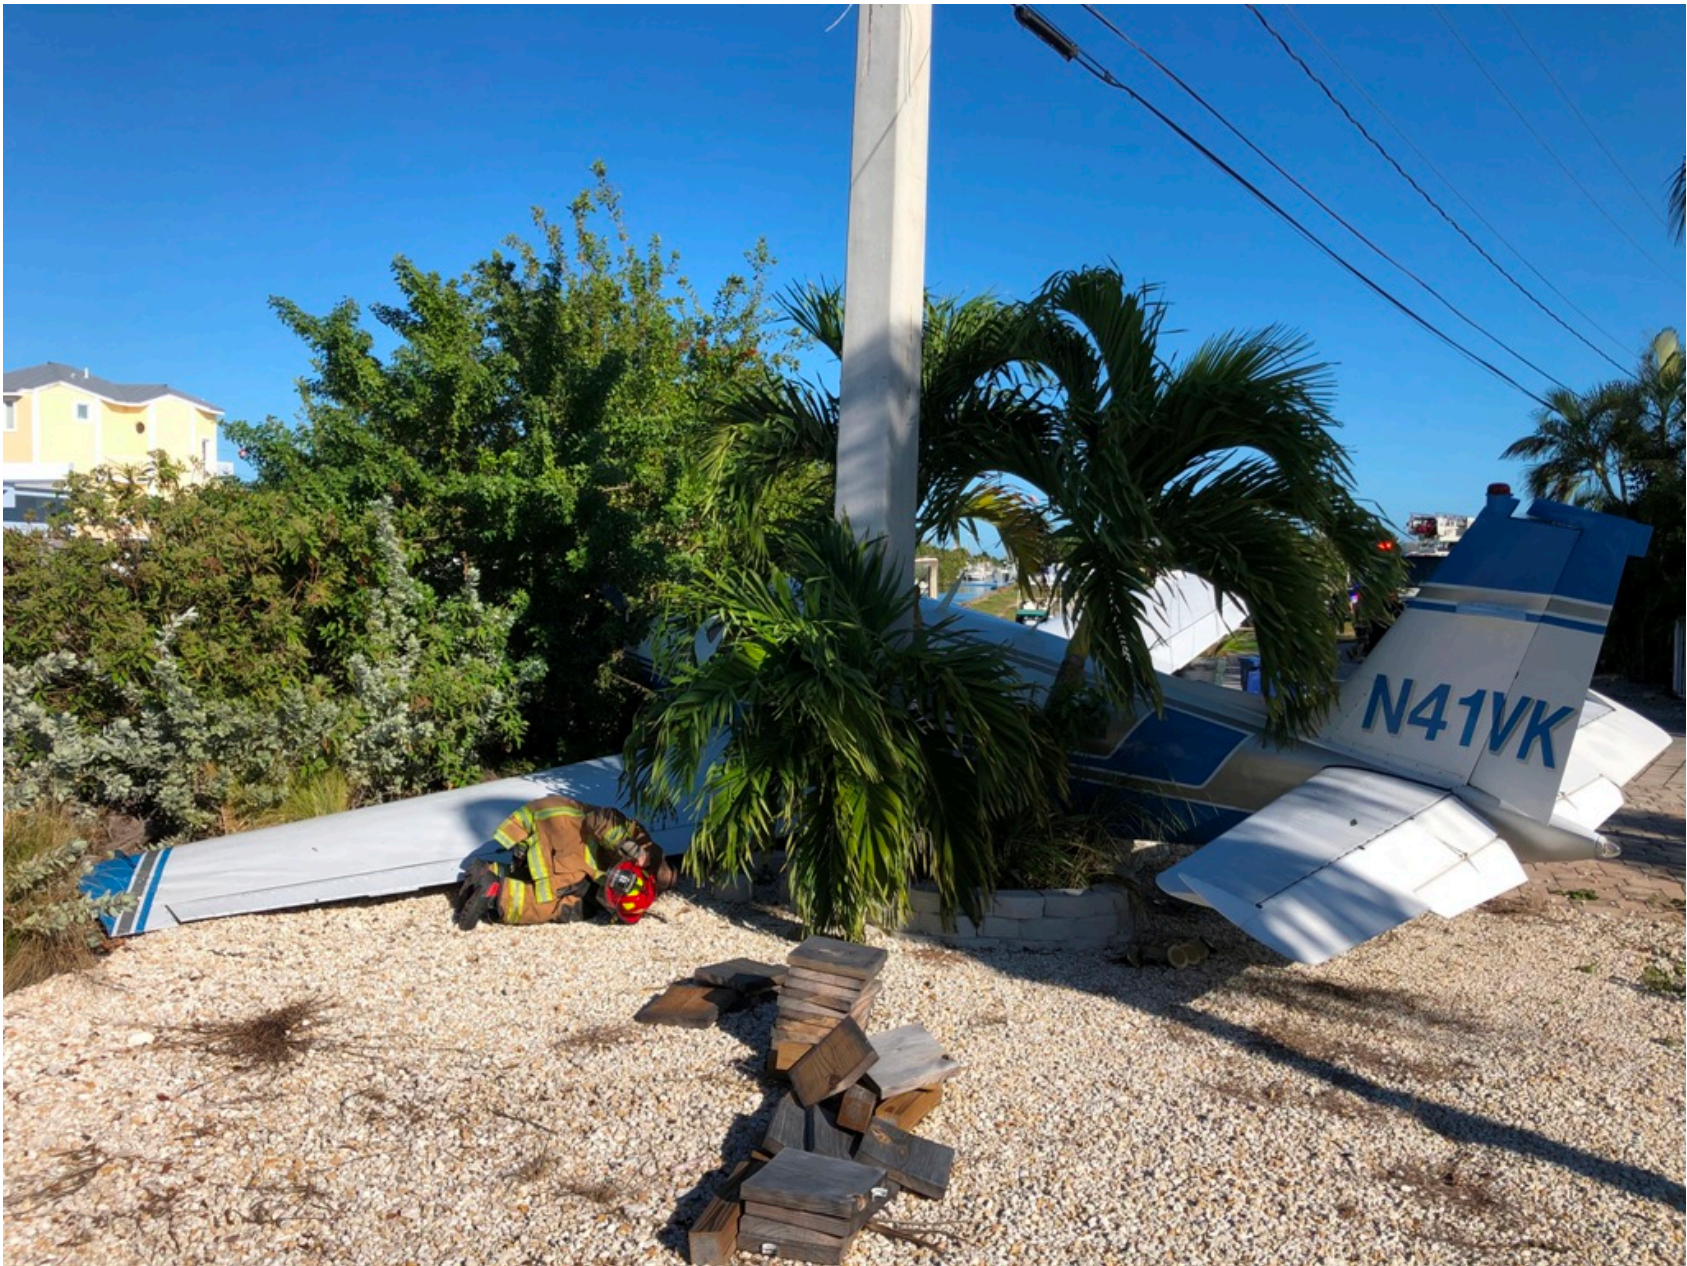
**Photo 2 - Digital Photograph From Airport Manager. Left Quartering View of the Airplane at the Accident Site Looking Forward.**

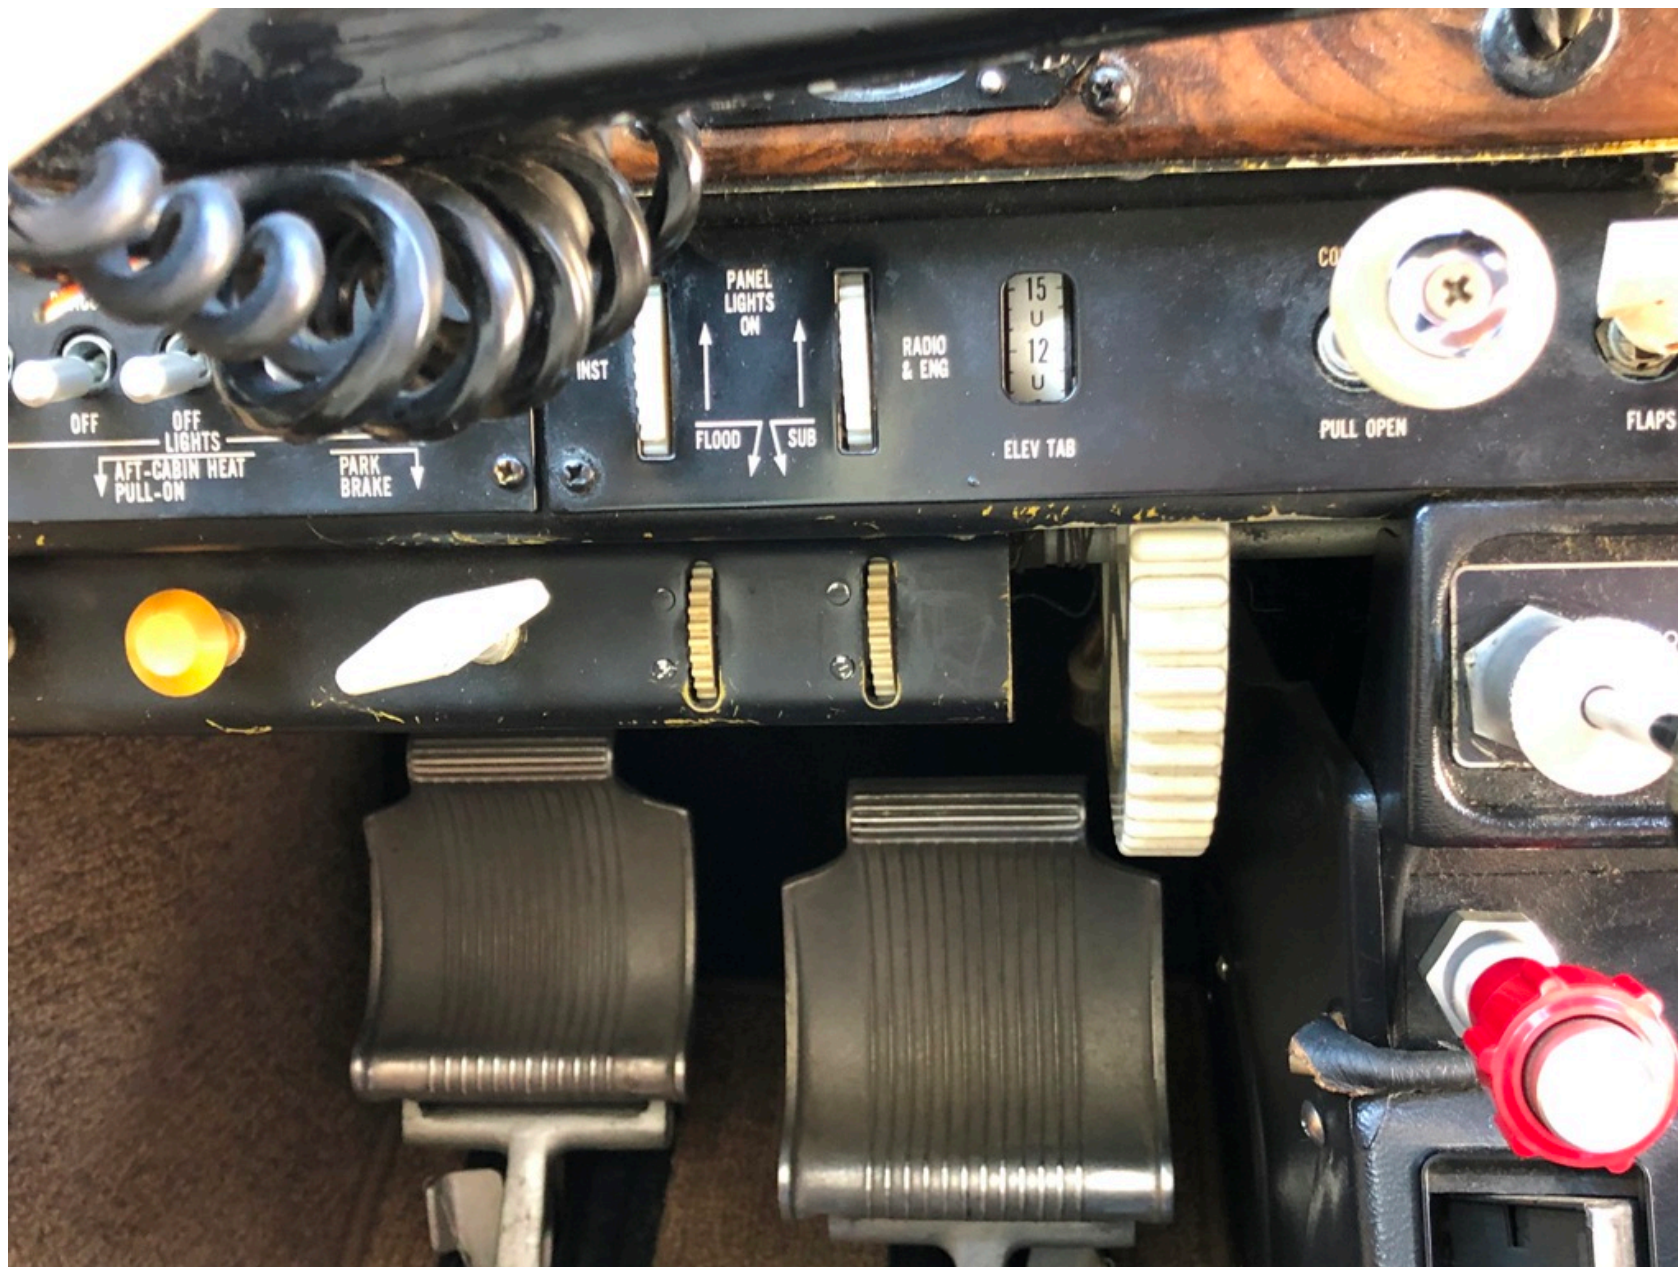
**Photo 3 - Digital Photograph From Airport Manager. View of The Lower Portion of the Instrument Panel. Note the Position of the Elevator Trim Indicator.**

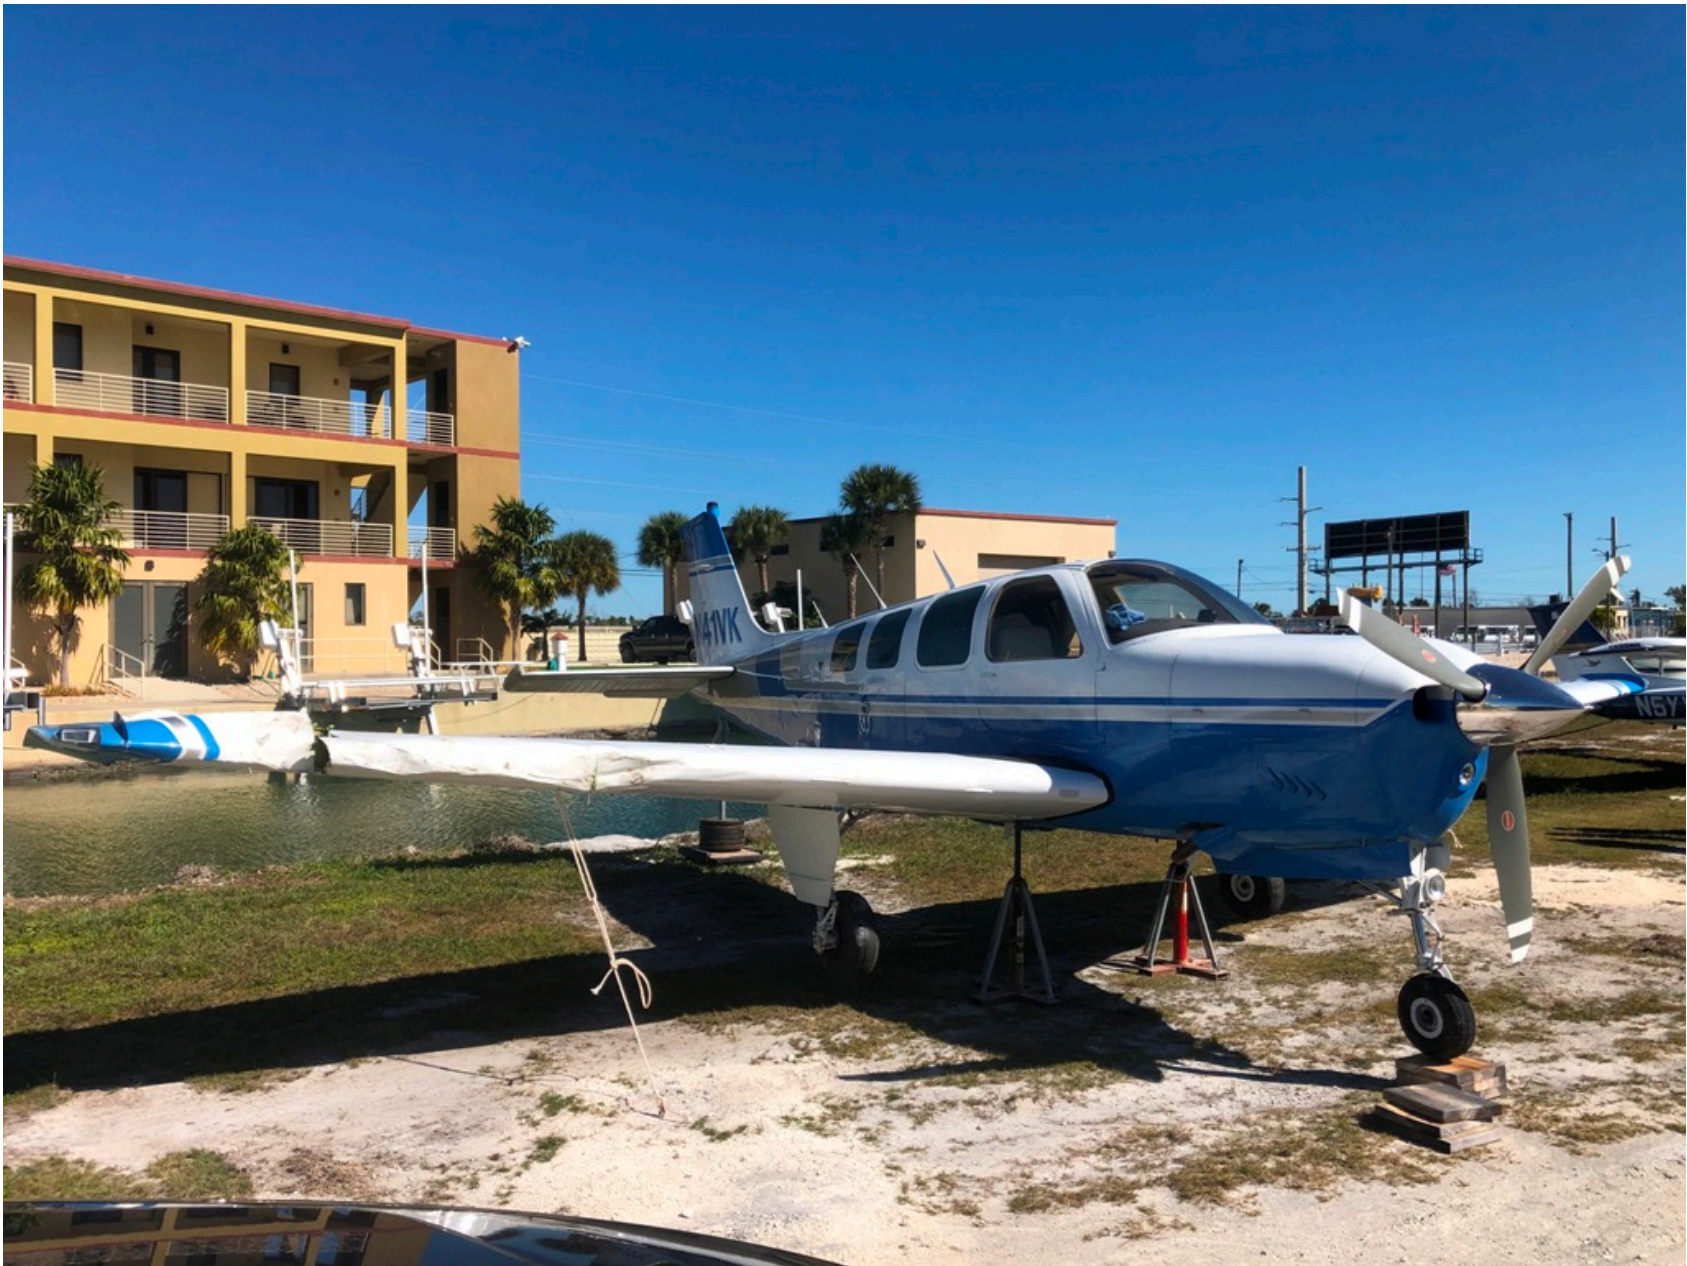
**Photo 4 - Digital Photograph From Airport Manager. Right Quartering View of the Airplane Following Recovery.**

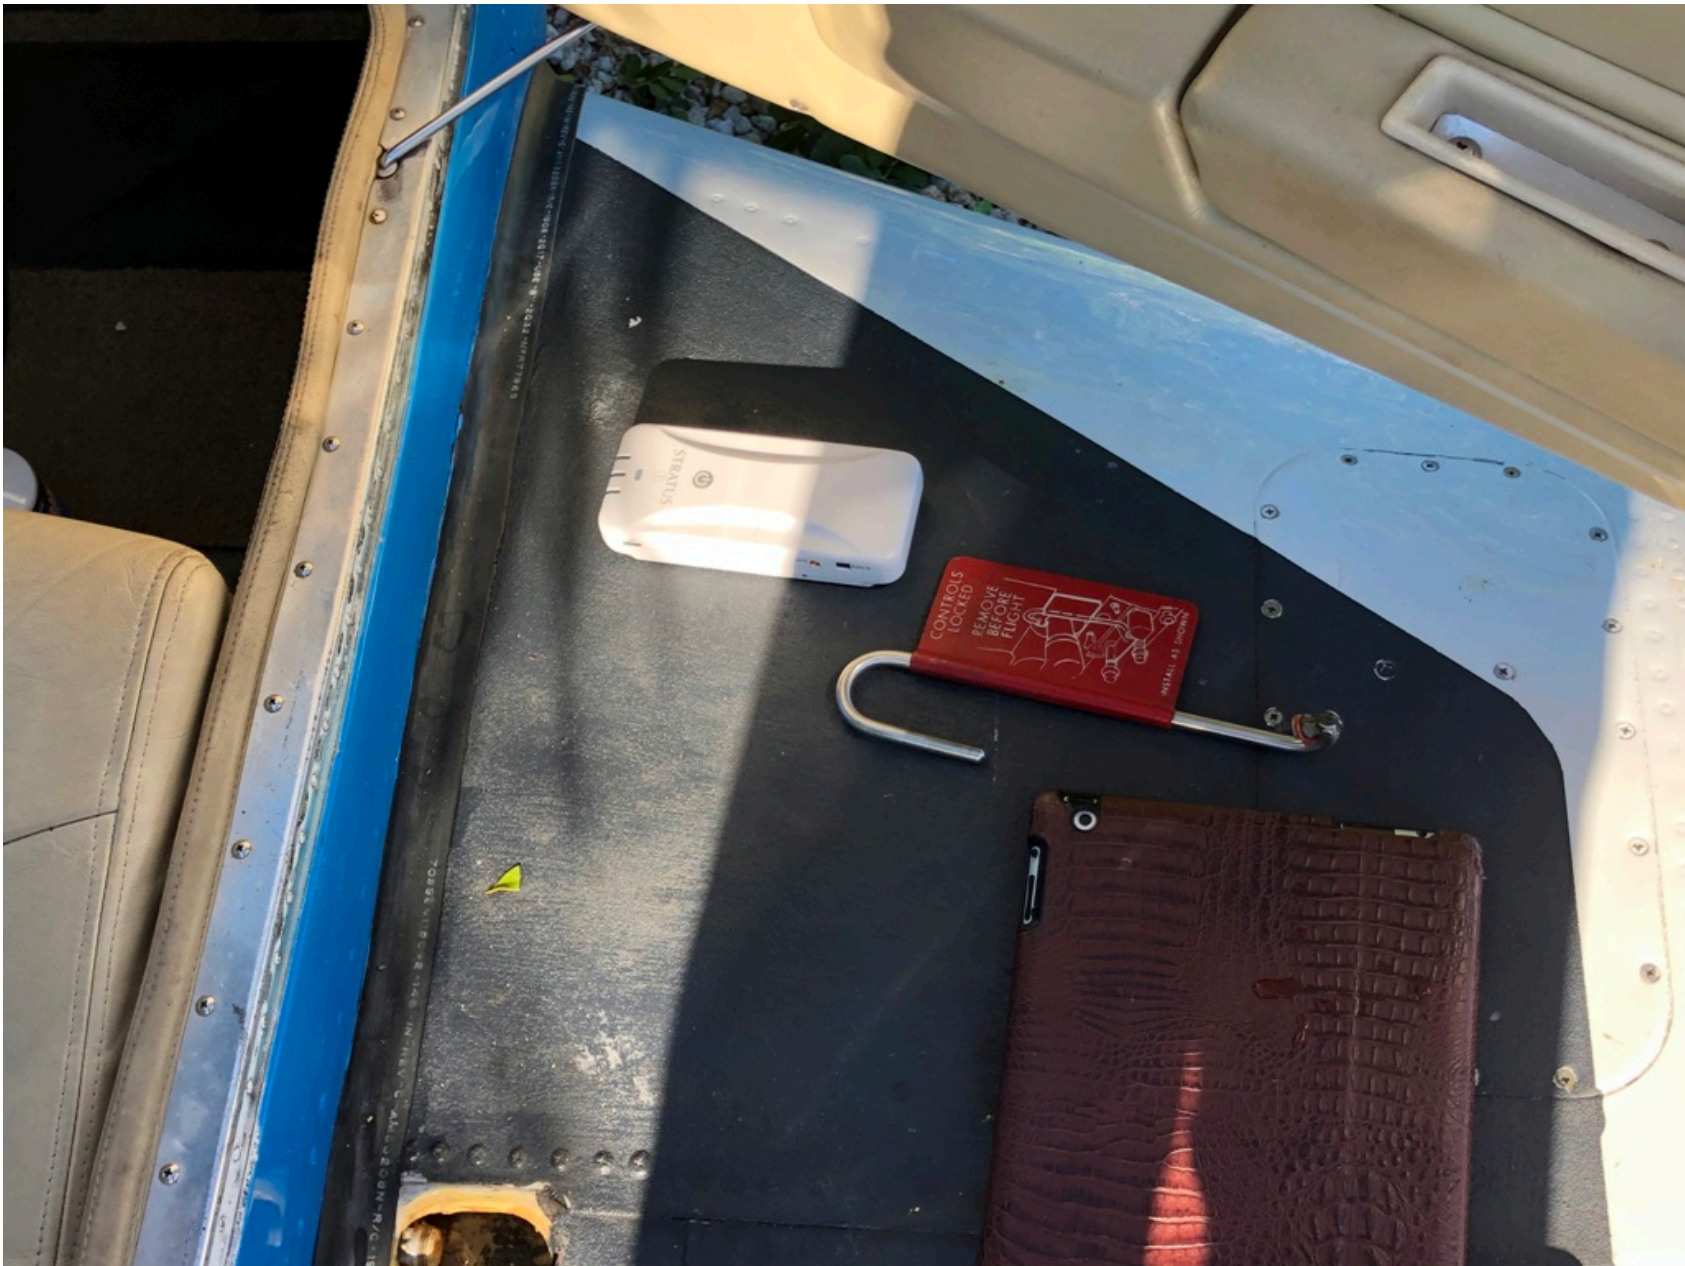
**Photo 5 - Digital Photograph From Airport Manager. Photograph taken at 1547 EST. View Depicts the As-Observed Position of the Gust Control Lock About 12 Minutes after the Accident.**

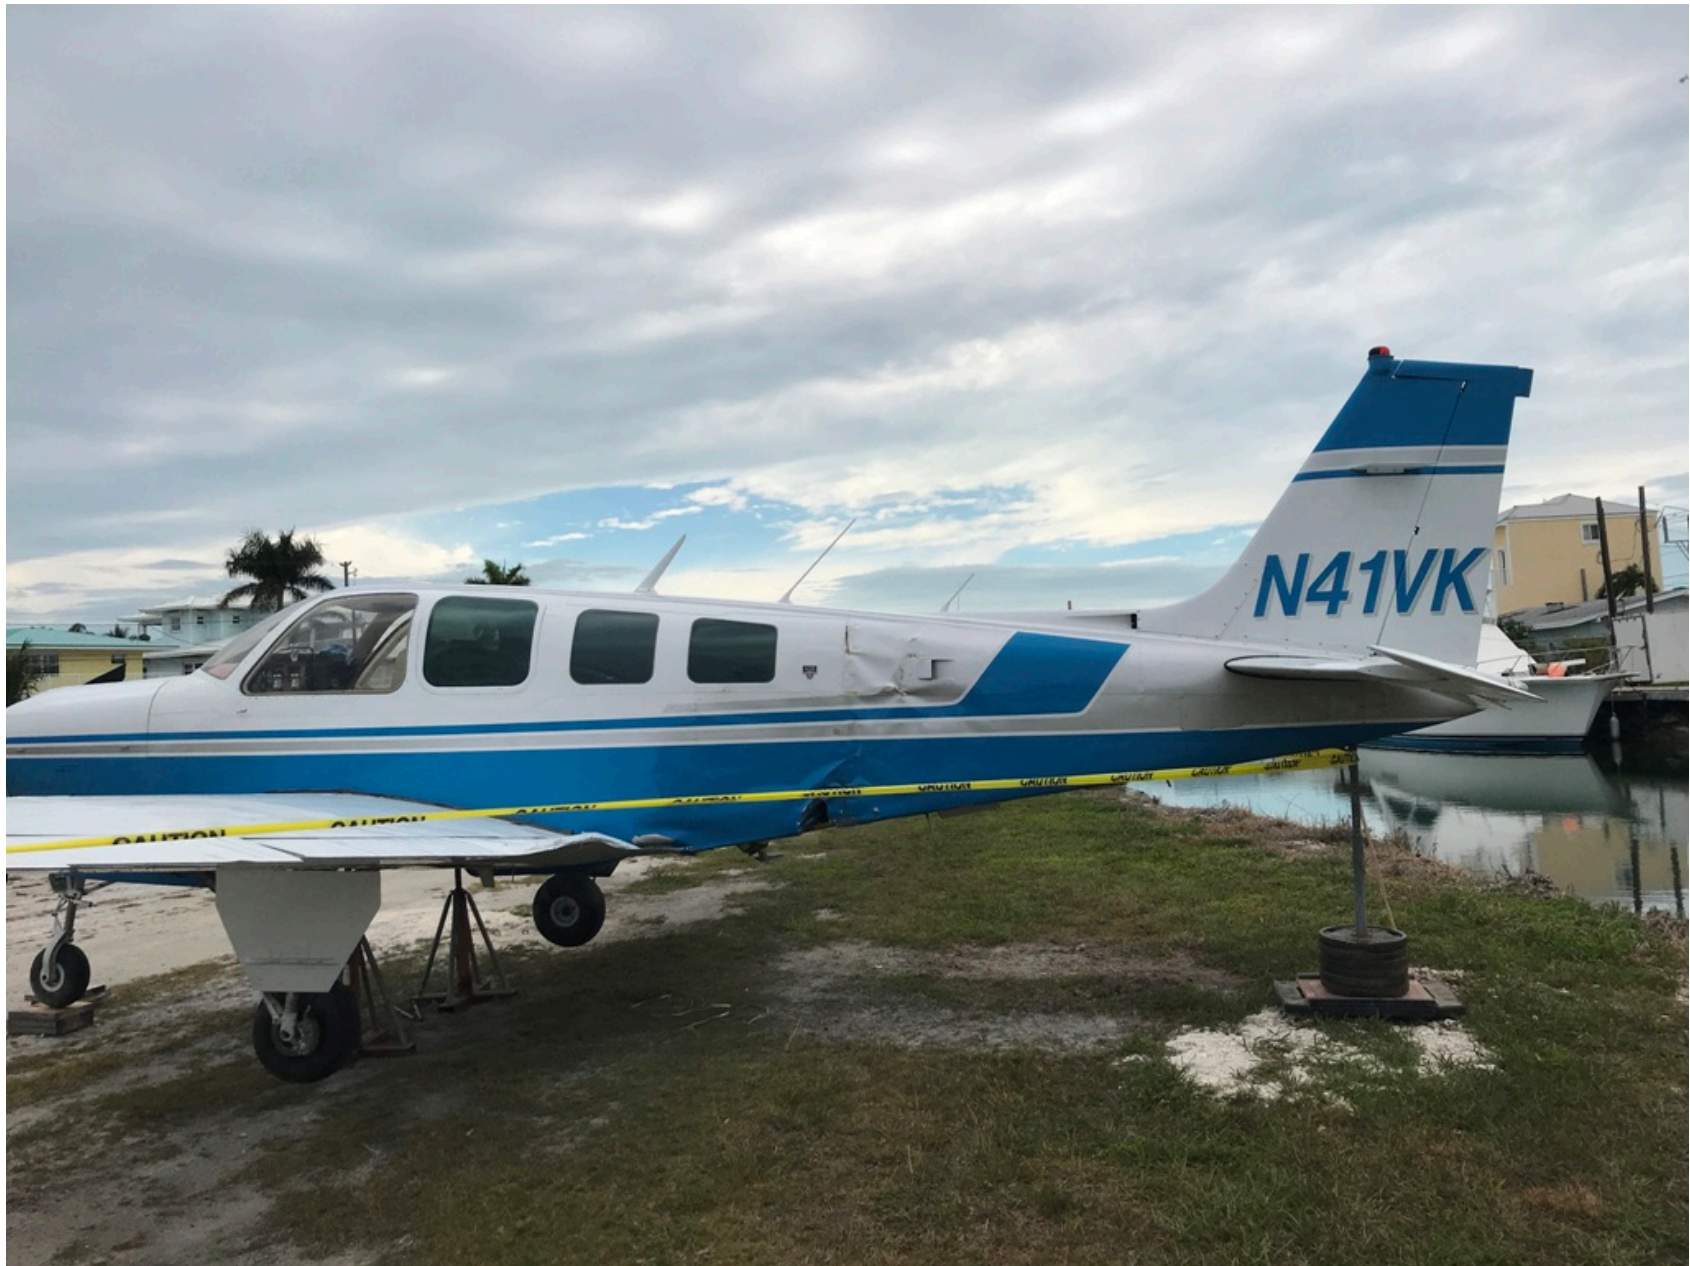
**Photo 6 – FAA Digital Photograph. Left Side View Taken After Recovery Depicting the Position of the Elevator Primary Flight Control Surface with the Gust Control Lock Installed.**

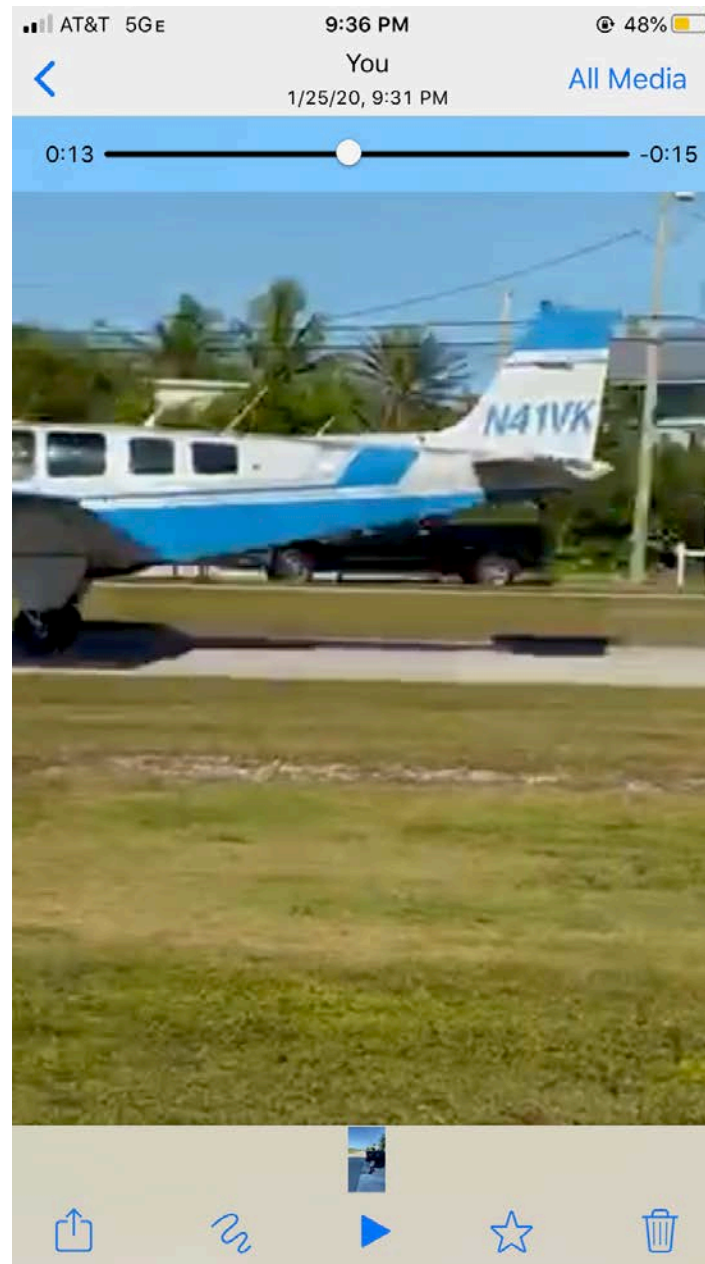
**Photo 7 – Left Side View of the Airplane During the Takeoff Extracted From Video Clip Provided to NTSB. Elevator Appears to be Trailing Edge Down Position.**

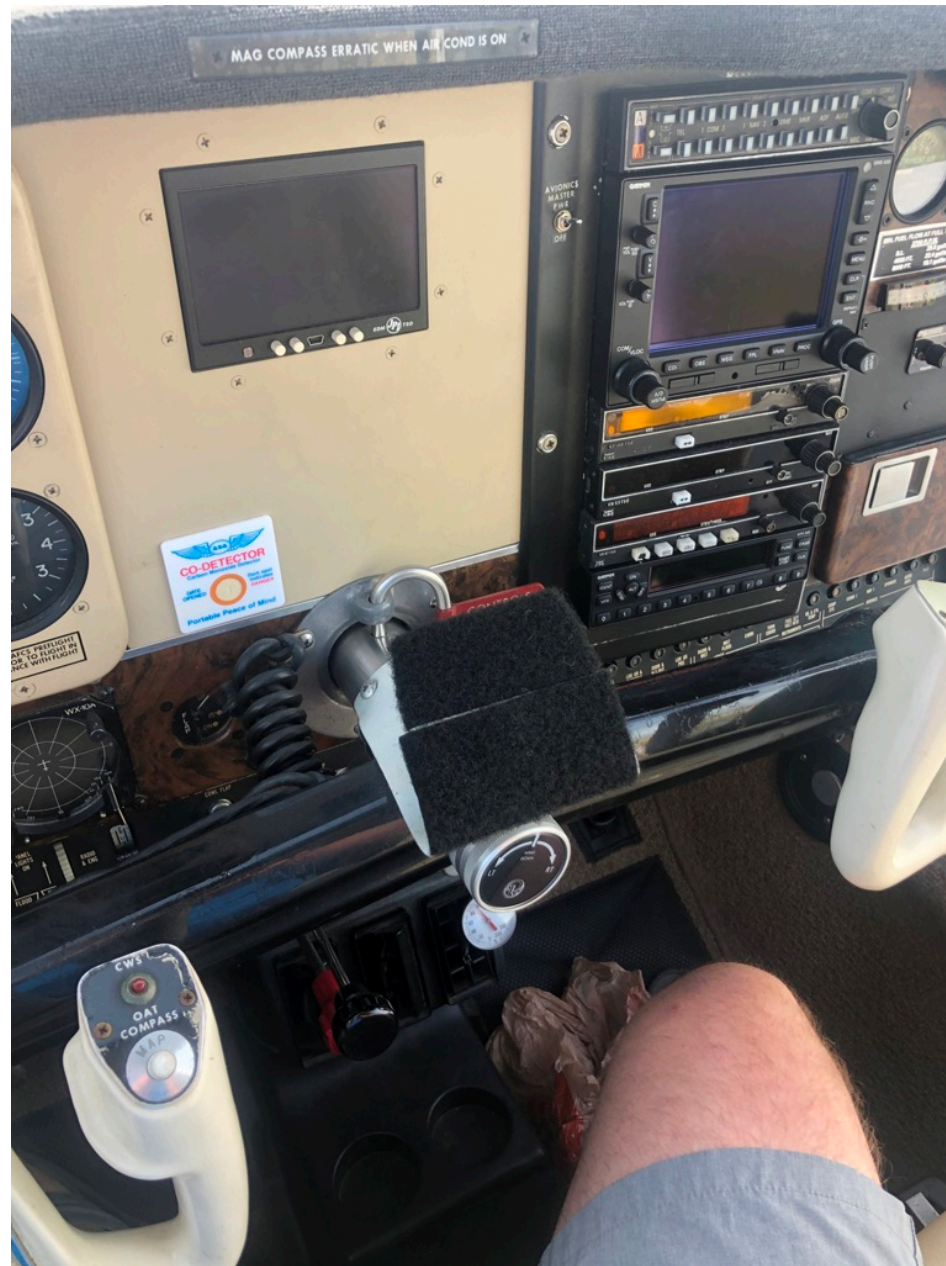
**Photo 8 - Digital Photograph From Airport Manager. View of a Portion of the Instrument Panel Depicting the Dual Control Yokes, and iPad Mount.**
