**NATIONAL TRANSPORTATION SAFETY BOARD**

Office of Aviation Safety  
Eastern Region

**Photo Array**

**ERA20LA121**

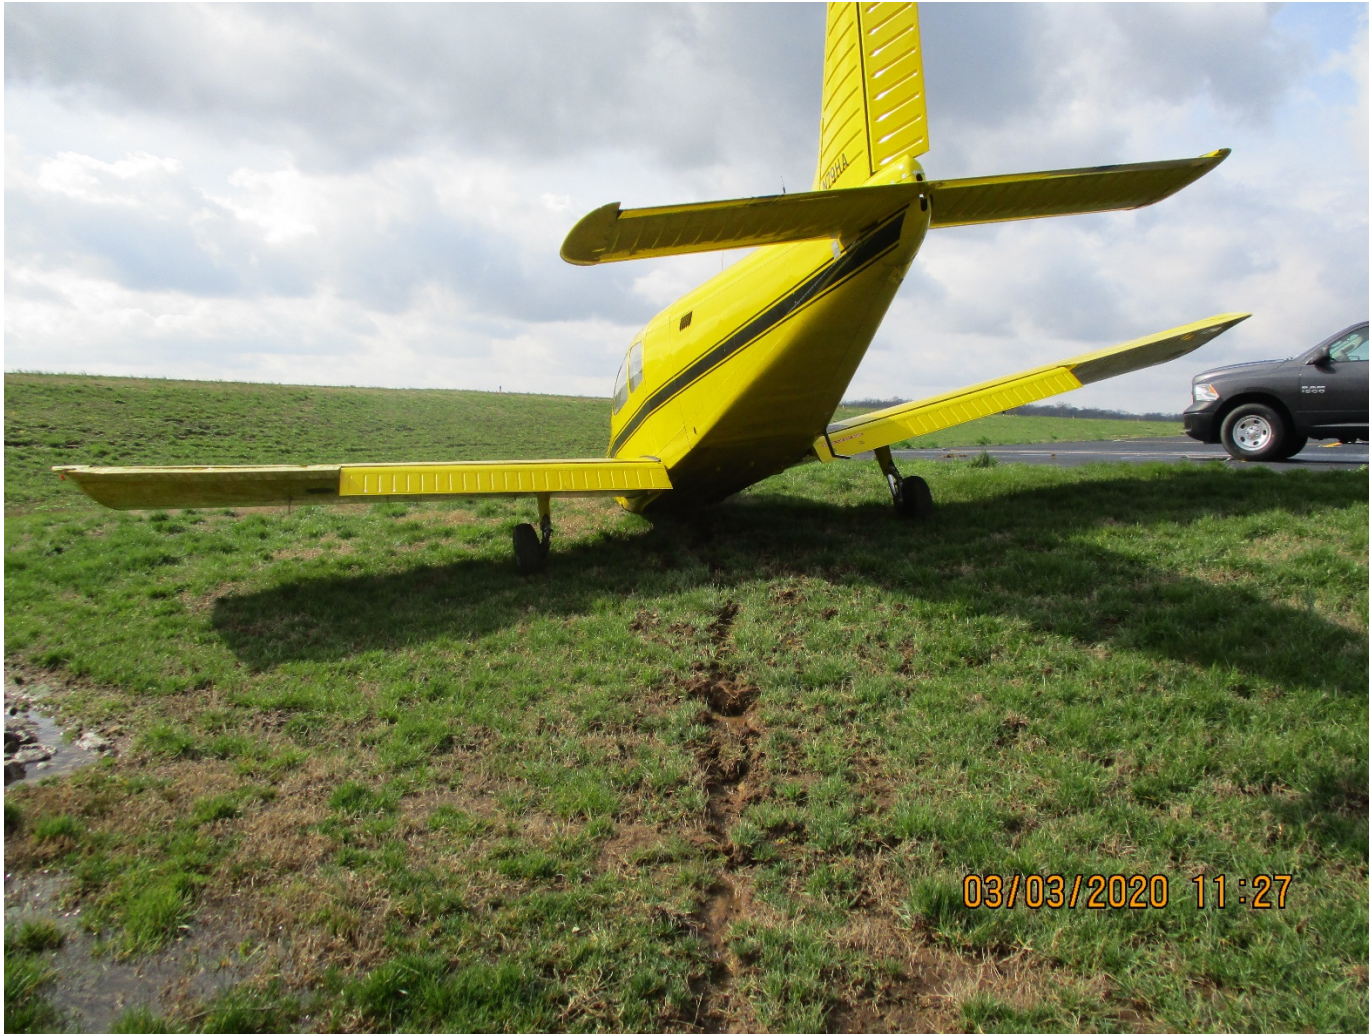
**Photo 1 – View of Airplane from Rear (Photo Courtesy of FAA)**

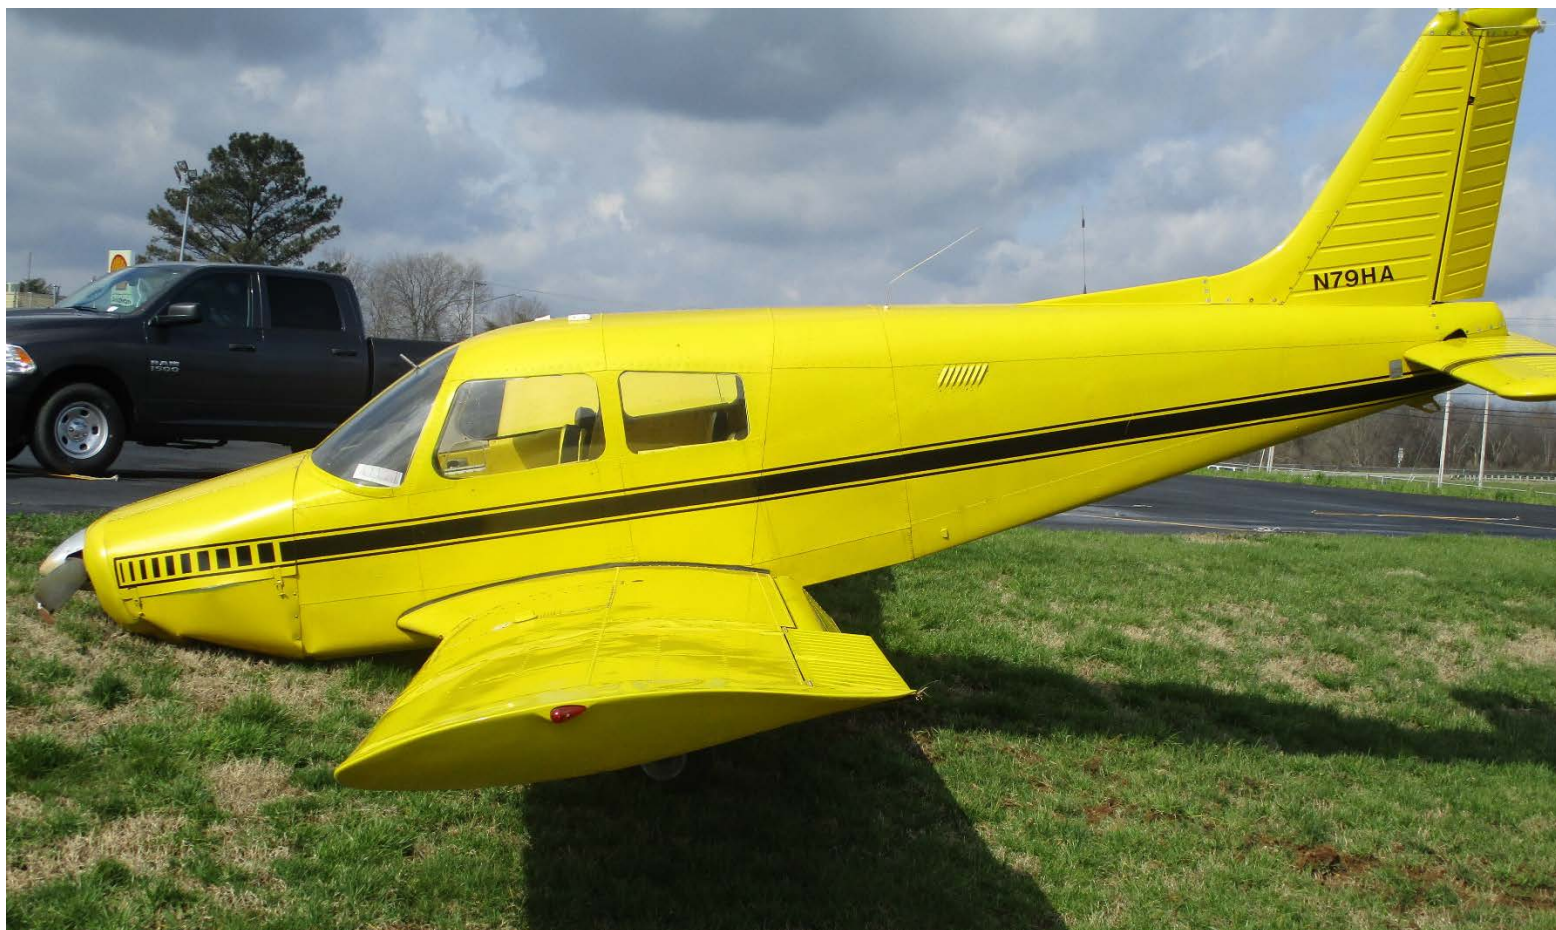
**Photo 2 – View of Airplane From Left (Photo Courtesy of FAA)**

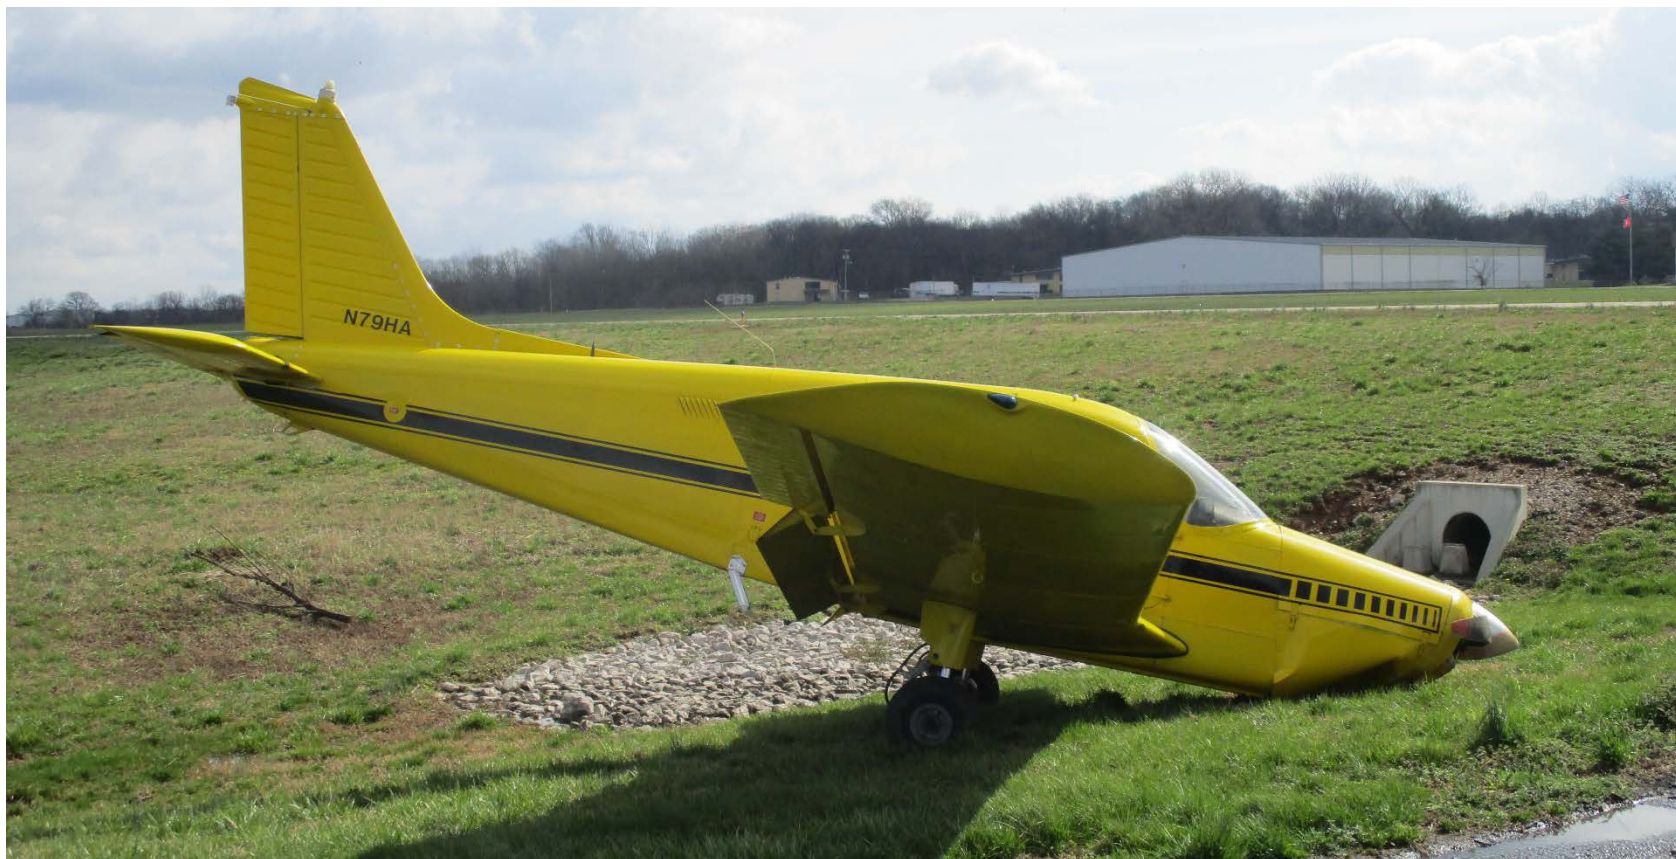
**Photo 3 – View of Airplane from Right (Photo Courtesy of FAA)**

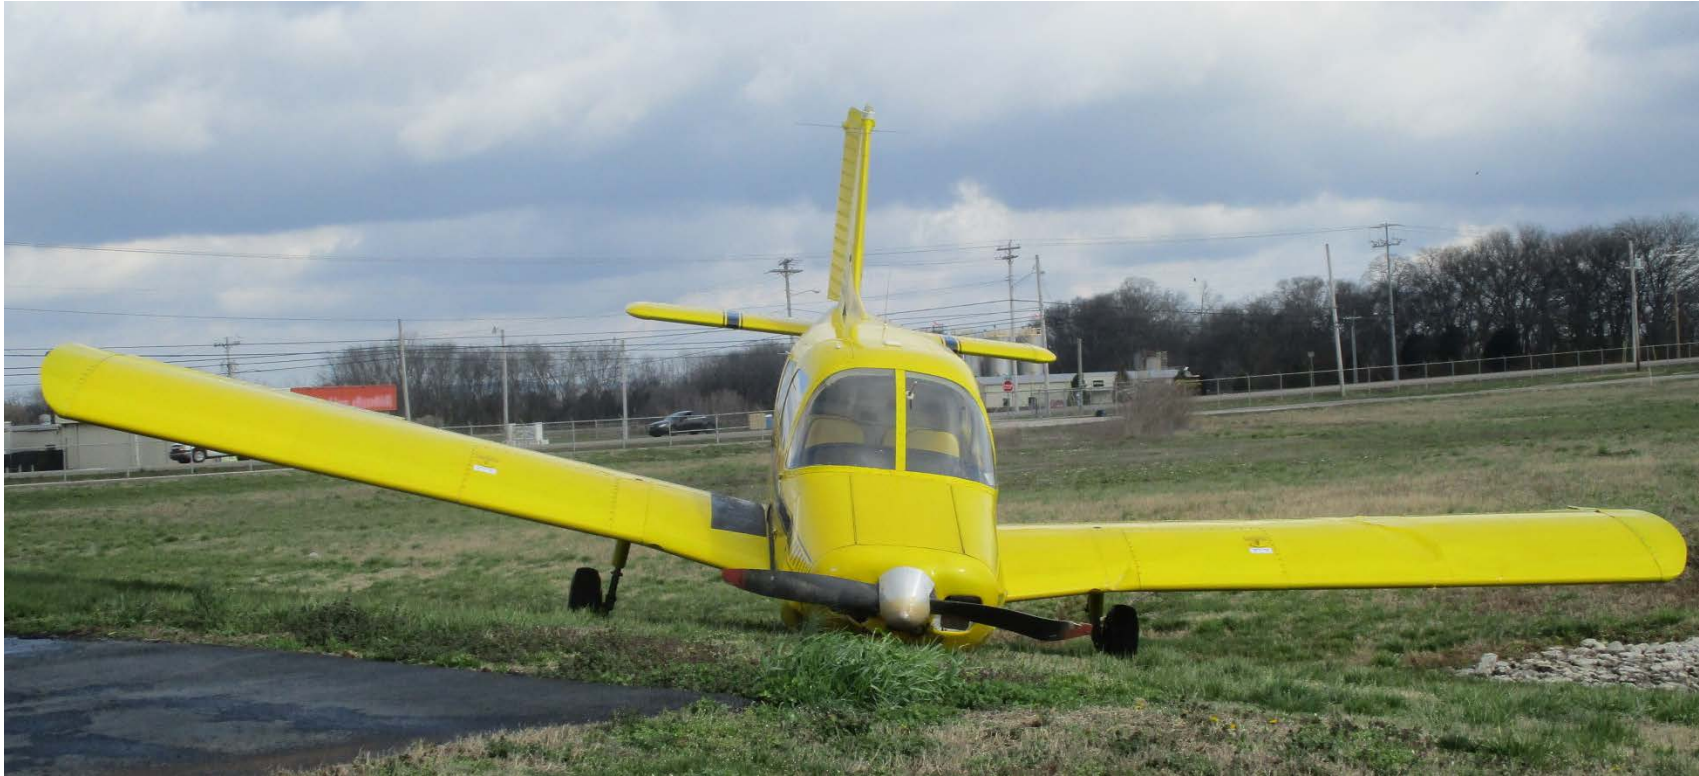
**Photo 4 – View of Airplane from Front (Photo Courtesy of FAA)**

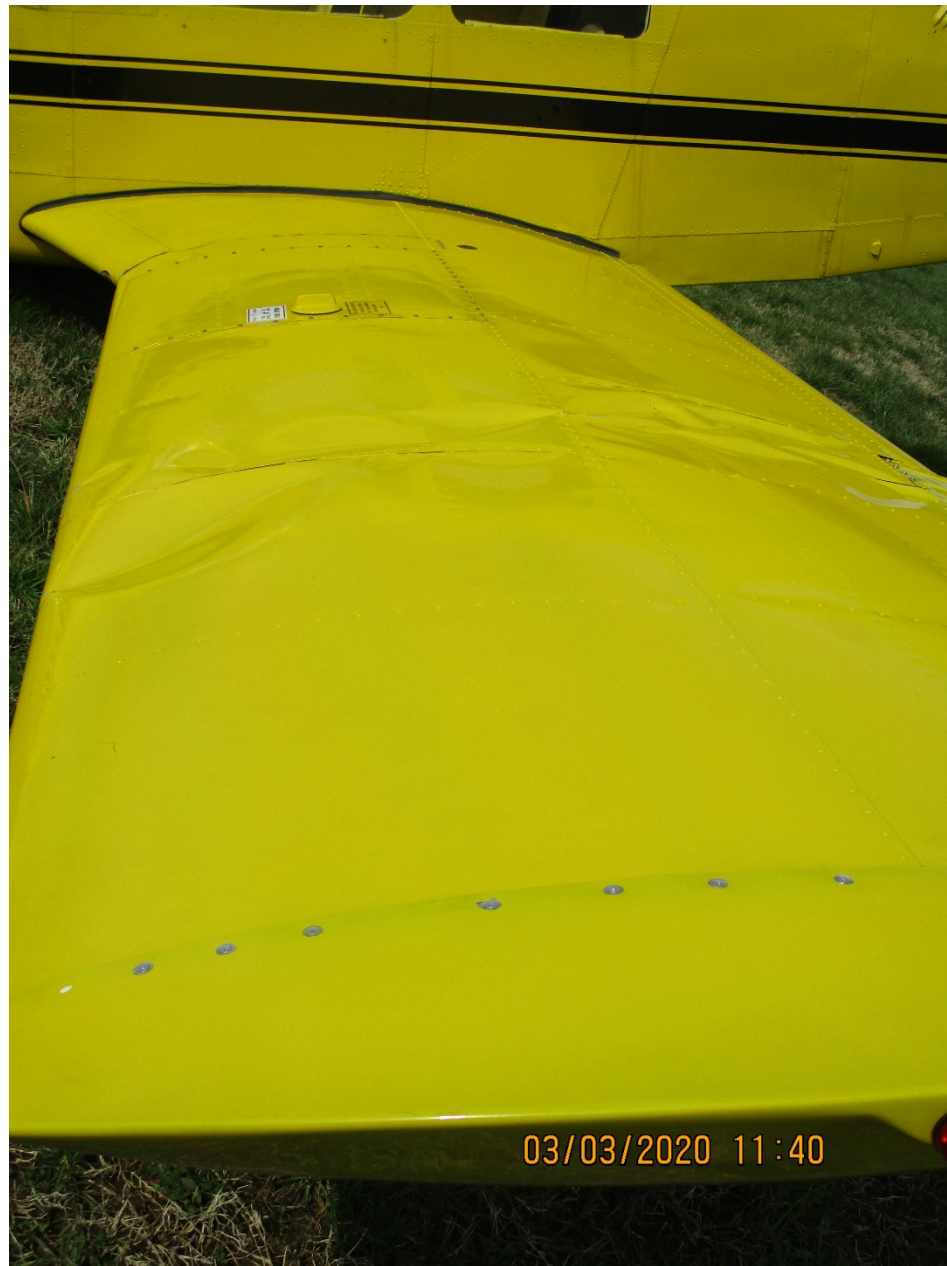
**Photo 5 – View of Left Wing Damage (Photo Courtesy of FAA)**

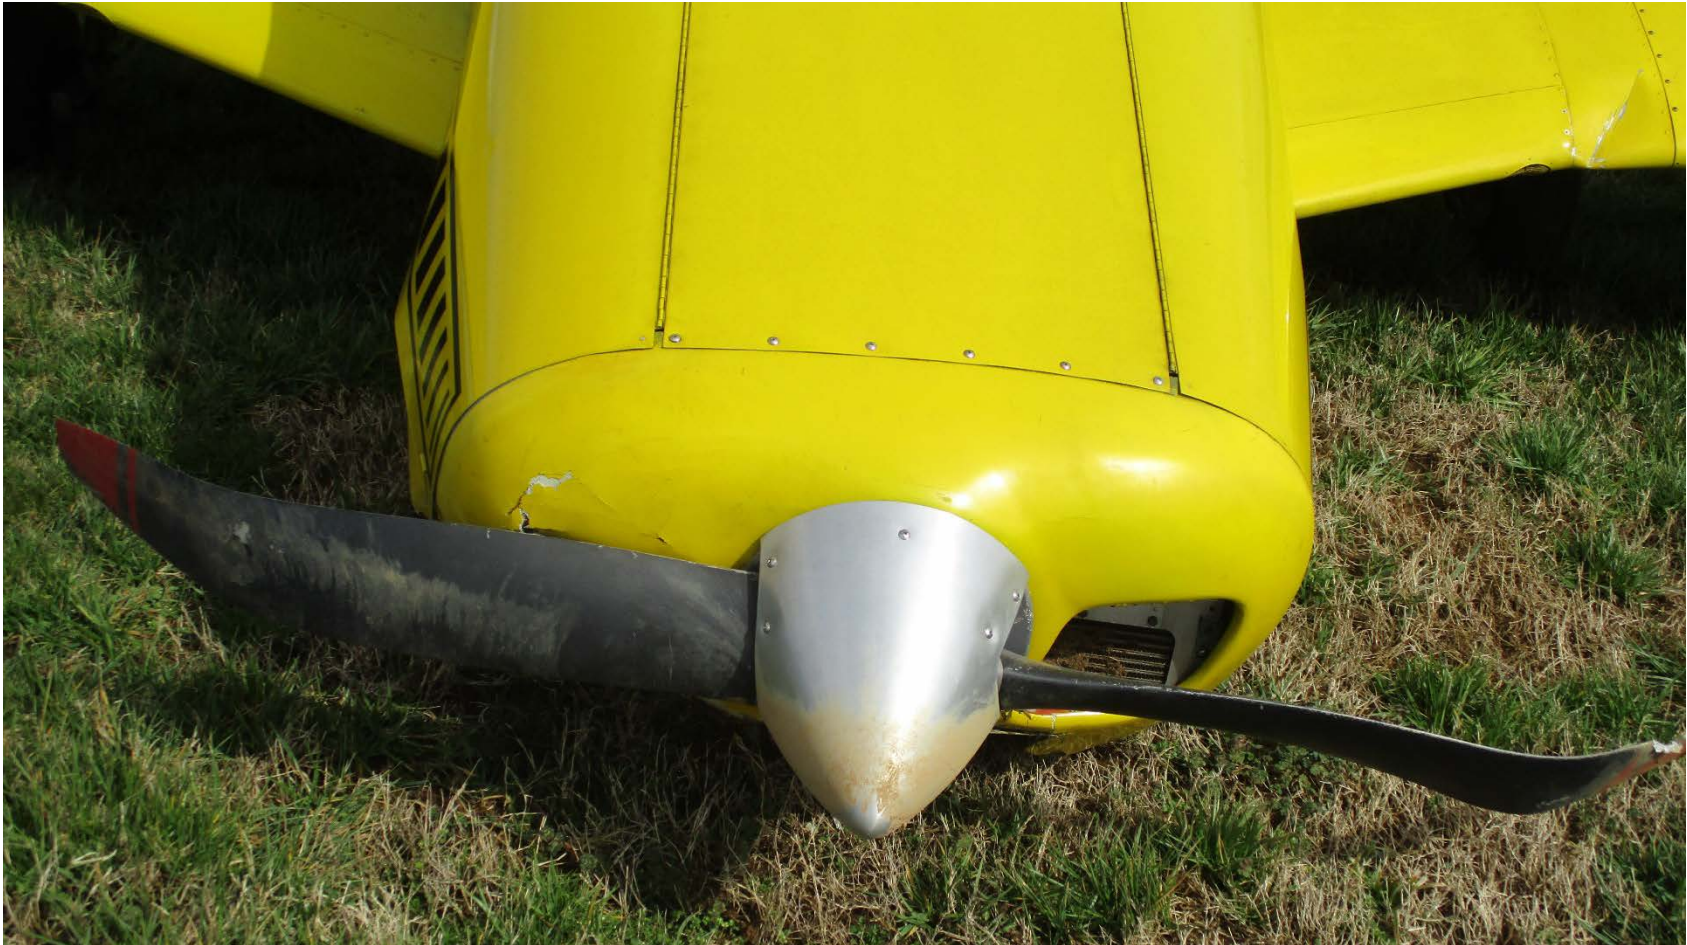
**Photo 6 – View of Propeller (Photo Courtesy of FAA)**

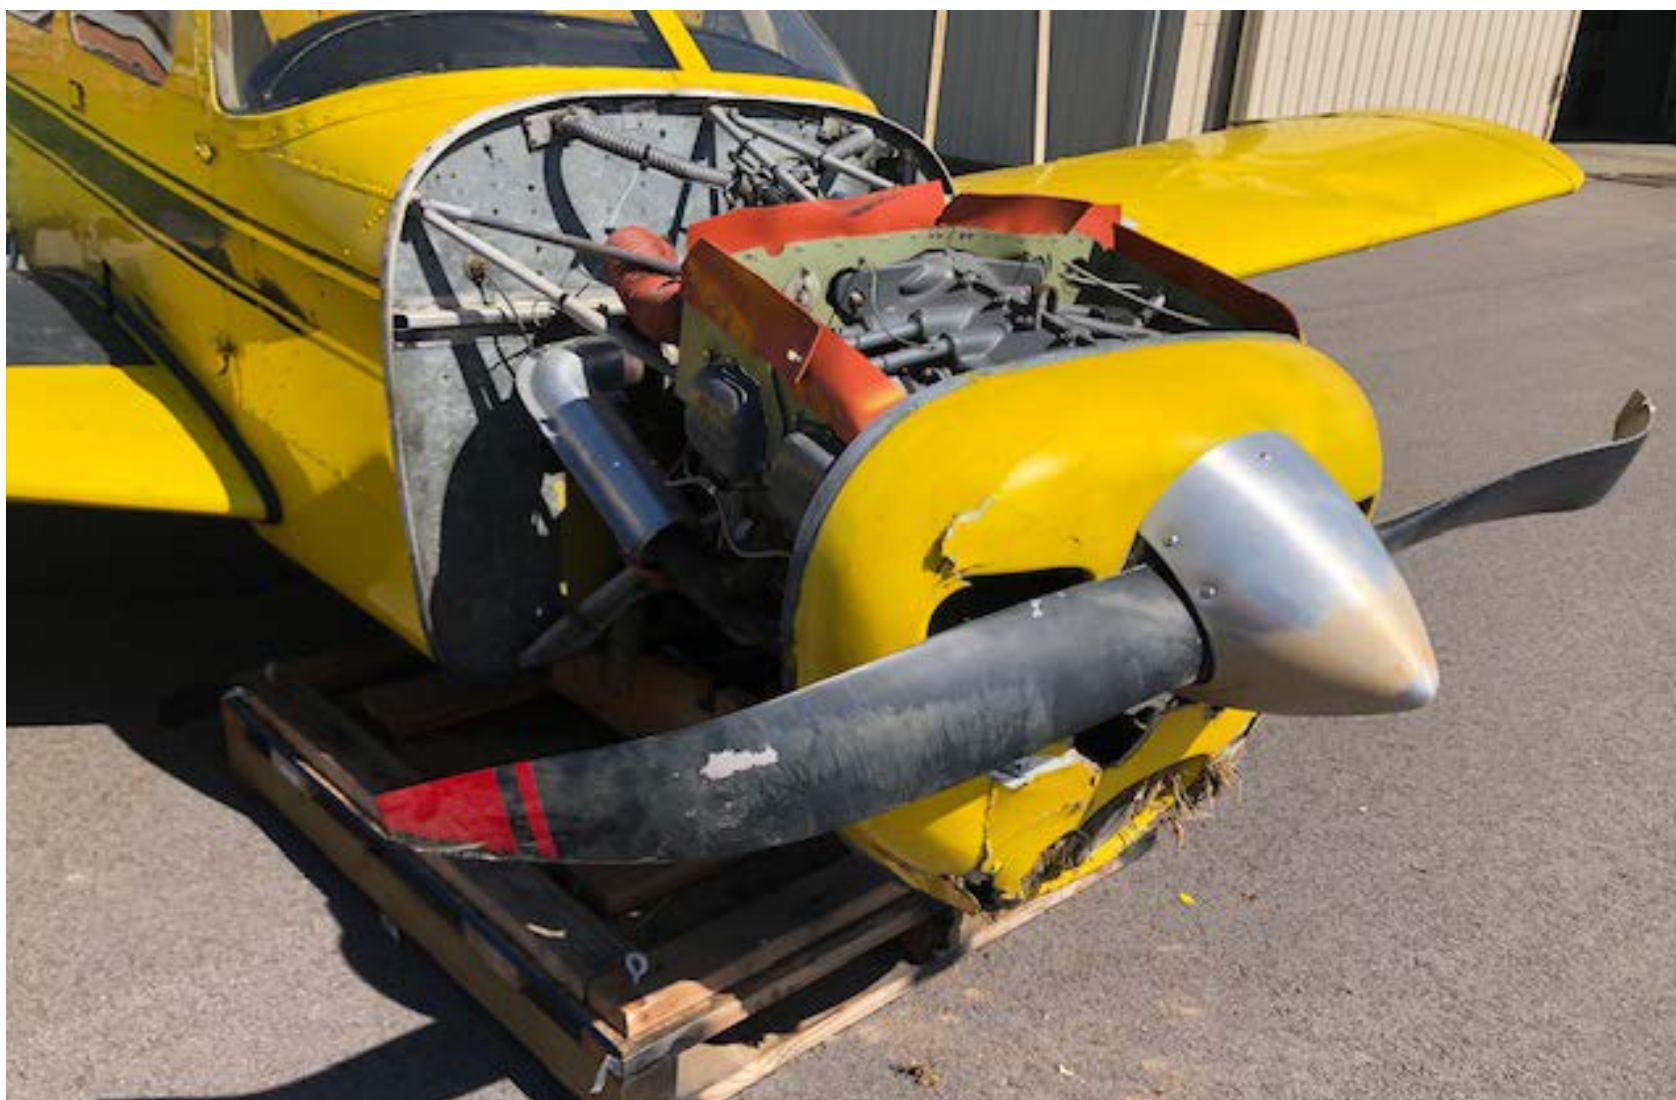
**Photo 7 – Engine Prior to Inspection (Photo Courtesy of John DeYager)**
