## **NATIONAL TRANSPORTATION SAFETY BOARD**

### **Specialist's Factual Report**

# **METEOROLOGY**

ERA20LA126

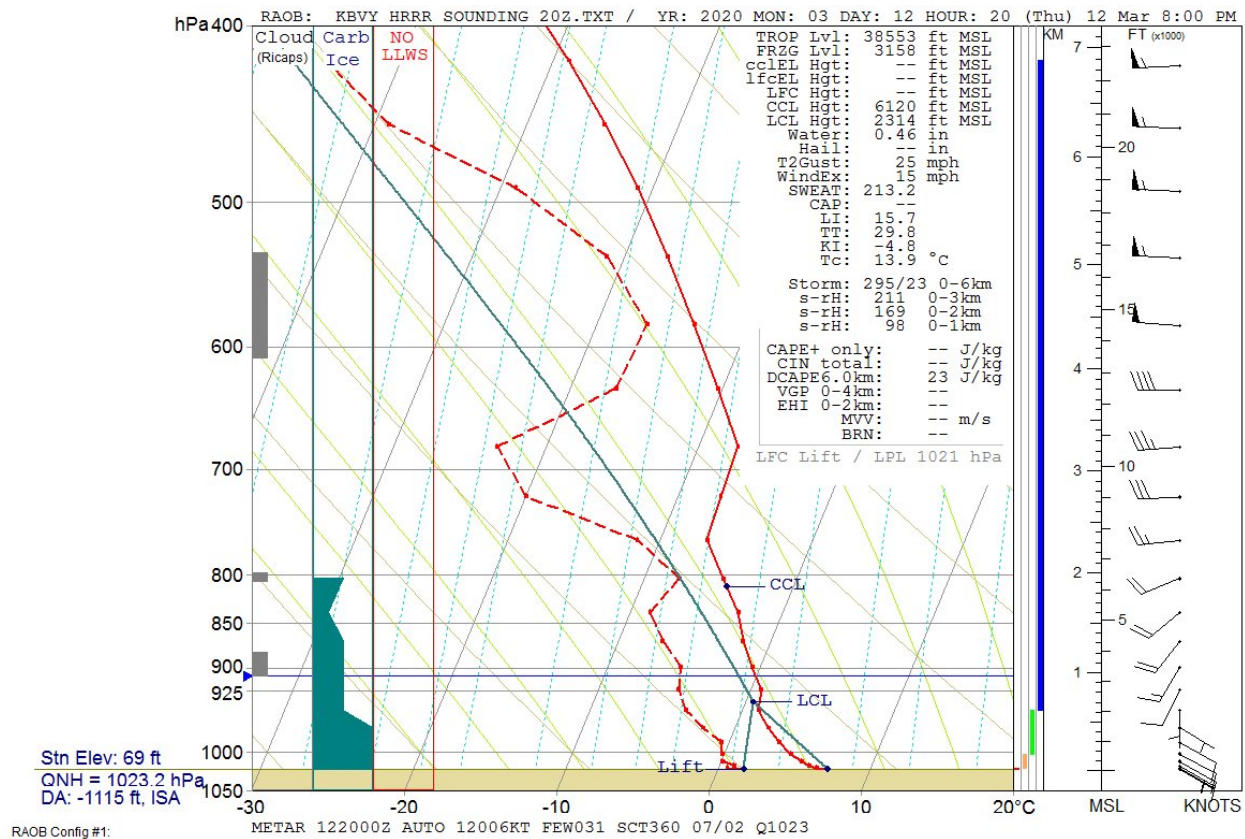
To determine the vertical structure of the atmosphere over the region High-Resolution Rapid Refresh (HRRR)<sup>1</sup> numerical model data were retrieved from the NOAA Air Resource Laboratory and plotted on a standard Skew T log P diagram<sup>2</sup> using the RAOB software<sup>3</sup> program. Figure 1 is a plot of the HRRR numerical model sounding for 1600 EDT from the surface to 400-hPa (approximately 24,000 ft) over the airport's coordinates. The HRRR model sounding depicted a near surface temperature of 7° C, and a dew point temperature of 2° C, with a surface wind from 120° at 6 knots. Except for the lowest several hundred feet of the surface, the atmosphere was characterized as stable with a Lifted Index of 15.7. The freezing level was identified at approximately 3,160 ft. The sounding supported carburetor icing from the surface through 6,000 ft and is indicated by the dark green bar on the left side of the diagram.

The HRRR wind profile indicated near surface winds from the southeast with the wind veering<sup>4</sup> to the south and southwest through 2,000 ft, and to the west above 7,000 ft. The mean 0 to 6 kilometer or 18,000 ft wind was from 295° at 23 knots.

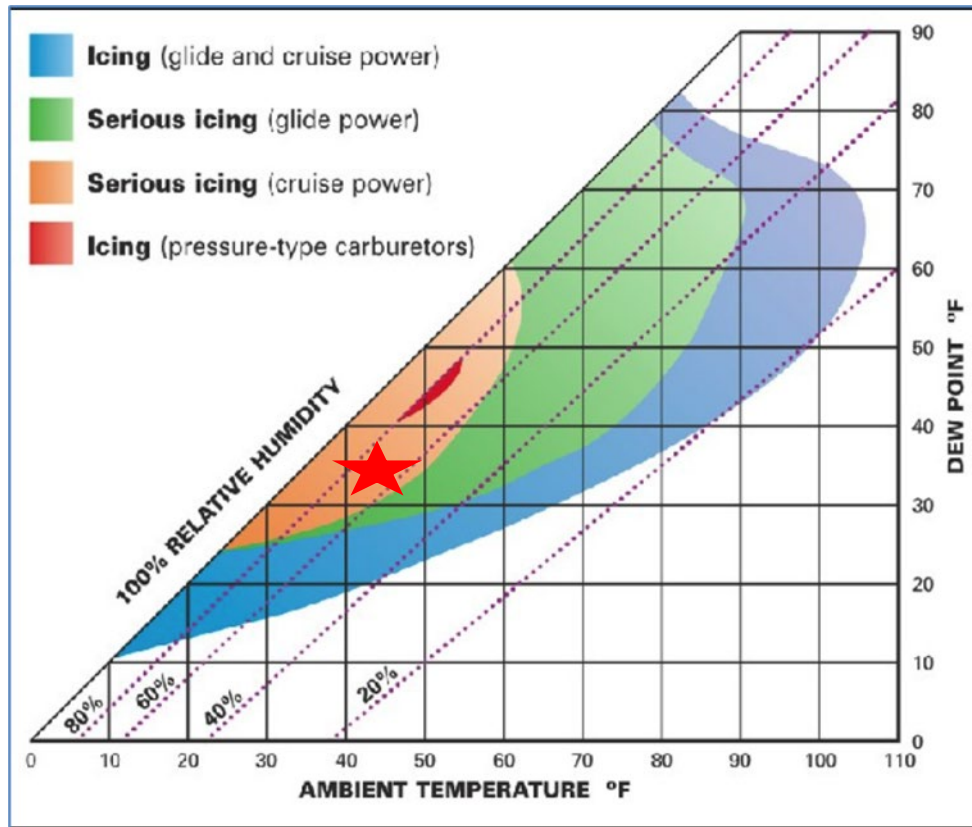
Figure 2 - Probability of carburetor icing at KBVY at the time of the accident are plotted as a red star.

A red star has been added to figure 2 to depict the conditions at KBVY at the time of the accident, which was in the “Serious Icing” category at cruise power.

*There are some steps a pilot can take to prevent, recognize, and respond to carburetor icing.*

*To prevent carburetor icing, the pilot should:*

- *Assure the proper functionality of the carburetor heat during the ground (Before Takeoff) check.*
- *Use carburetor heat on approach and descent when operating at low power settings, or in conditions where carburetor icing is probable.*

*The pilot should respond to carburetor icing by applying full carburetor heat immediately. The engine may run rough initially for short time while ice melts.*
