## MEMORANDUM FOR RECORD ERA20LA177

**Peter Wentz**  
**Air Safety Investigator**  
**Eastern Region Aviation**

**The following are excerpts from the engines manufacture report.**

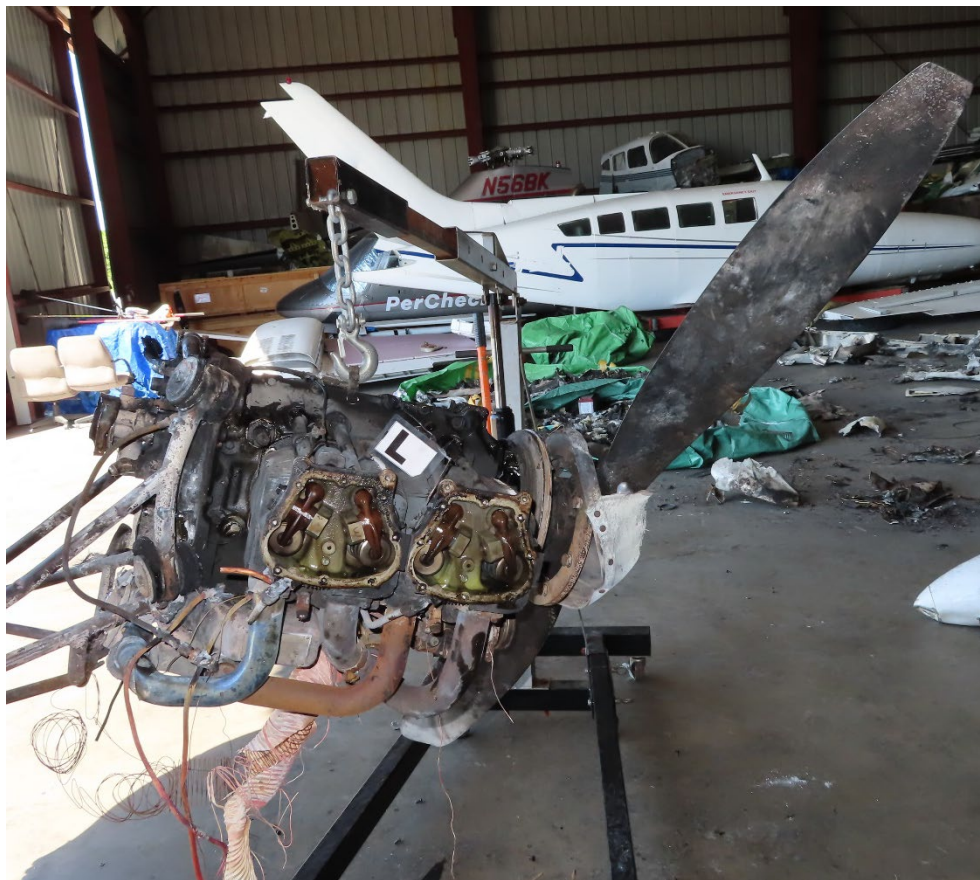
**Photograph #1 – Left engine.**

The engine was suspended from a lift and partially disassembled to facilitate the examination. The crankshaft was rotated by turning the propeller. Continuity of the crankshaft to the rear gears and to the valve train was observed. Compression and suction were observed from all four cylinders. The interiors of the cylinders were observed using a lighted borescope and no anomalies noted.

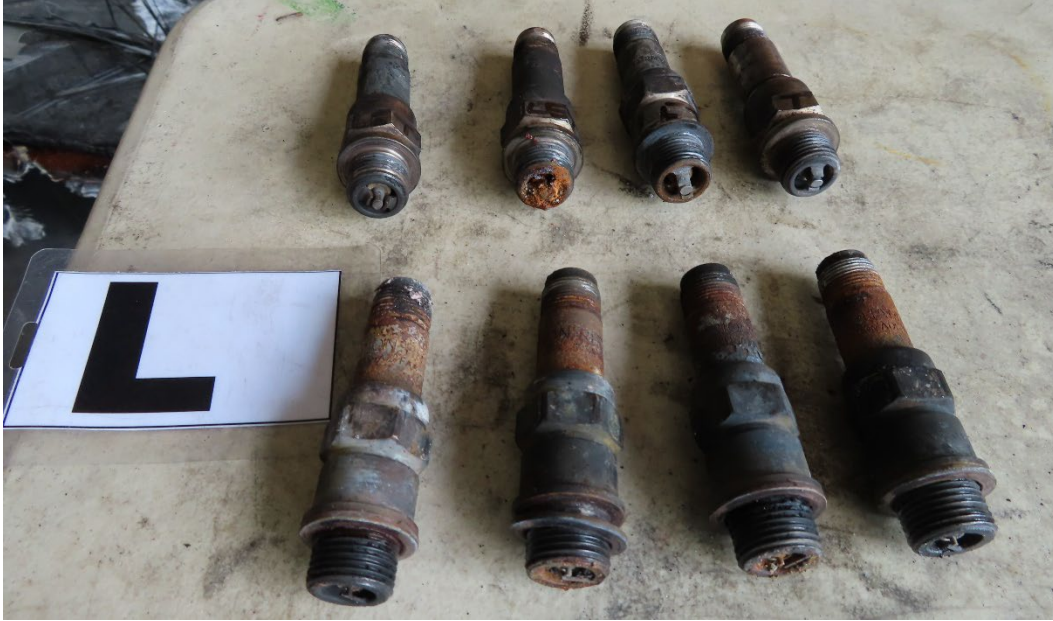
**Photograph #2 – Left engine spark plugs.**

The upper spark plugs were Tempest UREM38E. The lower spark plugs were Champion REM38S. The spark plug electrodes exhibited gray coloration and worn normal condition. The #2 upper and lower spark plugs electrode wells contained debris.

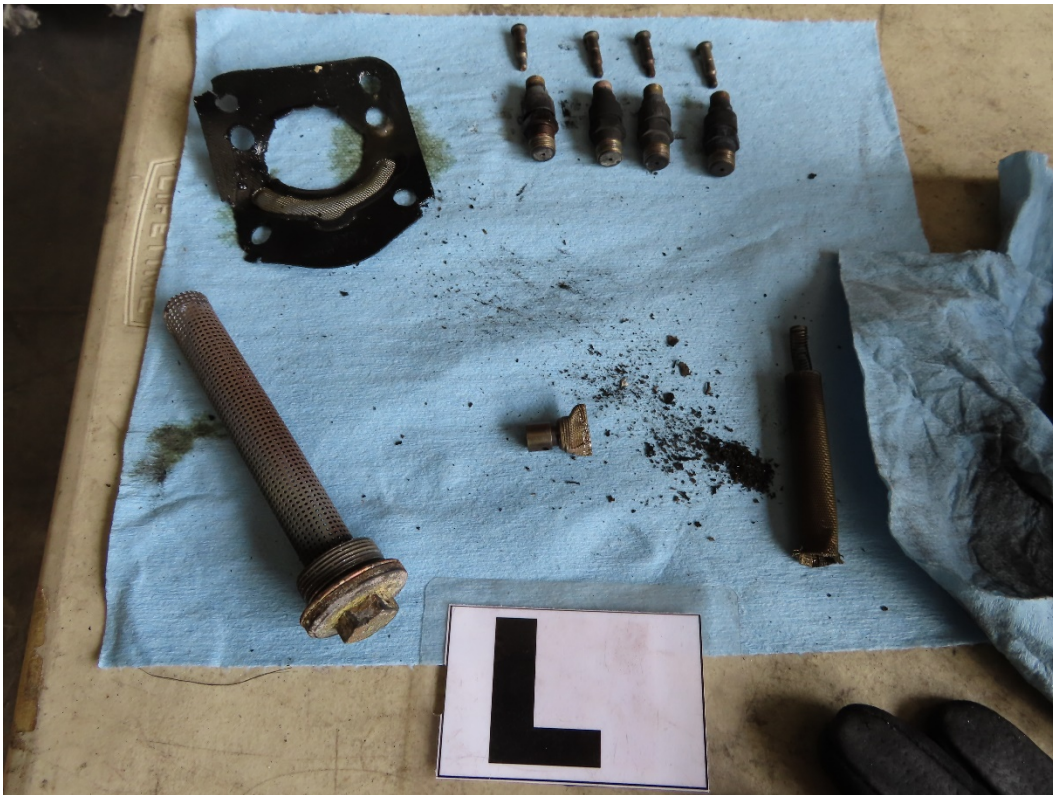
**Photograph #3 – Left engine injectors and oil screen.**

The fuel injector nozzles were unobstructed. The oil sump was partially consumed in the fire. The oil suction screen was absent of debris. The oil filter media was charred, and no metallic debris was observed.

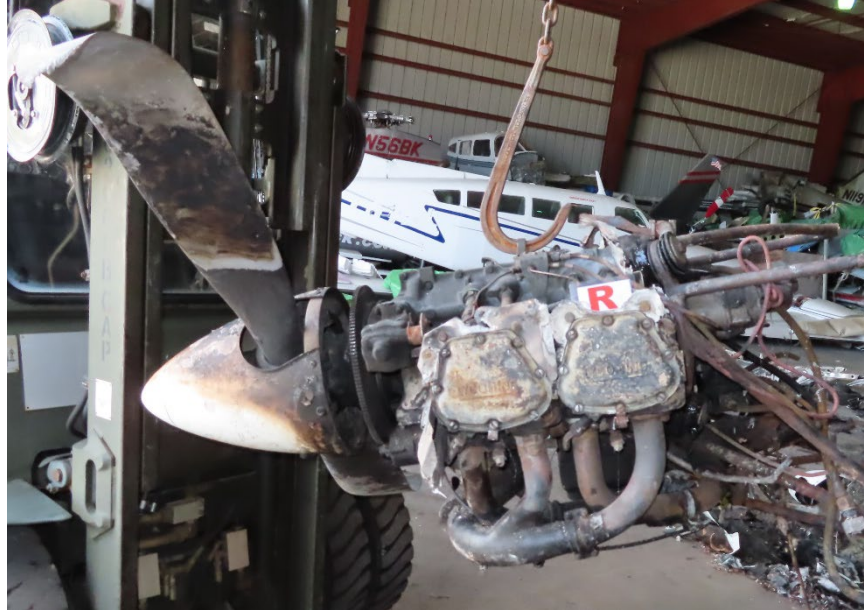
**Photograph #4 – Right engine.**

The engine was suspended from a lift and partially disassembled to facilitate the examination. The crankshaft was rotated by turning the propeller. Continuity of the crankshaft to the rear gears and to the valve train was observed. Compression and suction were observed from all four cylinders. The interiors of the cylinders were observed using a lighted borescope and no anomalies noted.

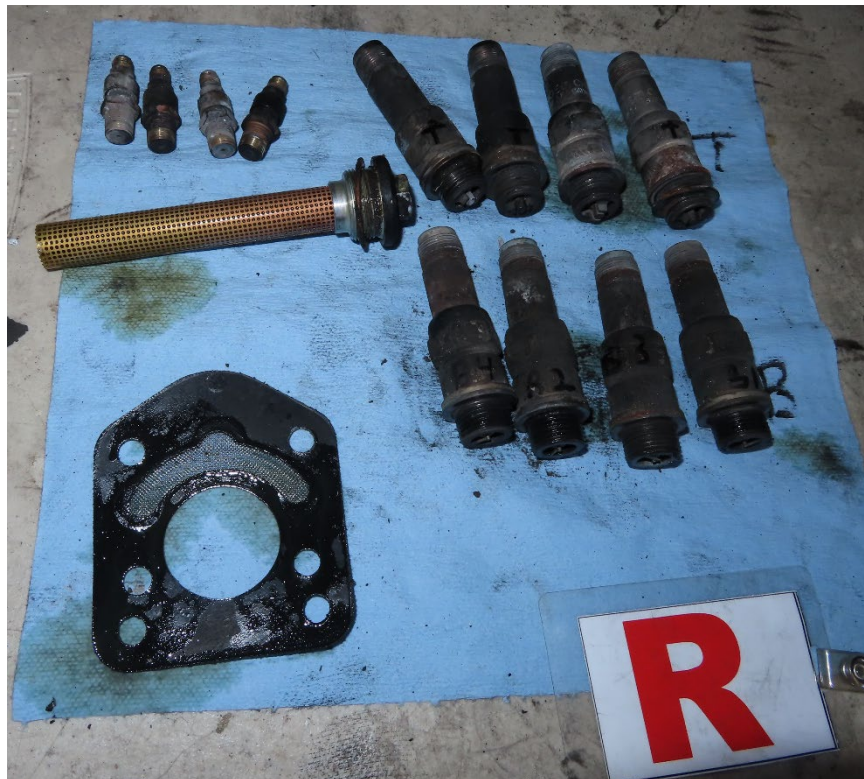
**Photograph #5 – Right engine spark plugs, injectors, and oil screen.**

The upper spark plugs were Champion REM38E. The lower spark plugs were Champion REM38S. The spark plugs electrodes exhibited gray coloration and worn normal condition. The #1, #2 and #3 nozzles were obstructed, the #4 fuel injector nozzle was unobstructed. The oil suction screen was absent of debris.
