## ENGINE EXAMINATION REPORT

| ENGINE MODEL | IO-520-BA |
| AIRCRAFT MAKE & MODEL | Beechcraft F33A |
| FILE NUMBER | 19-199 |

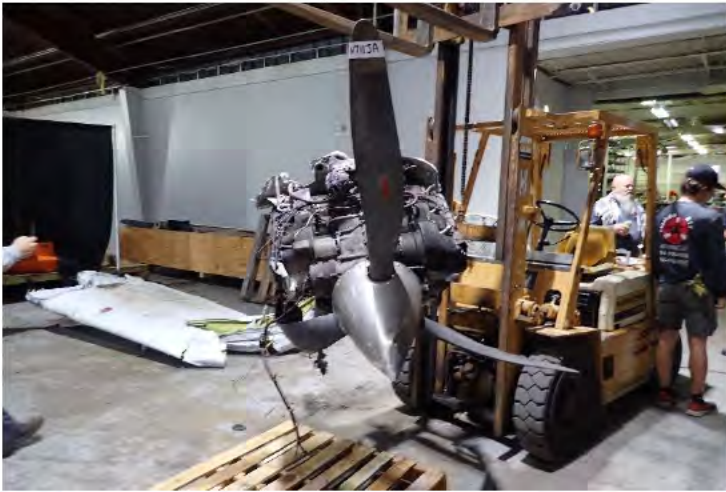
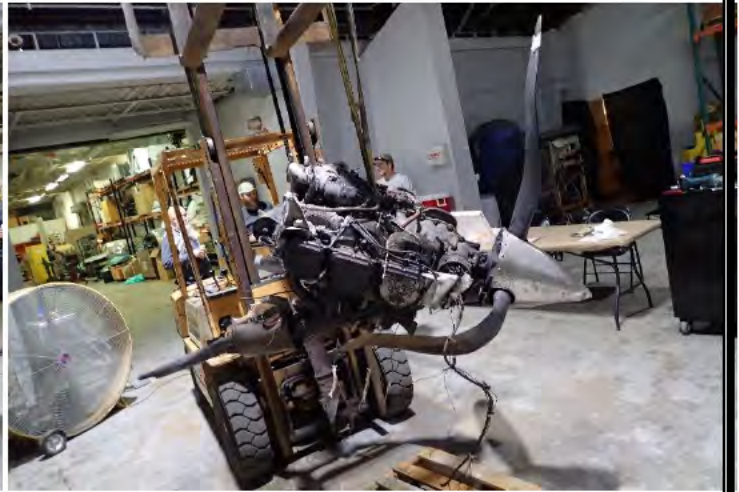
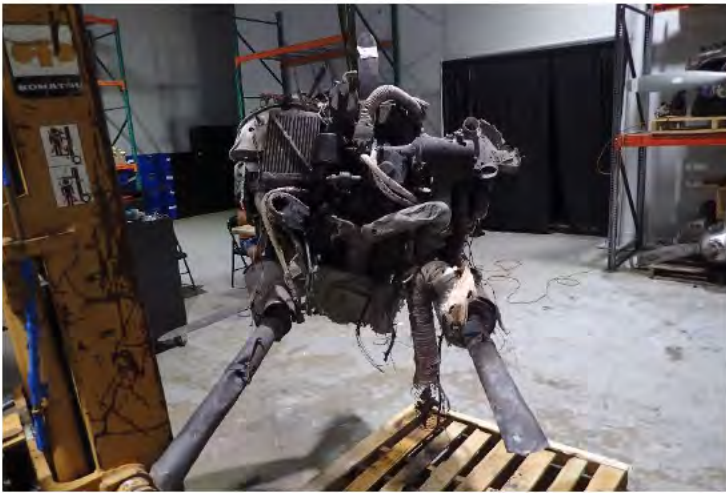
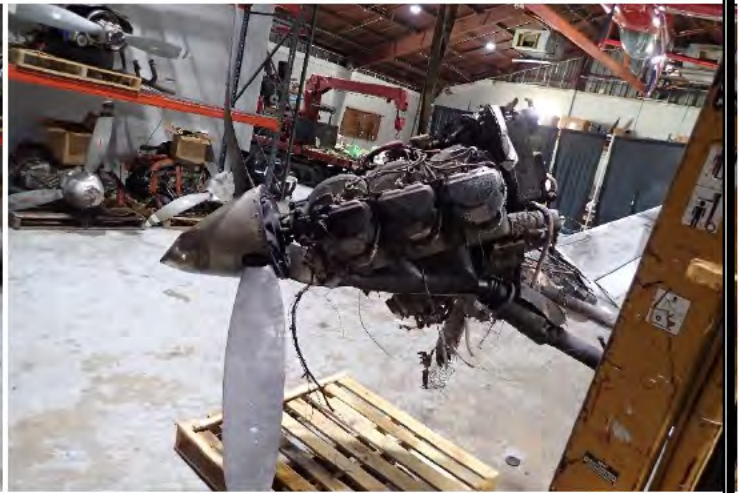
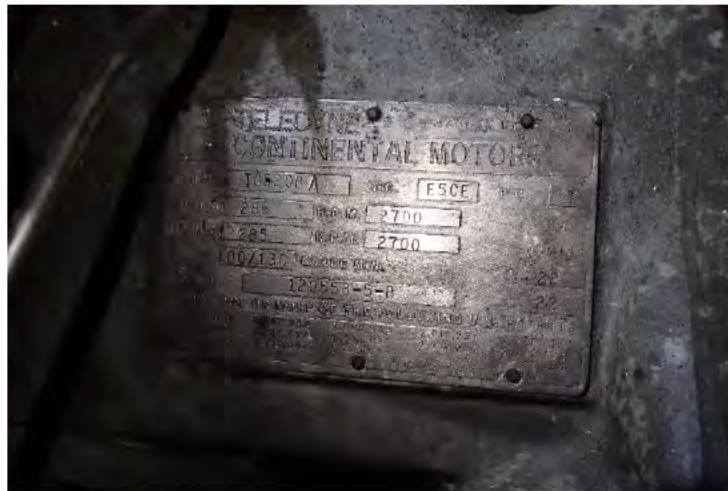
The engine displayed significant thermal and impact damage signatures with the bottom of the engine displaying the most thermal damage. The crankcase remained intact and there were no holes in the crankcase that would indicate a catastrophic internal engine failure. The three-blade, constant speed propeller remained attached to the crankshaft and the three propeller blades remained within the propeller hub. All six cylinders remained attached to their cylinder bays and displayed varying amounts of thermal damage.

Both magnetos remained attached to their installation points and displayed thermal discoloration. The ignition harness displayed impact and thermal damage signatures with the most thermal damage occurring to the bottom spark plug leads. All of the spark plugs remained installed in their cylinder and displayed varying amounts of thermal damage.

The fuel pump remained attached to its installation point and displayed thermal damage signatures. The throttle and metering assembly displayed significant thermal damage and remained attached to its installation point. The fuel manifold valve displayed minor thermal discoloration and remained secured to its installation point. The fuel nozzles remained secured in their cylinders and were undamaged.

The exhaust system displayed impact damage signatures with the most damage occurring to the tailpipes. There were no signs of exhaust leaks observed. The induction system displayed significant thermal damage and several of the intake components were partially melted. There were no signs of induction leaks observed.

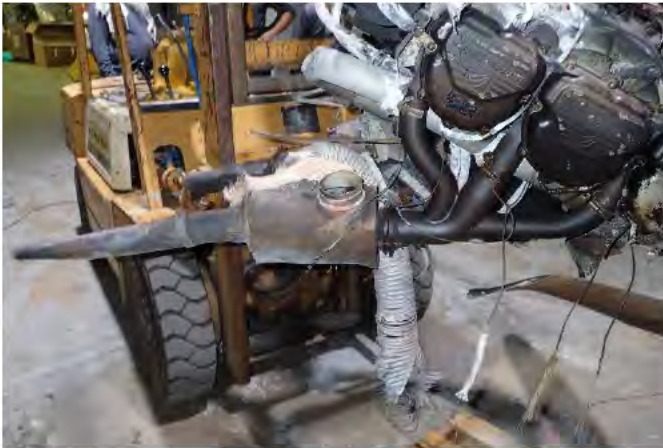
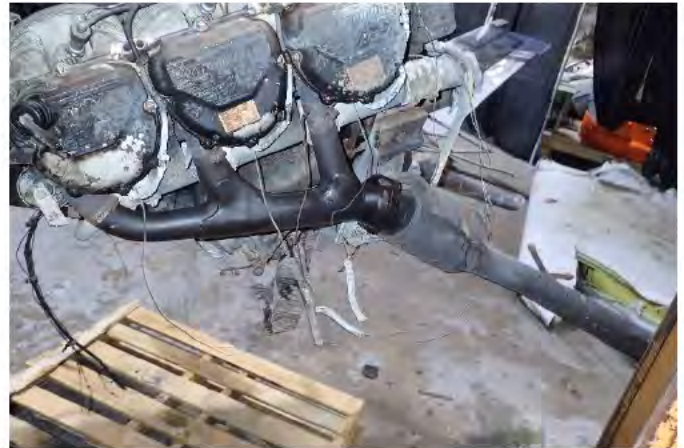
The exhaust system remained attached to the engine and displayed impact damage signatures. The tailpipes were removed, and it was observed that both of the flame cones remained intact. There were no signs of exhaust leaks or blockages observed.

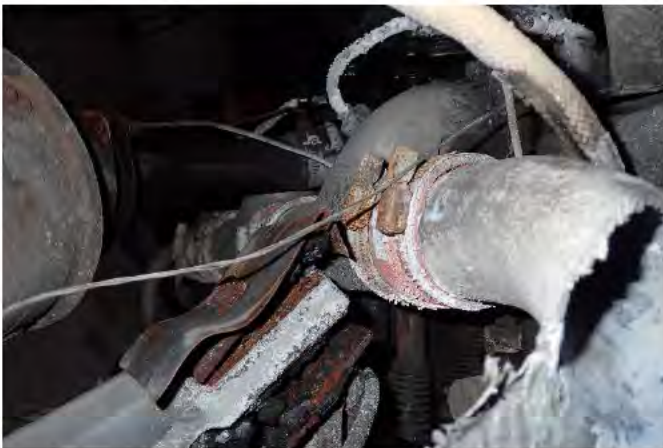
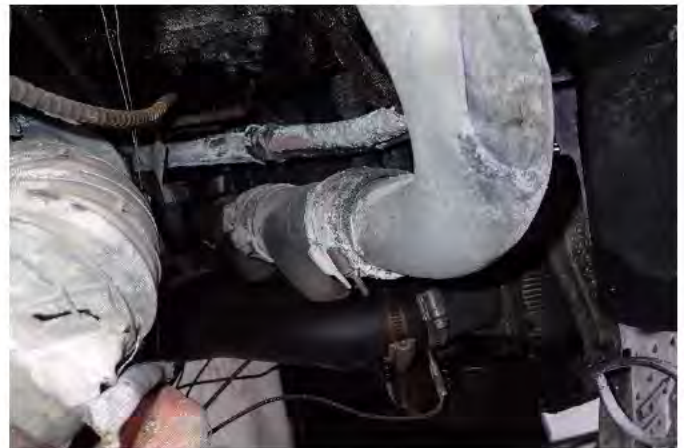
The induction system displayed significant thermal damage signatures and some impact damage signatures; a portion of the induction system had melted from the post-crash fire. The examination did not reveal any signs of intake leaks or blockages.

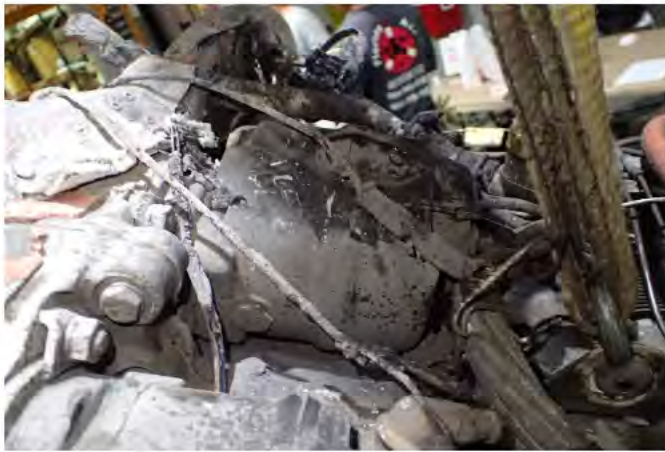
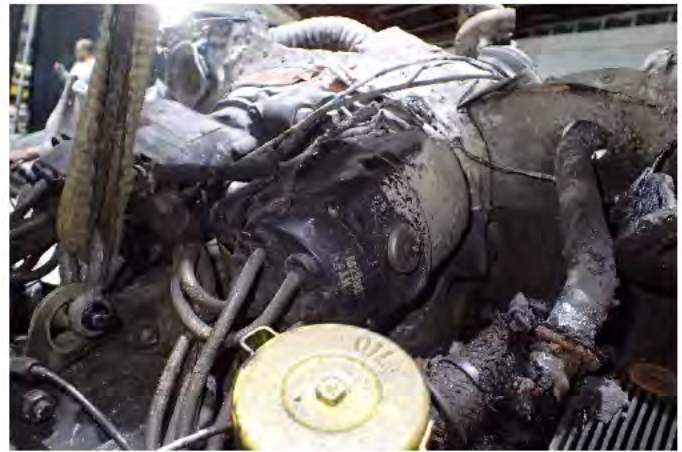
The magneto remained attached to its installation point and displayed thermal damage signatures. The magneto timing was checked and was found to be at 21° BTDC. During crankshaft rotation, it was observed that the impulse couplings were capable of normal operation. During impulse coupling operation the magneto displayed the ability to produce a spark on each post and was in sync with the right magneto.

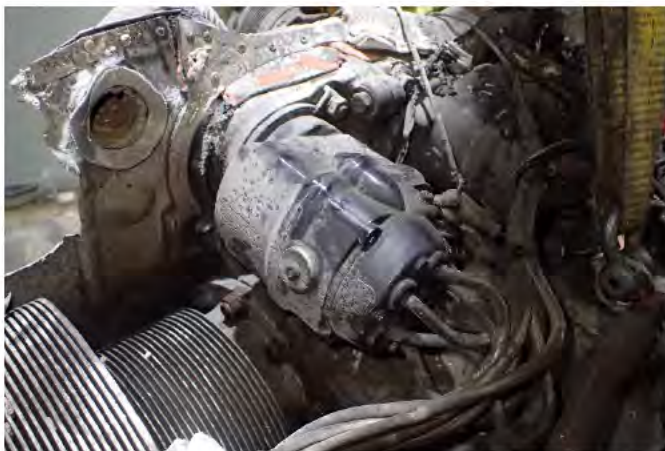
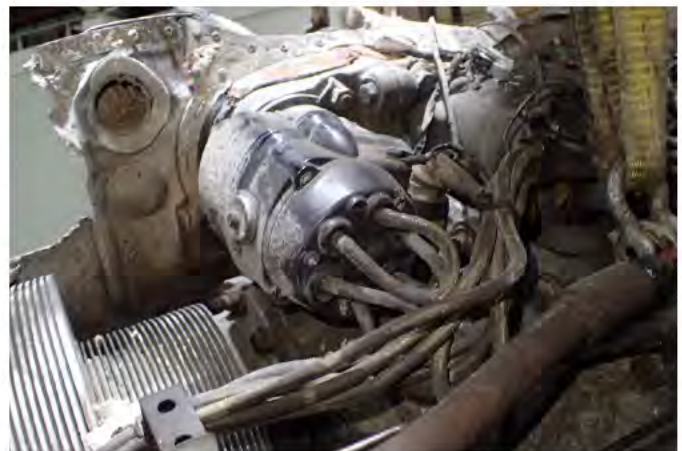
The magneto remained attached to its installation point and displayed thermal damage signatures. The magneto timing was checked and was found to be at 22° BTDC. During crankshaft rotation, it was observed that the impulse couplings were capable of normal operation. During impulse coupling operation the magneto displayed the ability to produce a spark on each post and was in sync with the left magneto.

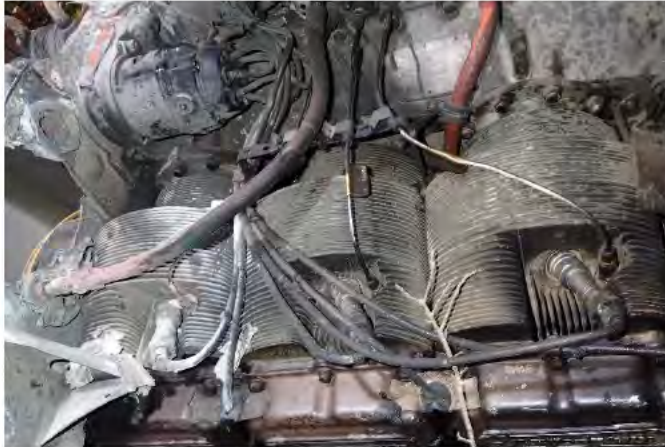
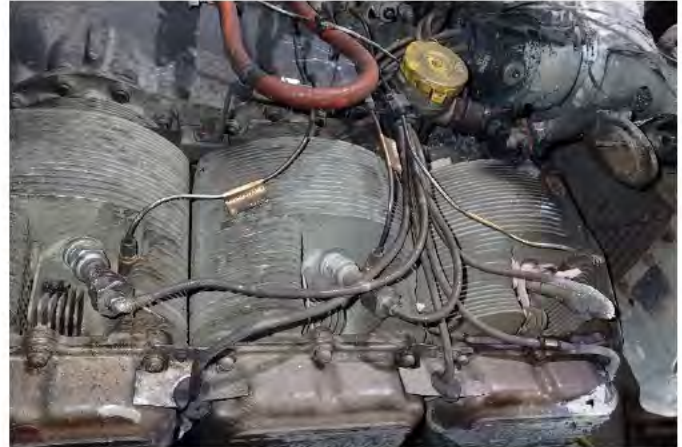
The ignition harness displayed impact and thermal damage signatures. There were no pre-impact anomalies observed.

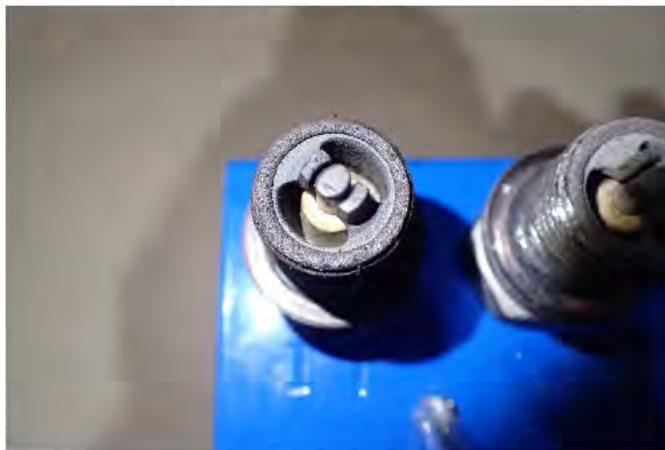
#1 Top Spark Plug

The spark plugs remained installed in their cylinders and displayed varying amounts of thermal damage signatures. The top spark plugs were removed for examination and the bottom spark plug electrodes were examined using a lighted borescope. Several of the bottom spark plug electrodes were partially submerged in oil which was consistent with post-accident accumulation. The observed electrodes displayed normal operating and wear signatures, several of the spark plugs were in a normal worn-out condition when compared with Champion Aviation Service Manual AV6-R

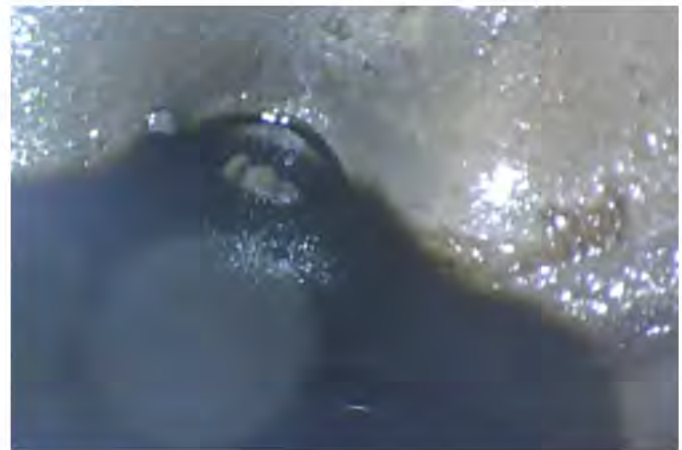
#1 Bottom Spark Plug (submerged in oil)

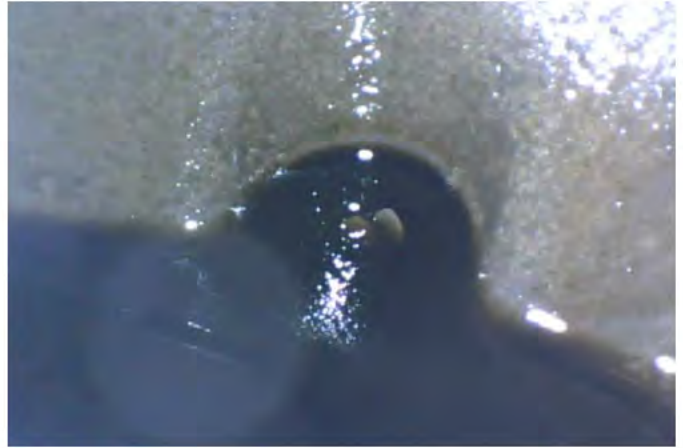
#3 Bottom Spark Plug (submerged in oil)

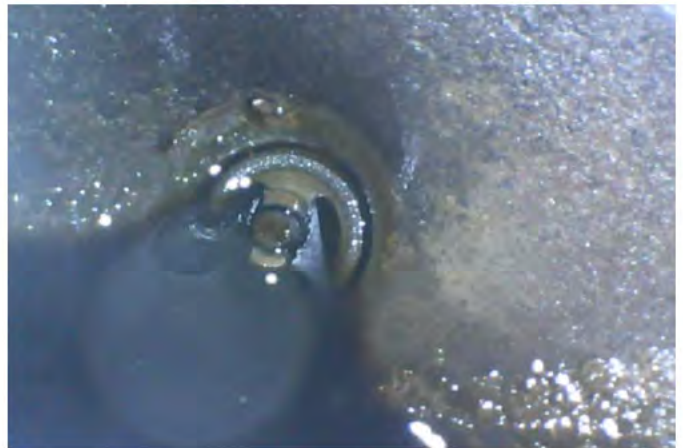
#5 Bottom Spark Plug (submerged in oil)

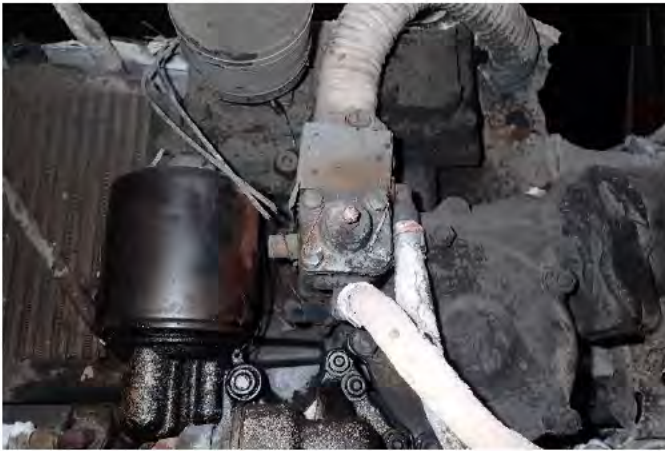
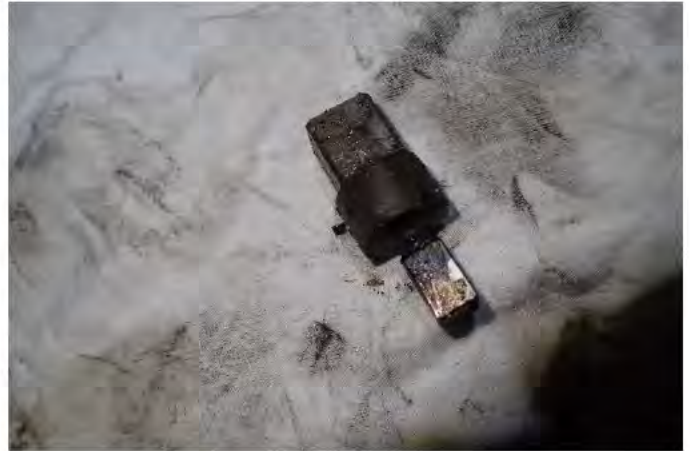
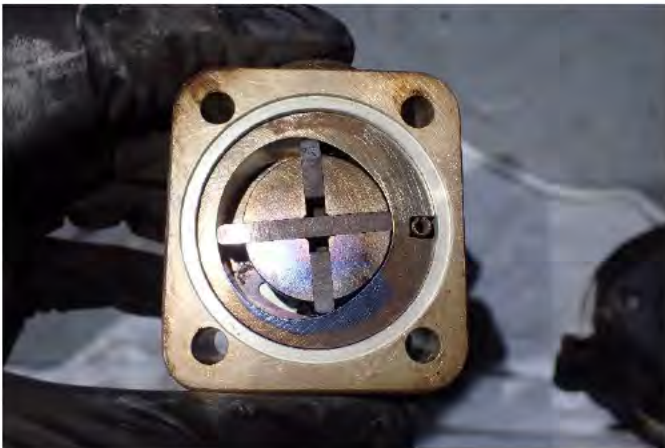
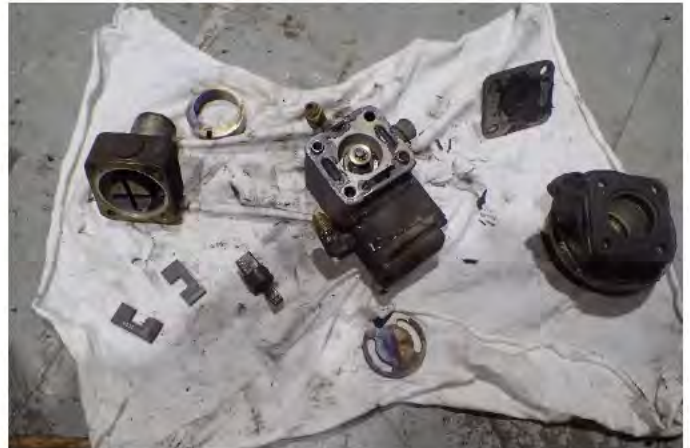
| FUEL PUMP | Manufacturer: CMI | P/N: Not observed | S/N: Not observed |
|---|---|---|---|
| Condition: | The fuel pump remained attached to its installation point and displayed impact and thermal damage signatures. The fuel pump was removed and the drive coupling was noted to be intact. The fuel pump drive shaft was unable to be rotated by hand which was consistent with the thermal damage observed. The fuel pump was disassembled and the internal components were visually examined. The components displayed thermal damage signatures as well as normal operating signatures. There were no anomalies observed. | | |

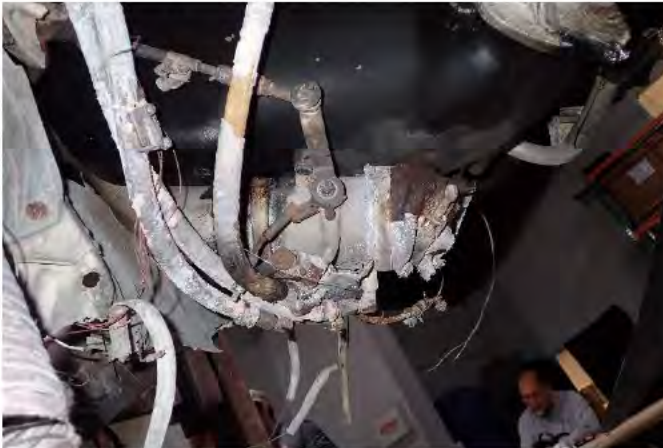
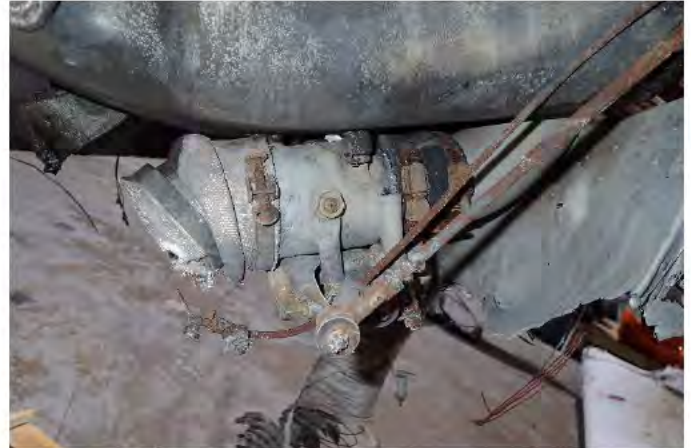
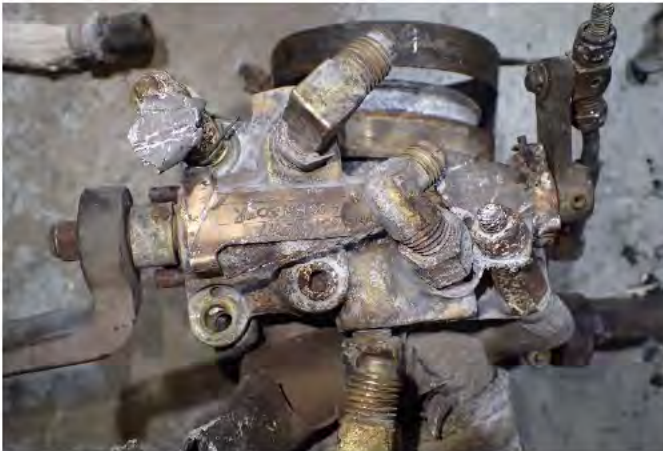
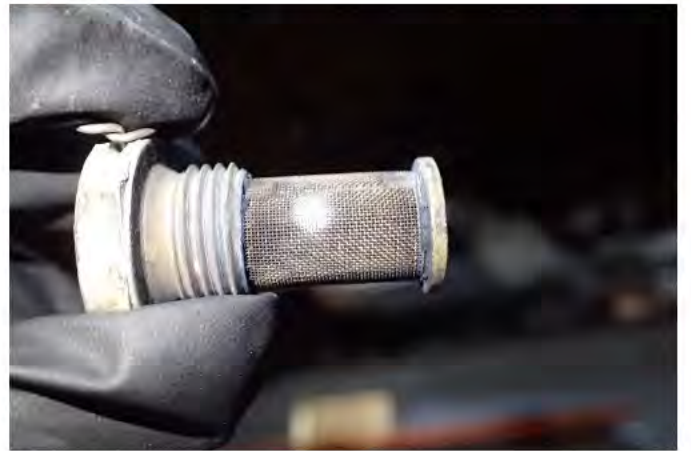
The throttle and metering assembly displayed significant thermal damage as well as impact damage. The throttle and mixture control rod ends remained attached to their respective control arms and the control arms were secured to their shafts. The fuel inlet screen was removed and there were no contaminants noted. The investigator was unable to disassemble the assembly any further due to the extensive thermal damage.

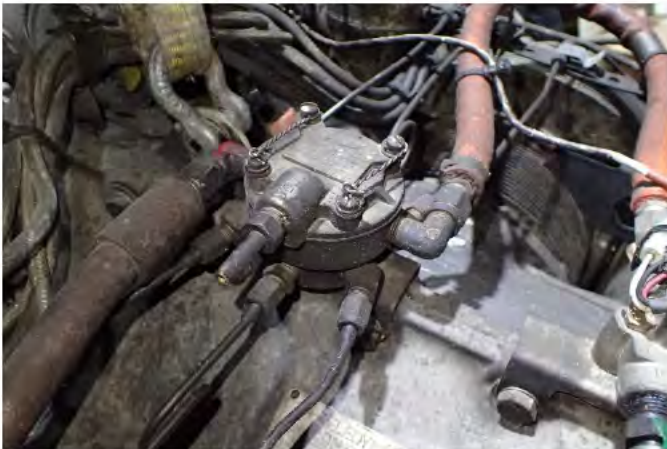
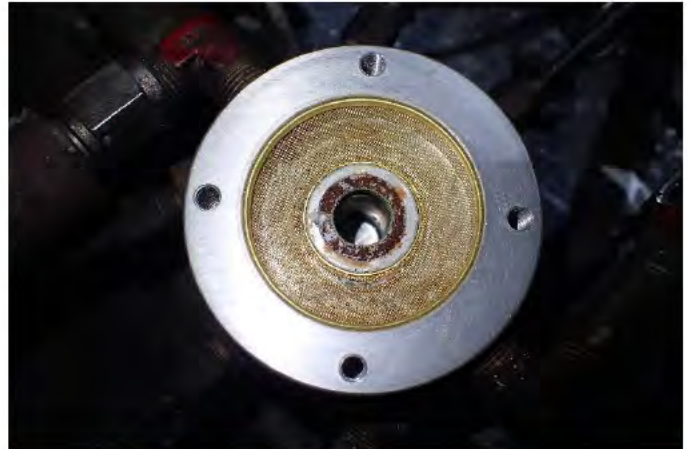
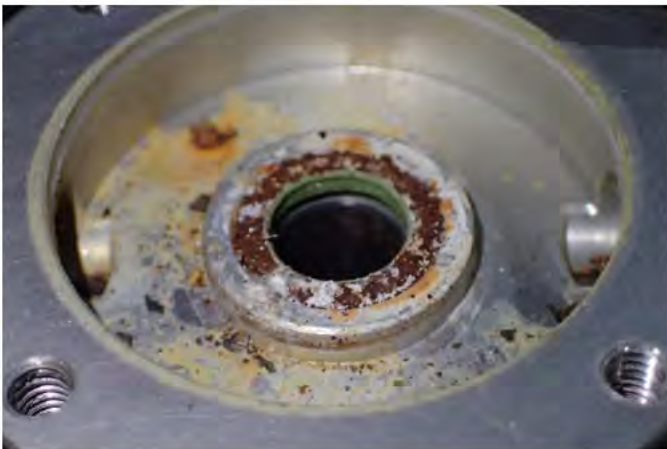
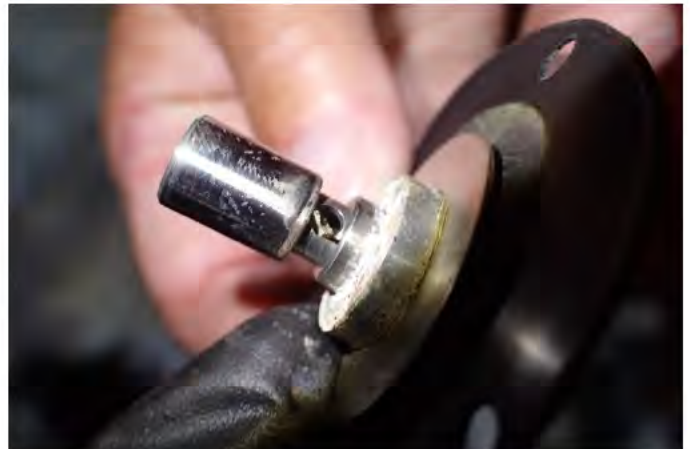
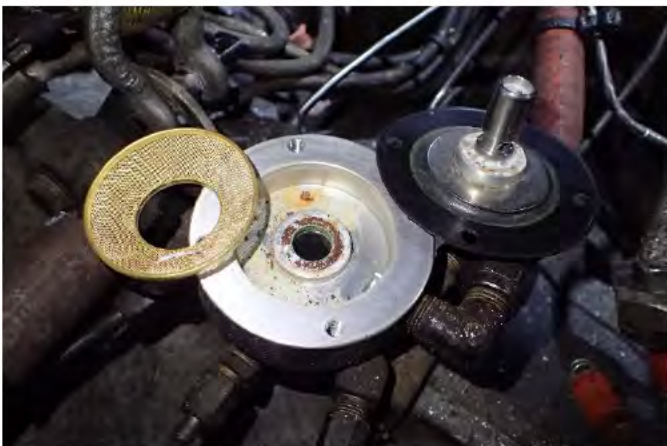
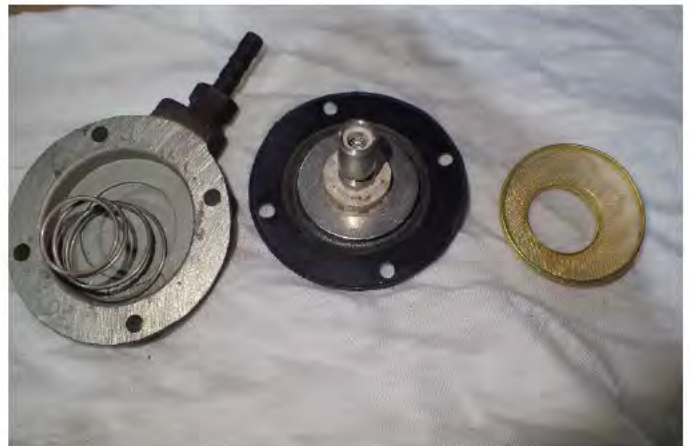
During the disassembly of the manifold valve, it was observed that the manifold valve contained a significant amount of corrosion. There were no further anomalies observed with the engine examination.

The manifold valve remained attached to its installation point and displayed minor thermal damage signatures. All of the fuel lines remained secure to the manifold valve. The manifold valve was disassembled and it was observed that there was a significant amount of corrosion as well as loose material associated with corrosion inside the manifold valve.

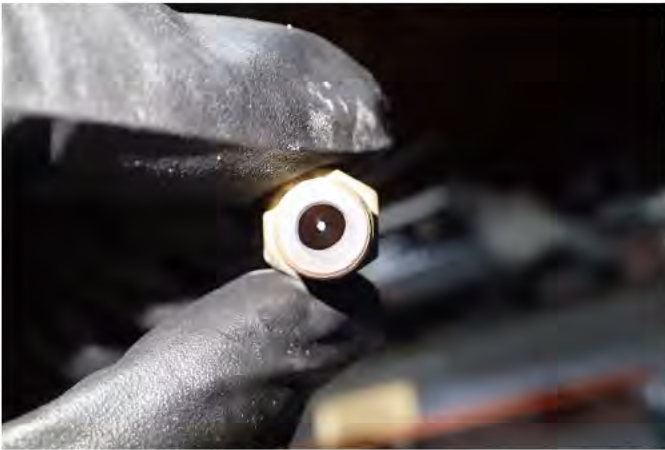
#1 Nozzle

| Position | #1 | #3 | #5 | #2 | #4 | #6 |
|---|---|---|---|---|---|---|
| Condition: | All of the fuel nozzles remained installed in their installation point and displayed minor thermal damage signatures. The nozzles were removed and were noted to be clear of any obstructions. | | | | | |

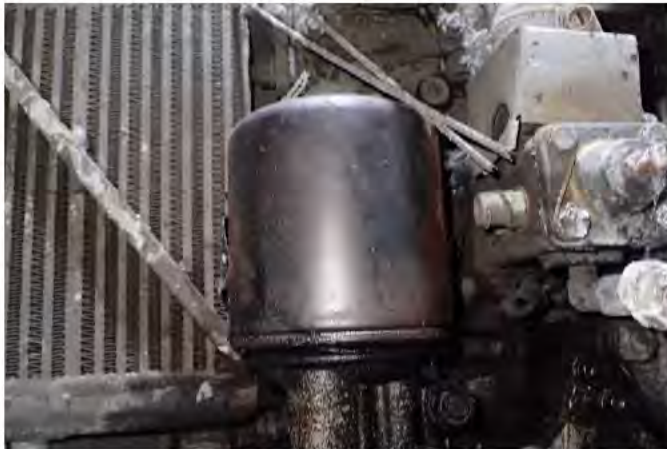
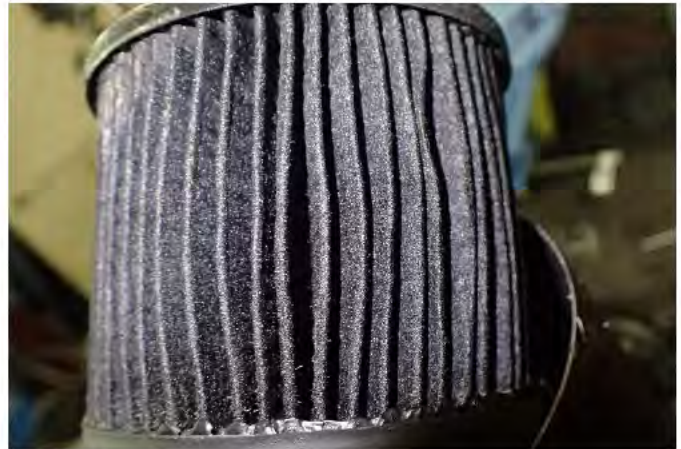
The oil filter remained attached to its installation point and displayed thermal damage signatures. It was noted that the oil filter was loose which is consistent with the thermal damage observed. The oil filter was removed and the filter housing was cut open. The filter pleats displayed thermal damage, however, there was no metallic material observed inside the filter pleats.

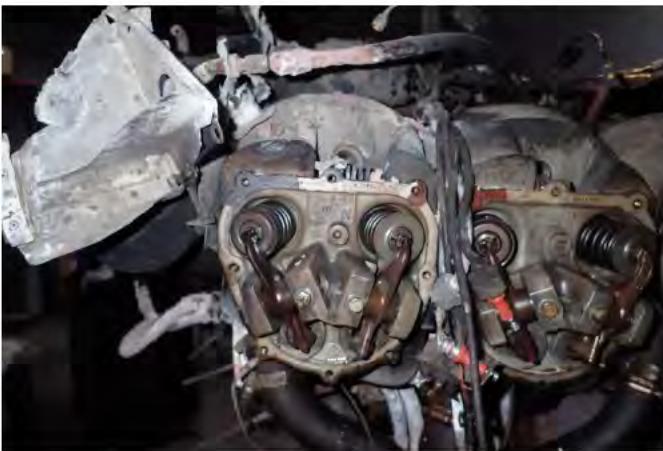
All of the cylinders remained attached to their cylinder bays and displayed varying amounts of thermal and impact damage. The cylinders were inspected using a lighted borescope; the piston faces, cylinder walls, and valve heads displayed normal operating and combustion signatures. The overhead components (valves, springs, and rocker arms) displayed normal operating signatures and operated normally during crankshaft rotation. During crankshaft rotation, it was observed that all six cylinders displayed good thumb compression and suction. There were no anomalies observed.

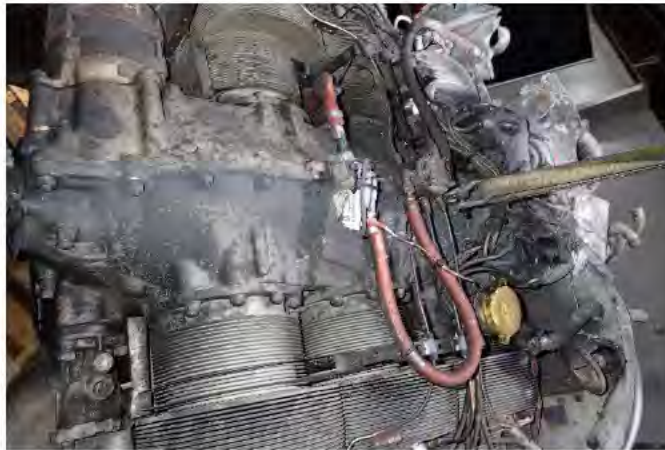
| Condition: | The crankcase remained intact and displayed minor thermal damage signatures. There were no holes in the crankcase that would indicate a catastrophic internal engine failure. There were no anomalies observed. | | | |

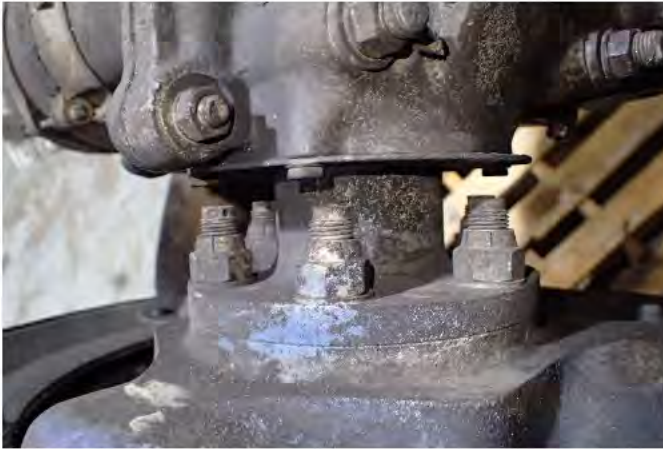
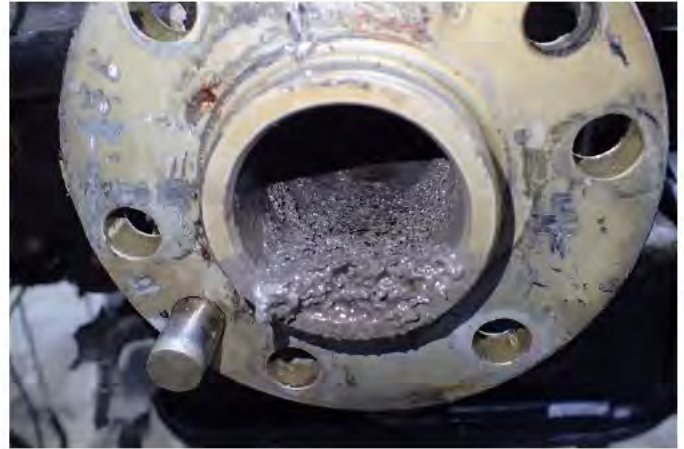
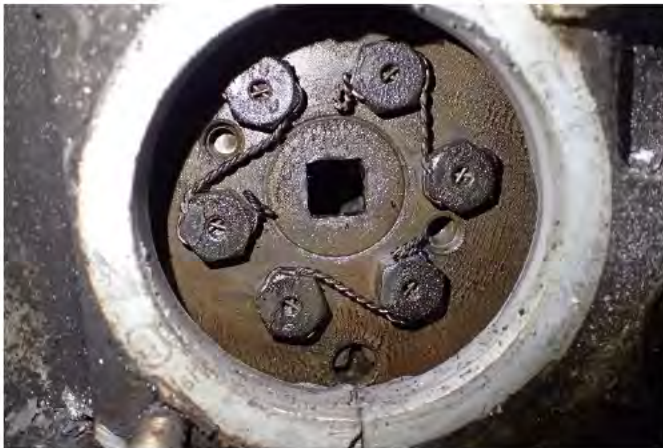
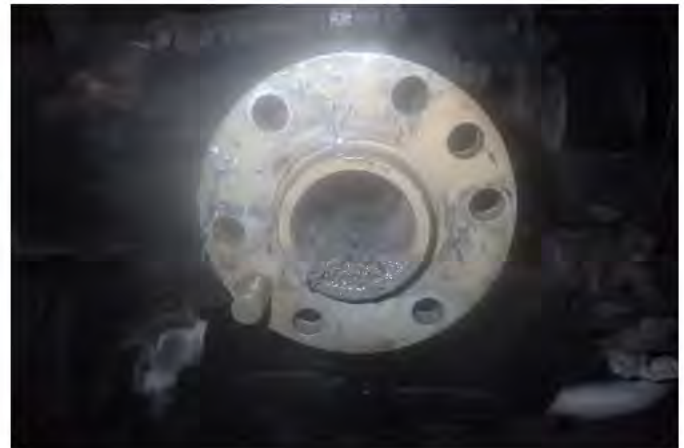
| CRANKSHAFT | Forging Number:<br>Inaccessible | S/N: N04CA280 | Heat code: Inaccessible |
|---|---|---|---|
| Condition: | The propeller flange remained attached to the rest of the propeller and was undamaged. The crankshaft was rotated by using a hand tool and continuity was established between the crankshaft, camshaft, connecting rods, and associated components. The crankshaft gear remained secure and displayed normal operating signatures. It was noted that there was a significant amount of sludge inside the crankshaft propeller oil cavity. There were no anomalies observed that would have prevented normal operation. | | |

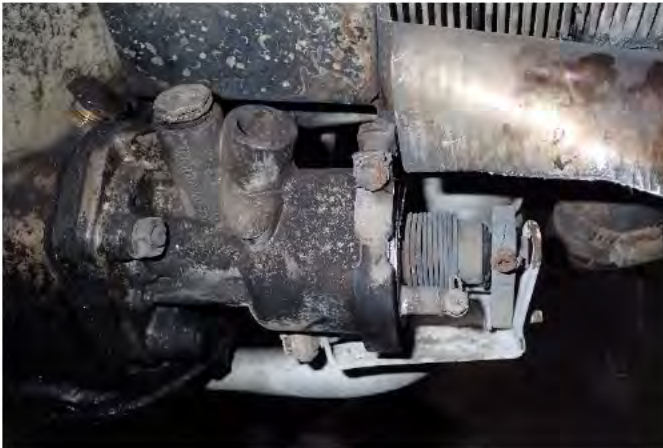
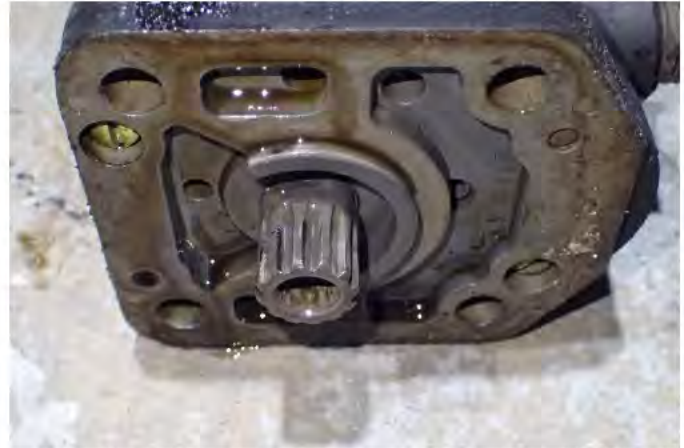
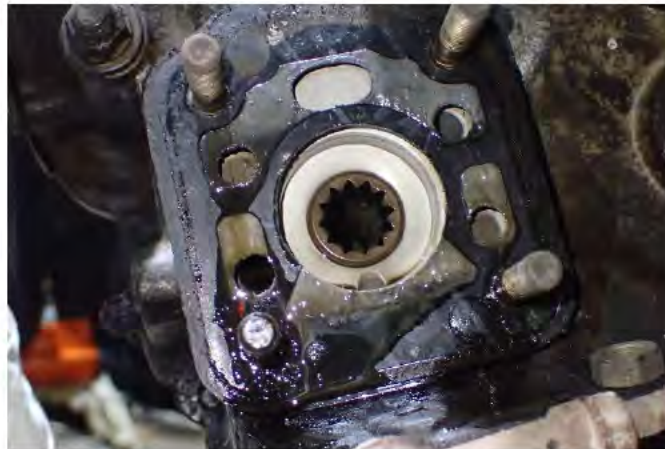
The propeller governor remained attached to its installation point and displayed thermal and impact damage signatures. The governor was removed and it was observed that the drive shaft remained intact and was capable of rotation with some resistance, the resistance was consistent with the thermal damage observed.

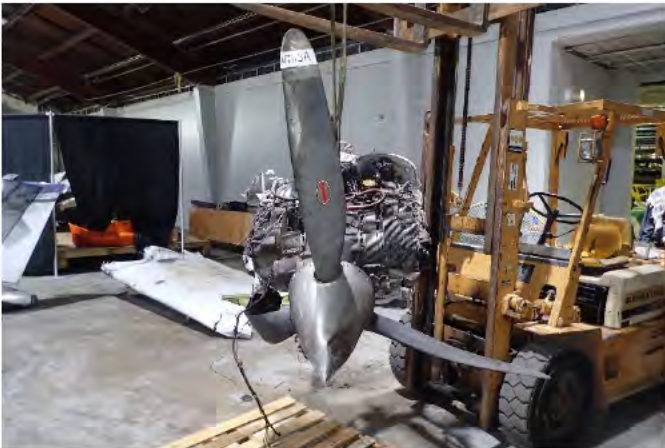
Propeller before removal

The three-blade, constant speed propeller remained attached to the crankshaft and all three propeller blades remained within the hub. The blades displayed varying amounts of impact and thermal damage signatures. The propeller blade marked "A" displayed significant thermal damage to the blade tip, minor S-bending deformation, and significant aft bending deformation. The propeller blade marked "B" displayed minor S-bending deformation. The propeller blade marked "C" displayed thermal damage signatures and minor aft bending deformation.
