## RECORD OF CONVERSATION

**Date: May 27, 2020**  
**Person Contacted: Robert Overstreet**  
**NTSB Accident Number: ERA20LA195**

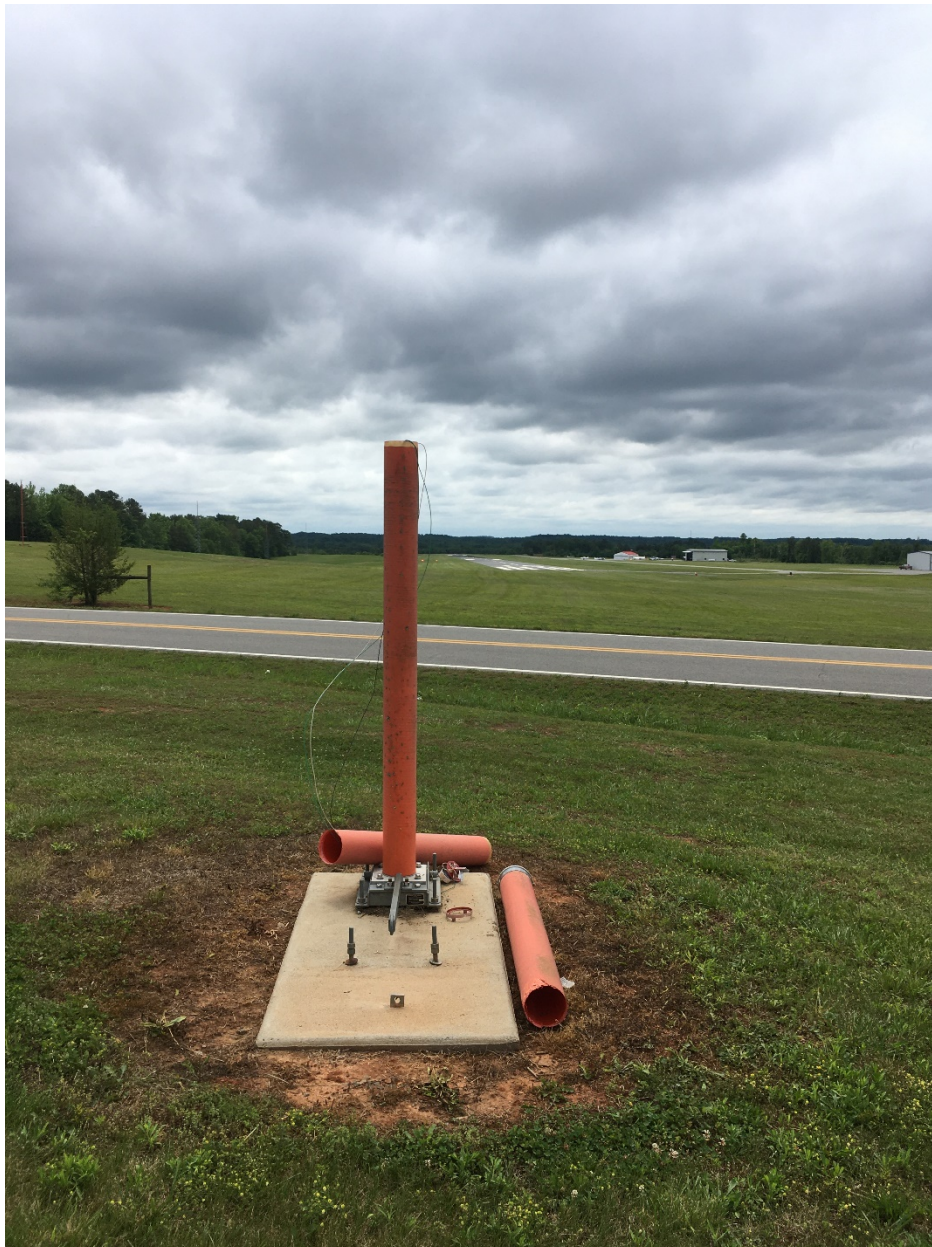
cell phone. He texted three pictures the same day at 1424 EDT (Figure). He confirmed the pole was located on airport property.

Figure: Digital Photograph Provided by Pilot Depicting Impacted Obstruction Light Pole in Foreground and Approach End of Runway in Background.

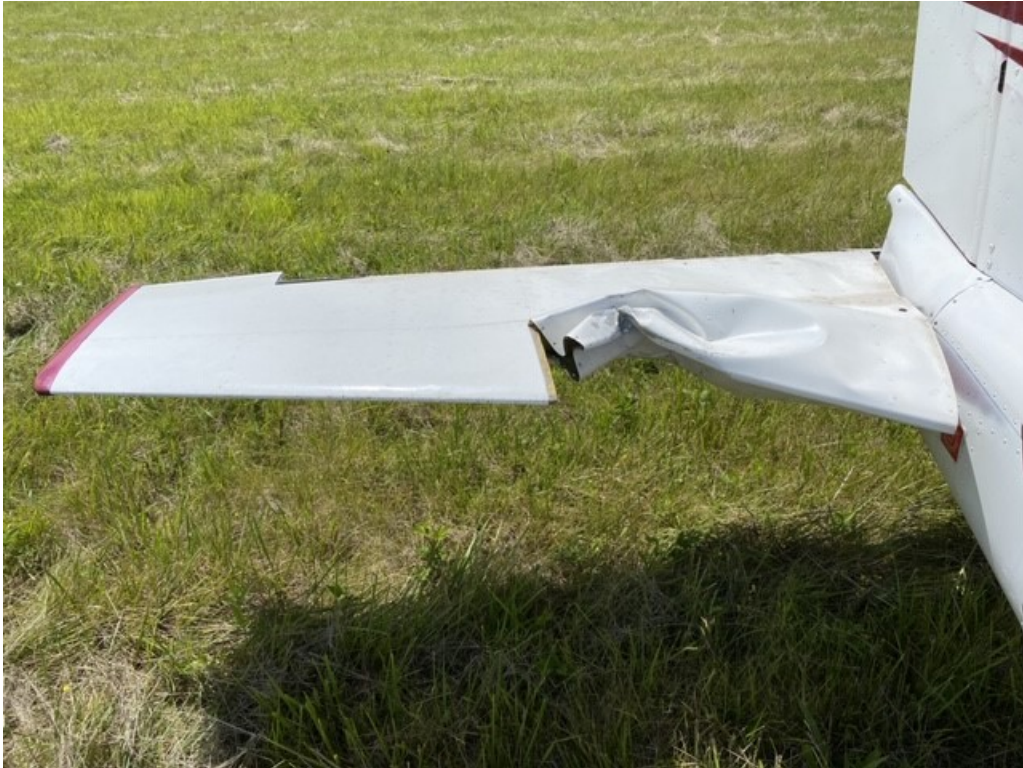
During the conversation he was advised that the damage to the right horizontal stabilator (Figure 1) classified the event as an accident. The damage would affect the flight characteristics of the airplane.

Figure 1: Photograph Provided by Victor Yore. View Depicting the Damage to The Right Horizontal Stabilator.
