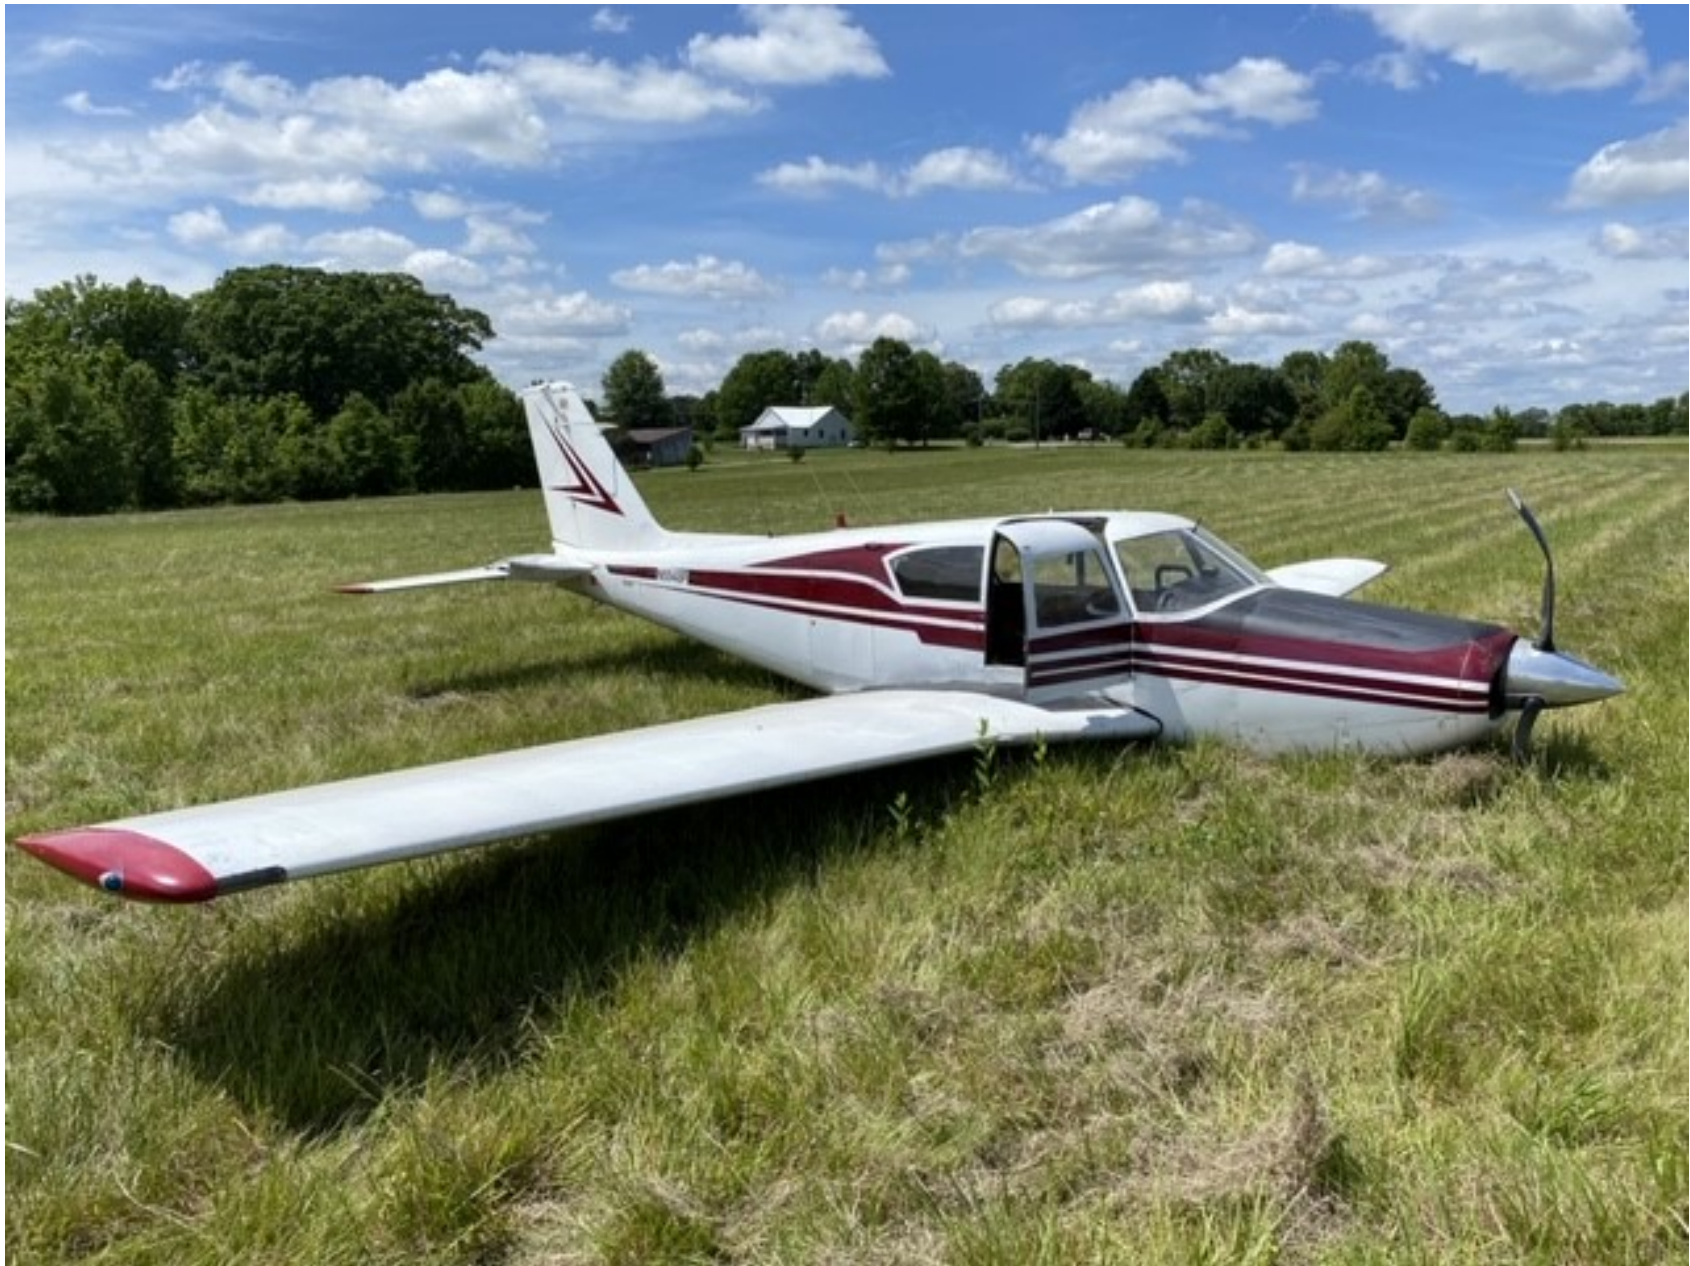
**Photo 1 – Digital Photograph From Victor Yore. Right Forward Quartering View of the Airplane at the Accident Site.**

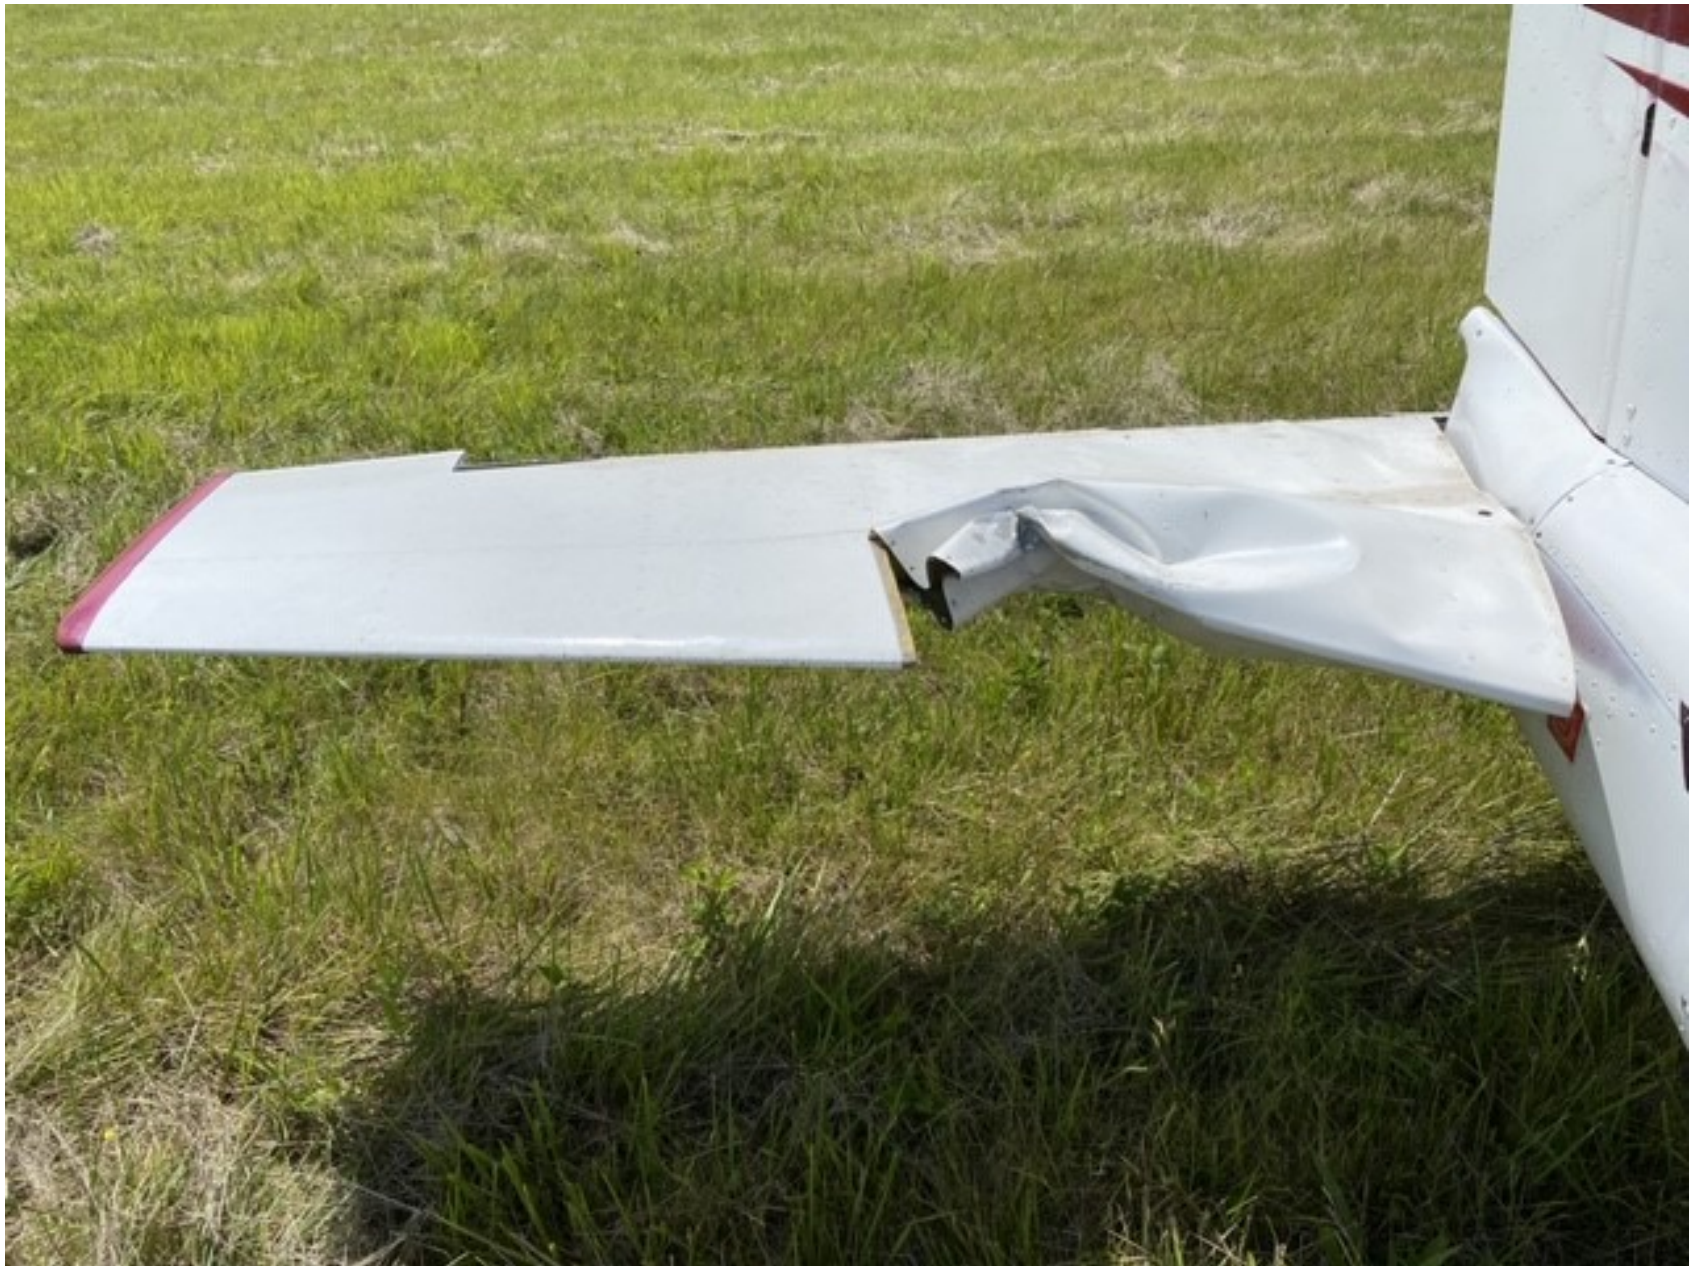
**Photo 2 - Digital Photograph From Victor Yore. View of the Right Horizontal Stabilizer.**

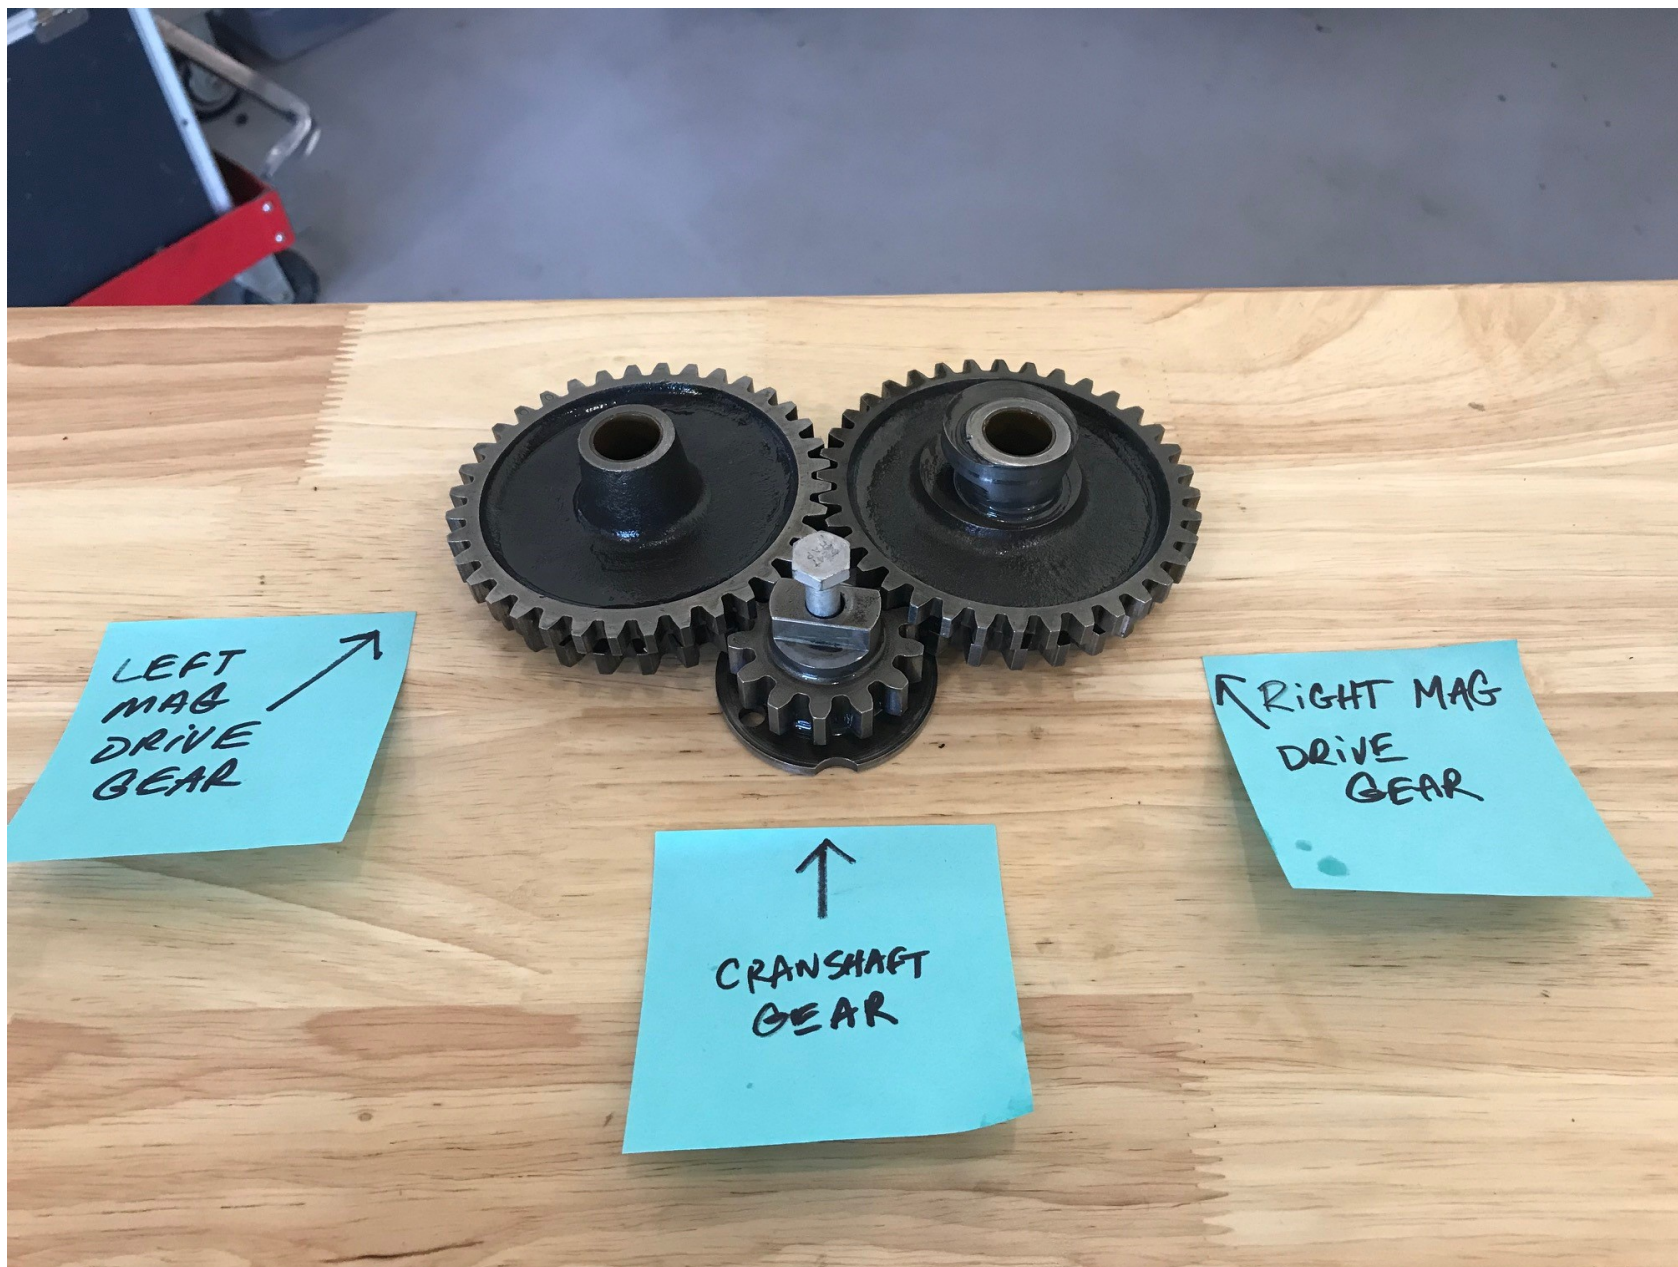
**Photo 3 – FAA Digital Photograph. View of the Crankshaft Gear and Left and Right Magneto Drive Gears.**

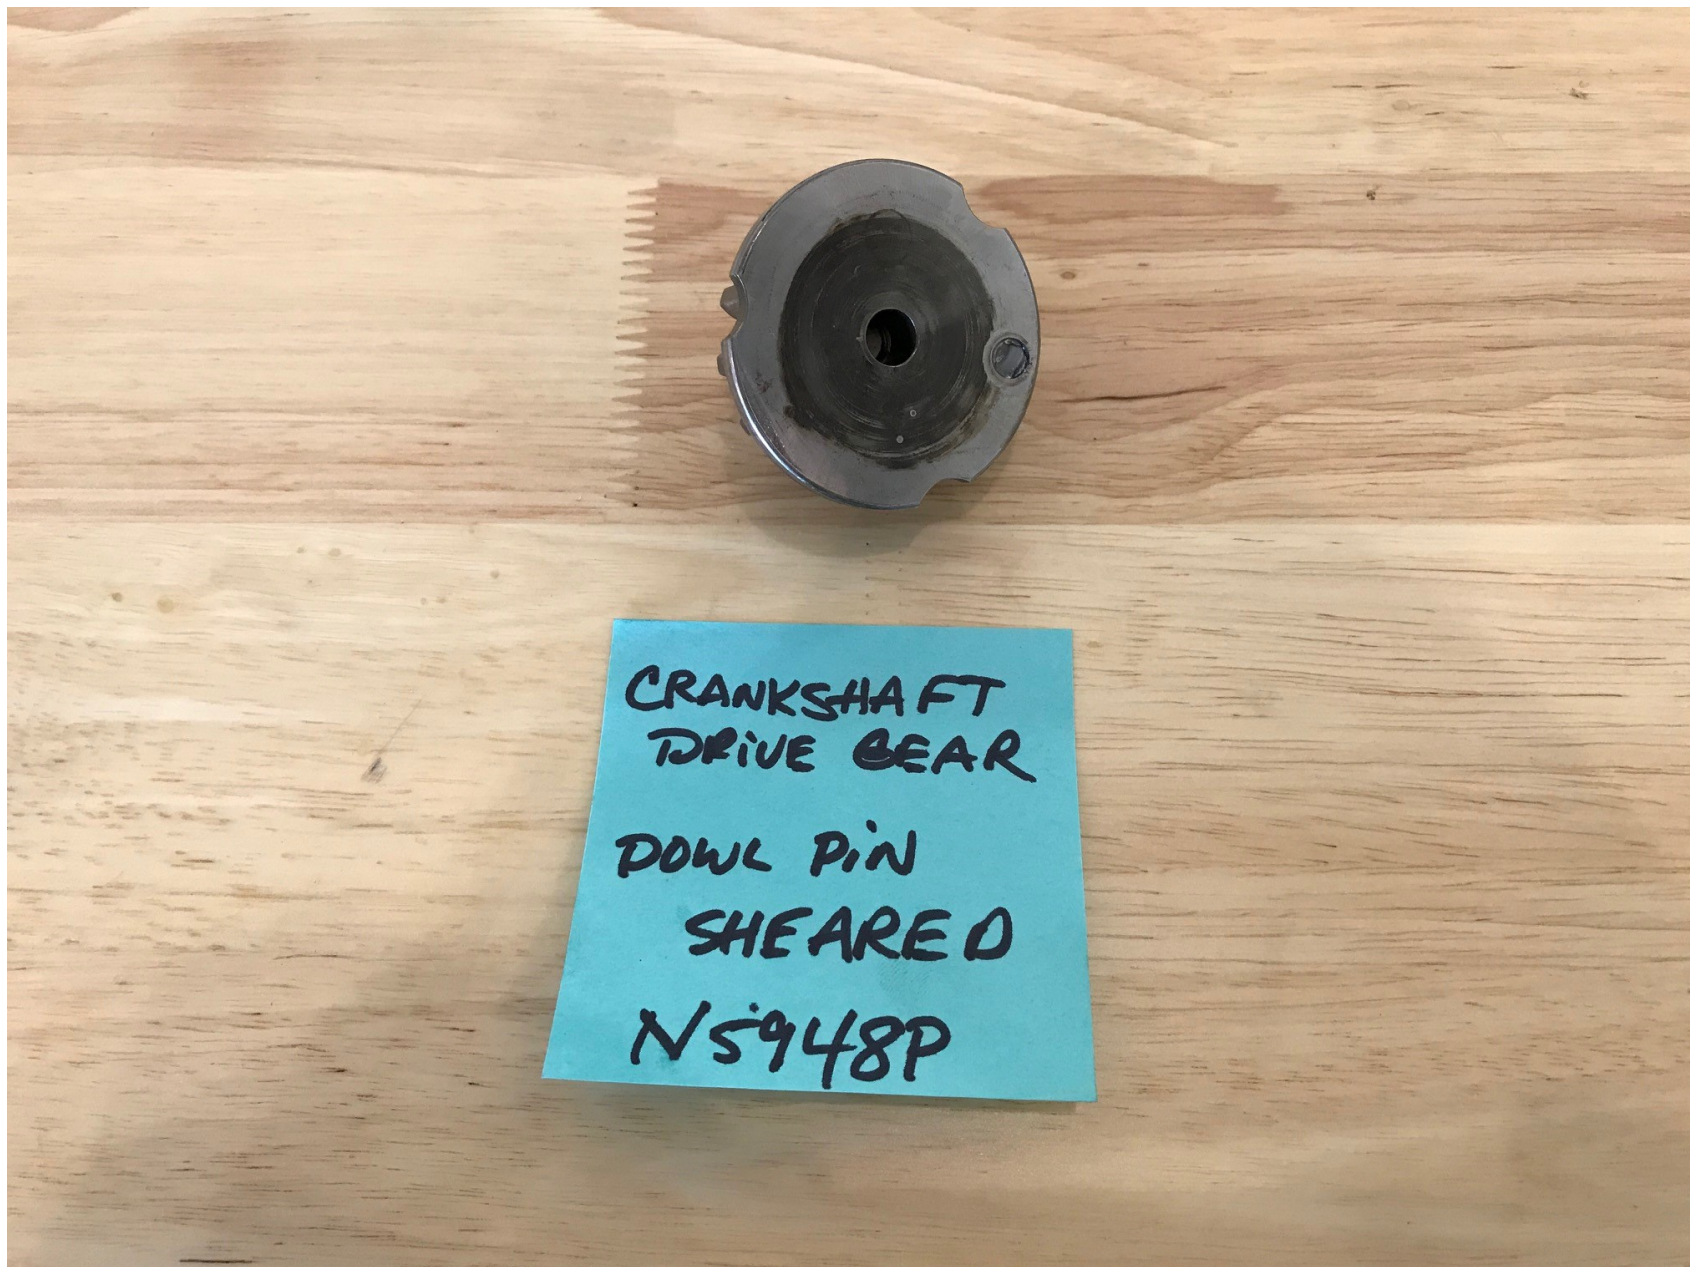
**Photo 4 - FAA Digital Photograph. View of the Crankshaft Gear and Sheared Alignment Dowel.**

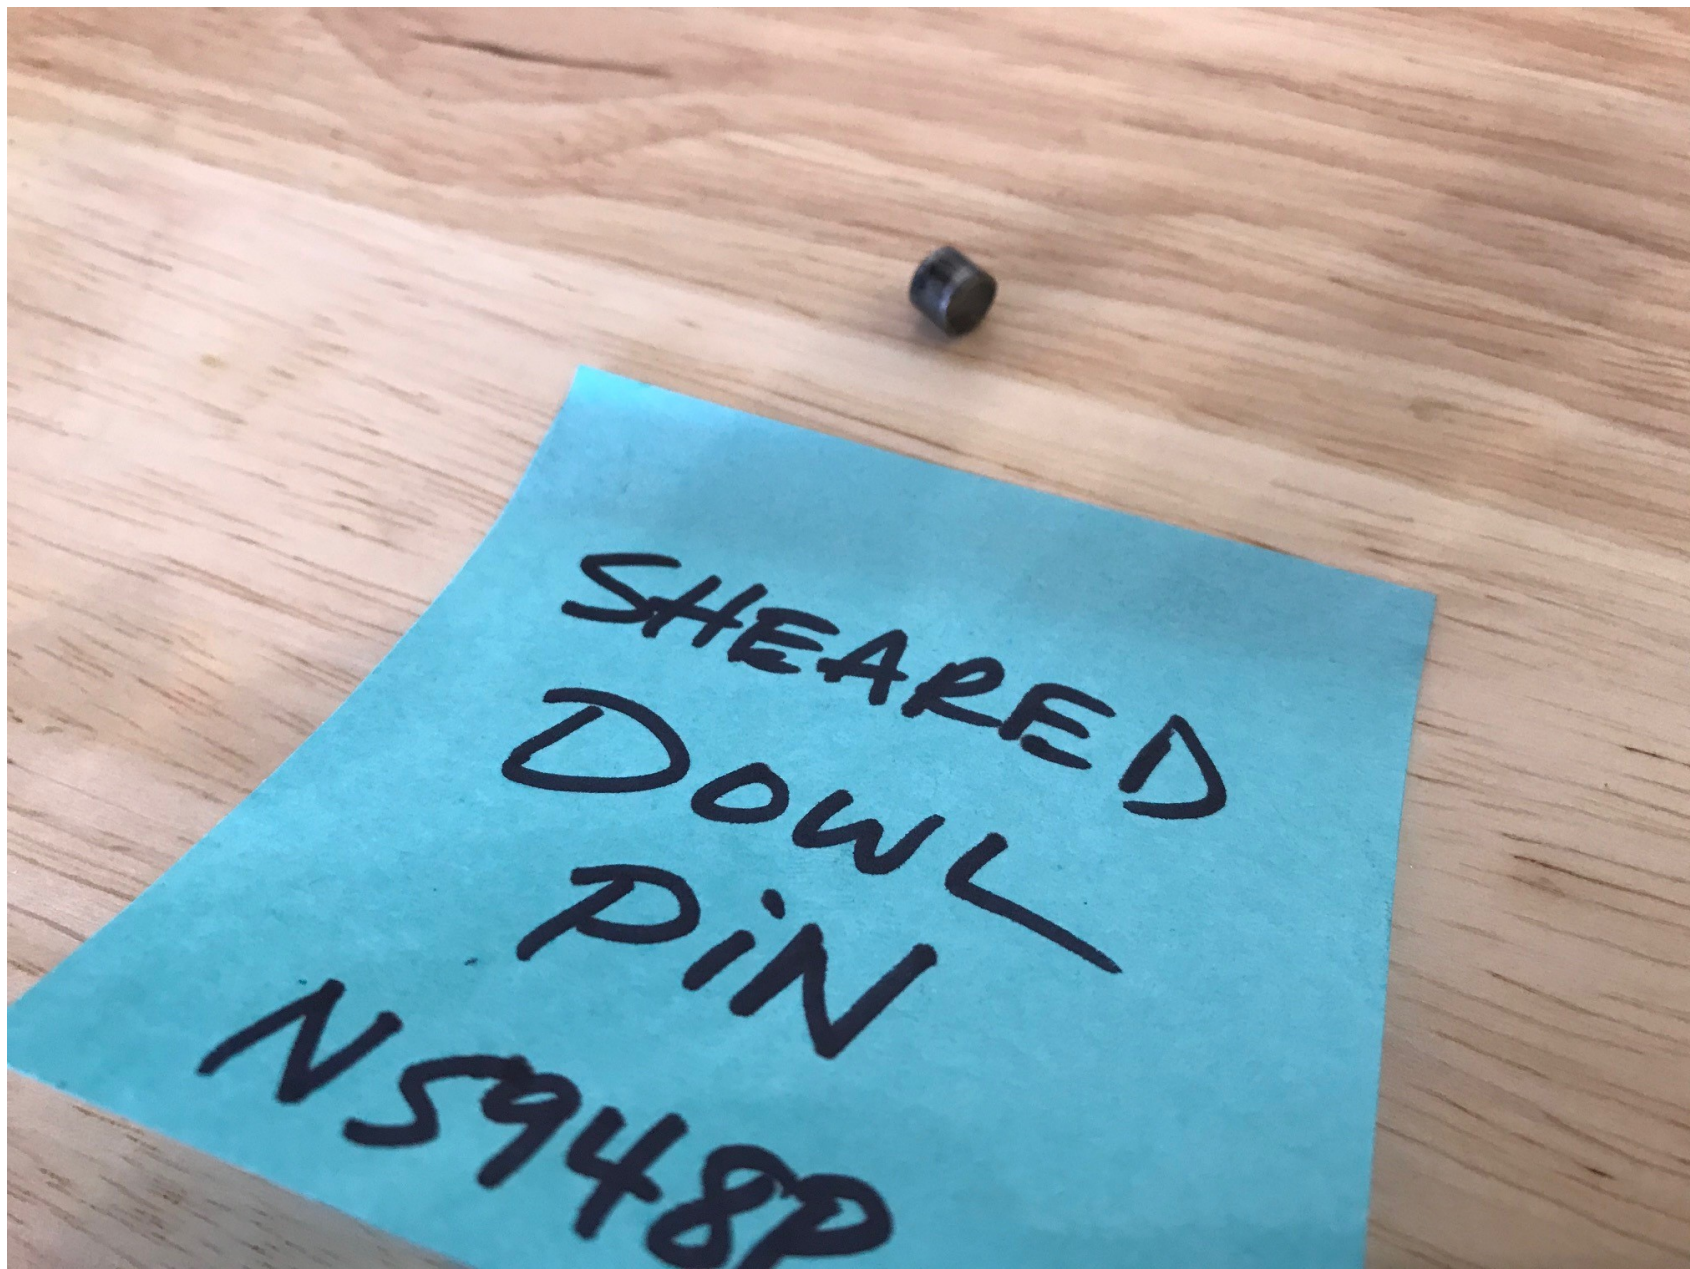
**Photo 5 - FAA Digital Photograph. View of the Sheared Alignment Dowel.**

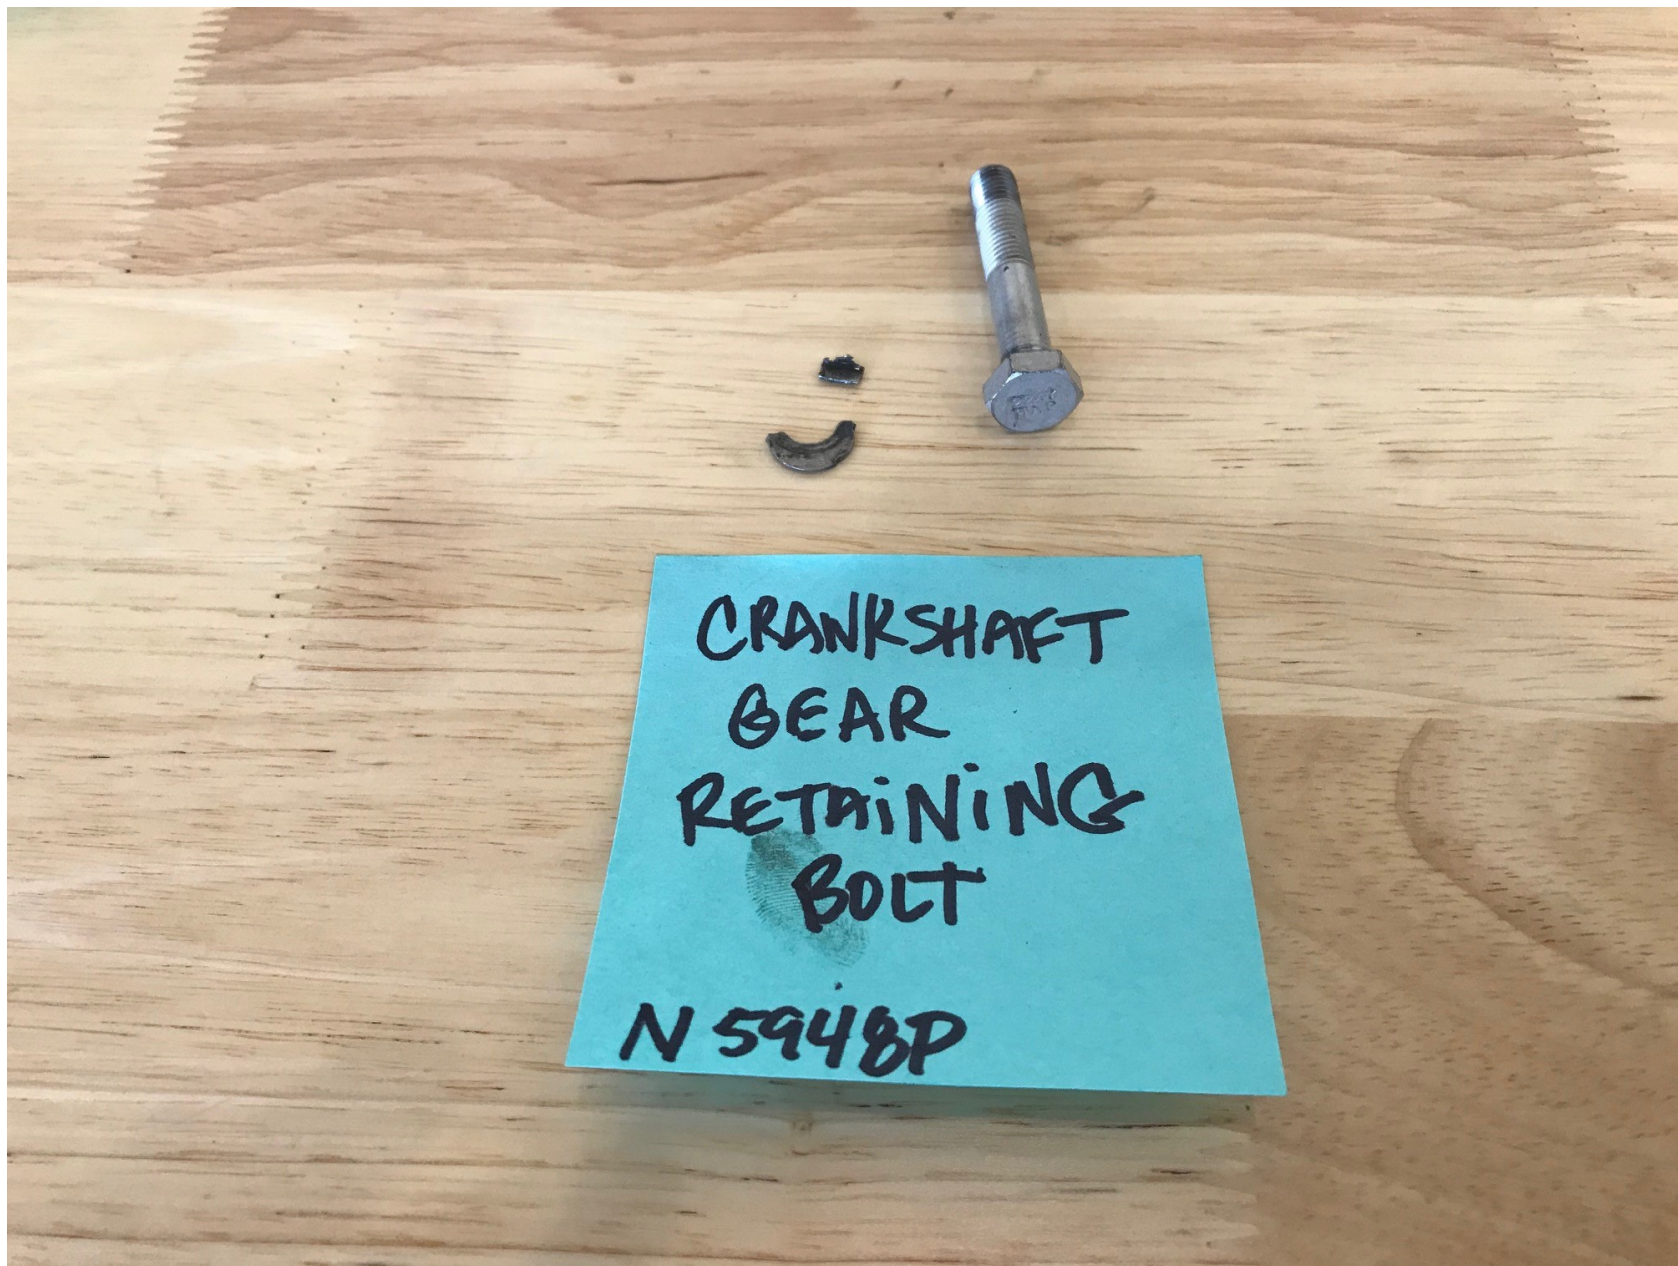
**Photo 6 - FAA Digital Photograph. View of the Crankshaft Gear Attachment Bolt and Fractured Lockplate.**

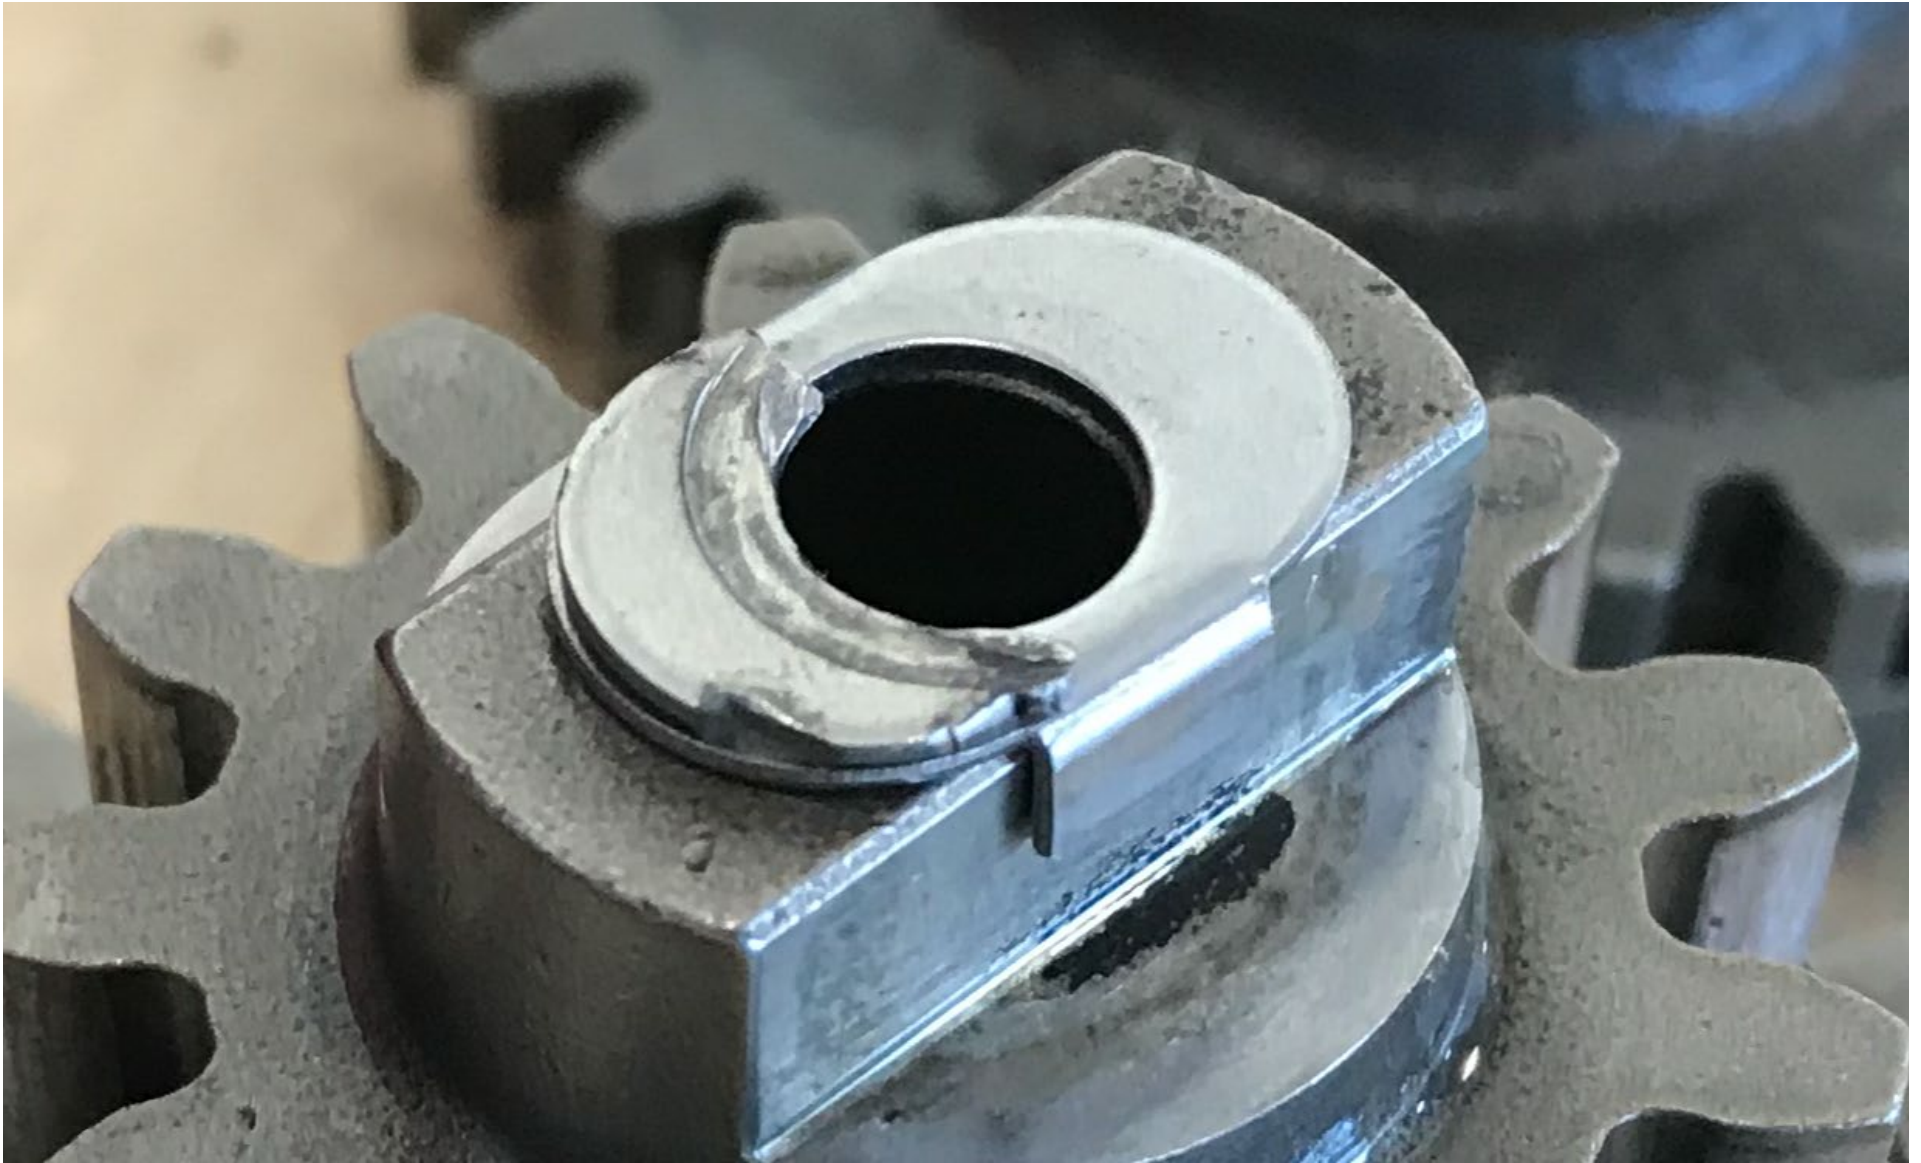
**Photo 7 - FAA Digital Photograph. View of the Crankshaft Gear, Exemplar Lockplate on the Bottom and Accident Lockplate on top. The FAA inspector Reported the Profile of the Accident Lockplate Matched the Un-Bent Profile of the Exemplar Lockplate.**

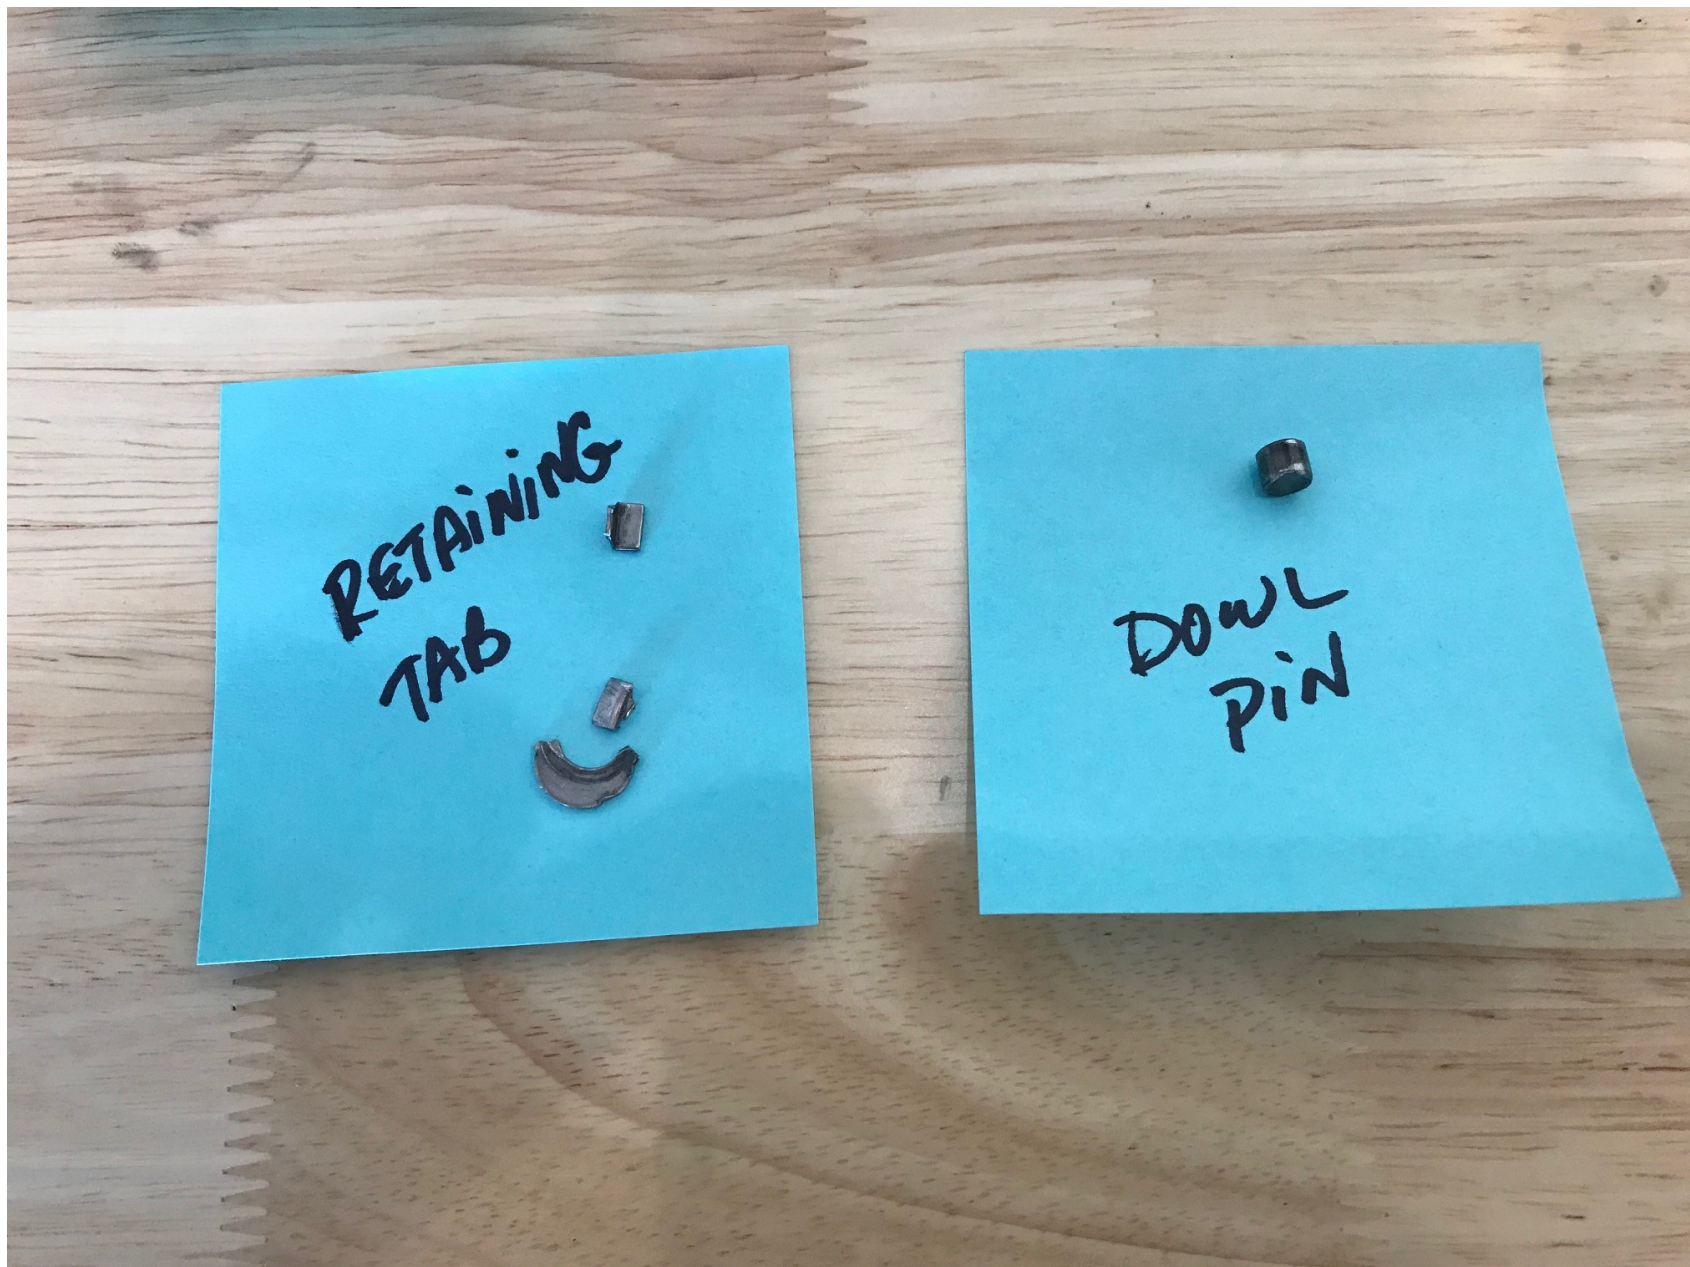
**Photo 8 - FAA Digital Photograph. View of the Fractured Lockplate, and Sheared Section of Alignment Dowel.**
