**Photo 1 – Aft View of Main Wreckage – Courtesy of Ozark Police Department**

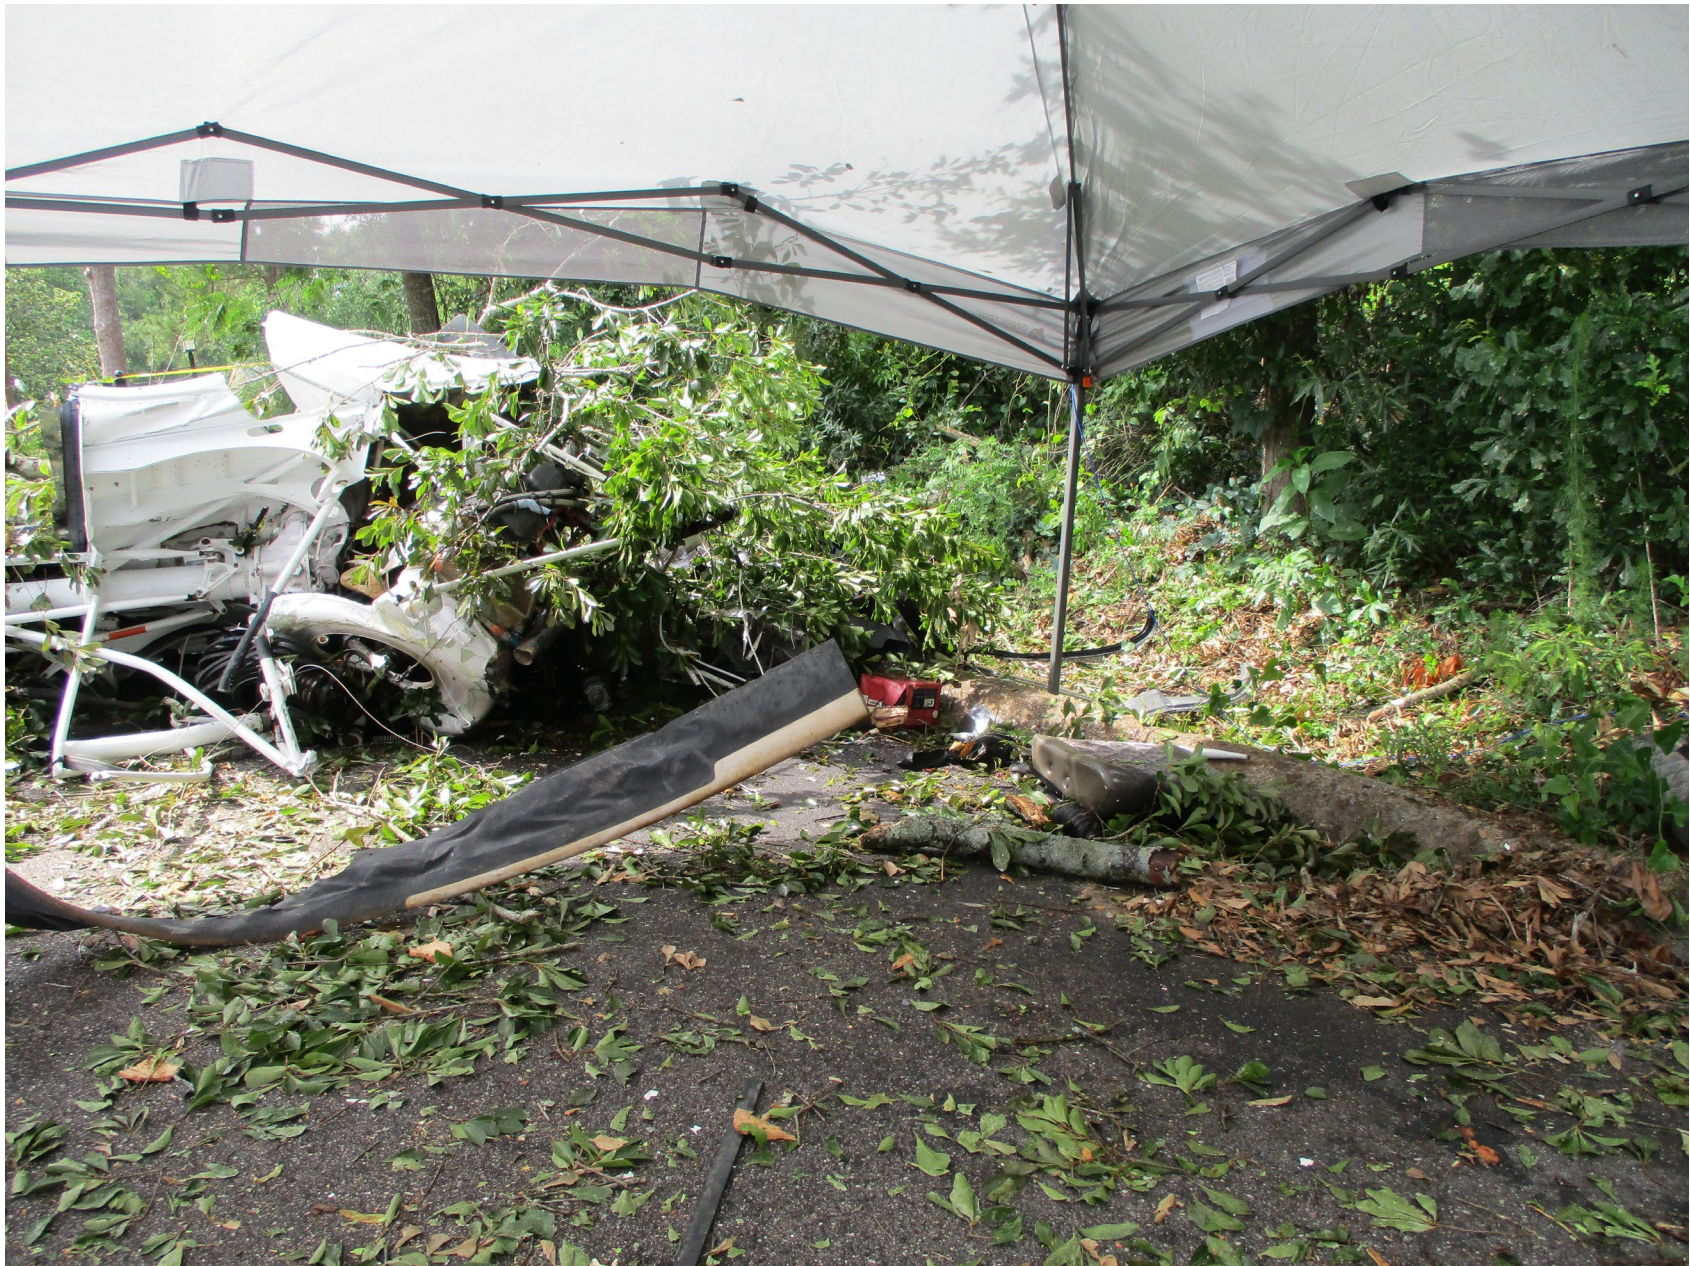
**Photo 2 – Side View of Main Wreckage – Courtesy of FAA**

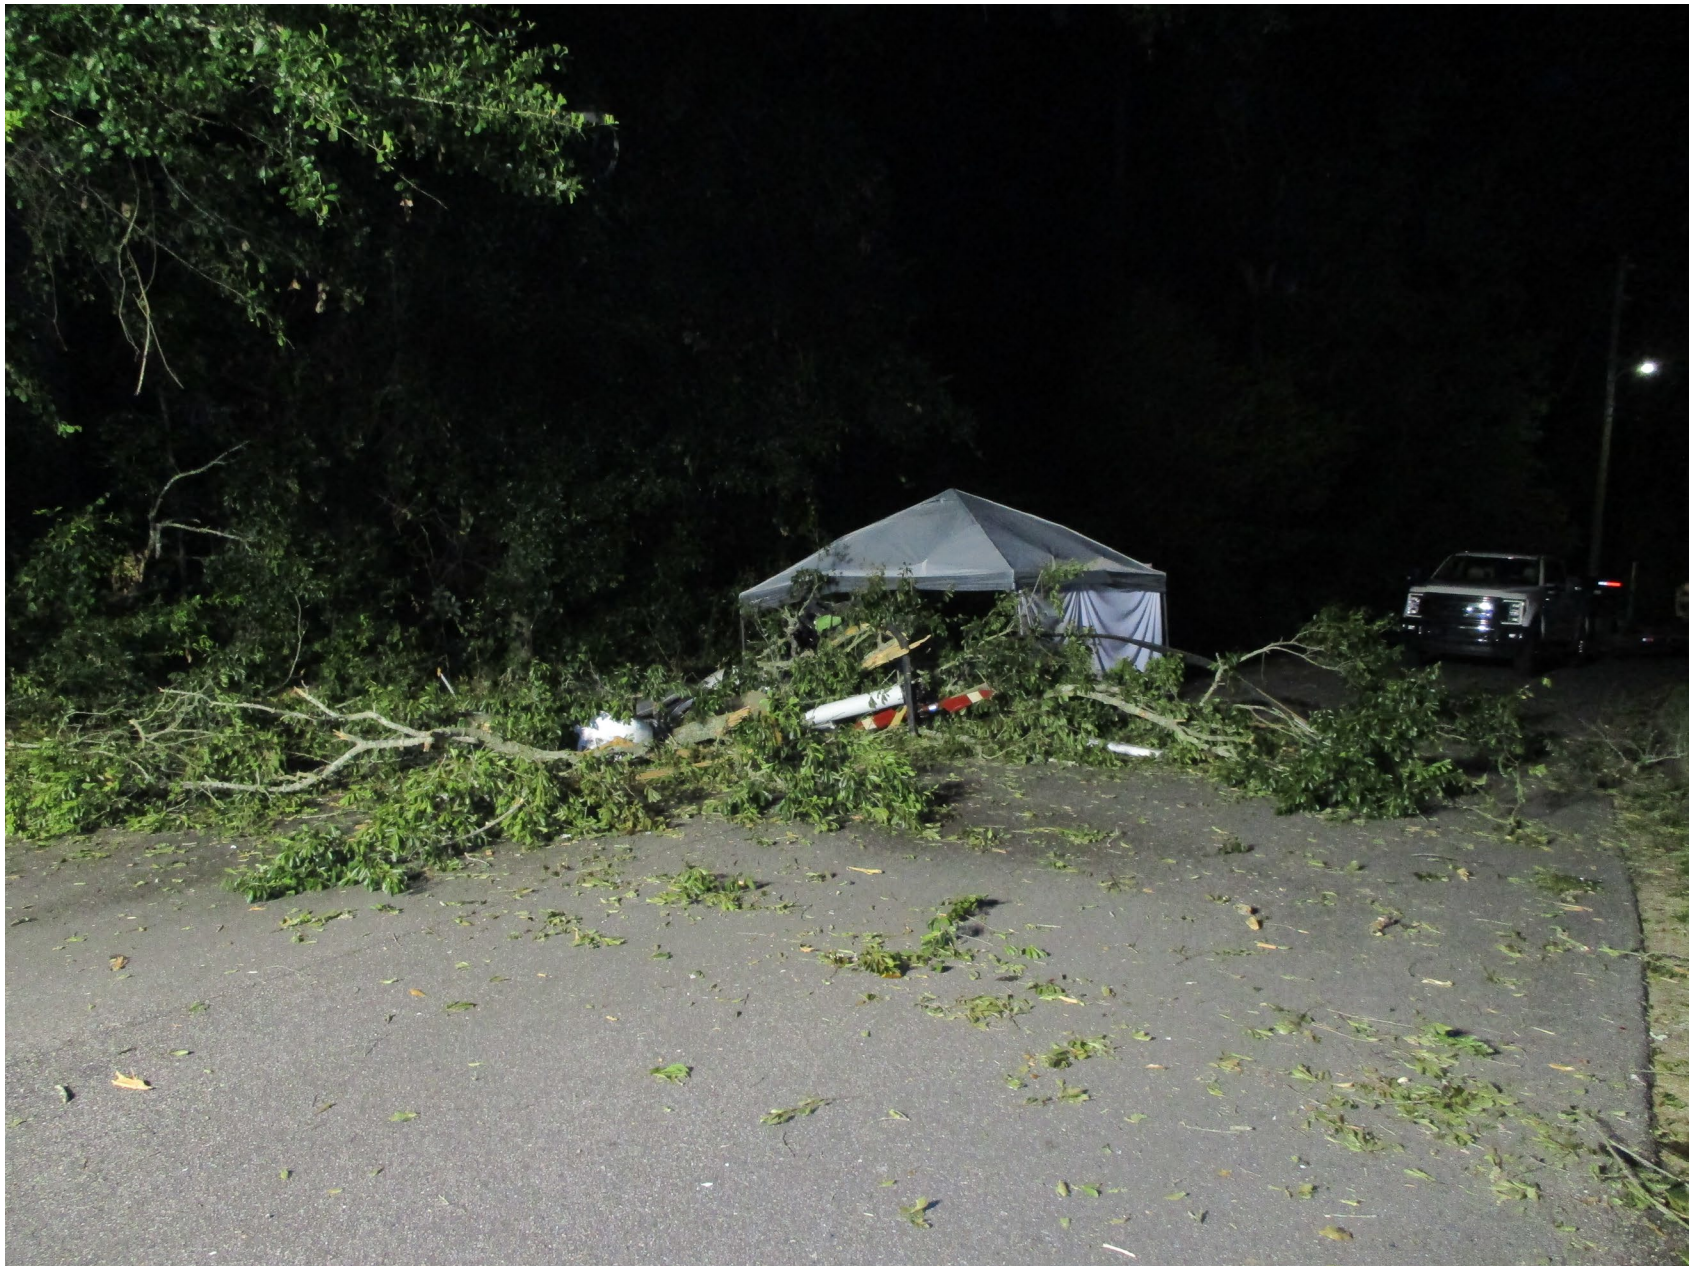
**Photo 3 – Debris from Trees – Courtesy of FAA**

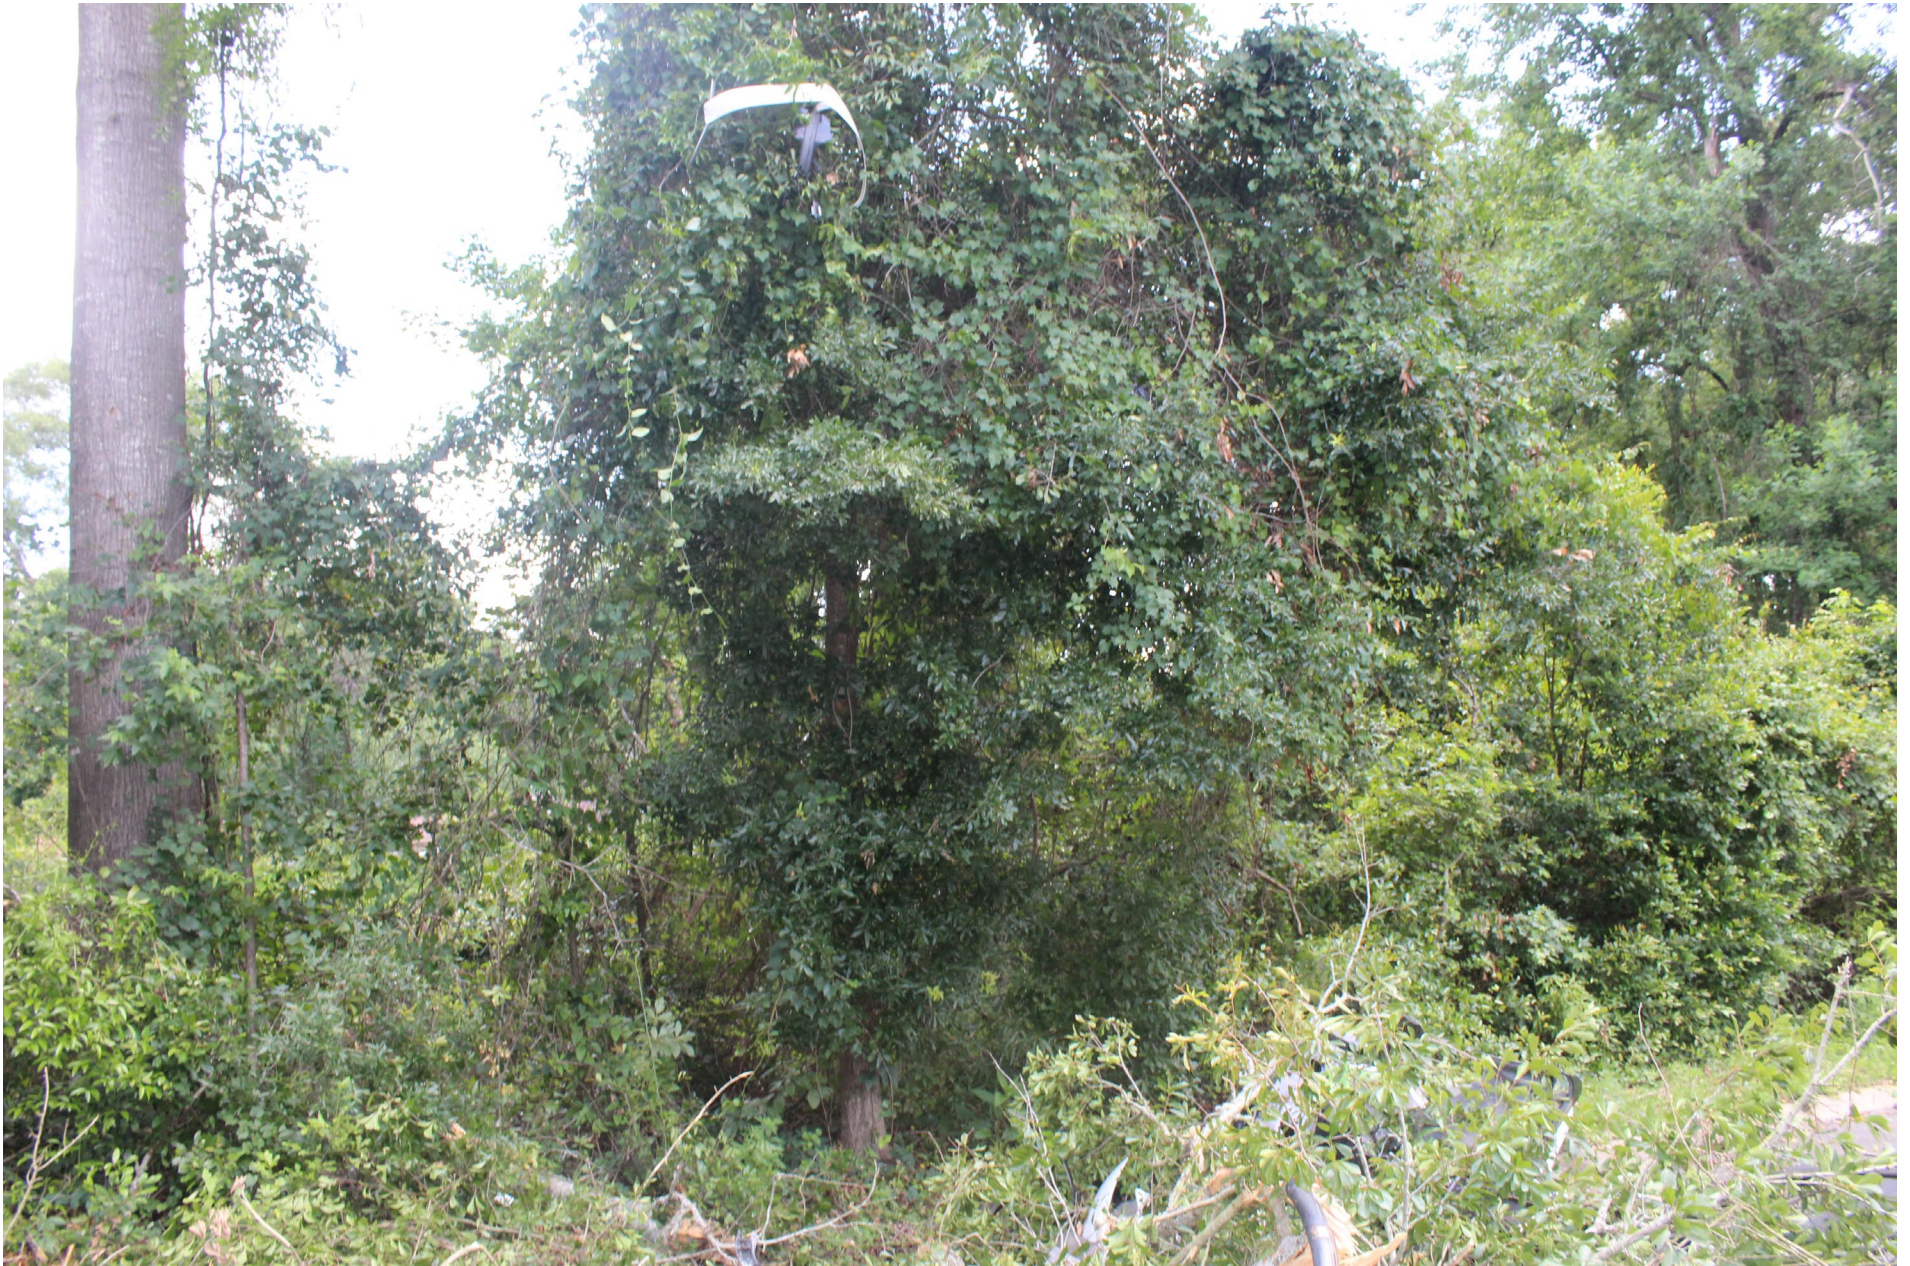
**Photo 4 – Wreckage in Tree – Courtesy of Ozark Police Department**

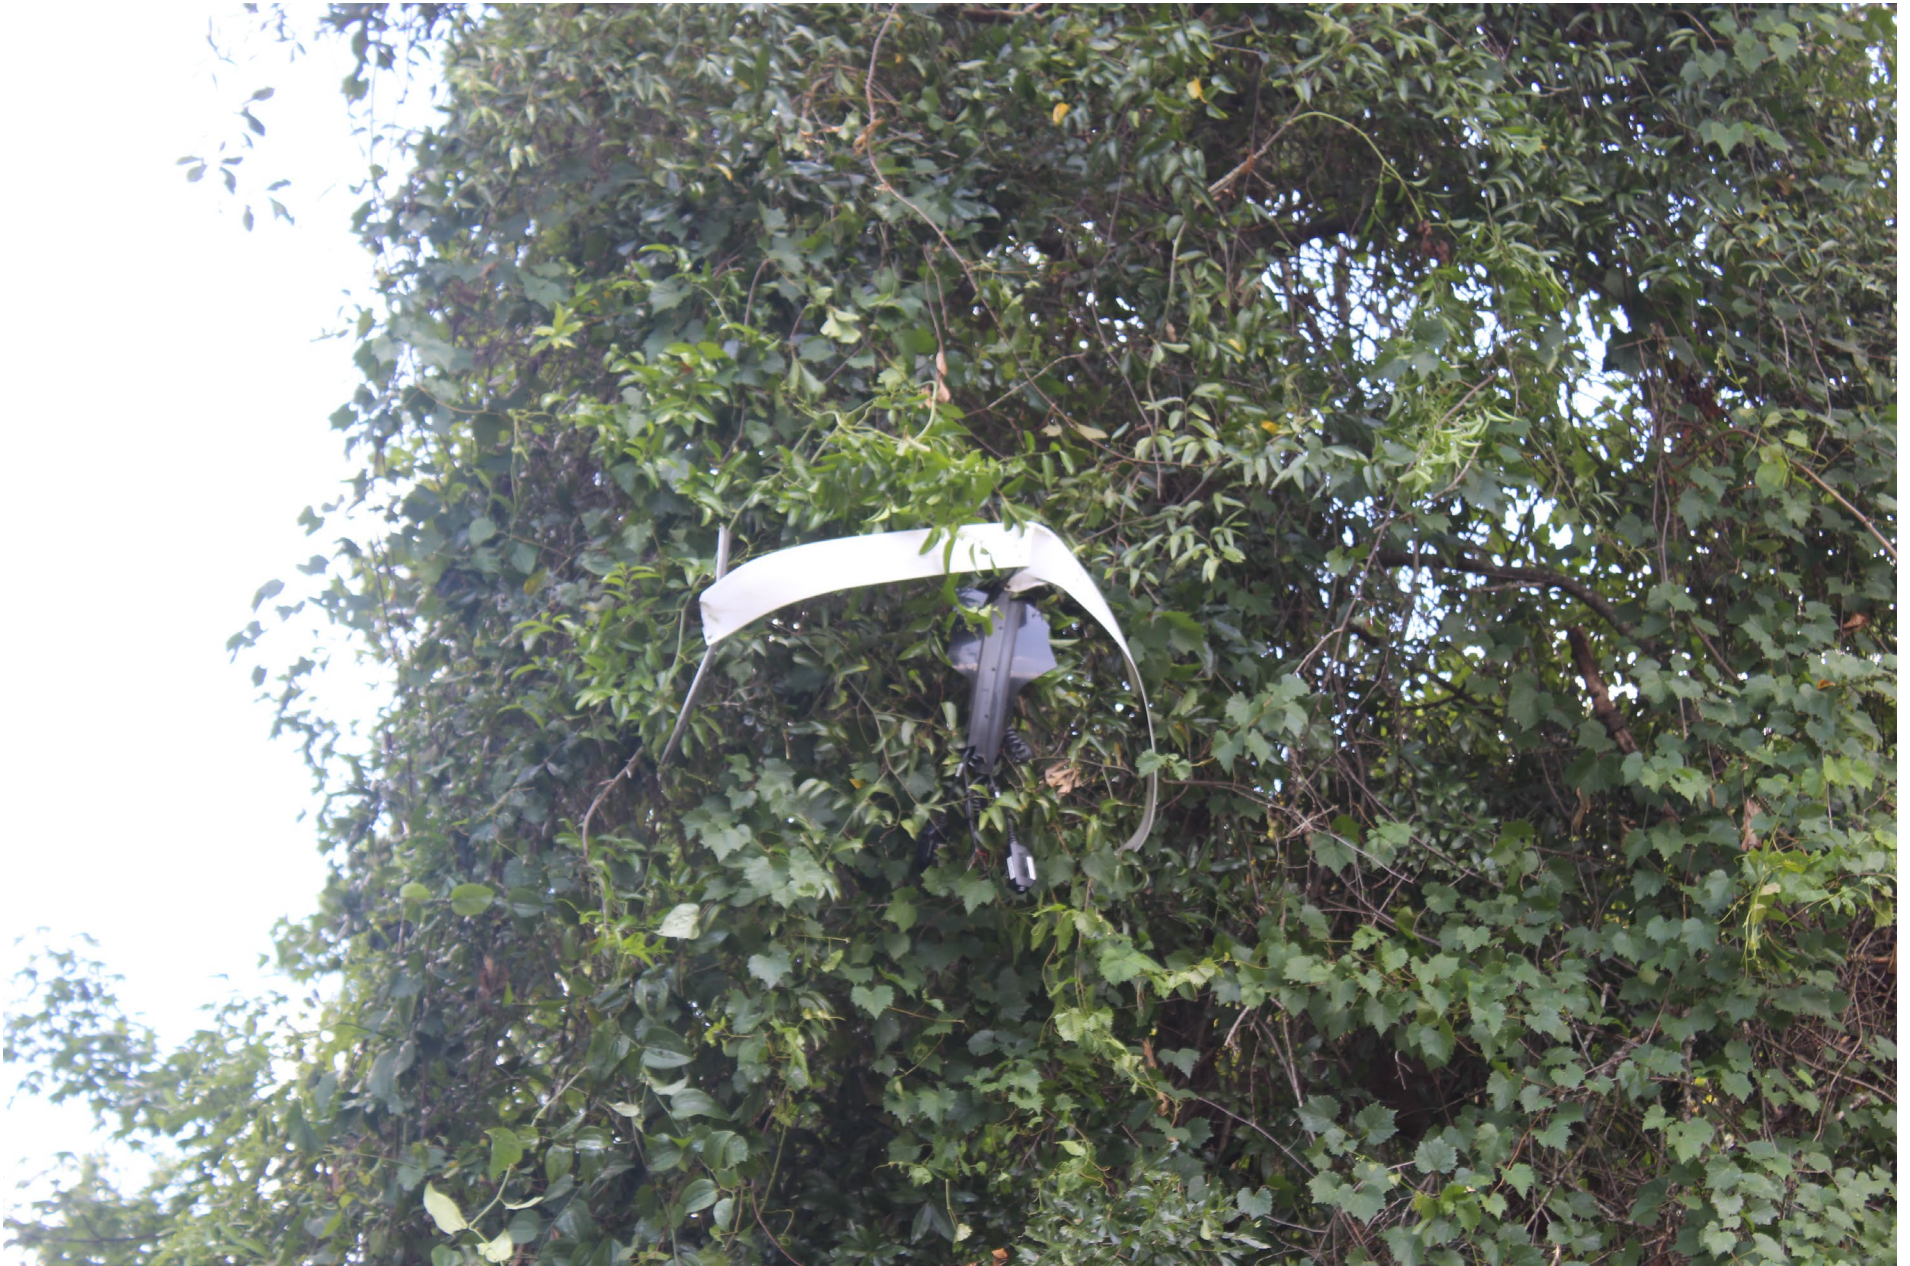
**Photo 5 – Close Up Photo of Wreckage in Tree – Courtesy of Ozark Police Department**

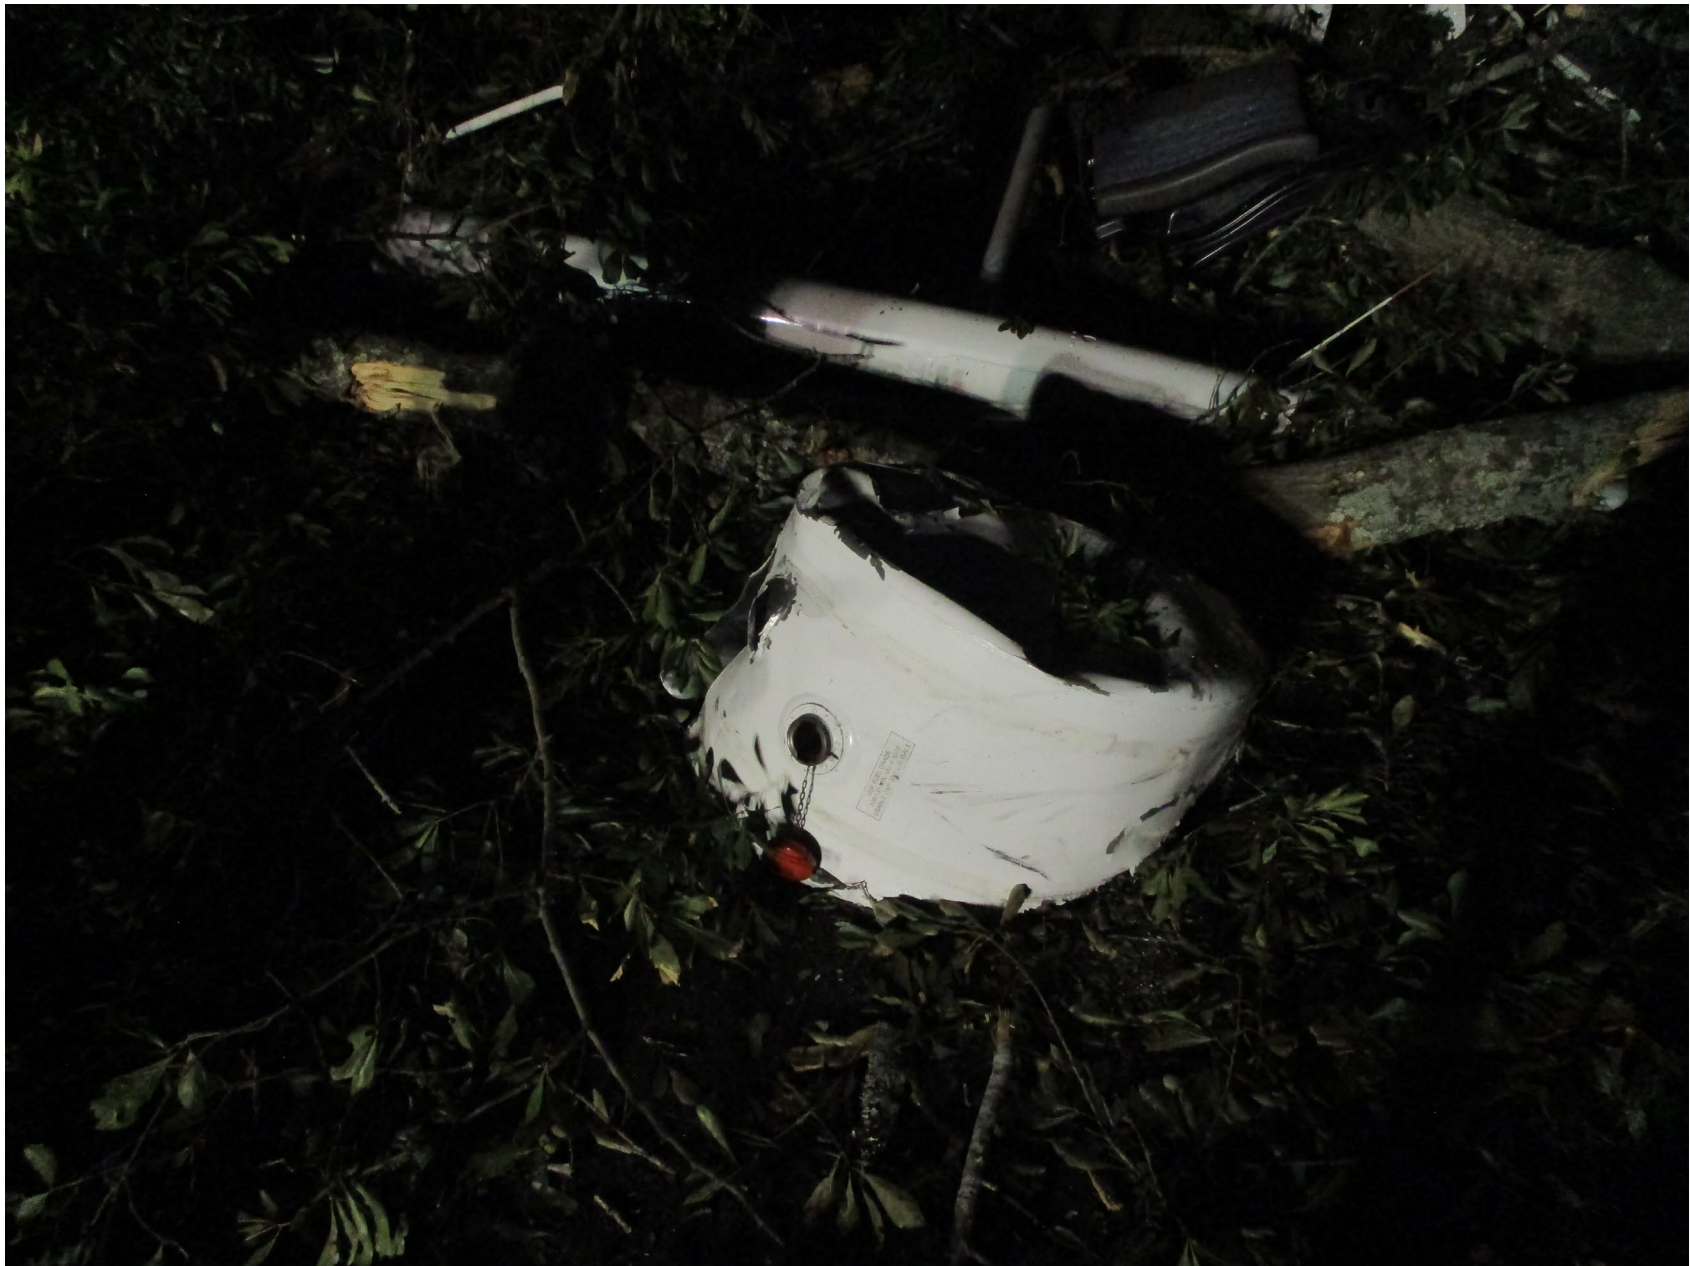
**Photo 6 – Photograph of Fuel Cap – Courtesy of FAA**

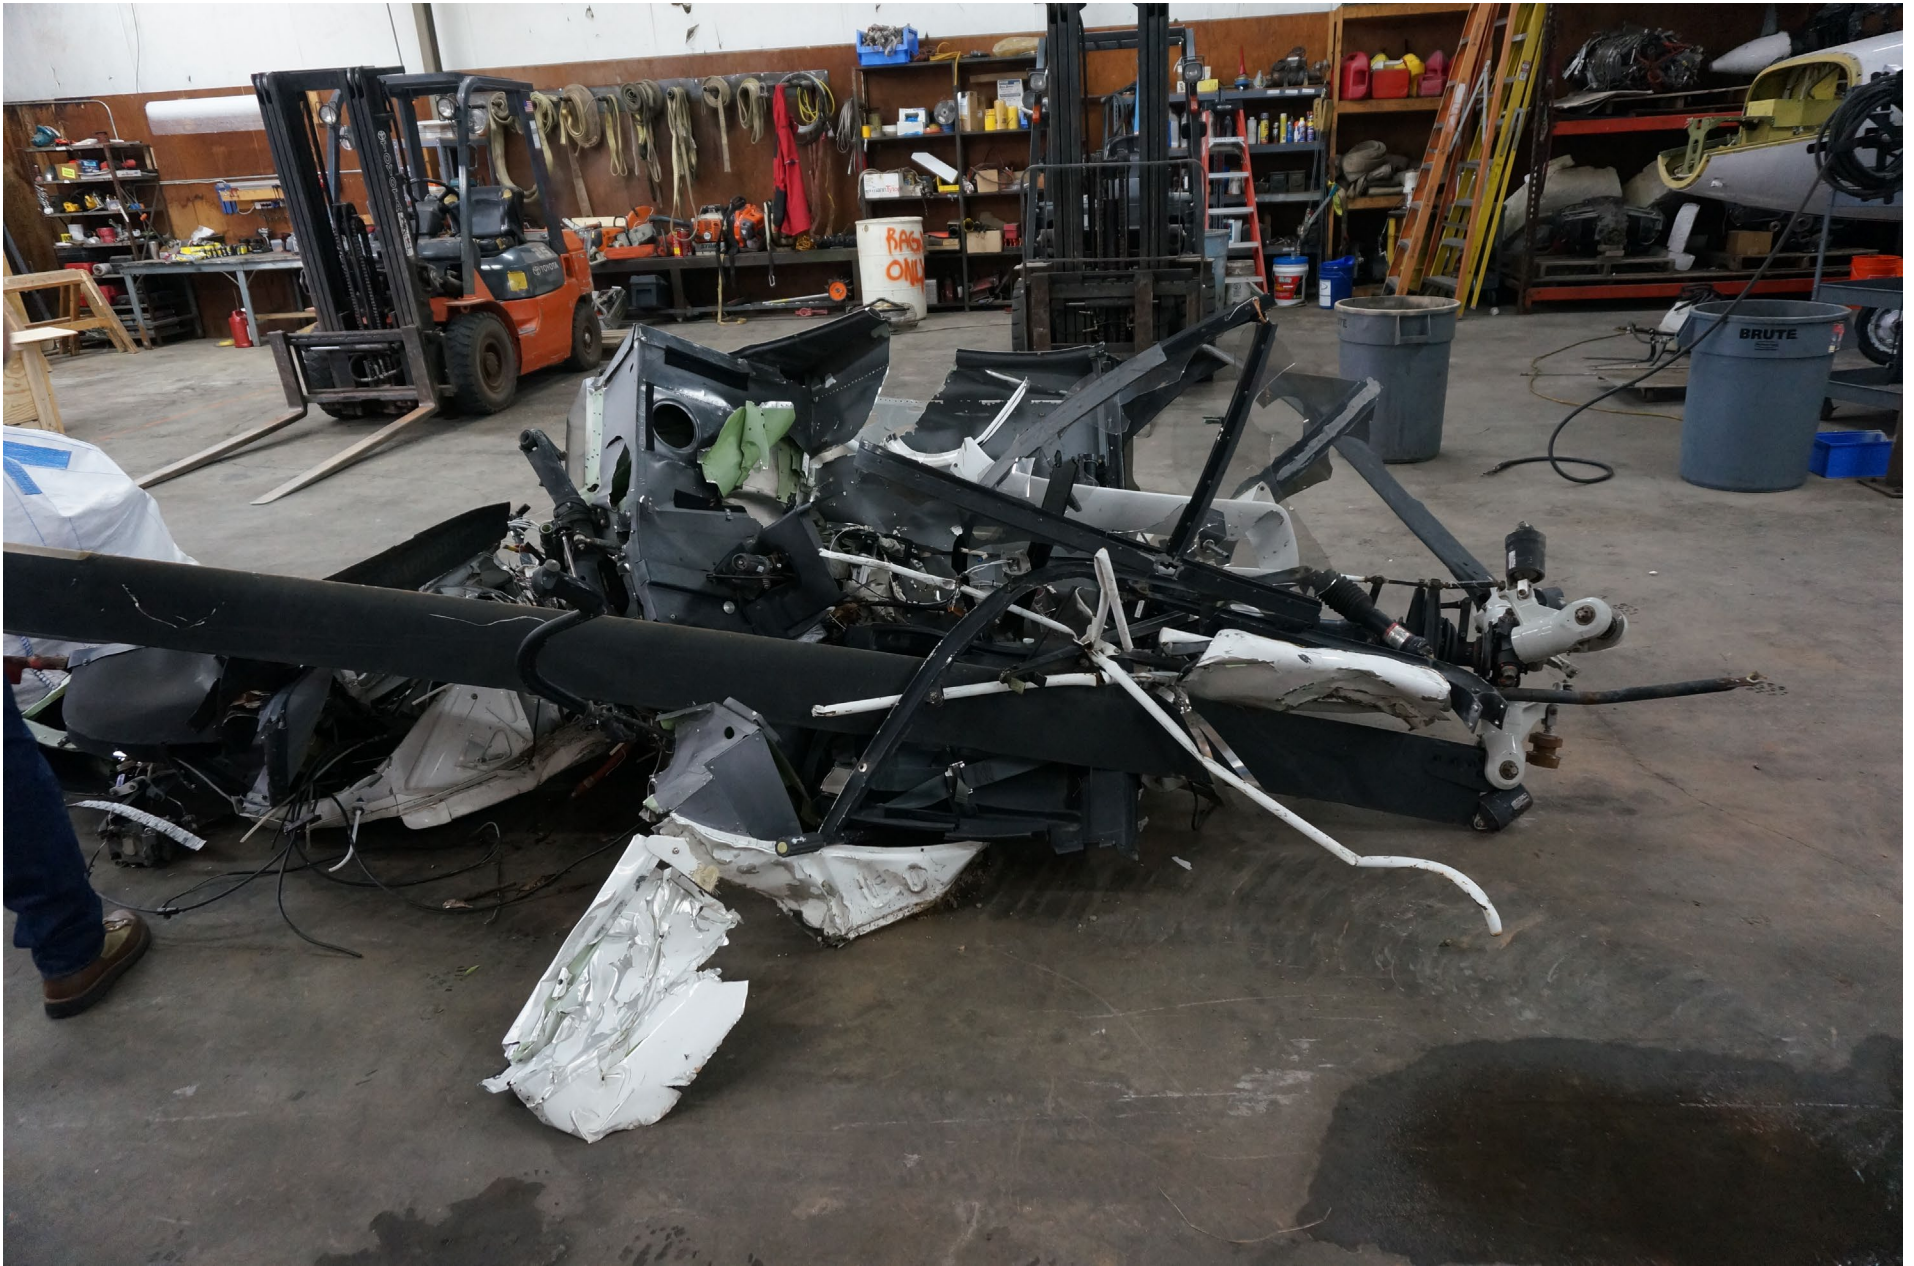
**Photo 7 – Main Wreckage After Recovery – Courtesy of NTSB**

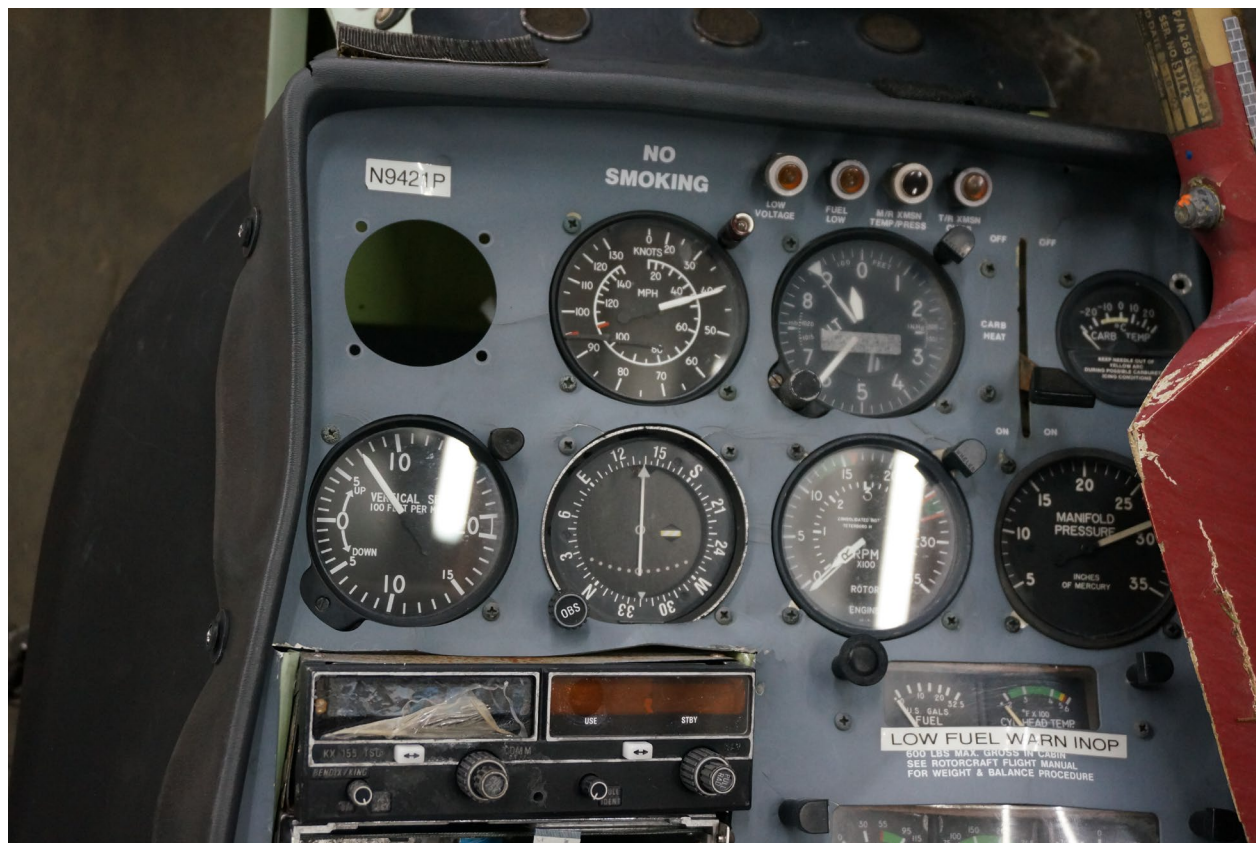
**Photo 8 – Upper Instrument Panel**

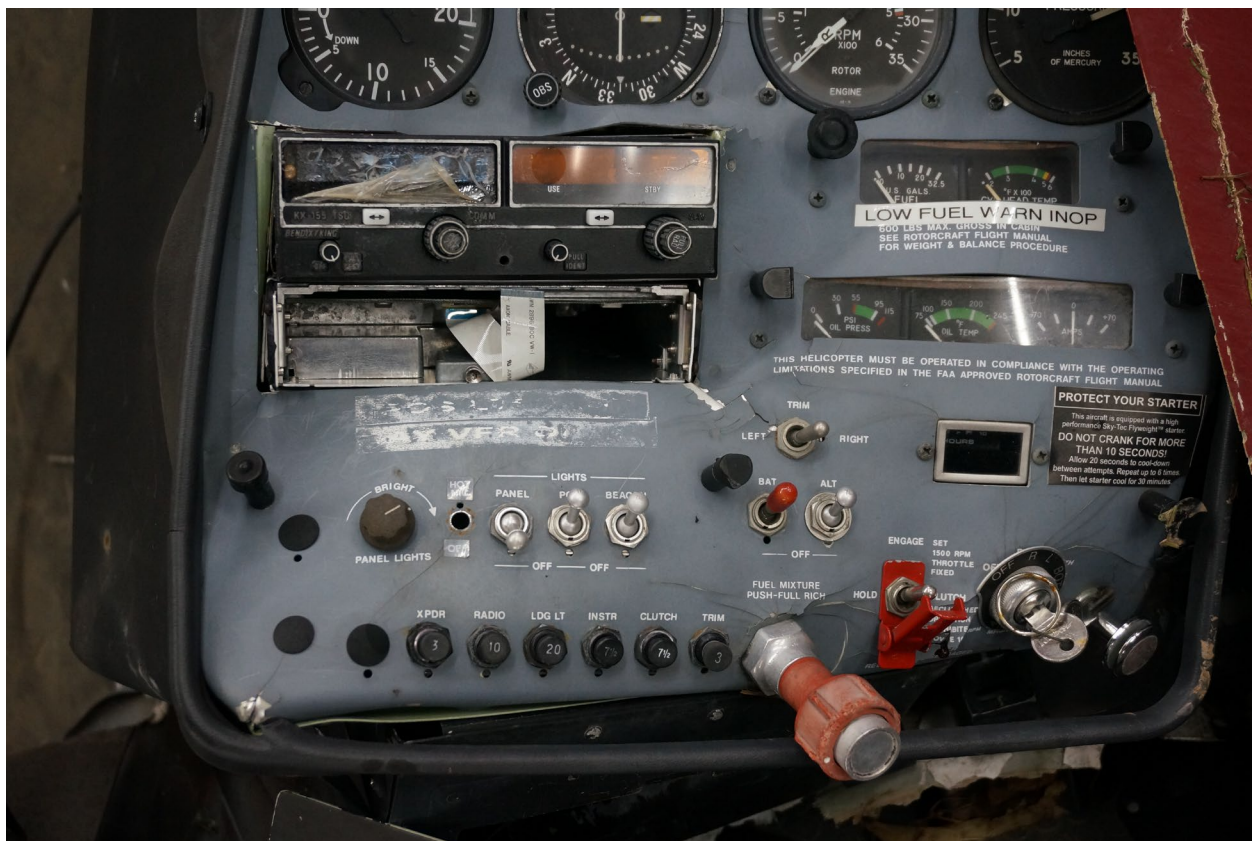
**Photo 9 – Lower Instrument Panel**

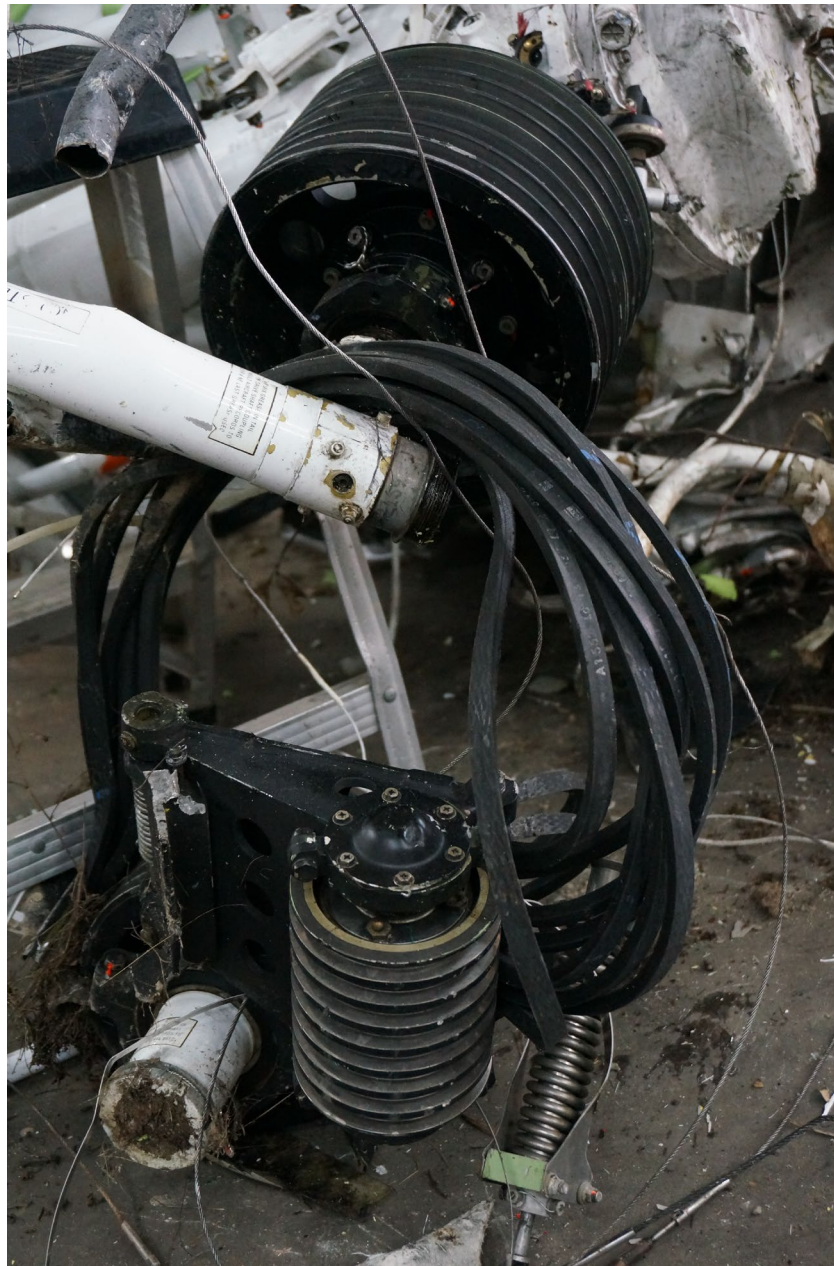
**Photo 10 – Belt Drive**

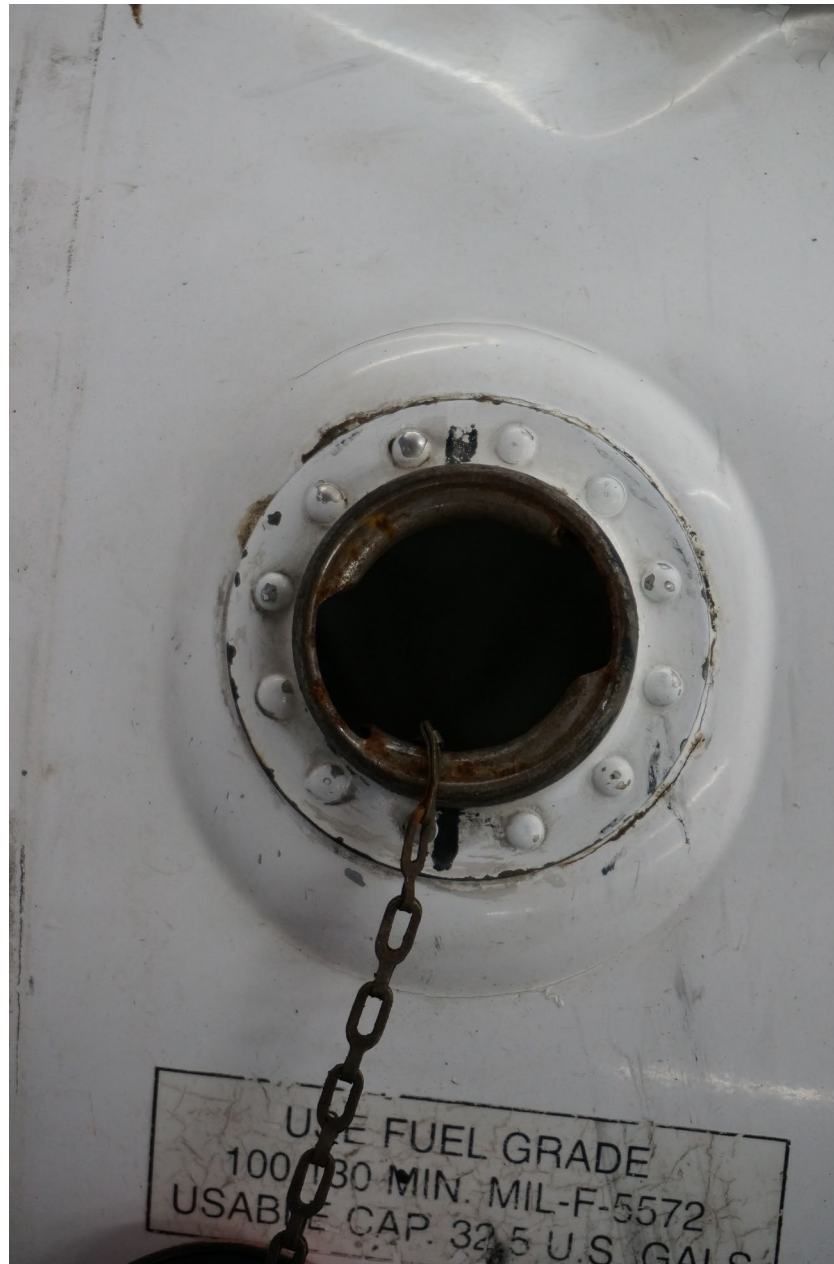
**Photo 11 – Fuel Filler**

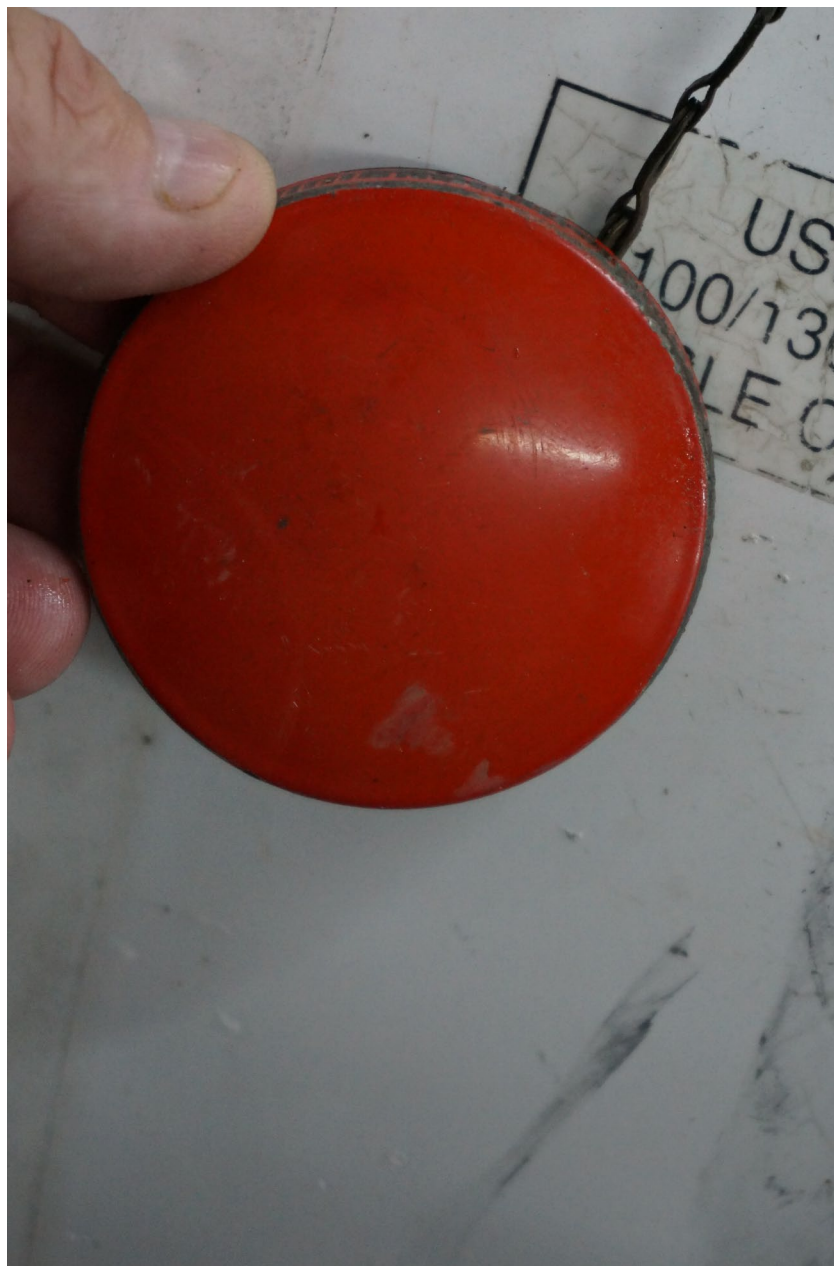
**Photo 12 – Fuel Cap Top**

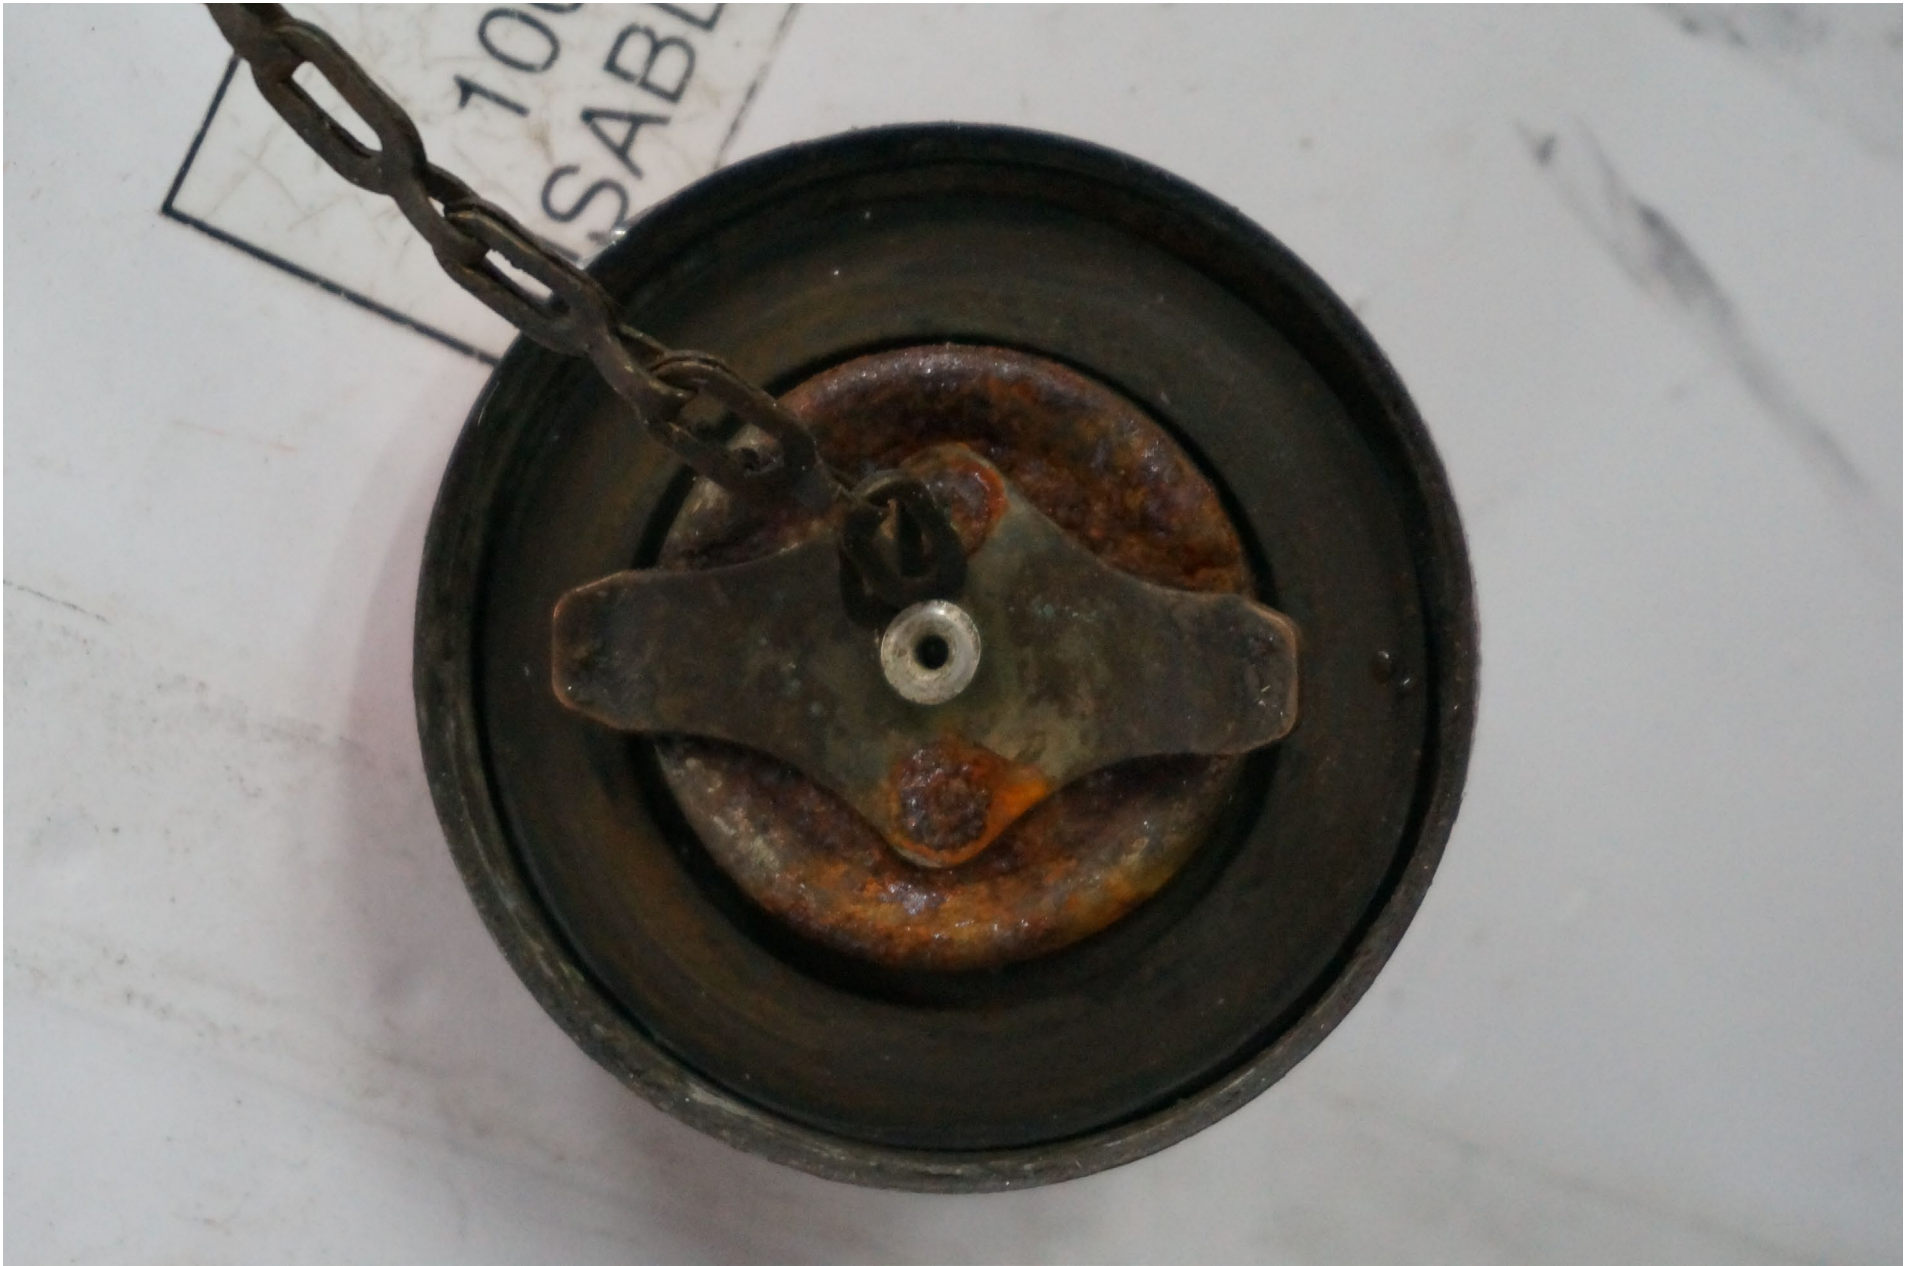
**Photo 13 – Inside of Fuel Cap**
