**Photo 1 – Aft View of Main Wreckage – Courtesy of Ozark Police Department**

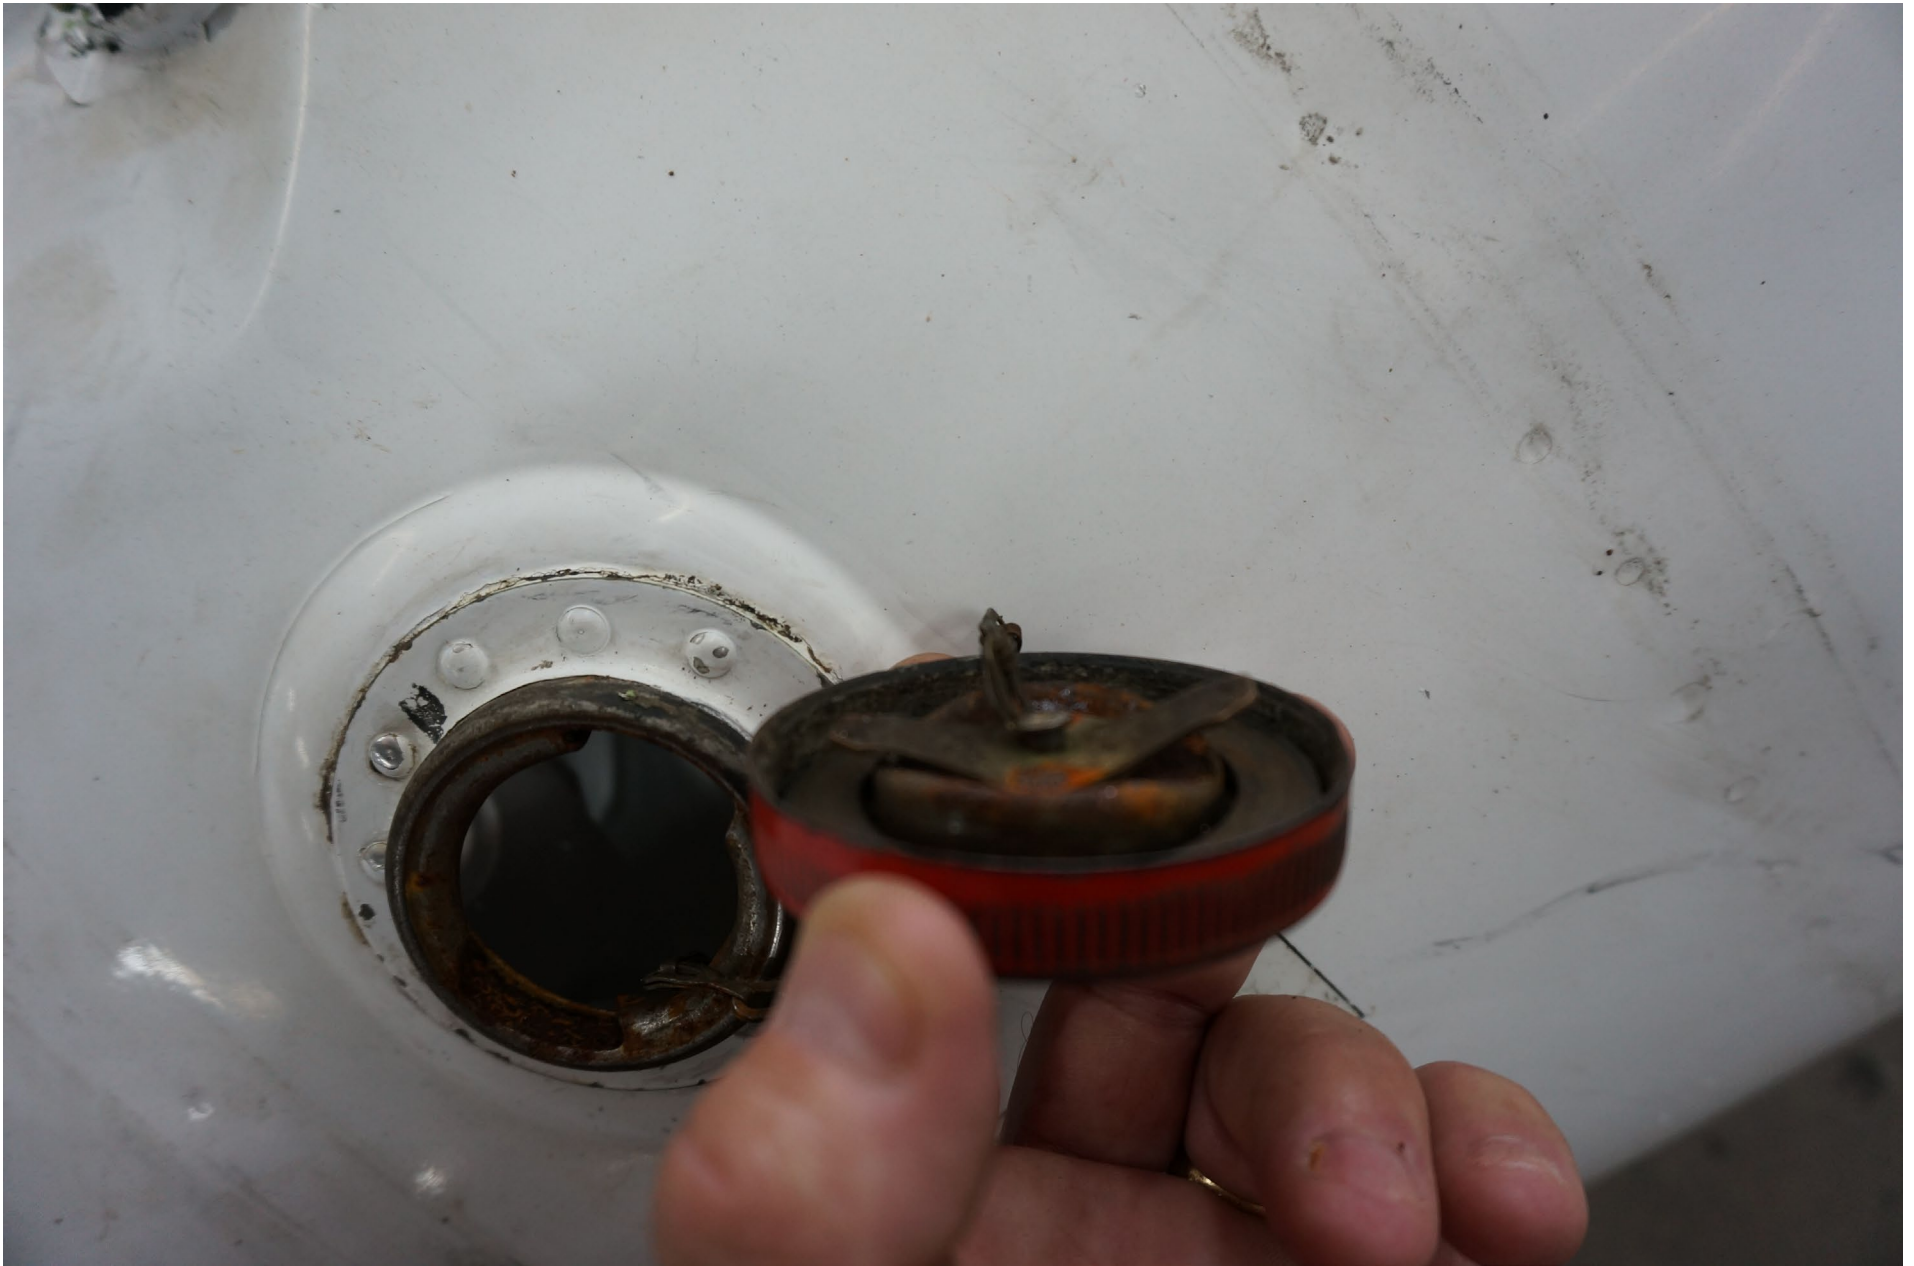
**Photo 14 - Inside of Fuel Cap (Side View of Locking Mechanism)**

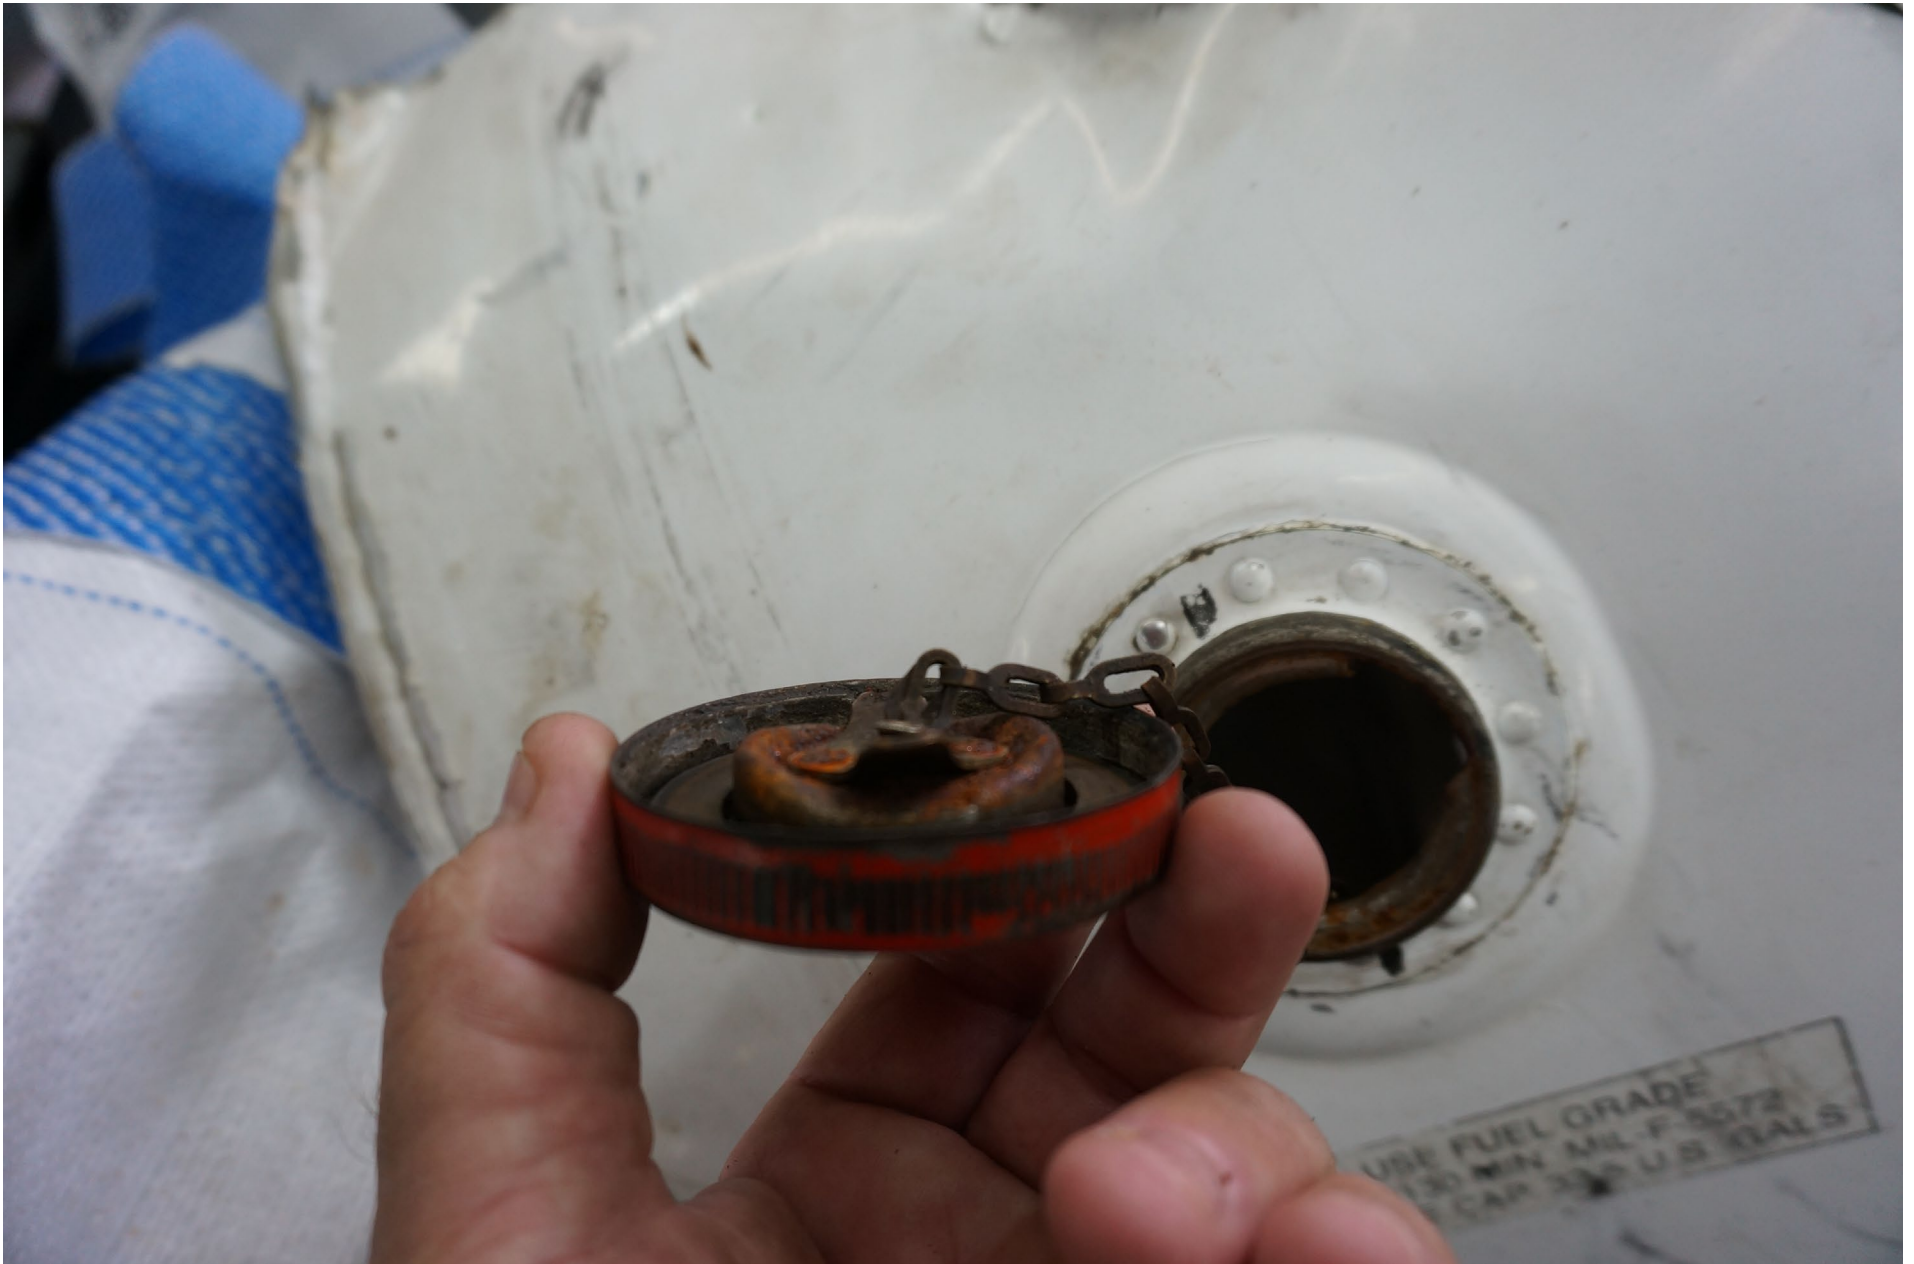
**Photo 15 – Inside of Fuel Cap (End View of Locking Mechanism)**

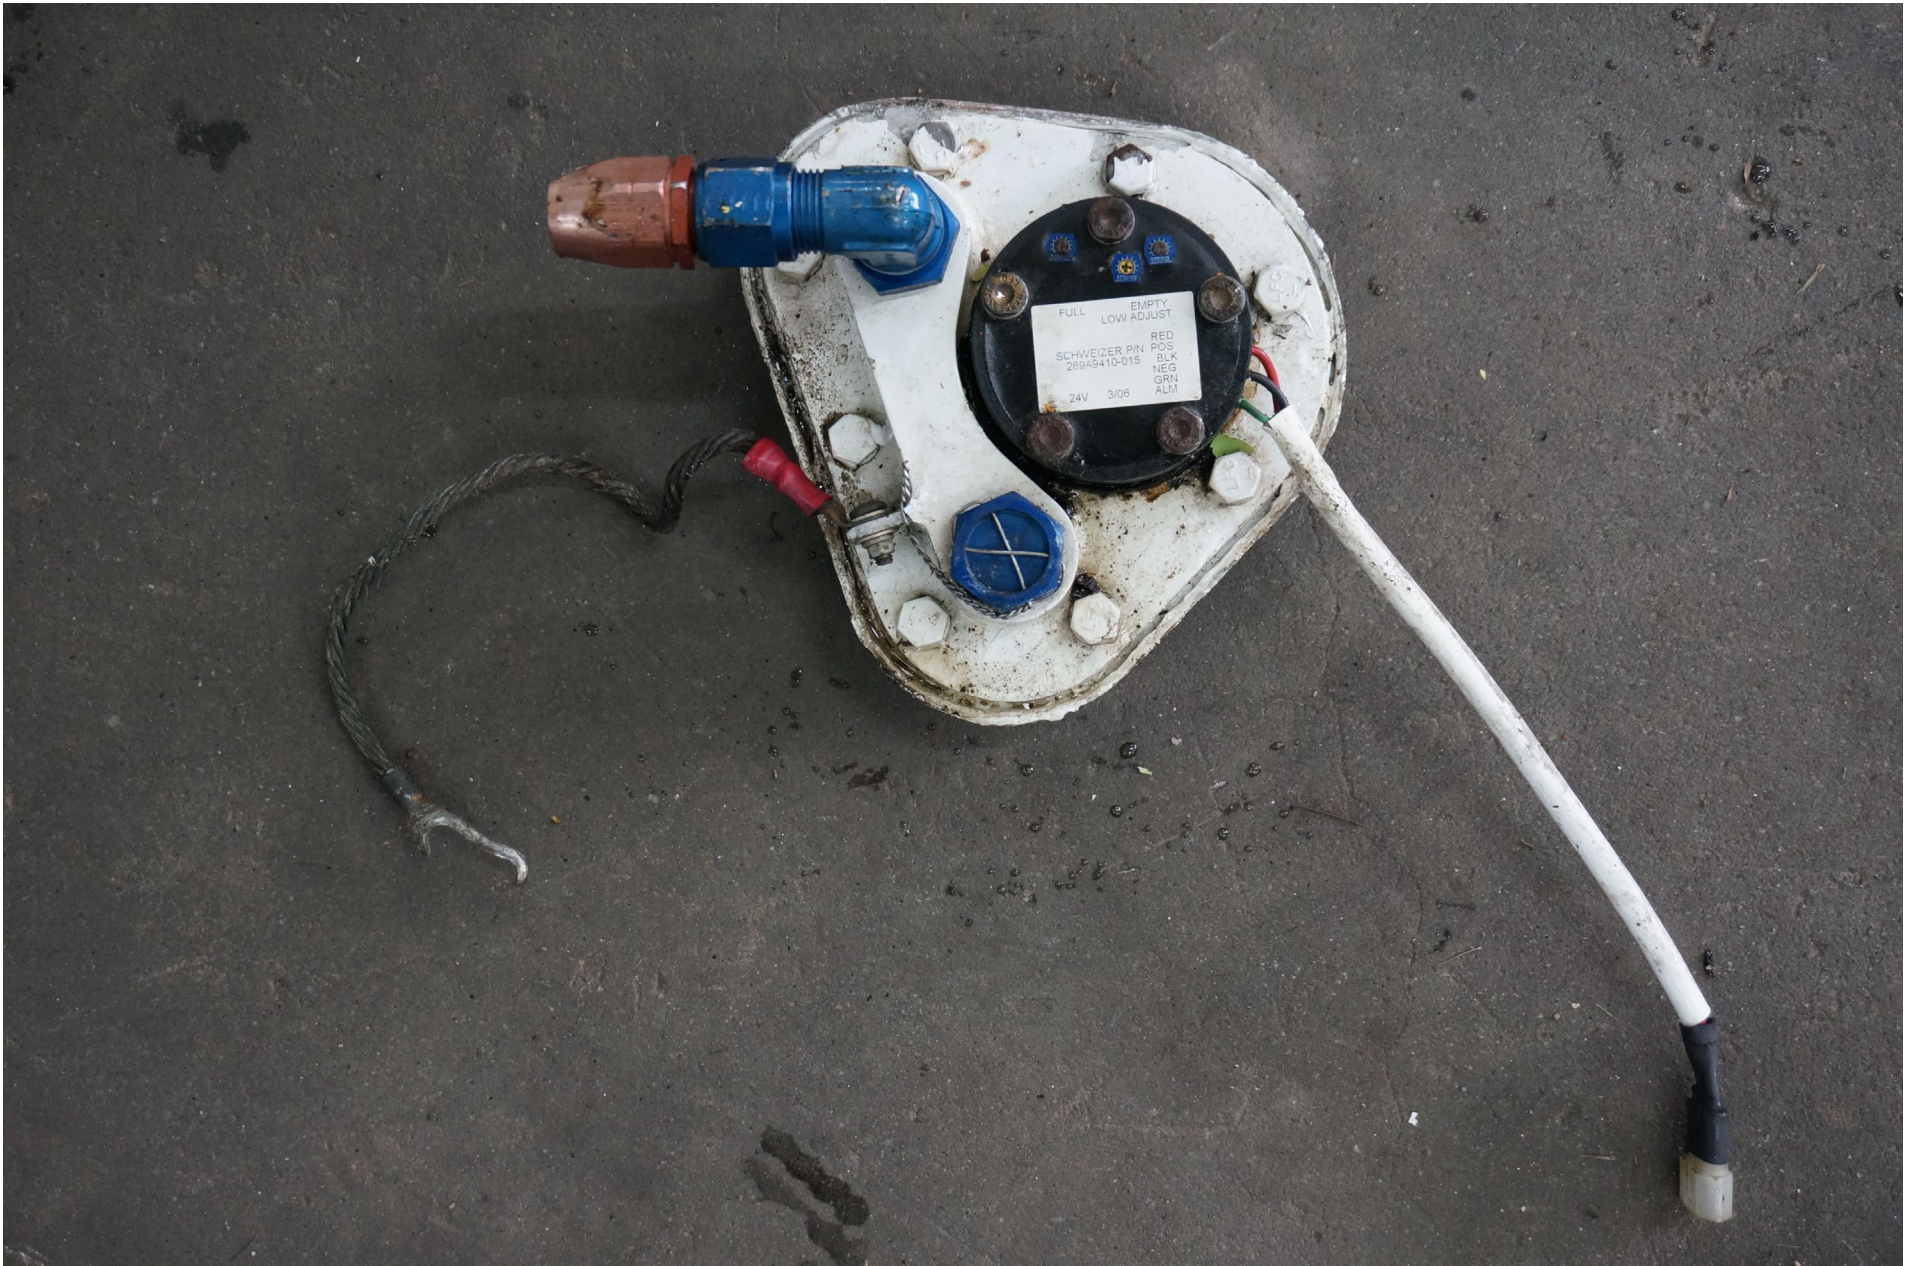
**Photo 16 – Fuel Tank Sump Flange (Adjustment Side)**

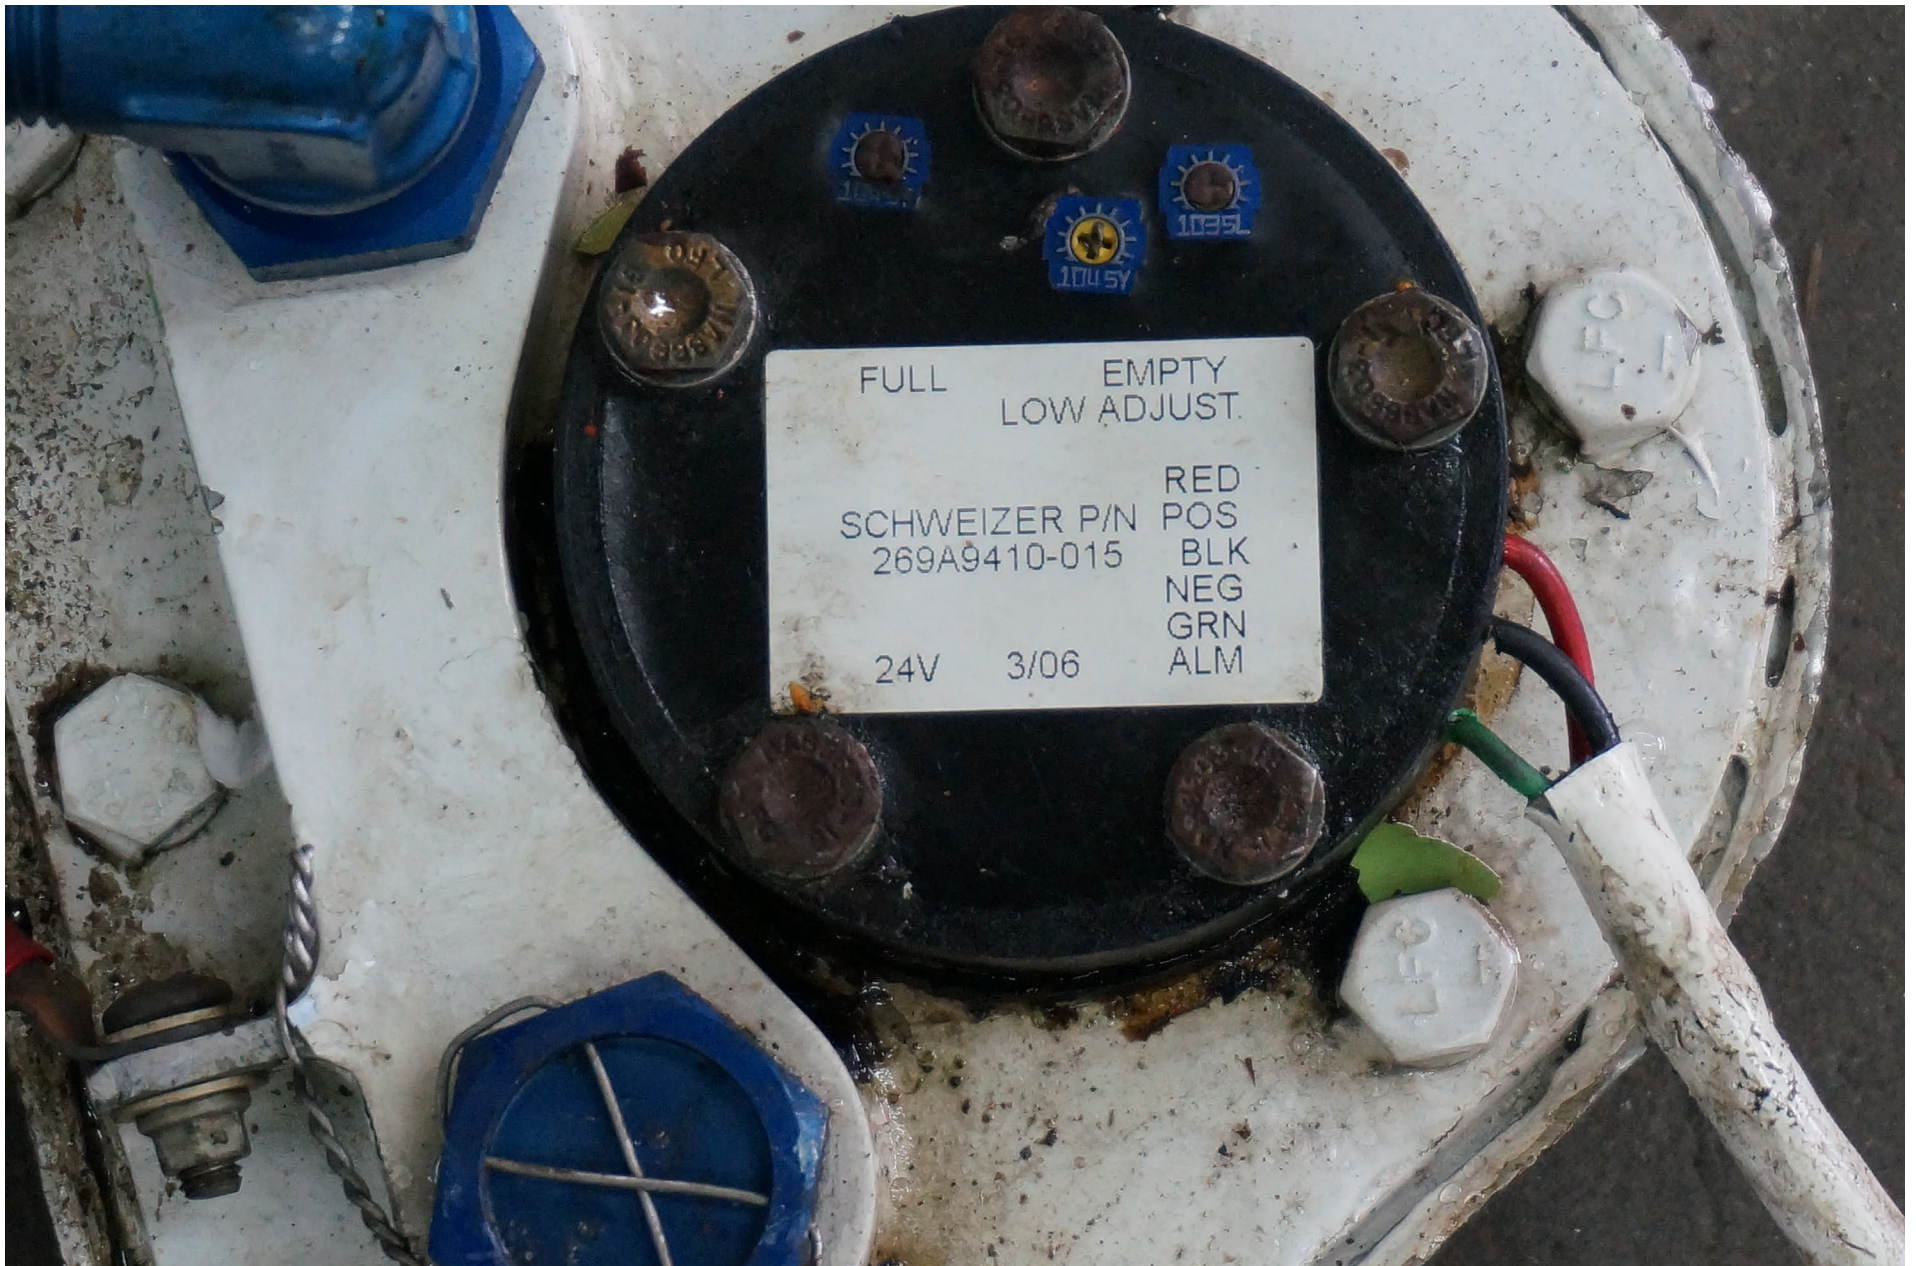
**Photo 17 – Close Up of Fuel Tank Sump Flange (Adjustment Side)**

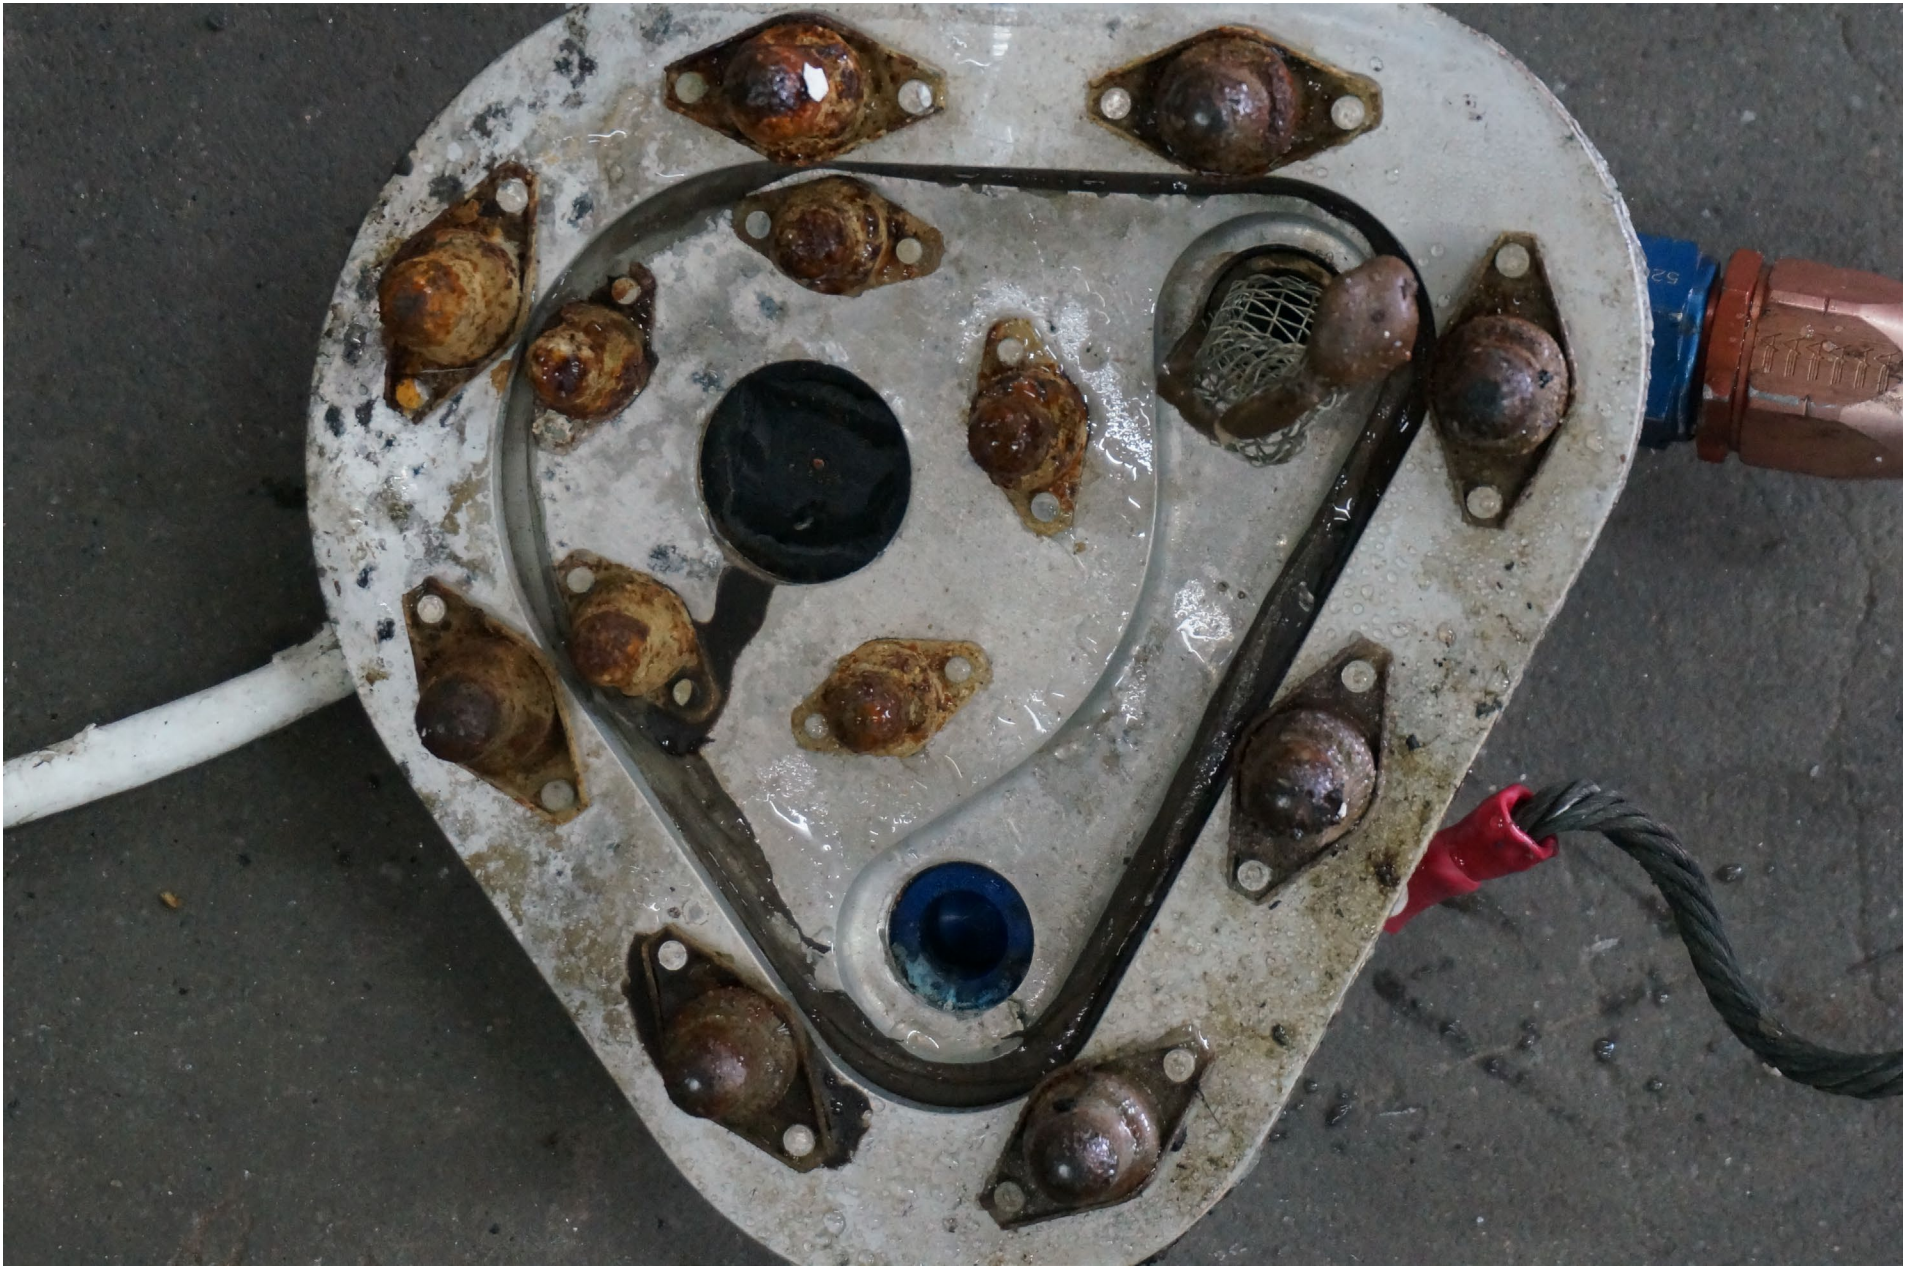
**Photo 18 – Fuel Tank Sump Flange (Probe Side)**

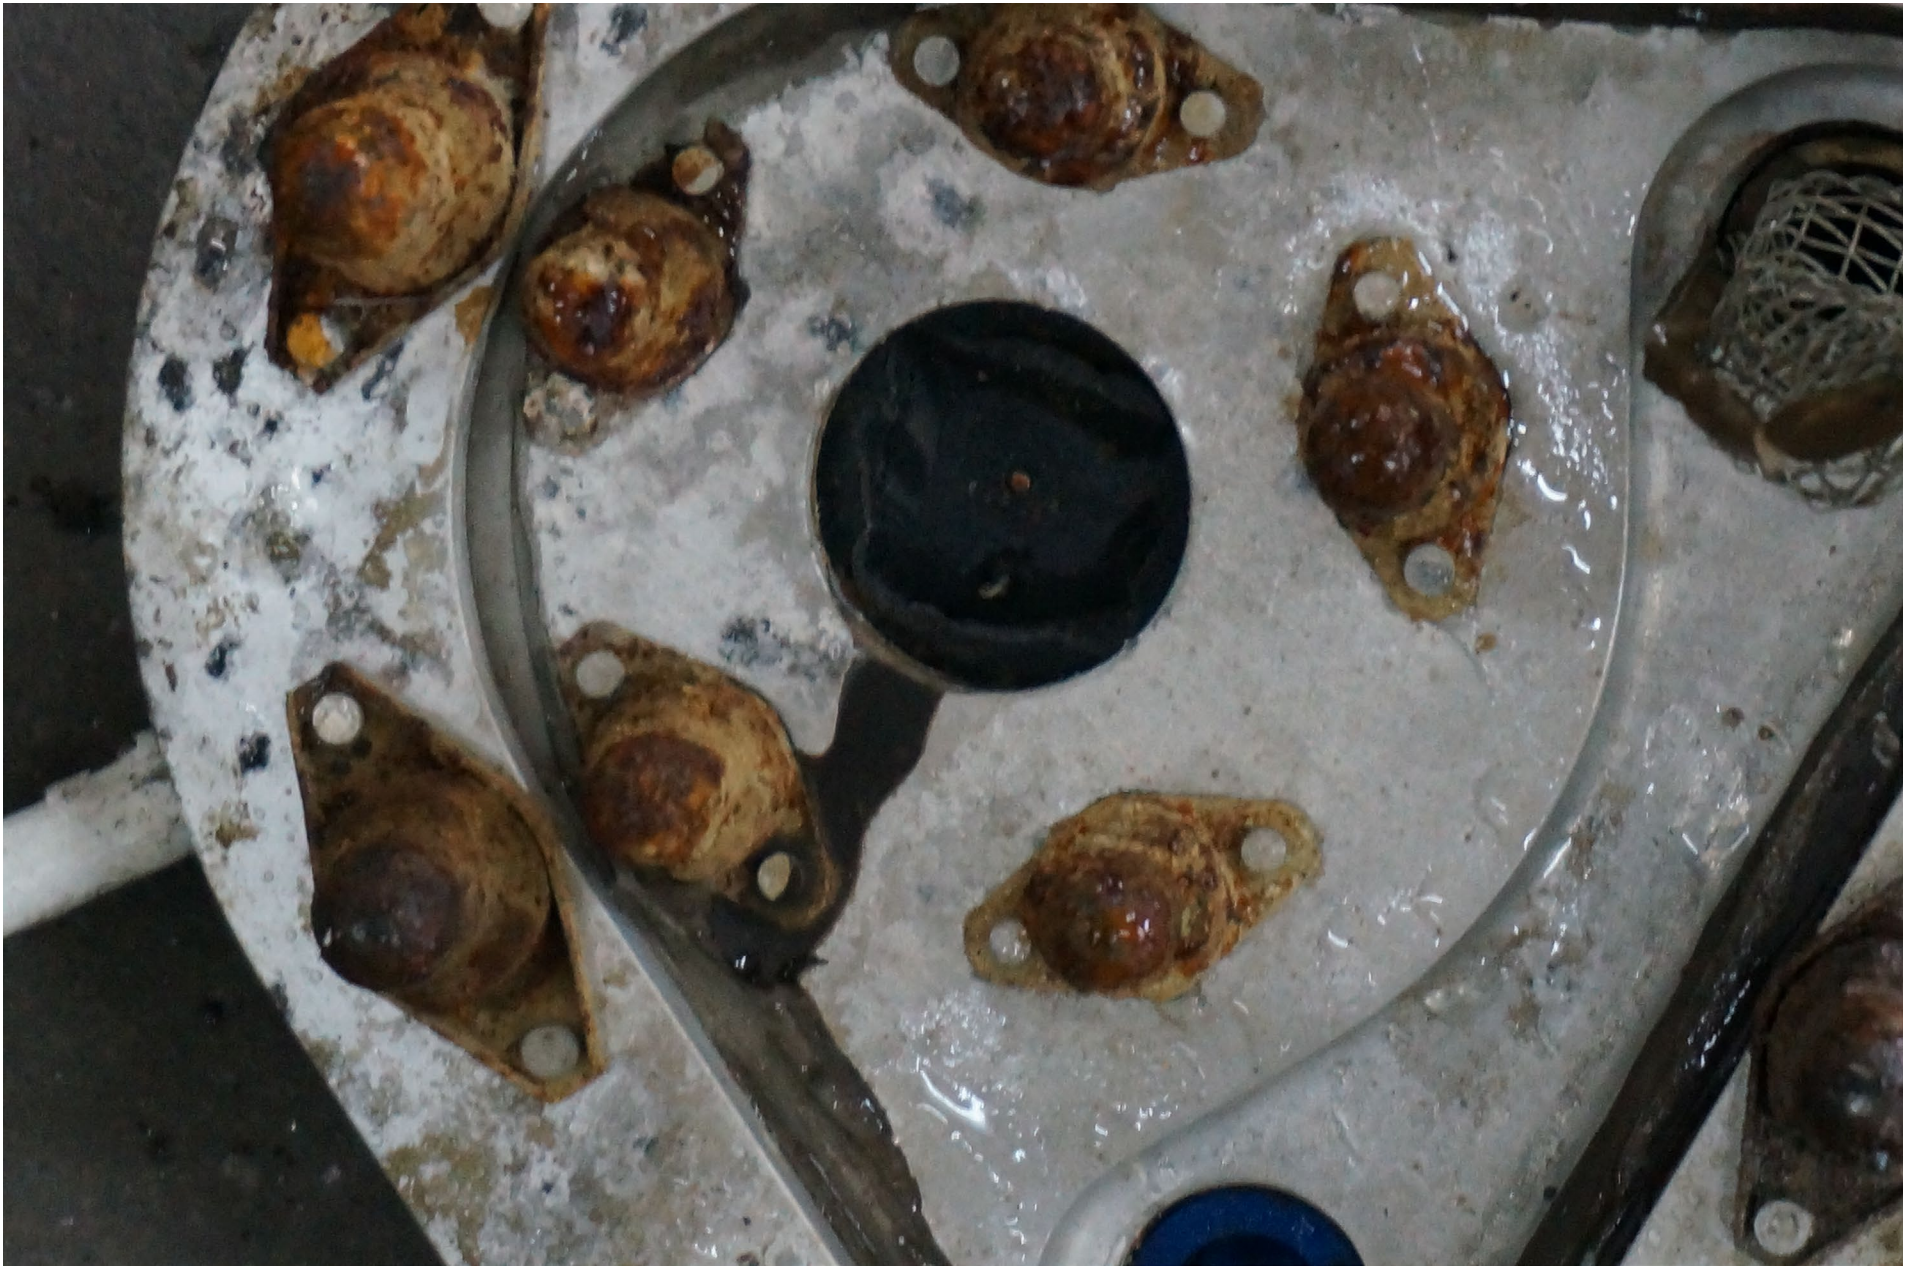
**Photo 19 – Close Up of Fuel Tank Sump Flange (Probe Side)**

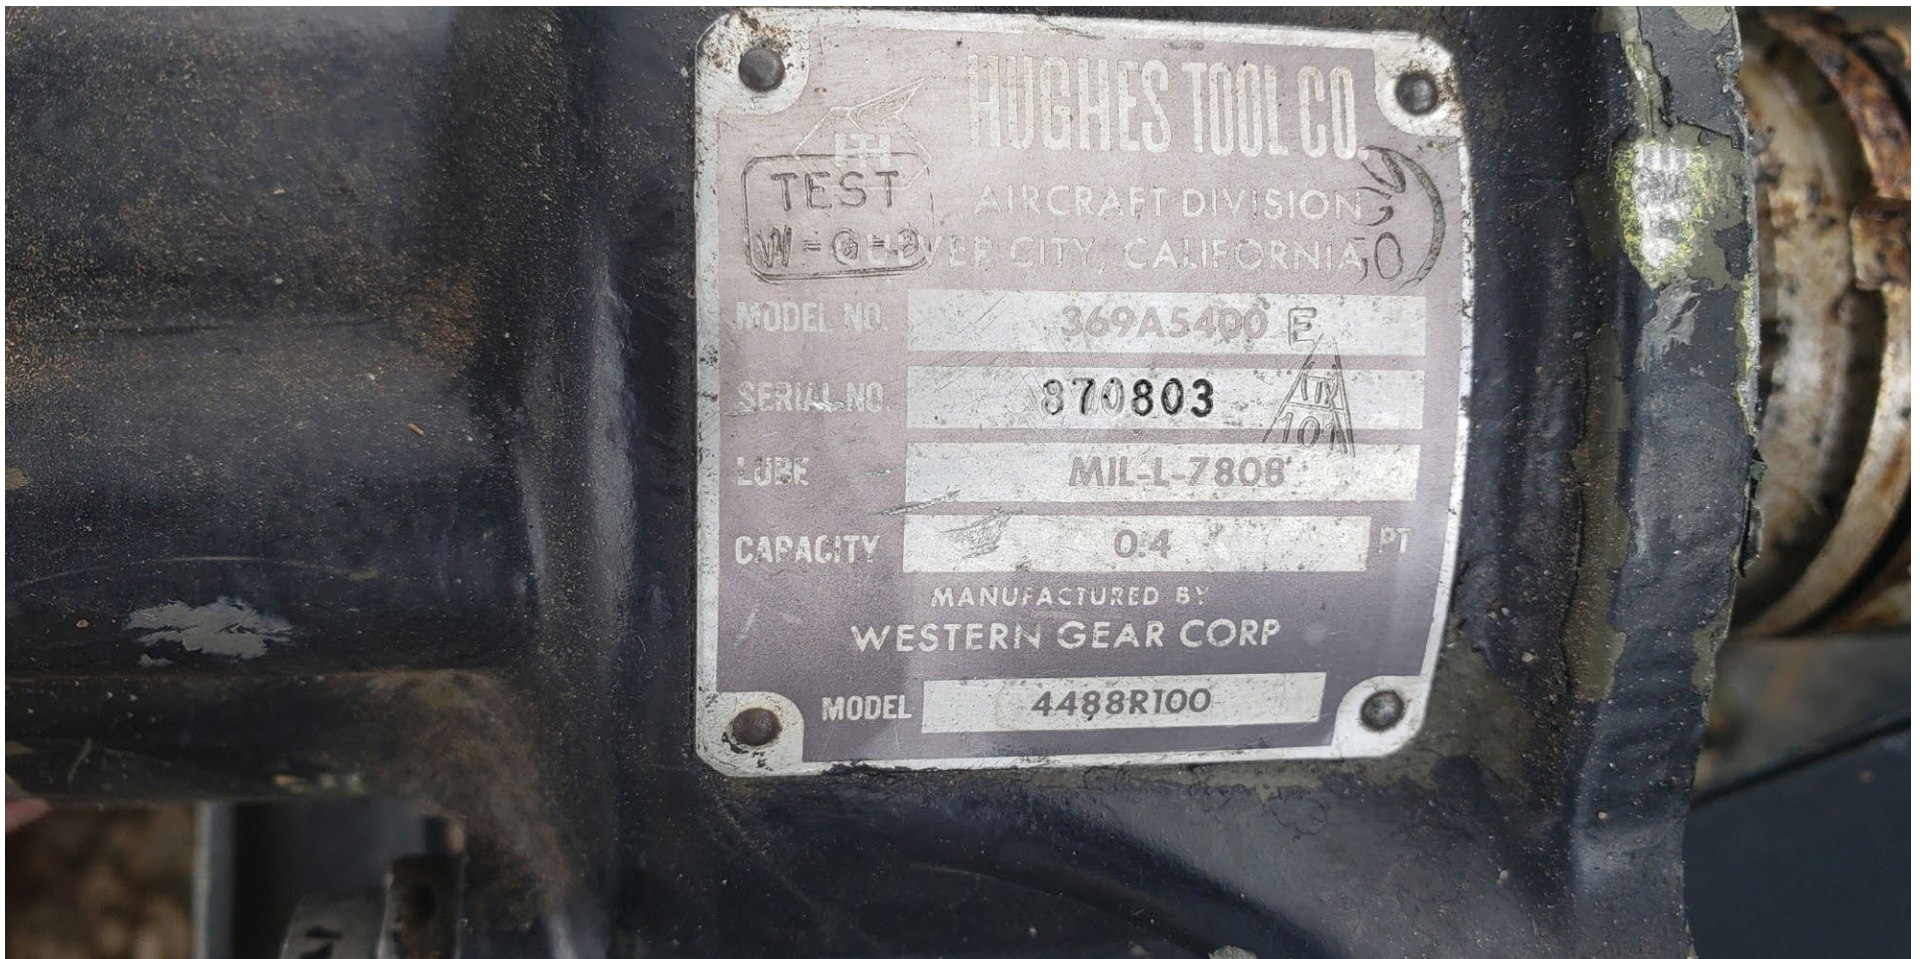
Photo 20 – Tail Rotor Gearbox Data Plate
