On June 15, 2020, Inspectors Brad Gottschalk, Daniel Butler, Joseph Kraus, and Neal Thorne from Memphis Flight Standards District Office (FSDO), CE-21 and Inspector Angela Kachinski from Nashville FSDO, CE-19 observed Mr. Chris Ferraraccio of Wingnuts Aviation in the evaluation of an IO360 Engine which was installed on N6989P. The observation took place at Springfield, TN (M91). During the debrief, we all agreed that one pre-impact anomaly was noted concerning fuel sampled at various locations described below in the fuel system comments.

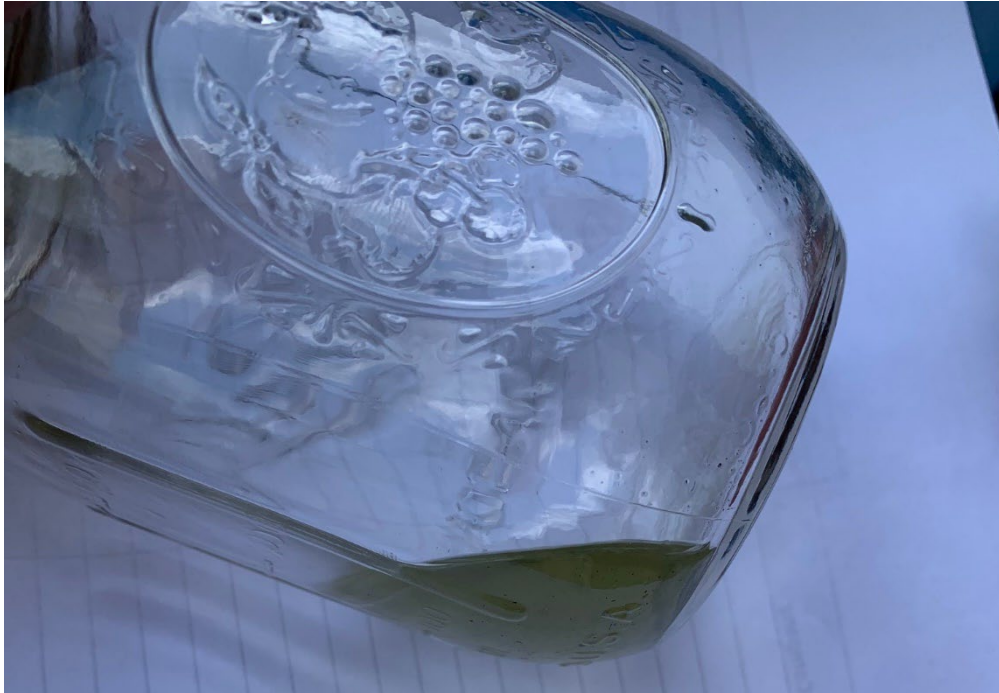
No visible damage was noted to any fuel system component. The cockpit controls for throttle, mixture, and alternate air were operated and verified from stop to stop. A fuel sample was obtained from the carburetor bowl which displayed a cloudy [green/yellow] tint. A second fuel sample obtained from the fuel supply hose was clear liquid with a blue tint. A third sample obtained from the main gascolator sump was clear with blue tint. The electric boost pump powered on and pumped liquid. The

**Photograph 1 – Fuel sample #1 – obtained from carburetor bowl.**

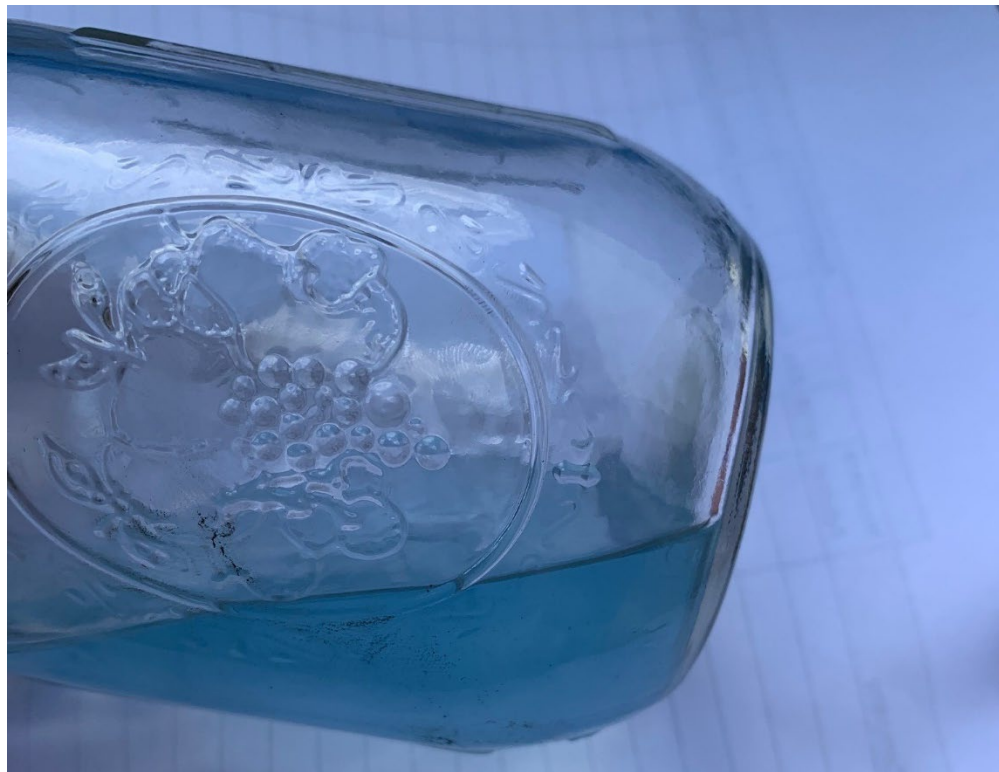
**Photograph 2 – Fuel sample #2 – obtained from fuel supply hose.**
