# NATIONAL TRANSPORTATION SAFETY BOARD

## MATERIALS LABORATORY FACTUAL REPORT

Report No. 21-043

Place : San Juan, Puerto Rico  
Date : June 2, 2020  
Vehicle : Piper PA-23-250, N14181  
NTSB No. : ERA20LA202  
Investigator : Timothy Monville, AS-ERA

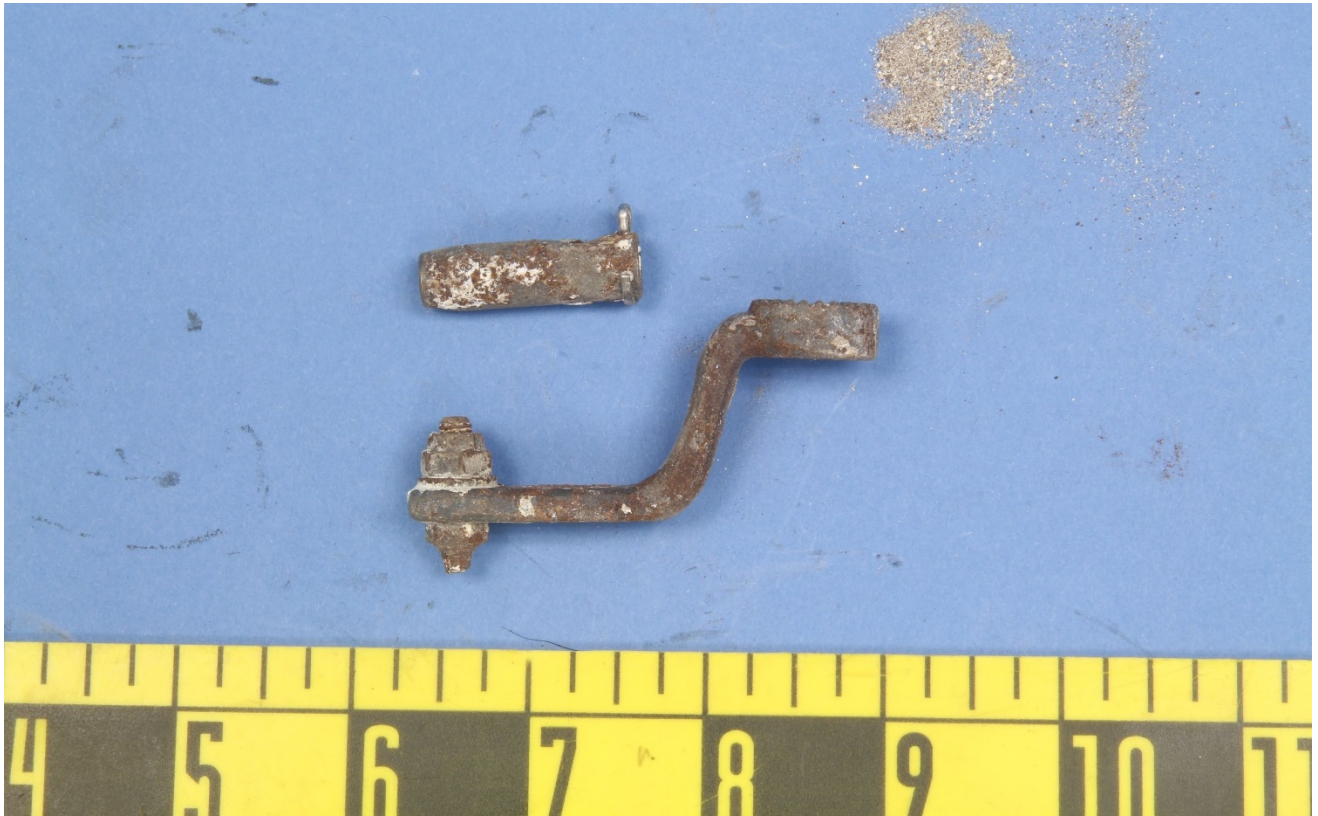
Two pieces from the left engine throttle connection from the airplane were received by the NTSB Materials Laboratory, as illustrated in Figure 1. The positions shown in Figure 1 do not correspond with the support positions on the aircraft prior to sectioning. The throttle connection assembly consisted of remnants of the throttle lever attached to a fractured ball screw (Figure 2) and a spring type joint assembly ball.

Figure 1 – The pieces from the throttle connection, as received. Also included was an amount of dust and sand debris.

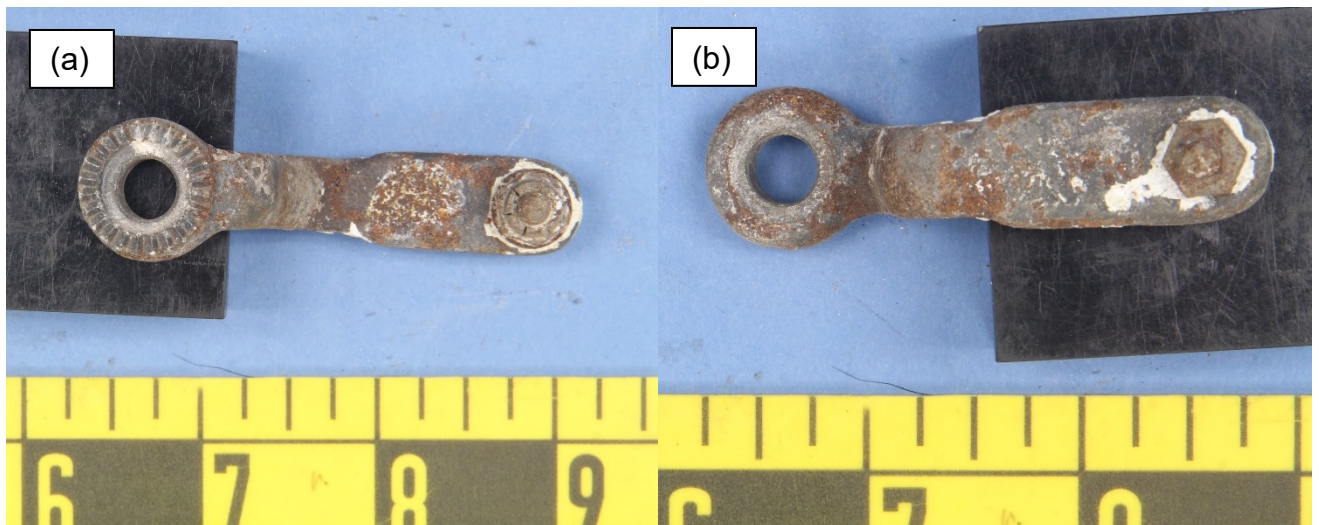
Figure 2 – The throttle lever, viewed from (a) the face with the threaded portion of the ball screw with the nut, and (b) the face with the fractured ball screw neck.

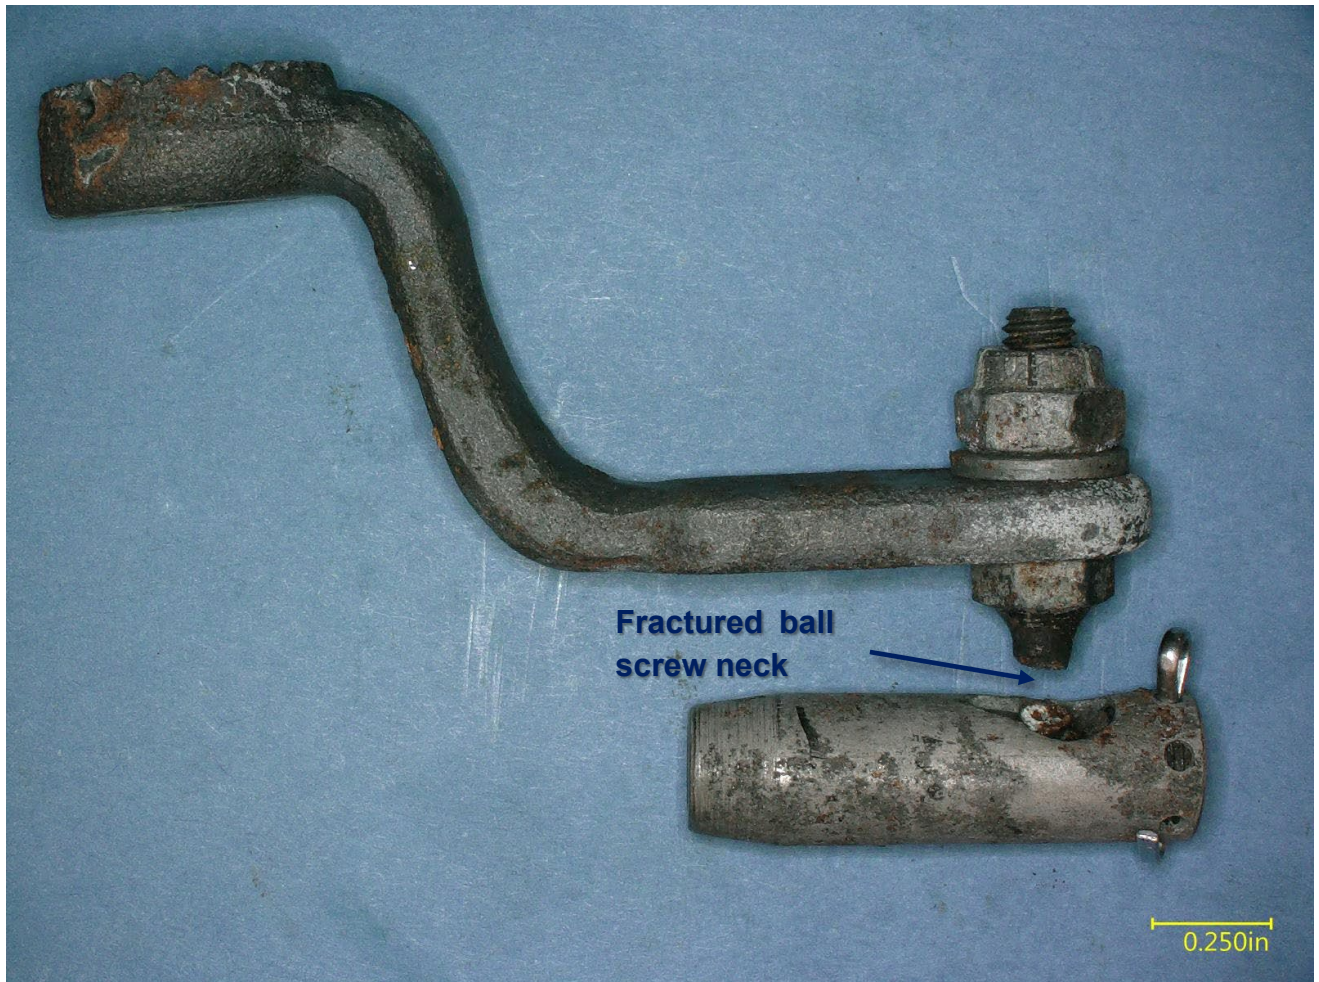
As illustrated in Figure 3, the ball screw assembly and throttle lever were joined by a threaded ball screw. This piece had fractured along the neck parallel with the outer shell surface at the opening on the bottom of Figure 3. The threaded portion of the ball screw was still affixed to the throttle lever by a washer and nut. The spherical head of the ball screw was held in place by the internal pressure of a spring and an adjusting screw, locked in by a cotter pin.

Figure 3 – Side view of the throttle lever and the ball joint assembly shell remnants, approximately positioned at the time of fracture of the ball screw.

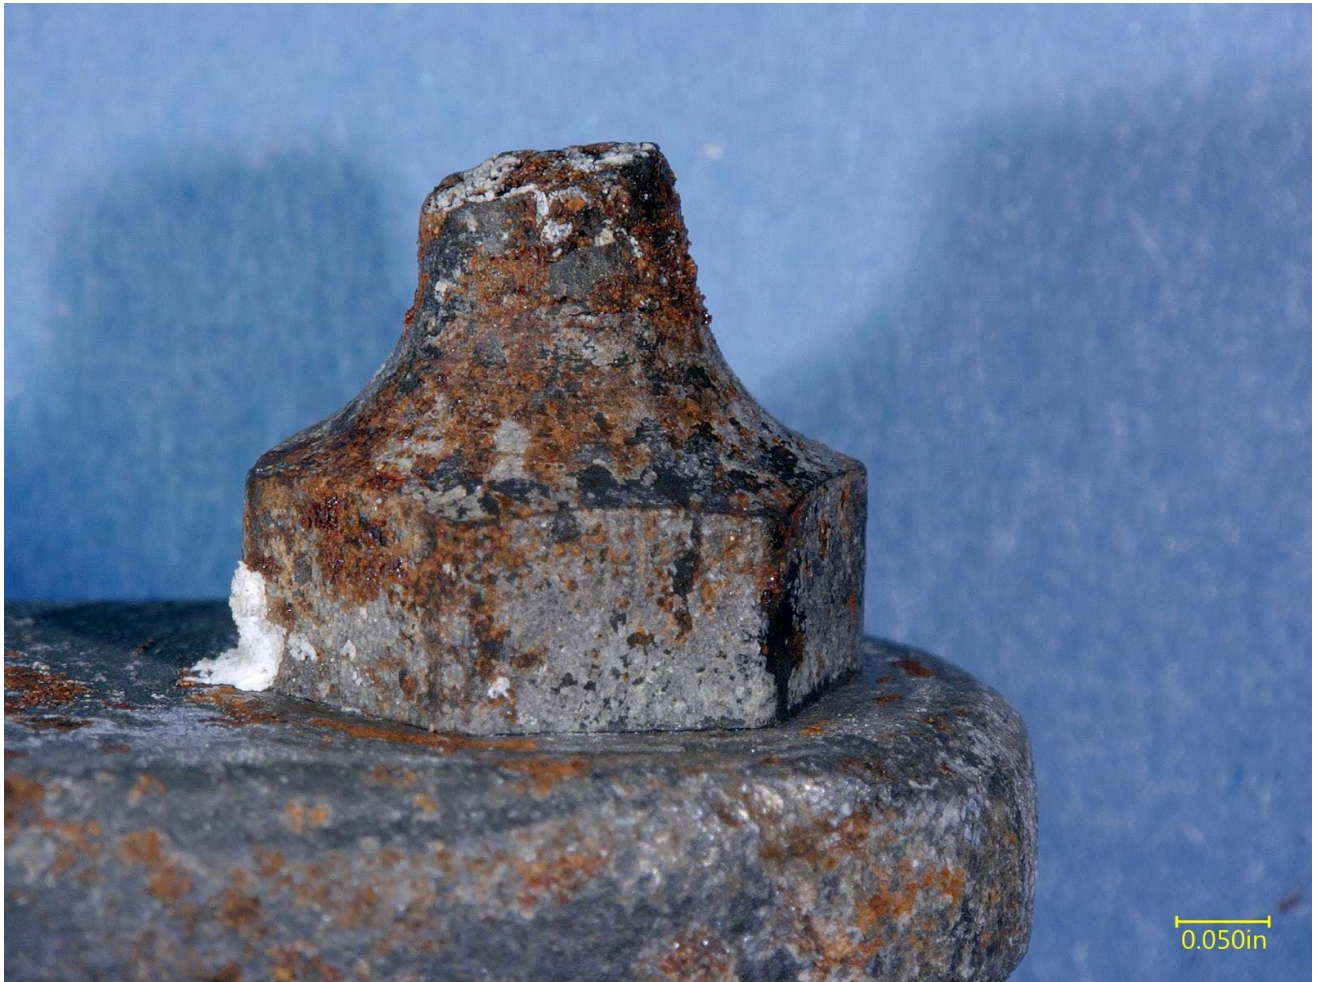
Figure 4 shows a closer view of the side of the fractured neck of the ball screw remnant, viewed from the arm side. As shown in this figure, as well as other figures in this report of the remnants in the as-received condition, all the surfaces were covered with flaky, dark brown compounds, consistent with iron oxide. The surfaces also exhibited brittle white compounds and dull gray material. These compounds were found to be consistent with salt deposits from exposure to marine environments.

Figure 4 – Side view of the fracture surface of the ball screw remnant, still connected to the throttle lever, as received.

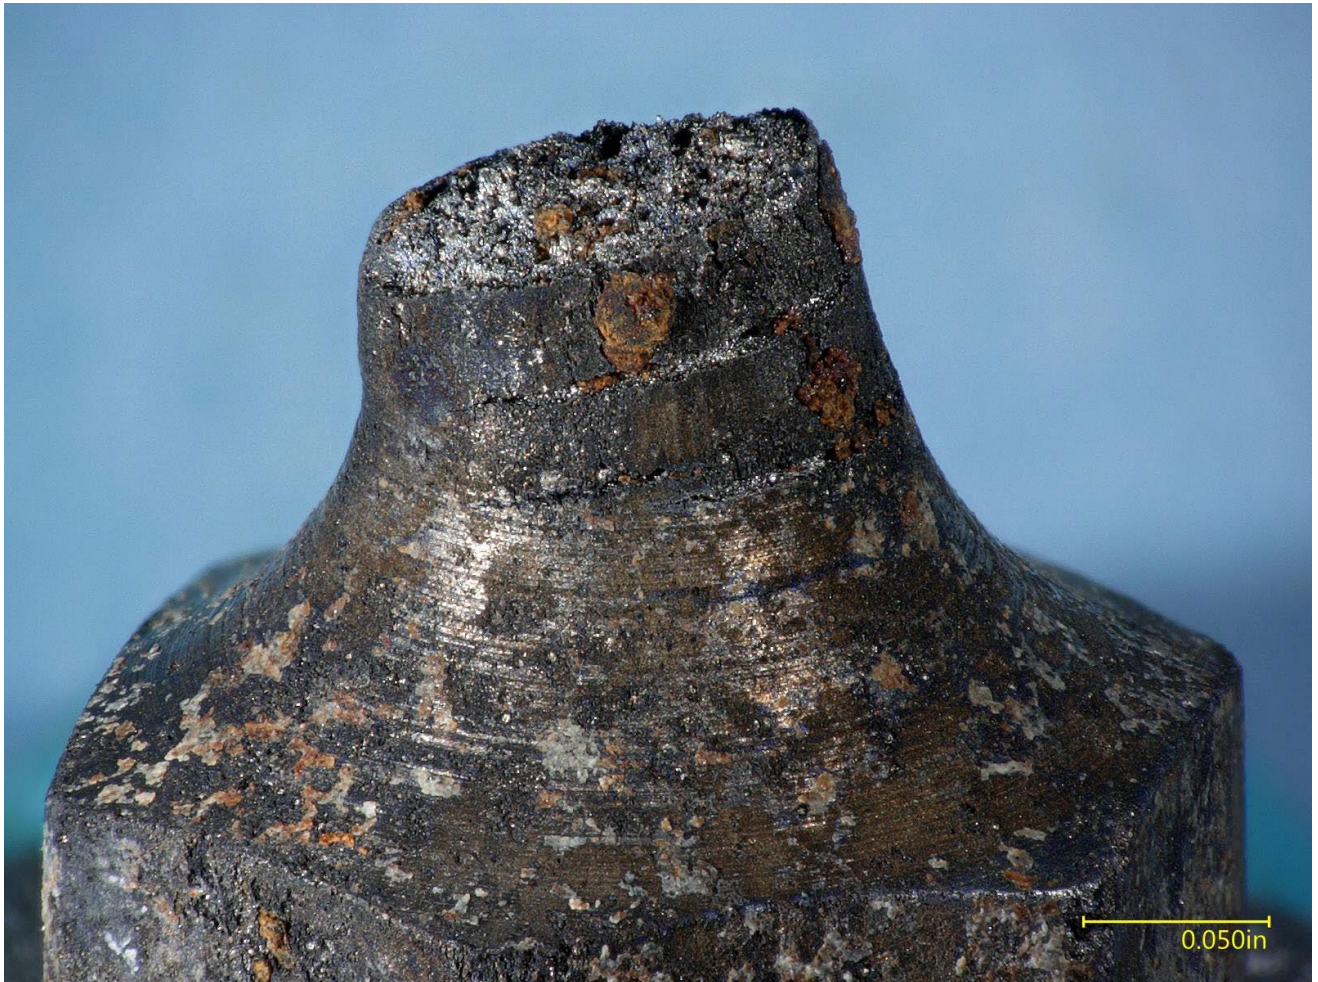
To be examined, these remnants, and particularly the fracture surfaces, were cleaned using acetone in an ultrasonic cleaner. Figure 5 shows the same fractured neck of the ball screw, after cleaning. The fracture surface is visible, with a general orientation perpendicular to the neck direction. The fracture surface and neck were angled toward the direction of the throttle lever. On the opposite side, three semicircular cracks or tears were visible, parallel to the fracture surface and facing away from the throttle lever. These features were consistent with localized deformation from bending, with the tension side having been characterized by parallel cracks (facing the reader in Figure 5), and the compression side exhibiting localized buckling.

Figure 5 – The ball screw neck fracture from Figure 4, after cleaning, showing parallel secondary cracks and a general deformation of the neck.

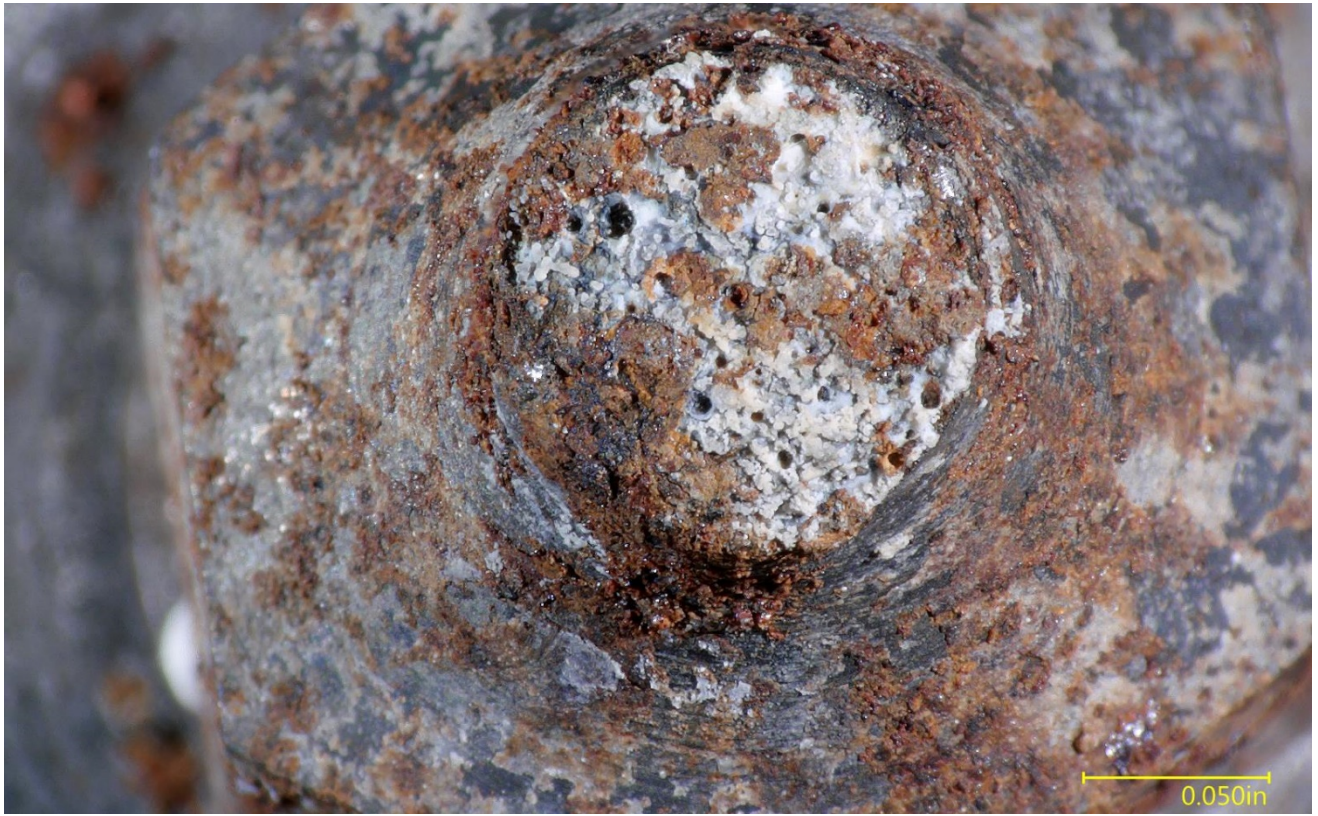
Figure 6 shows a planar view of the fracture surface from the threaded side of the ball screw remnant, as received. This figure demonstrated the degree of salt deposits and corrosion products present on the fracture surface. After cleaning, the fracture surface appeared as shown in Figure 7. The fracture surface was generally rough in texture, with a dull, gray luster. The periphery of the fracture surface appeared more reflective than the interior, with a flatter appearance. This area is demarcated with a dashed yellow circle in the figure.

Figure 6 – View of the fracture surface of the ball screw neck from the throttle lever side, as received.

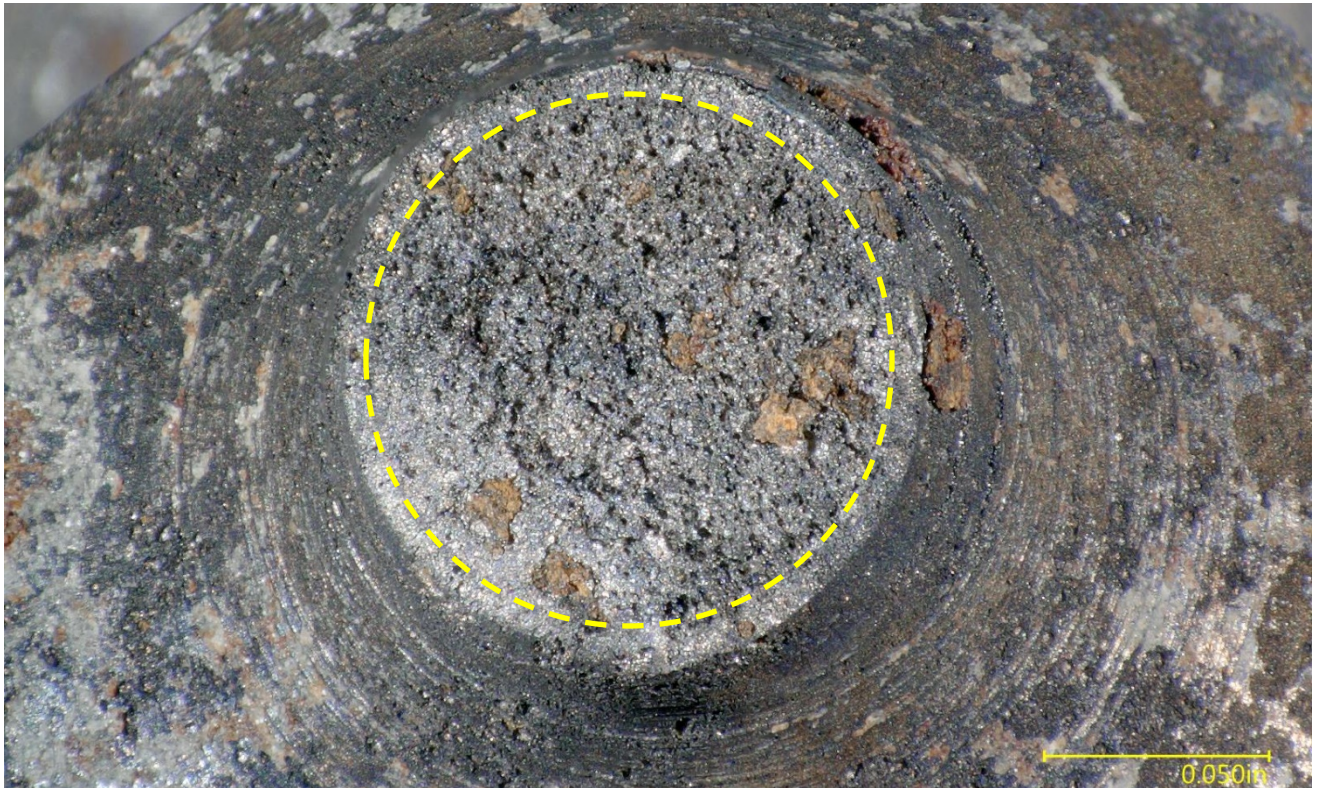
Figure 7 – View of the throttle lever side ball screw neck fracture surface, after cleaning. The dashed oval represents the different fracture regions on the surface.

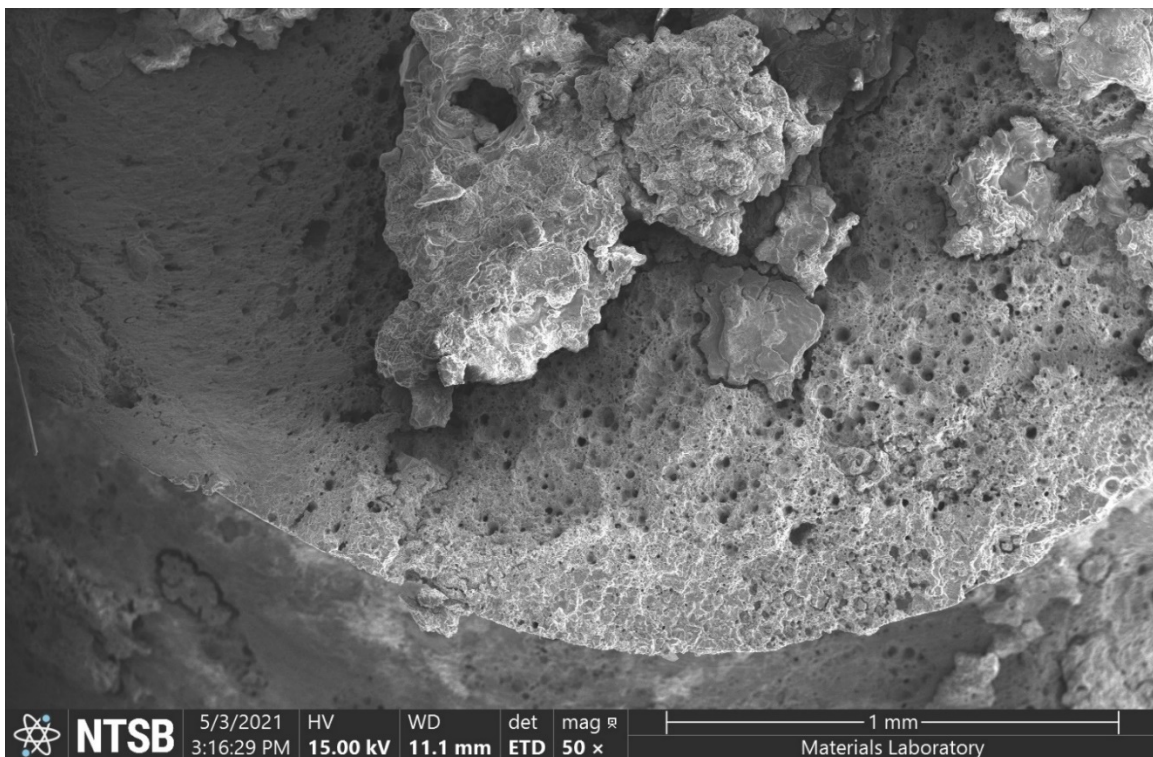
This fracture surface in Figure 7 was examined using a scanning electron microscope (SEM). A typical area of an edge of the fracture surface is shown in Figure 8. Even after cleaning, much of the surface remained contaminated with post-fracture deposits—these compounds were nonconductive, which manifested as noise in the SEM micrographs.

Figure 8 – Secondary electron (SE) micrograph of a portion of the neck fracture surface.

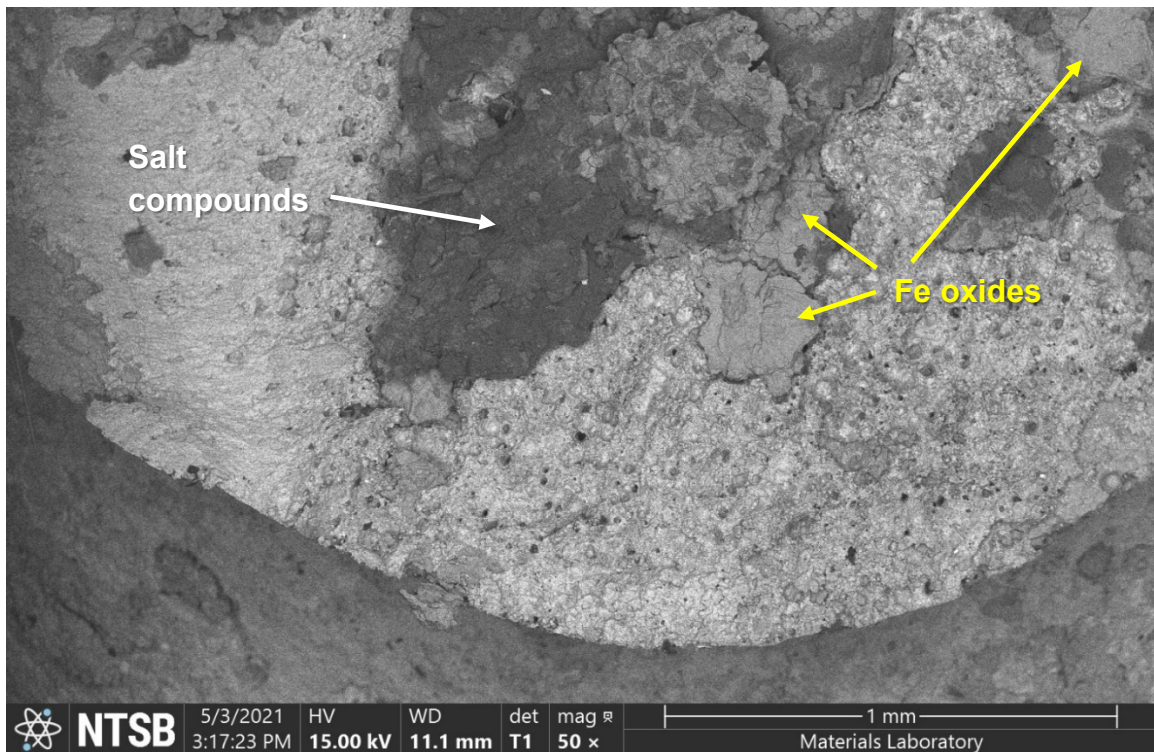
In backscattered contrast, these compounds generally exhibited a darker color, consistent with salts and iron oxides.<sup>1</sup> Figure 9 is annotated to show these compounds, identified using energy dispersive x-ray spectroscopy (EDS). The salts contained Mg, Ni, Cl, and Br, along with other trace elements. The bare fracture surface exhibited a composition consistent with mild or carbon steel. The surface exhibited a high Cd content, consistent with a cadmium coating.

Figure 9 – Backscattered electron (BE) micrograph of a portion of the fracture surface in Figure 8.

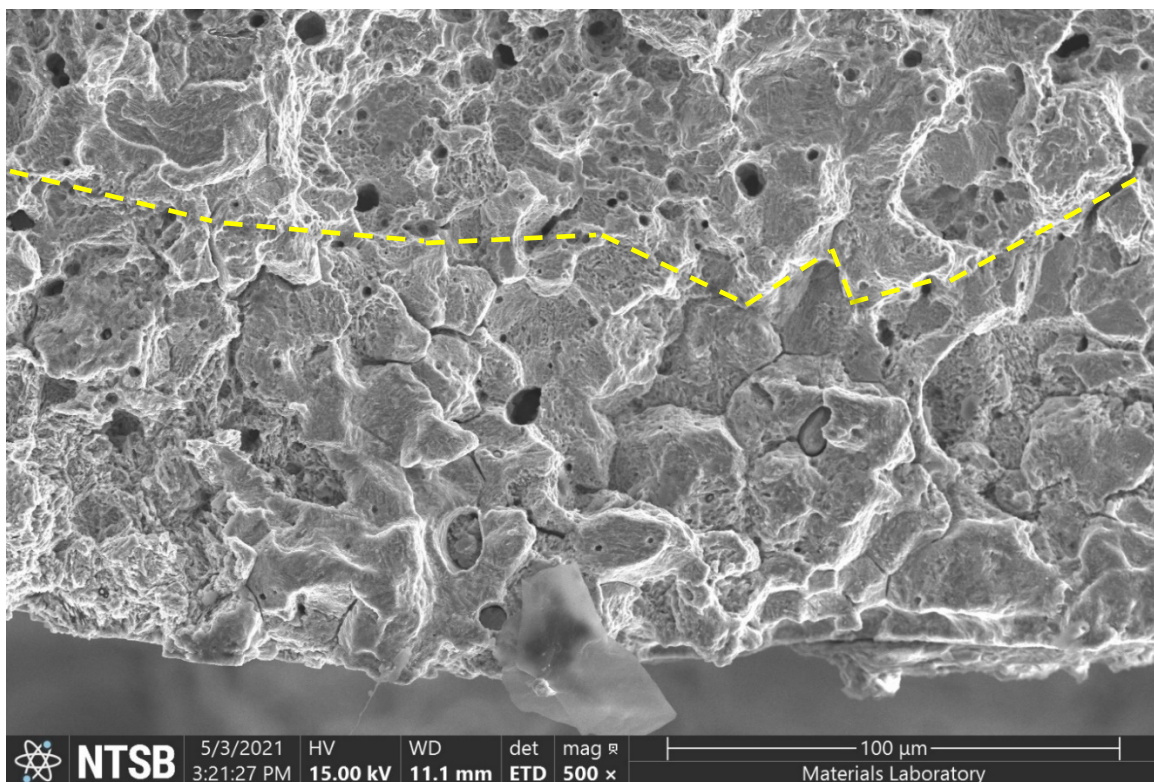
Looking again at the edge of the fracture surface, one can discern a contrast in fracture features between the outer and inner regions. Figure 10 shows a closer view of these different features, annotated with a dashed yellow line to highlight the transition. Figure 11 shows a typical view of the interior features. While damaged from removal of

The outer regions exhibited features typified in Figures 12 and 13. These showed the faceted flat characteristics of crystalline grains, consistent with intergranular fracture. The intergranular fracture was only present on the outer regions of the fracture surface. As illustrated in Figure 10, this outer region was approximately 0.004 inches (100  $\mu\text{m}$ ) in depth.

Figure 10 – SE micrograph of the edge of the fracture surface, showing two regions of different fracture features (dashed line).

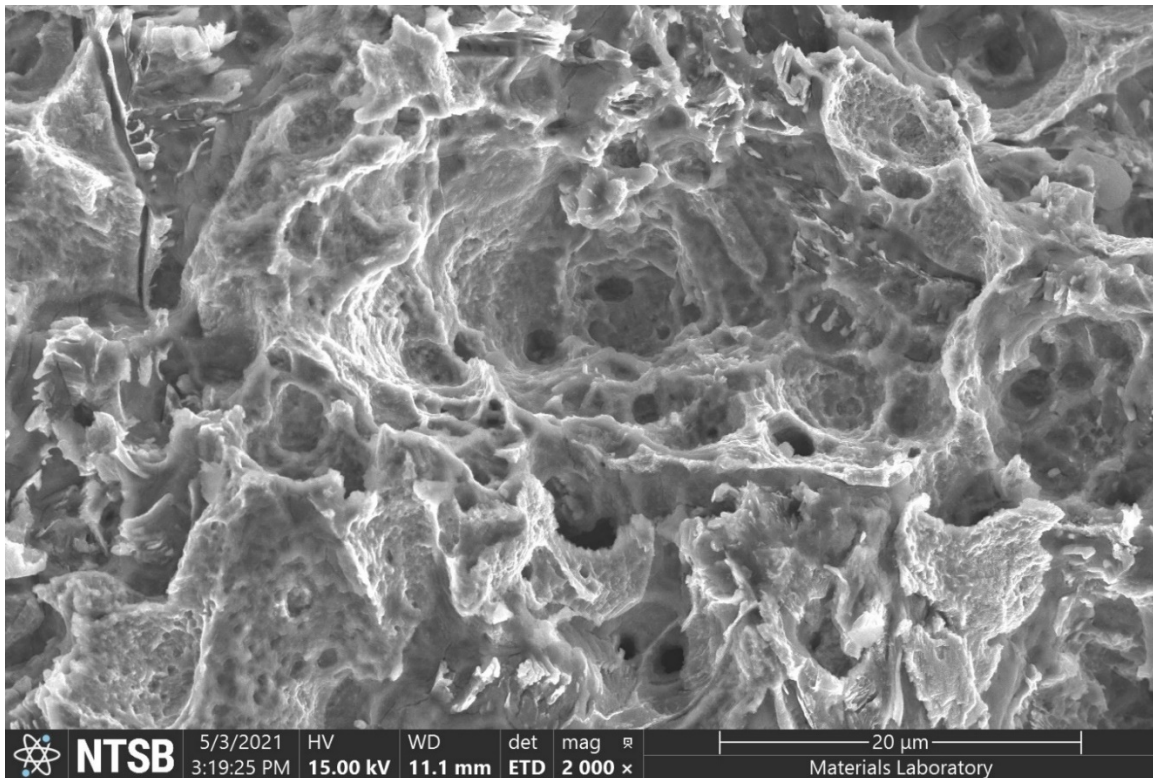
the surface oxides and salts shown in Figure 6, the surface still exhibited a morphology consistent with dimpled rupture. These features were consistent with ductile overstress fracture.

Figure 11 – SE micrograph of the inner fracture surface regions, showing dimpled rupture.

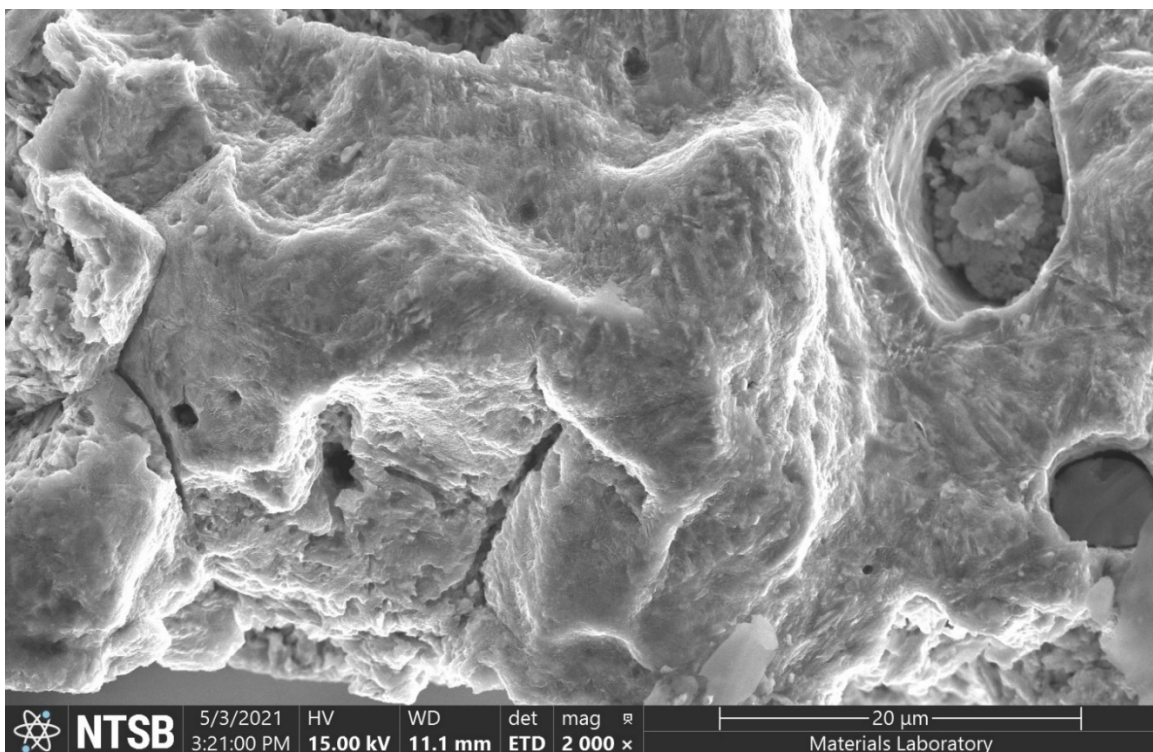
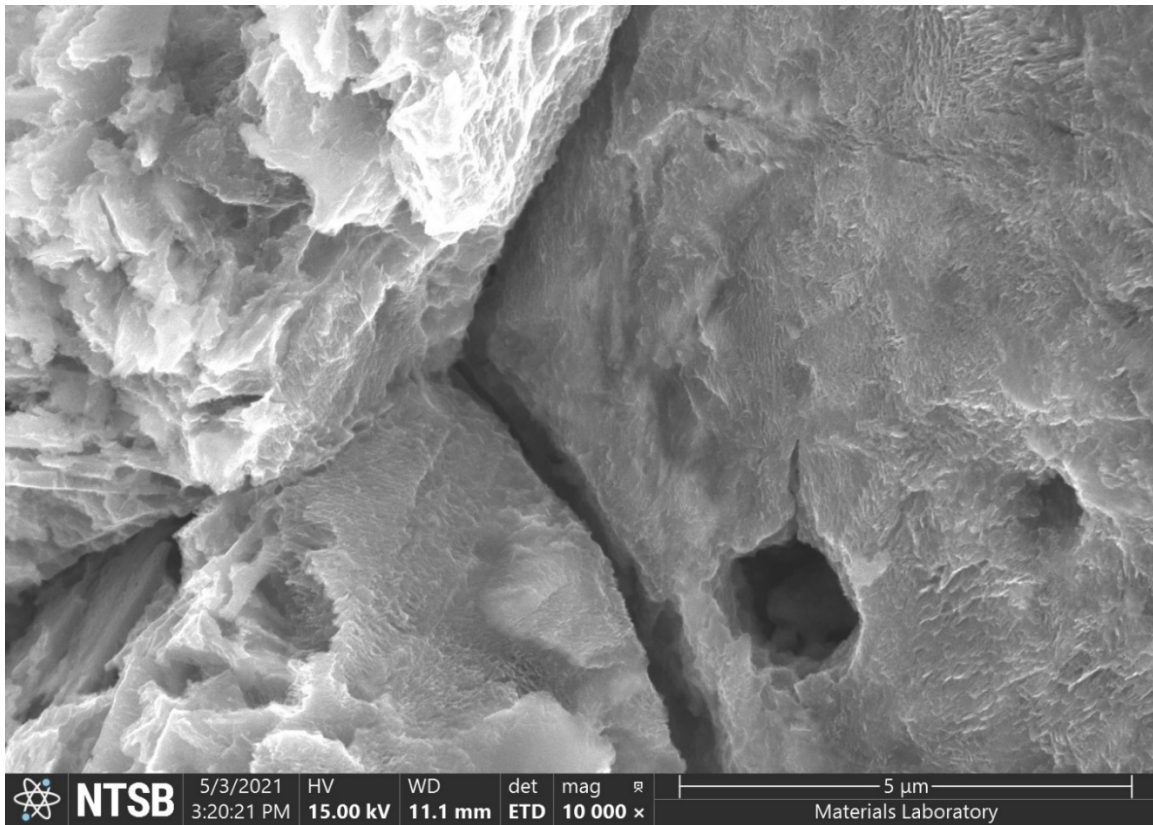
Figure 12 – SE micrograph of the outer fracture features, showing intergranular fracture.

Figure 13 – SE micrograph of a closer view of the intergranular fracture in Figure 12.

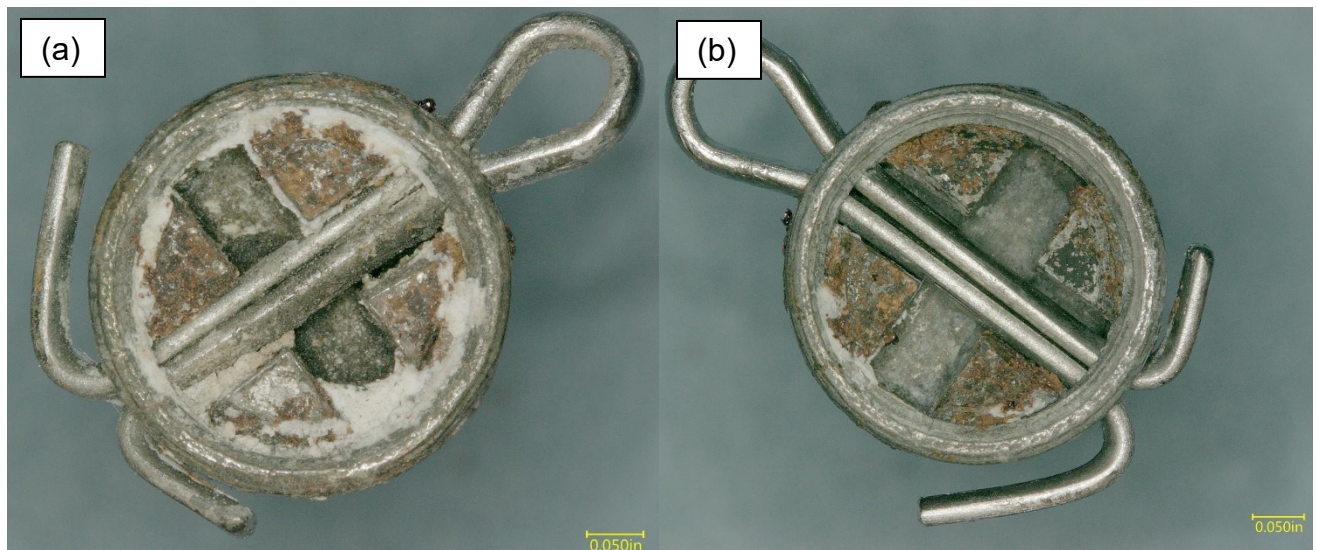
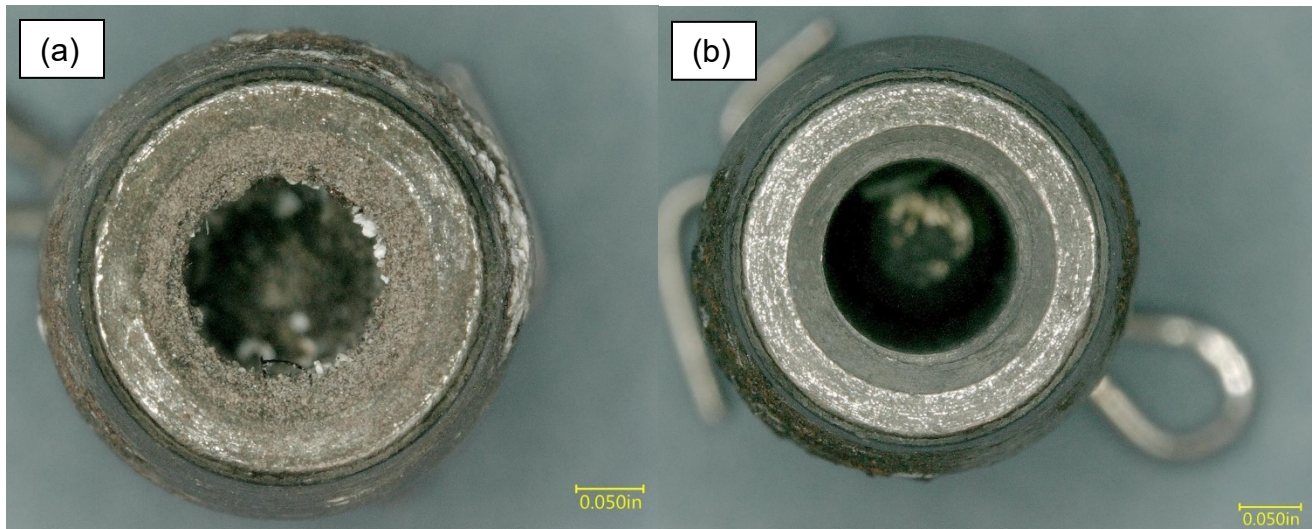
Figures 14a and 15a show the faces of the ball joint assembly shell as received, and Figures 14b and 15b show the same faces after cleaning with acetone. The side of the shell assembly with the ball screw fracture surface facing the reader is illustrated in Figure 16, as received. Like the mating surface on the throttle lever, this fracture surface was completely covered in corrosion compounds and salt deposits (see Figure 17).

Figure 14 – View of the cotter pin side of the ball joint assembly remnant (a) before and (b) after cleaning.

Figure 15 – View of the opposite side of the ball joint assembly from Figure 14, (a) before and (b) after cleaning.

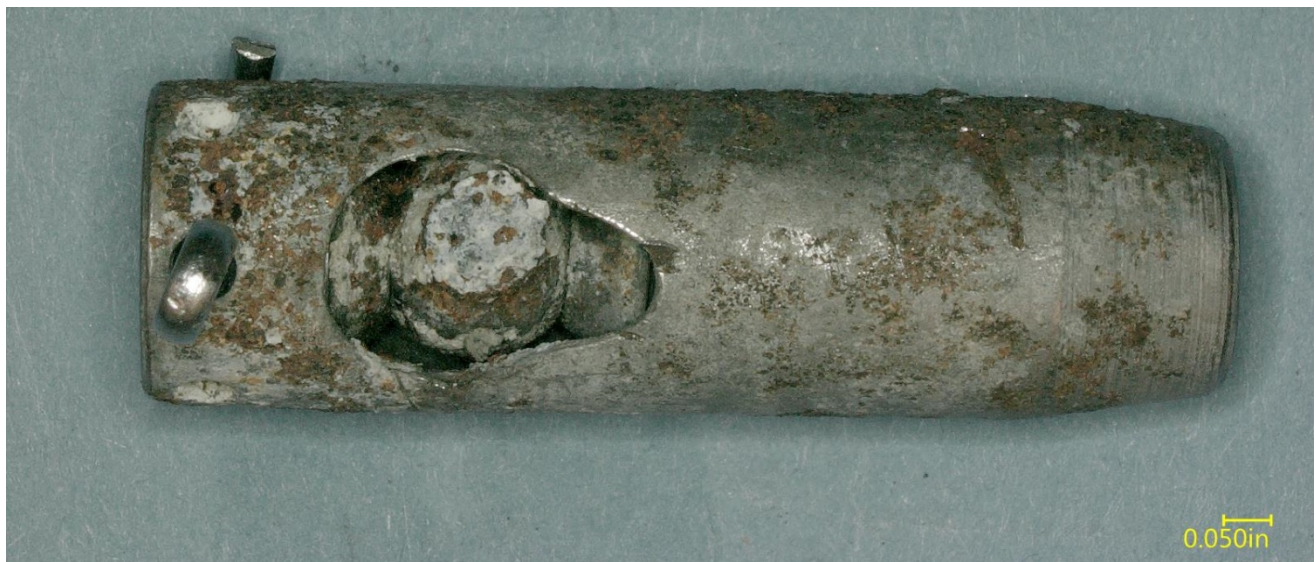
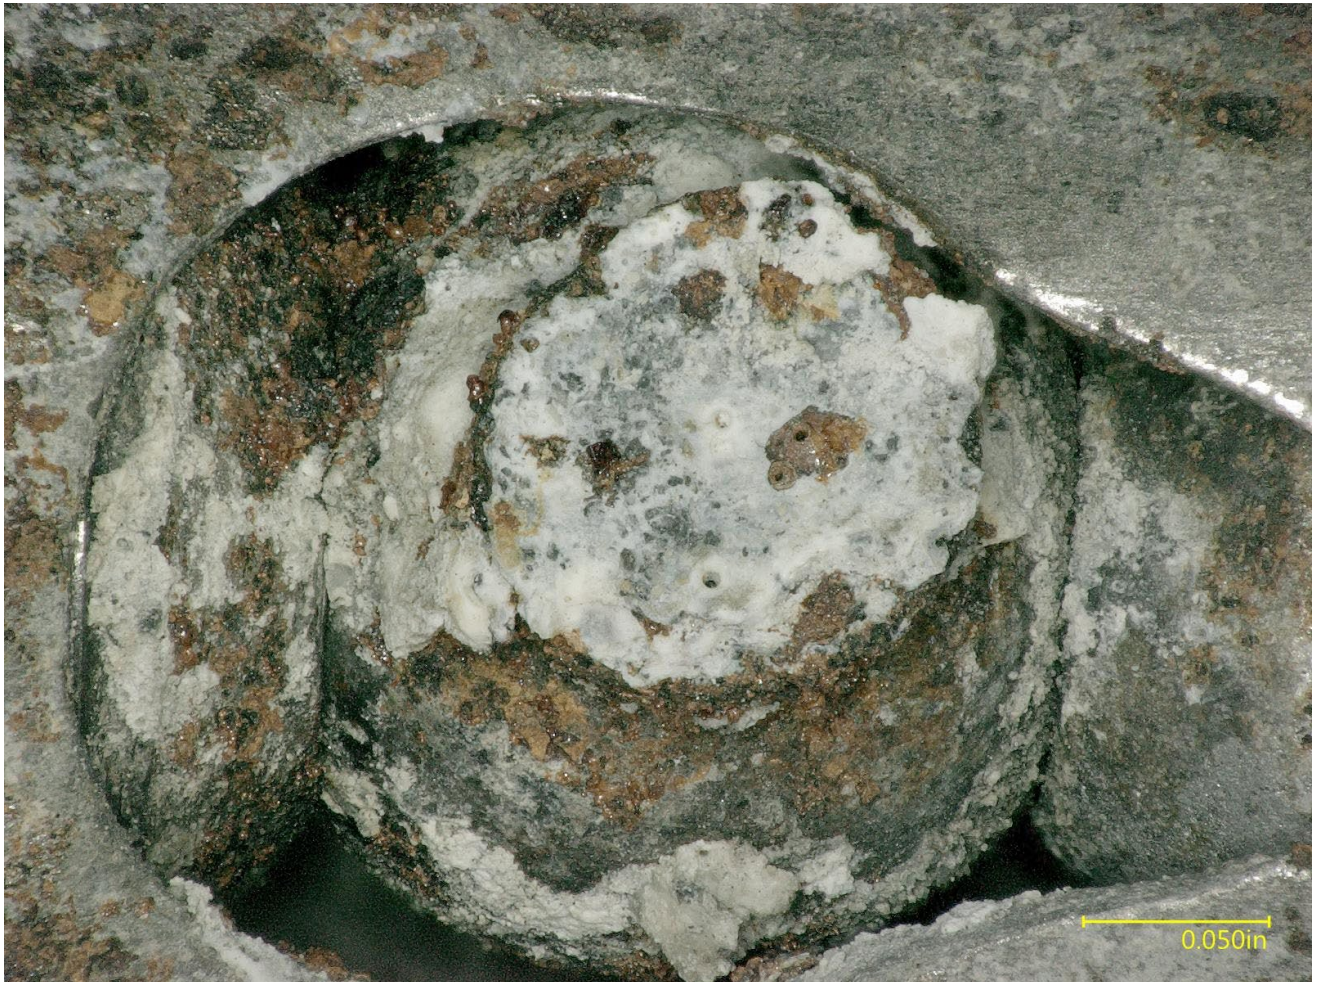
Figure 16 – View of the ball joint assembly remnant and the ball screw neck fracture surface, as received.

Figure 17 – Closer view of the ball screw neck remnant fracture surface, as received.

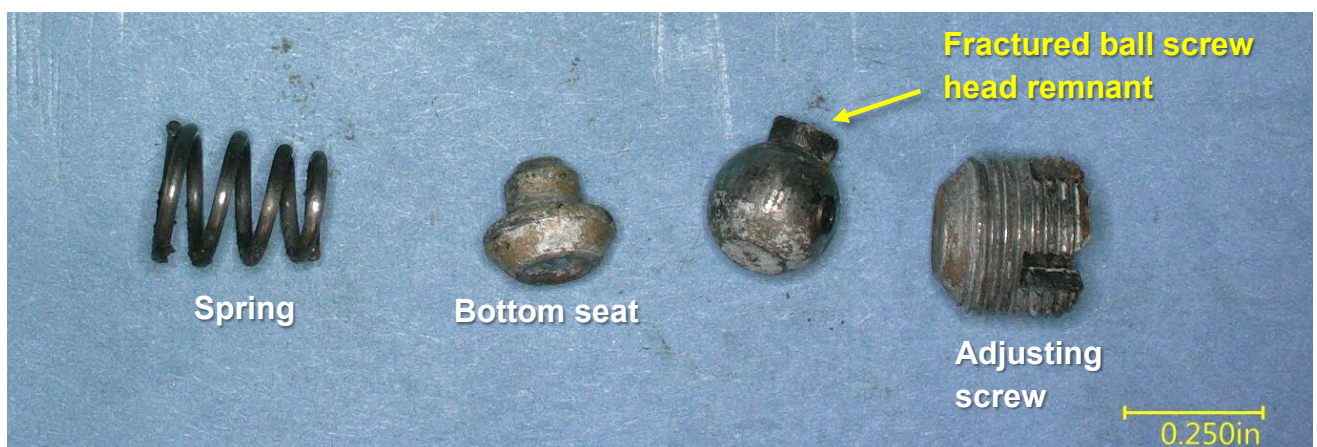
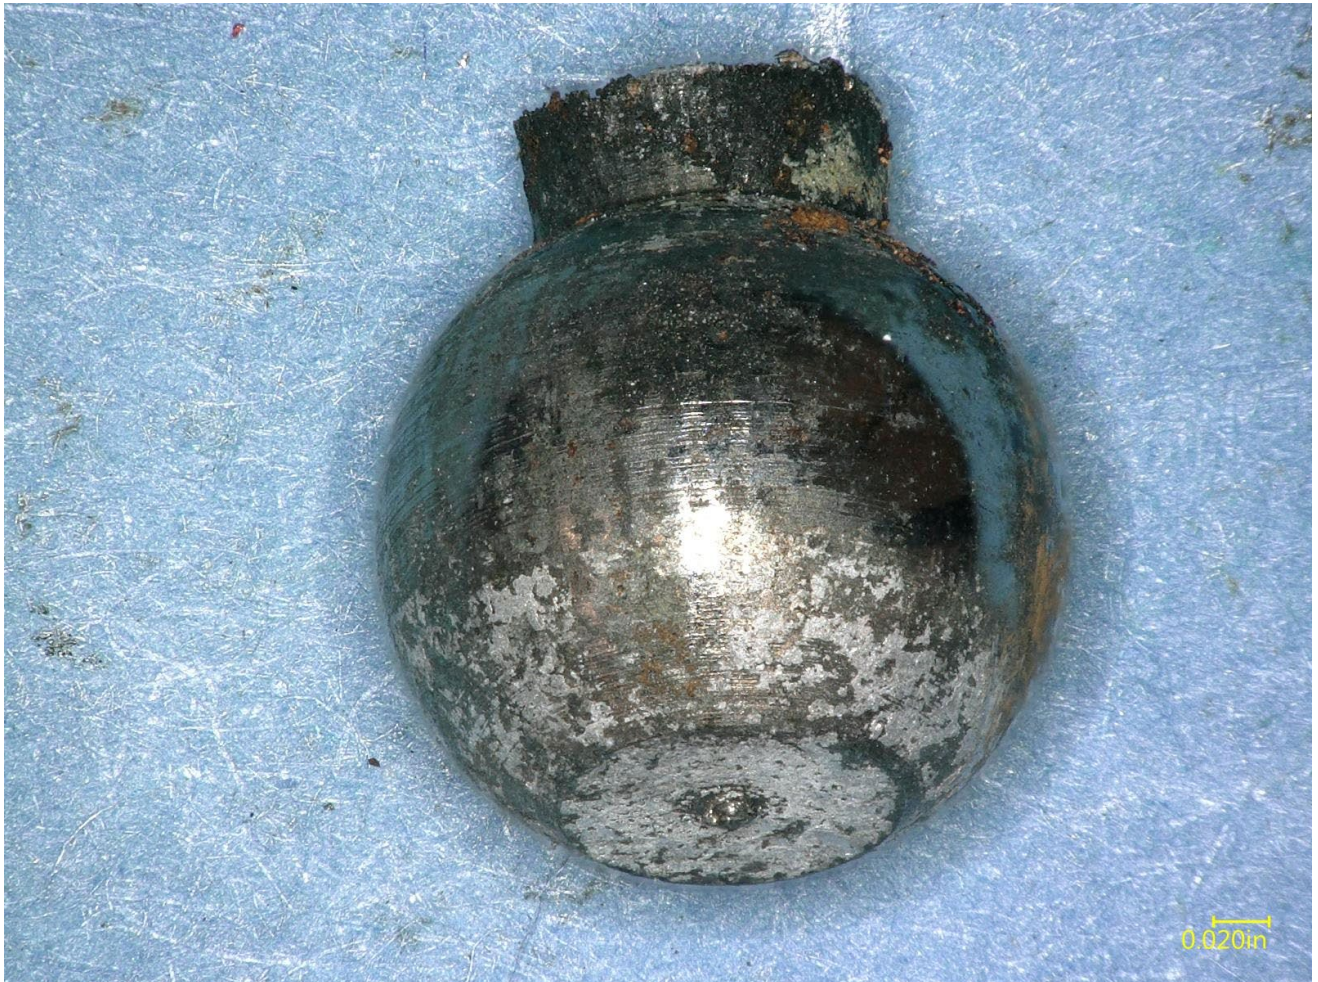
After cleaning with acetone, the cotter pin was removed, and the ball joint assembly was taken apart. Figure 18 shows the interior components of the ball joint assembly, which consisted of the spring, bottom seat, fractured remnants of the ball screw head, and the adjusting screw. Figure 19 shows a closer view of the side of the ball screw, after disassembly and cleaning. The fracture surface was oriented perpendicular to the neck direction, located approximately 0.05 inches above the ball to neck transition.

Figure 18 – View of the internal components from the ball joint assembly remnants after removal of the cotter pin and disassembly.

Figure 19 – Closer view of the head and fractured neck of the ball screw remnant from Figure 18, viewed from the side.

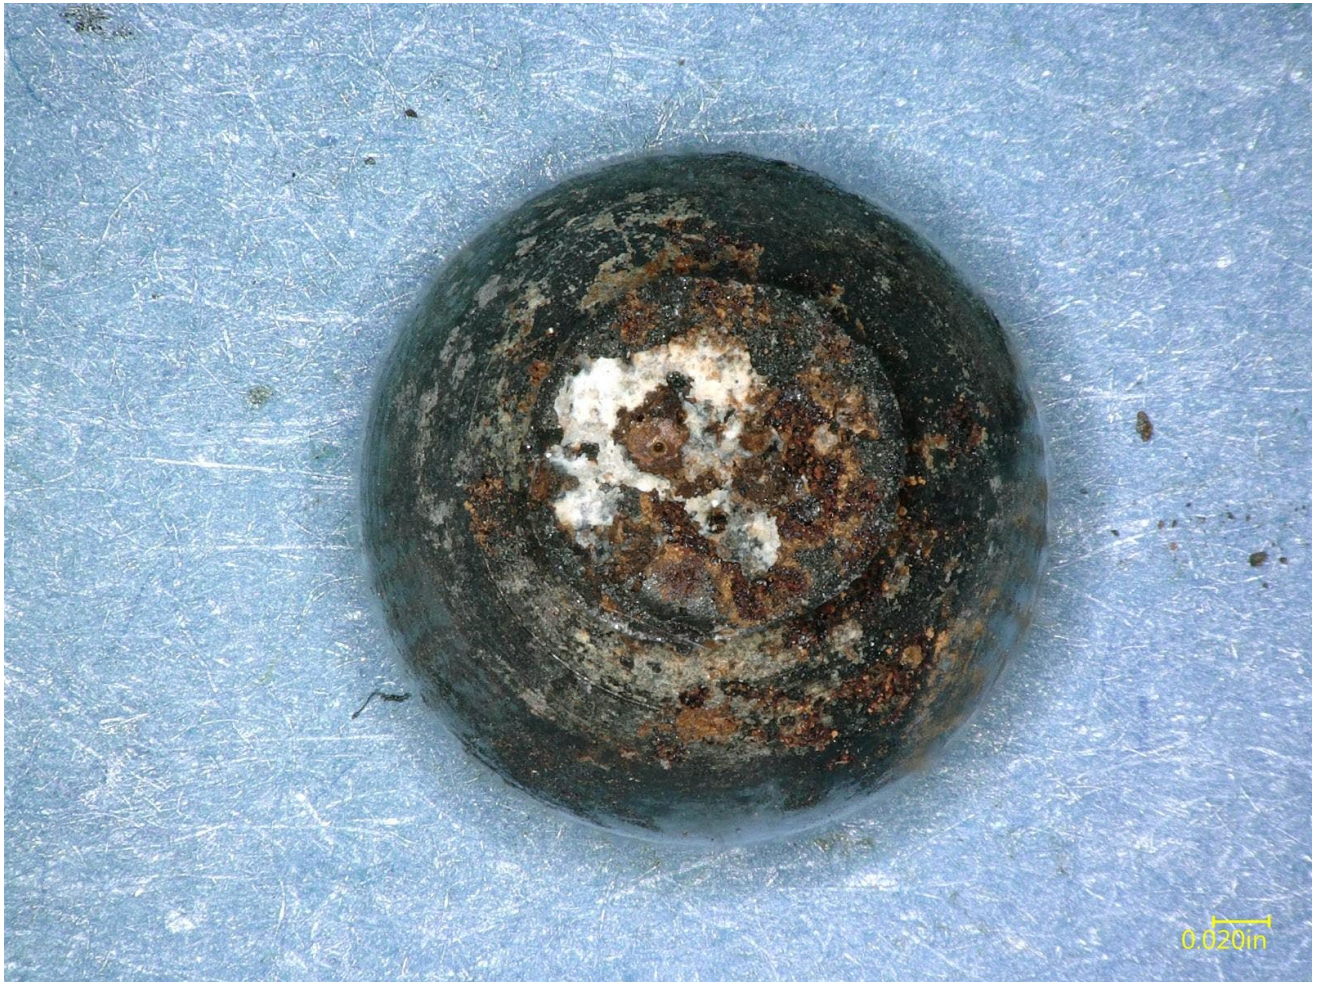
Figure 20 shows the ball side fracture surface, after cleaning. Due to the degree of post-fracture contamination, the surface had to be repeatedly cleaned. The removal of the salts and oxides left much of the fracture surface damaged. However, selected areas did exhibit discernible fracture features that could be observed using a SEM. Figure 21 shows a typical area of the interior of the fracture surface, revealing dimpled rupture. Figure 22 shows a typical outer area of the fracture surface, exhibiting intergranular fracture features. These features were consistent with those of the mating fracture surface from the lever side.

Figure 20 – View of the ball screw neck fracture surface from the head side, after cleaning.
